Inspection Photos

API: 011-06032

Operator: STRACHAN EXPLORATION INC

Inspection Date: 2/21/2024

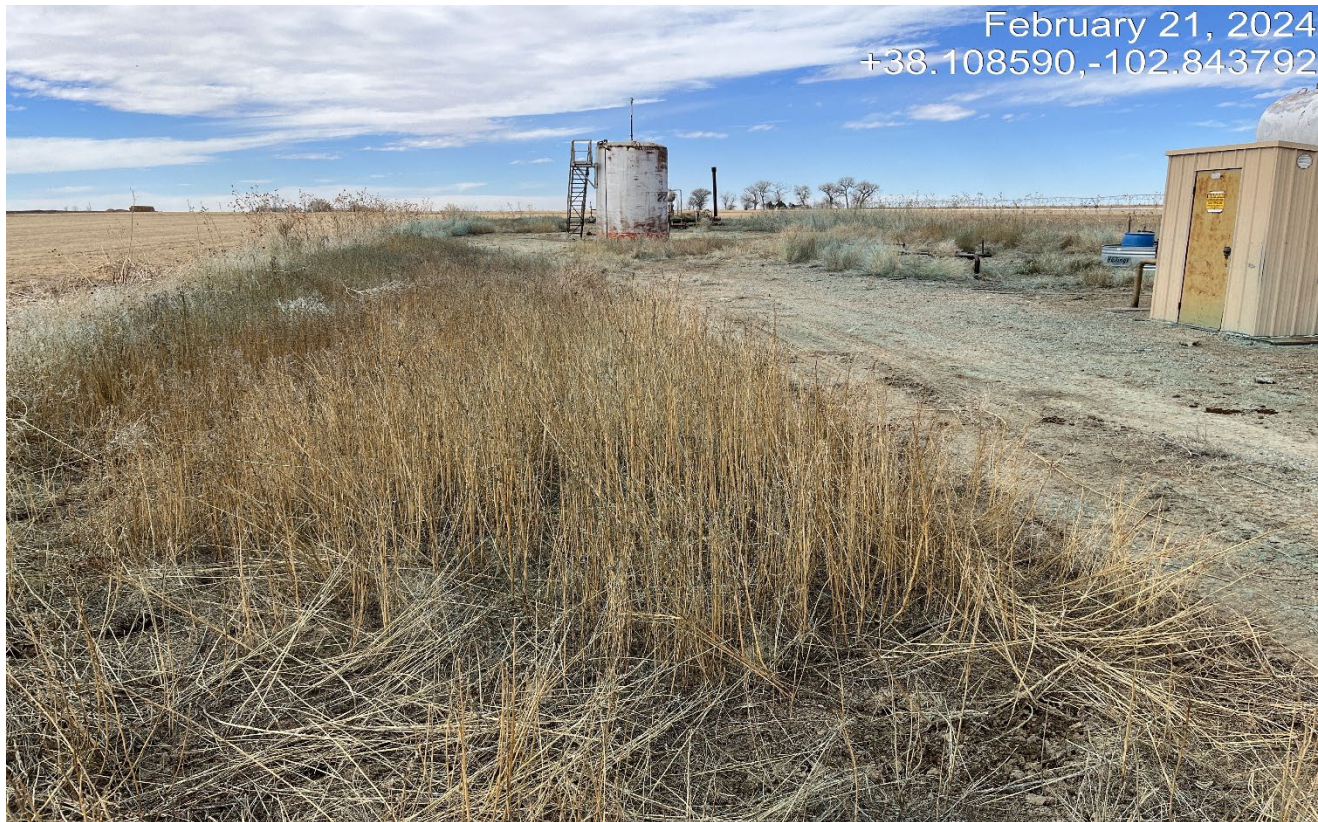
Photo 1. Facing west toward the location. There are tall undesirable weeds at the location that need to be controlled and removed. Previous CA was not completed.

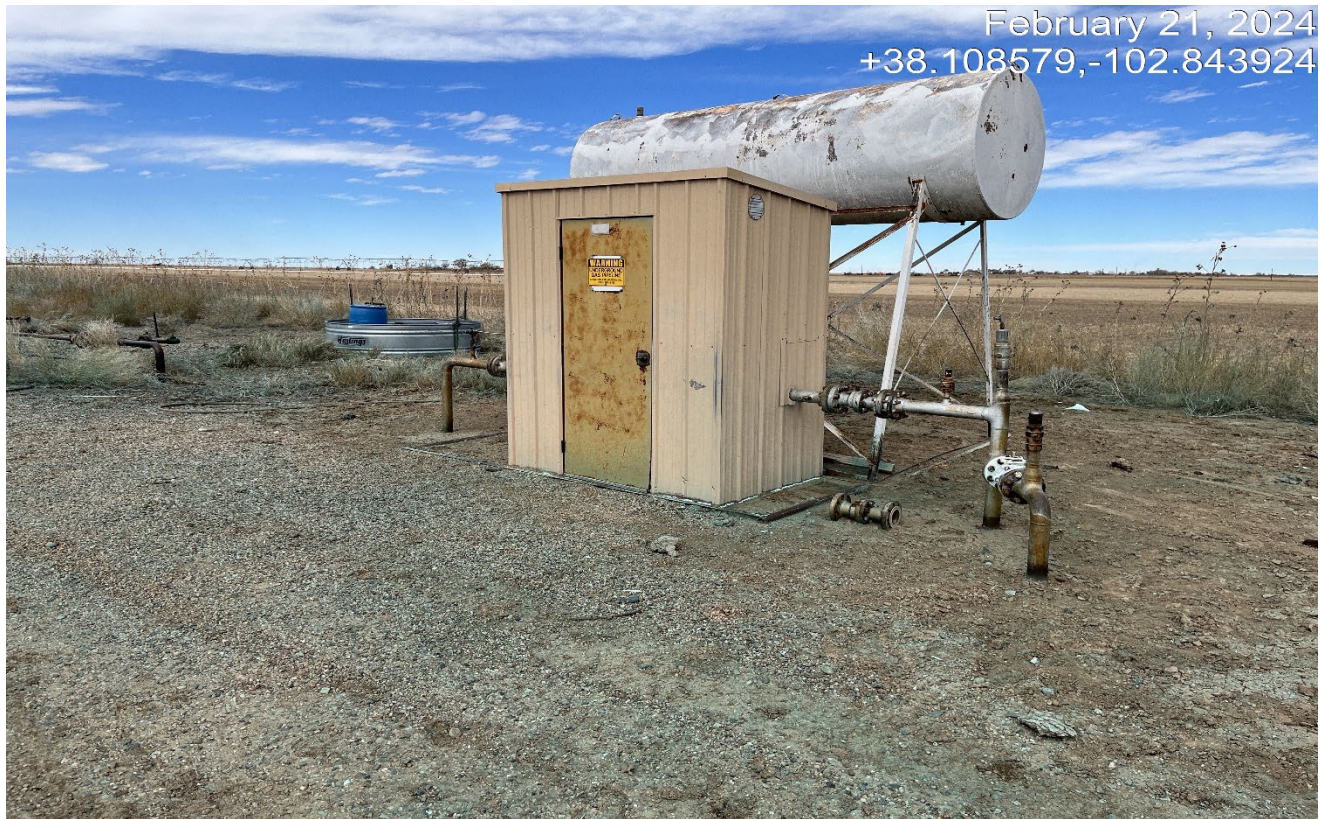
Photo 2. Facing toward the meter shed. There is no secondary containment of the fuel/chemical tank behind the shed.

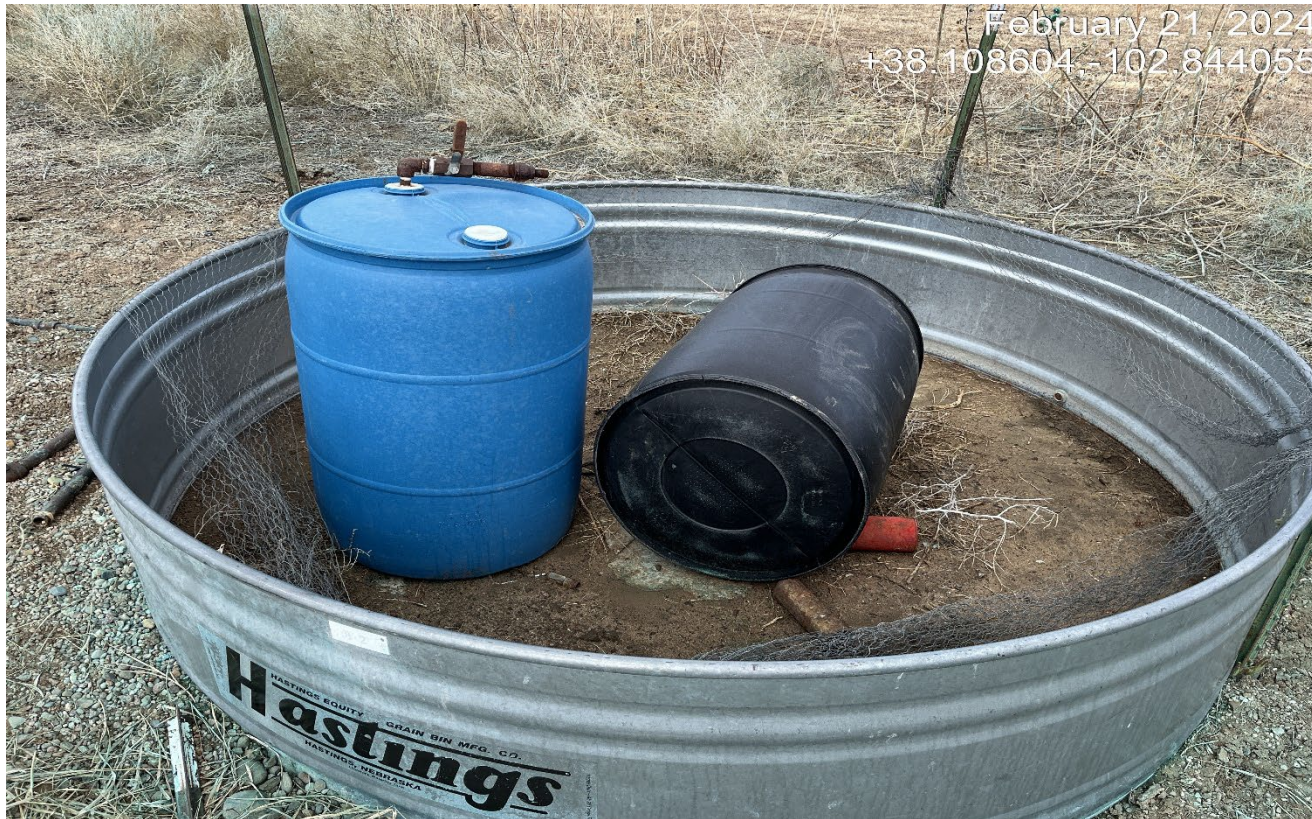
Photo 3. There are plastic drums with no labeling and one appears to be empty and not in use.

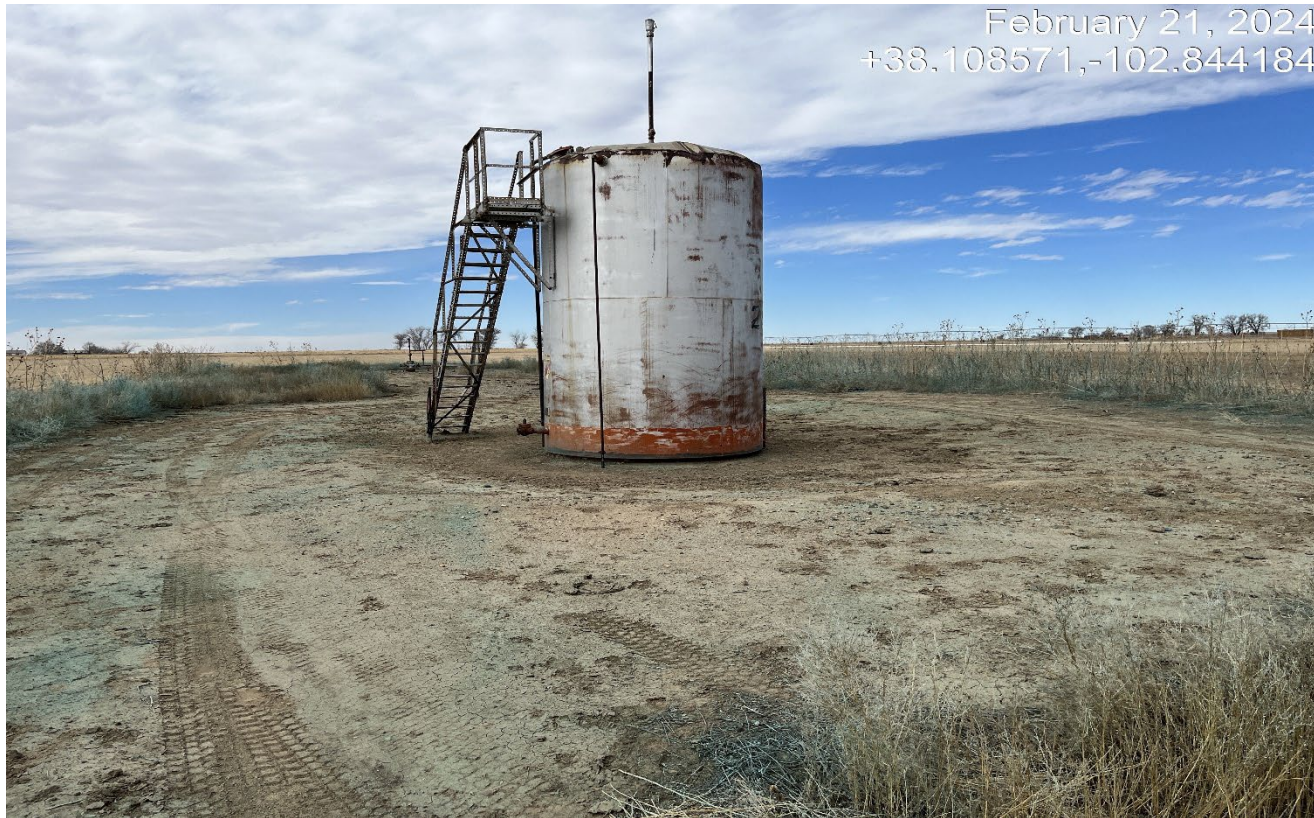
Photo 4. Facing toward the tank battery. There is insufficient secondary containment to contain a spill. Previous corrective action was not completed.

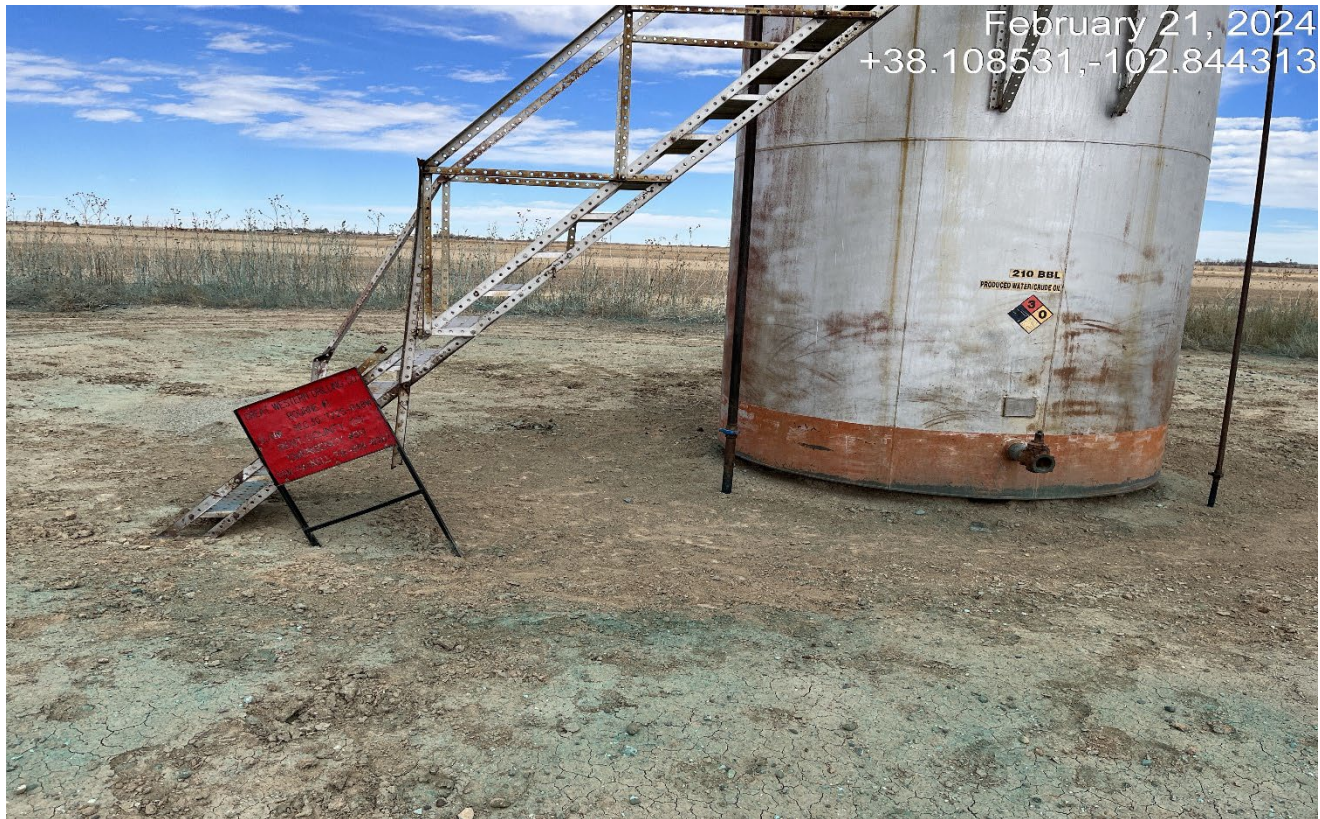
Photo 5. The sign at the tank does not reflect the current Operator sand is faded. Previous CA was not completed.

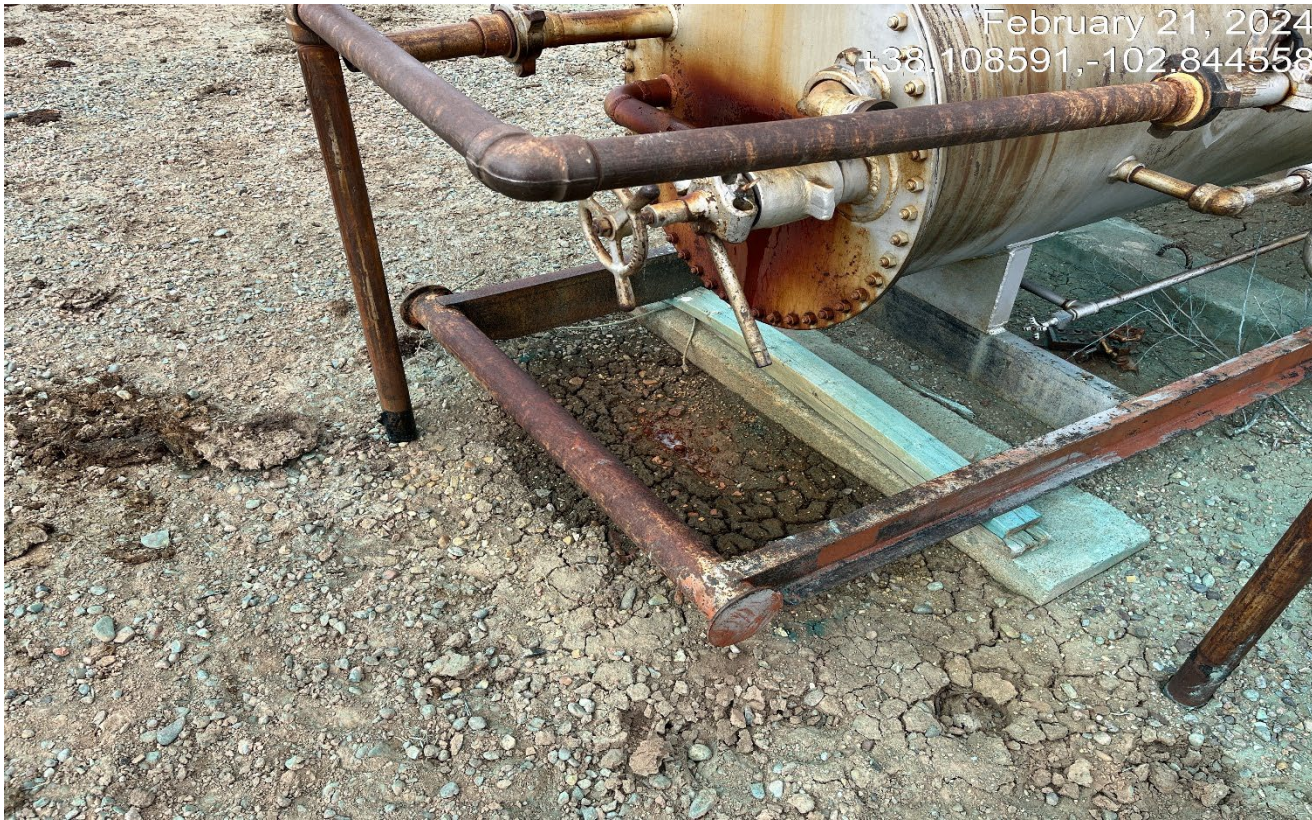
Photo 7. There is a dripping leak at the separator and stained soils. Previous corrective action was not completed.

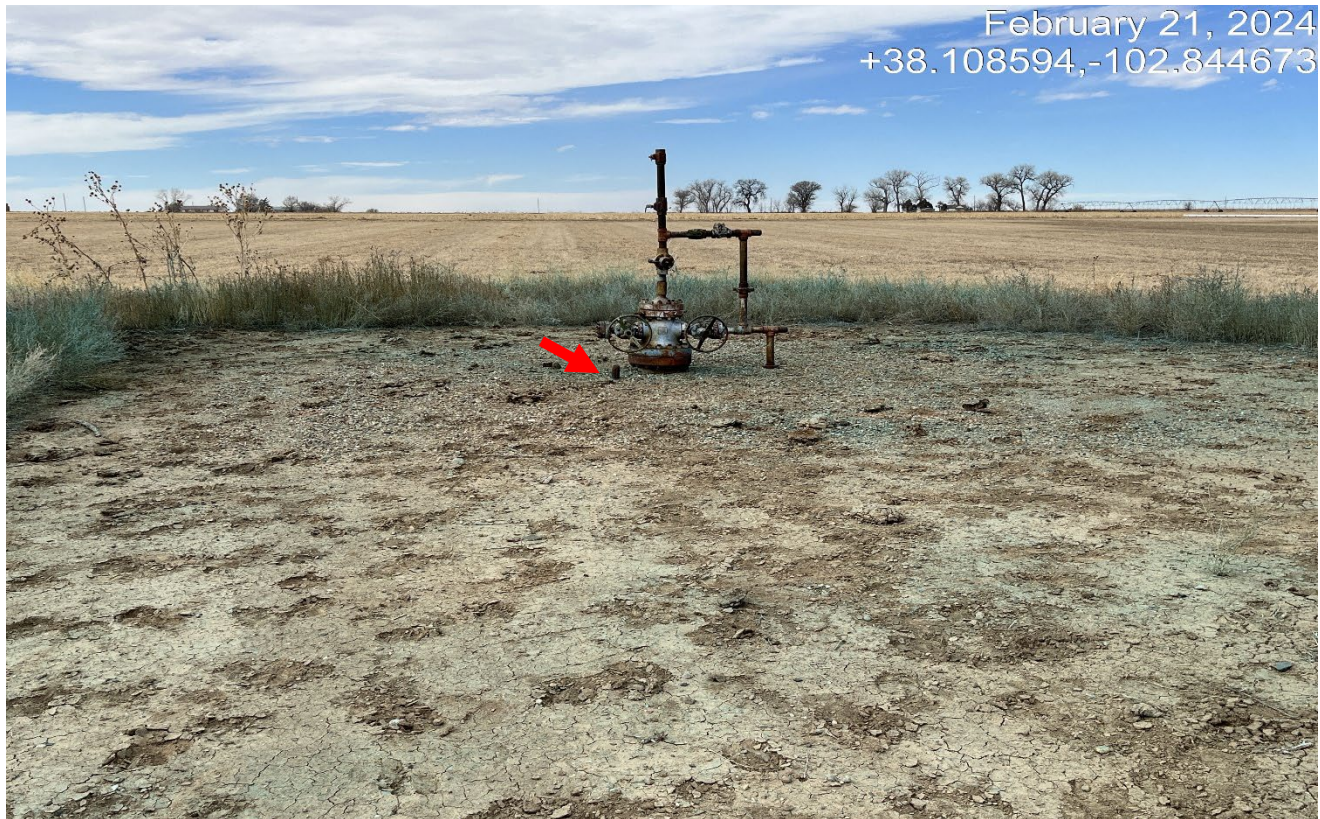
Photo 8. Facing toward the well. There is an uncapped pipe riser shown at red arrow.
