Inspection Photos

API: 099-06063

Operator: RENEGADE OIL & GAS COMPANY LLC

Inspection Date: 2/21/2024

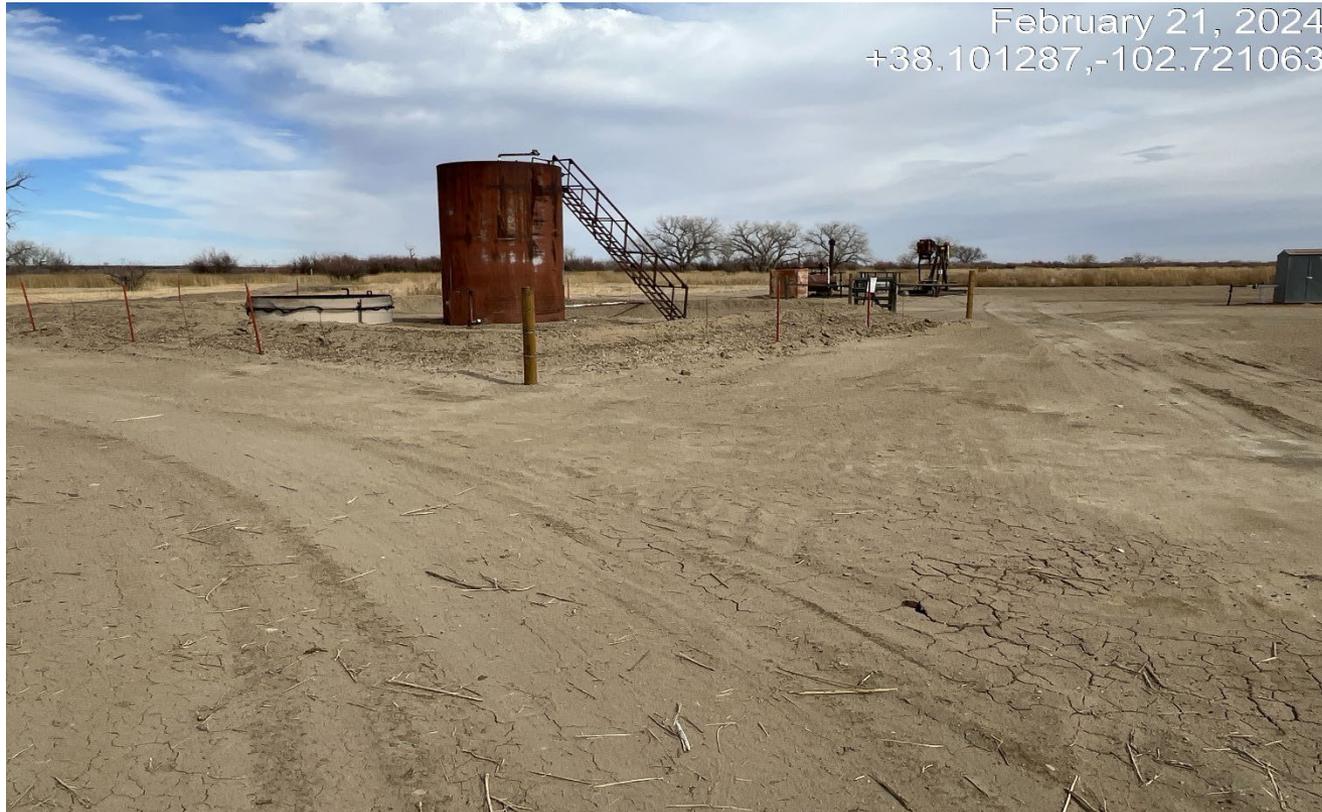
Photo 1. Facing northeast toward the tank battery. The berm has been built up around the tank and the fence was repaired.

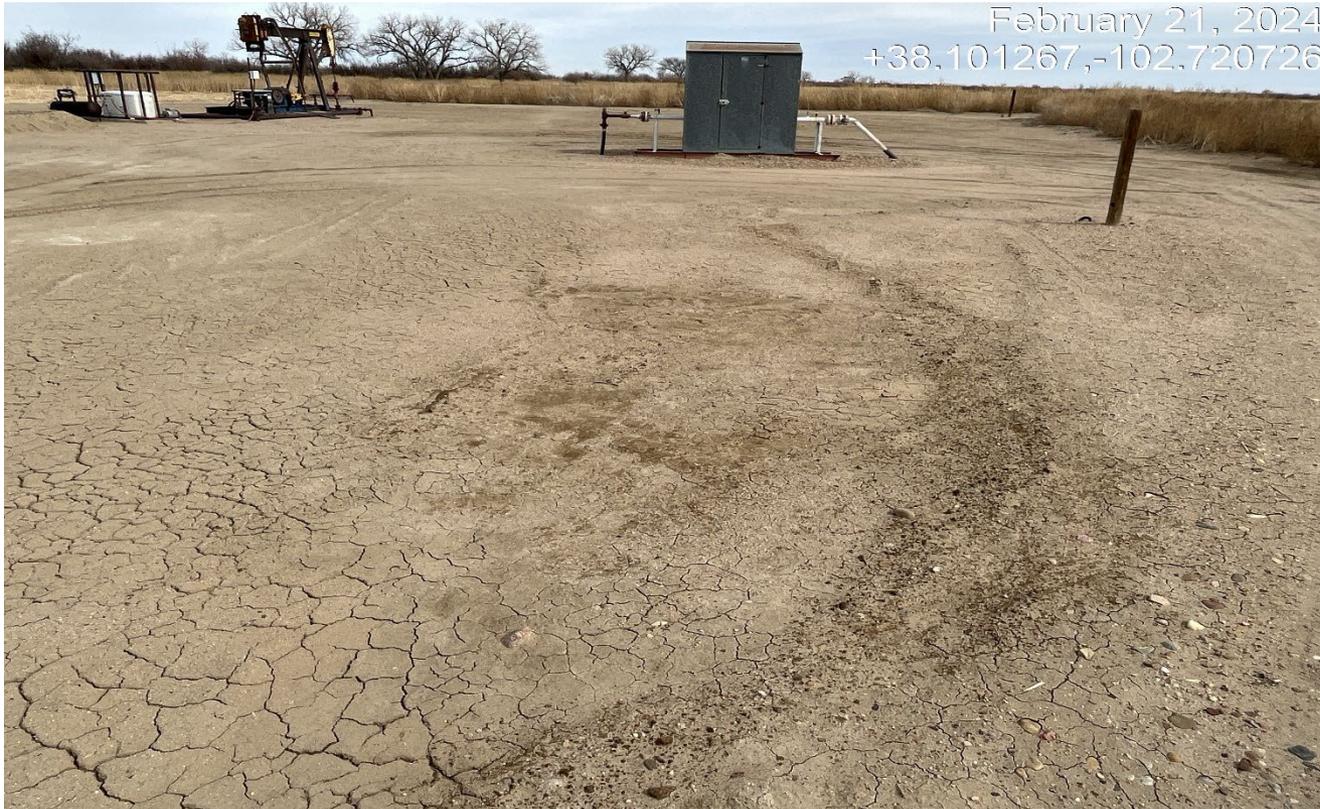
Photo 2. Facing northeast toward the wellsite. There still appears to be oil staining that needs to be cleaned up better.

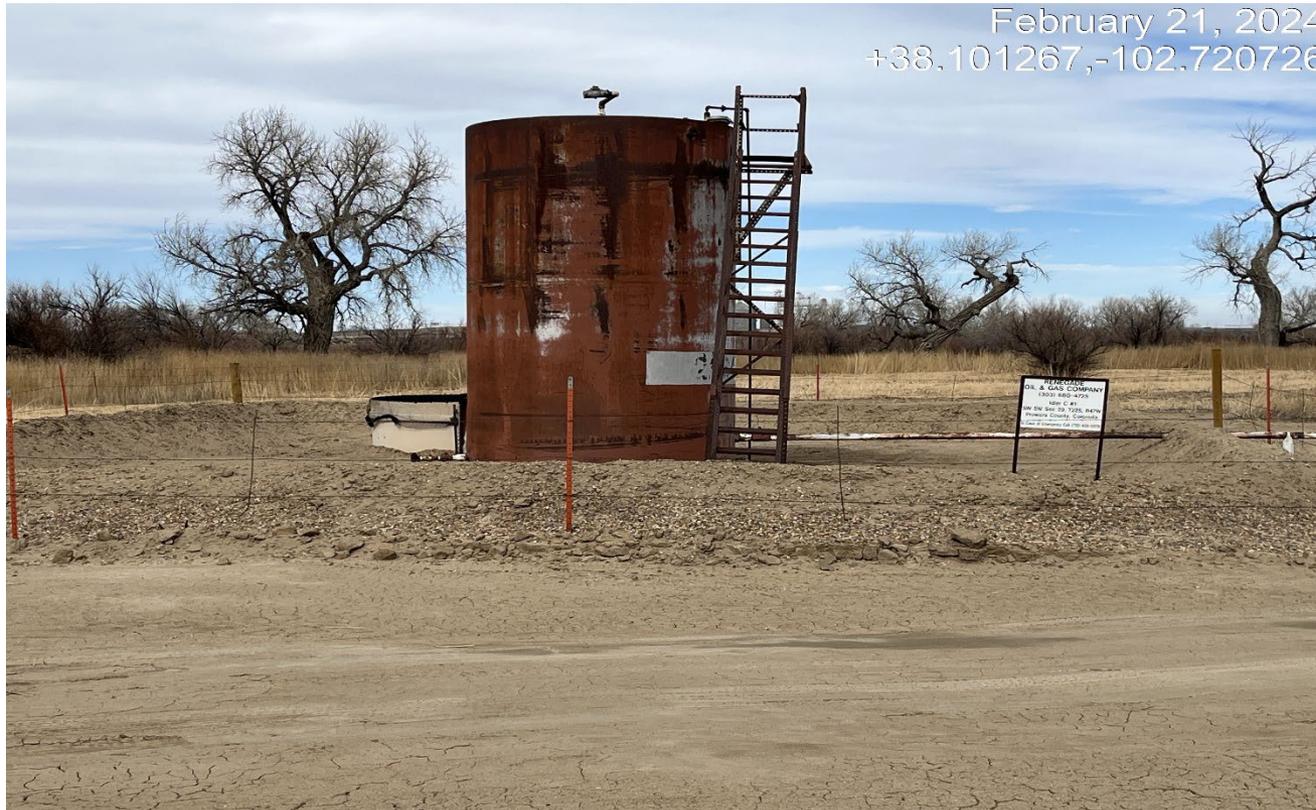
Photo 3. Facing toward the tank battery. The berm has been rebuilt and a fence was installed around the tank battery.

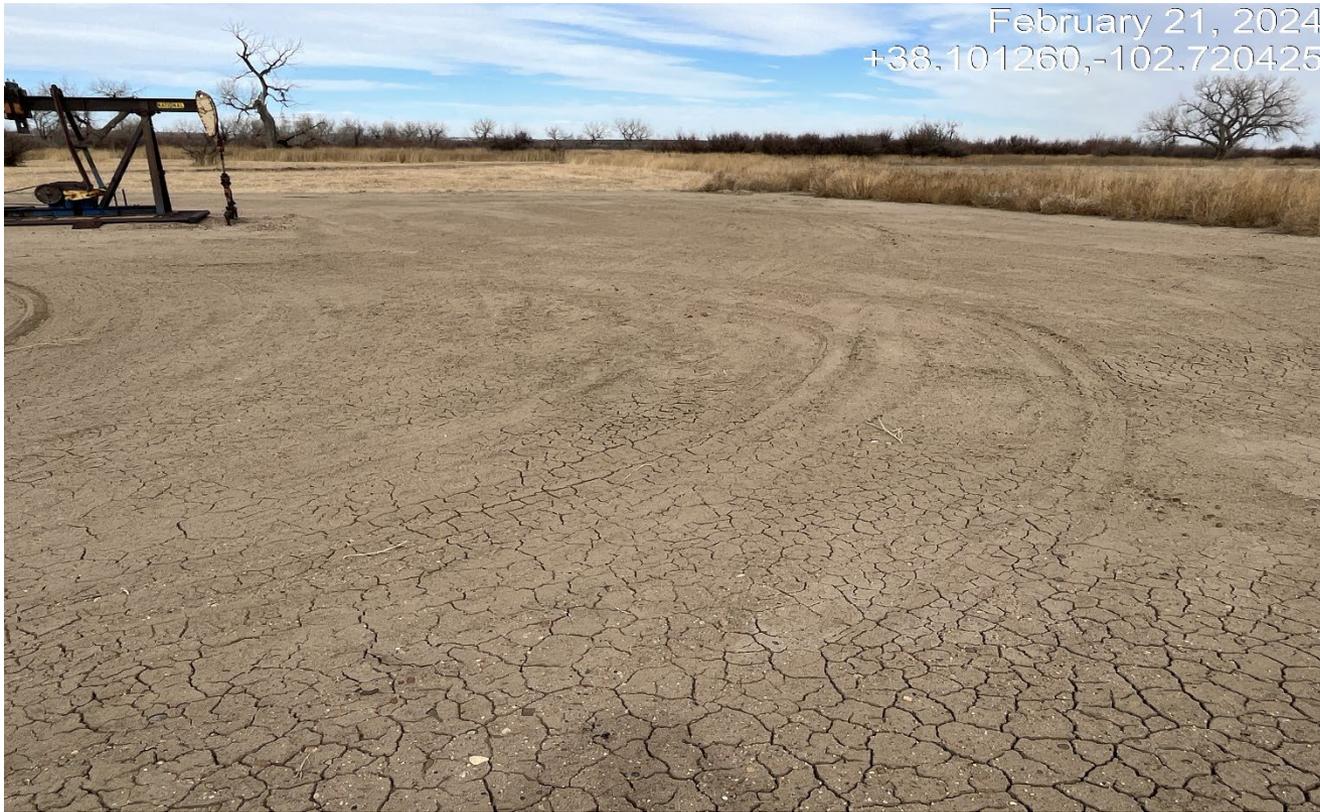
Photo 4. Facing southeast at the location. Unused areas of the location need to be reclaimed.

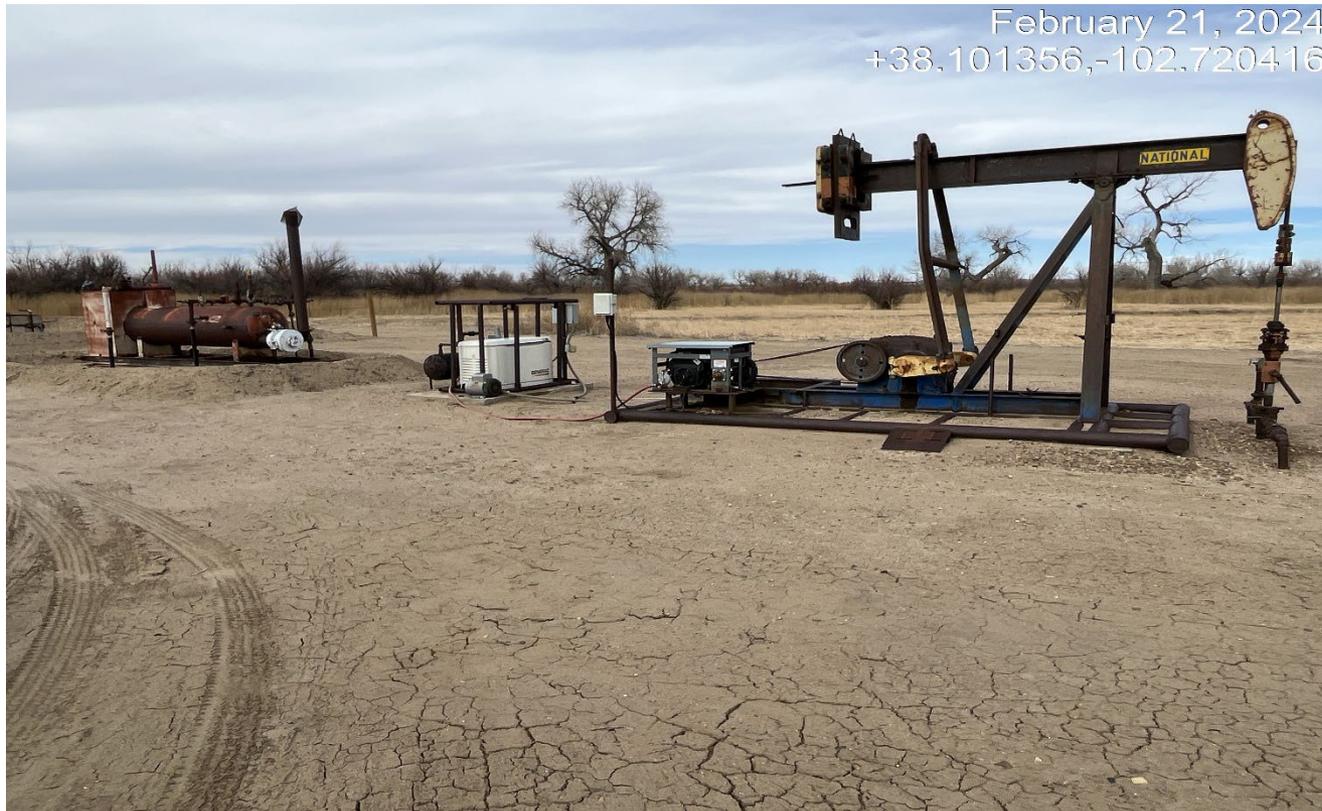
Photo 5. Facing toward the well pumpjack.

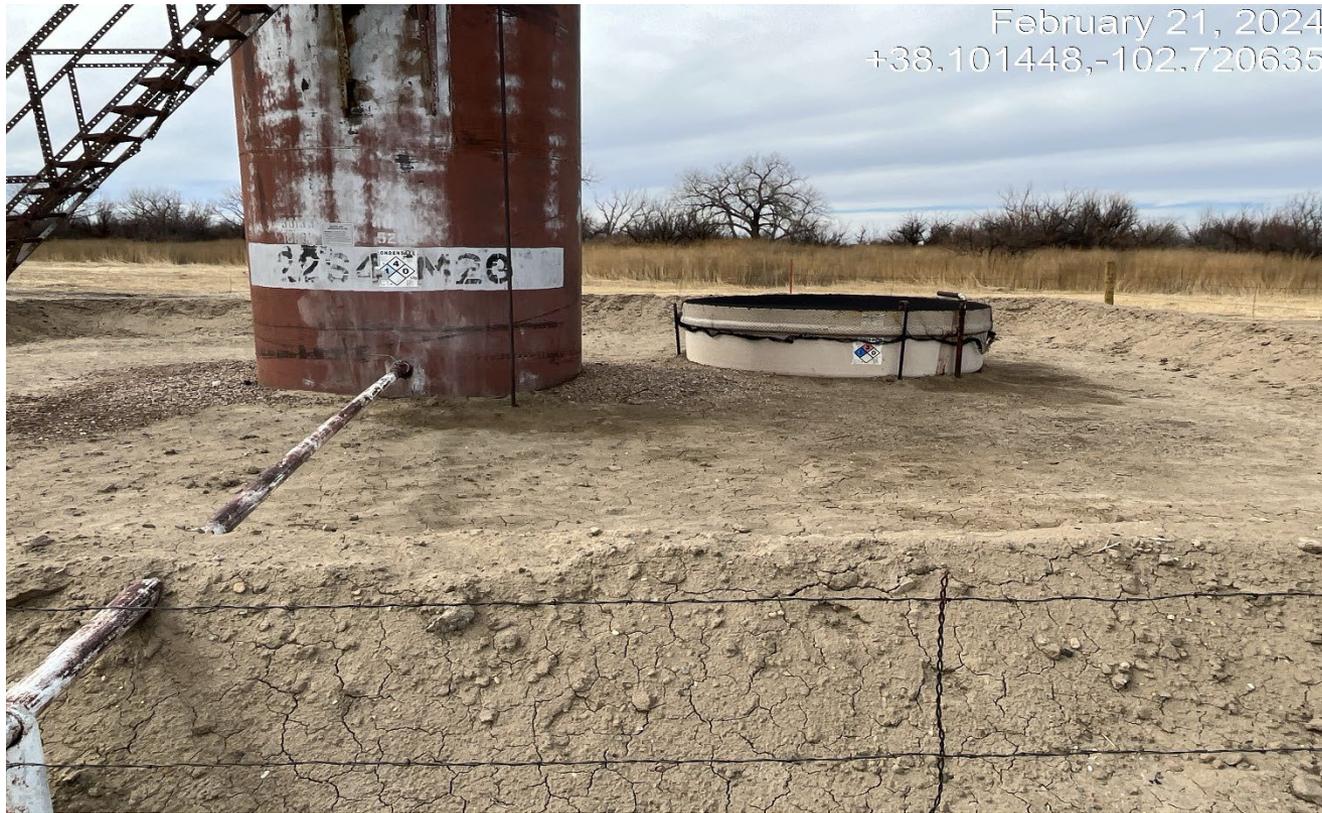
Photo 6. Facing toward the tank battery. It appears impacted soils have been cleaned up and netting was installed on the open top tank.
