Hilcorp Energy Company
Van Schaick 5
Location ID: 313128

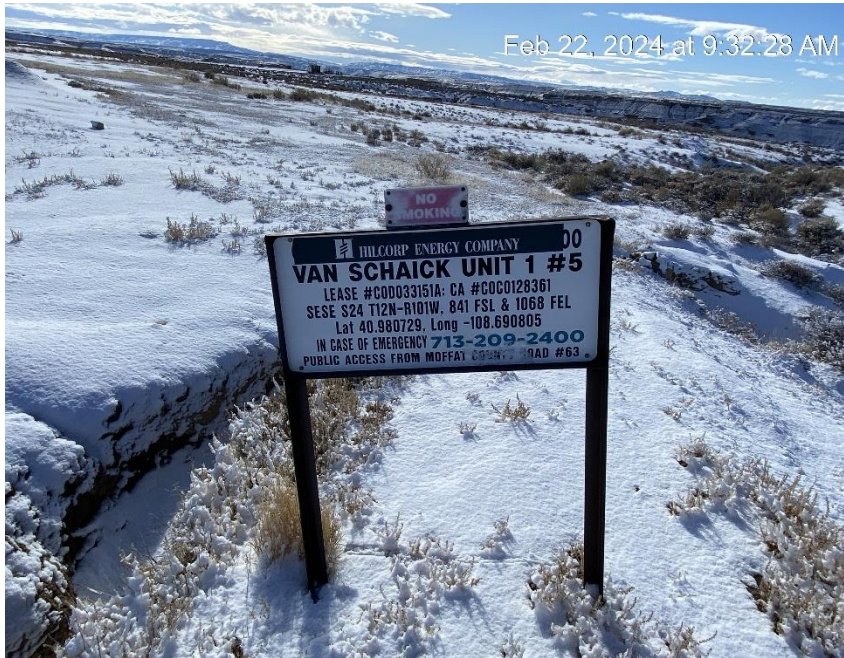
As signs are replaced additional information will be required

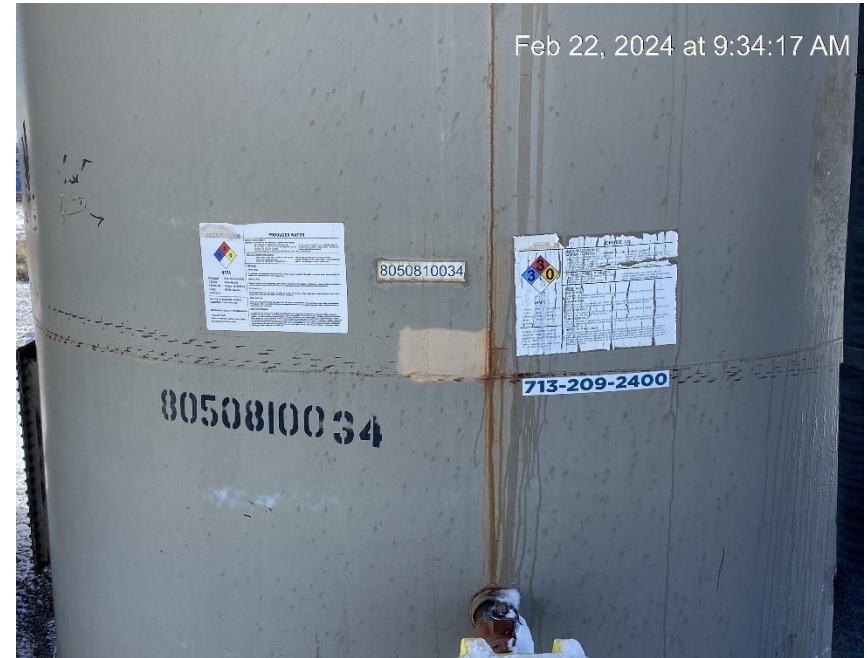
Tank label missing required information

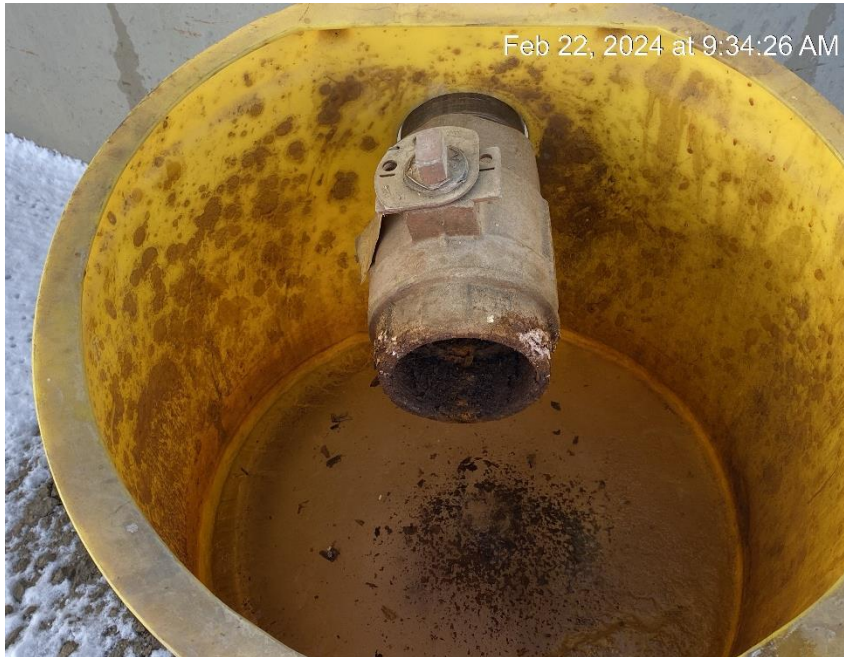
Open end load line

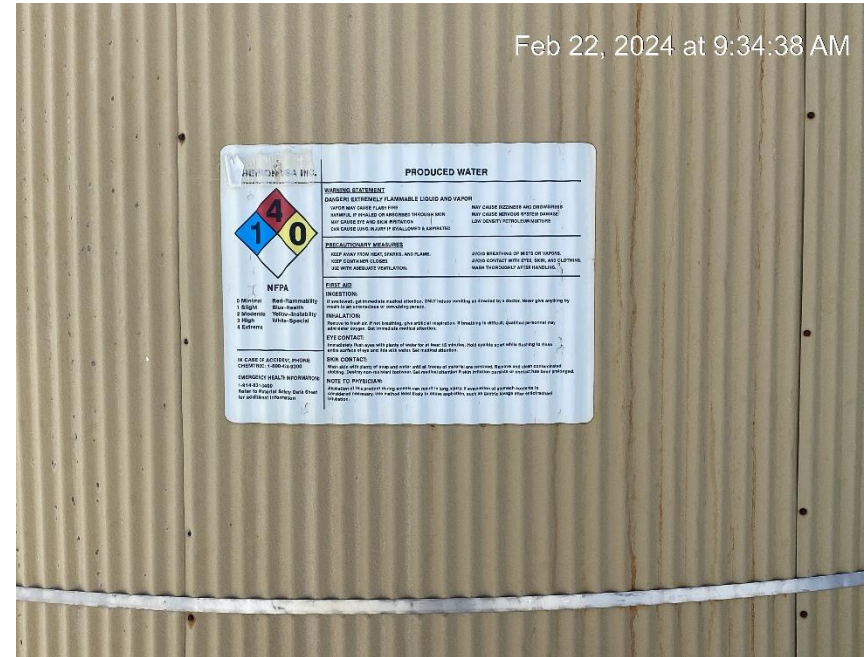
Tank label missing required information

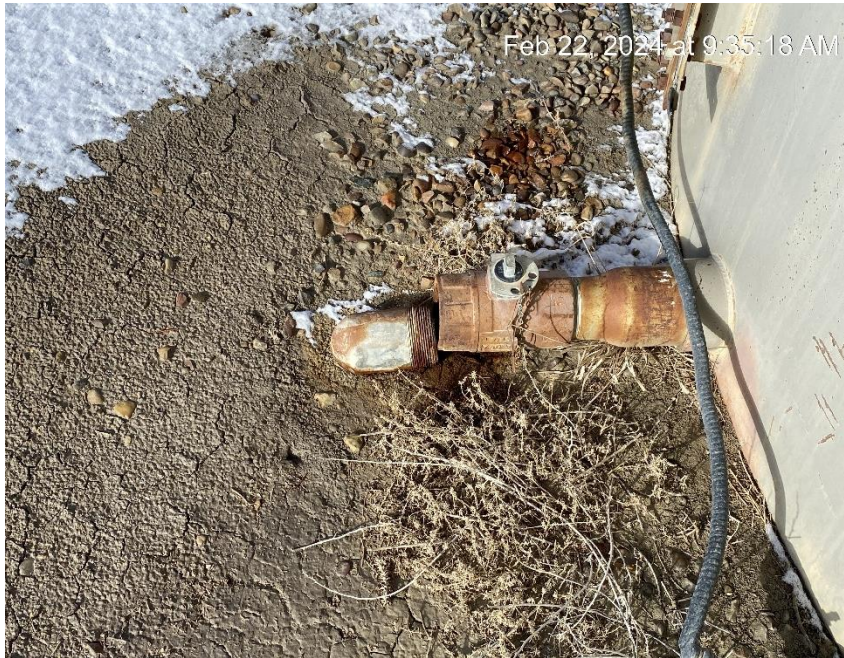
Open end load line

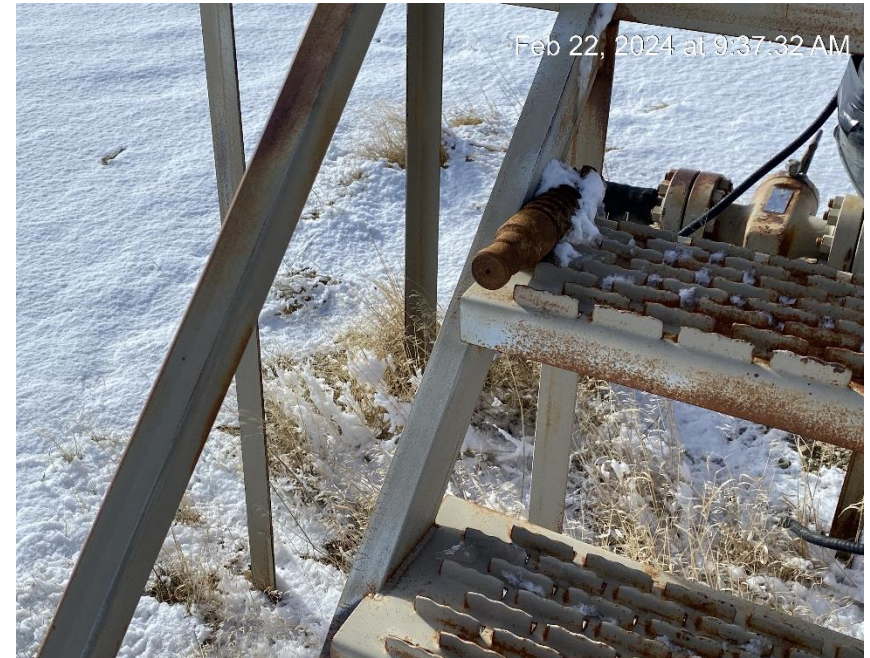
Debris

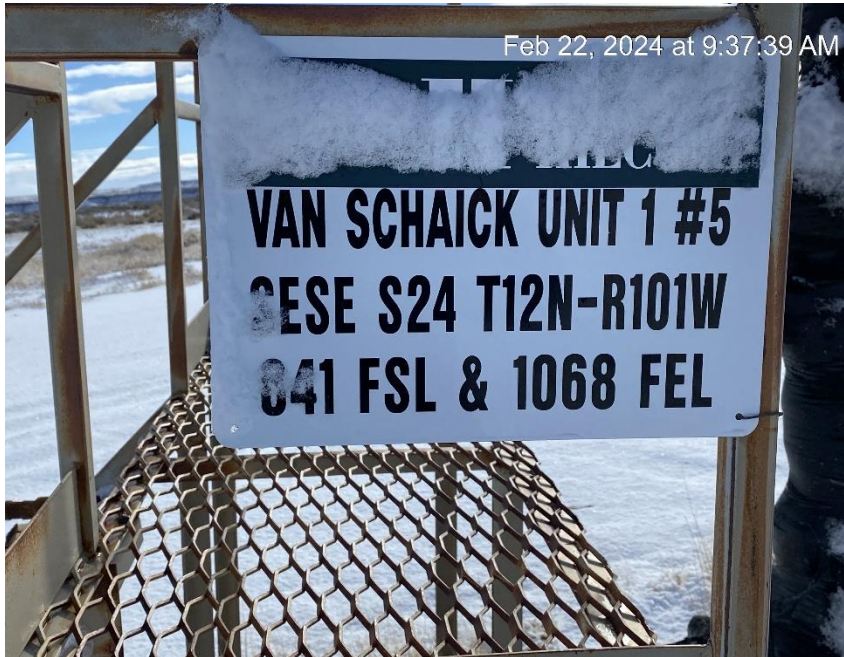
As signs are replaced additional information will be required

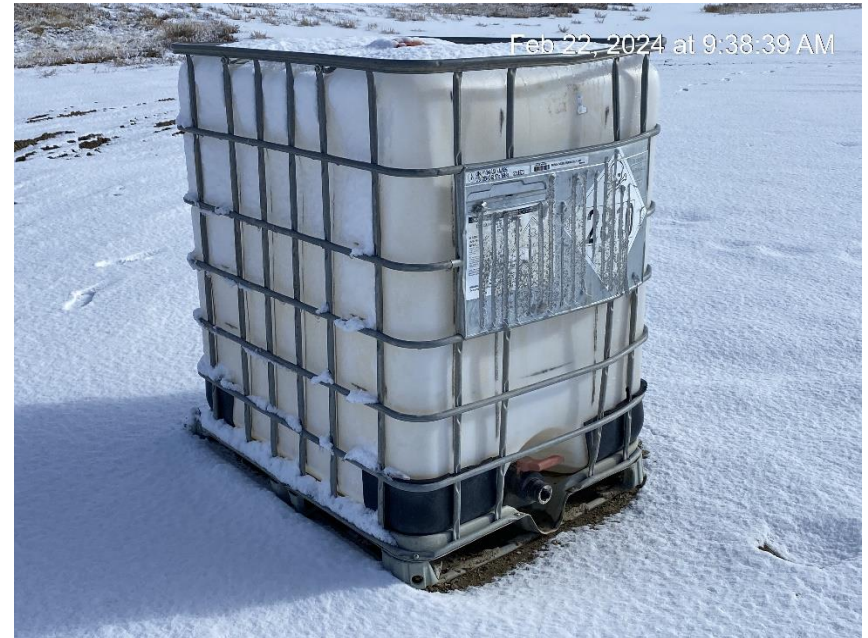
Debris

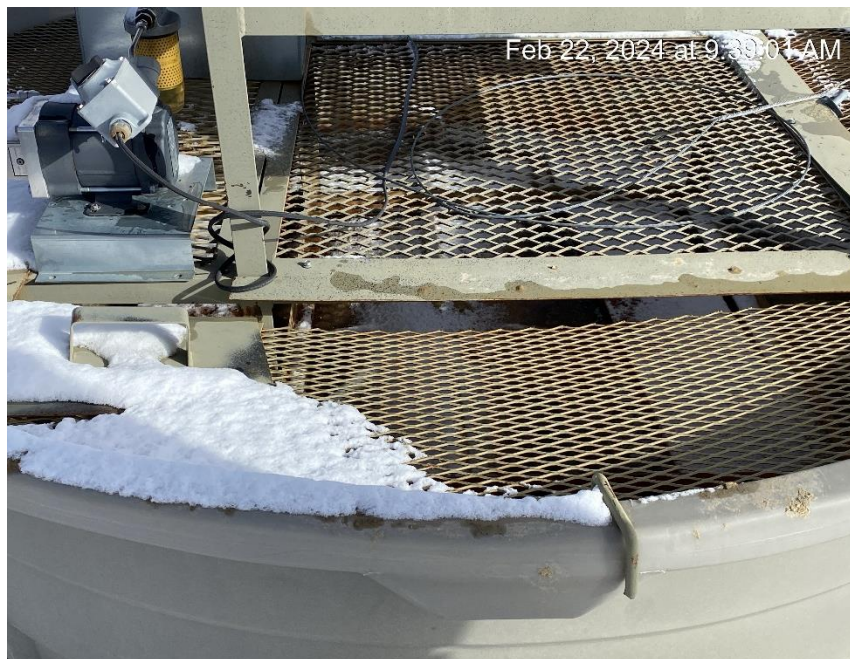
Open to wildlife

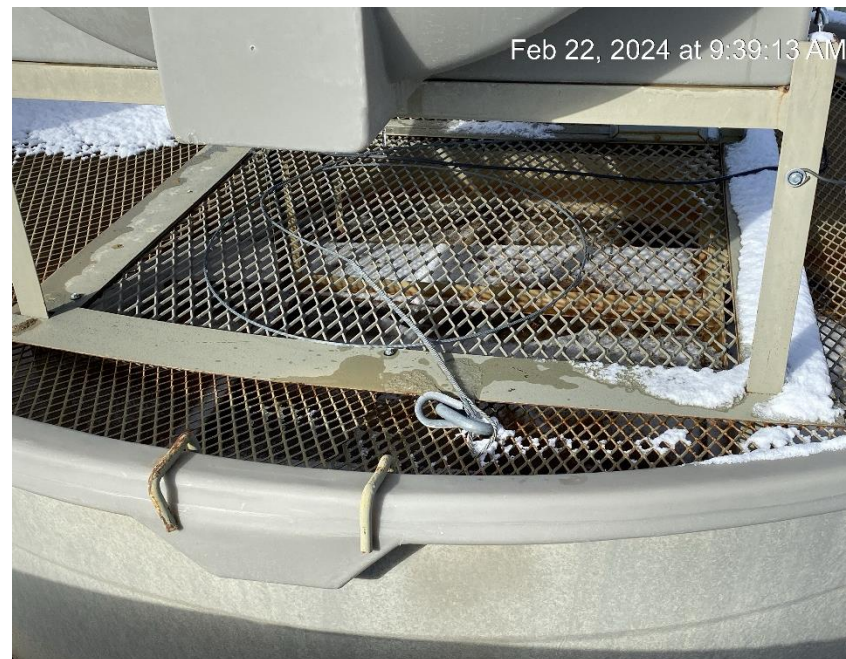
Debris

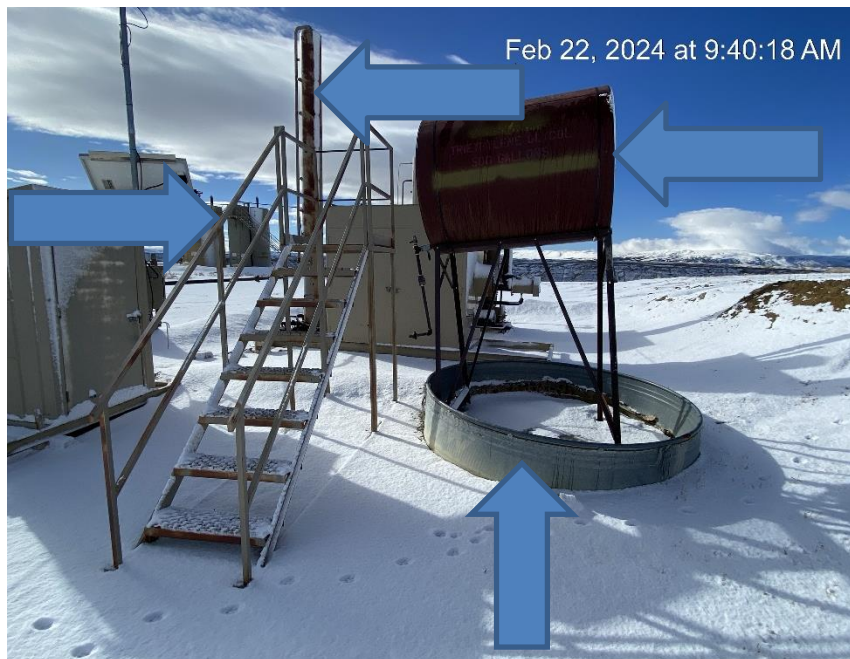
Unused equipment

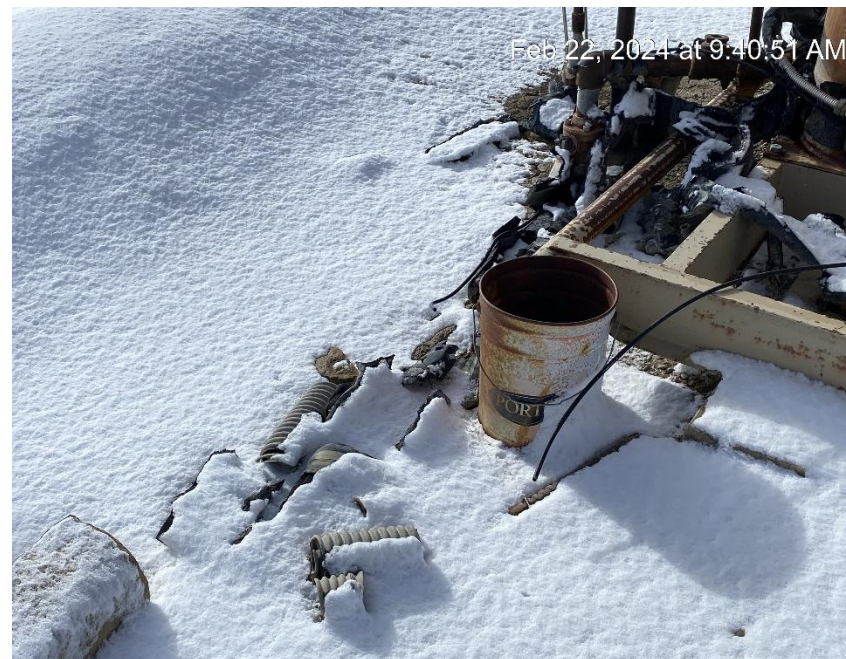
Debris

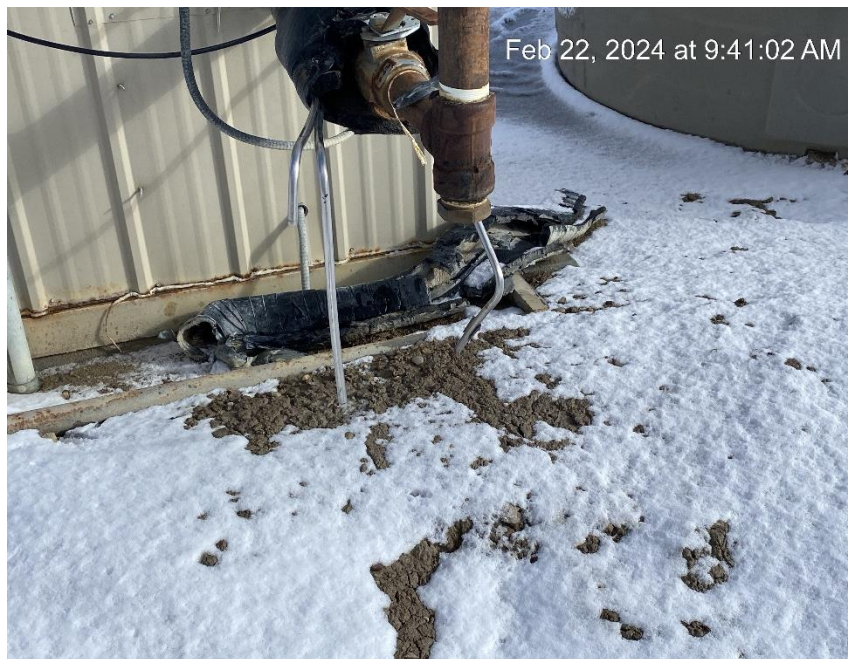
Debris

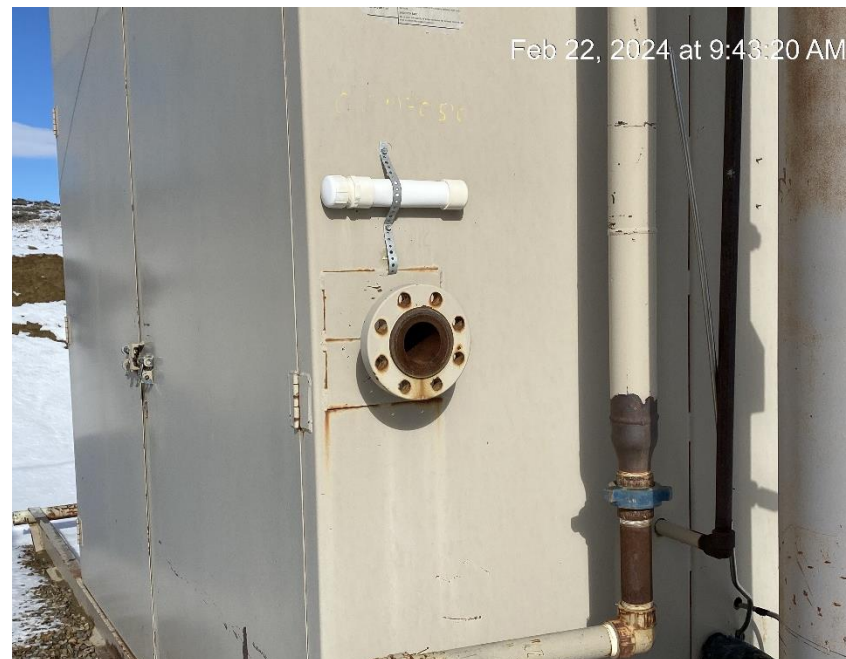
Open to wildlife

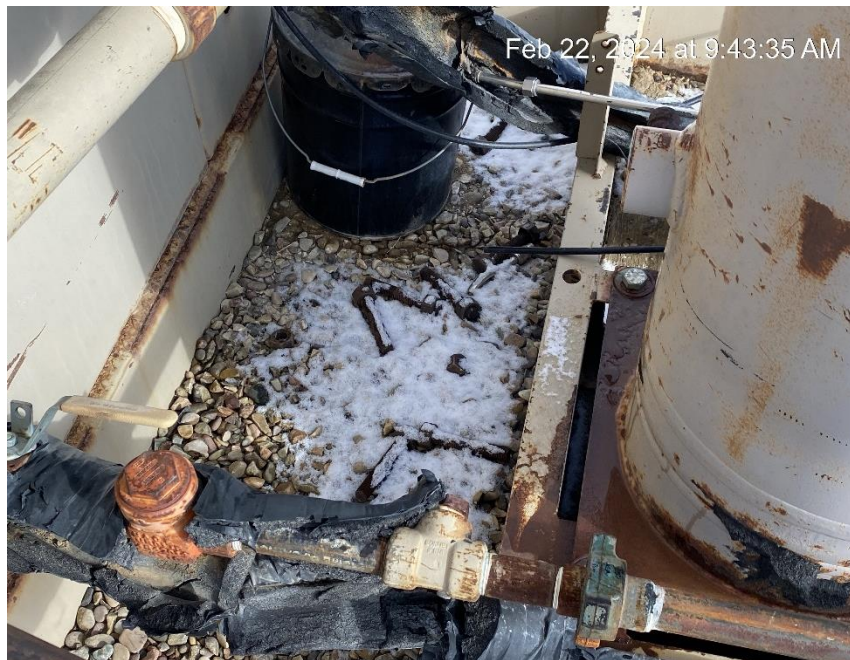
Debris

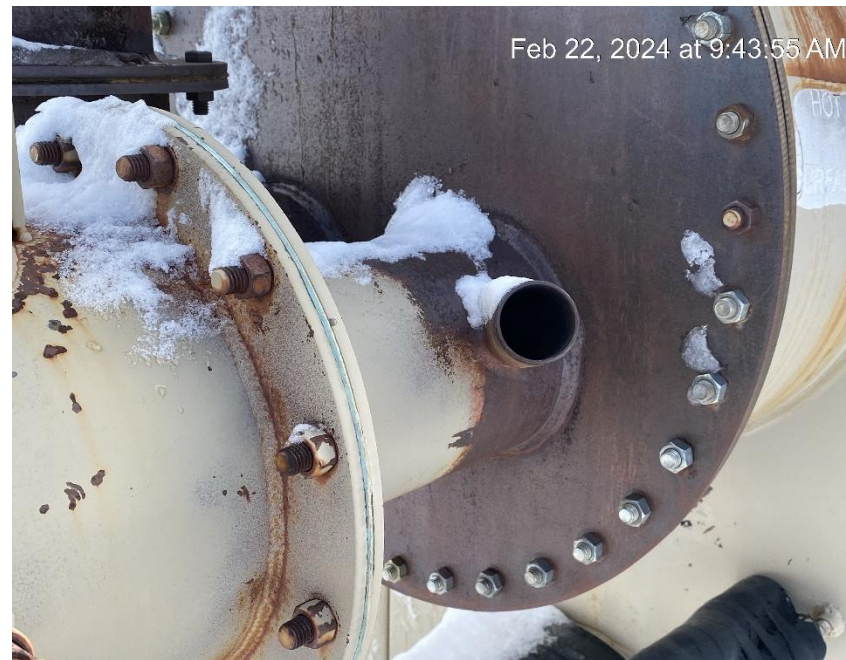
Open to wildlife
