## Inspection Photos

Location Name: CAERUS PICEANCE LLC SCHAEFFER 11-8 (I11W) Pad

Location ID: 334561

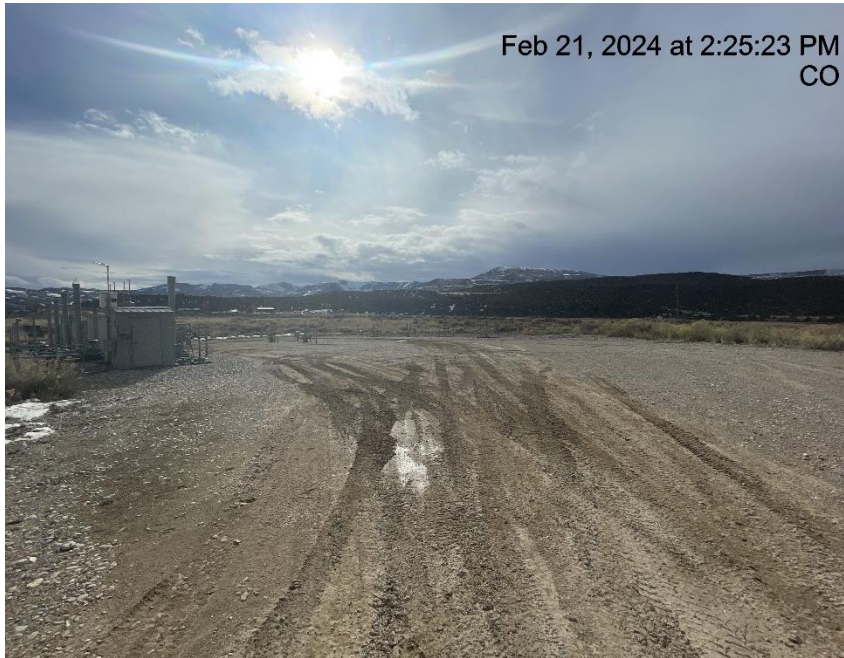
**Photo # 7225 From entrance to location**

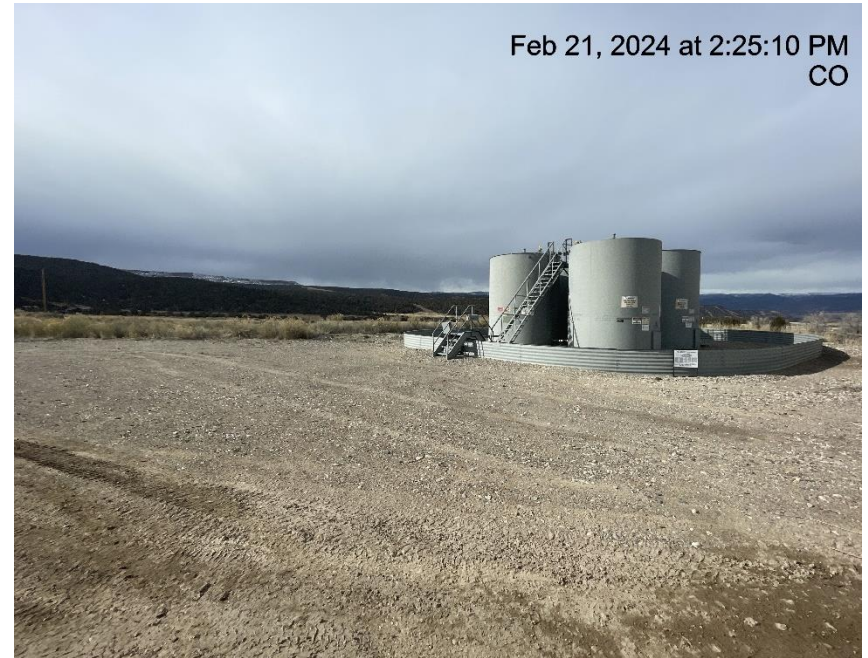
**Photo # 7226 From entrance to location**

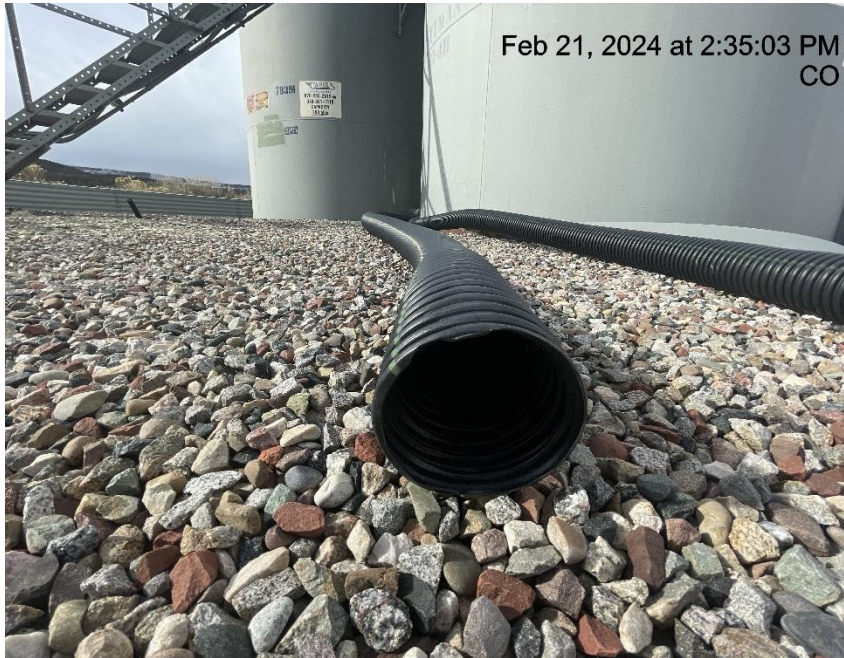
**Photo # 7233 Flowline heating insulation open  
ended/wildlife hazard/available for entry by wildlife**
