Inspection Photos

Location Name: TEP ROCKY MOUNTAIN LLC, GM-66S96W/23SWSW

Location ID: 335388

Date: 2/22/2024

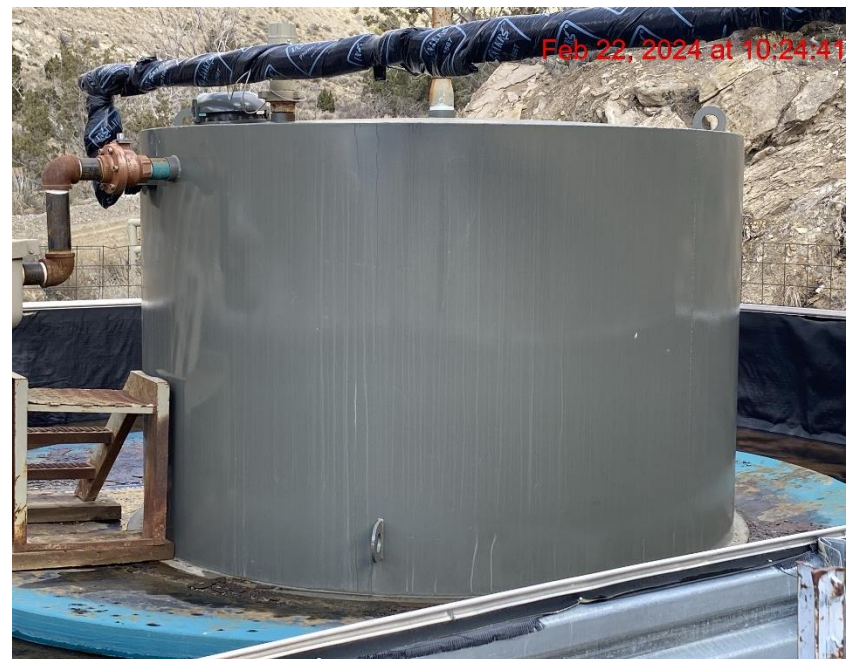
Tank Not Labeled – Photo #09468

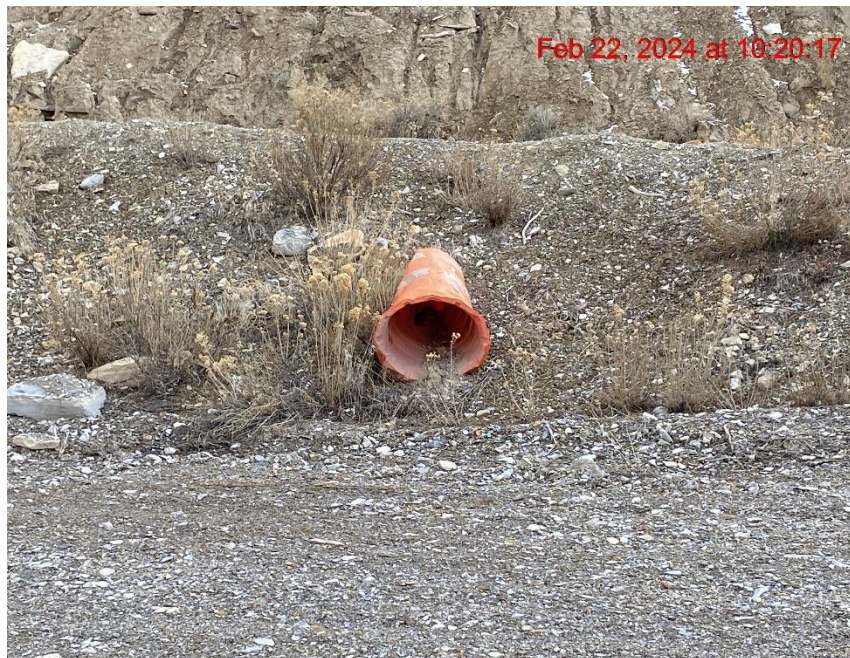
Debris – Photo #09462

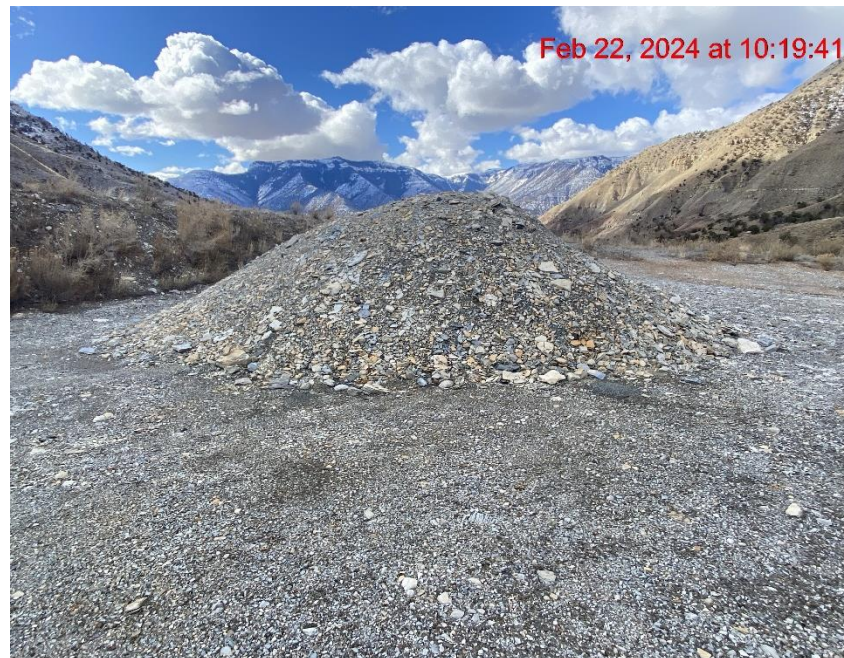
Unprotected Soil Stockpile – Photo #09460

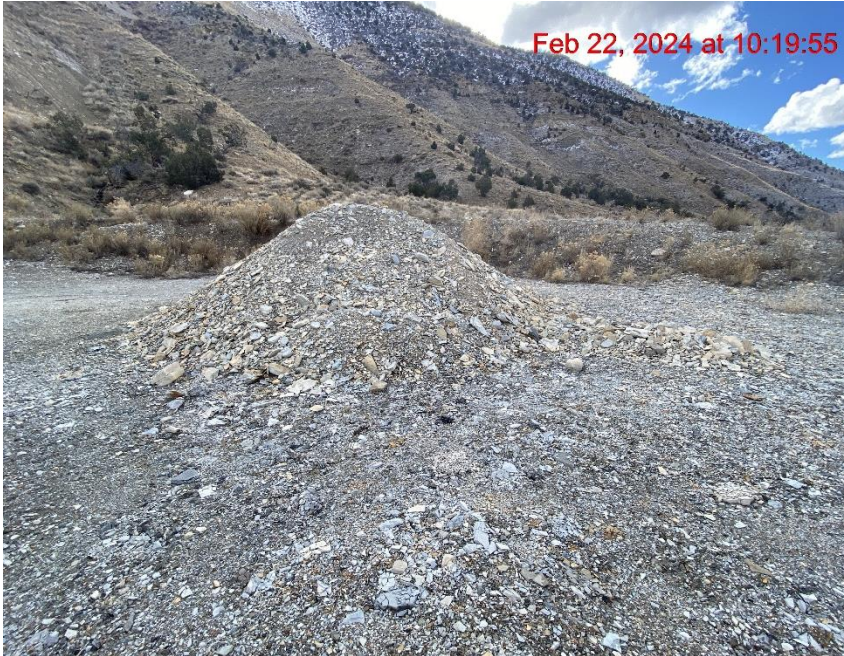
Unprotected Soil Stockpile – Photo #09461

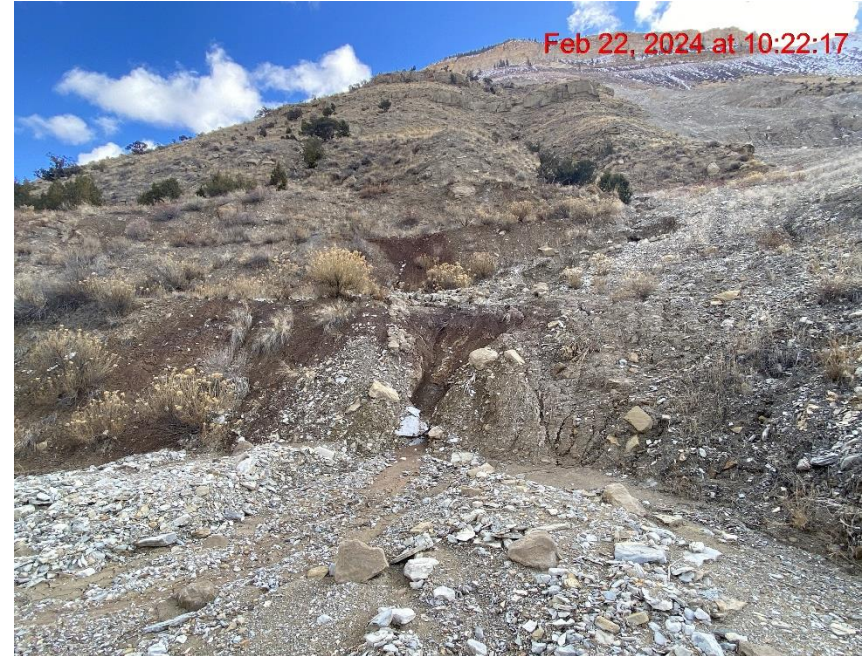
Insufficient Erosion Control – Photo #09464

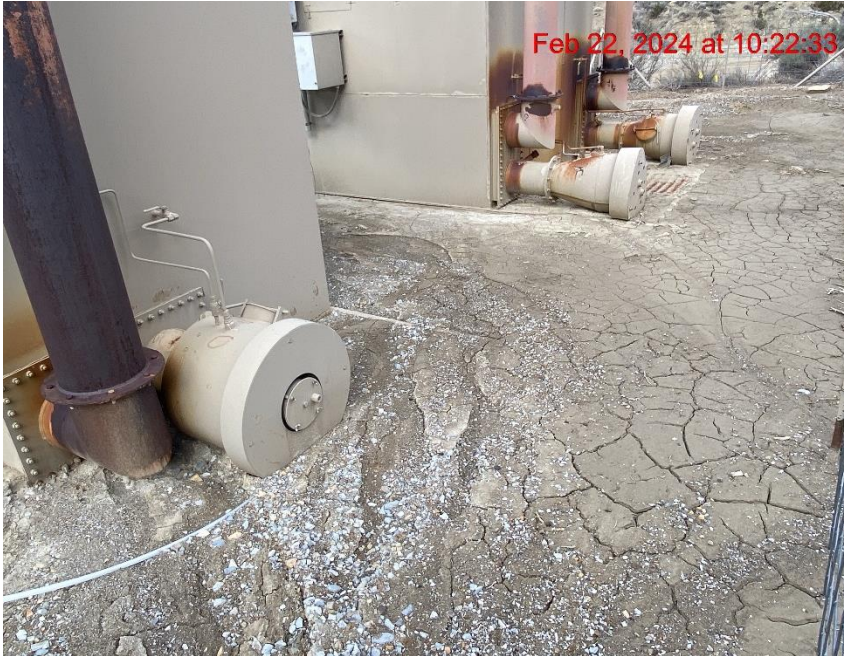
Insufficient Erosion Control/Sediment Encroaching on Production Equipment – Photo #09465

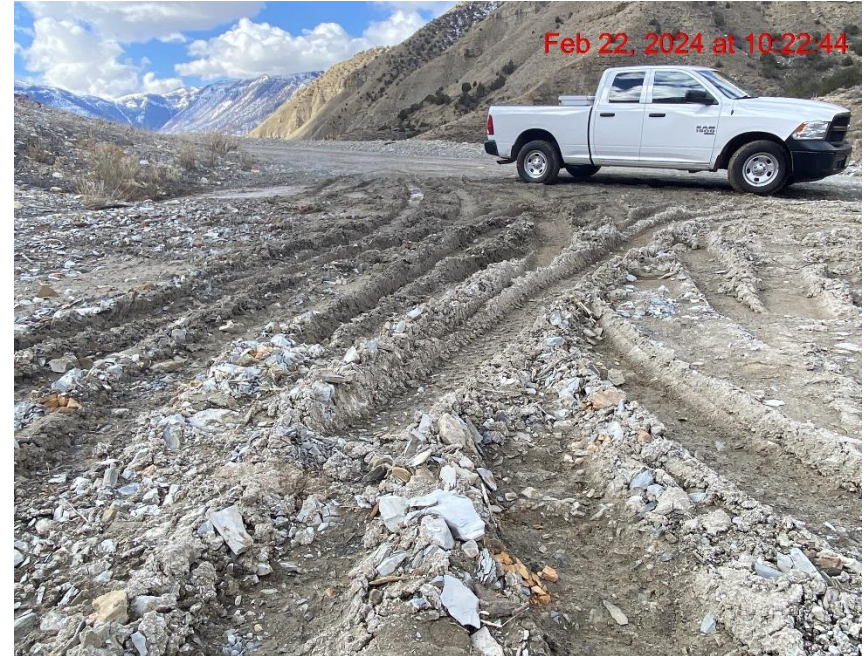
Lack of Stabilization/Insufficient Vehicle Tracking BMPs at Location Entrance/Exit – Photo #09466
