Inspection Photos

Location Name: CAERUS PICEANCE LLC SCHAEFFER 12-6C (F12W) Pad

Location ID: 311608

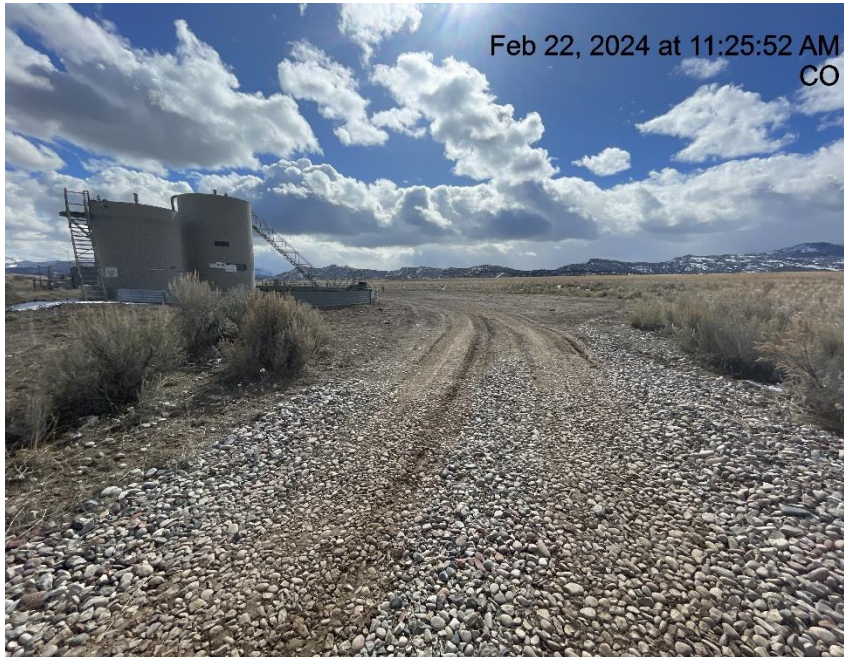
Photo # 7377 From entrance to location

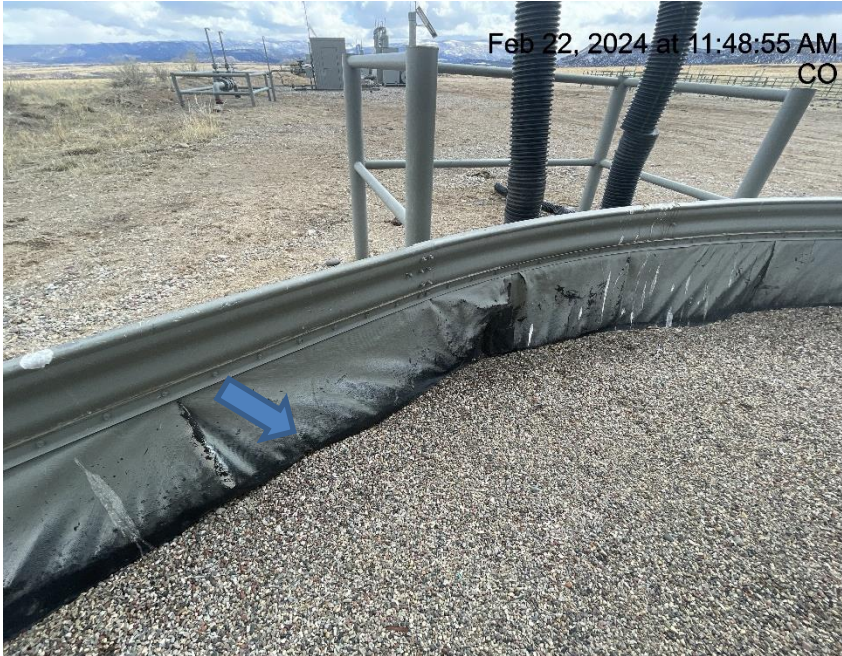
Photo # 7385 Hole in liner/liner needs maintenance

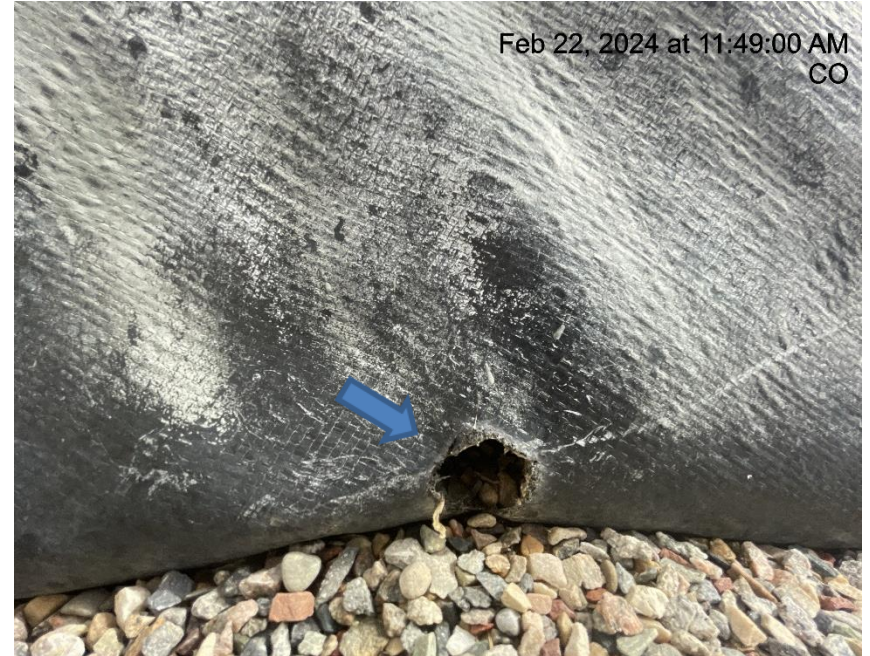
Photo # 7386 Hole in liner/liner needs maintenance

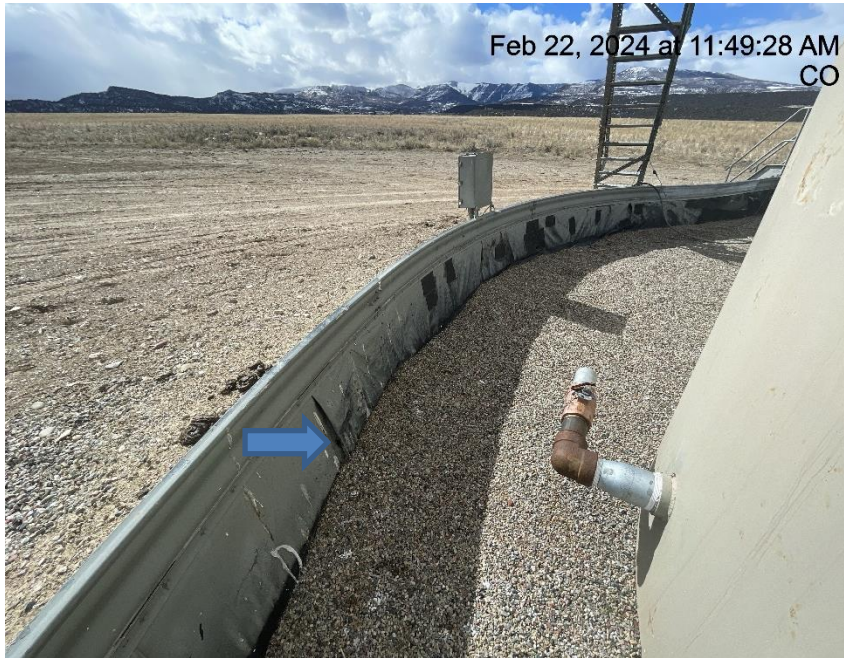
Photo # 7387 Hole in liner/liner needs maintenance

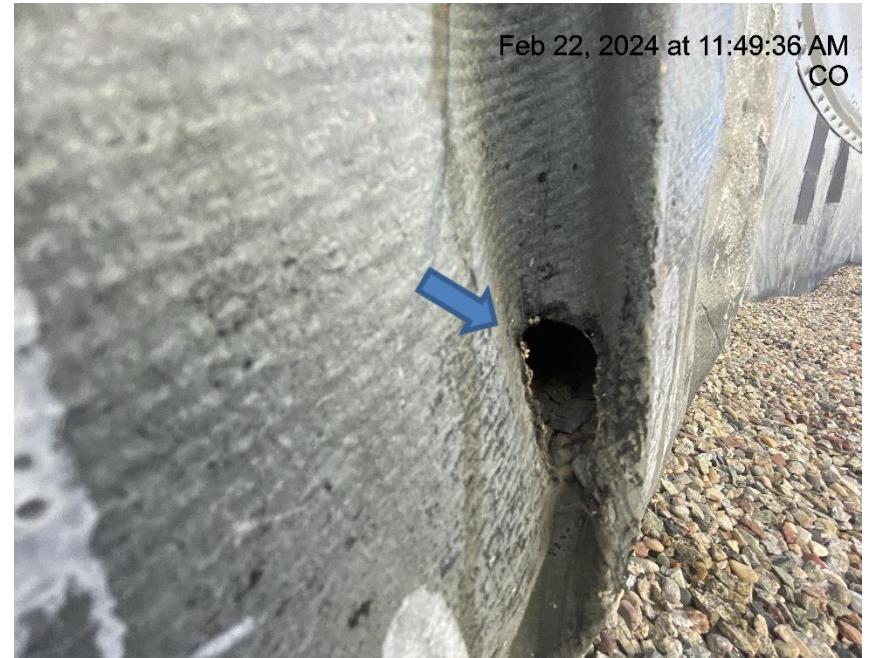
Photo # 7388 Hole in liner/liner needs maintenance

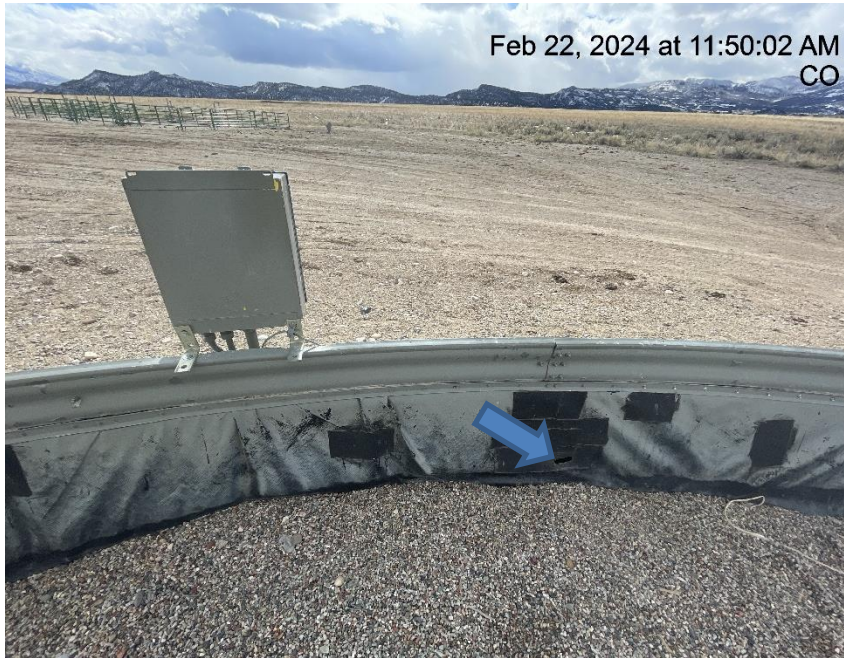
Photo # 7389 Hole in liner/liner needs maintenance

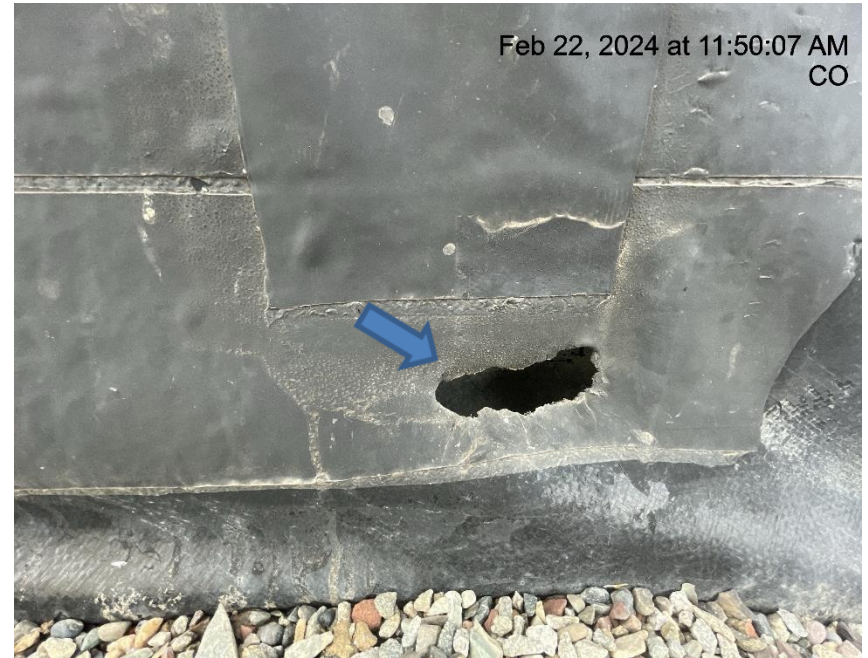
Photo # 7390 Hole in liner/liner needs maintenance
