Inspection Photos

Location Name: CAERUS PICEANCE LLC SHAEFFER 12-3 (D12) Pad

Location ID: 334603

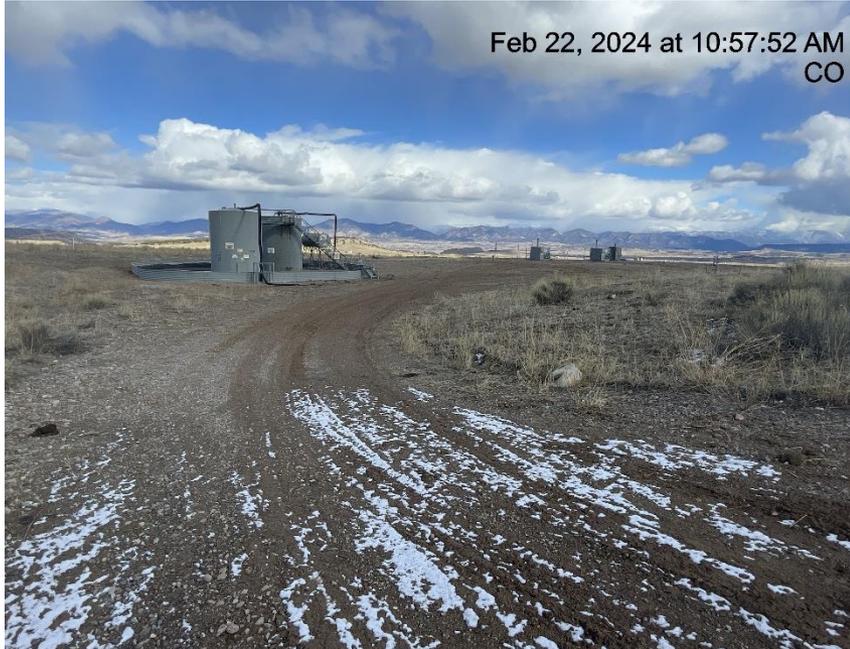
Photo # 7343 From entrance to location

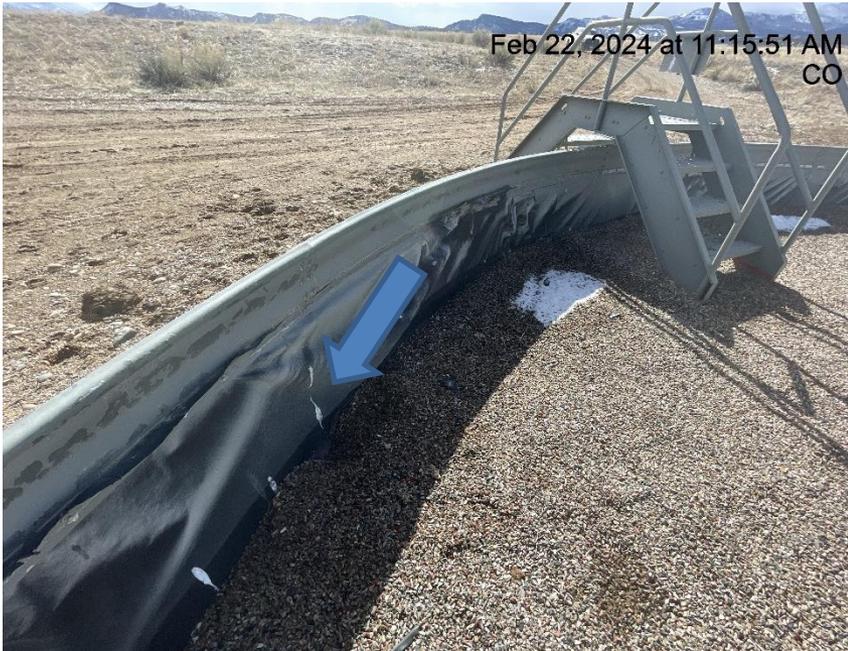
Photo # 7347 Hole in liner/liner needs maintenance

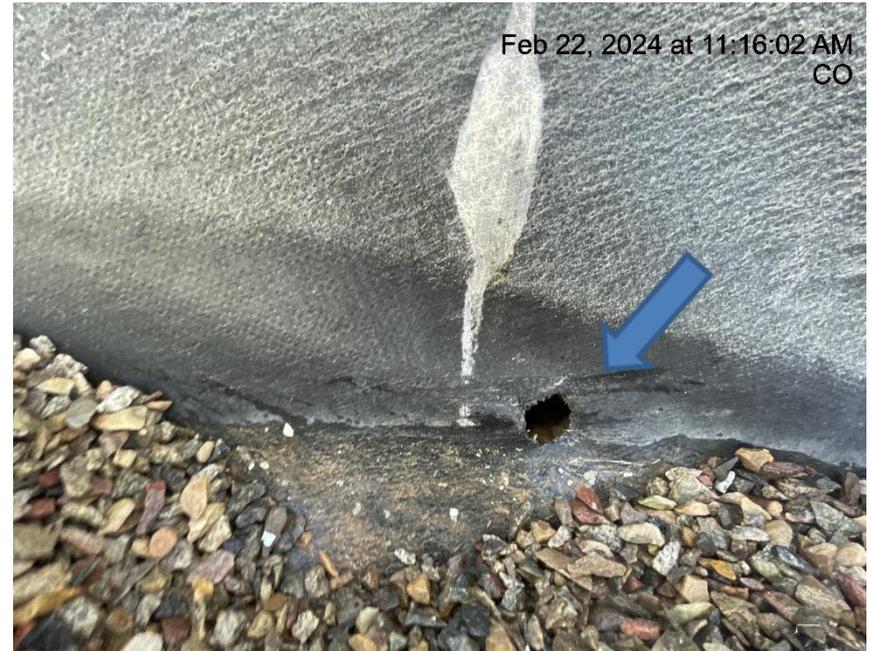
Photo # 7348 Hole in liner/liner needs maintenance

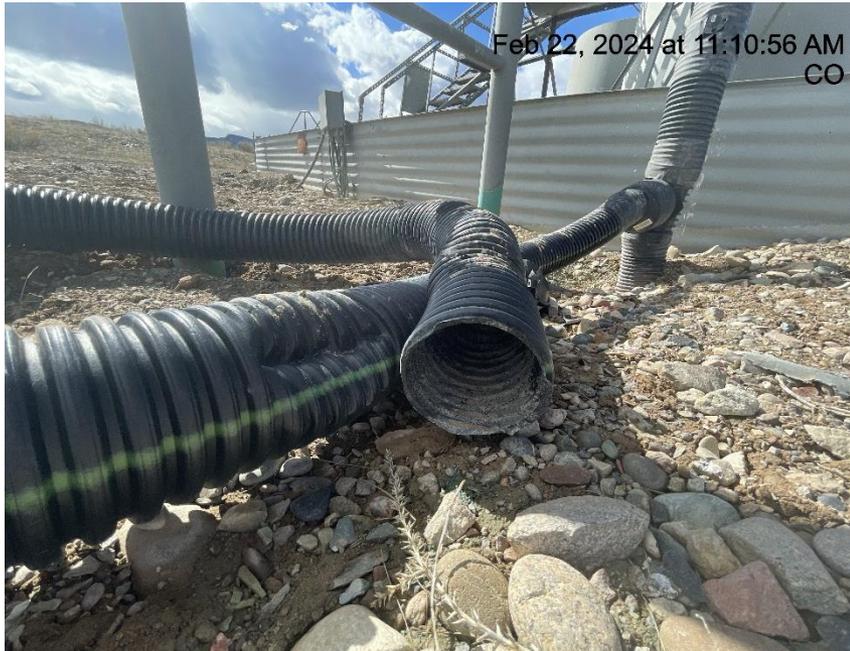
Photo # 7349 Flowline heating insulation open ended/wildlife hazard/available for entry by wildlife

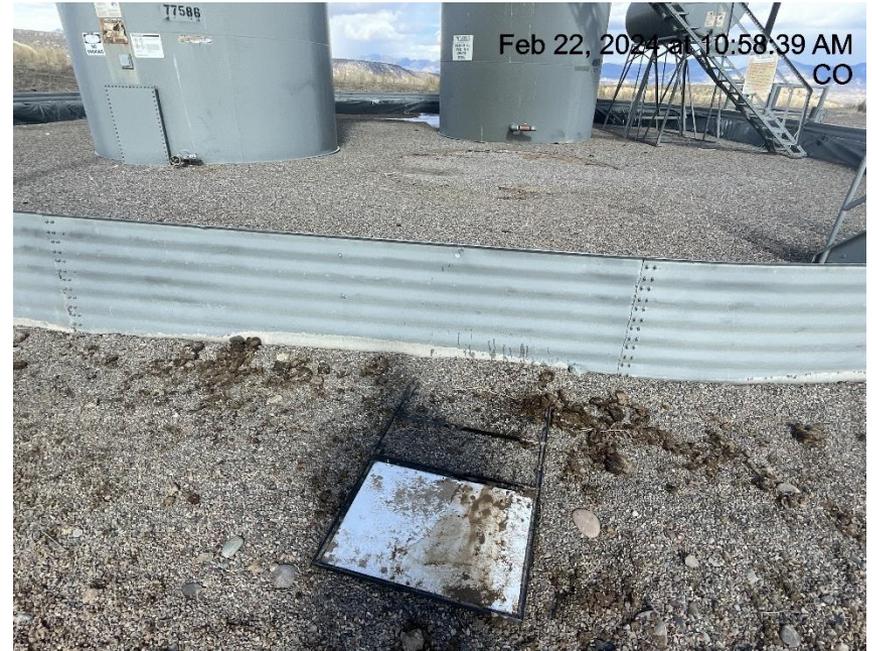
Photo # 7350 Battery sign laying on the ground/sign not properly posted

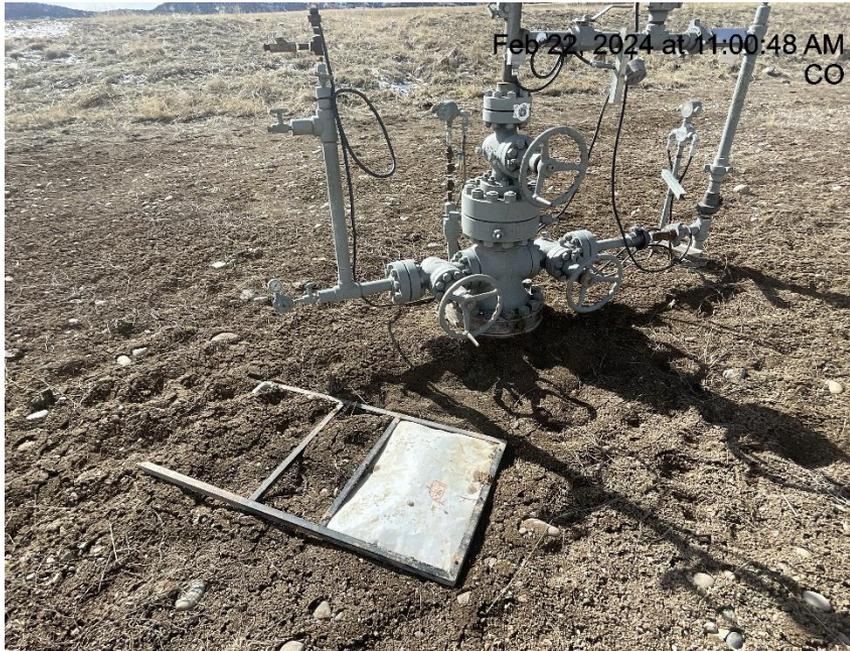
Photo # 7351 Sign laying on the ground

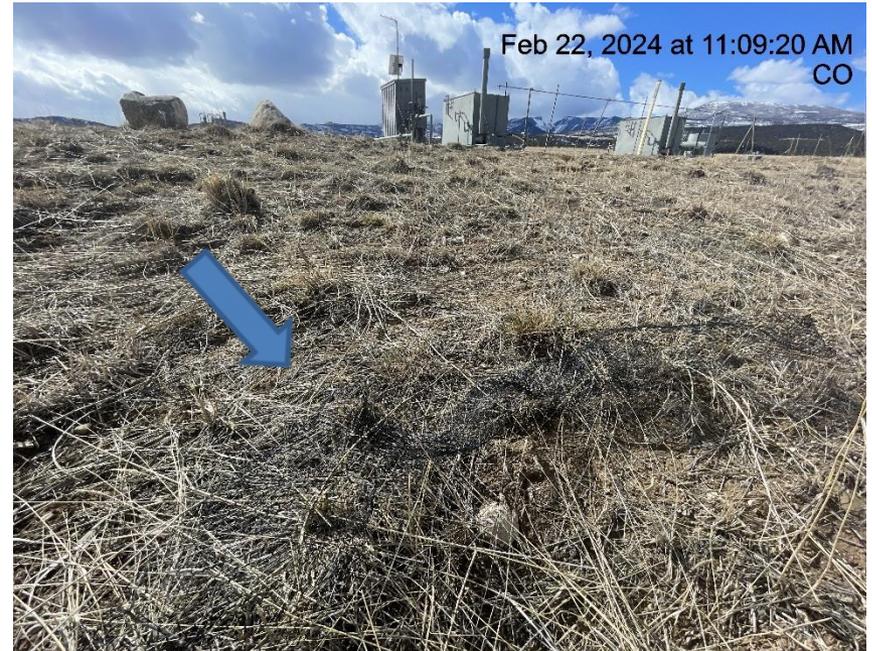
Photo # 7352 Debris

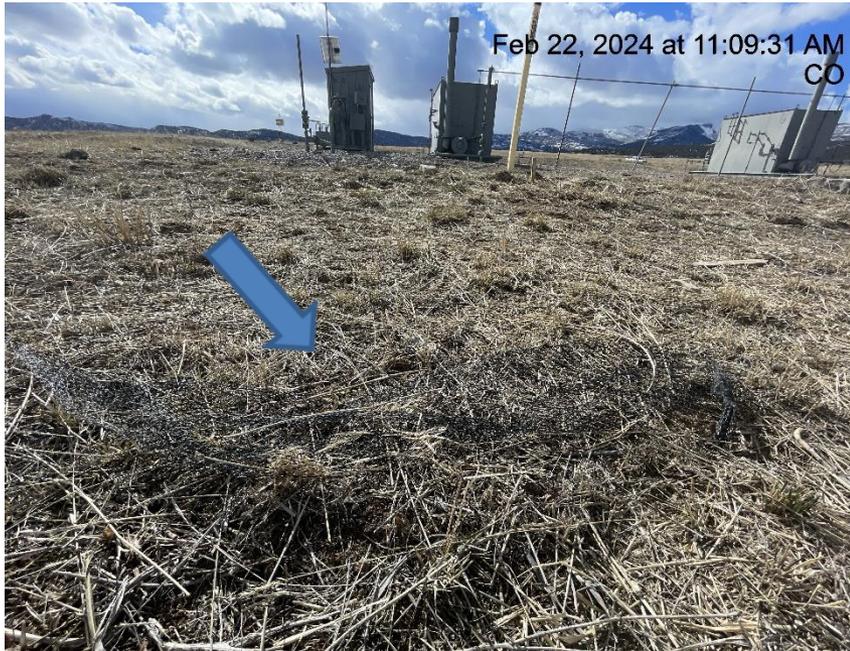
Photo # 7353 Debris

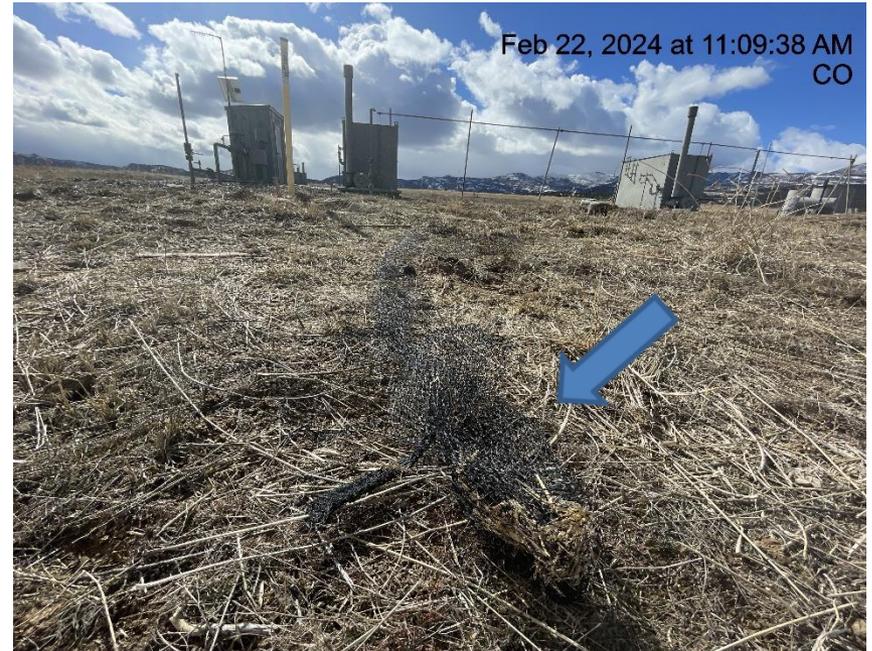
Photo # 7354 Debris

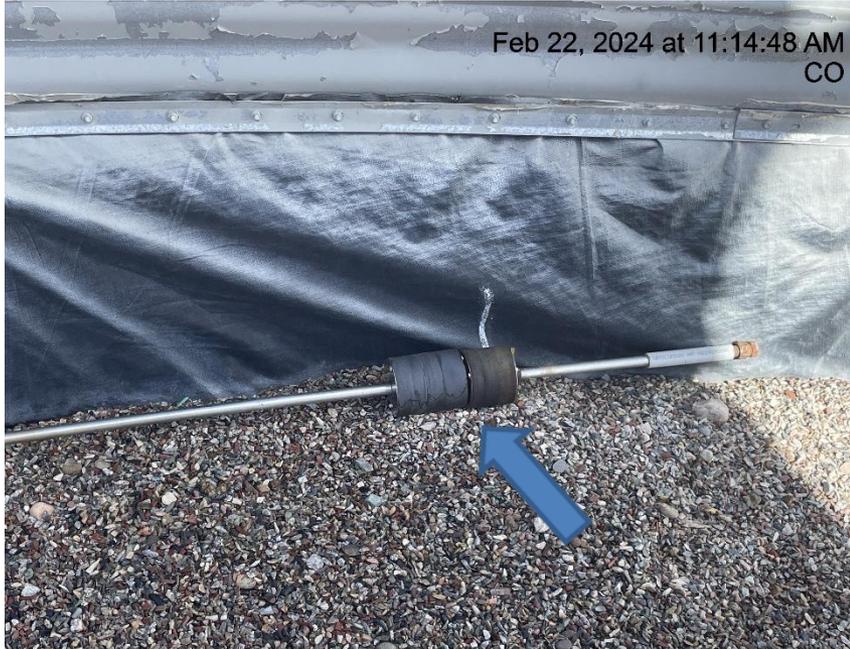
Photo # 7355 Debris
