# Interim Reclamation and Stormwater Inspection

Operator: EXTRACTION OIL & GAS INC - 10459

Location ID: 446906

Inspection Photos  
Location Name: Winder South 9-E Pad  
Location ID: 466906

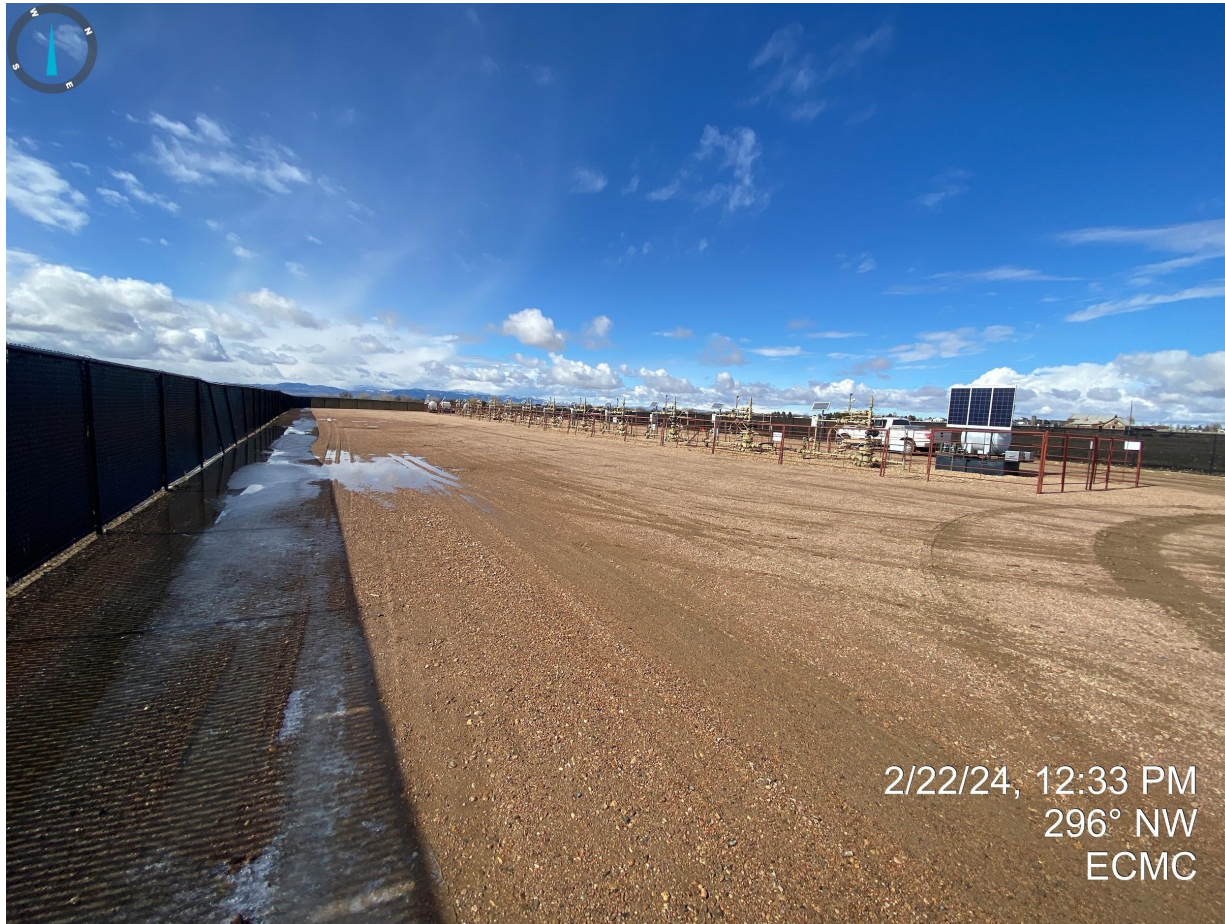
**Photo 1.** Interim reclamation activities have been performed to reduce the size of the pad only needed for production operations.

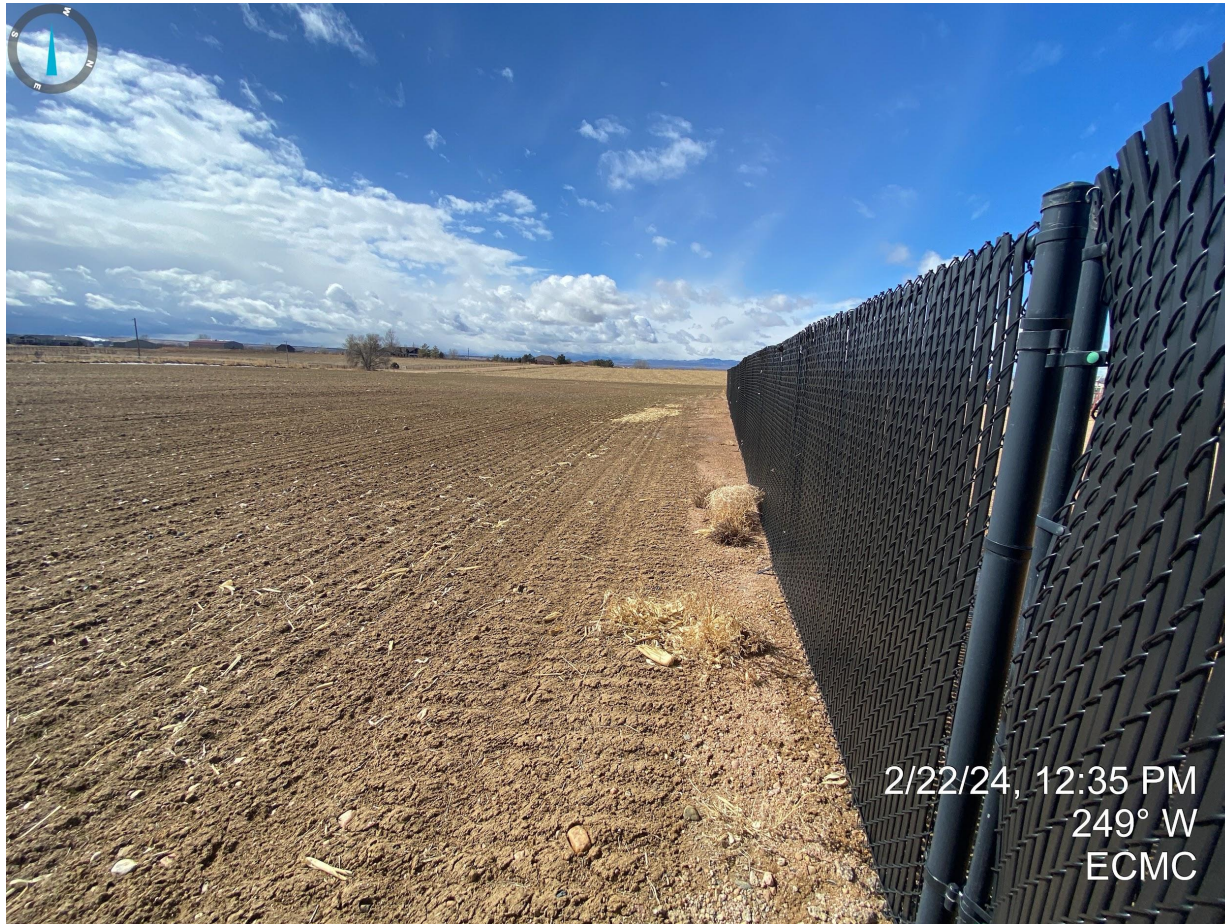
**Photo 2.** South side of location. Interim areas are currently fallow cropland. A future inspection will be conducted during the next growing season to verify vegetative compliance with Rule 1003.

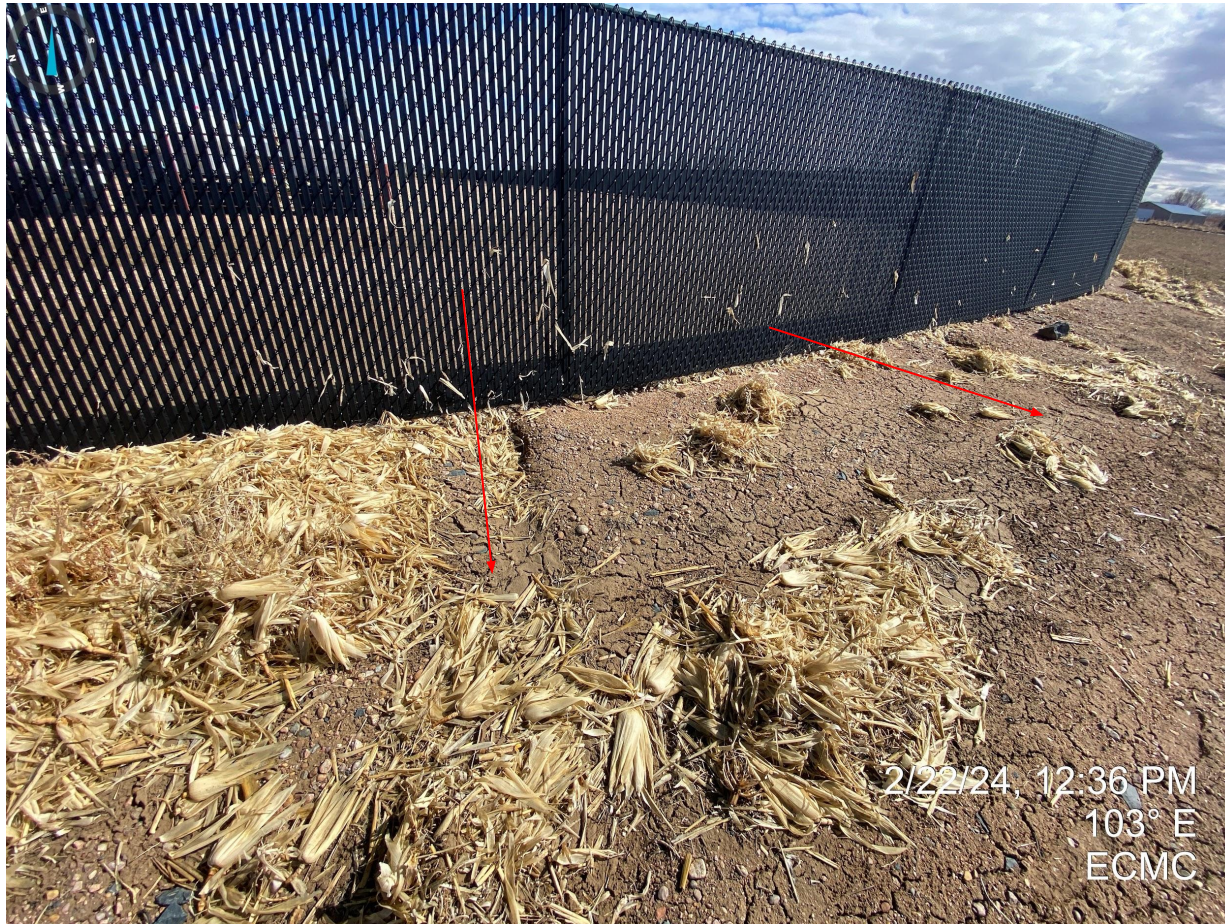
**Photo 3.** Erosion degradation (e.g. riling) observed on the western side of the location. Stormwater control measure/BMPs should be implemented to prevent sediment laden stormwater from exiting off location and into adjacent cropland.

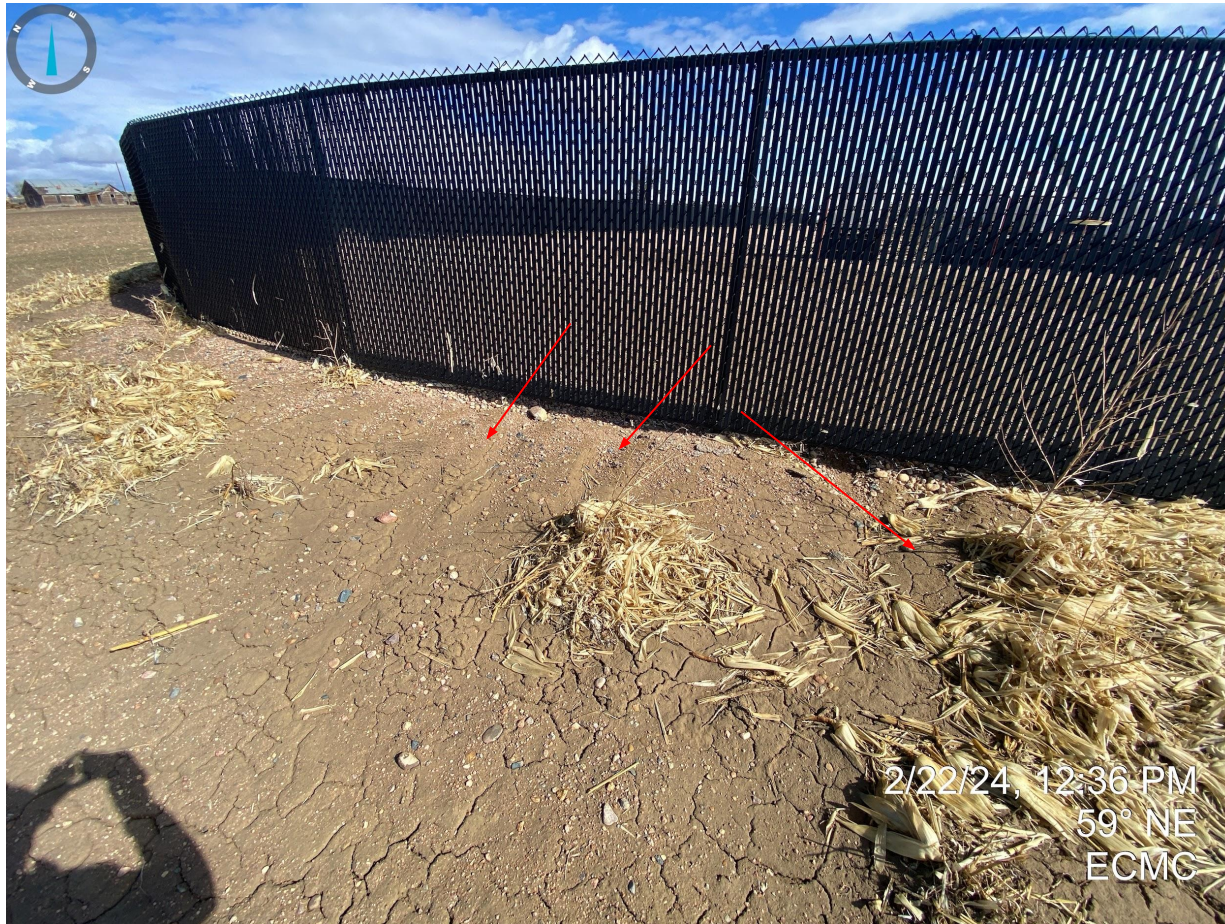
**Photo 4.** West side of location; see comments in Photo 3.

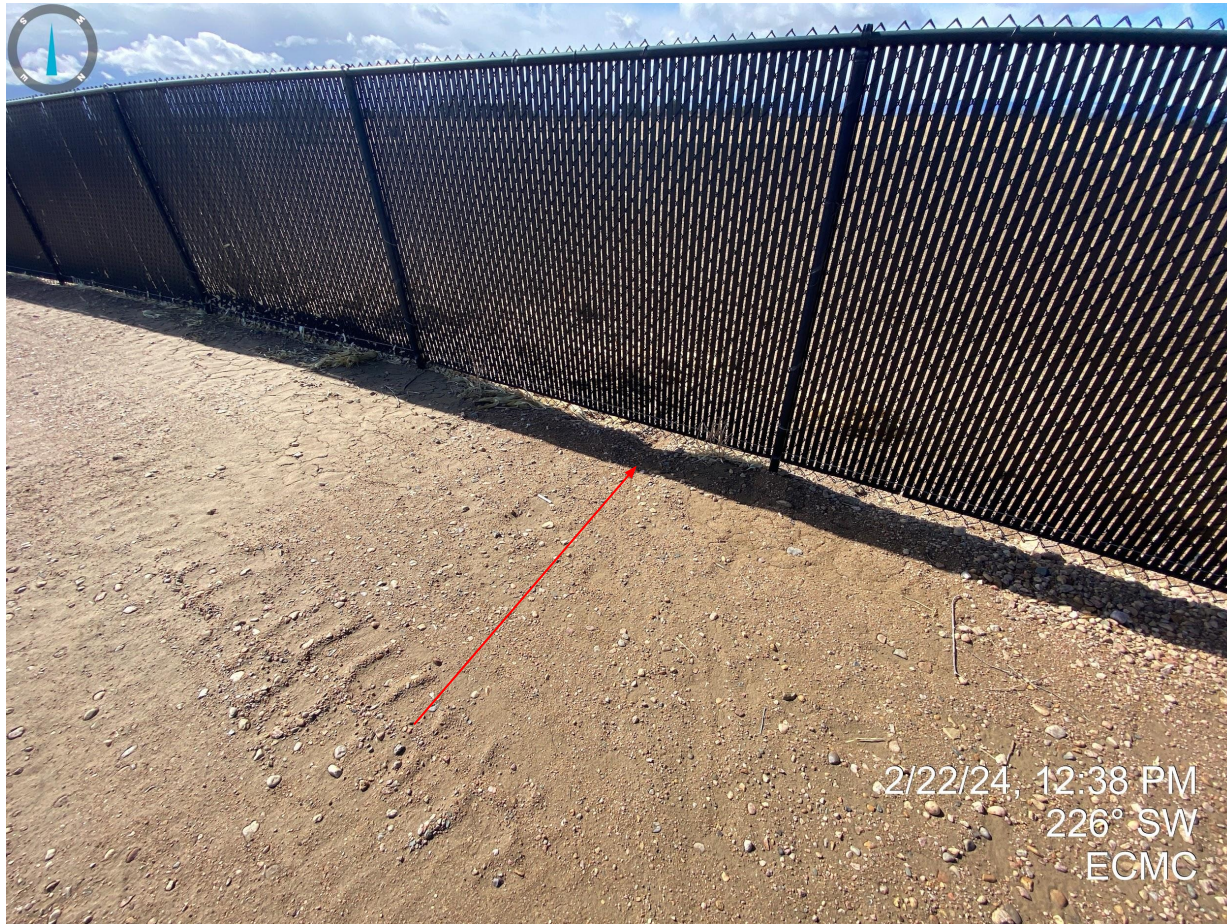
**Photo 5.** Taken from inside of location, west side. See comments in Photo 3.
