# Interim and Stormwater Inspection

February 12, 2023

Operator: GMT Exploration Company LLC - #10243

Location ID: 479194

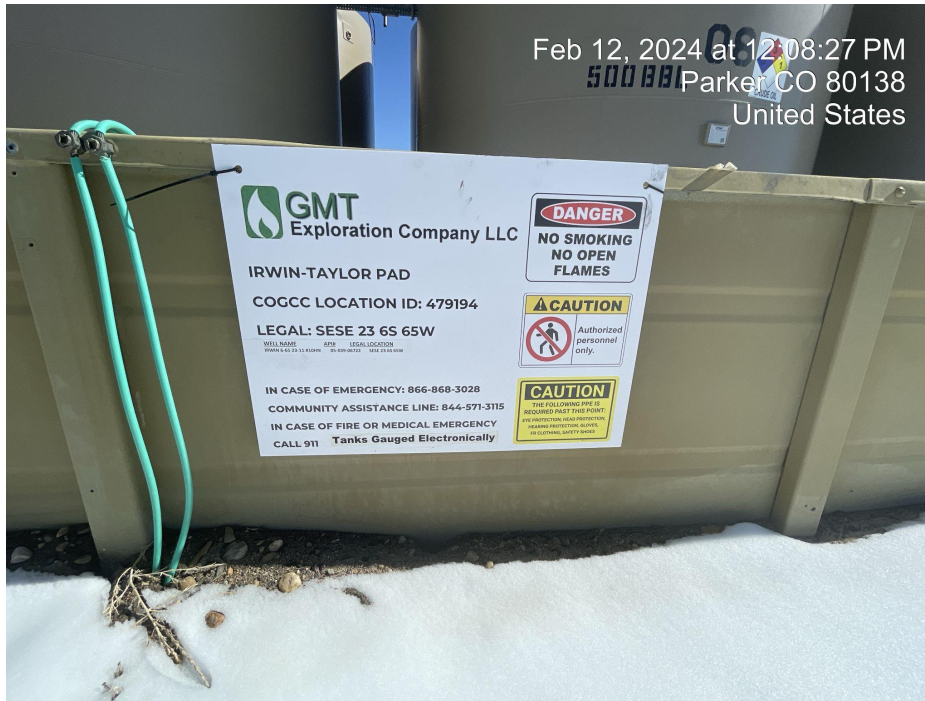
**Photo 1.** Photo taken of location sign.

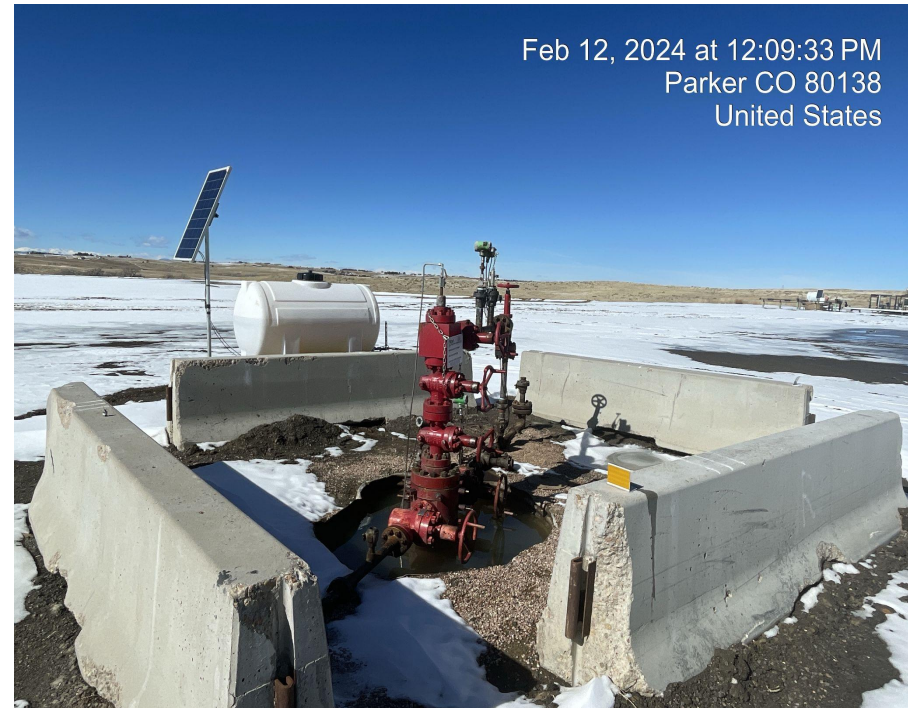
**Photo 2.** Photo taken of wellhead on site. Photo taken facing northeast.

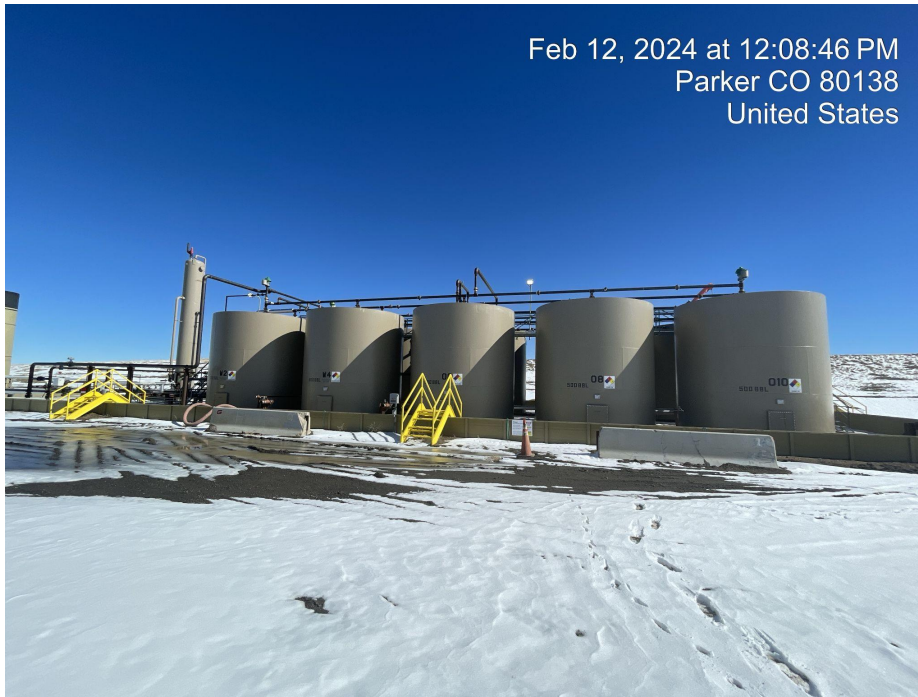
**Photo 3.** Photo taken of tank battery on site. Photo taken facing southeast.

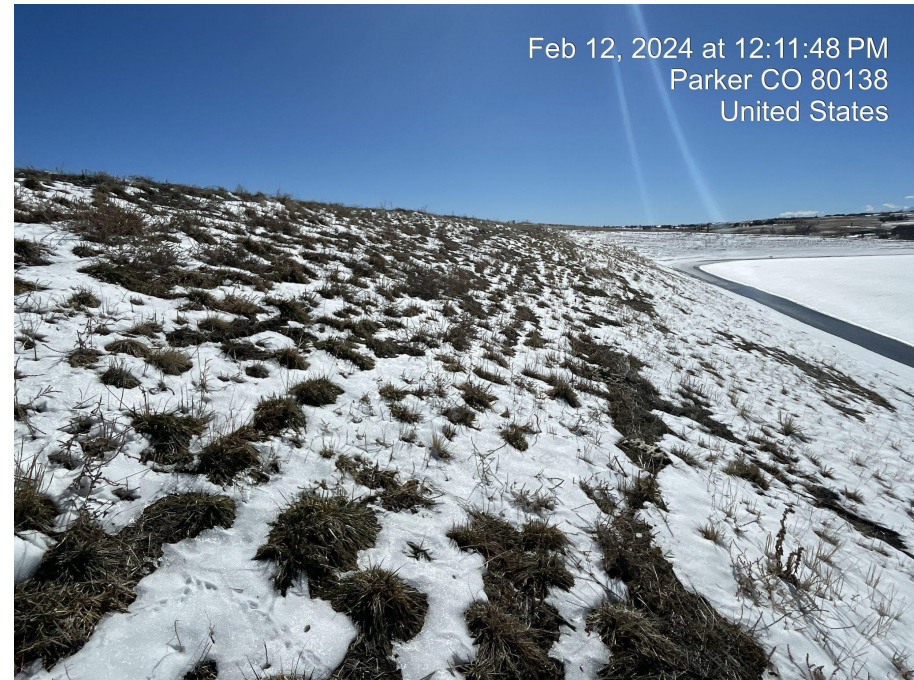
**Photo 4.** Photo taken of vegetation in topsoil stockpile in interim reclaimed area of well pad. Photo taken facing south.

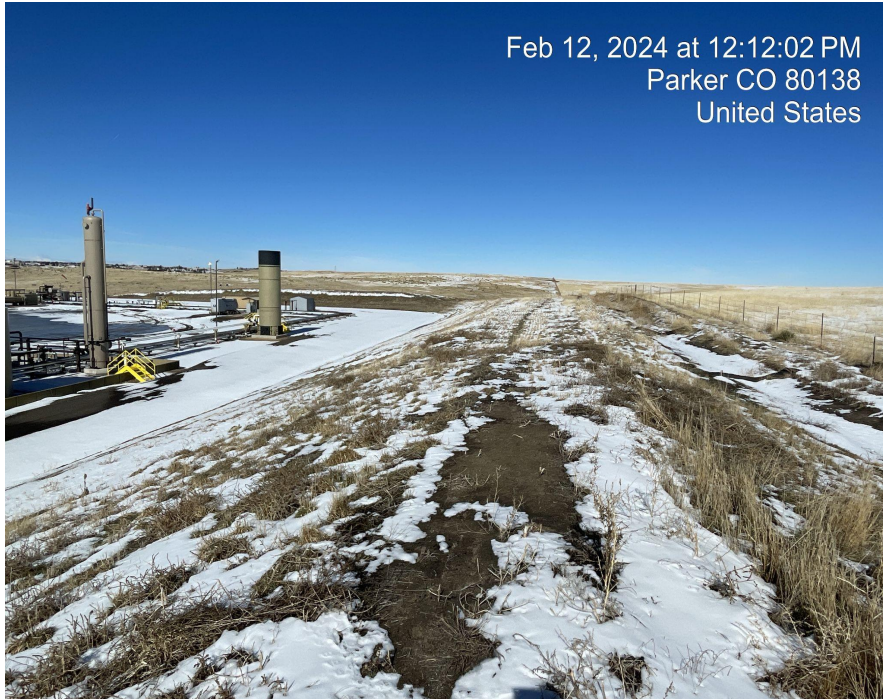
**Photo 5.** Photo taken of vegetation on topsoil stockpile in interim reclaimed area of well pad. Photo taken facing north.

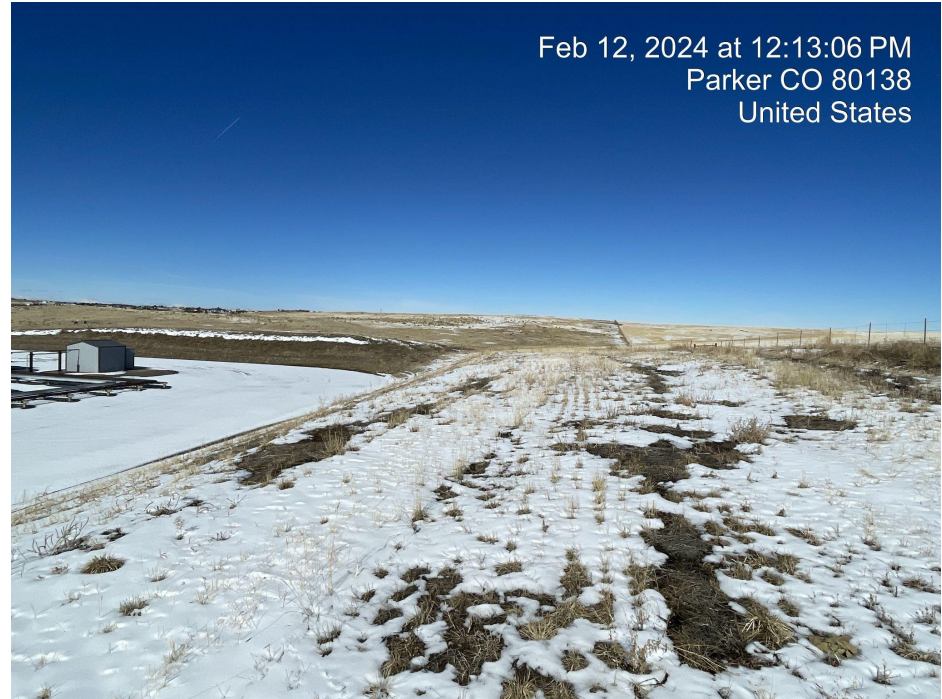
**Photo 6.** Photo taken of vegetation on topsoil stockpile in interim reclaimed area of well pad. Photo taken facing north.

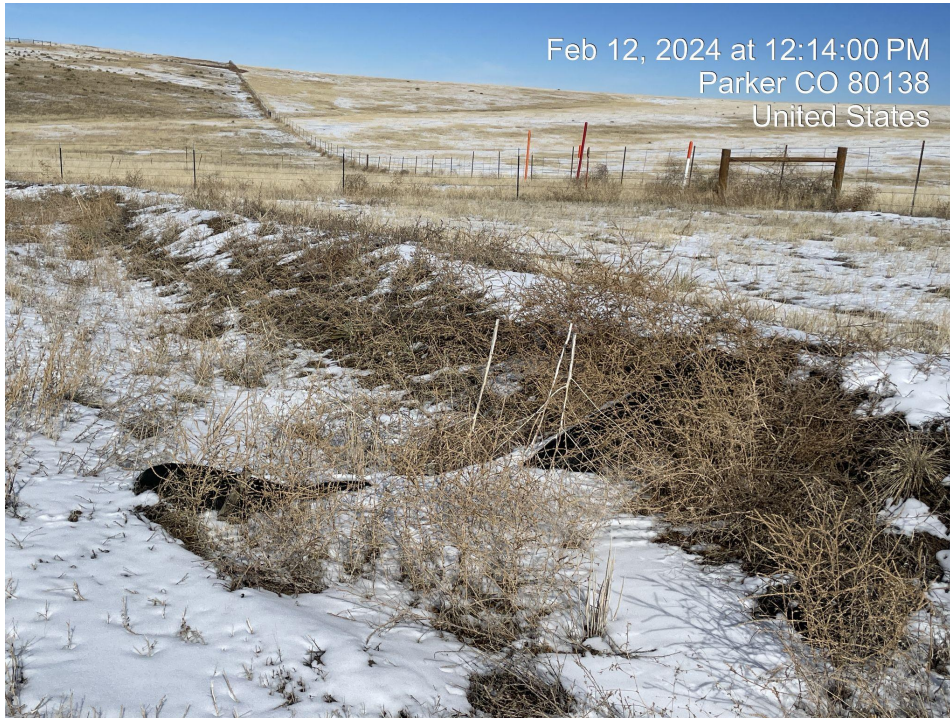
**Photo 7.** Photo of weeds (russian thistle) in perimeter ditch on the east side of site. Photo tank facing north.

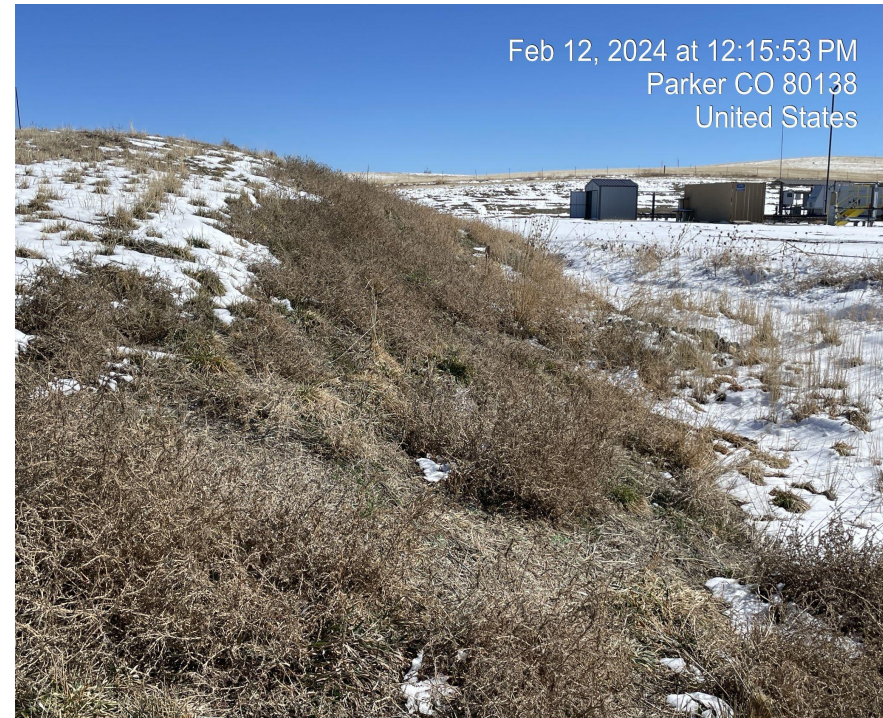
**Photo 8.** Photo of weeds (russian thistle & kochia) on the east side of pad. Photo taken facing south.

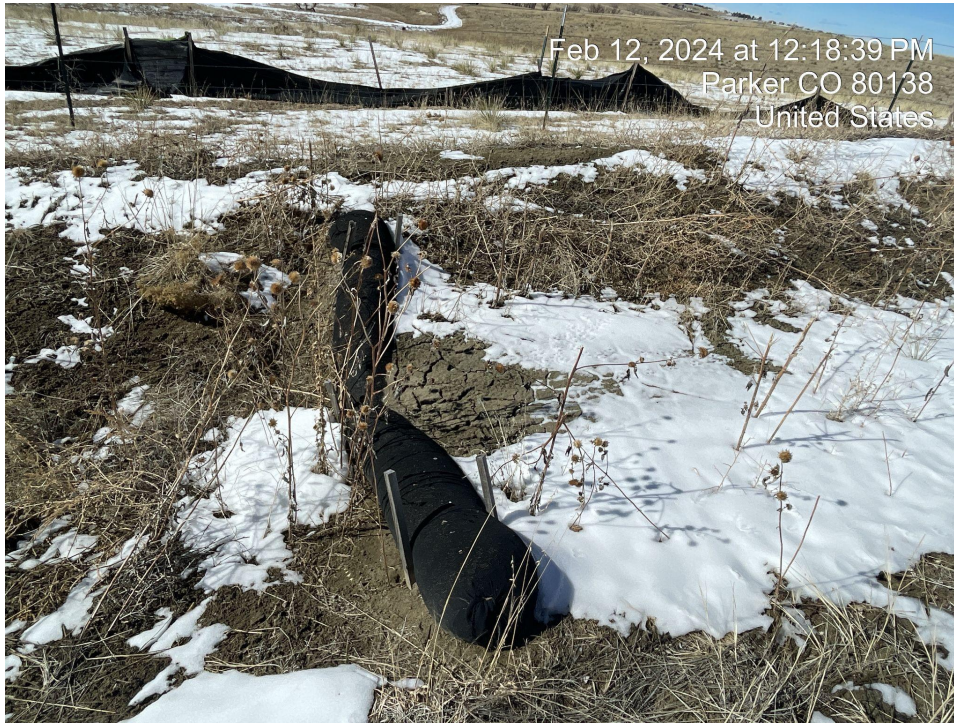
**Photo 9.** Photo of sediment laden check dams in perimeter ditch . Photo tank facing north.

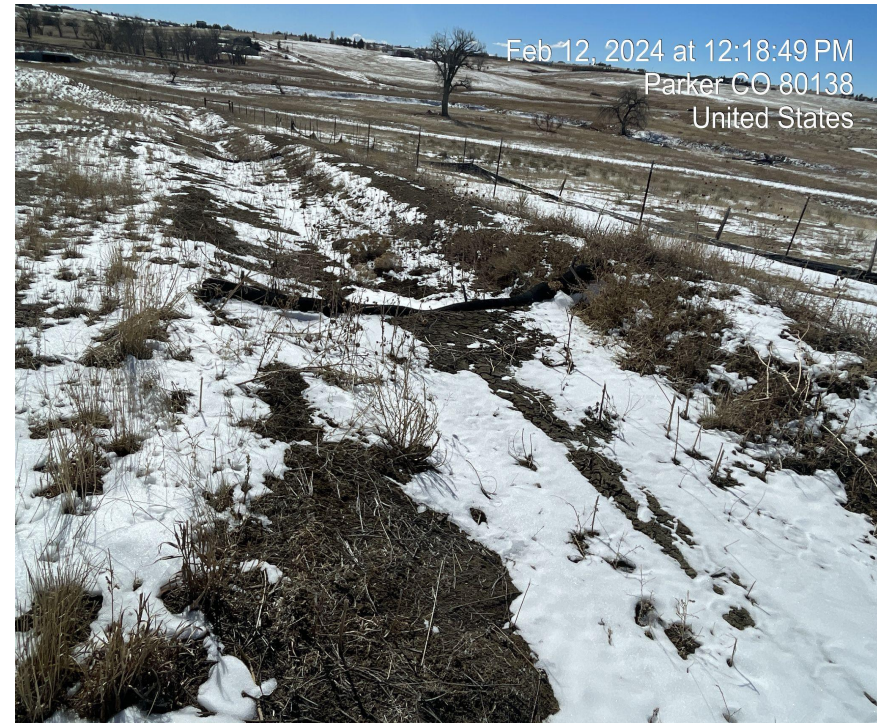
**Photo 10.** Photo of sediment laden check dams in perimeter ditch . Photo tank facing west.

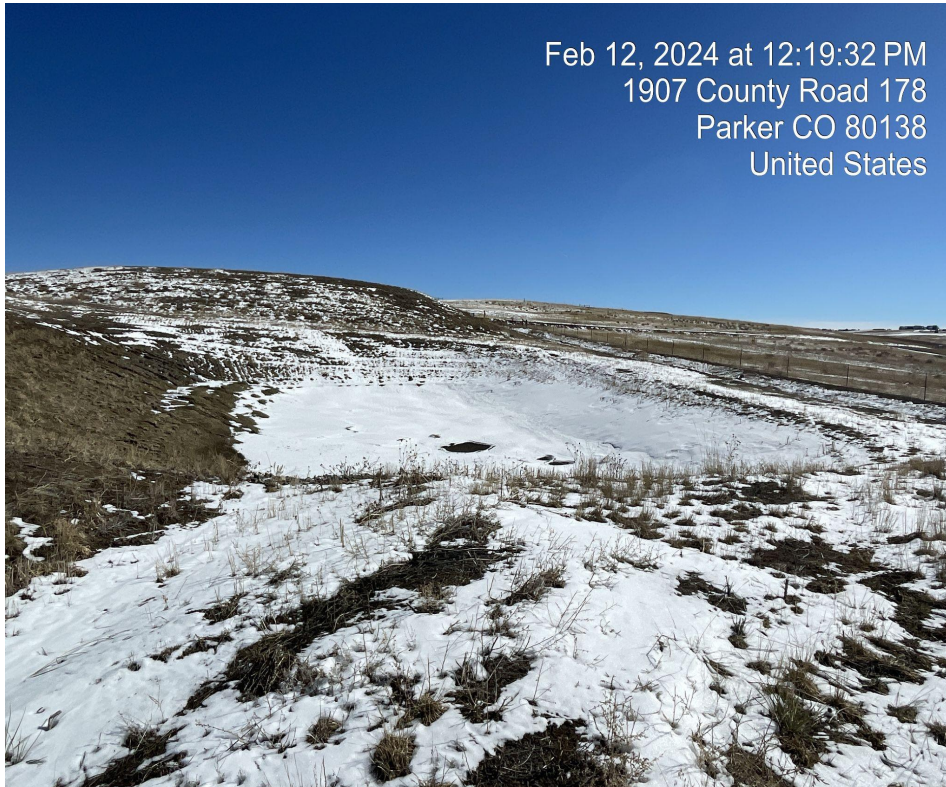
**Photo 11.** Photo of large sediment basin on north side of pad.  
Photo taken facing west.

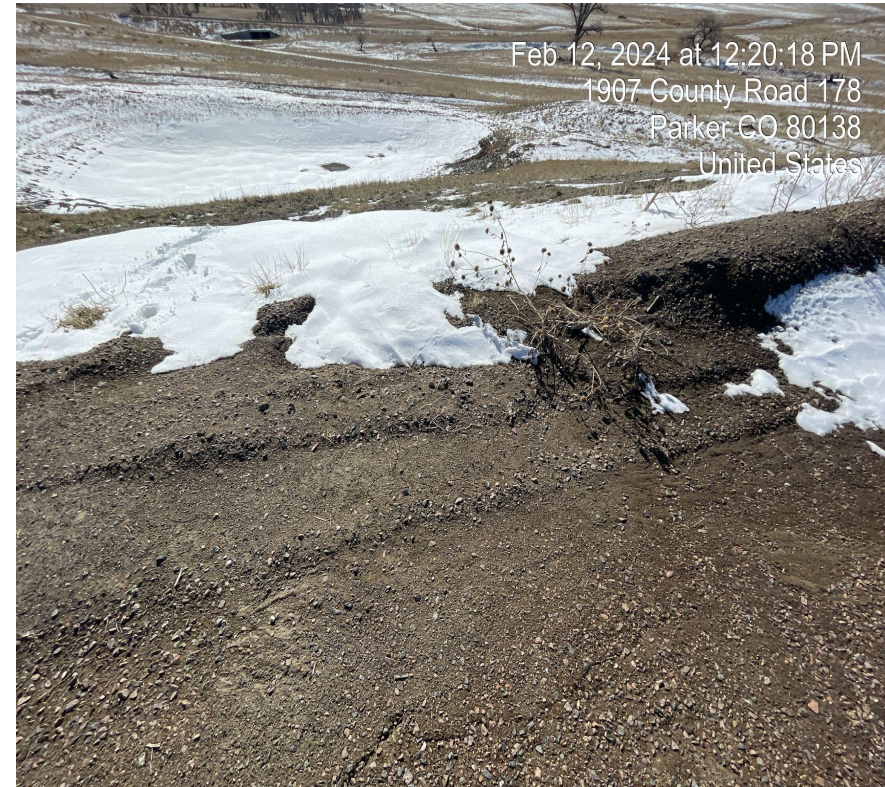
**Photo 12.** Photo of reeling in pad perimeter on the west side of pad. Photo taken facing west.
