Operator: Extraction Oil and Gas
Location Name: Winder South 9-E Pad
Loc ID: 446906
Inspection: 708200940

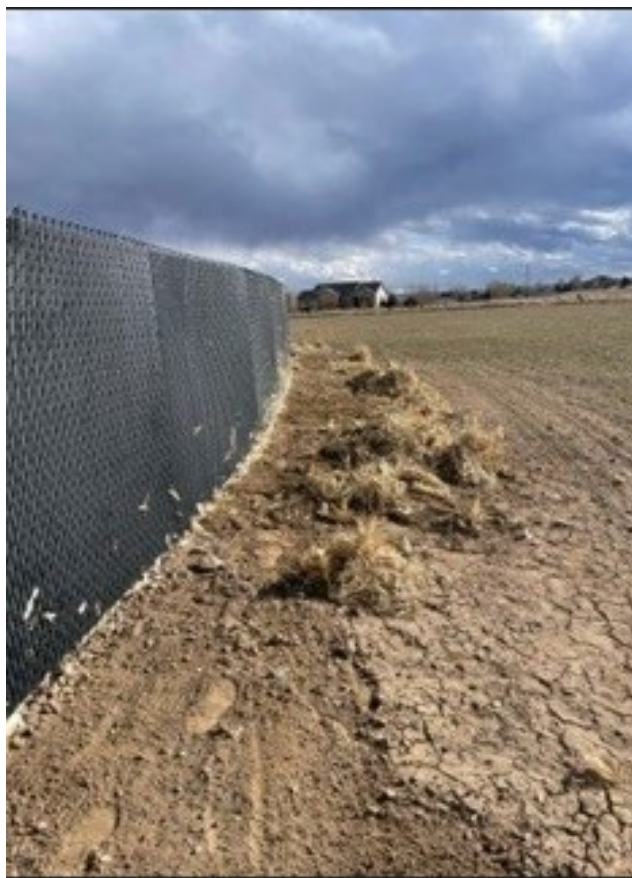
Exhibit A

CA: This location does not comply with Rule 1002.f. During this inspection, Staff observed erosion degradation (e.g. riling) occurring on the west side of the production areas. Stormwater control measures/BMPs should be implemented to prevent stormwater runoff, and sediment, from entering adjacent cropland. Refer to attached inspection photos. Install or repair required BMPs per Rule 1002.f.

CA Resolution: BMPs have been repaired to comply with Rule 1002.f.
