Inspection Photos

Location Name: CAERUS PICEANCE LLC GMU 23-14 (C26NW) Pad

Location #: 335163

COLORADO
Energy & Carbon Management
Commission
Department of Natural Resources

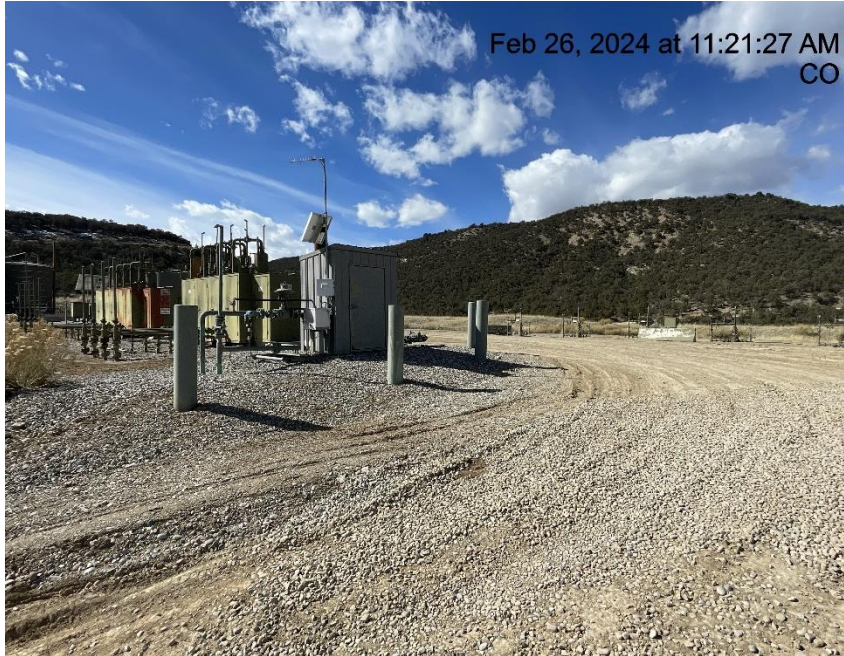
Photo # 7570 From entrance to location

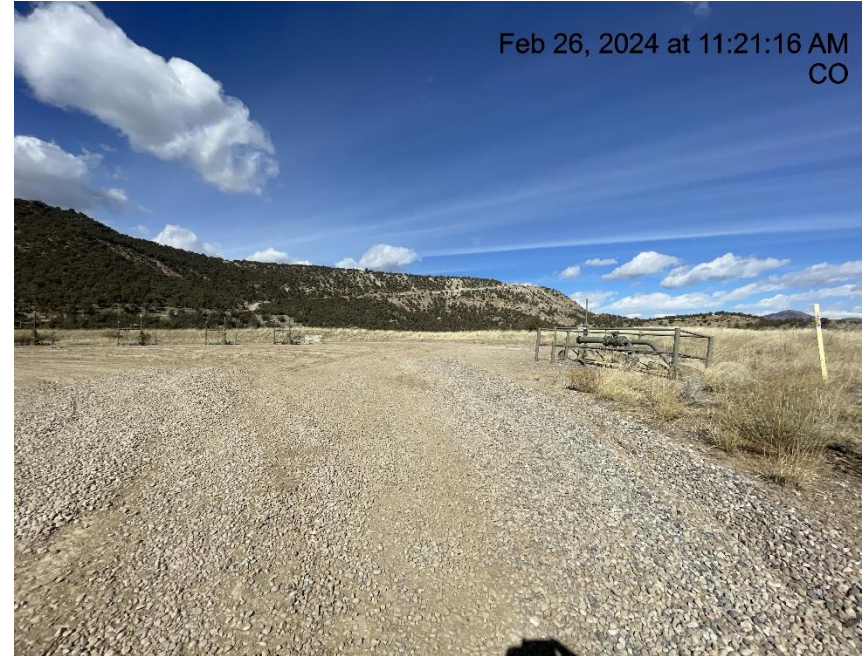
Photo # 7571 From entrance to location

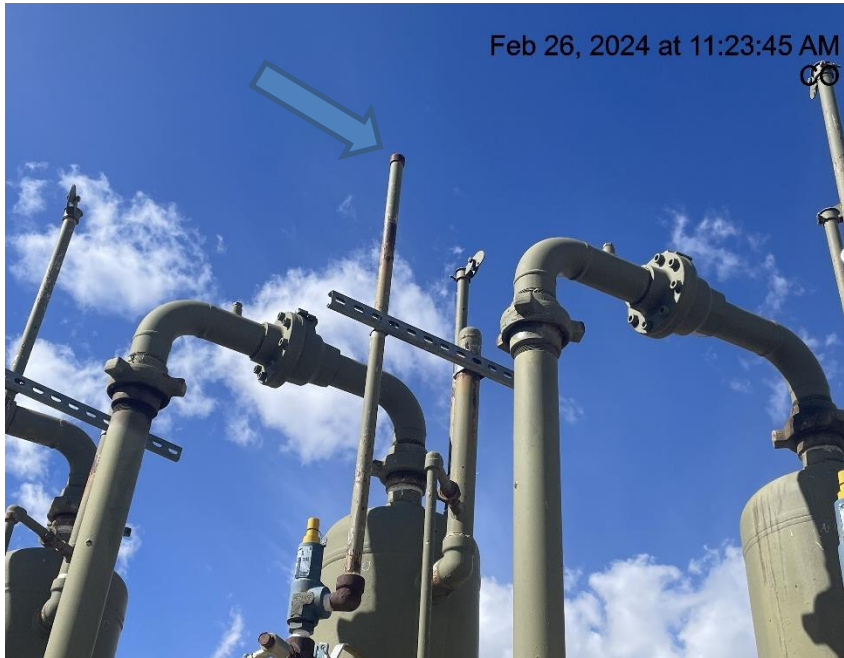
Photo # 7582 PRV vent line lacks cap

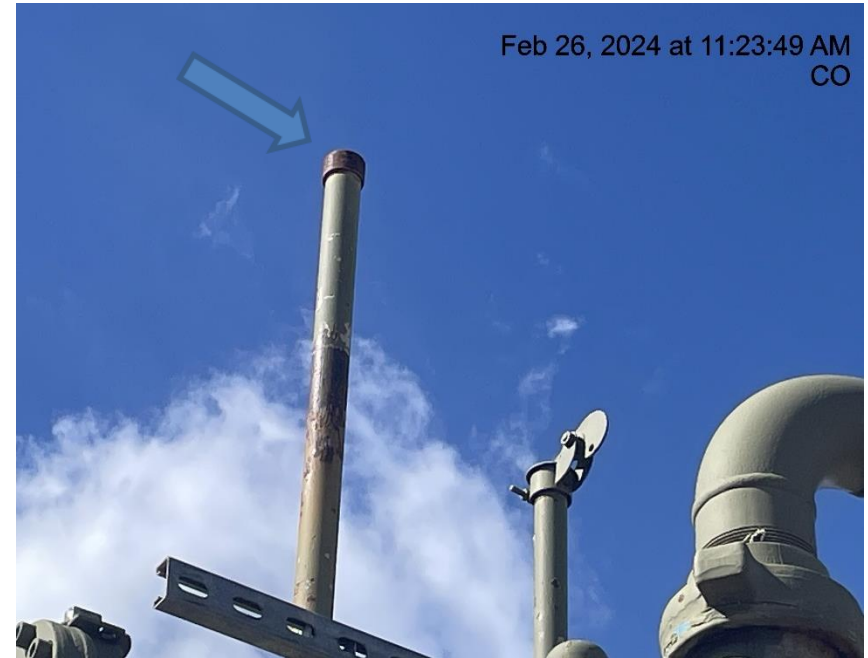
Photo # 7583 PRV vent line lacks cap

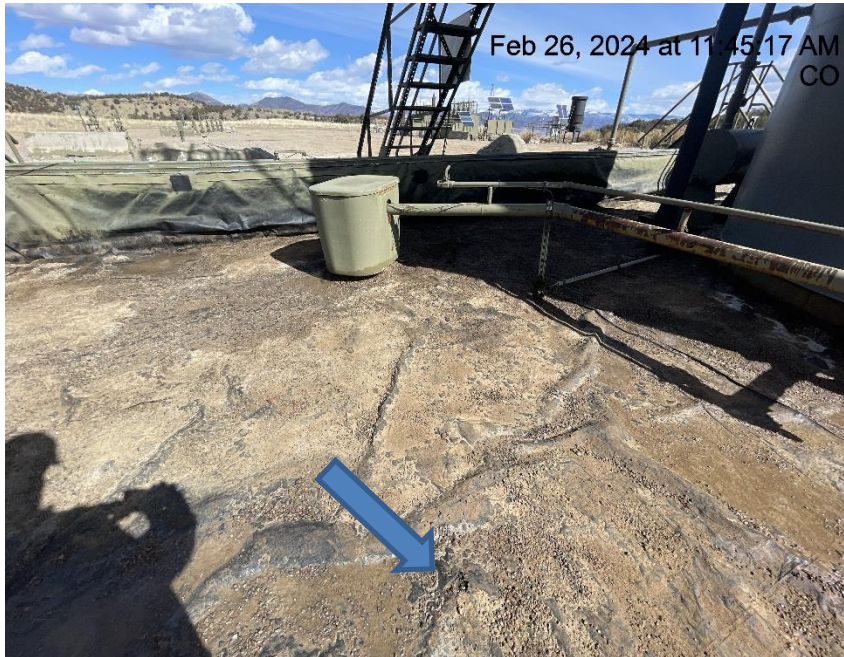
Photo # 7584 Hole in liner/liner needs maintenance

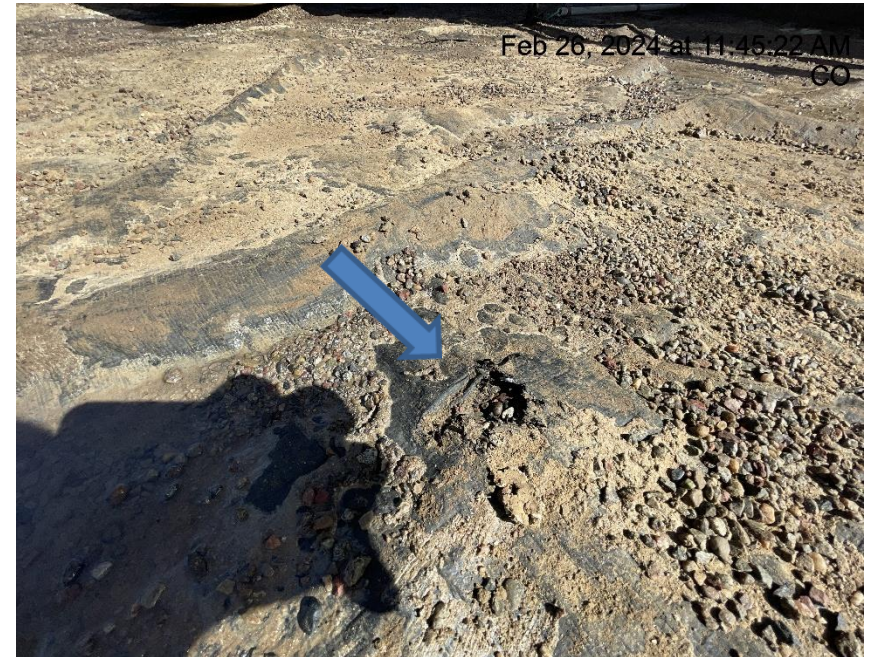
Photo # 7585 Hole in liner/liner needs maintenance

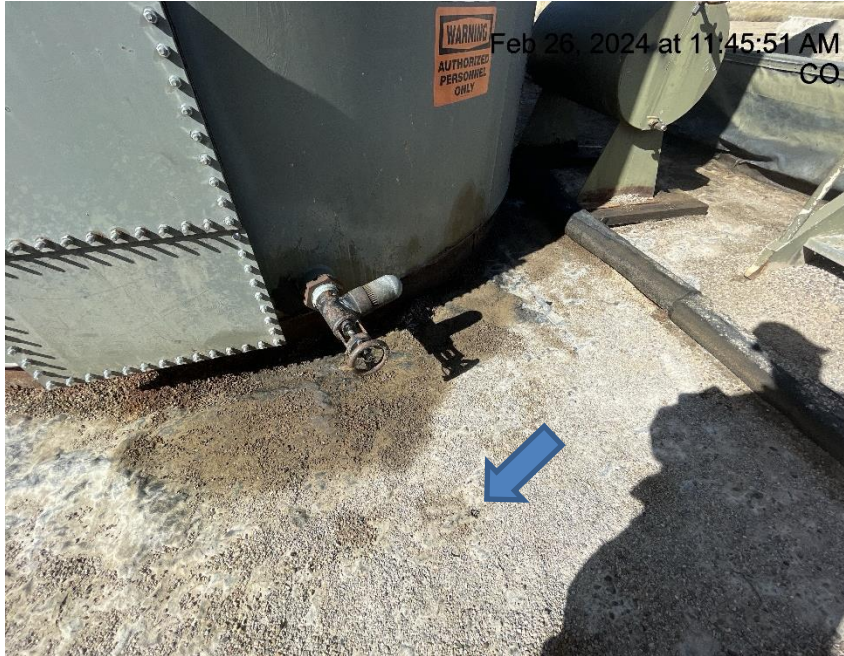
Photo # 7586 Hole in liner/liner needs maintenance

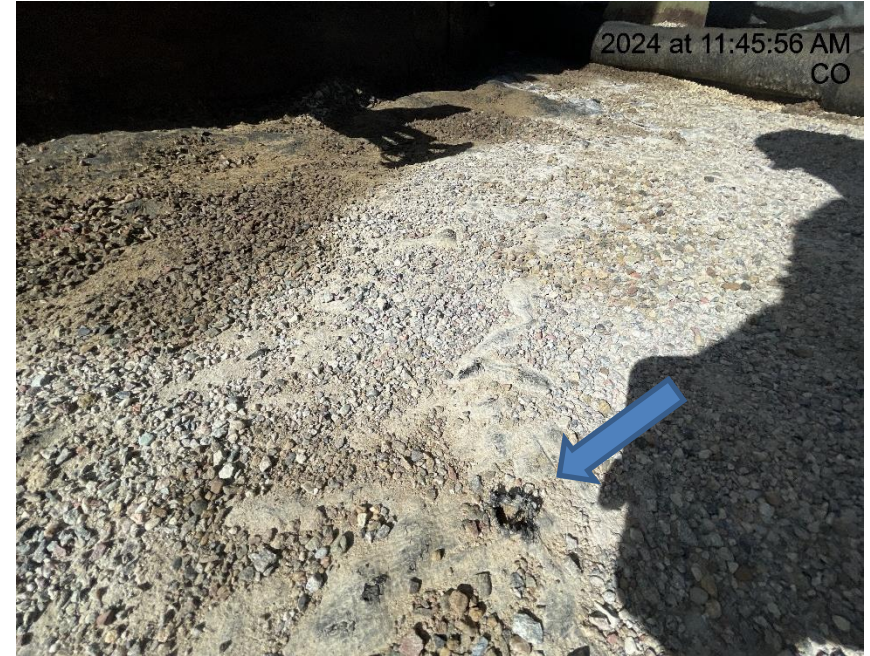
Photo # 7587 Hole in liner/liner needs maintenance

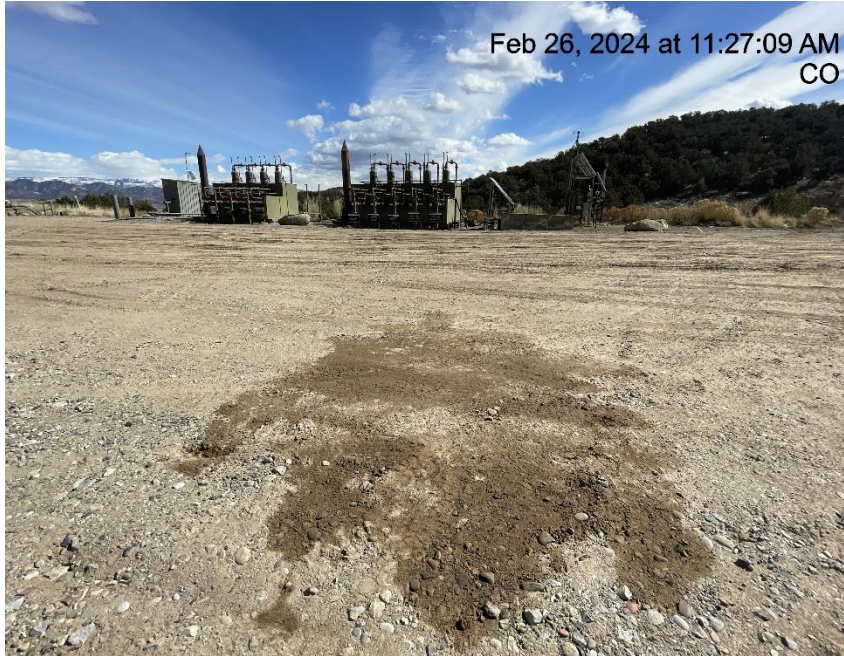
Photo # 7588 Stained soils & gravel

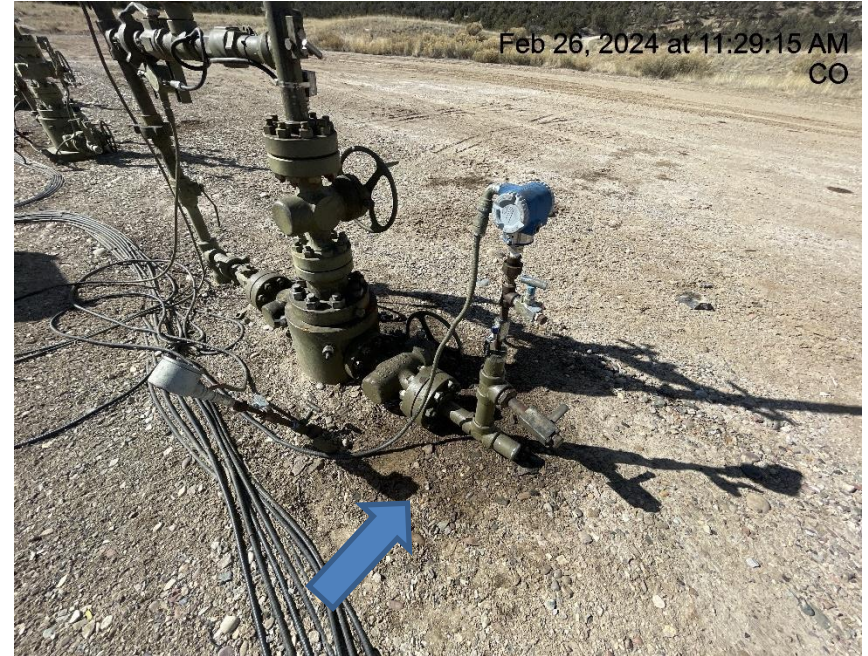
Photo # 7589 Stained soils & gravel

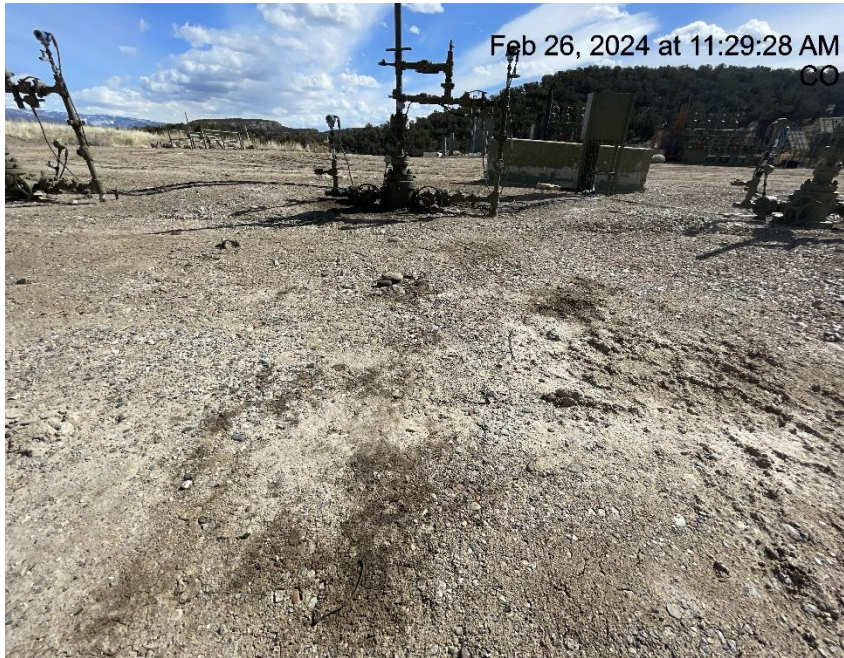
Photo # 7590 Stained soils & gravel

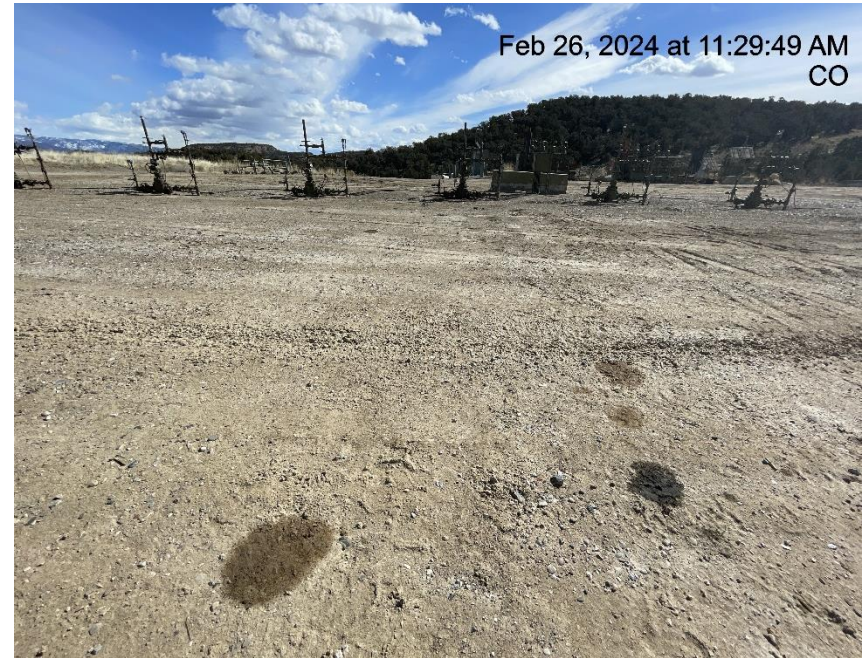
Photo # 7591 Stained soils & gravel

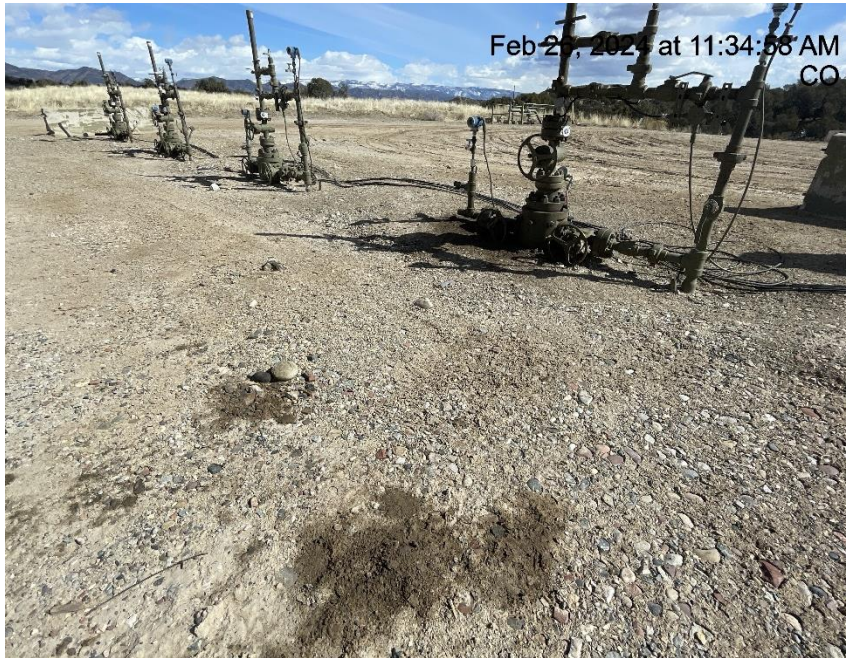
Photo # 7592 Stained soils & gravel

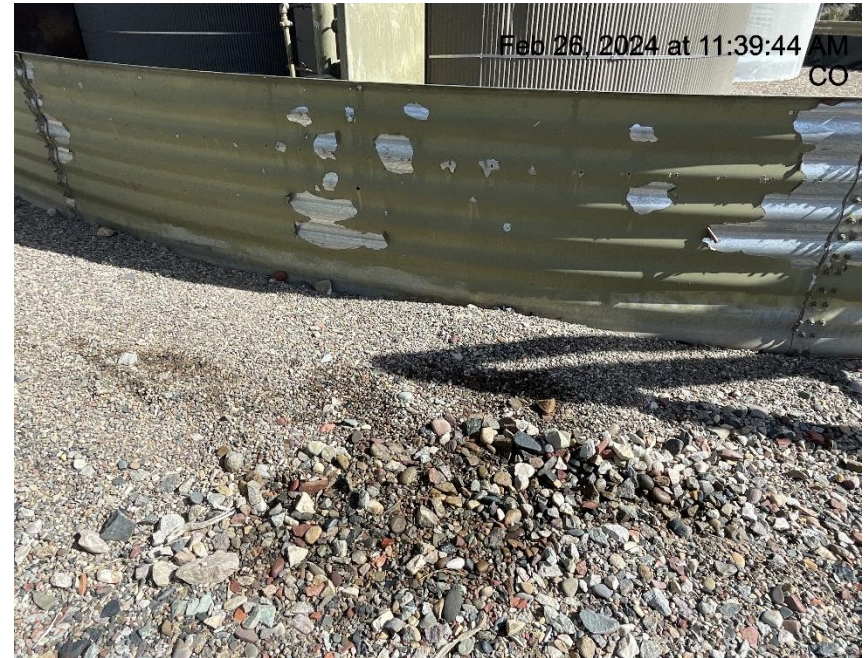
Photo # 7593 Stained soils & gravel
