WELL NAME: CARIBOU 42-32, API #: 071-08763, INSP. # 695109160

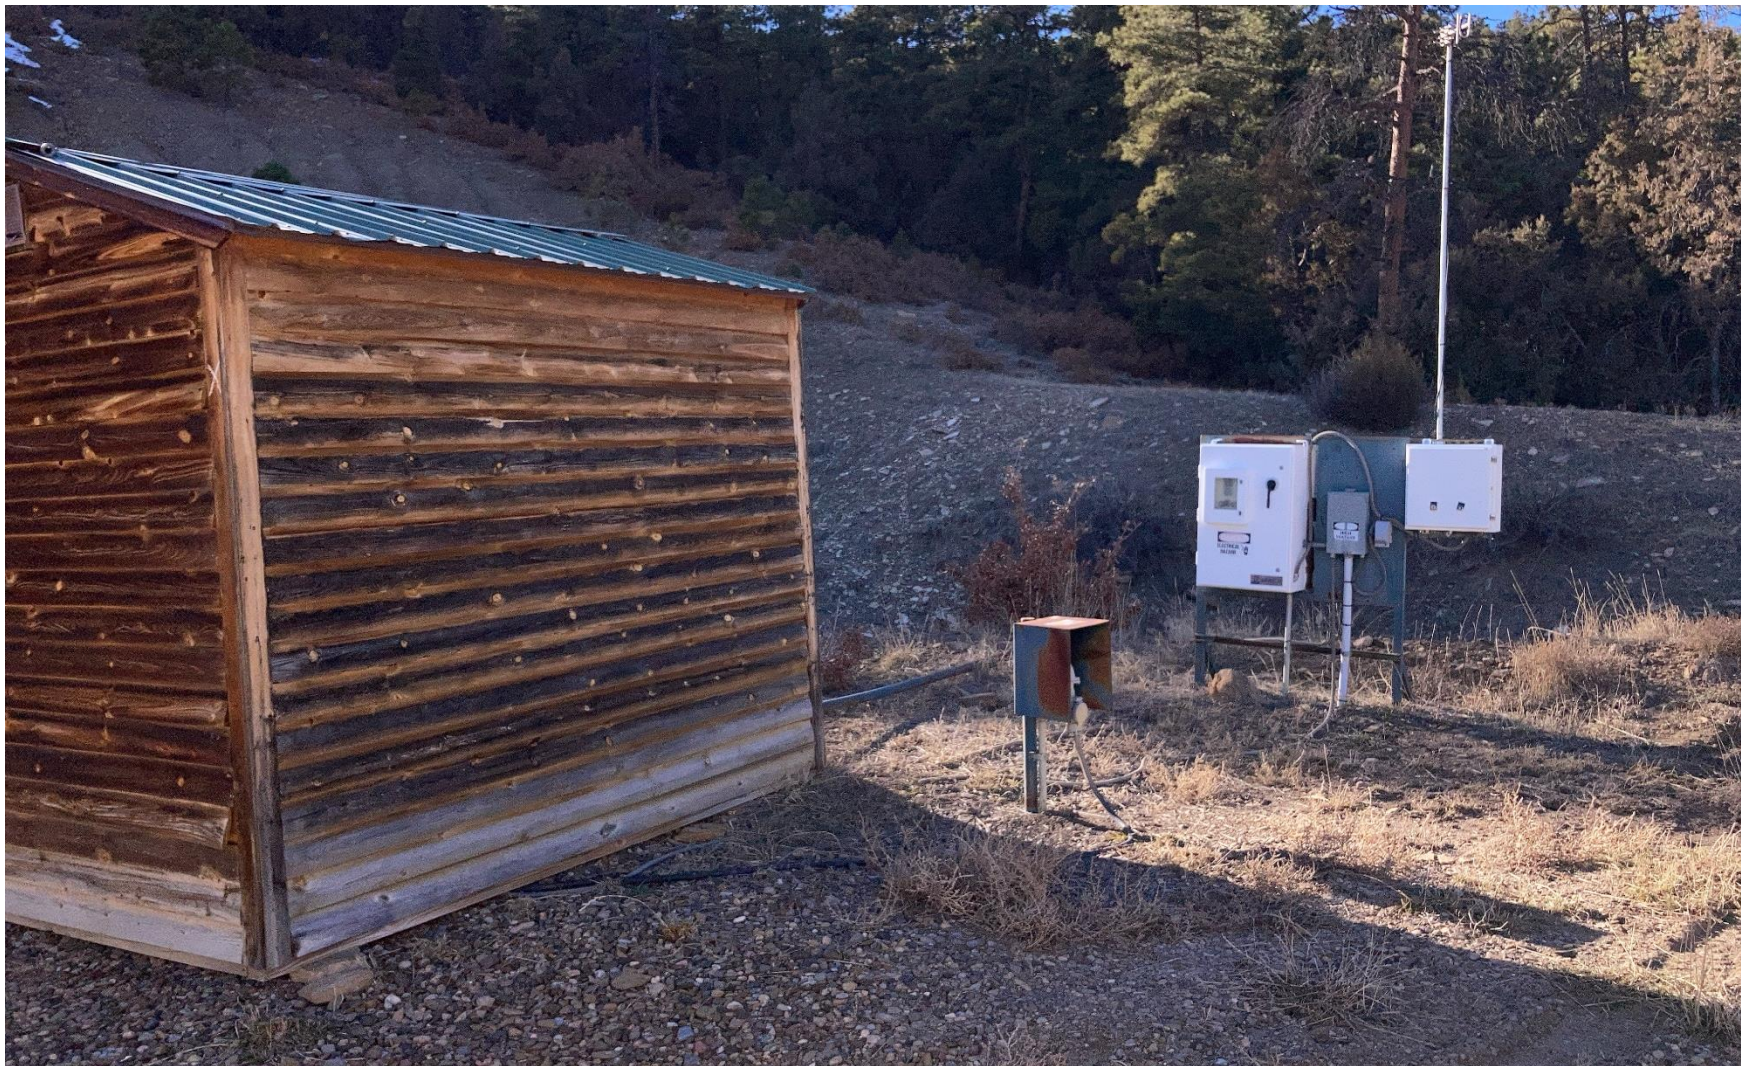
PHOTO 2: LOCATION

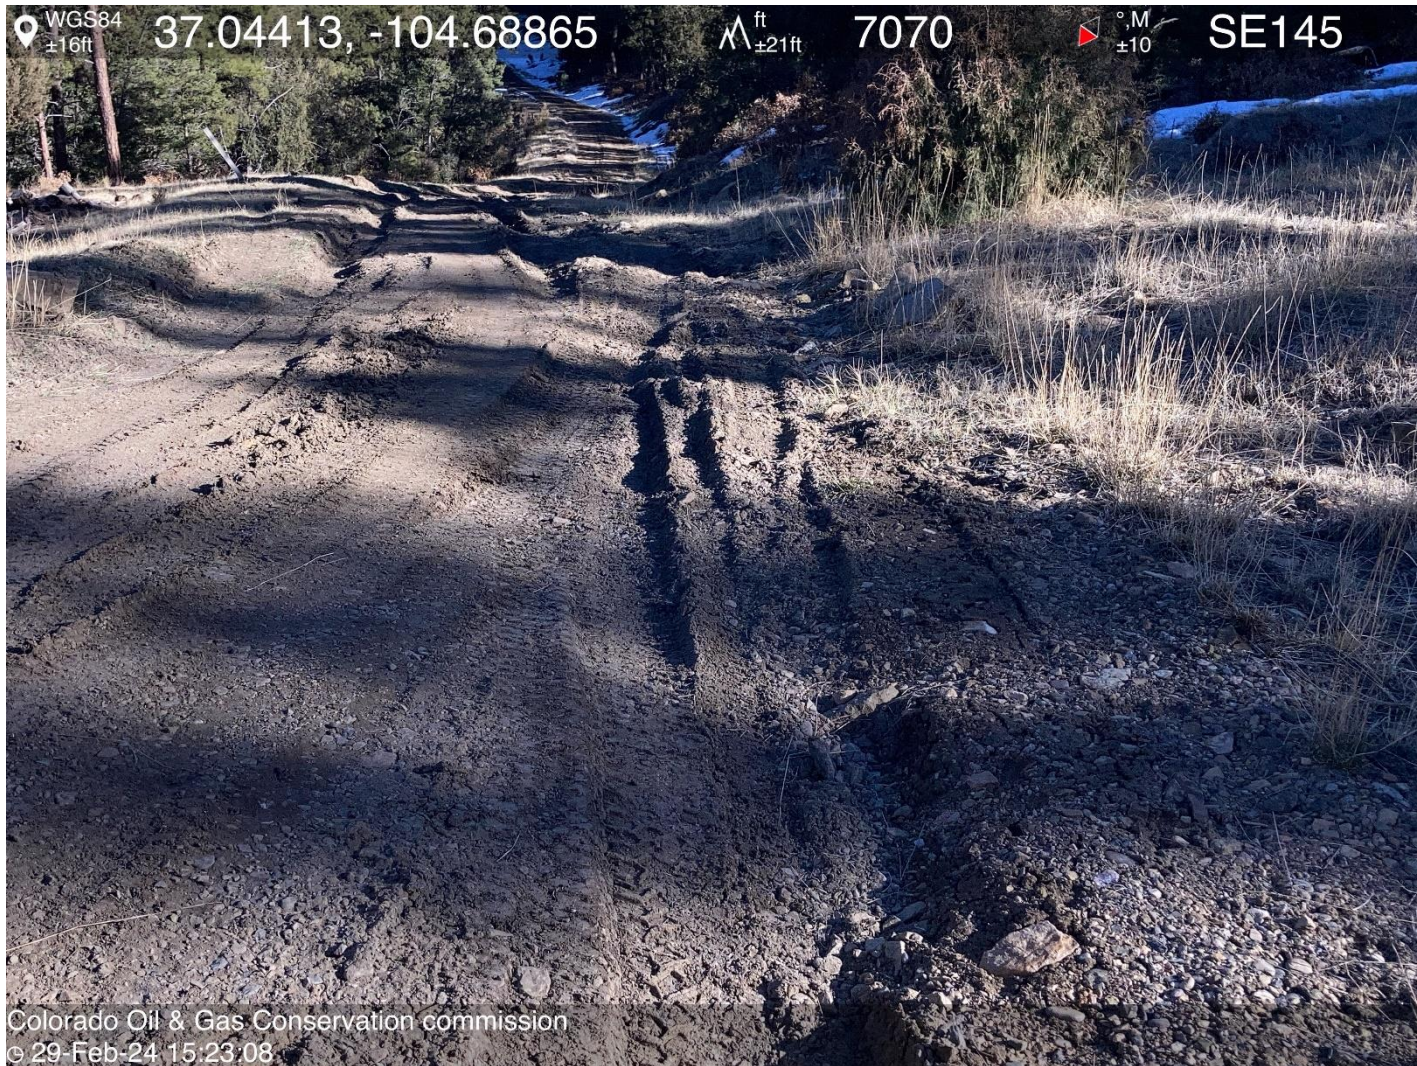
PHOTO 4: BMP'S ALONG ROW ARE NOT ADEQUATE OR HAVE FAILED, EROSION AND COMPACTION ISSUES CAUSING HEAVE TRENCHING ON ROW. REPAIR OR INSTALL AND MAINTAIN PROPER EROSION AND MIGRATION BMP'S PER RULE 1002. CA DATE 3-29-2024.
