Inspection Photos

Location Name: CAERUS PICEANCE LLC ALP Fee 24-6B (J24NW) Pad

Location #: 335058

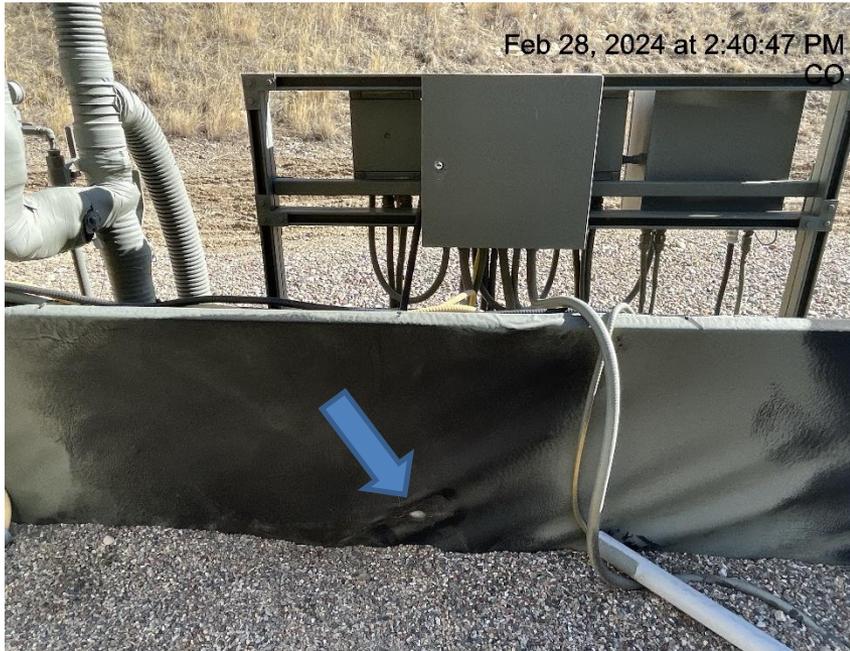
Photo # 7839 Hole in containment liner/liner needs maintenance

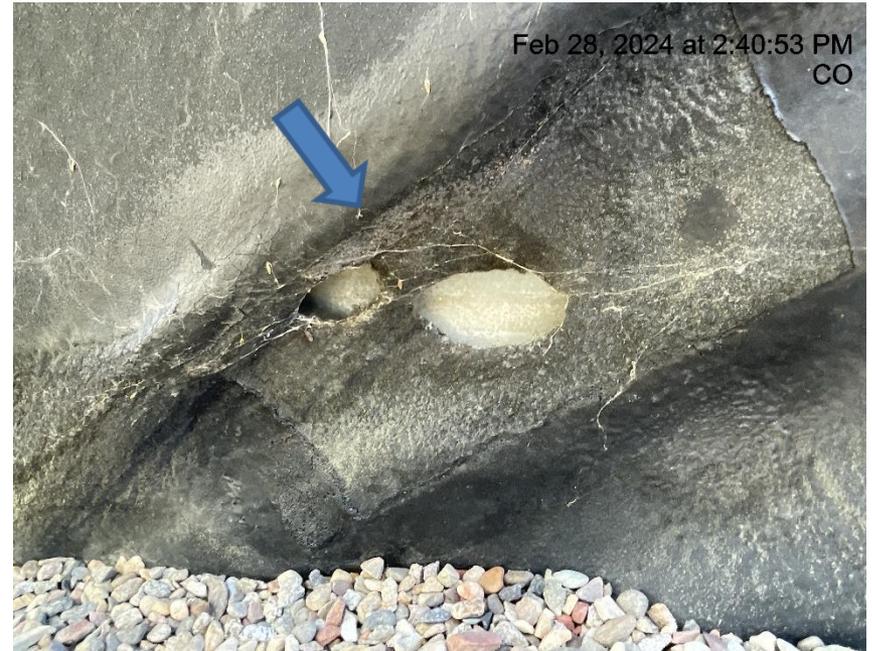
Photo # 7840 Hole in containment liner/liner needs maintenance

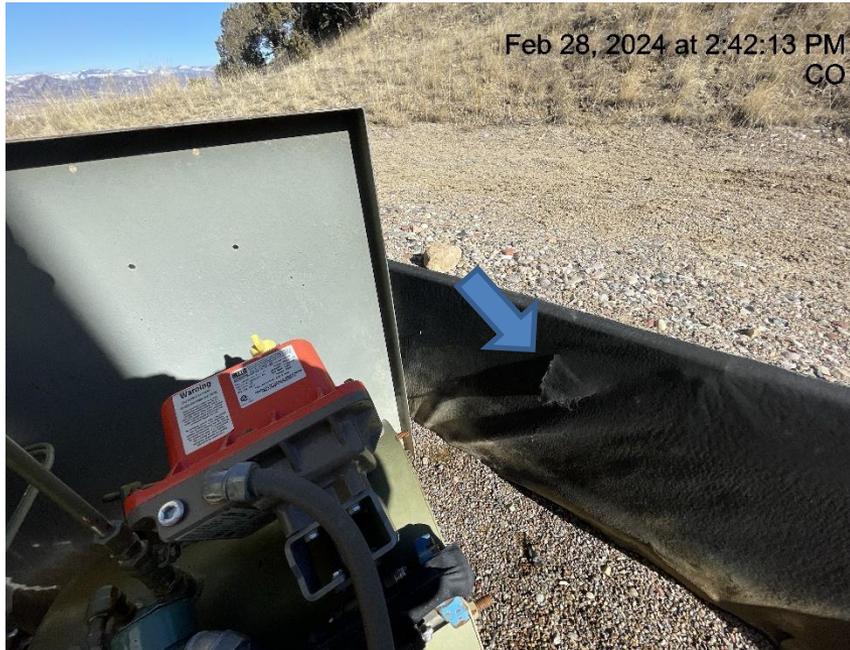
Photo # 7841 Hole in containment liner/liner needs maintenance

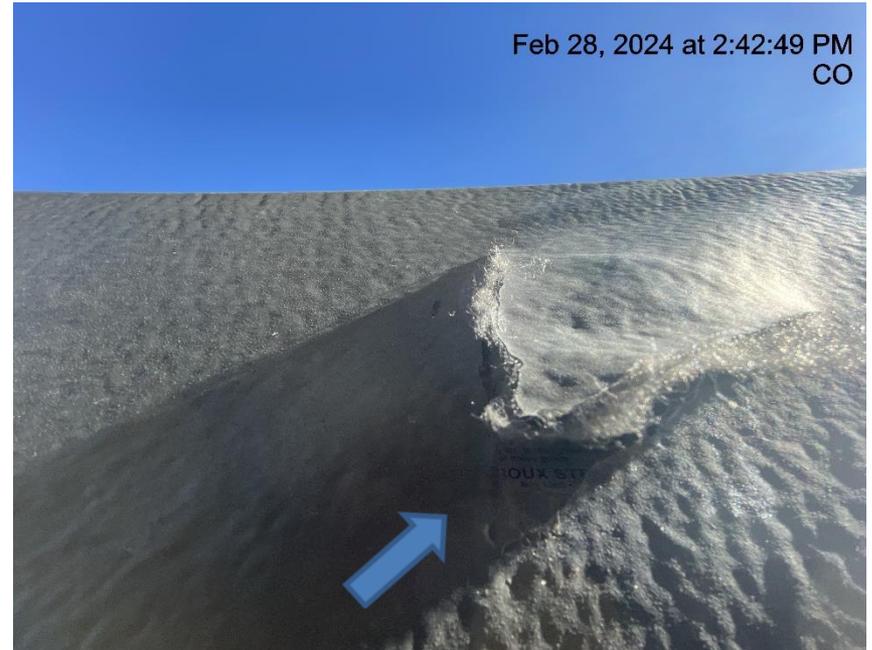
Photo # 7842 Hole in containment liner/liner needs maintenance

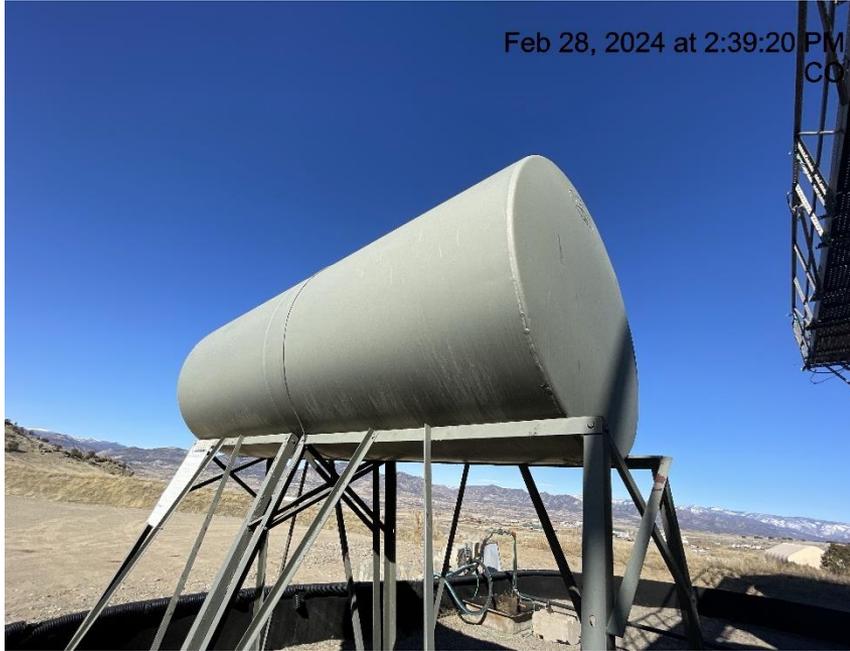
Photo # 7843 Methanol tank lacks required info

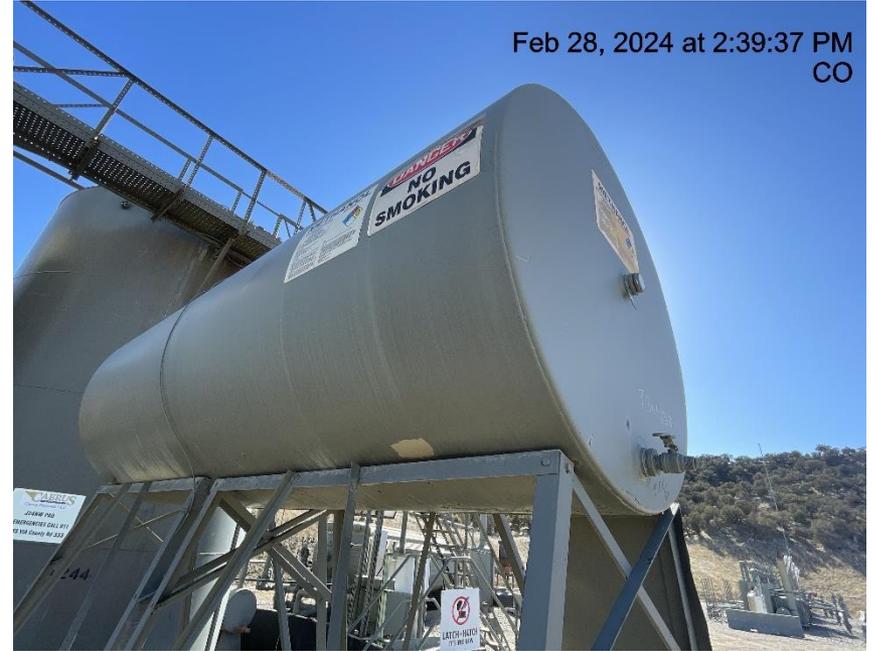
Photo # 7844 Methanol tank lacks required info

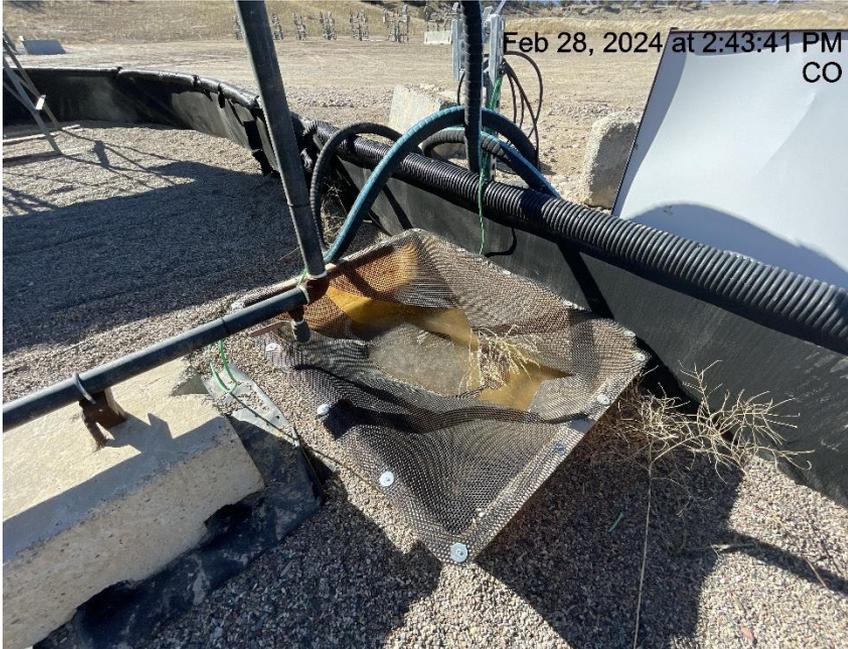
Photo # 7845 Wildlife protection on containment needs maintenance

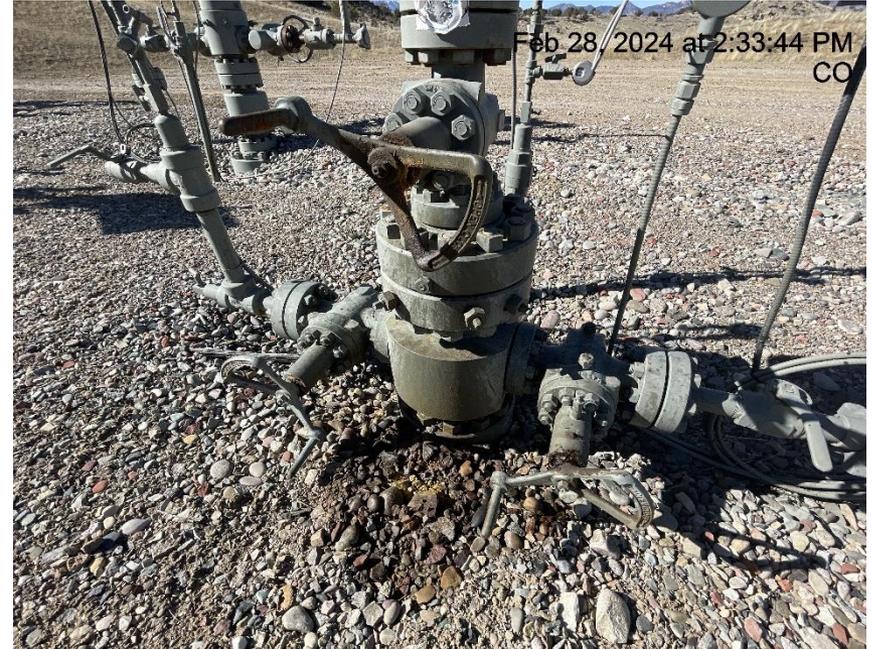
Photo # 7846 Stained soils & gravel

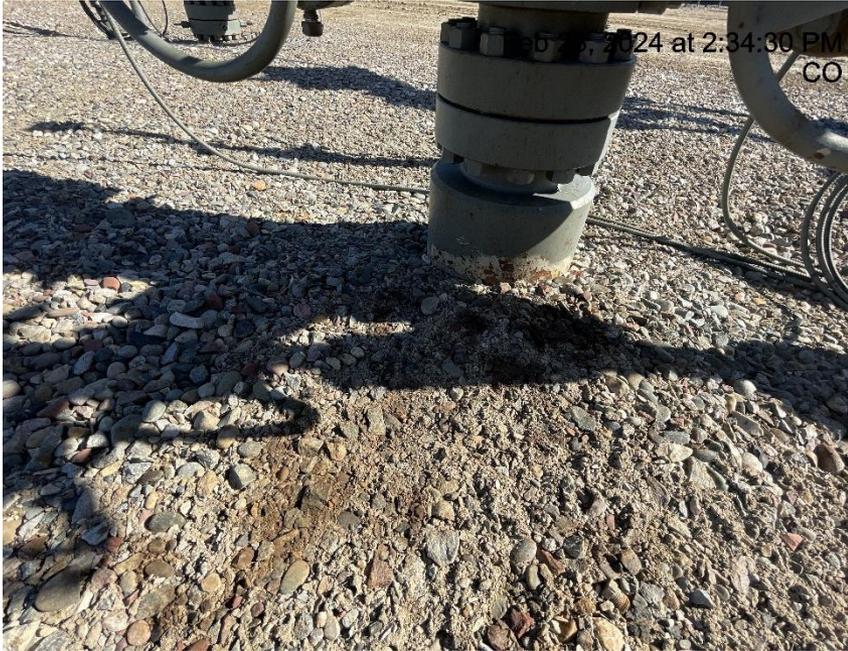
Photo # 7847 Stained soils & gravel

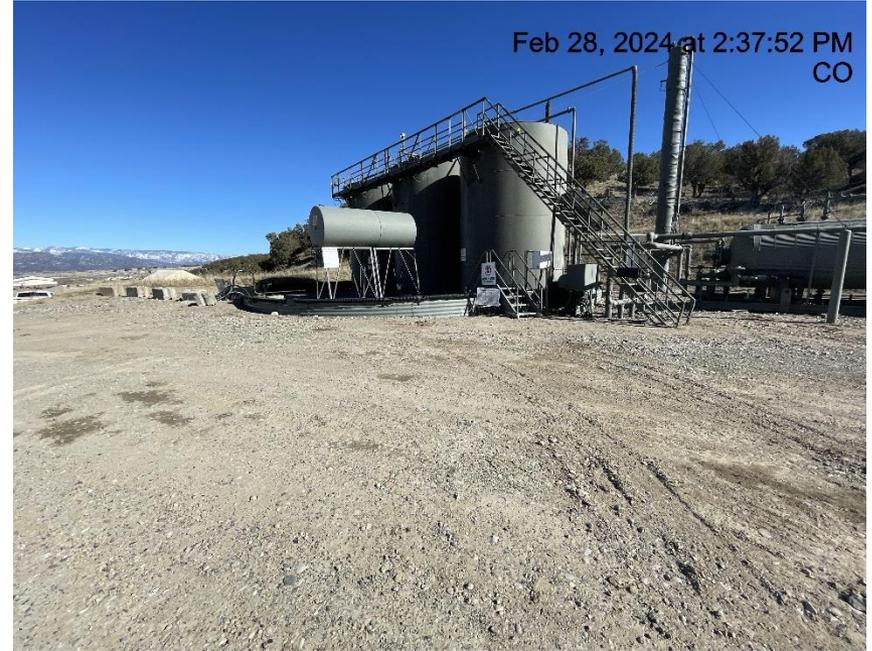
Photo # 7848 Stained soils & gravel

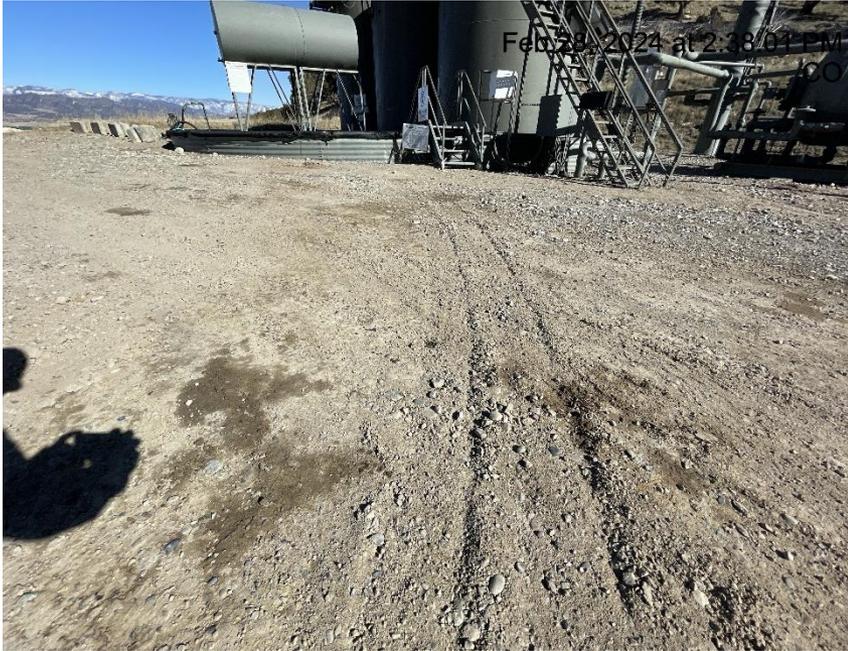
Photo # 7849 Stained soils & gravel

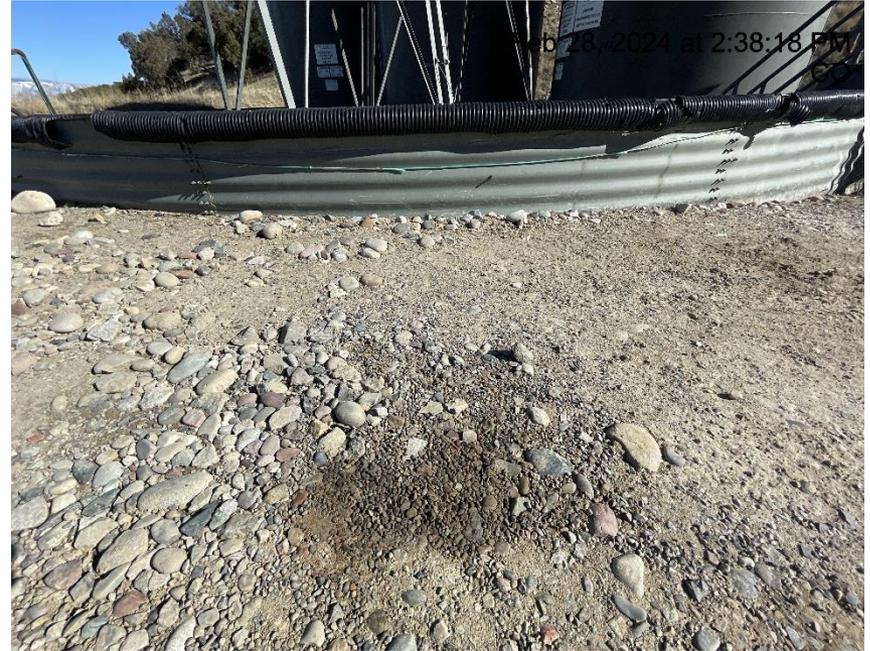
Photo # 7850 Stained soils & gravel

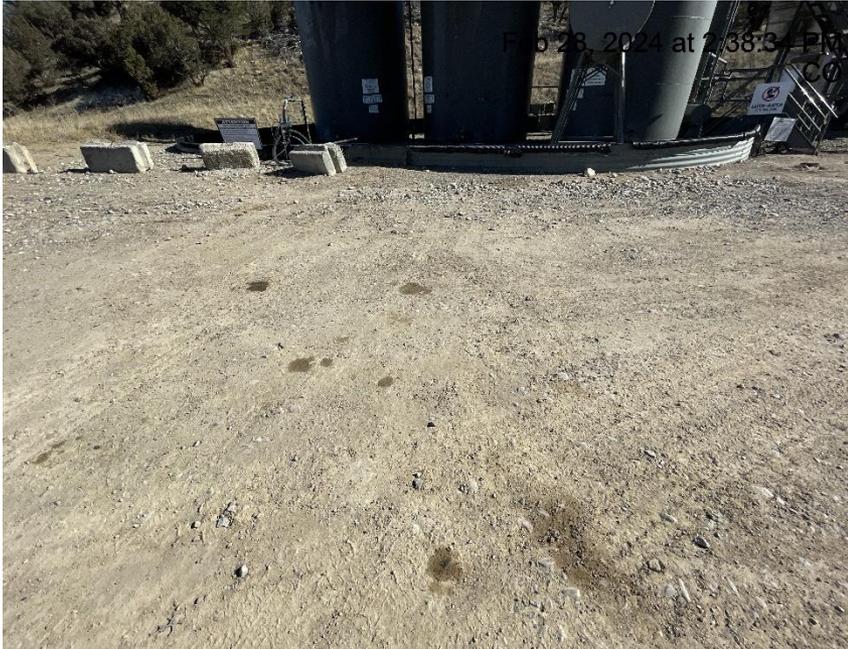
Photo # 7851 Stained soils & gravel

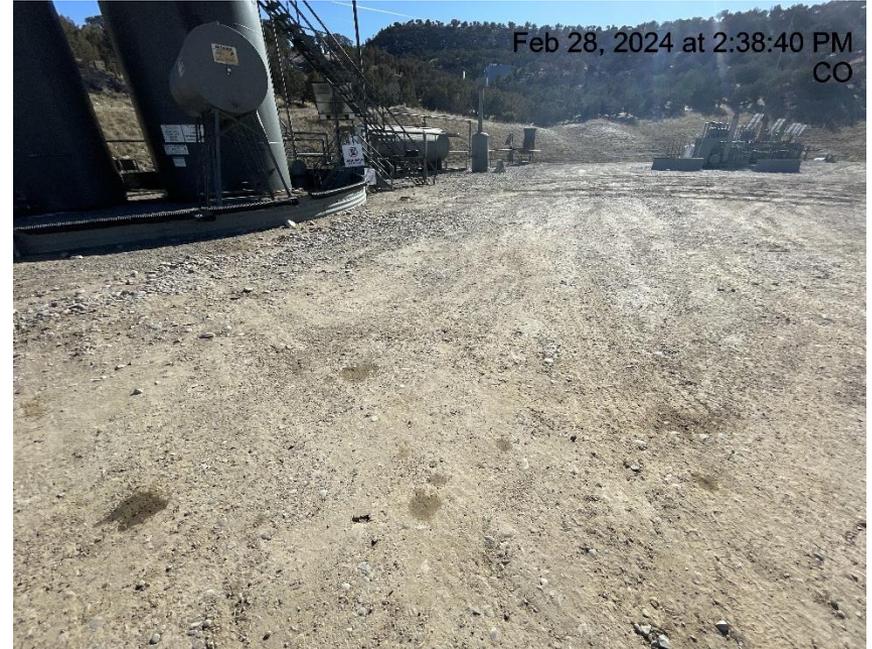
Photo # 7852 Stained soils & gravel

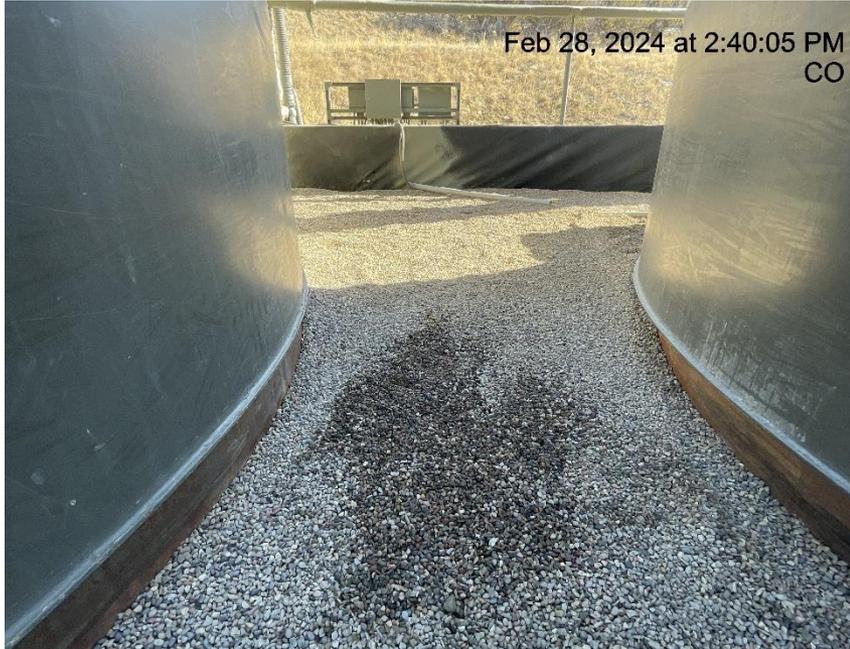
Photo # 7853 Stained gravel

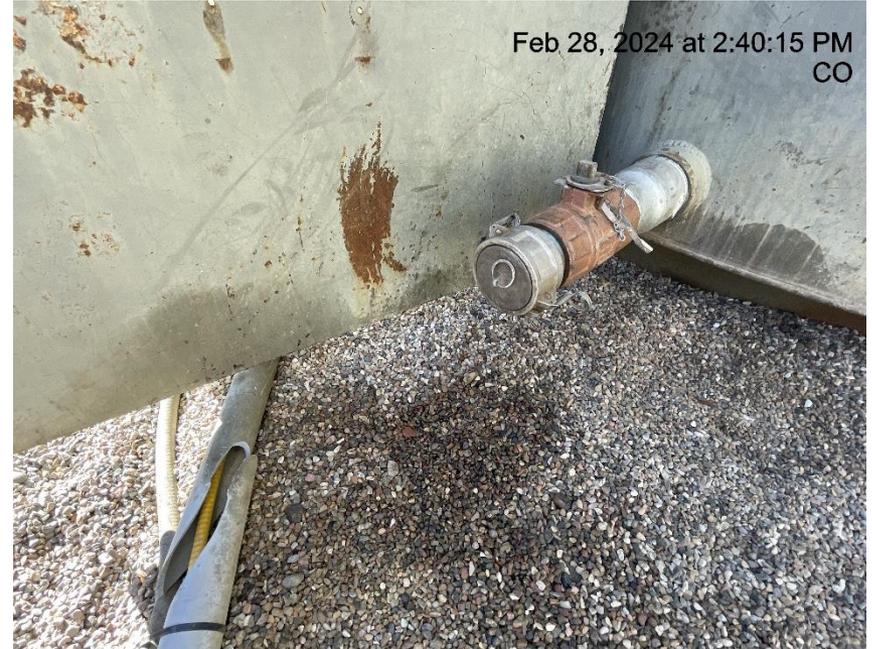
Photo # 7854 Stained gravel

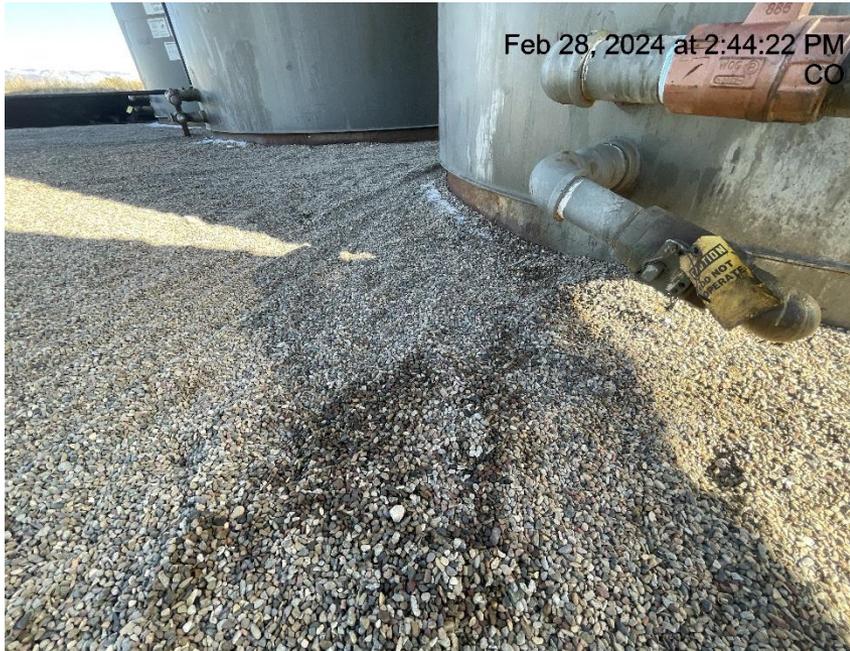
Photo # 7855 Stained gravel
