## Inspection Photos

Location Name: TEP ROCKY MOUNTAIN LLC MOBILE 11-20 Pad

Location #: 322510

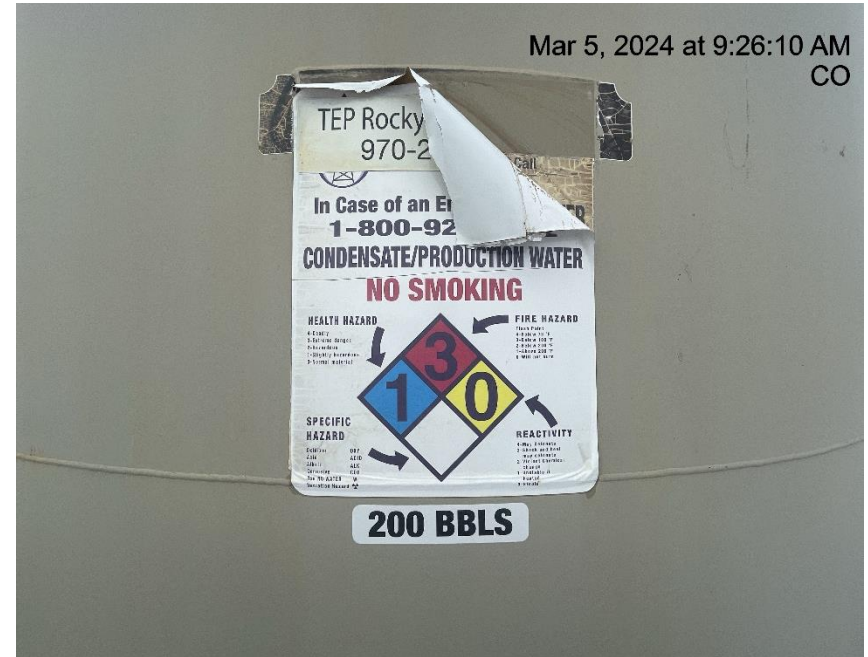
Photo # 8198 Tank label losing adhesion & some required info is not visible

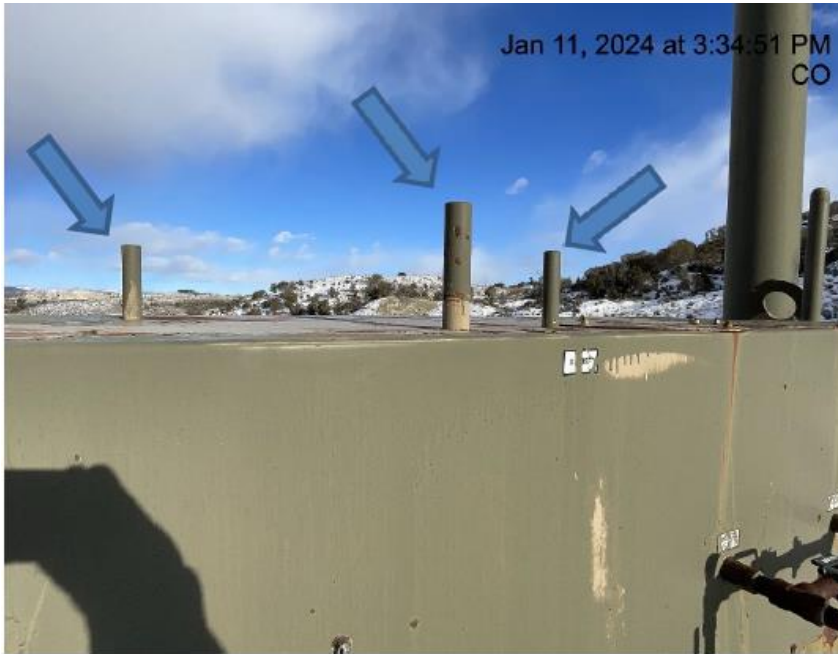
Photo # 2673 From inspection 708902787 conducted on 01/11/2024 PRV & rupture disc vent lines lack caps

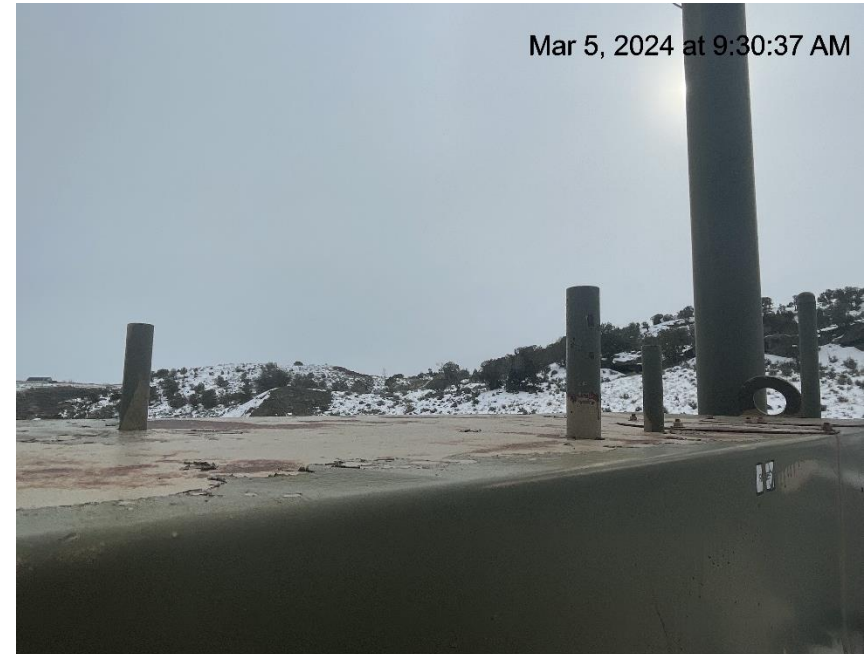
Photo # 8199 PRV & rupture disc vent lines lack caps

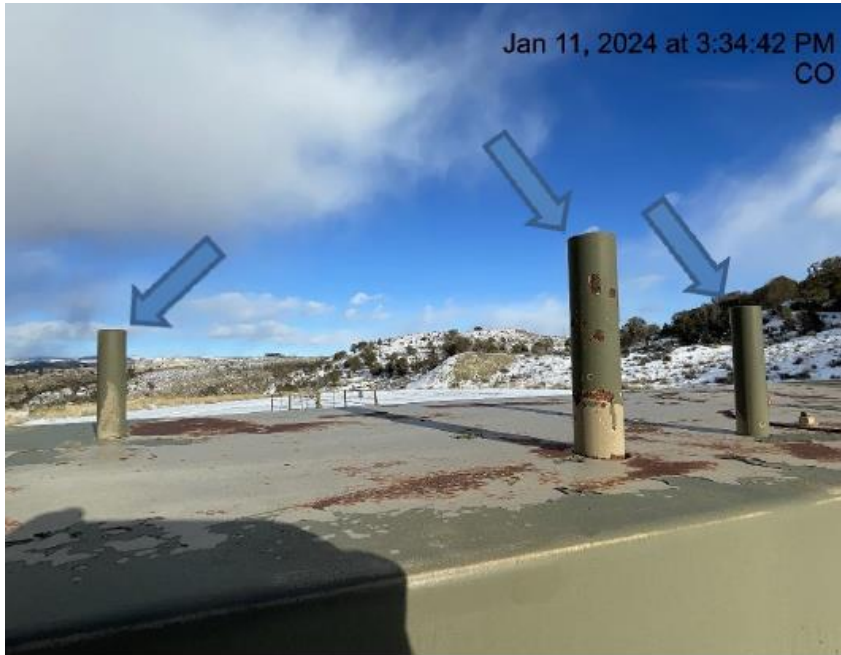
Photo # 2674 From inspection 708902787 conducted on 01/11/2024 PRV & rupture disc vent lines lack caps

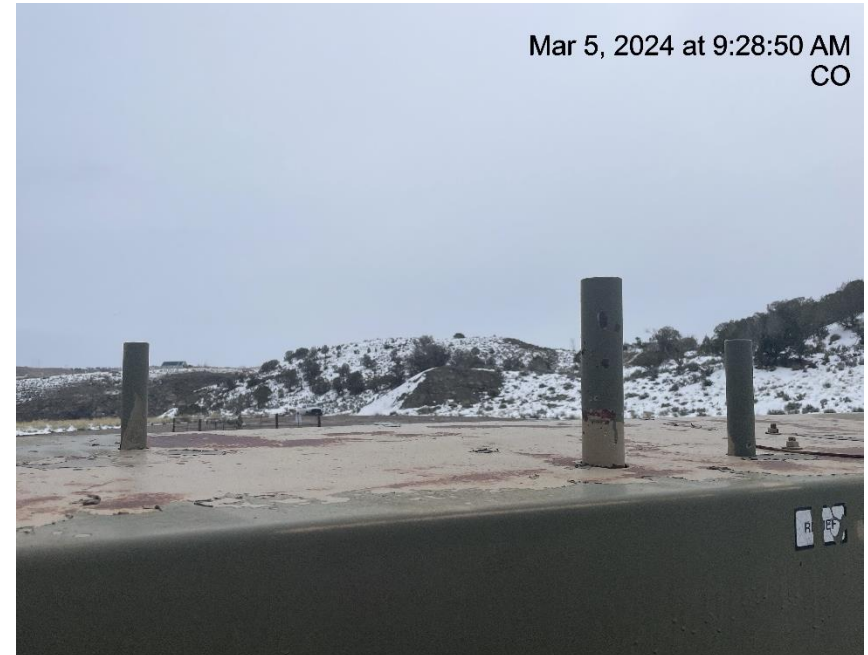
Photo # 8200 PRV & rupture disc vent lines lack caps

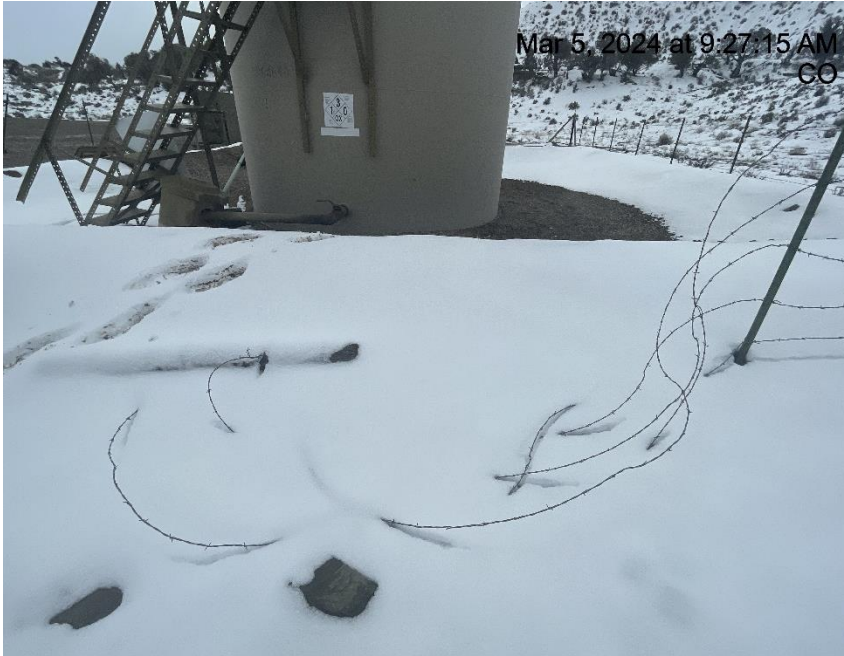
**Photo # 8201 Barbed wire fence needs maintenance/barbed wire laying on ground/wildlife hazard**
