Inspection Photos
Location Name: Darlene East 29-N-20-11C
Location ID: 452153

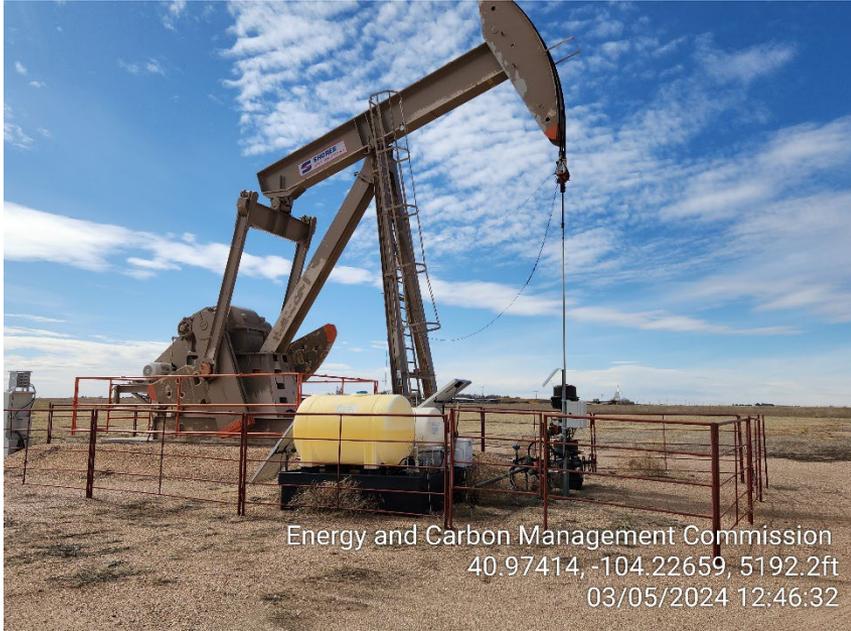
Photo 1 – Pumping Unit

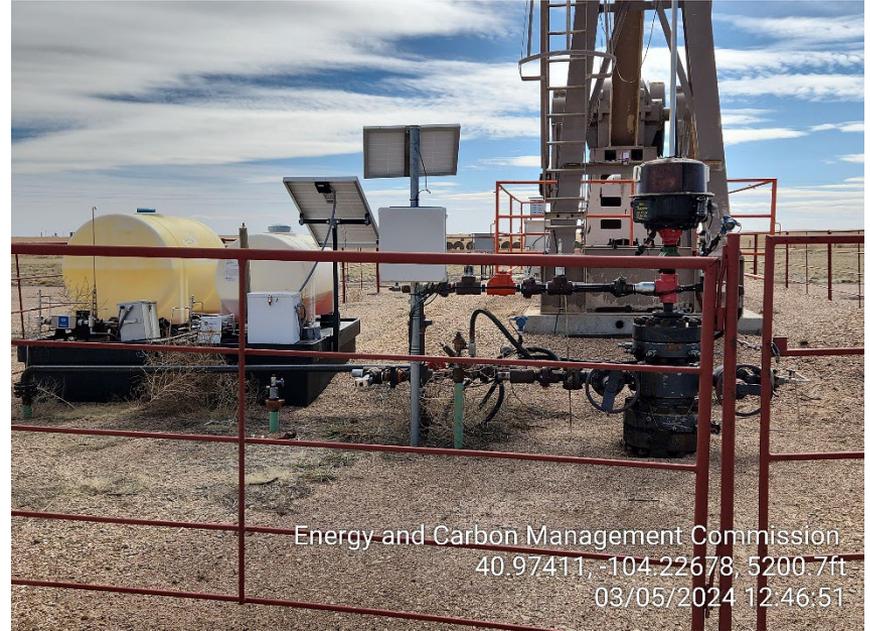
Photo 2 – Wellhead

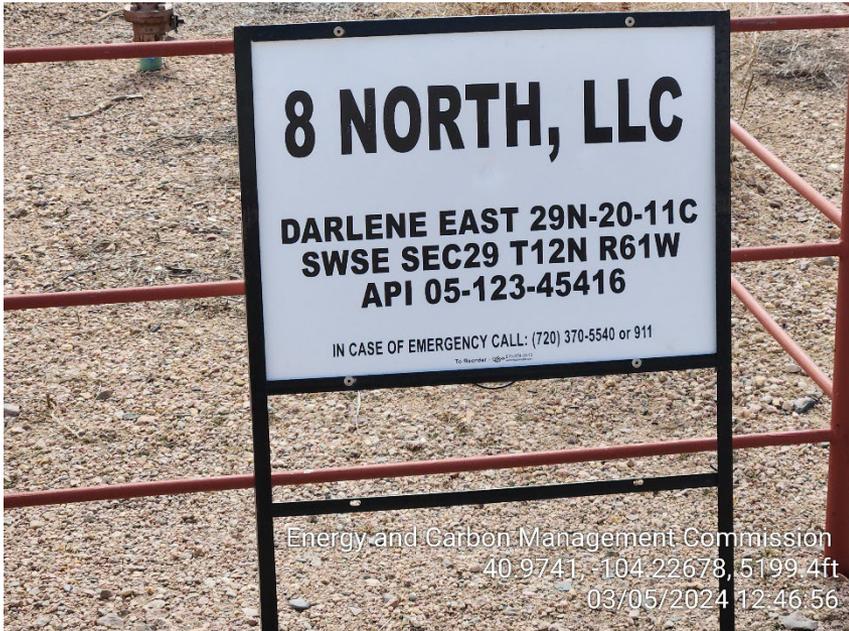
Photo 3 – Well Sign

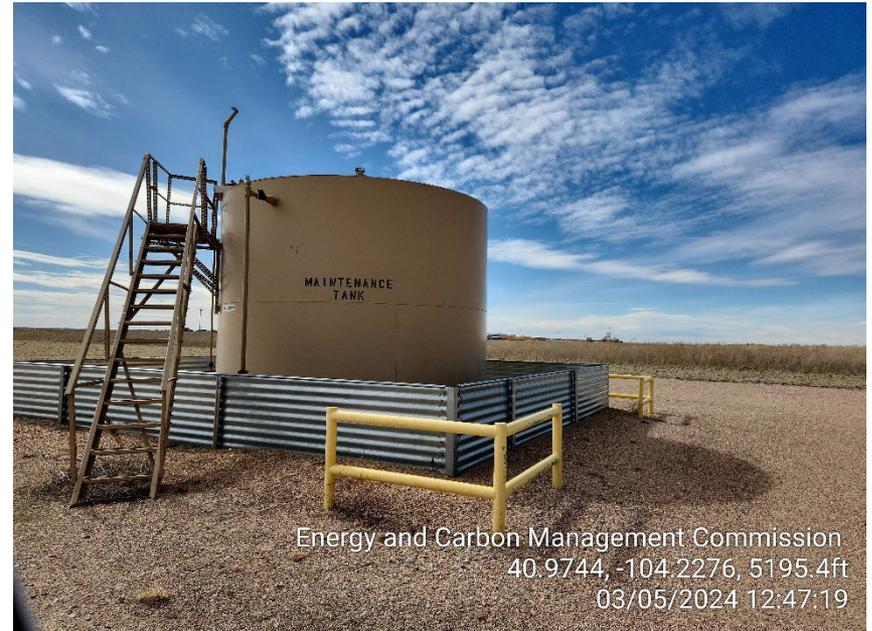
Photo 4 – Maintenance Tank

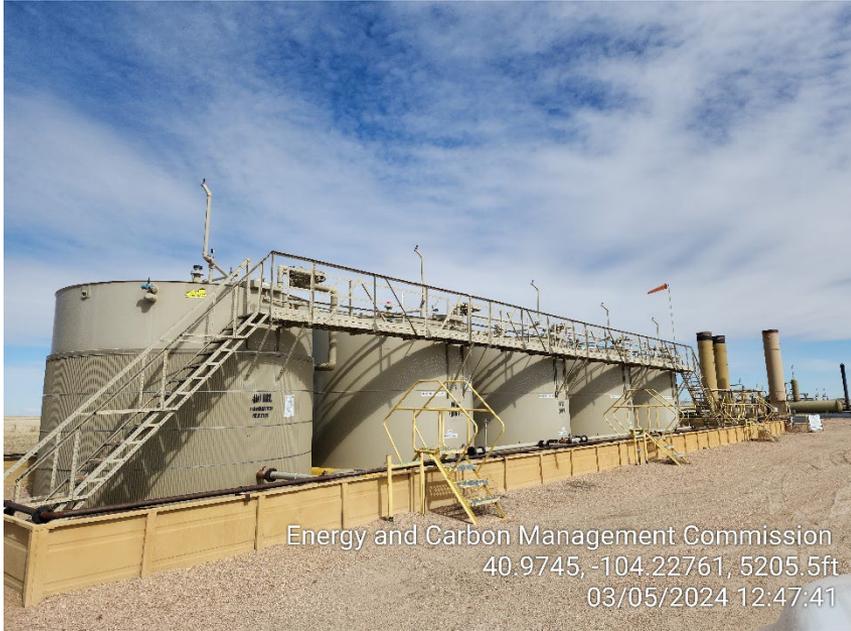
Photo 5 – Tank Battery

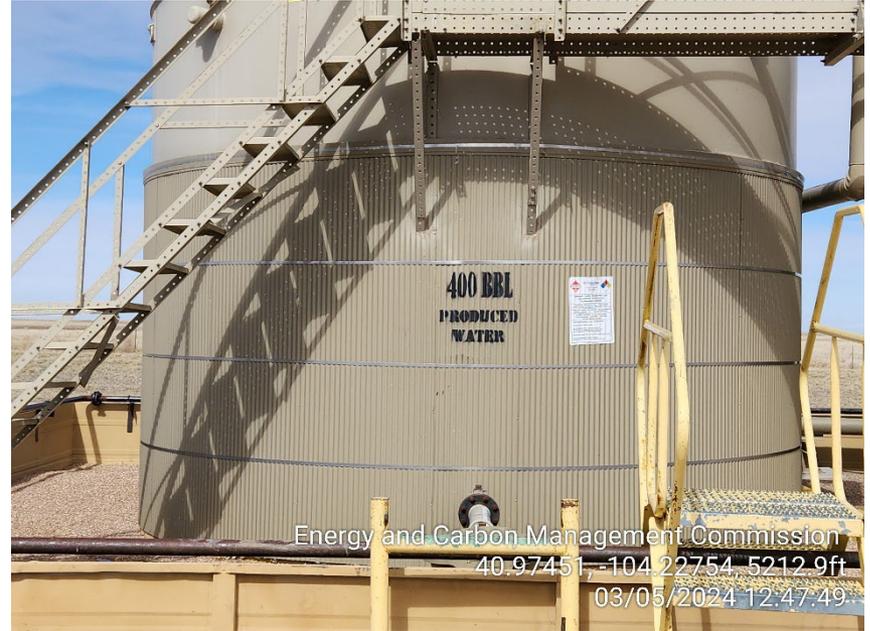
Photo 6 – NFPA Label missing on Produced Water Tank

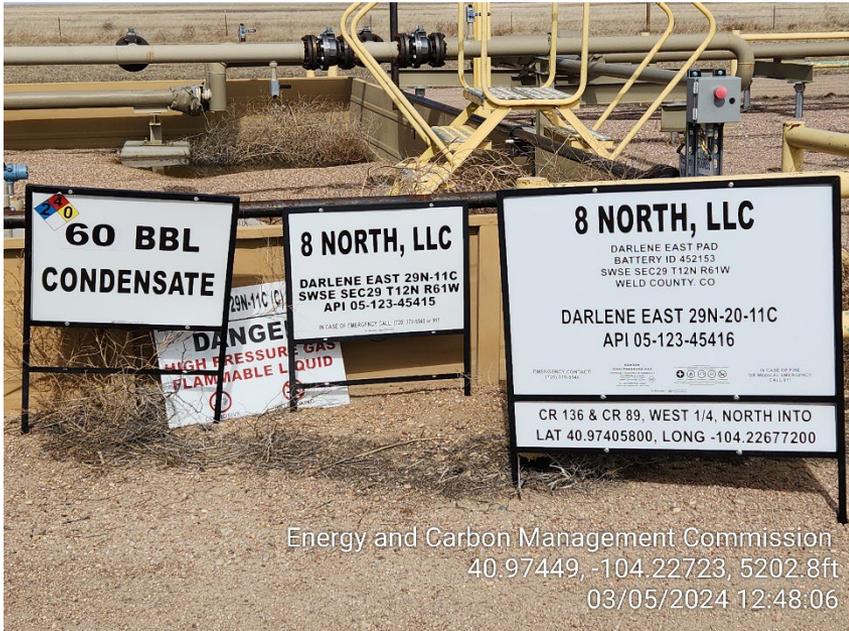
Photo 7 – Tank Battery Sign

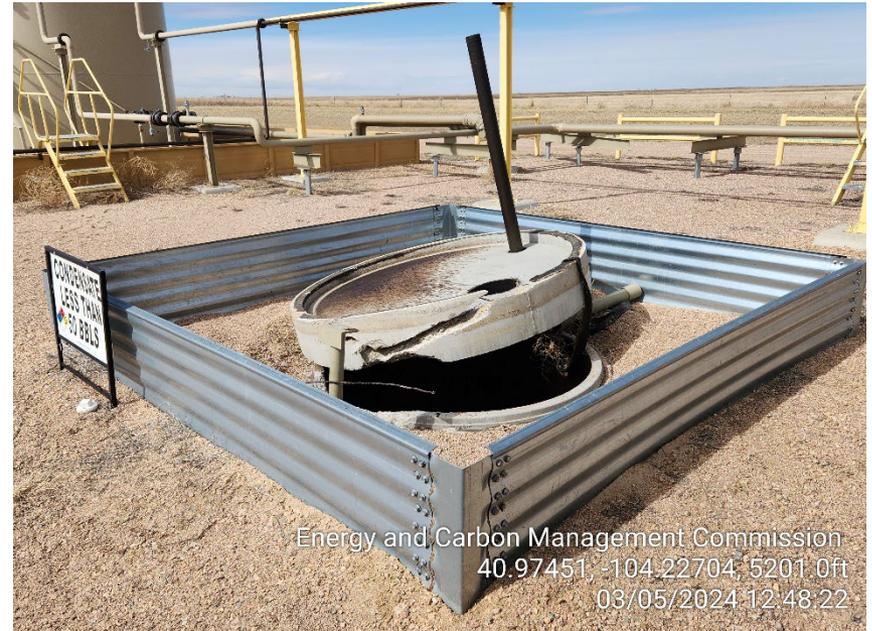
Photo 8 – Lid Cover is open to Atmosphere

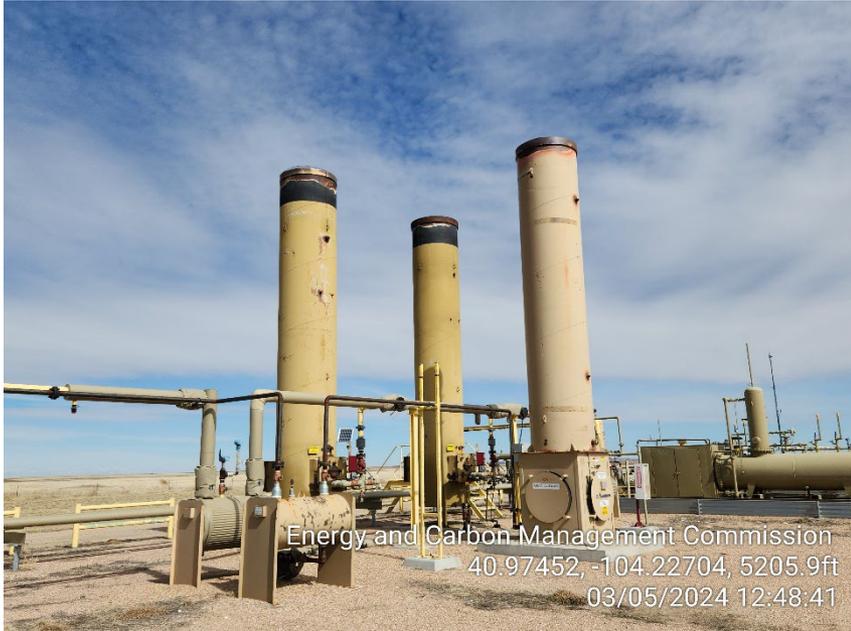
Photo 9 – ECDs

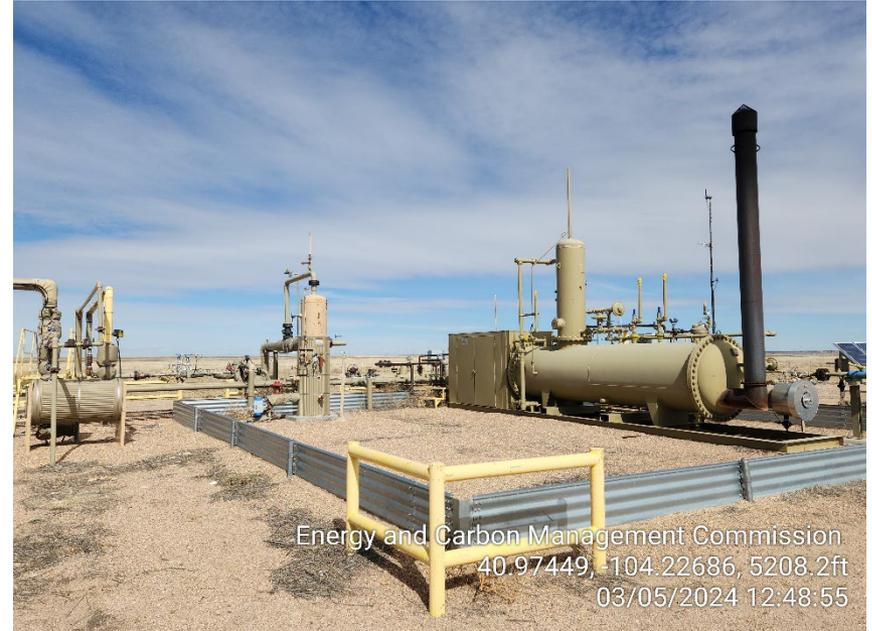
Photo 10 – Separators

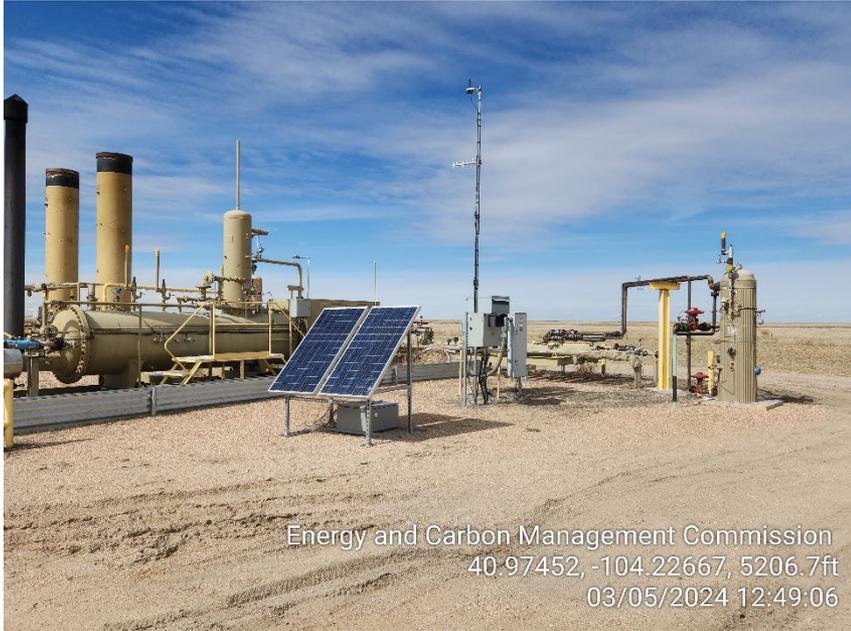
Photo 11 – Separator

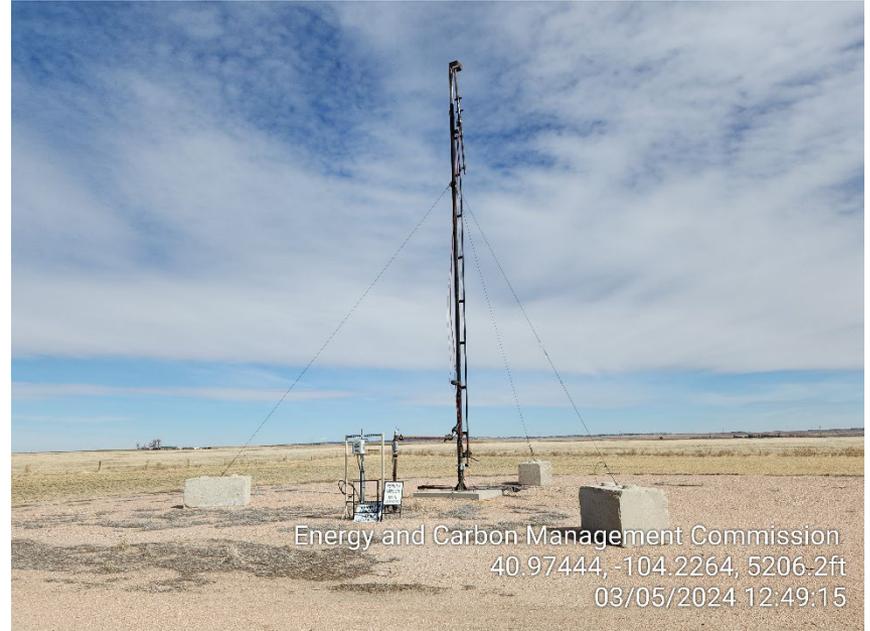
Photo 12 – Flare

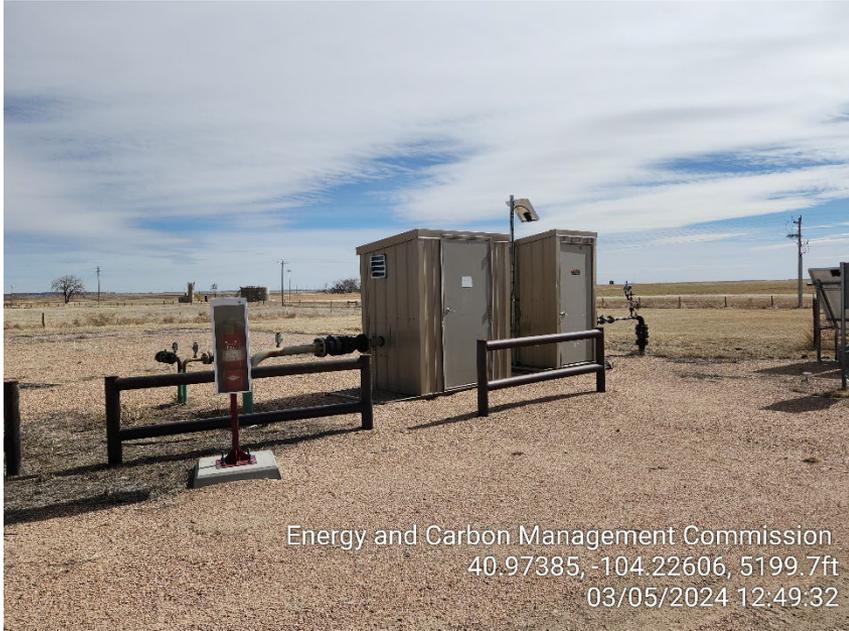
Photo 13 – Gas Meter Houses
