Inspection Photos

Operator: TEP ROCKY MOUNTAIN LLC #96850

Location ID: 323916

Inspection Doc: 696205659

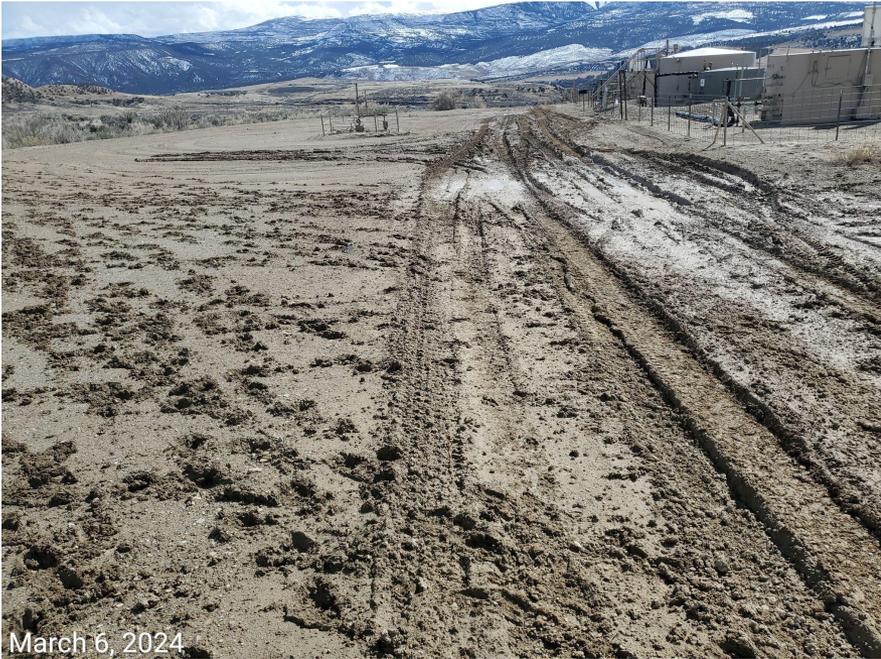
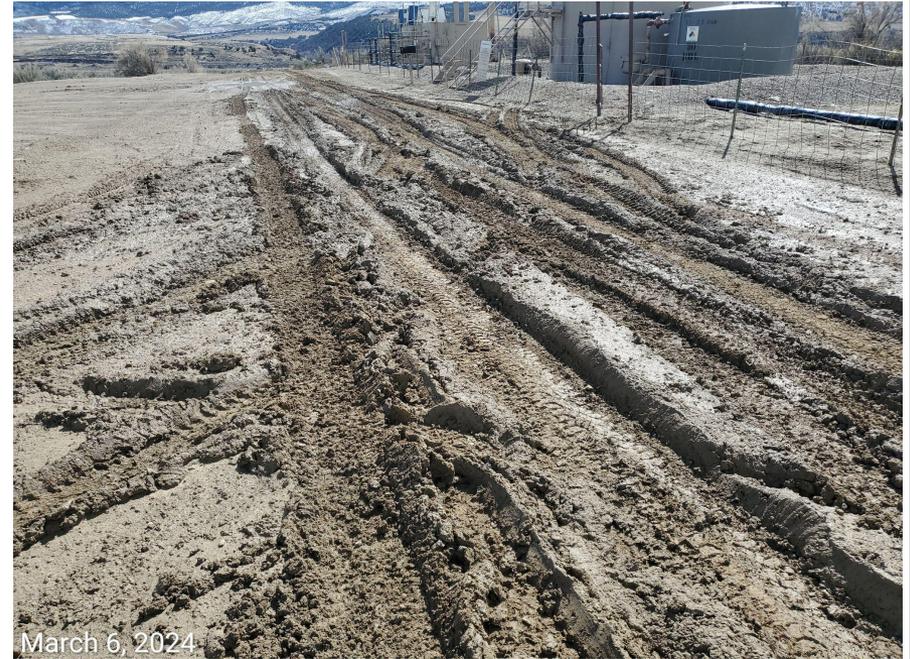
Photo 1: Photos taken from the working pad surface of the Location. Photo shows BMPs to stabilize the working pad surface, as well as to minimize tracking and sediment transport have not been maintained in a proper functioning condition.

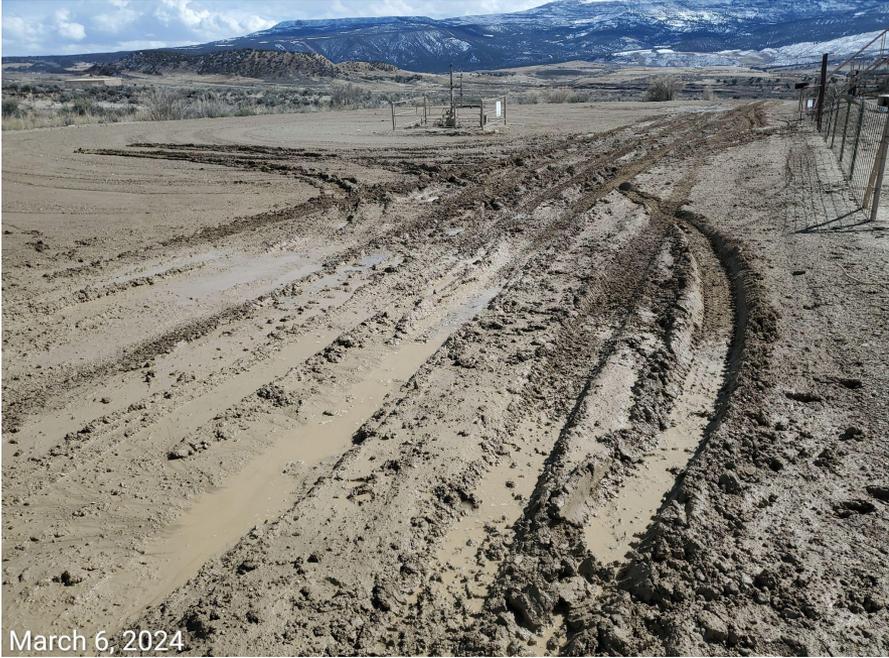
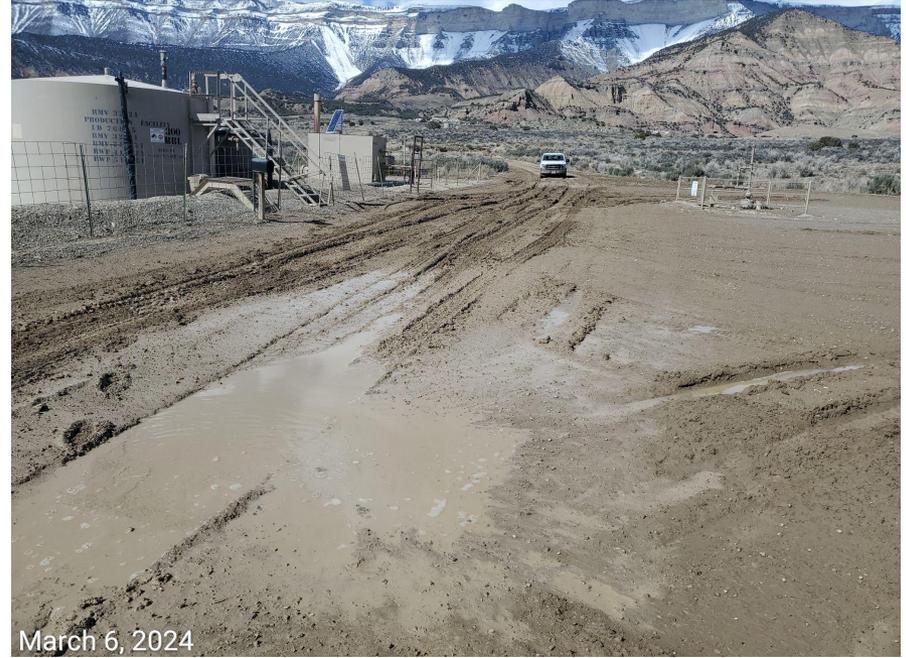
Photo 2: Photos taken from the working pad surface of the Location. Photo shows BMPs to stabilize the working pad surface, as well as to minimize tracking and sediment transport have not been maintained in a proper functioning condition.

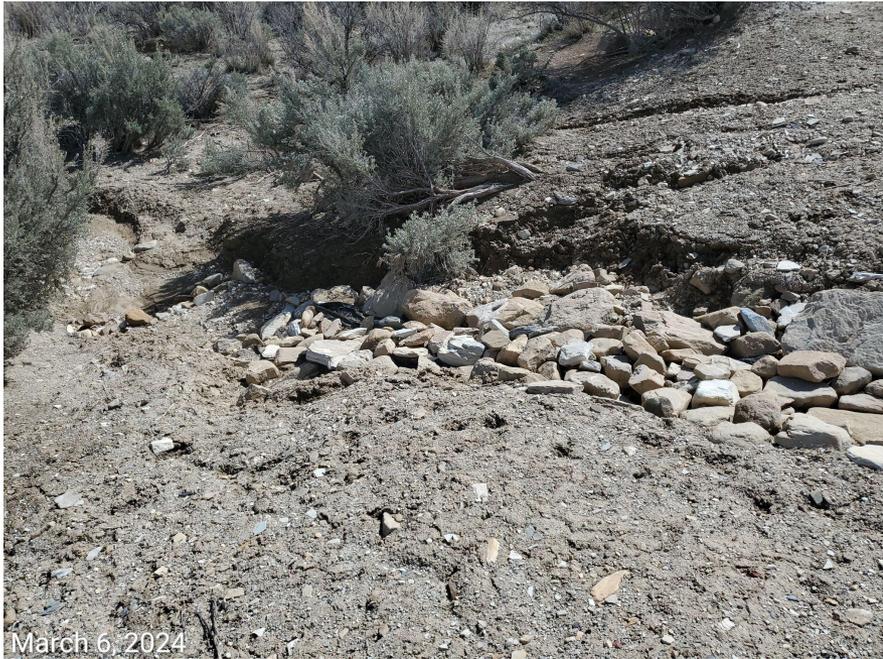
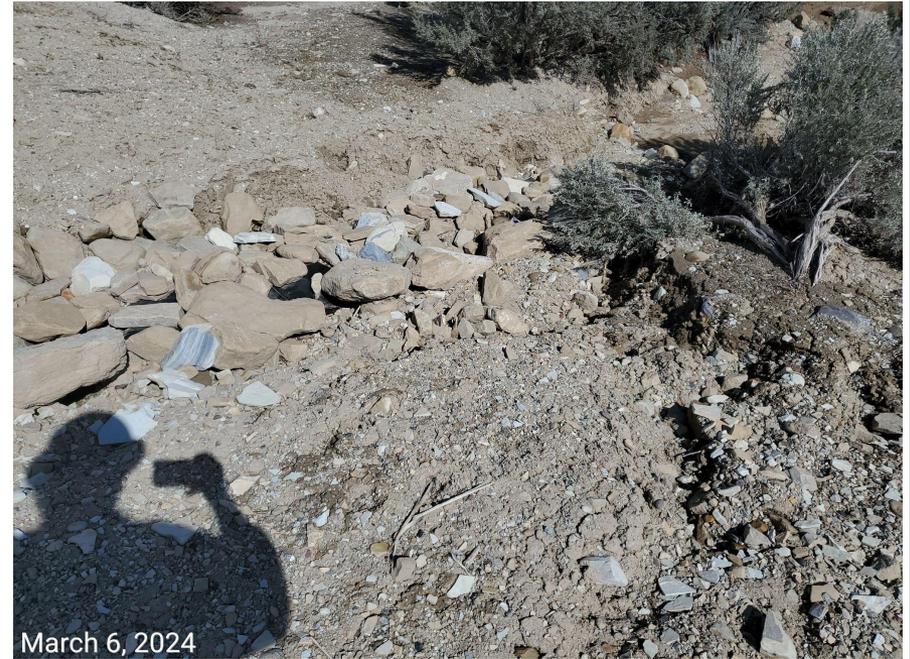
Photo 3: Photos taken from an outlet on the southeast end of the Location. Outlet has not been installed or maintained in proper functioning condition per good engineering practice; erosion degradation evident to the slopes and the control measure.

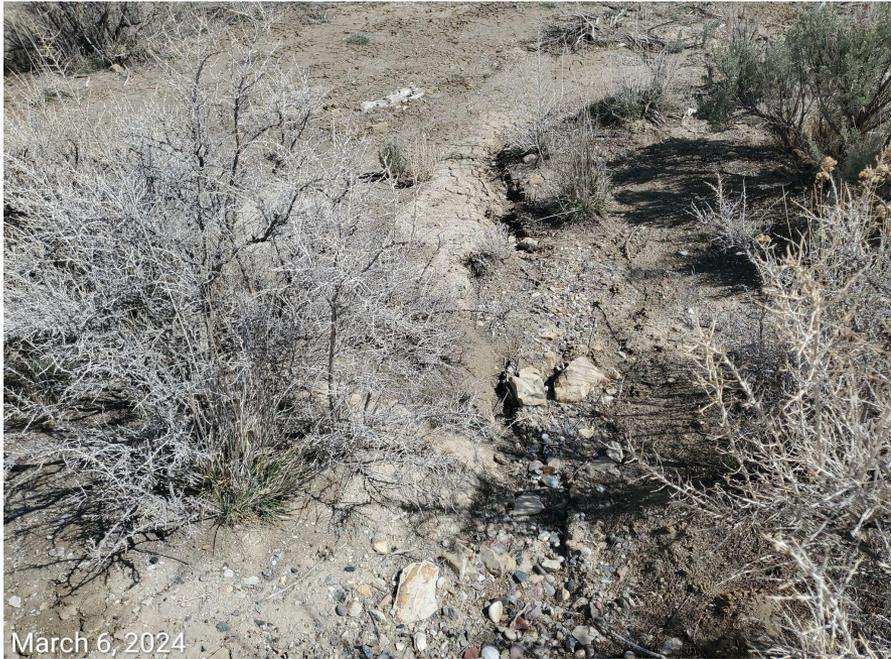
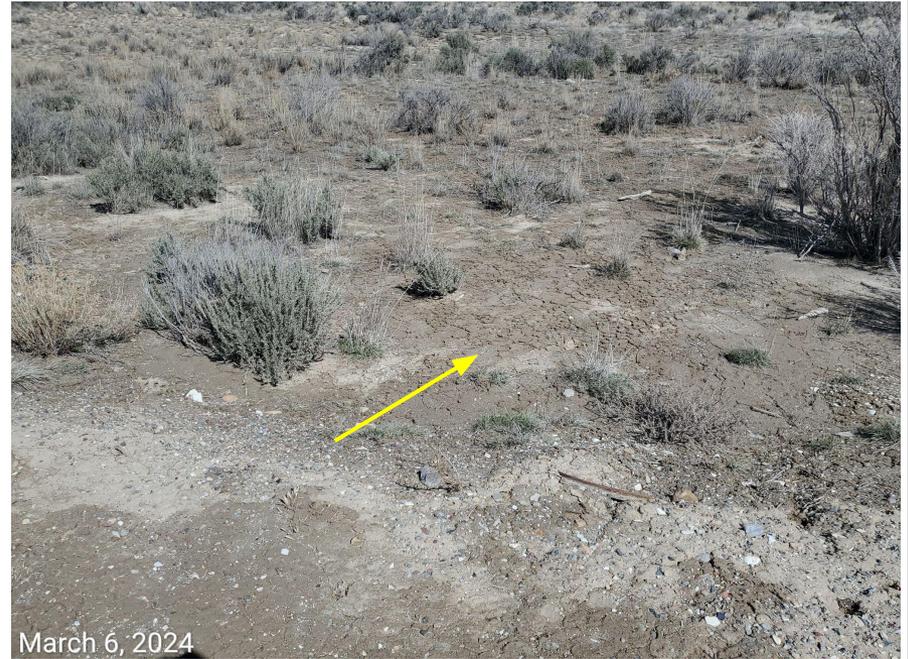
Photo 4: Photo left example of erosion degradation observed along the eastern areas of the Location. Photo right example showing sediment deposition within the interim areas of the Location due to stormwater runoff from the pad. Sediment appears to be impacting vegetation.

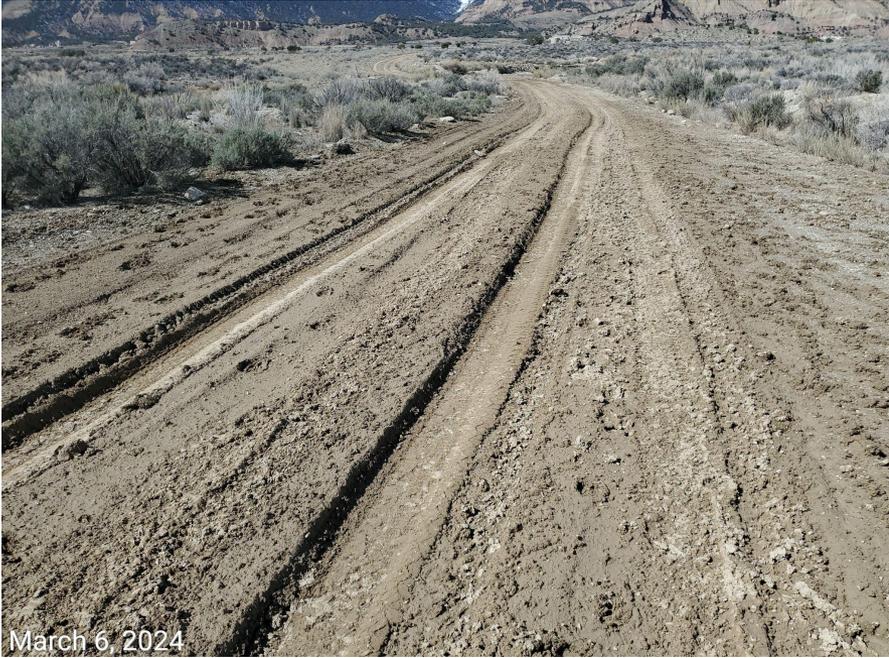
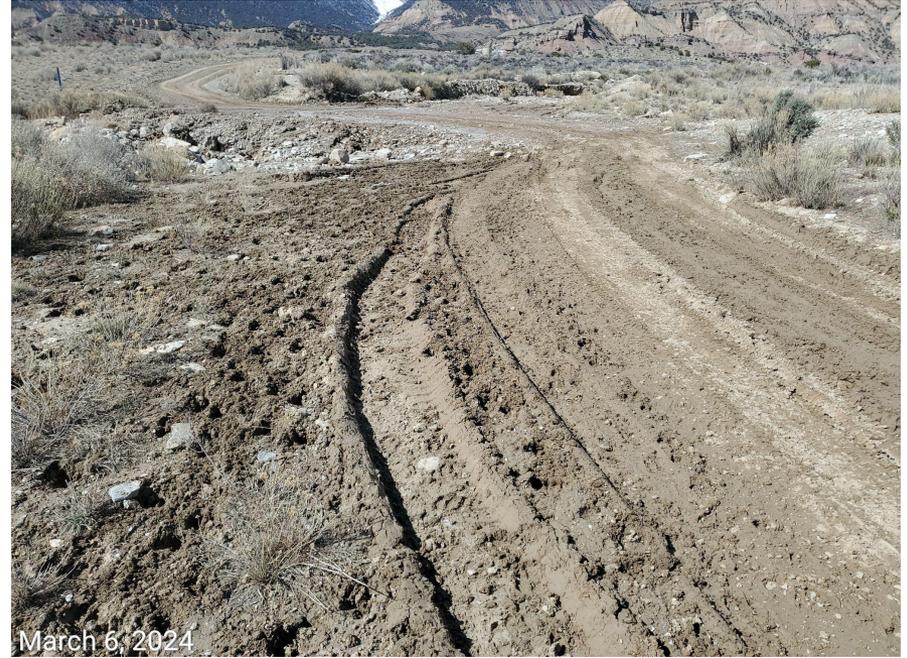
Photo 5: Photo taken from the access road north of the Location. Photos examples showing the access road lacks stabilization and appropriate BMPs to manage runoff.

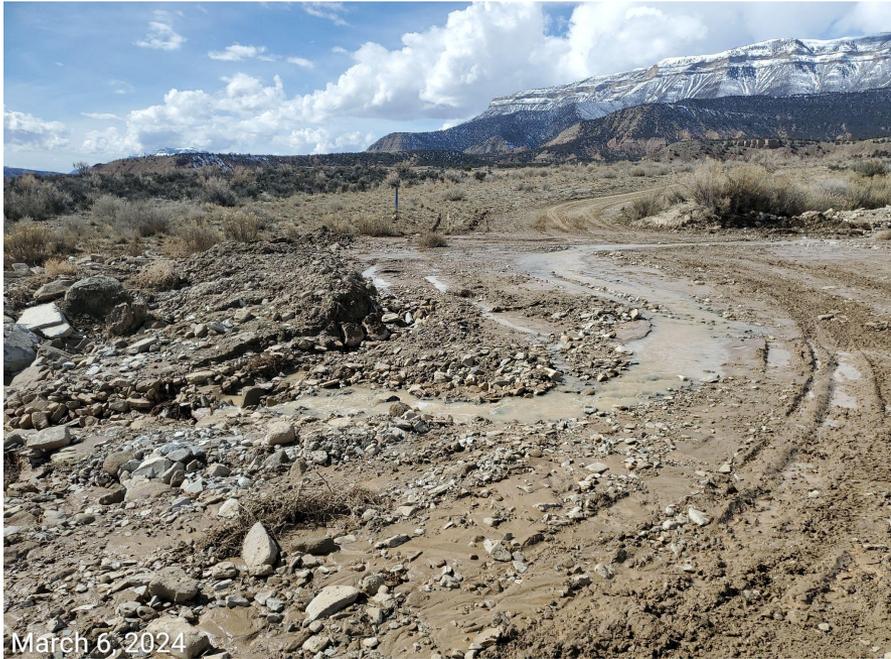
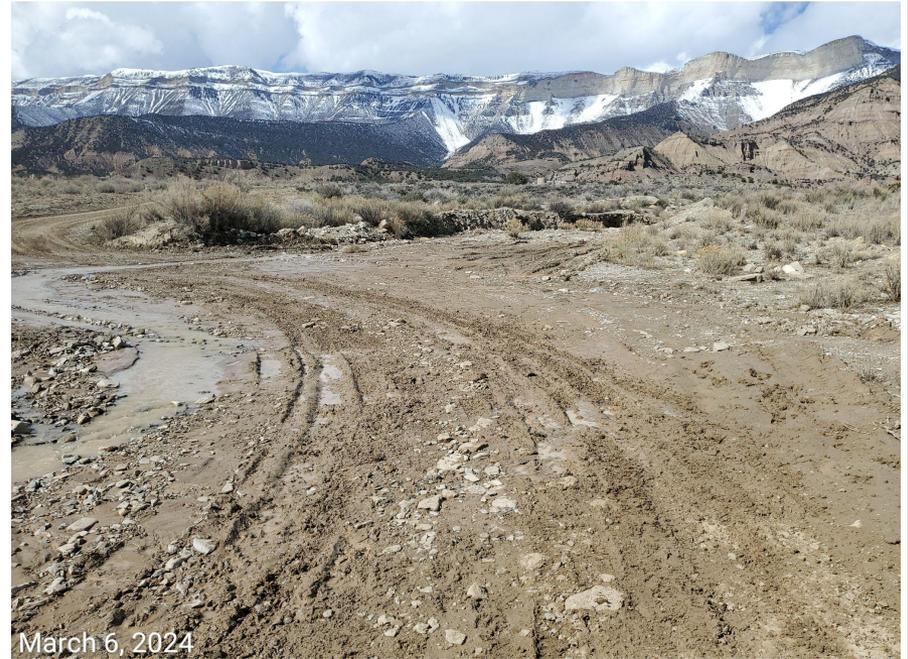
Photo 6: Photos 6-10 taken from the access road north of the Location. Photos examples showing that the road has not been constructed with a properly engineered stream crossing; vehicle tracking and degradation apparent at the crossing, impacting a riverine system and Waters of the State. Stream is a direct tributary to the Colorado river.

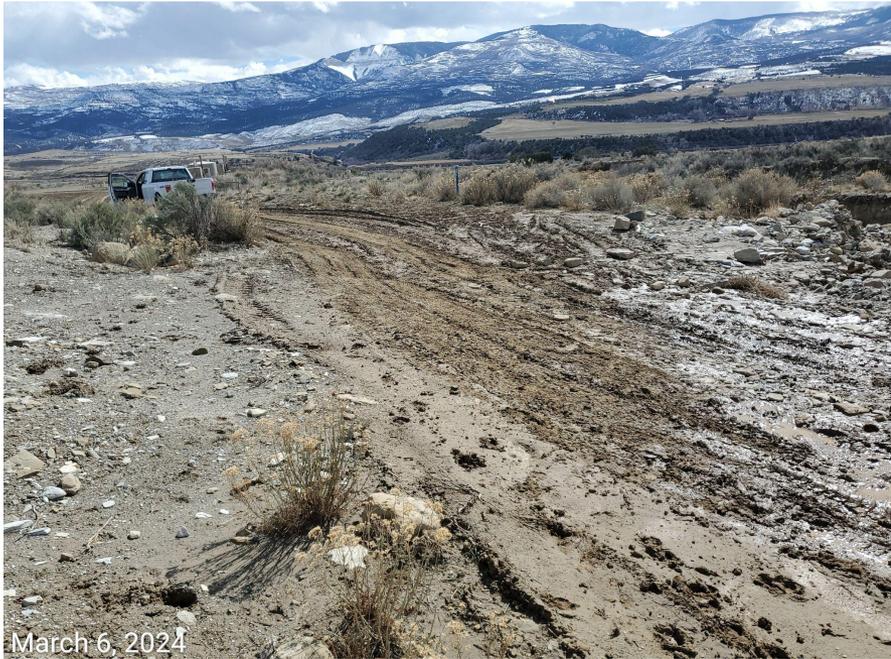
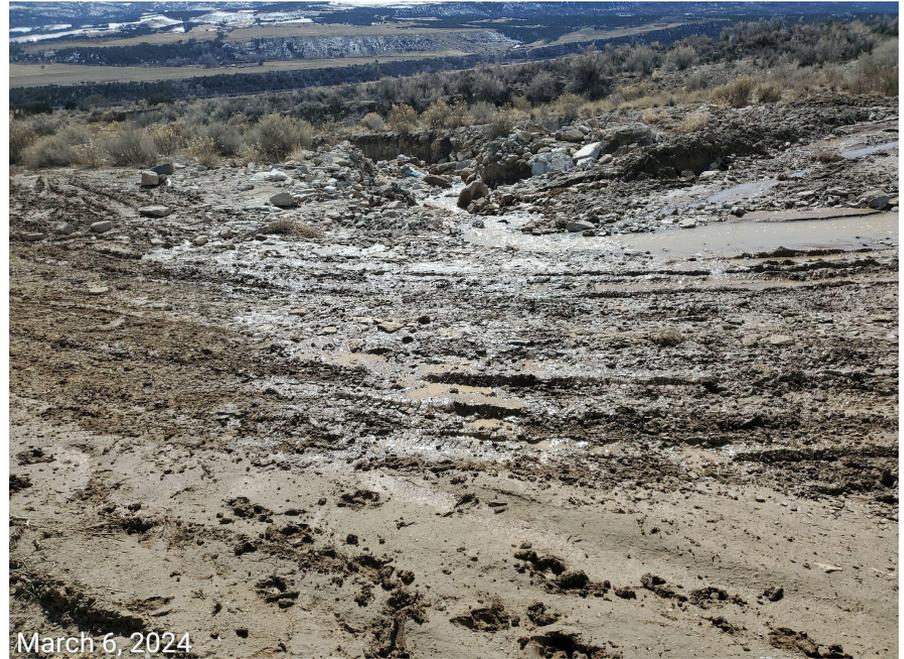
Photo 7: See comments under photo 6.

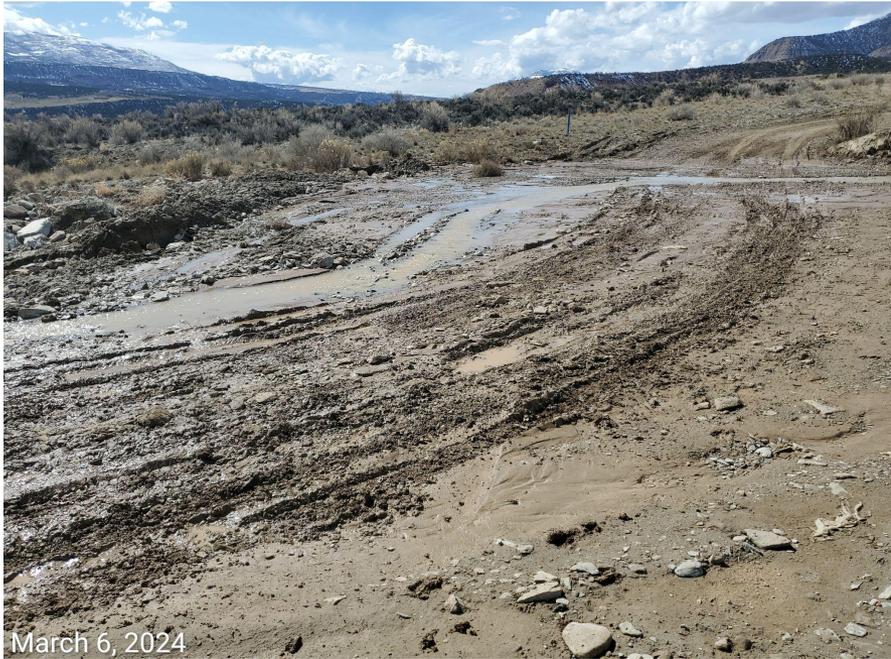
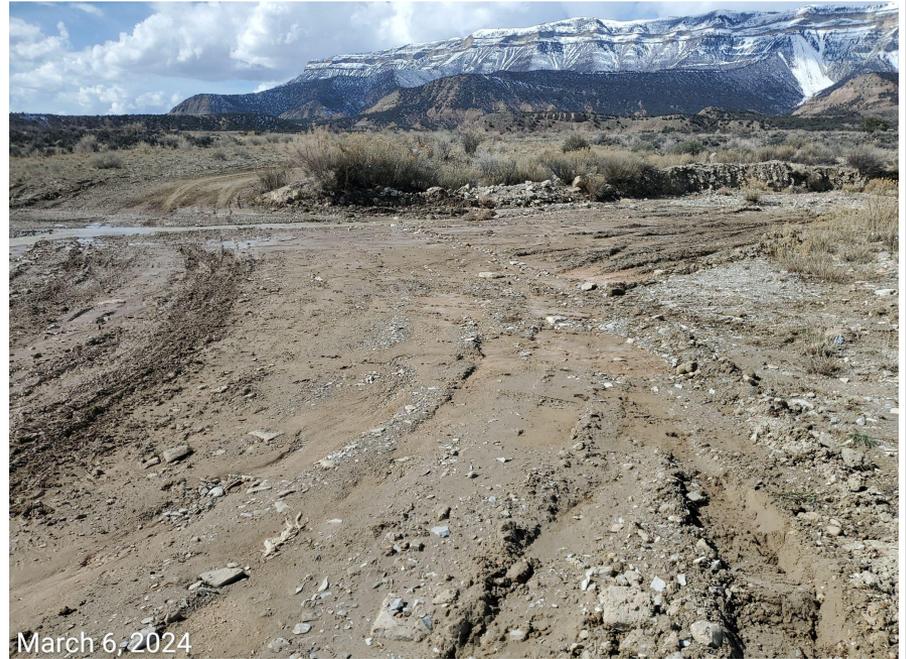
Photo 8: See comments under photo 6.

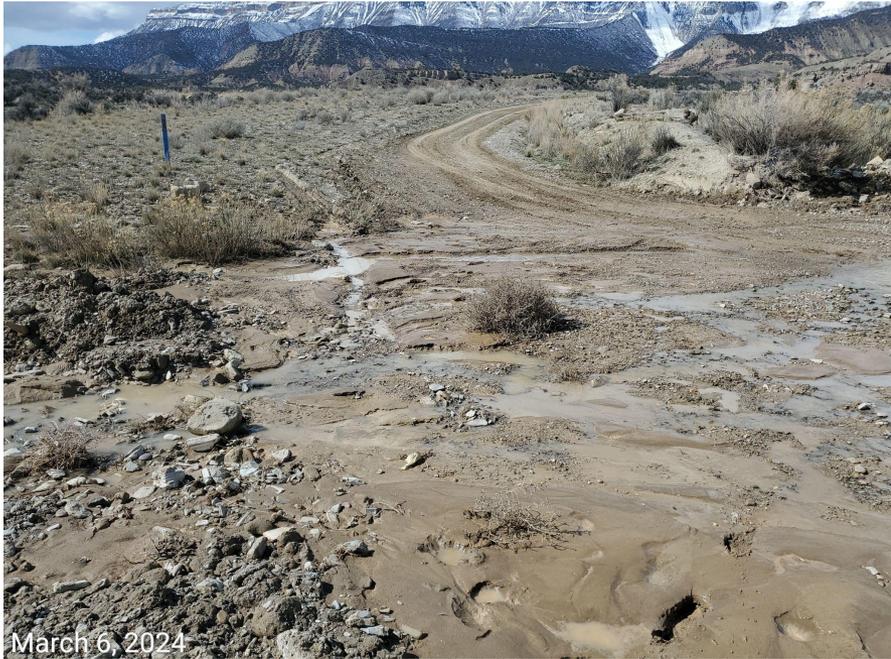
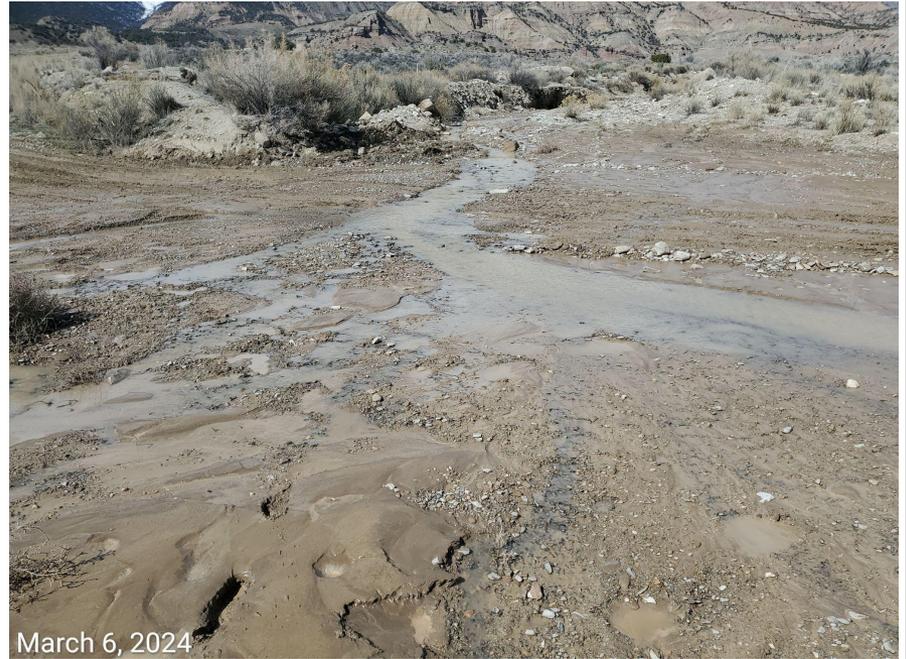
Photo 9: See comments under photo 6.

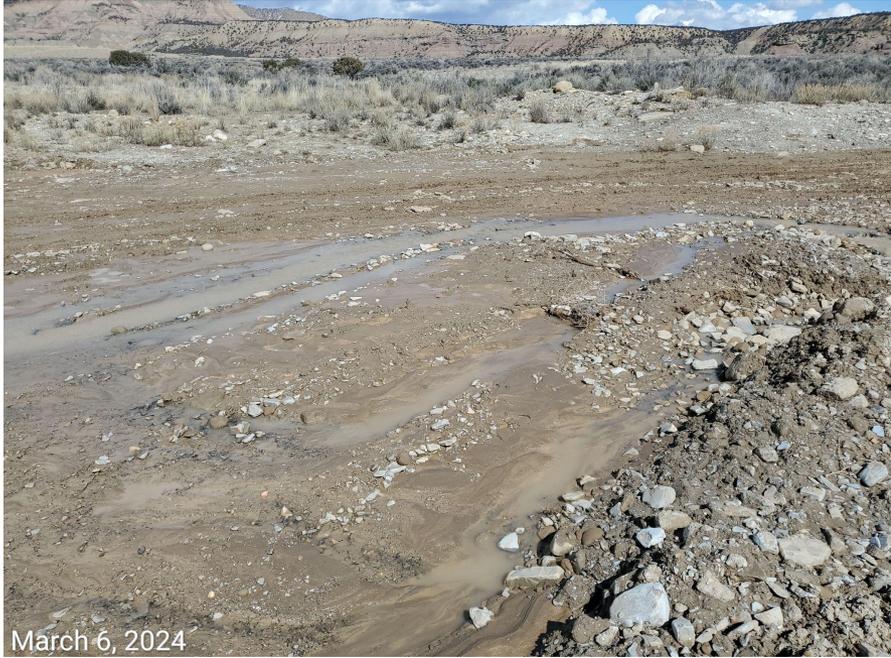
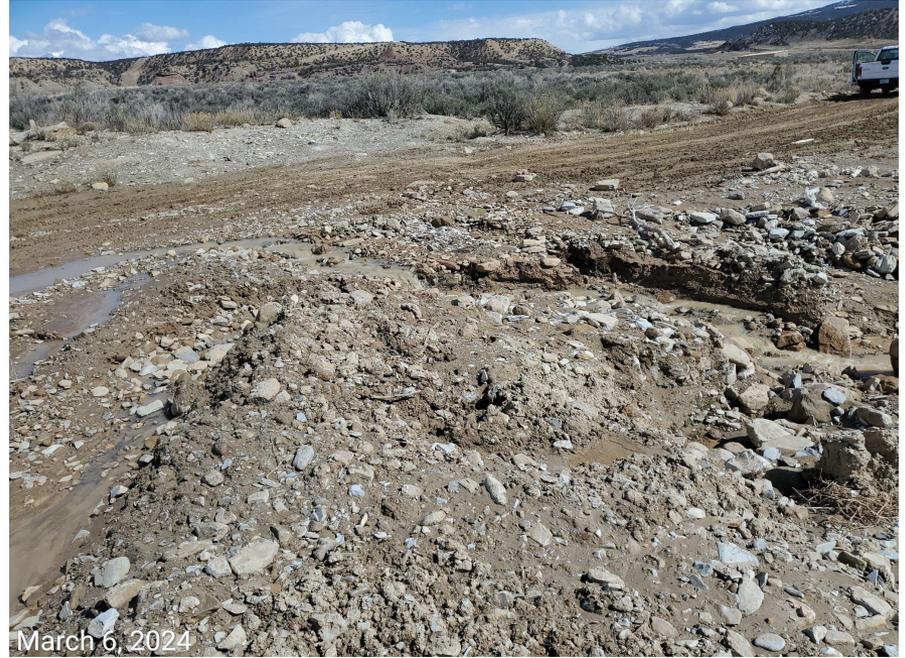
Photo 10: See comments under photo 6.
