Final Reclamation Inspection

Operator: Hilcorp Energy Company - 10133

Location ID: 325510

Inspection Photos
Location Name: Davis Gas Unit 1
Location ID: 325510

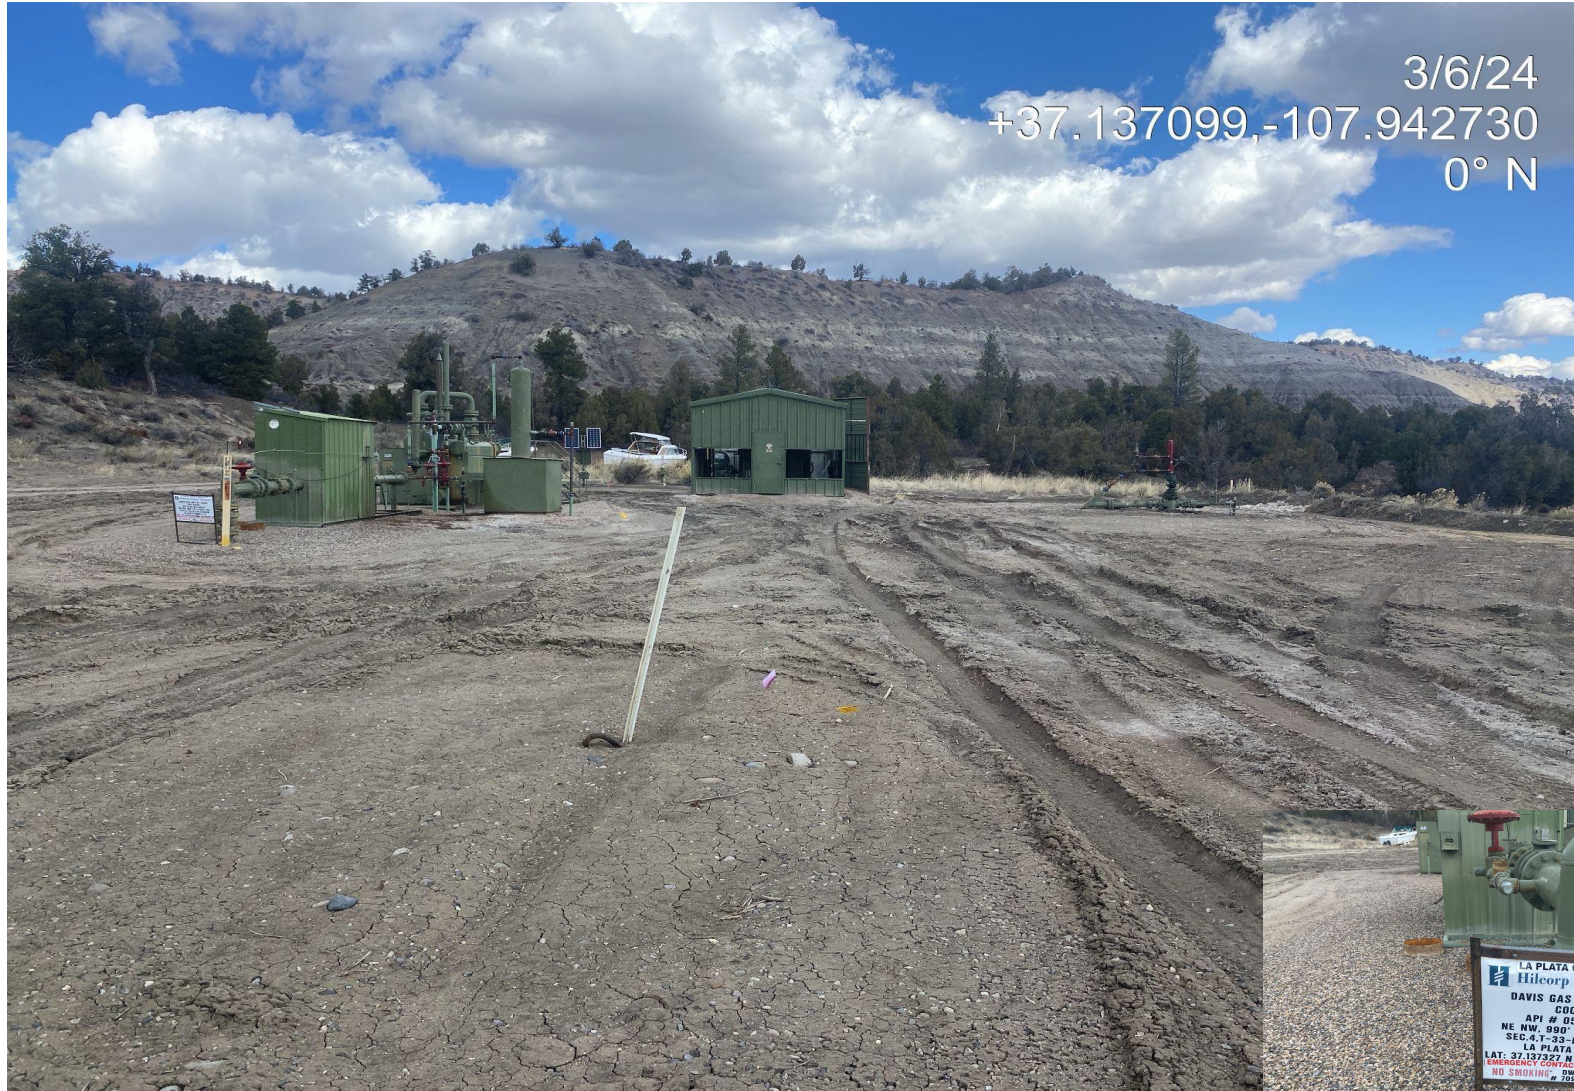
Photo 1. Overview of the disturbance taken from the entrance facing center.

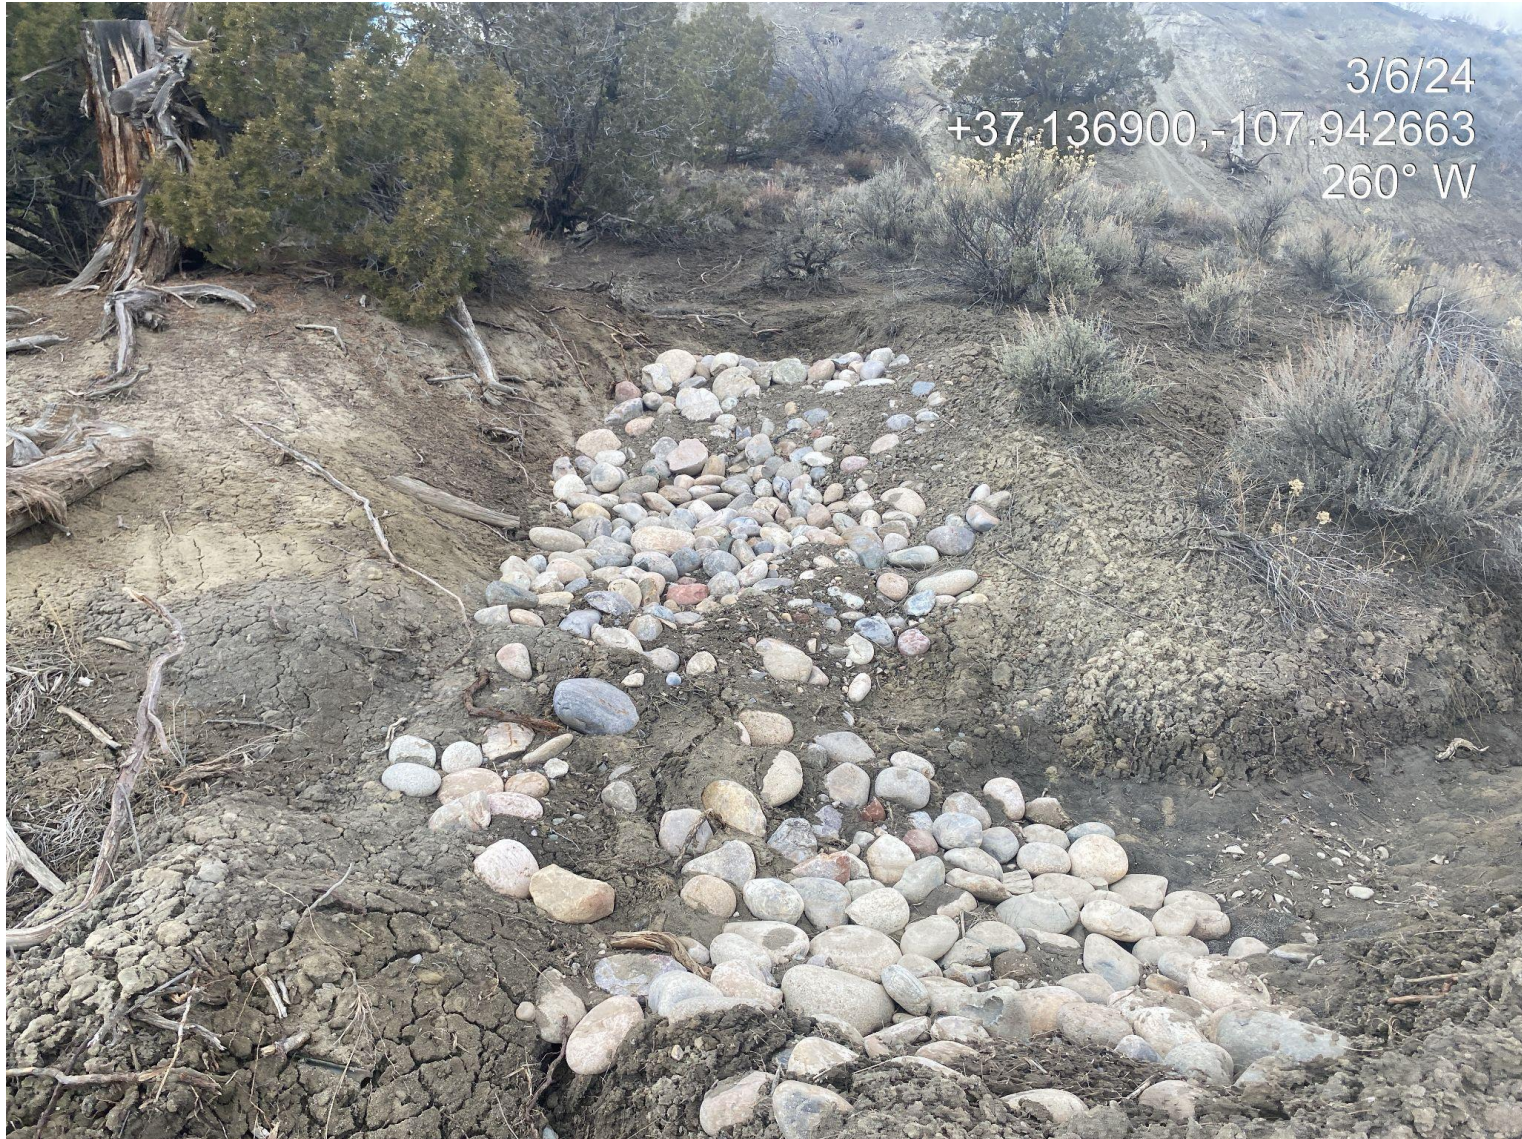
Photo 2. View of stormwater BMPs that are inadequate and have not been installed per good engineering practices.

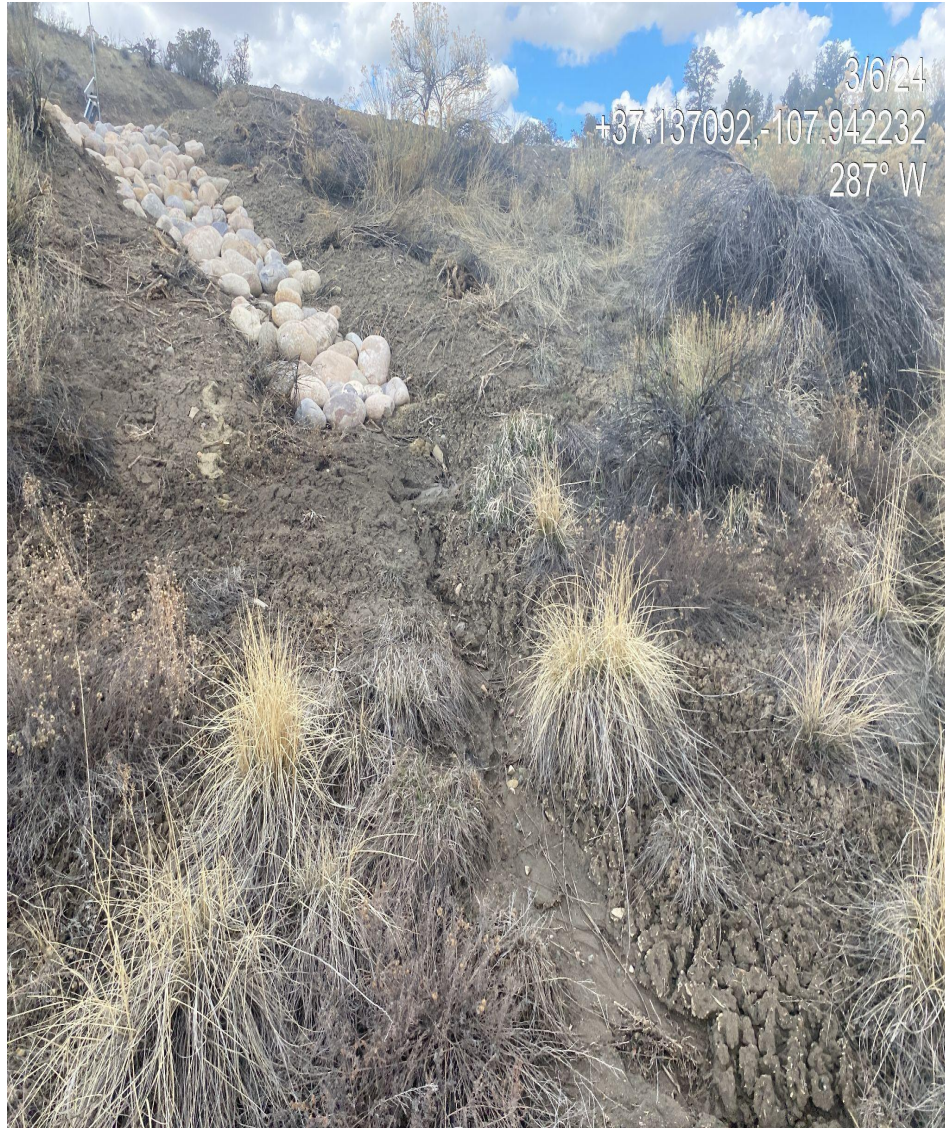
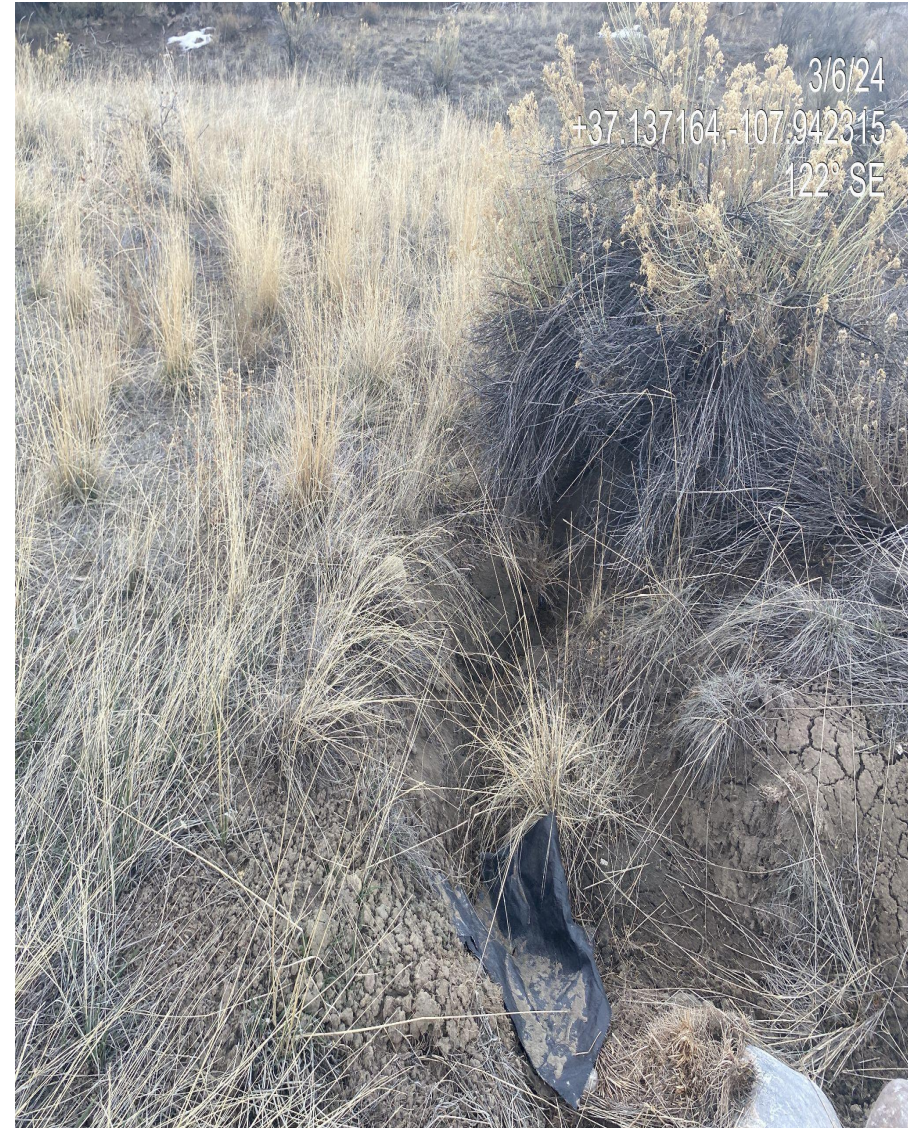
Photo 3. View of additional stormwater BMPs in the eastern interim reclamation area that are inadequate and have not been installed per good engineering practices. Rill and gully erosion forming down hill of the BMPs.

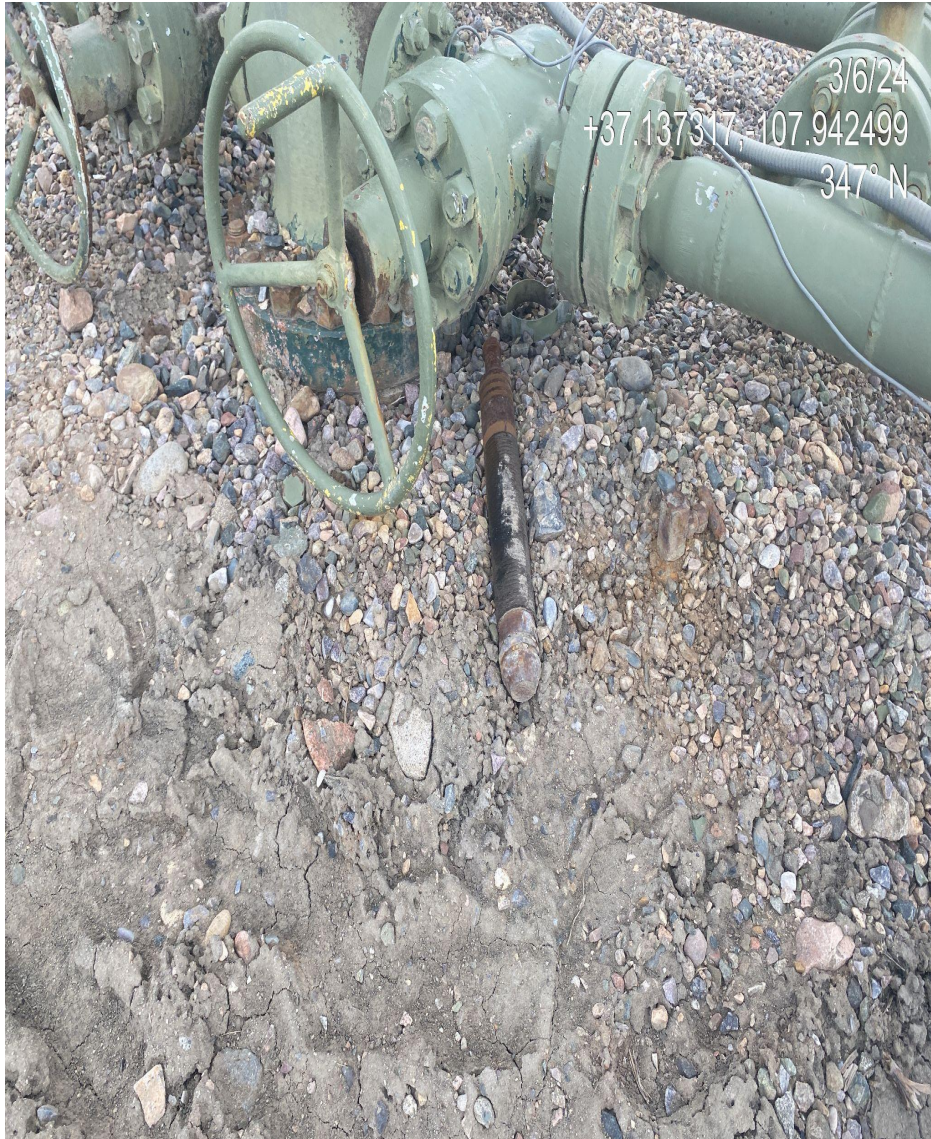
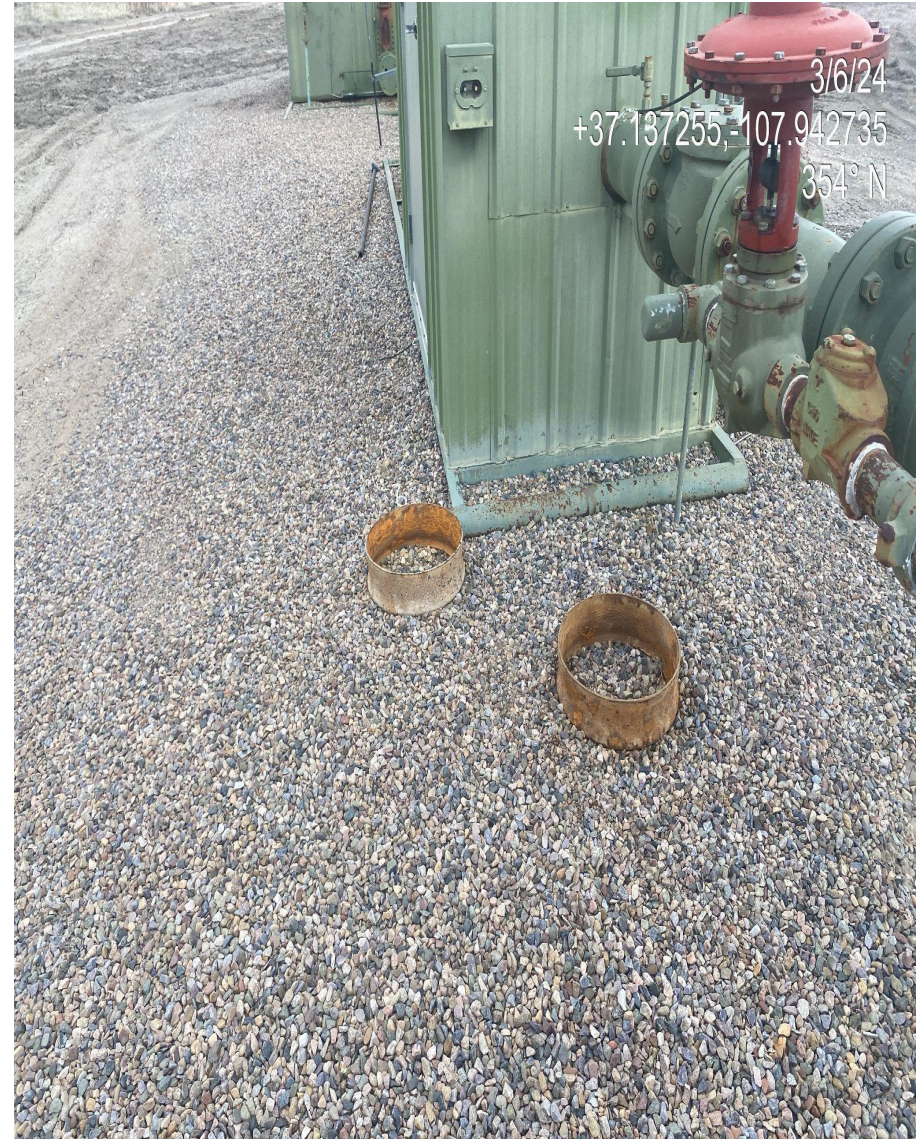
Photo 4. View of unused oil and gas equipment on location.

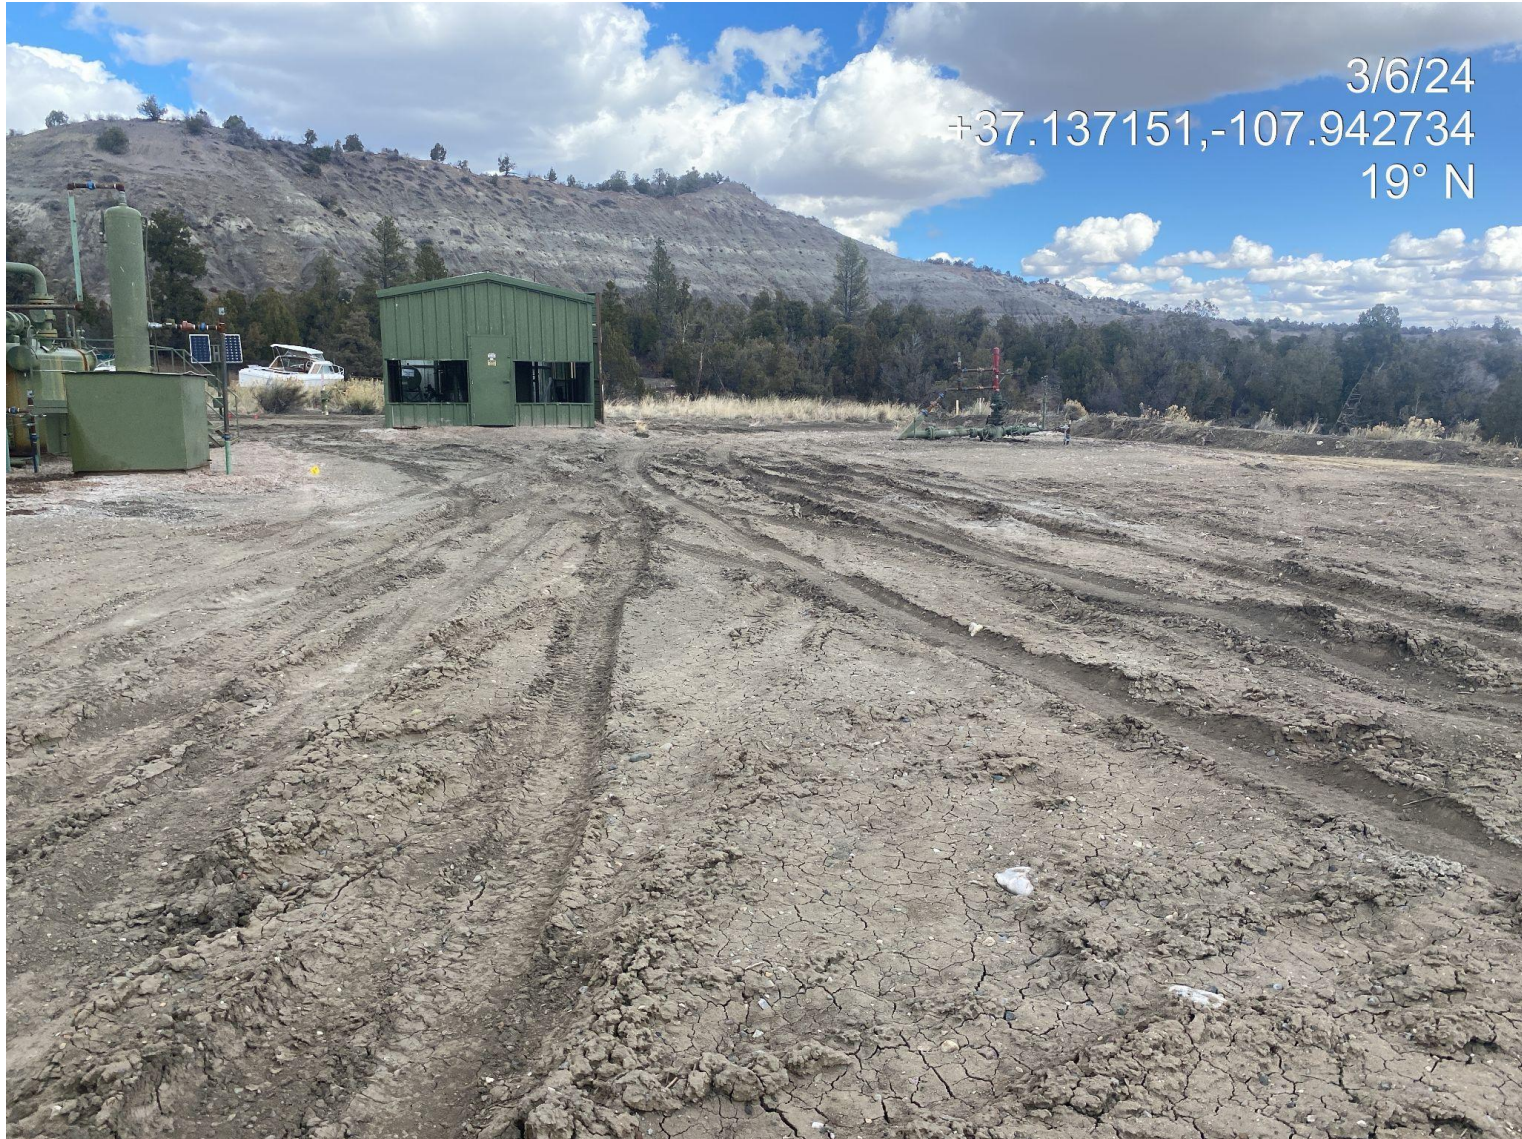
Photo 5. View of rutting observed site wide; additional stabilization is needed to minimize site degradation.

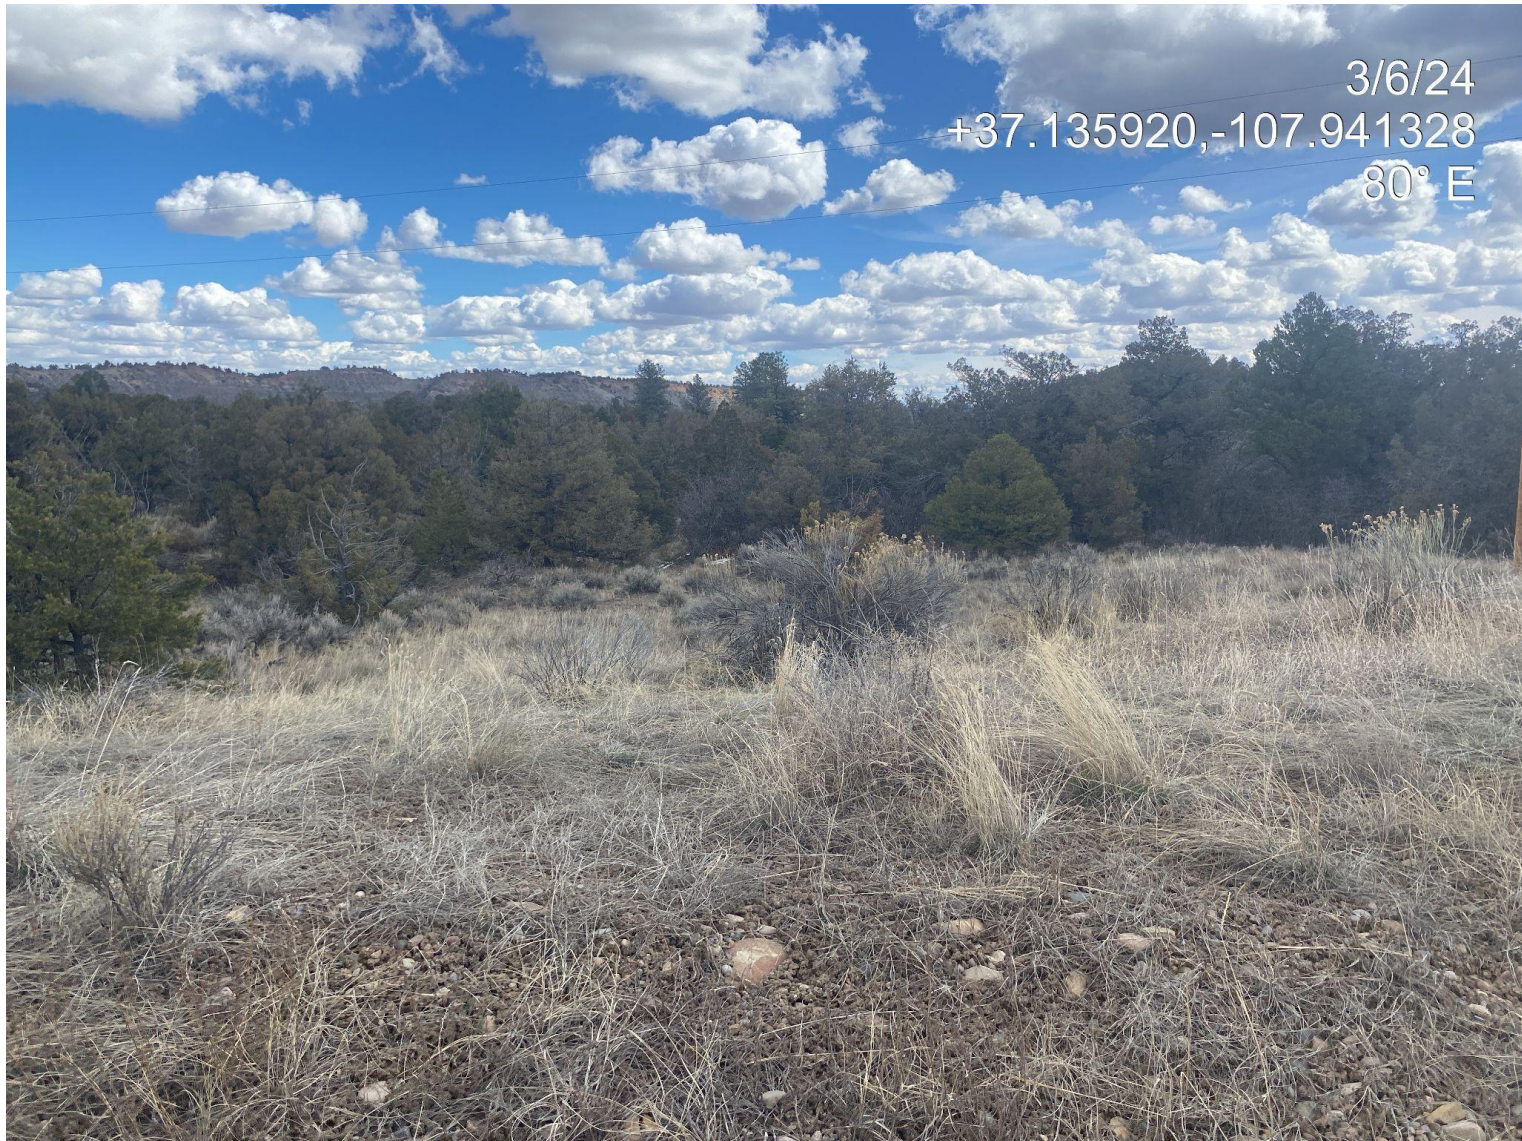
Photo 6. View of reference area comprised of smooth brome, crested wheatgrass, sagebrush and juniper.
