Construction and Stormwater Inspection

Date: 03/11/2024

Operator: BONANZA CREEK ENERGY OPERATING
COMPANY LLC - 8960

Inspection Photos
Location Name: State North Platte F-36 Pad
Location ID: 433511

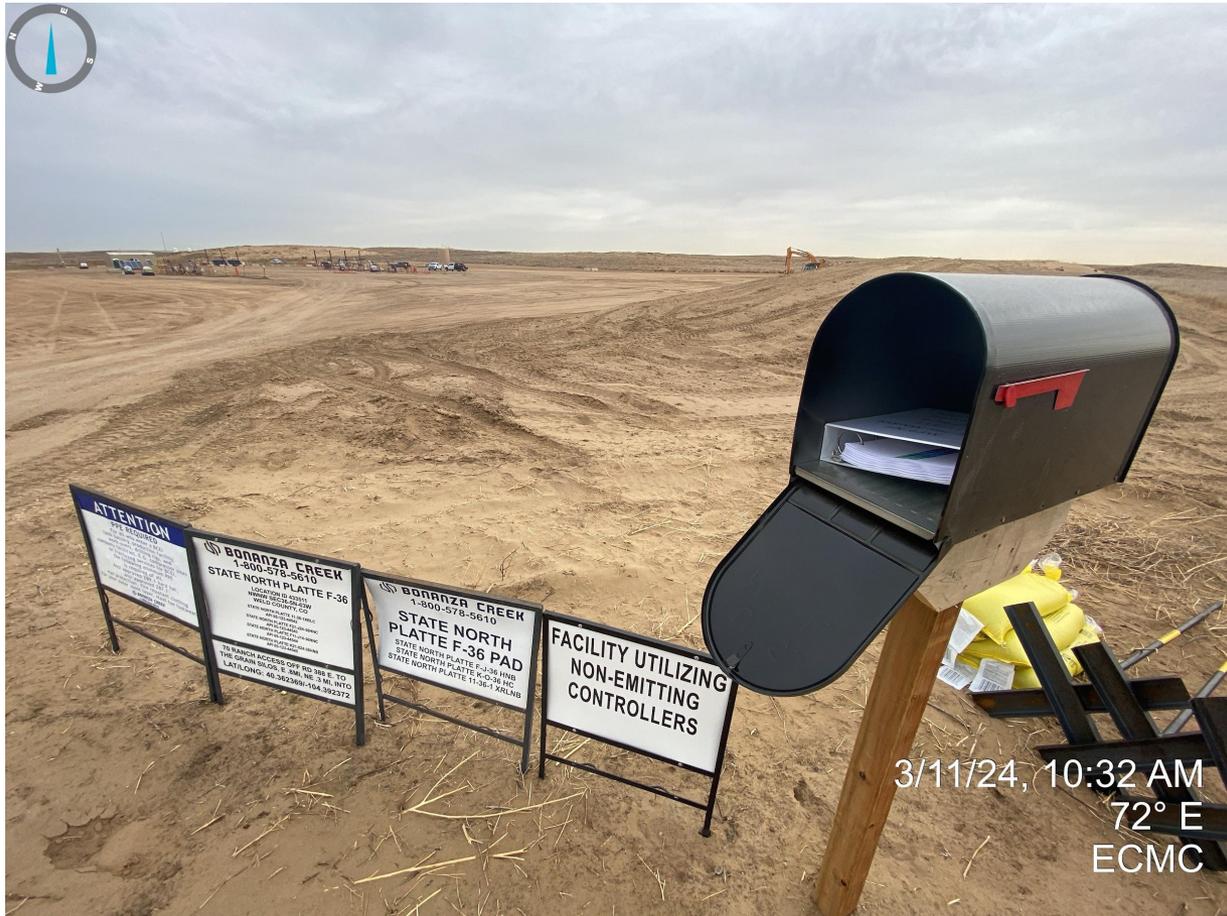
Photo 1. A copy of the approved Form 2A (doc #403355947) was posted on location, in compliance with Rule 406.c.

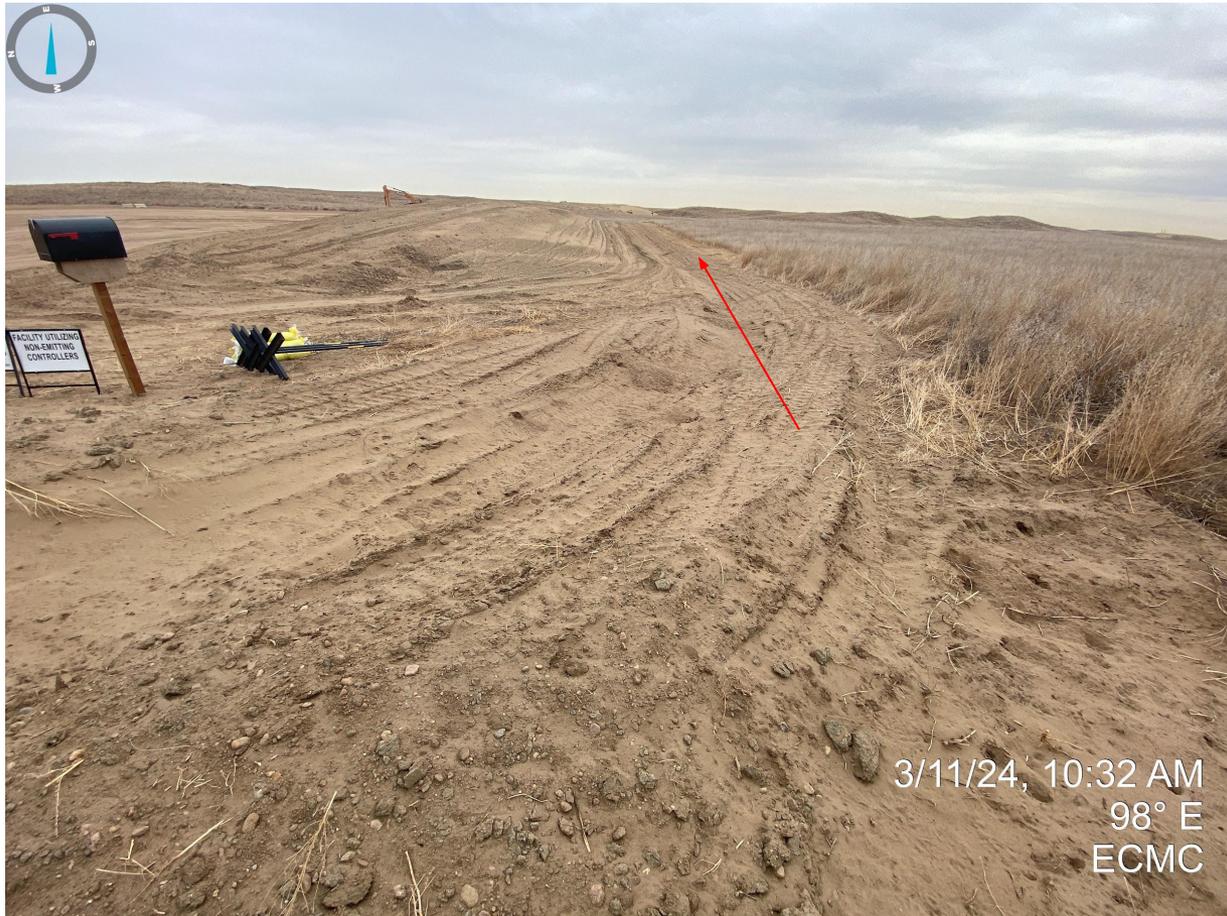
Photo 2. South side of location, near entrance. Perimeter stormwater control (ditch and berm) has been constructed around the location. Soils appear to be unstabilized and require additional stabilization BMPs.

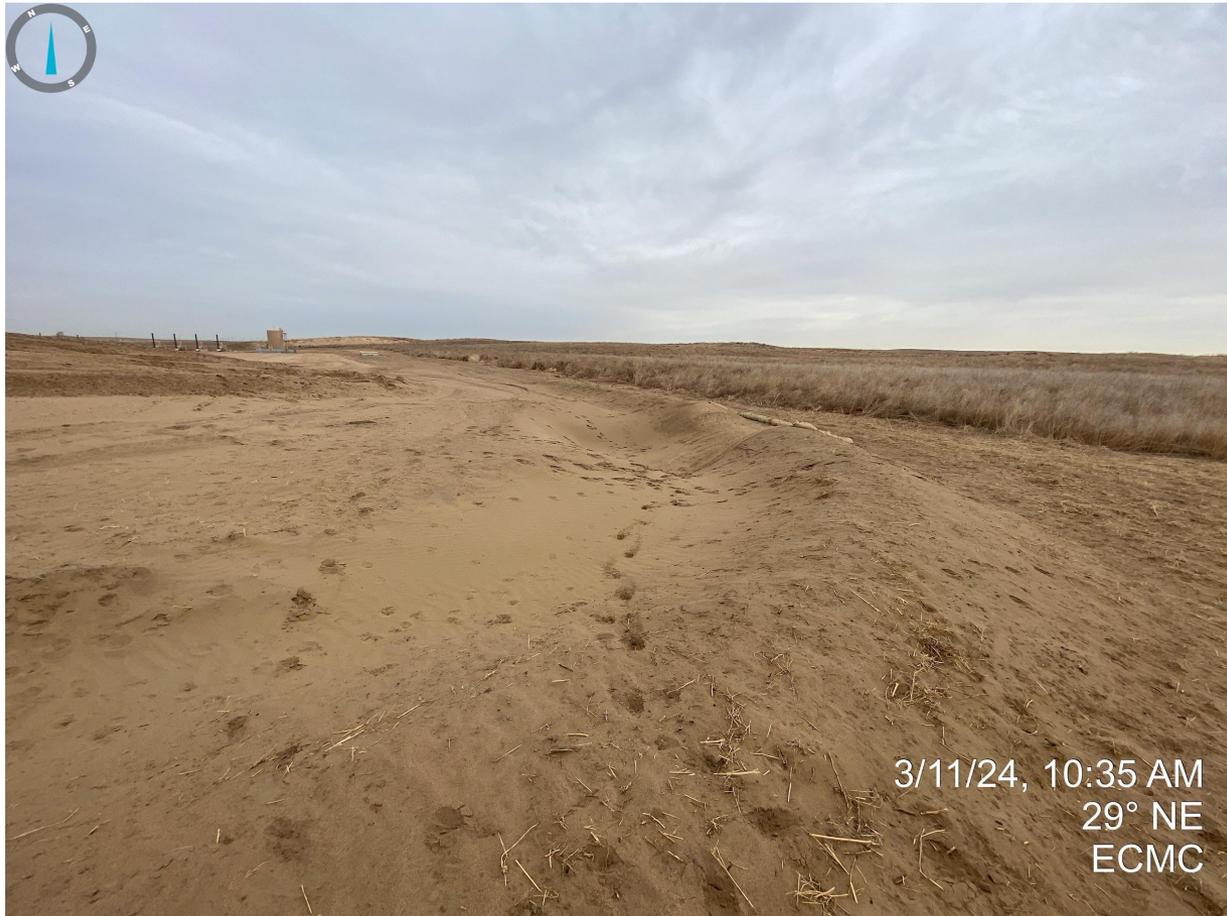
Photo 3. Southeast corner of location. A sediment trap has been installed on the perimeter of the location. Soils appear to be unstabilized with evidence of wind erosion and blown sand deposition. Additional stabilization BMPs are required on the loose soils.

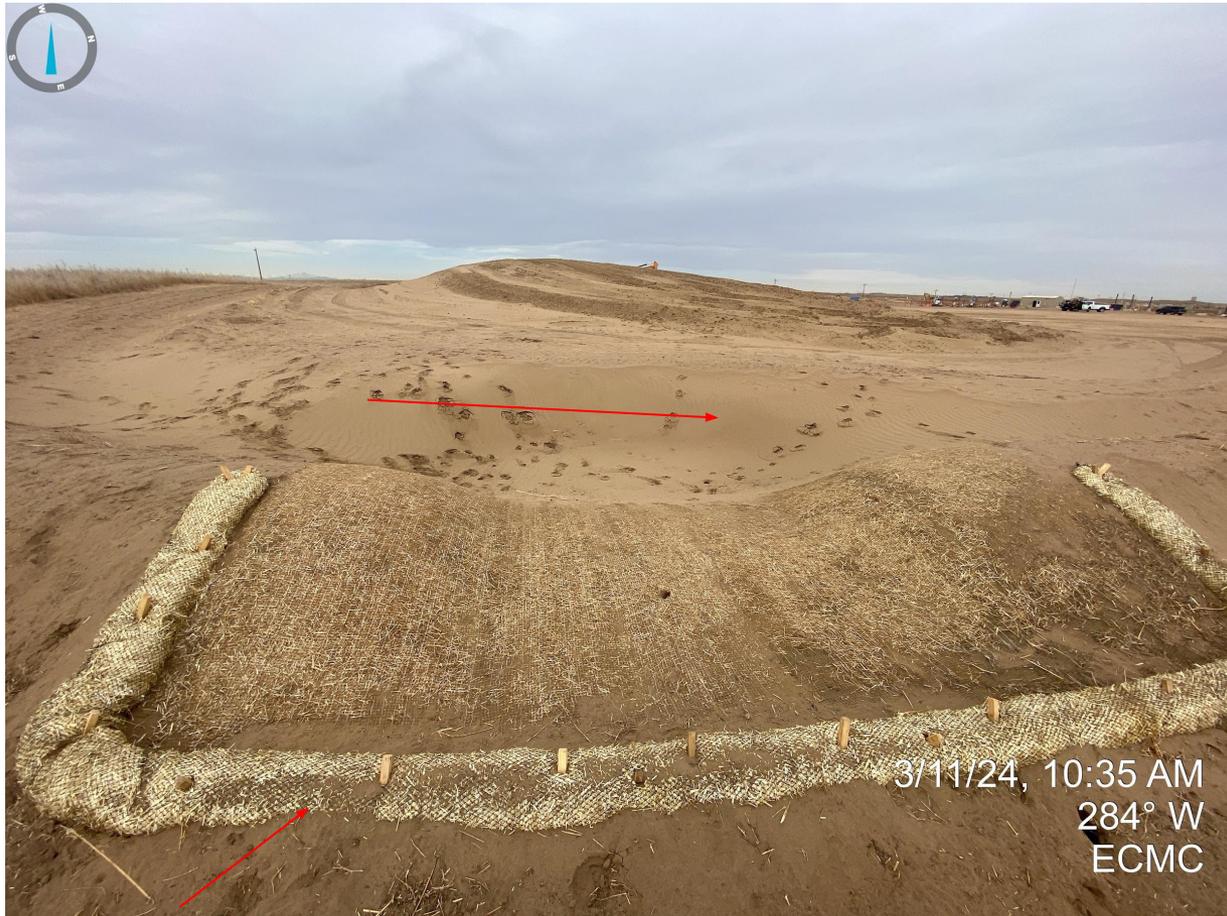
Photo 4. Continued from Photo 3. Red arrow indicates blow sand deposition from the unstabilized areas.

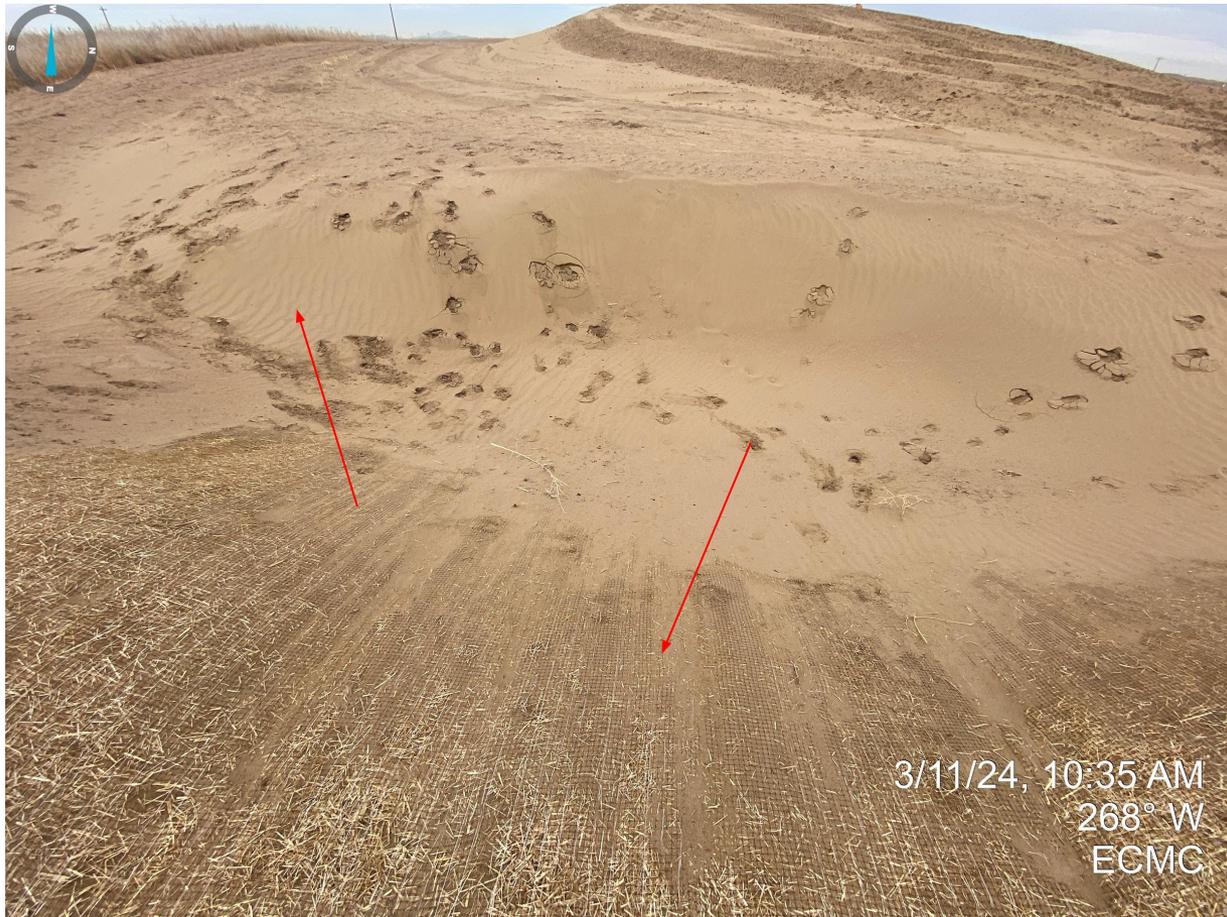
Photo 5. Continued from Photo 4. Red arrows indicate blow sand deposition occurring from wind erosion. Erosion control mat is beginning to fill with sediment.

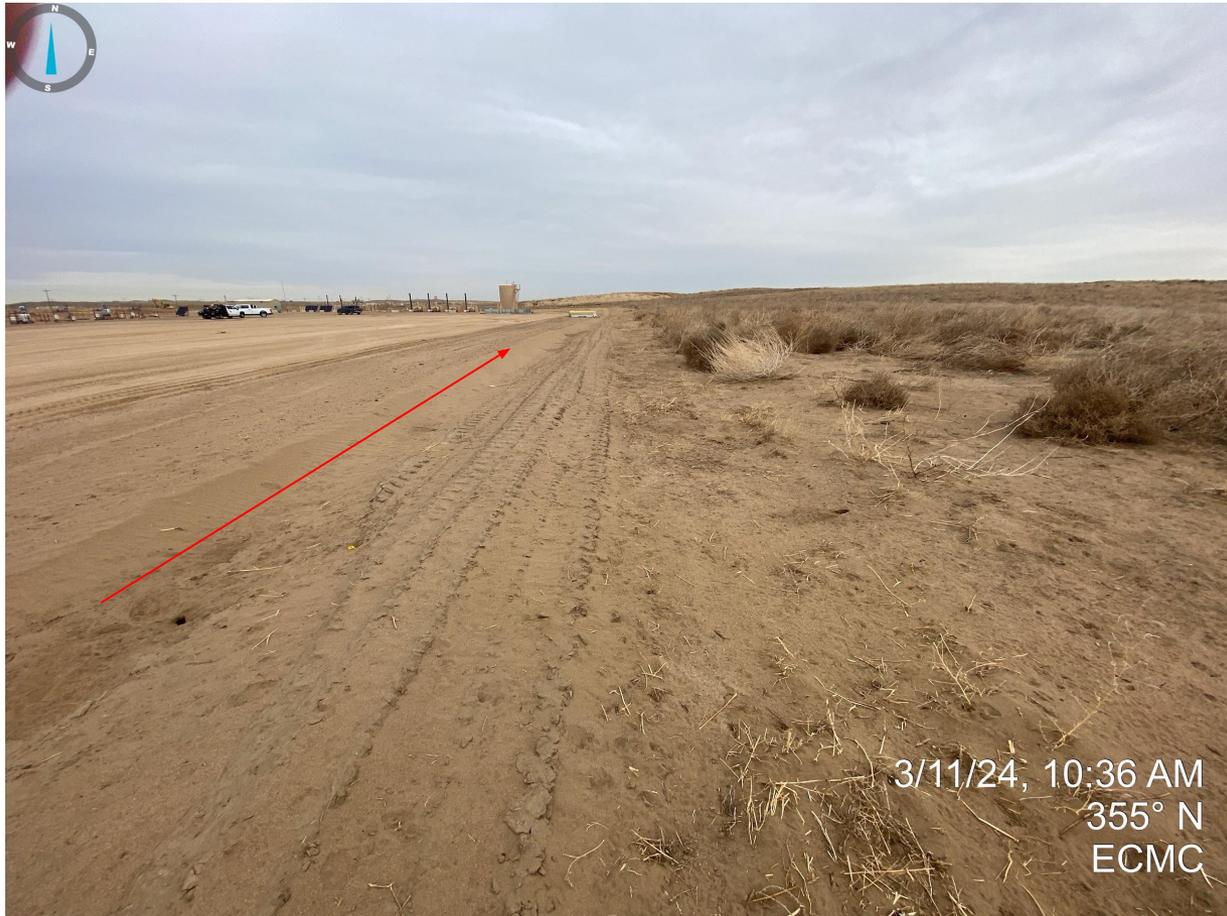
Photo 6. East side of location. Perimeter stormwater control (ditch and berm) has been constructed around the location. Soils appear to be unstabilized and require additional stabilization BMPs.

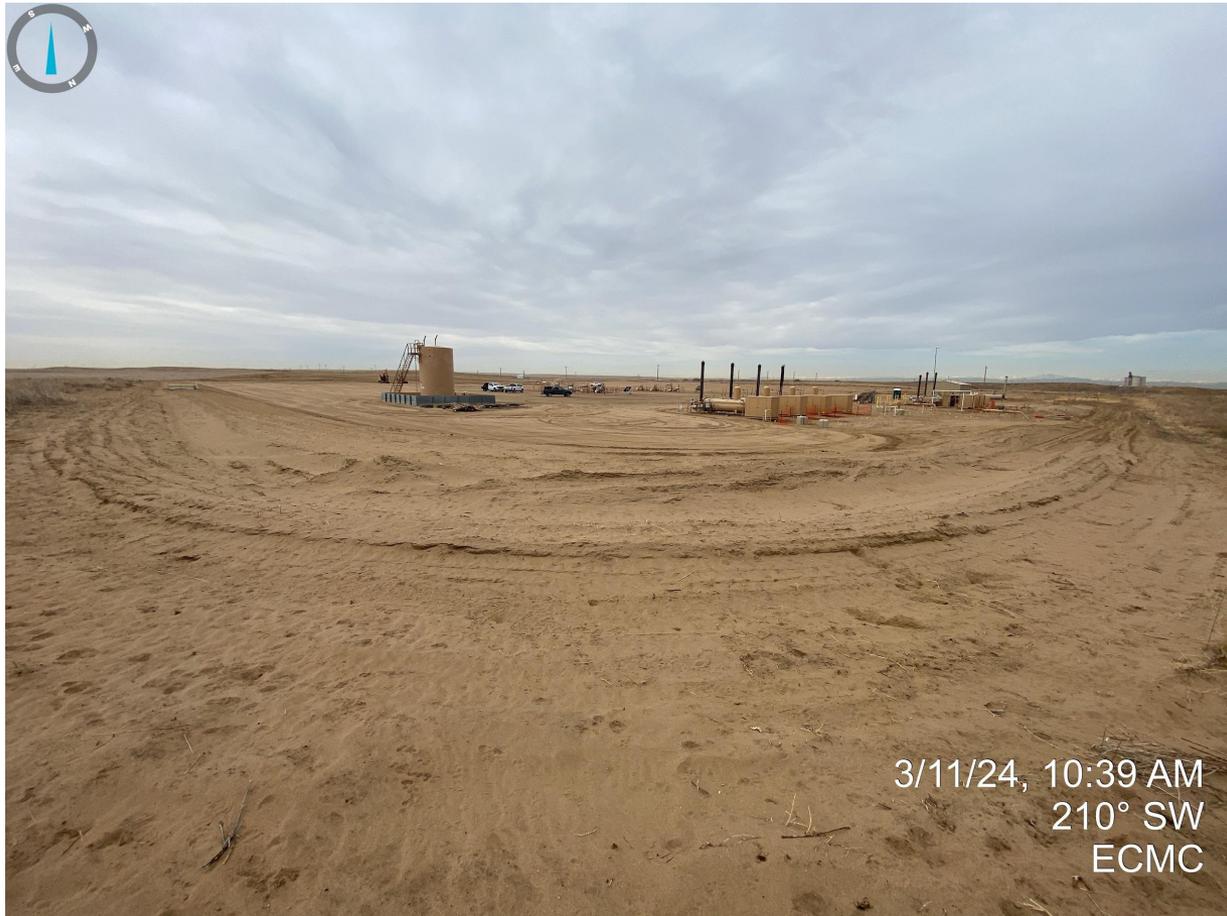
Photo 7. Northeast corner of location. Perimeter stormwater control (ditch and berm) has been constructed around the location. Soils appear to be unstabilized and require additional stabilization BMPs.

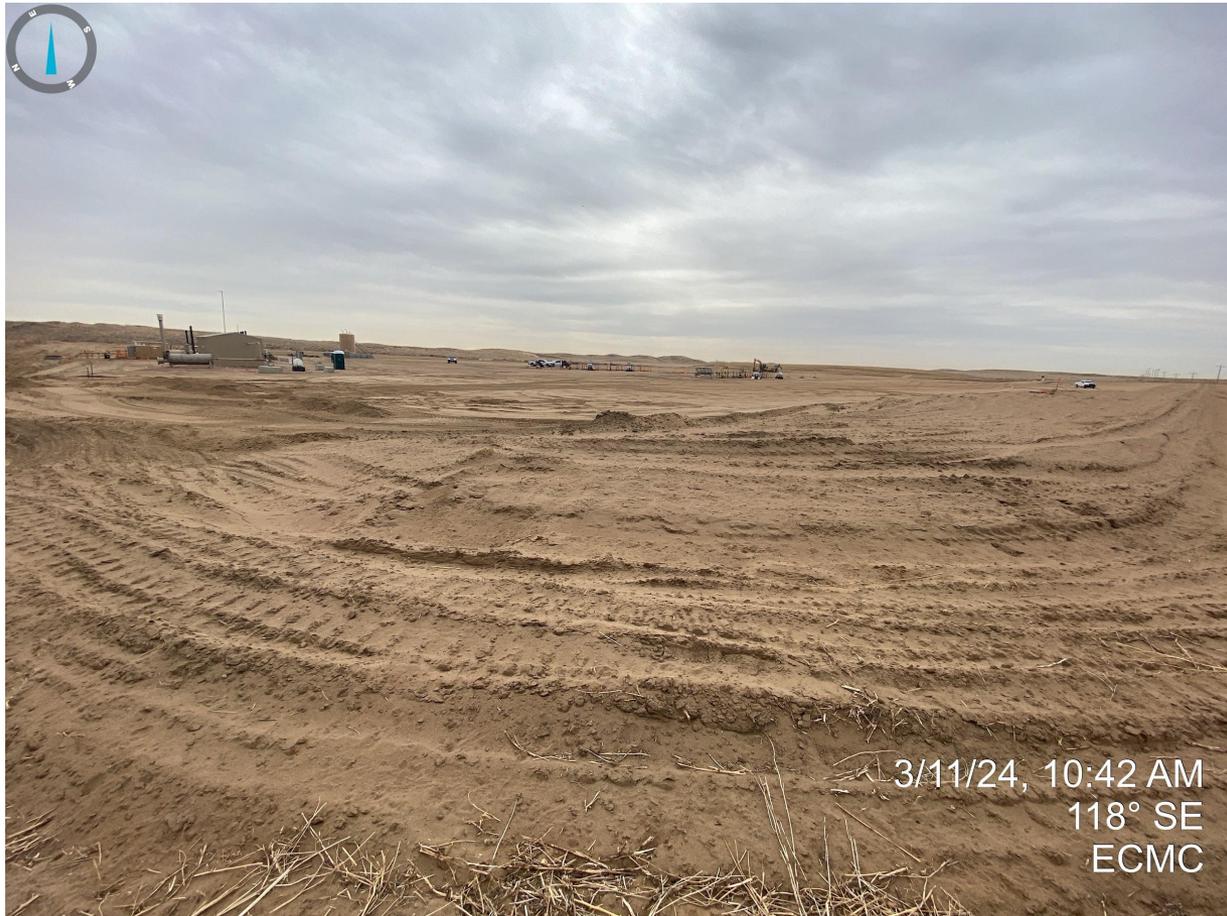
Photo 8. Northwest corner of location. Perimeter stormwater control (ditch and berm) has been constructed around the location. Soils appear to be unstabilized and require additional stabilization BMPs.

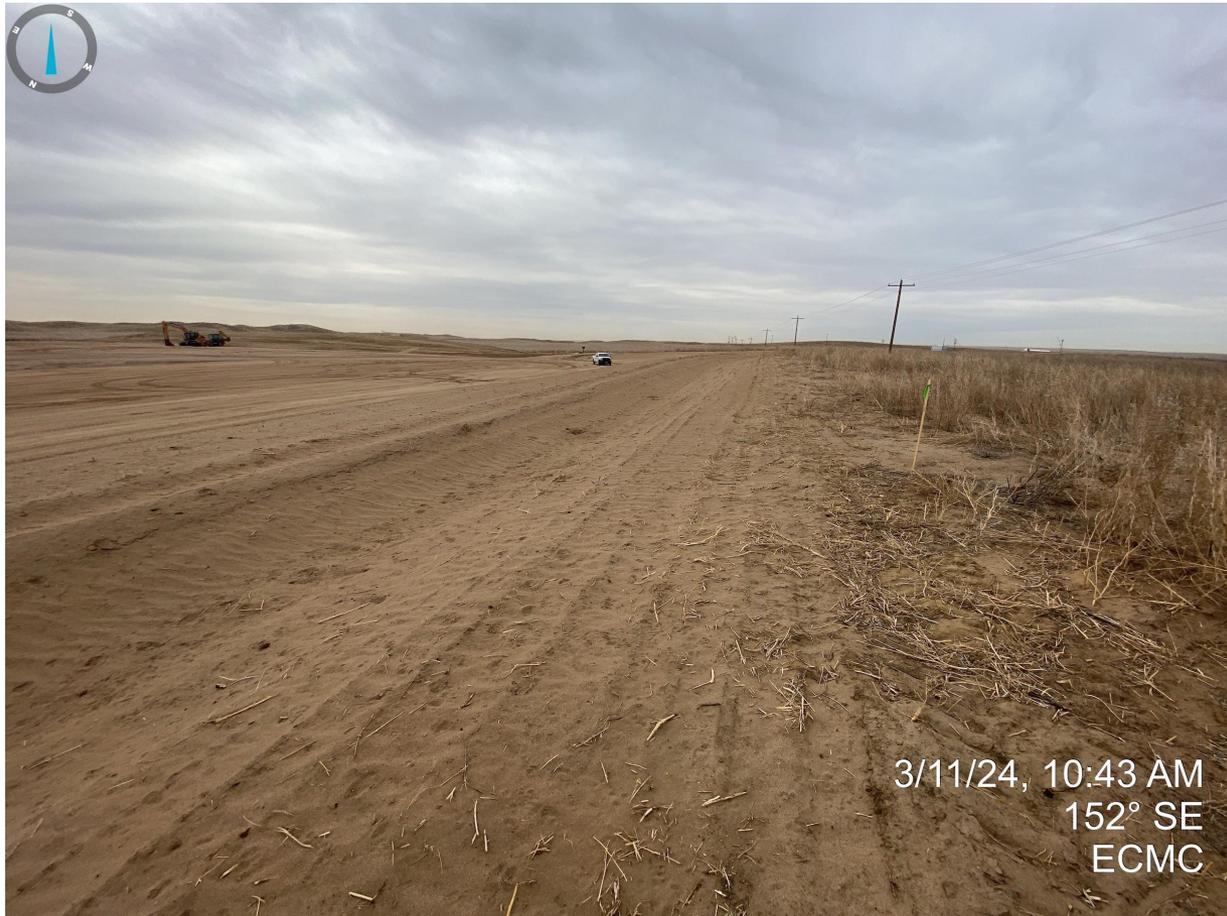
Photo 9. West side of location. Perimeter stormwater control (ditch and berm) has been constructed around the location. Soils appear to be unstabilized and require additional stabilization BMPs.

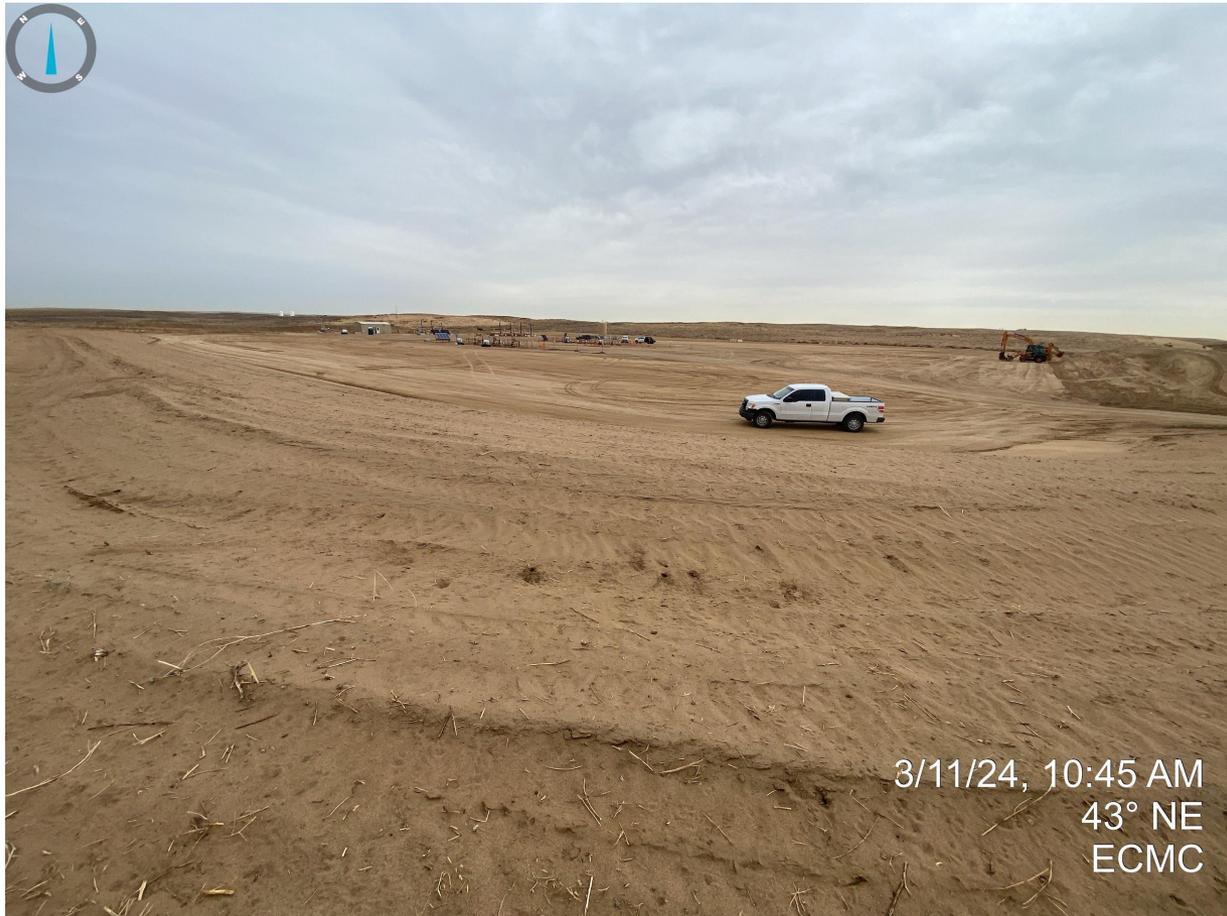
Photo 10. Southwest corner of location. Perimeter stormwater control (ditch and berm) has been constructed around the location. Soils appear to be unstabilized and require additional stabilization BMPs.

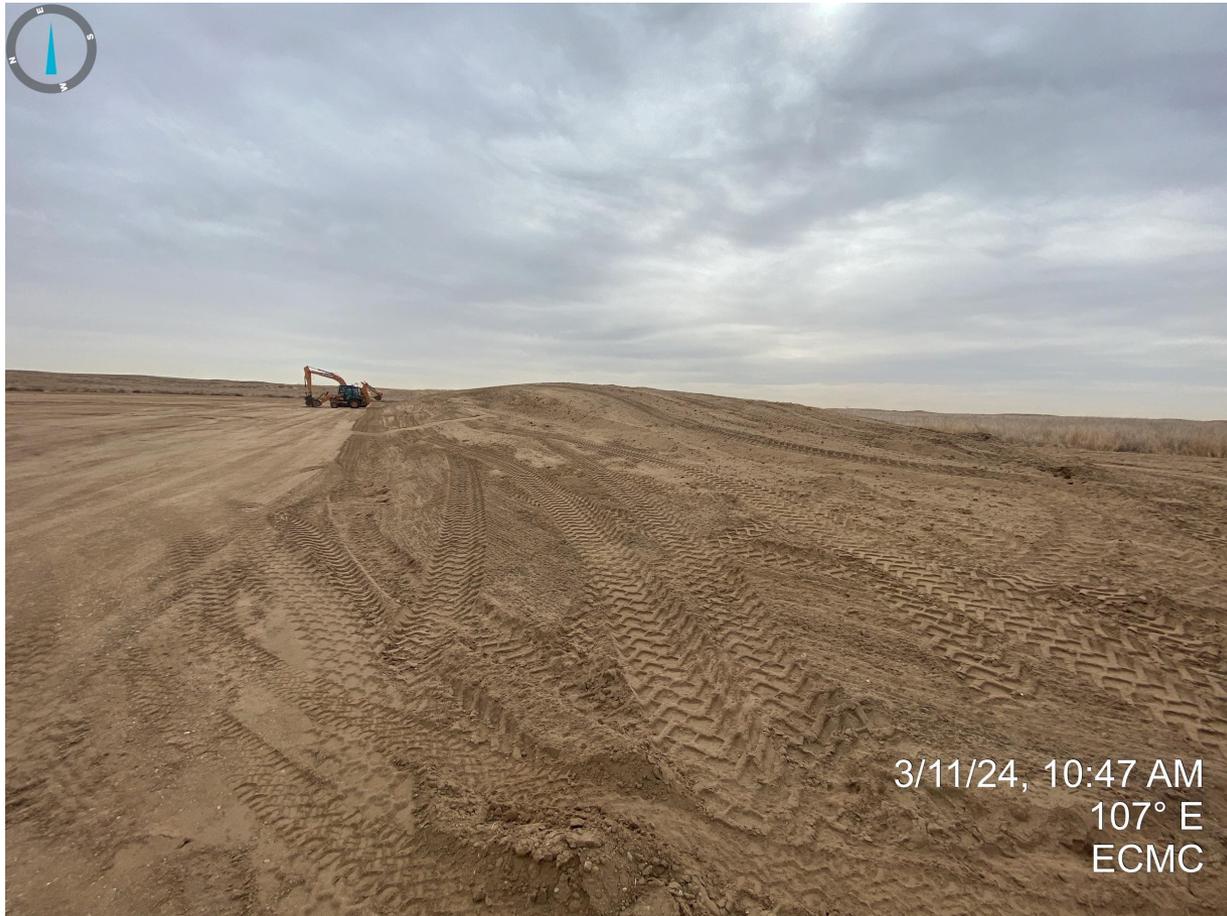
Photo 11. West side of topsoil stockpile. The stockpile does not appear to be properly stabilized from wind/water erosion with evidence of unstabilized soils. Temporary BMPs (e.g. equipment tracking) should be implemented prior to selecting more permanent BMPs.

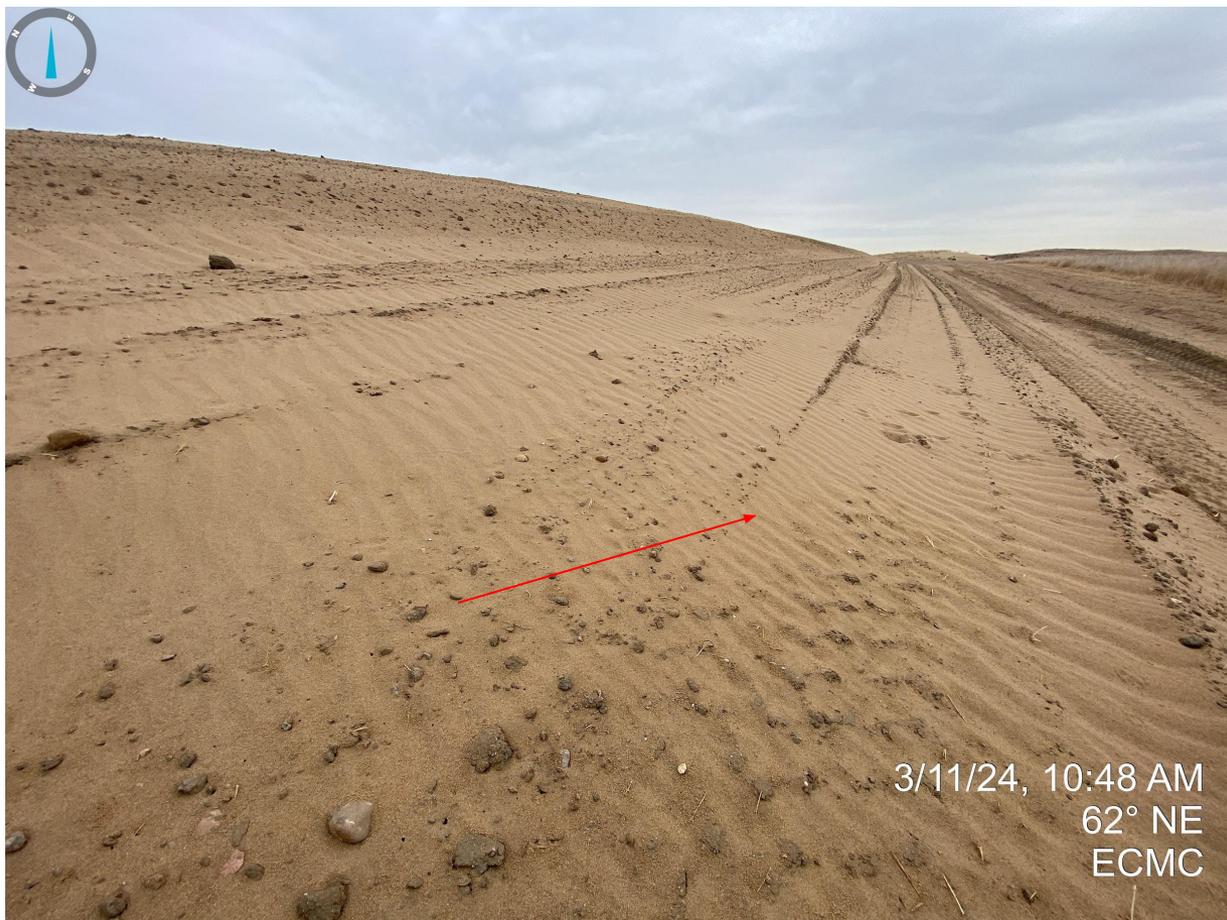
Photo 12. South side of topsoil stockpile. The stockpile does not appear to be properly stabilized from wind/water erosion with evidence of unstabilized soils. Temporary BMPs (e.g. equipment tracking) should be implemented prior to selecting more permanent BMPs. Red arrow indicates an example of wind erosion.

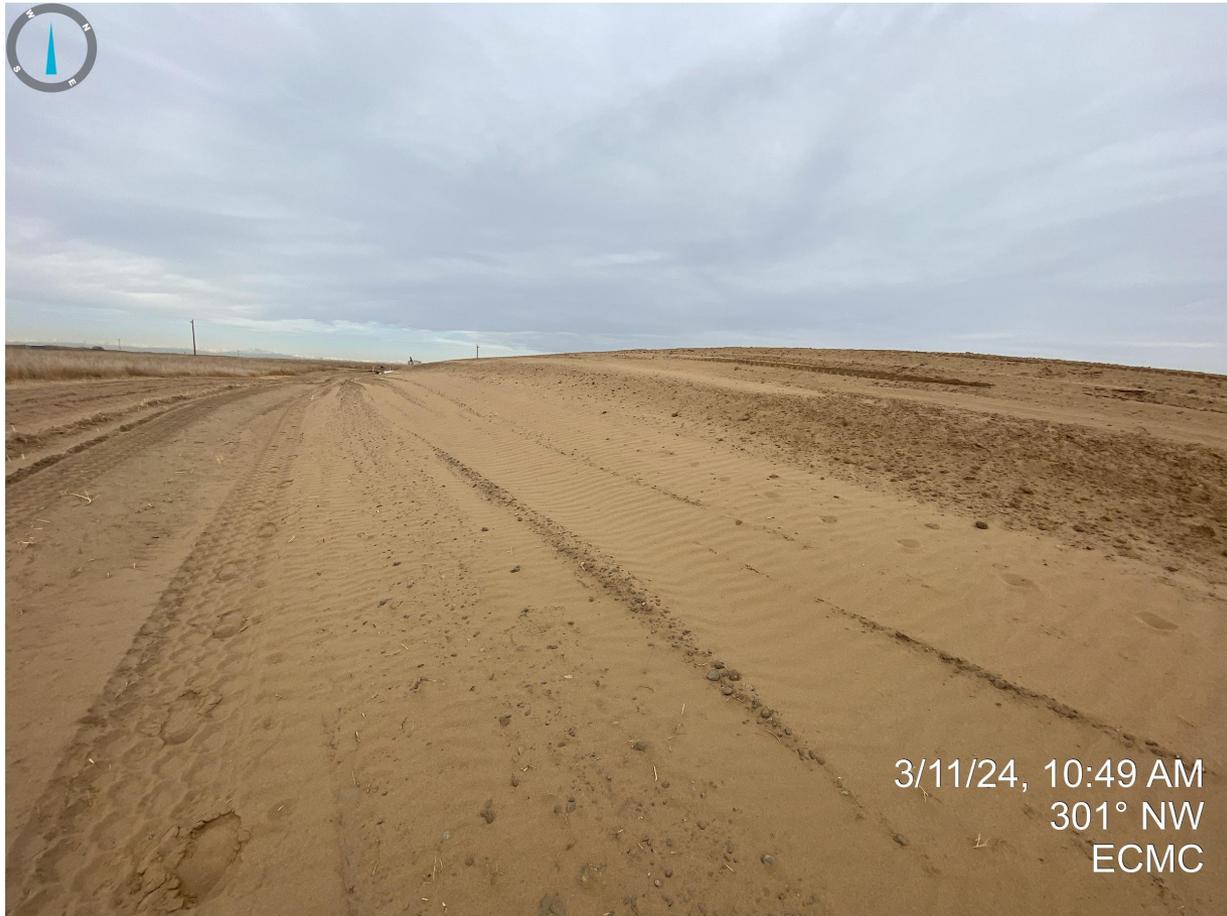
Photo 13. East/south side of topsoil stockpile. The stockpile does not appear to be properly stabilized from wind/water erosion with evidence of unstabilized soils. Temporary BMPs (e.g. equipment tracking) should be implemented prior to selecting more permanent BMPs.

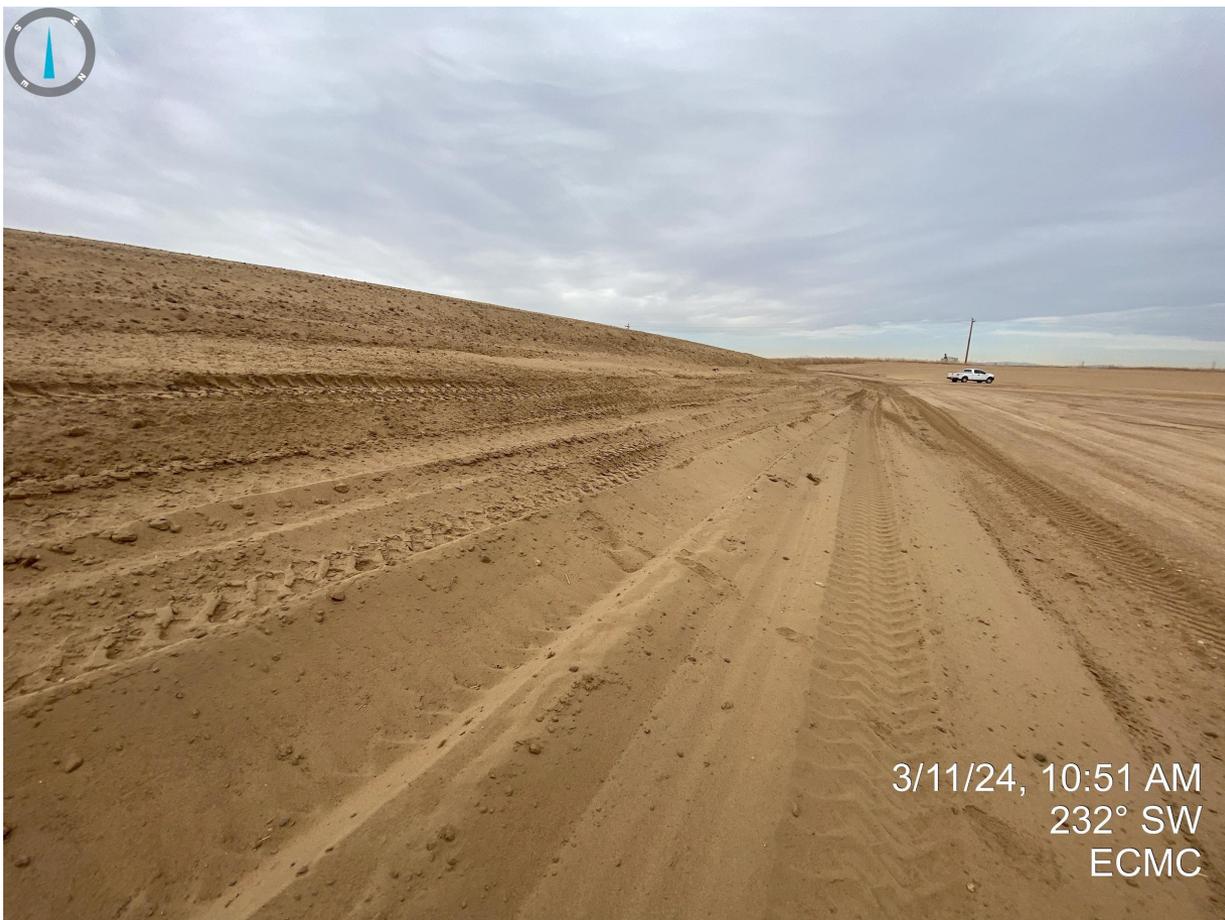
Photo 14. North side of topsoil stockpile. The stockpile does not appear to be properly stabilized from wind/water erosion with evidence of unstabilized soils. Temporary BMPs (e.g. equipment tracking) should be implemented prior to selecting more permanent BMPs.

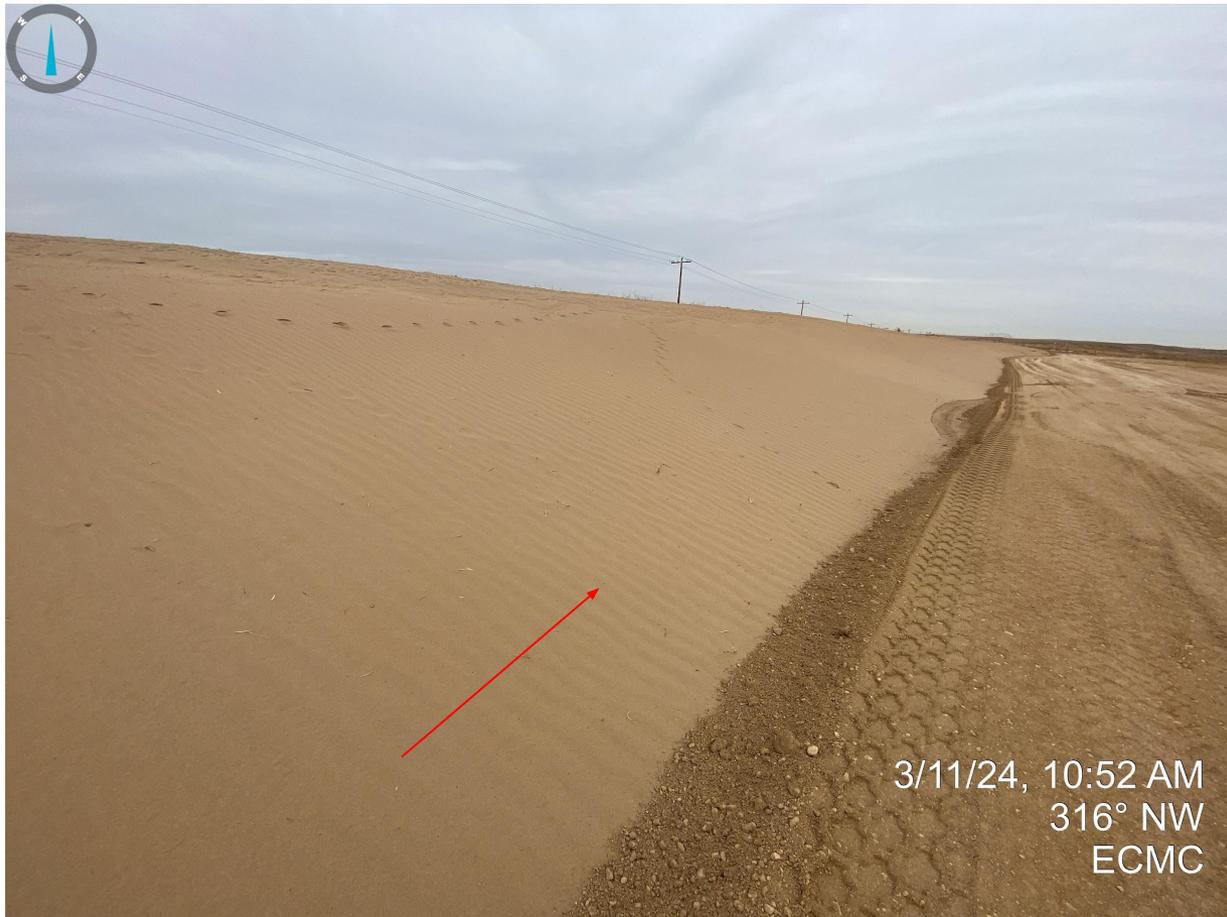
Photo 15. West side of location. The cut slopes do not appear to be properly stabilized from wind/water erosion with evidence of unstabilized soils. Temporary BMPs (e.g. equipment tracking) should be implemented prior to selecting more permanent BMPs. Evidence of wind erosion indicated by red arrow.

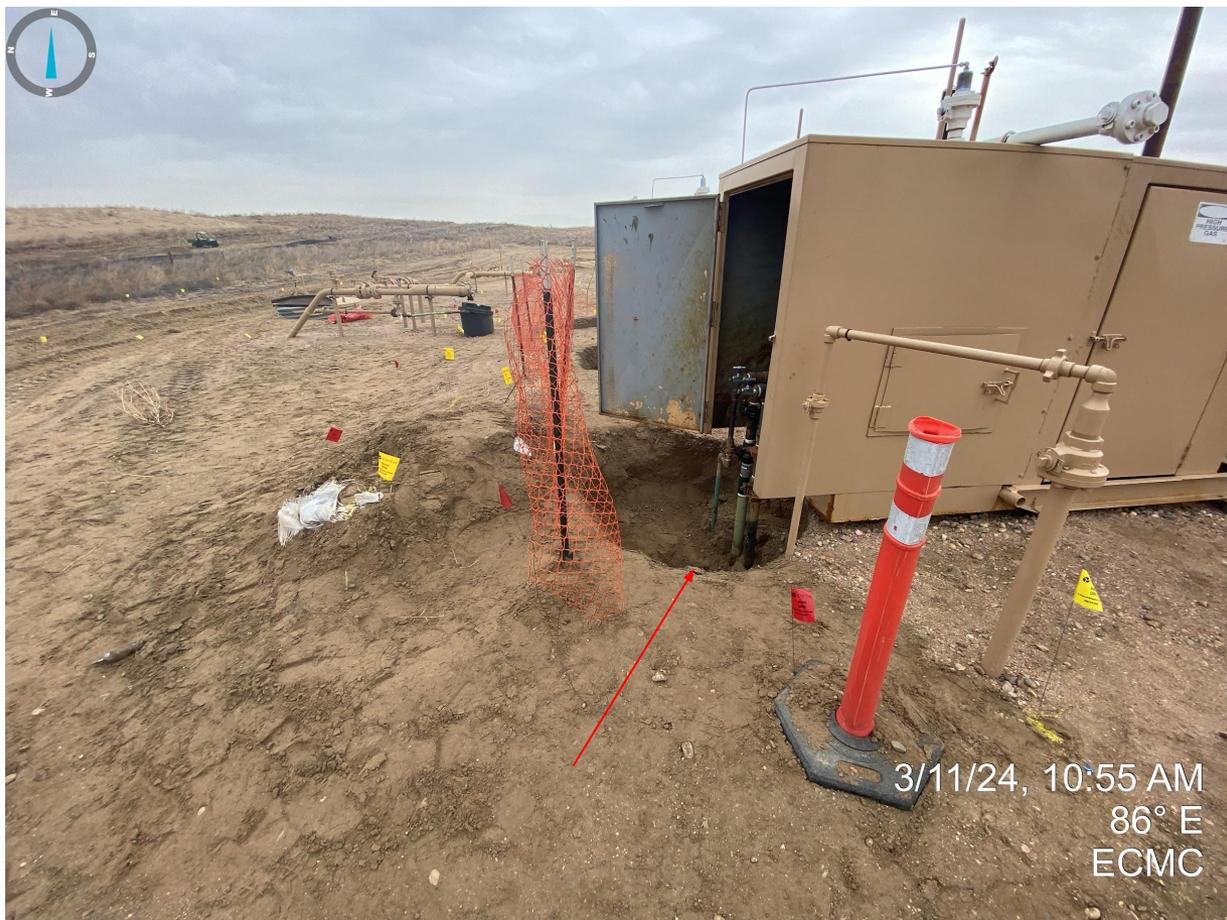
Photo 16. North side of location. Open excavations are not adequately fenced to exclude wildlife and/or people. Operator shall ensure that all open excavations are properly fenced when the location is unattended.

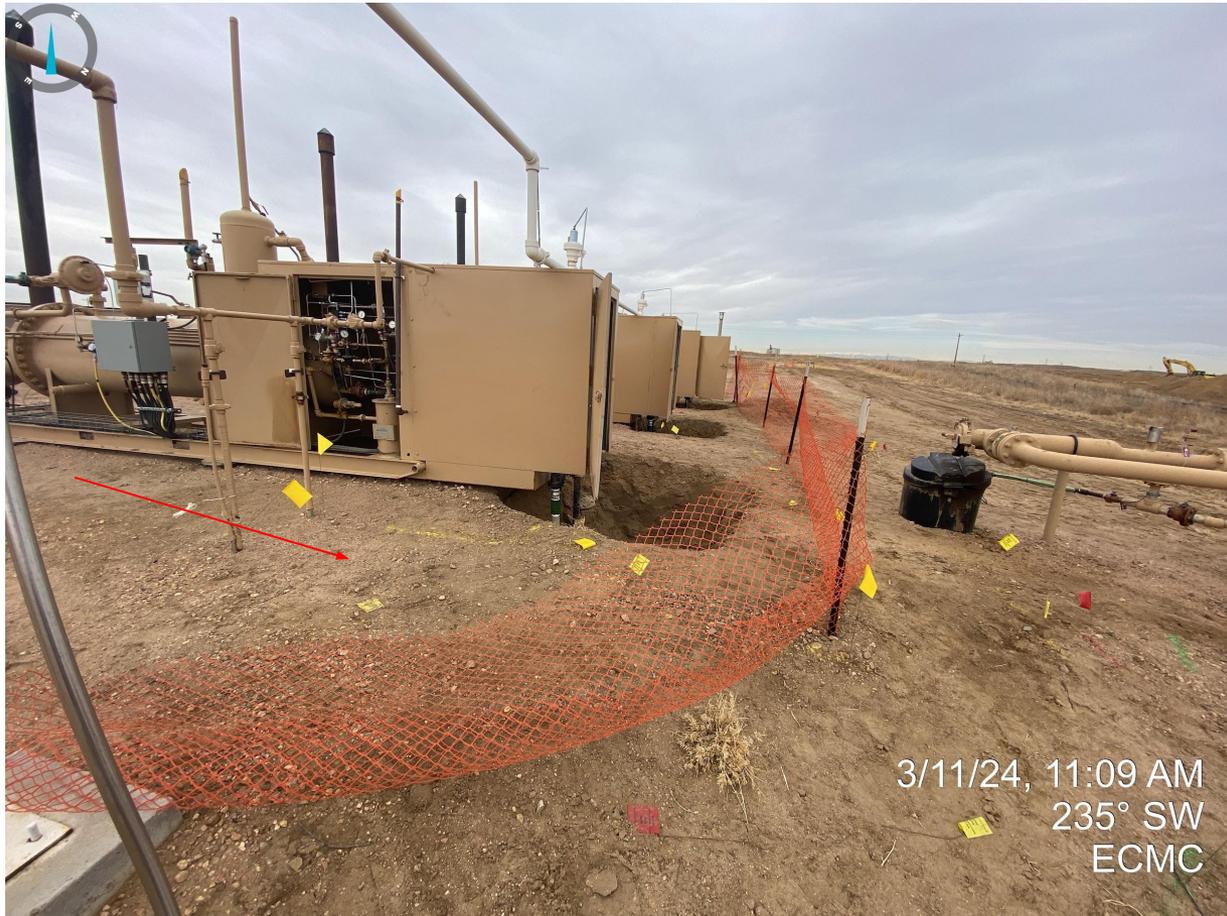
Photo 17. See comments in Photo 16.

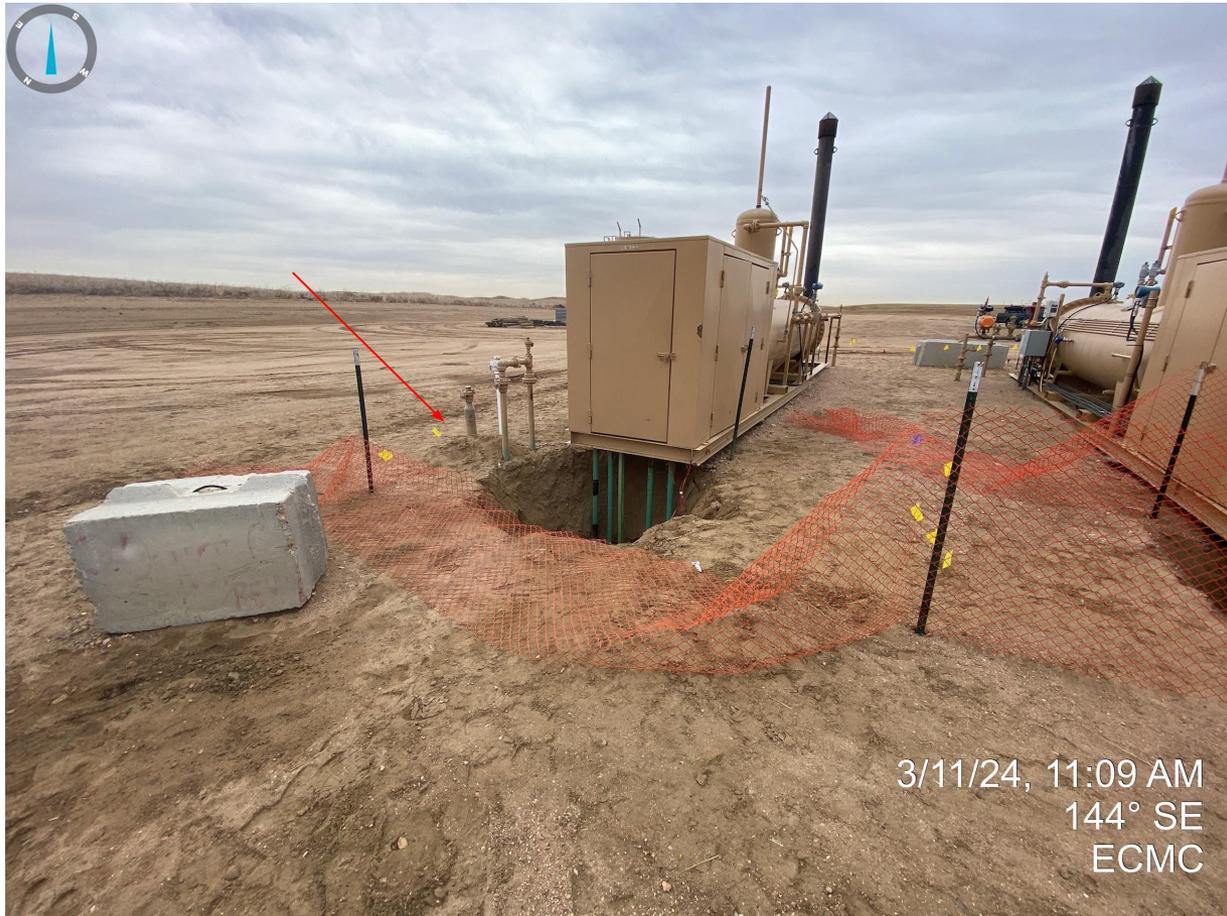
Photo 18. See comments in Photo 16.

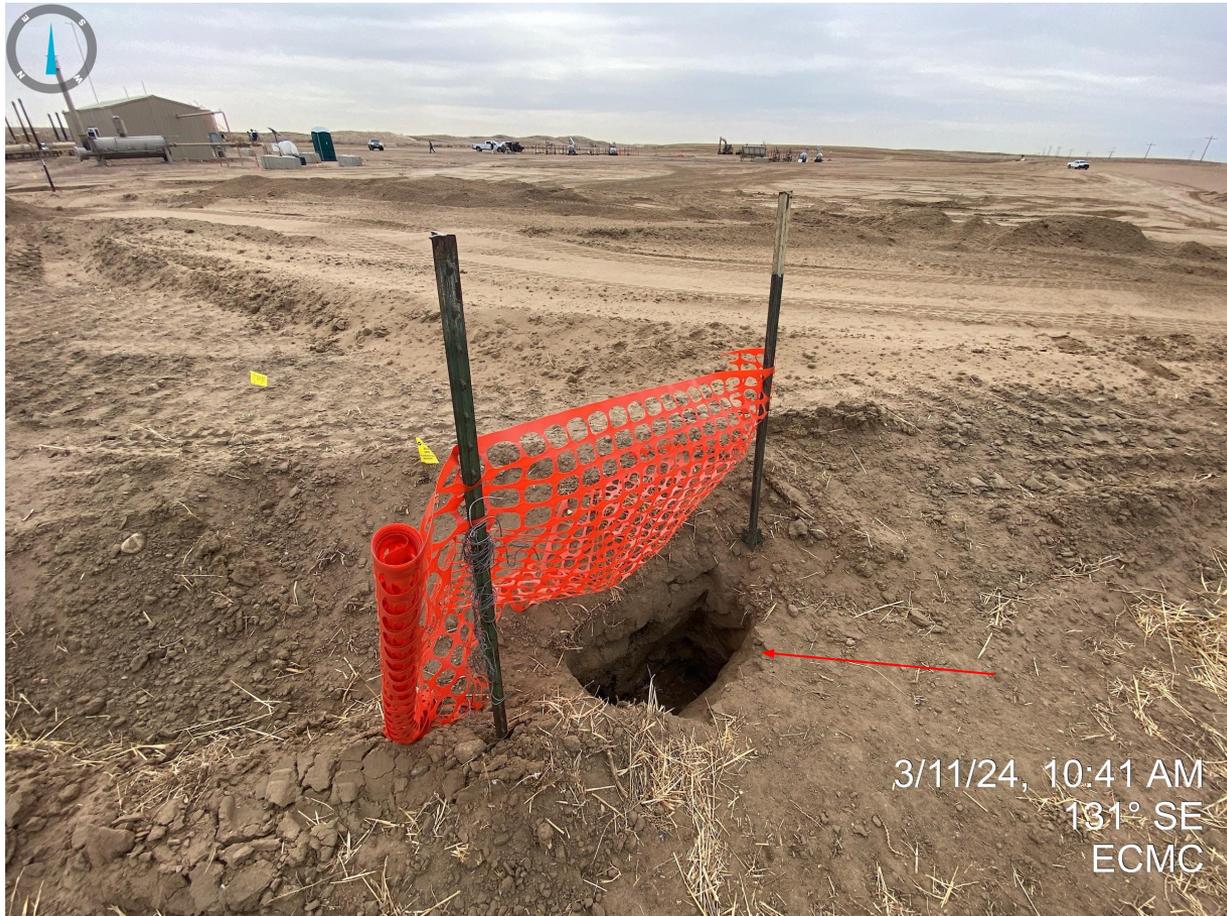
Photo 19. Southwest corner of the location; see comments in Photo 16.
