Inspection Photos

Location Name: TEP ROCKY MOUNTAIN LLC Valley Farms I Pad

Location ID: 335553

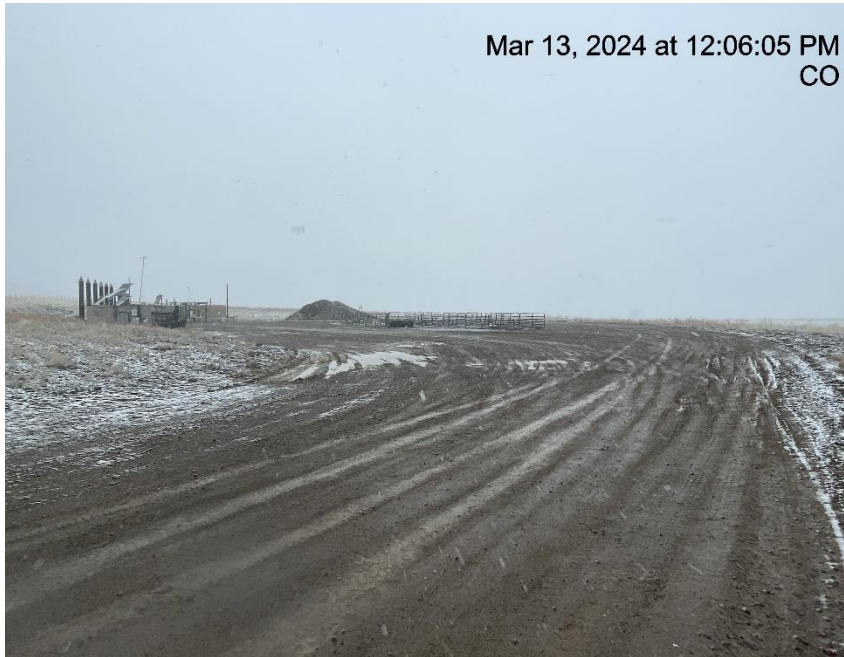
Photo # 9764 From entrance to location

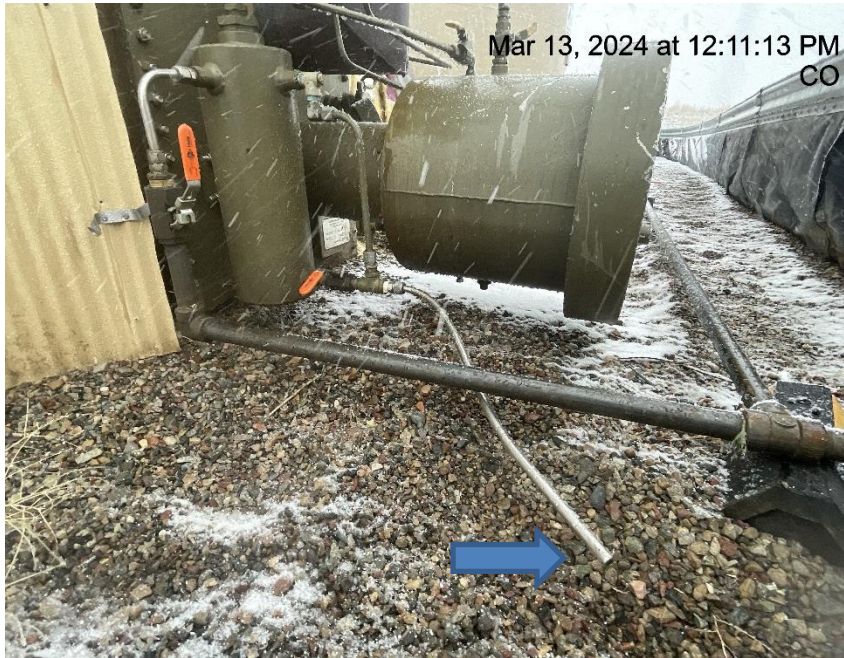
Photo # 9772 PRV vent line does not comply with CECMC pressure safety device rules & also terminates in an unsafe manner.

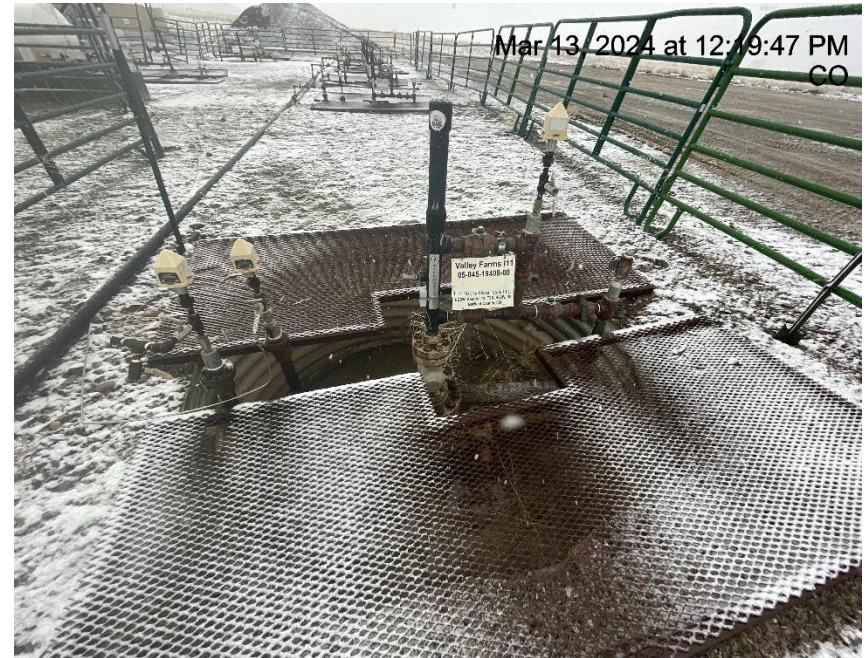
Photo # 9773 Cellar lacks wildlife egress/wildlife hazard

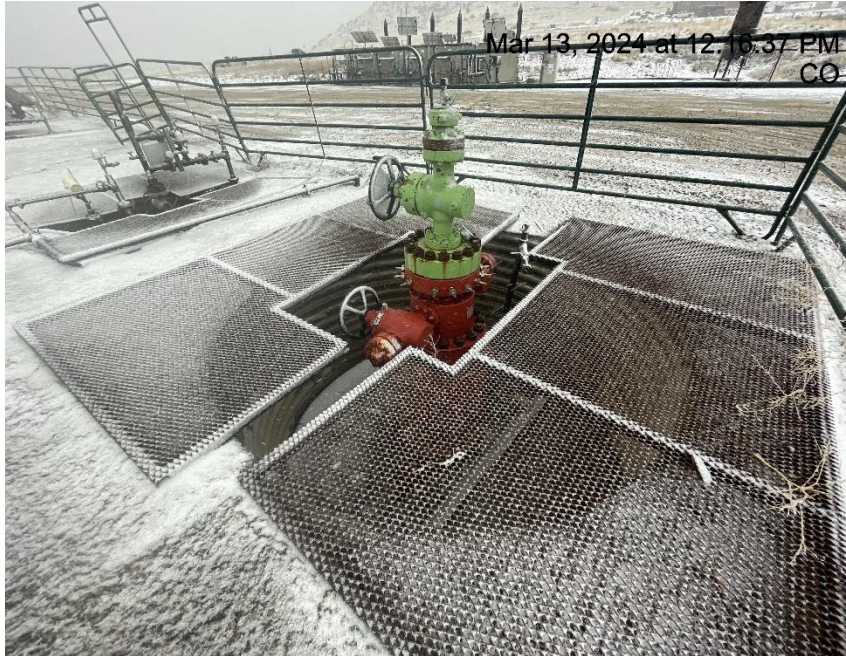
Photo # 9774 Cellar cover not properly installed/wildlife & personnel hazard

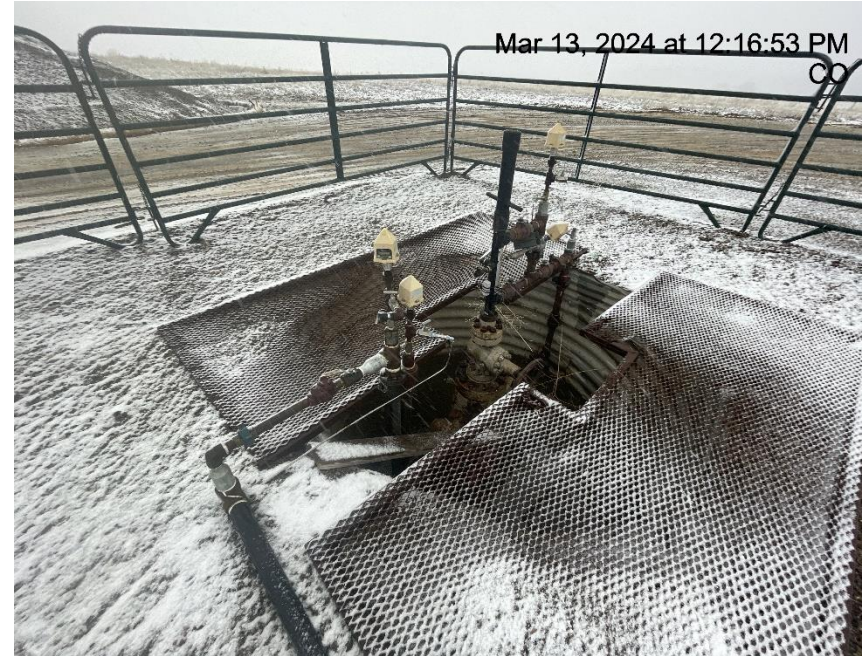
Photo # 9775 Cellar cover not properly installed/wildlife & personnel hazard

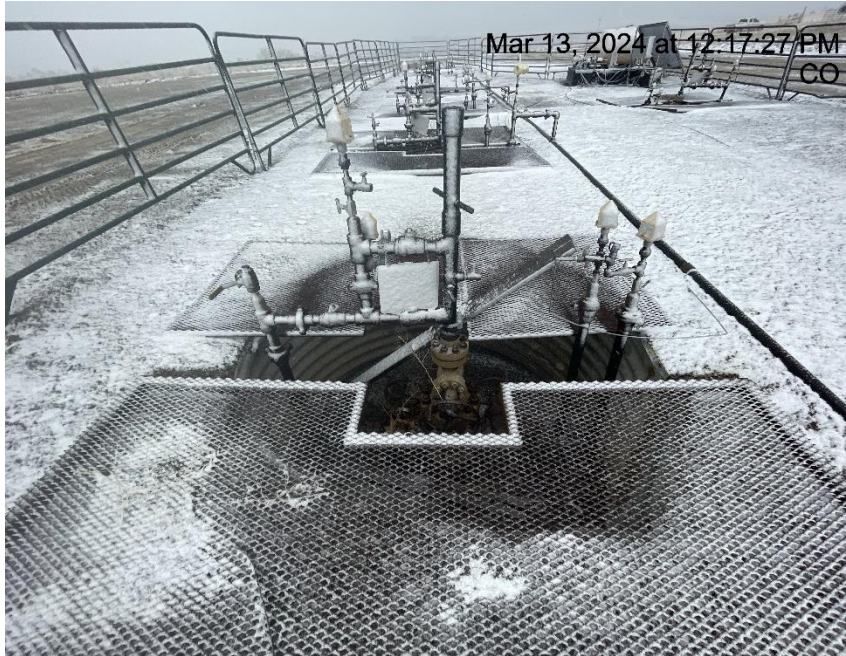
Photo # 9776 Cellular cover not properly installed/wildlife & personnel hazard

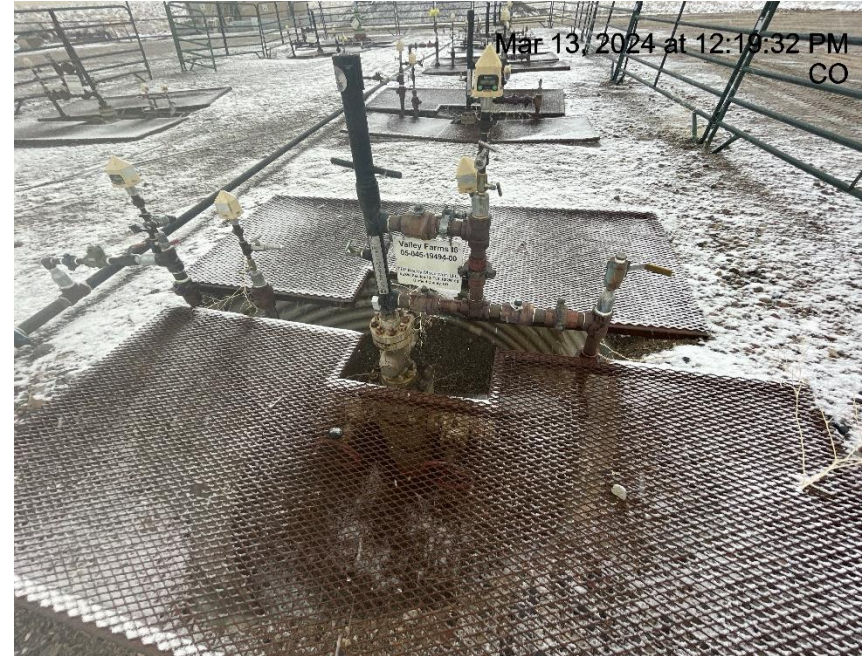
Photo # 9777 Cellular lacks wildlife egress/wildlife hazard

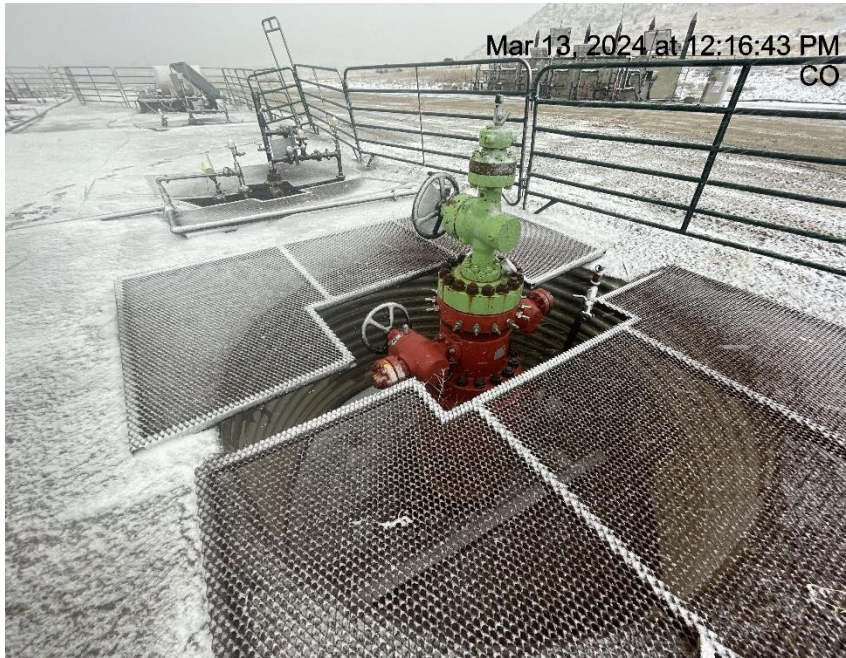
Photo # 9778 Cellar lacks wildlife egress/wildlife hazard
