Inspection Photos

Location Name: TEP ROCKY MOUNTAIN LLC FRIPORT 14-22 Pad

Location ID: 322506

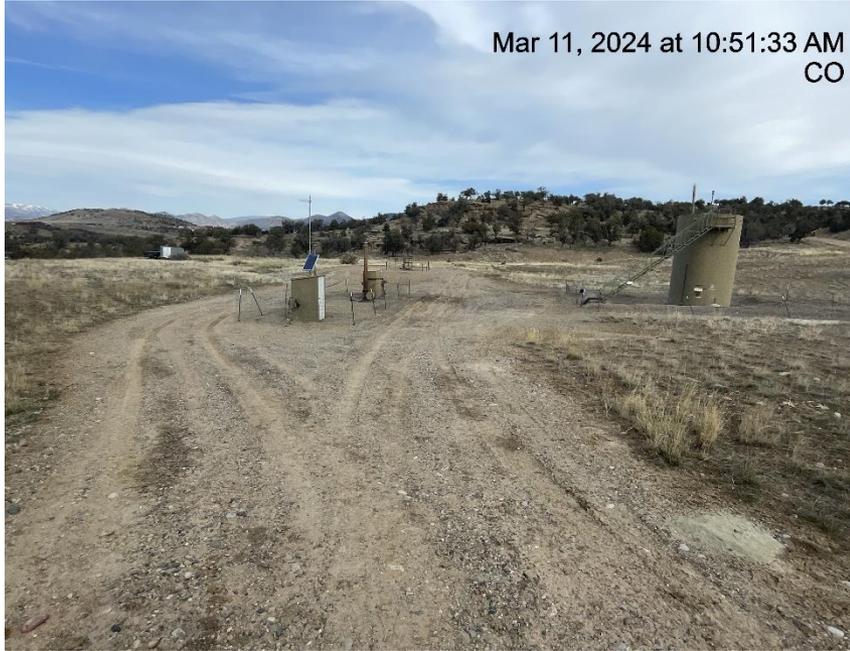
Photo # 9141 From entrance to location

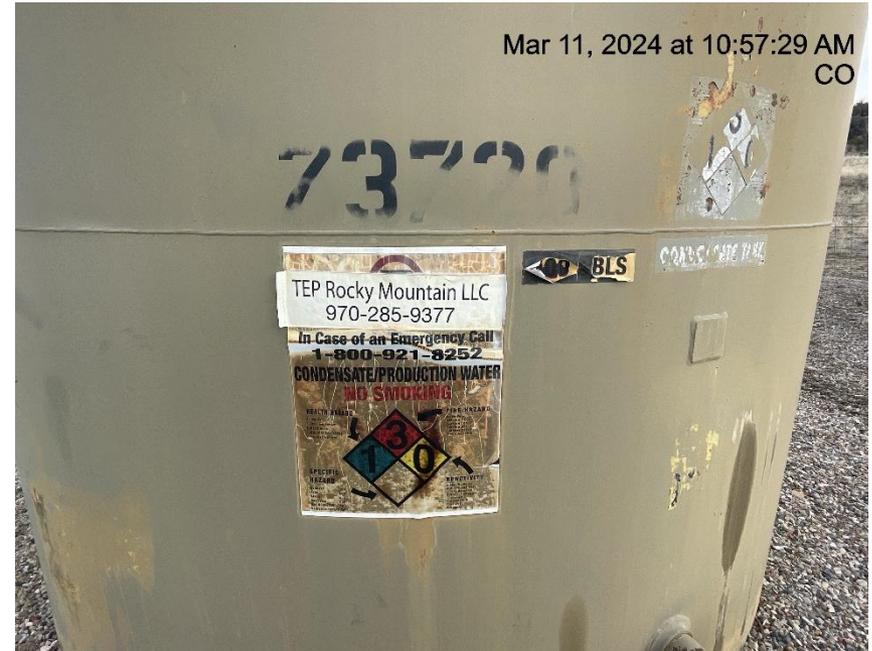
Photo # 9146 Tank label damaged & some required information is illegible

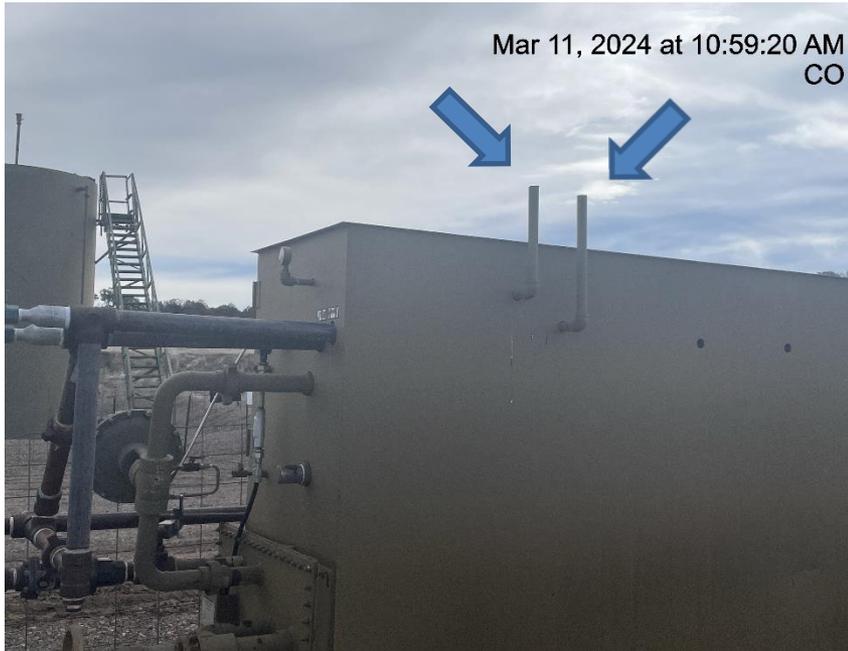
Photo # 9147 PRV & rupture disc vent lines lack caps/do not comply with CECMC pressure safety device rules

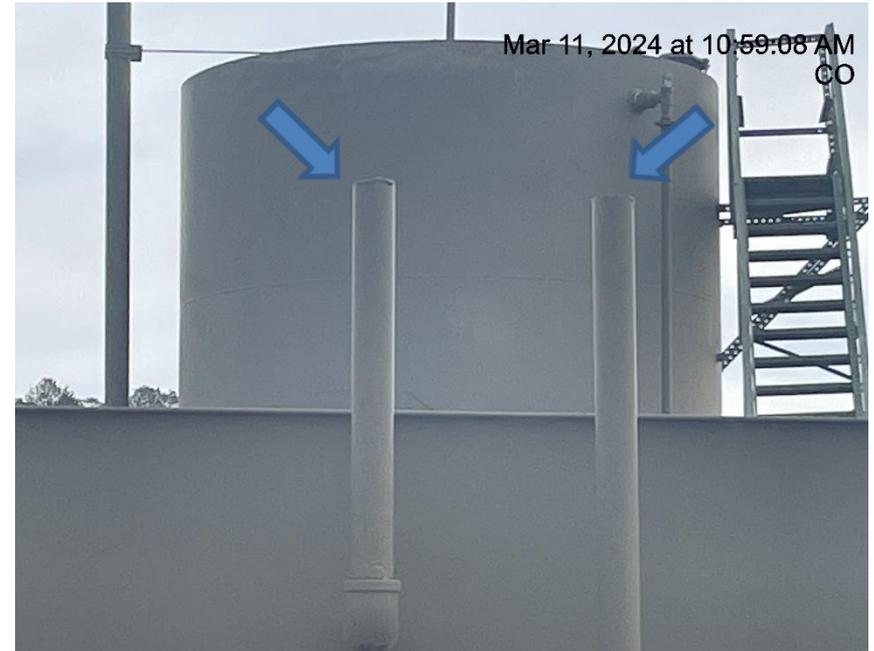
Photo # 9148 PRV & rupture disc vent lines lack caps/do not comply with CECMC pressure safety device rules
