Inspection Photos

Location Name: TEP ROCKY MOUNTAIN LLC LAST DANCE 10-3 Pad

Location ID: 324246

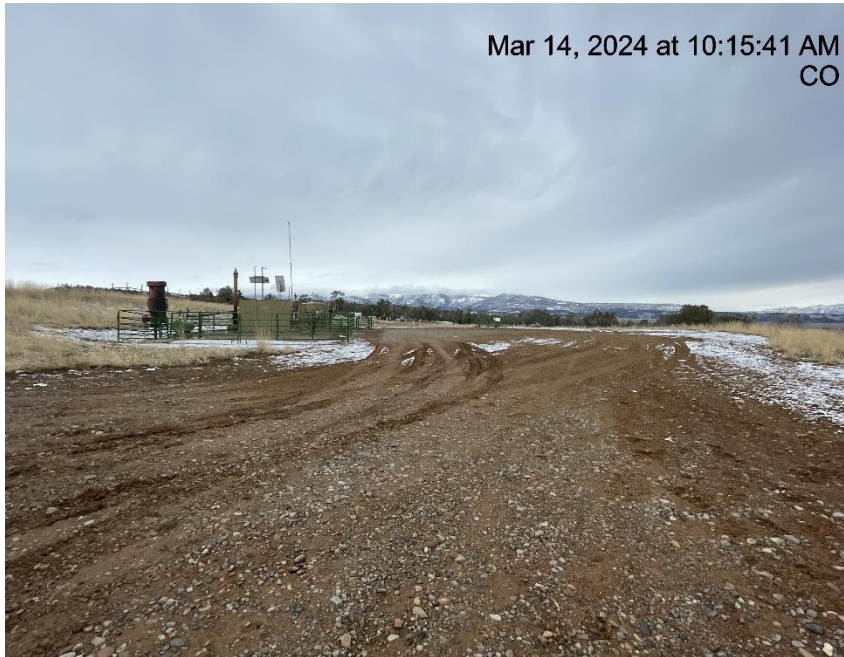
Photo # 2 From entrance to location

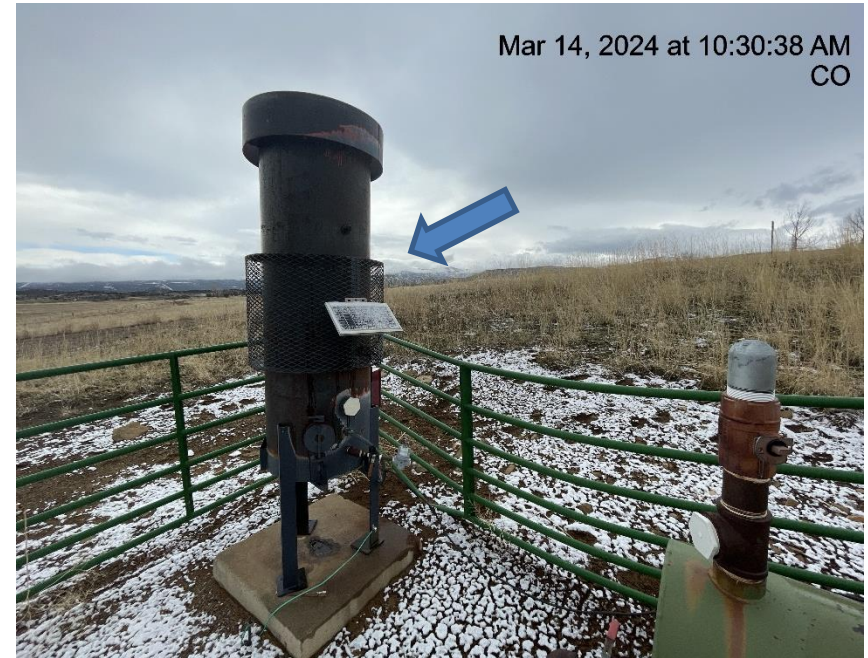
Photo # 7 Unused equipment

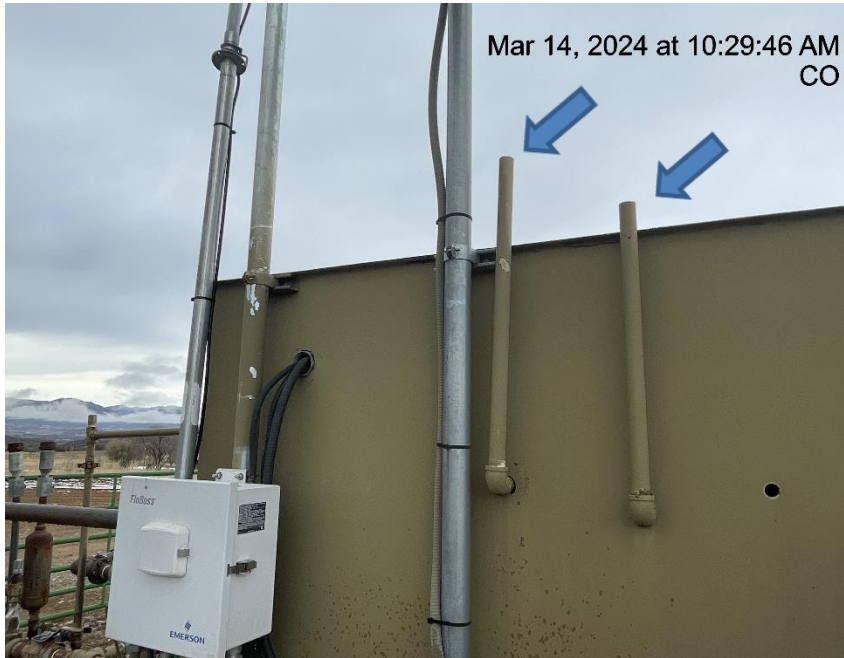
Photo # 8 PRV & rupture disc vent lines lack caps/do not comply with CECMC pressure safety device rules

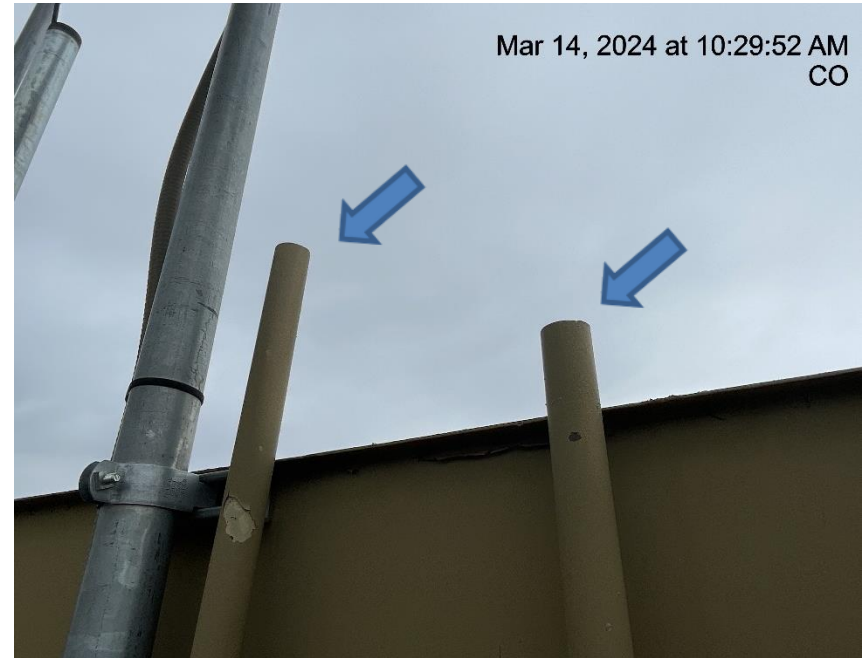
Photo # 9 PRV & rupture disc vent lines lack caps/do not comply with CECMC pressure safety device rules

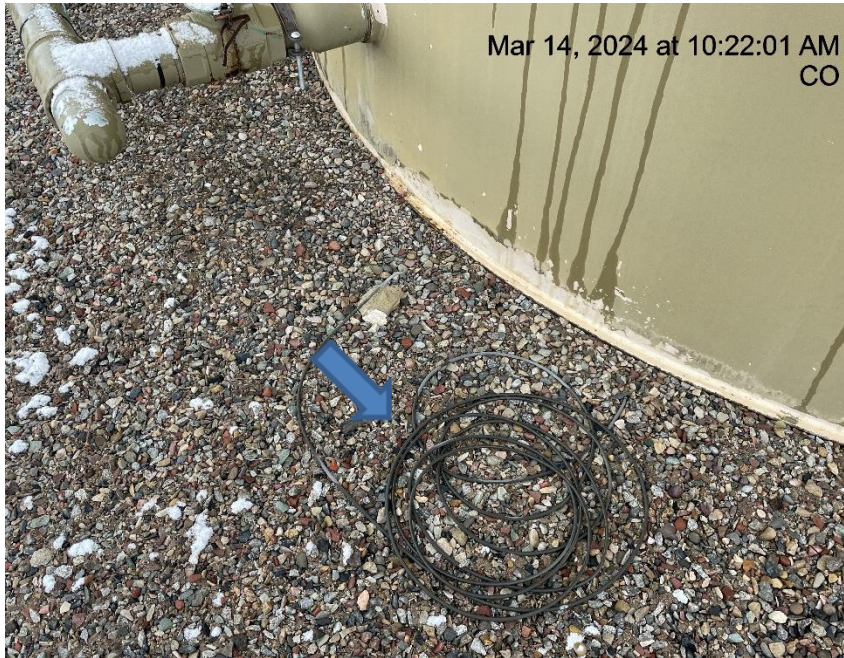
Photo # 10 Debris
