Inspection Photos
Location Name: Castor LC 27-72HN
Location ID: 422413

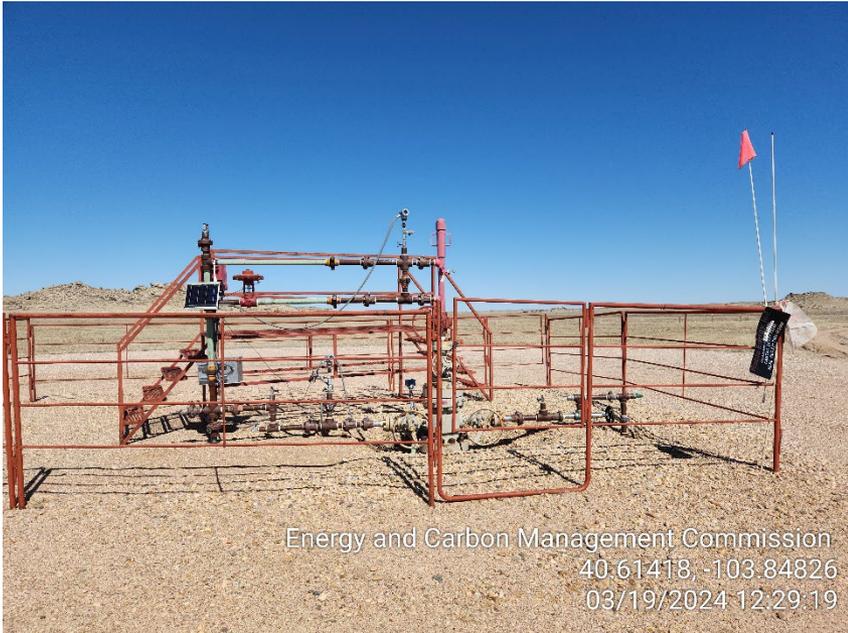
Photo 1 – Wellhead

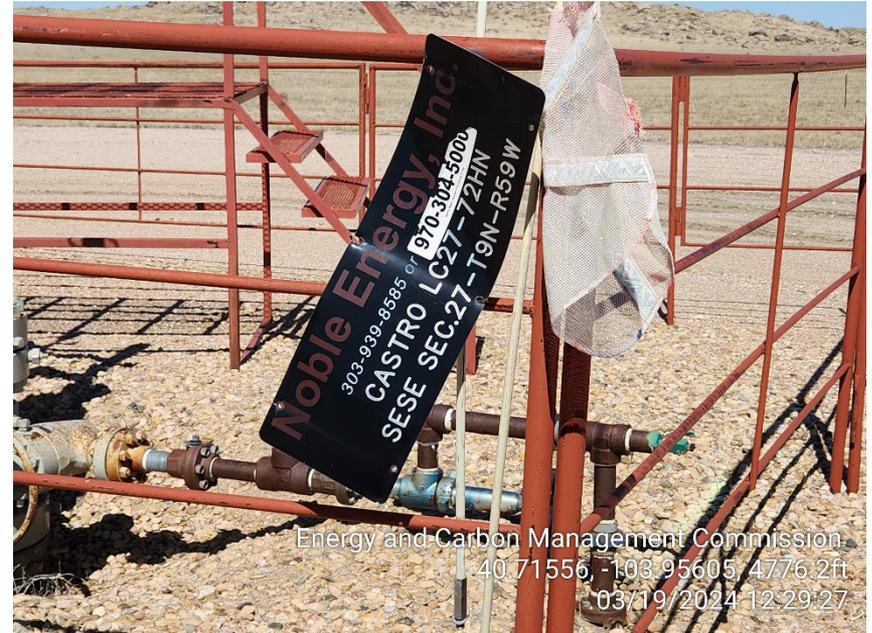
Photo 2 – Wellhead Sign

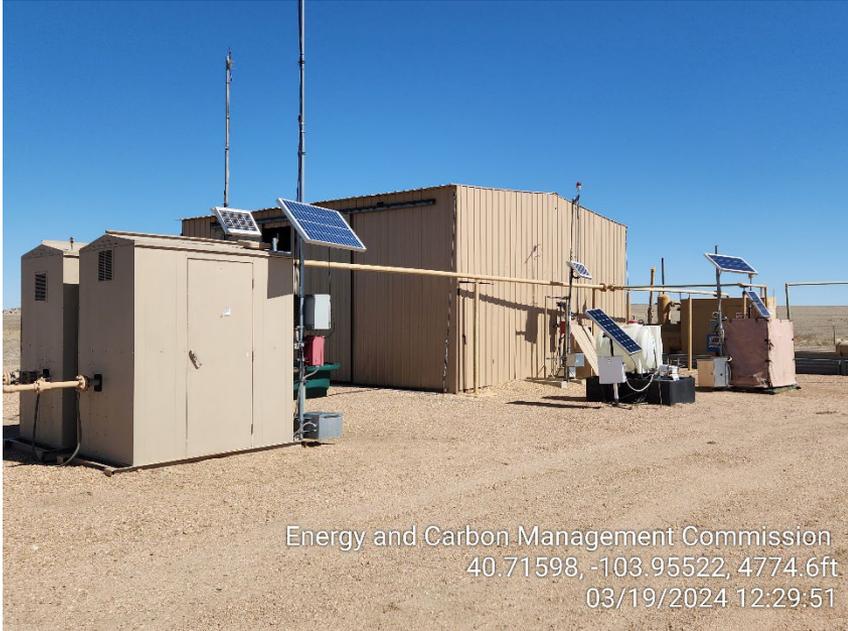
Photo 3 – Compressor, Gas Meters and VRU

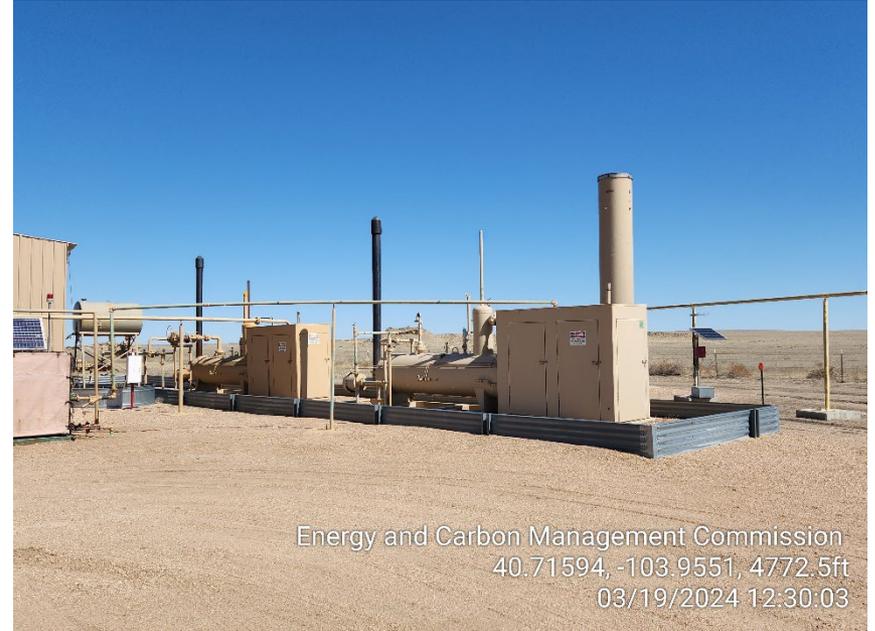
Photo 4 – Separators

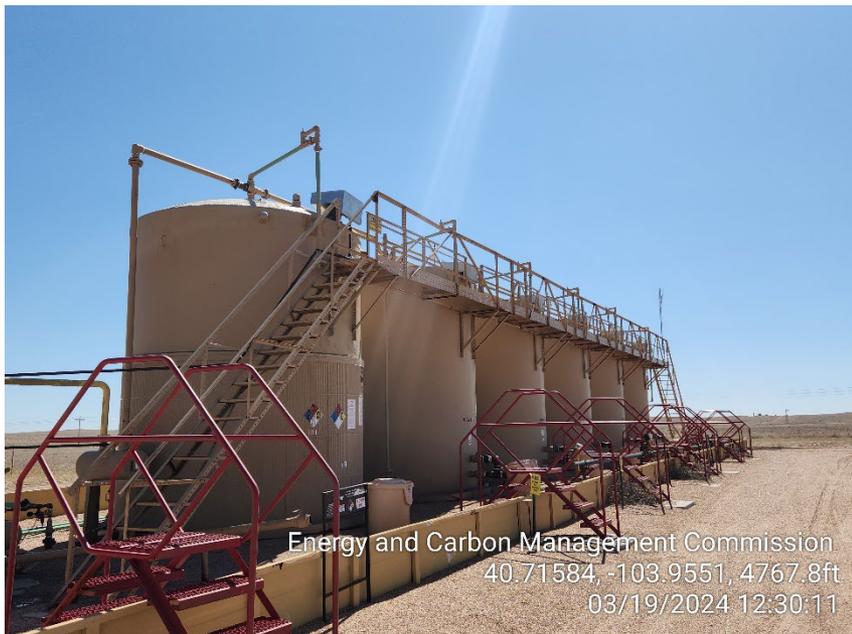
Photo 5 – Tank Battery

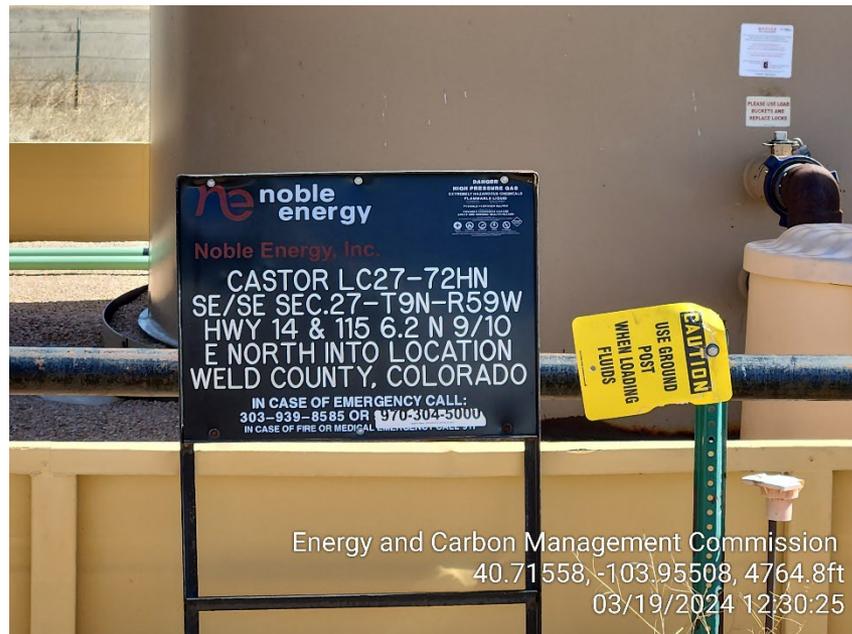
Photo 6 – Tank Battery Sign

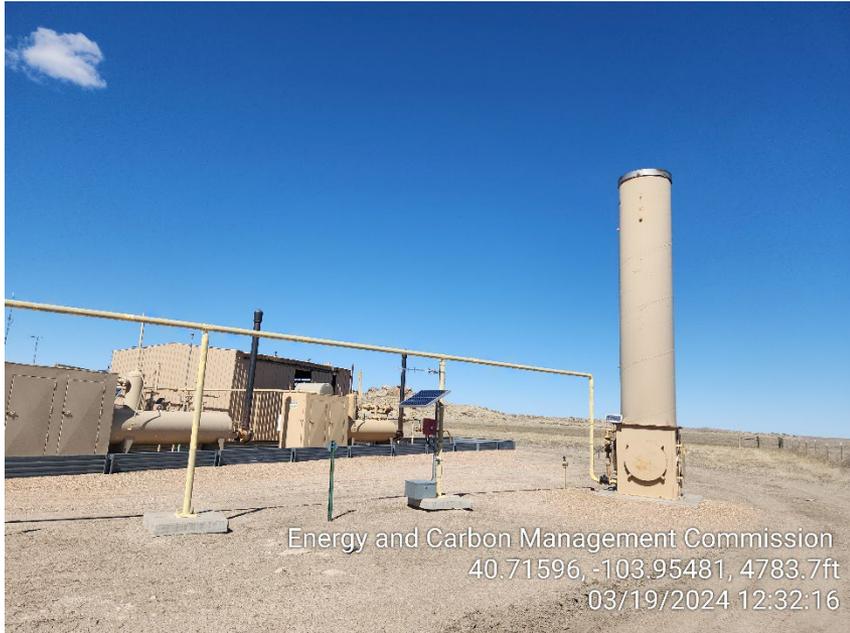
Photo 7 – ECD

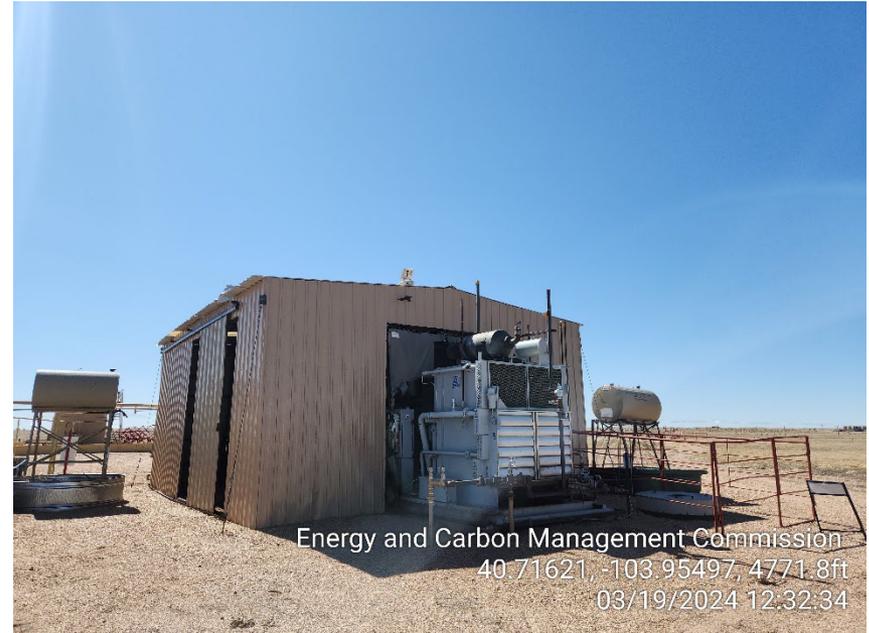
Photo 8 – Compressor

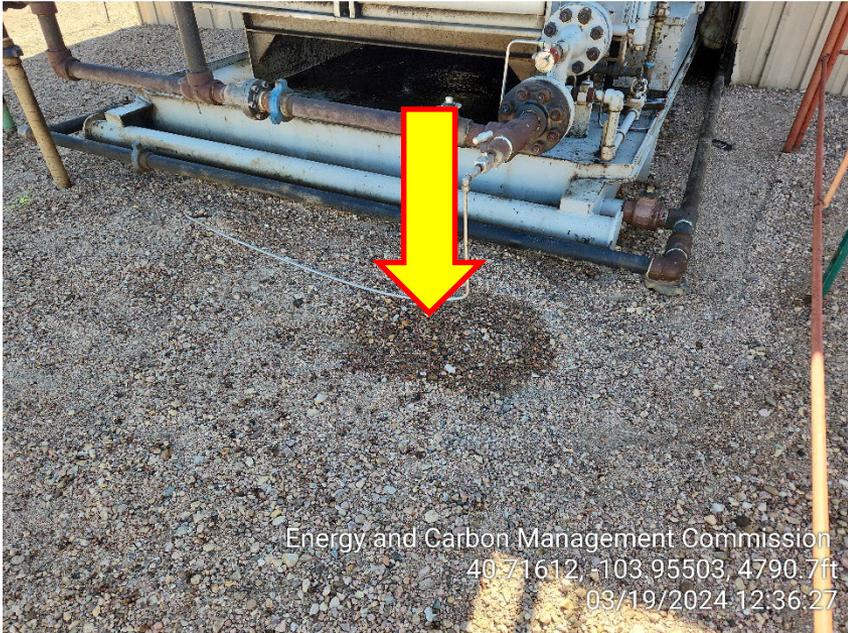
Photo 9 – Stained Soil

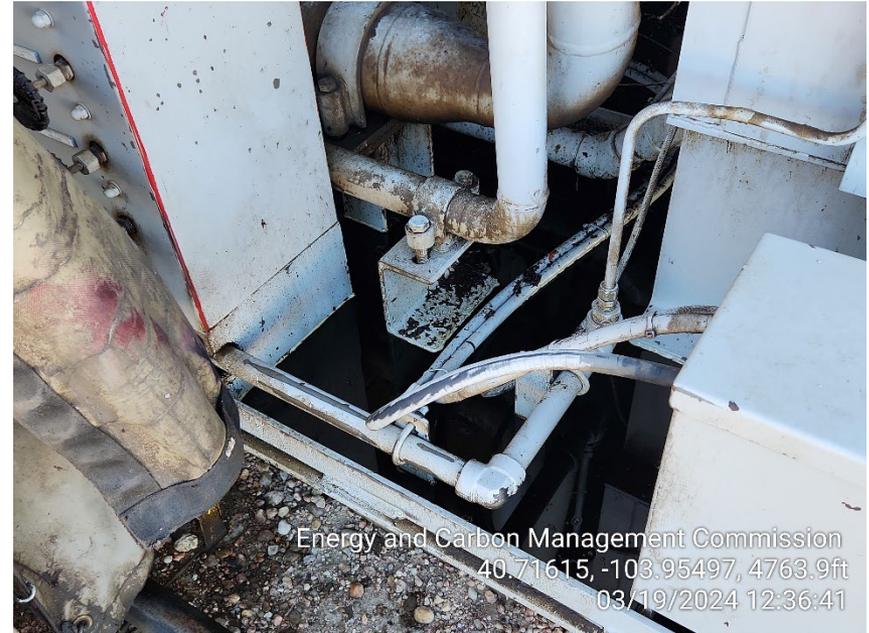
Photo 10 – Oily Waste

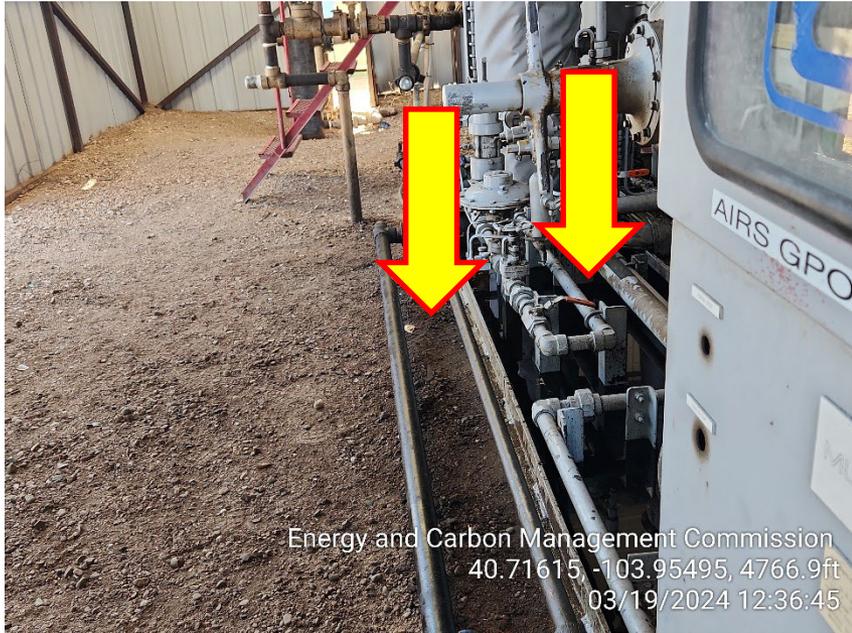
Photo 10 – Stained Soil and Oily Waste

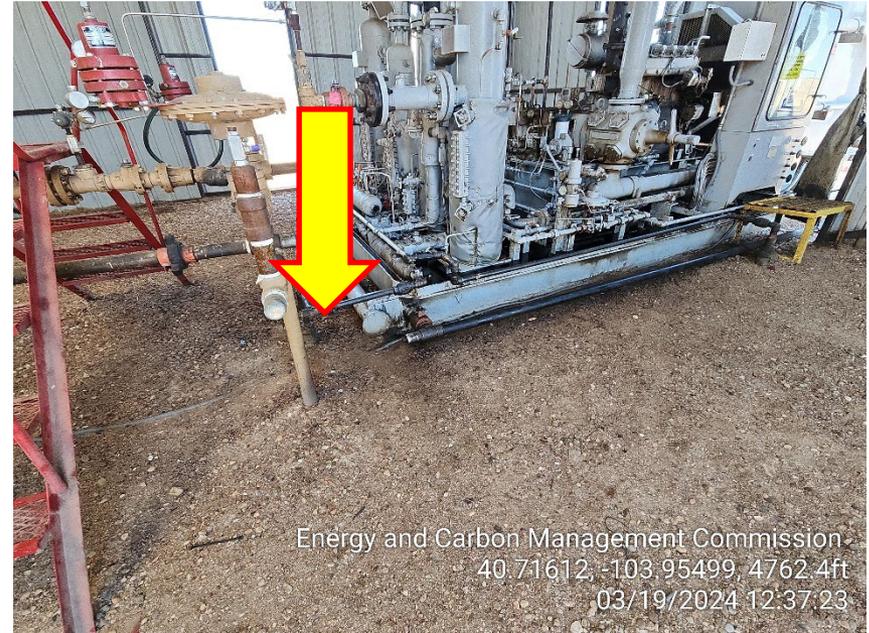
Photo 12 – Stained Soil

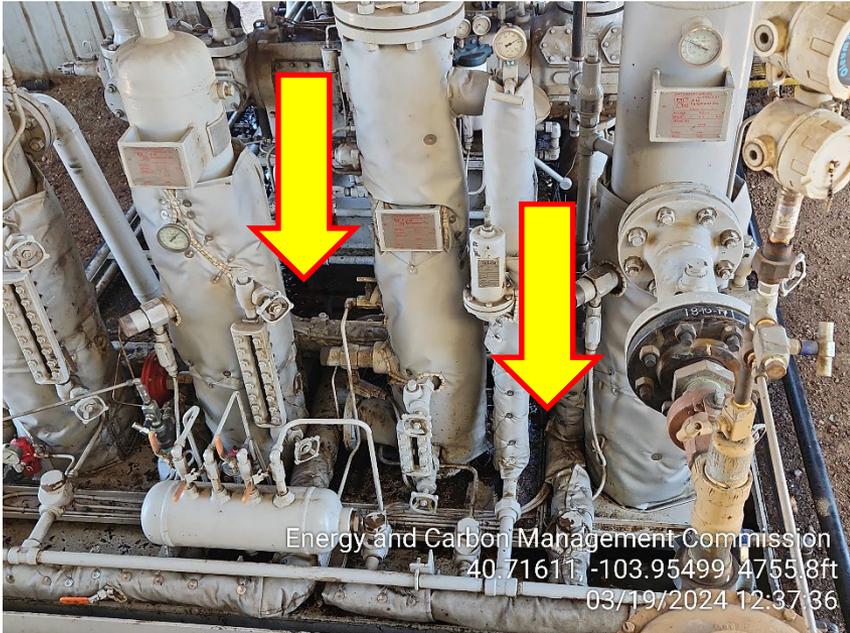
Photo 13 – Oily Waste

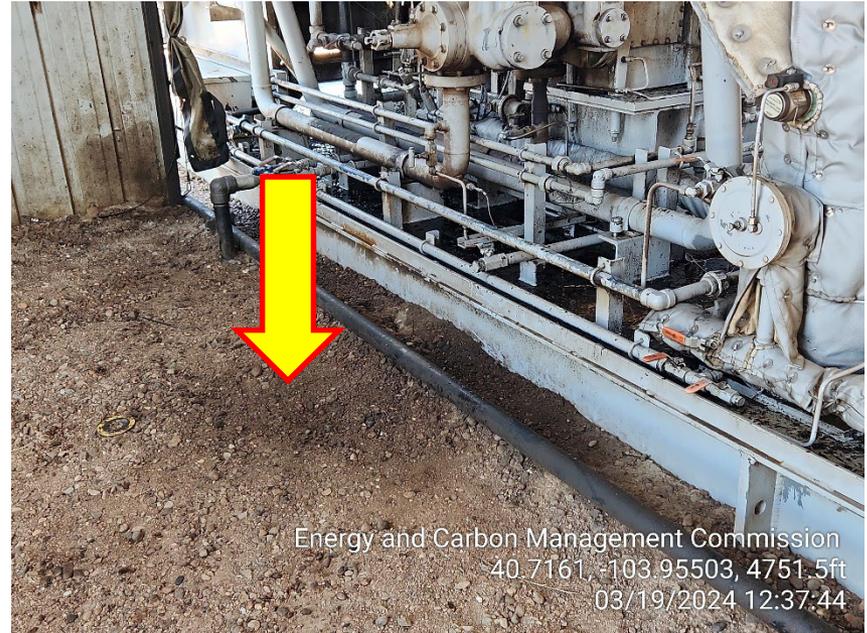
Photo 14 – Stained Soil

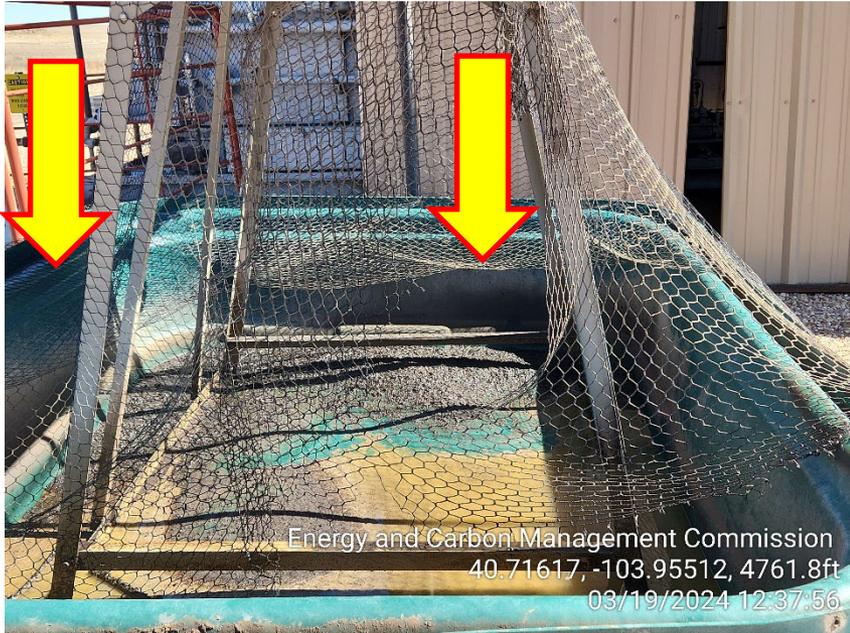
Photo 15 – Wildlife Netting in disrepair

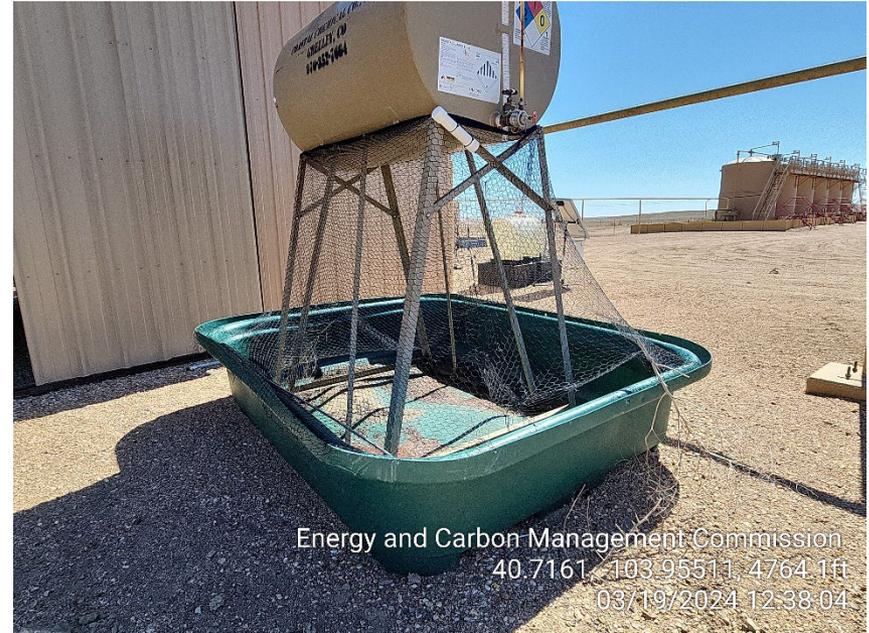
Photo 16 – Wildlife Netting in disrepair
