**KT Resources LLC
Ant Hill Unit 30-42
Location ID: 316154**

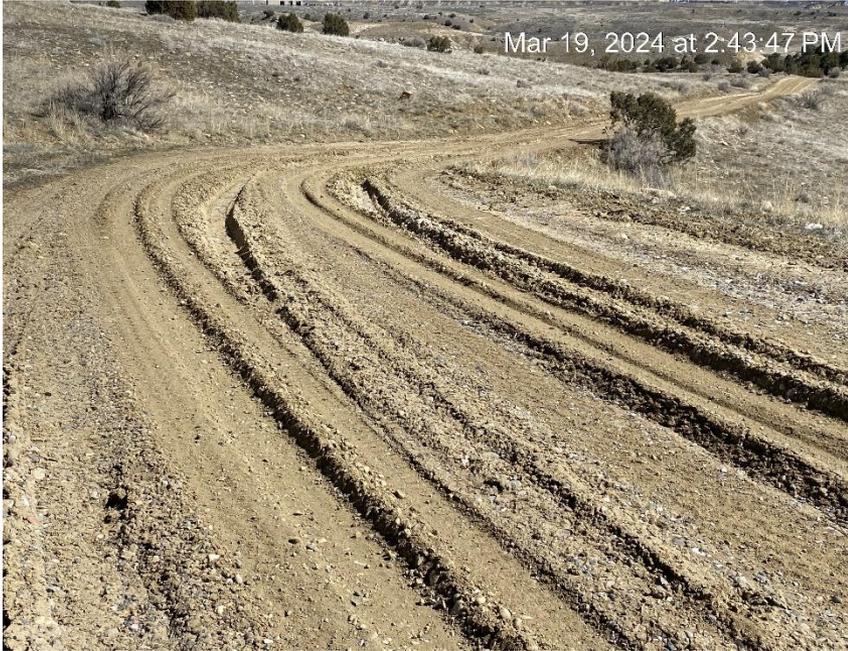
Stormwater BMPs need implementation

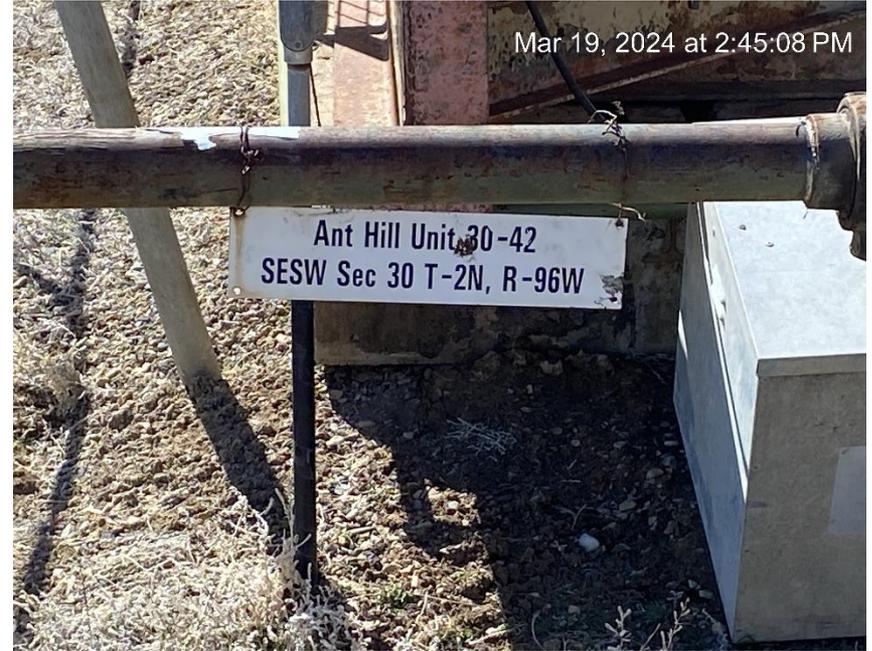
As signs are replaced additional information is required

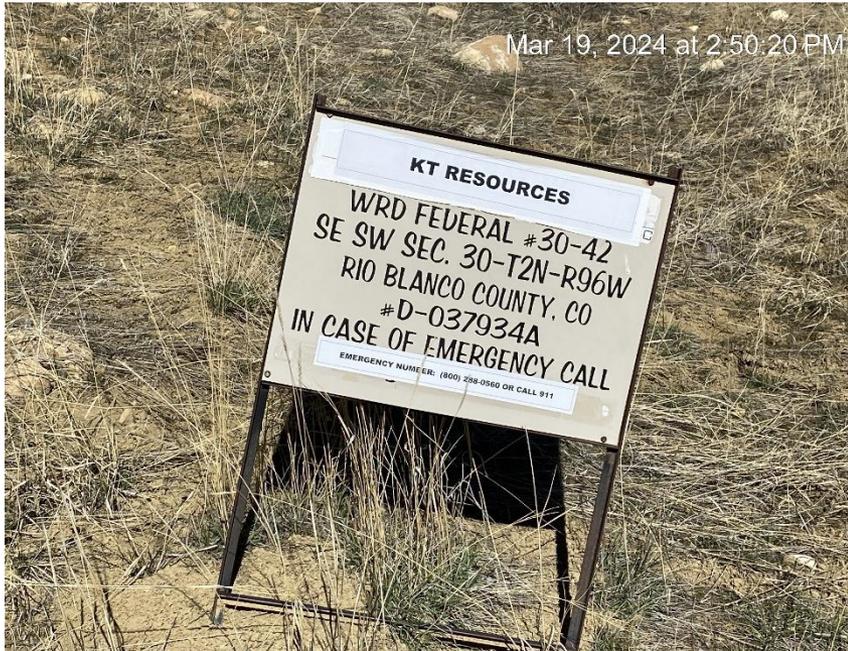
Ant Hill Unit not WRD Federal

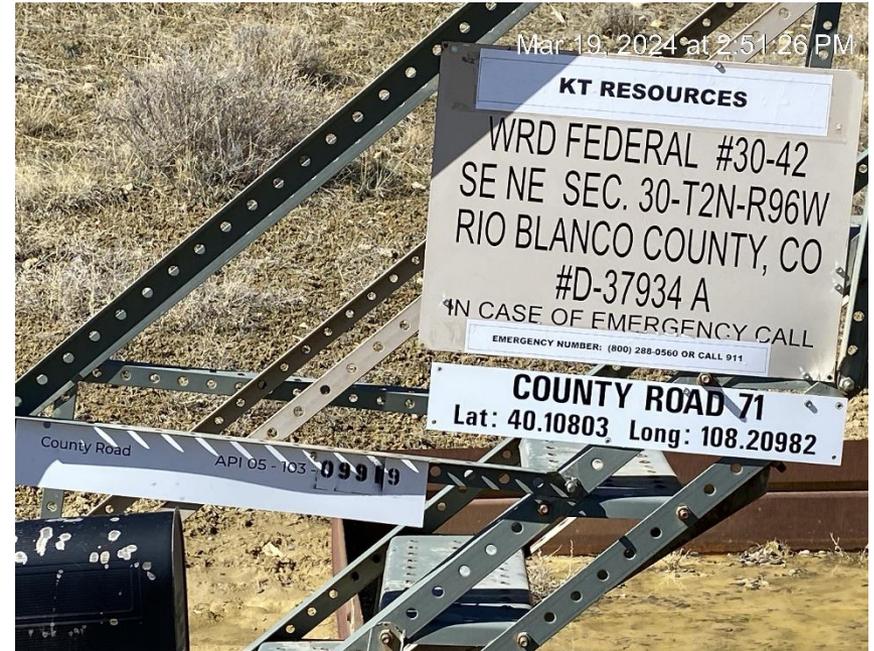
Ant Hill Unit not WRD Federal

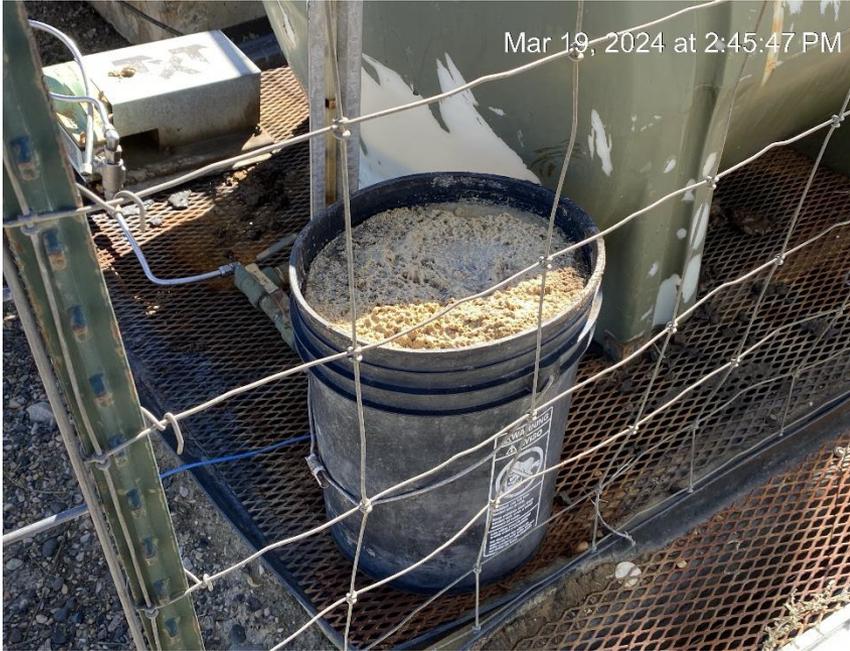
Debris

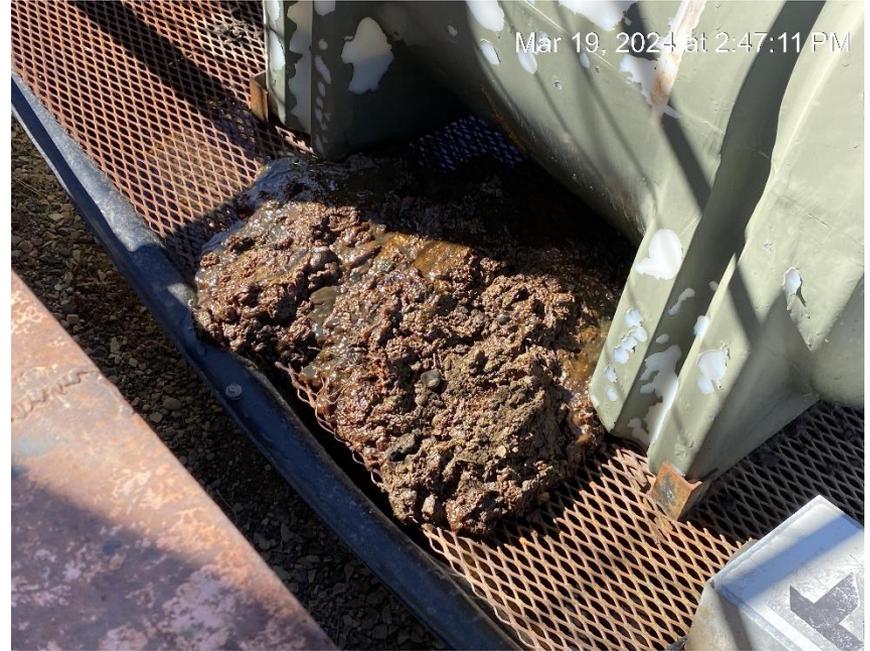
Oily waste placed on containment

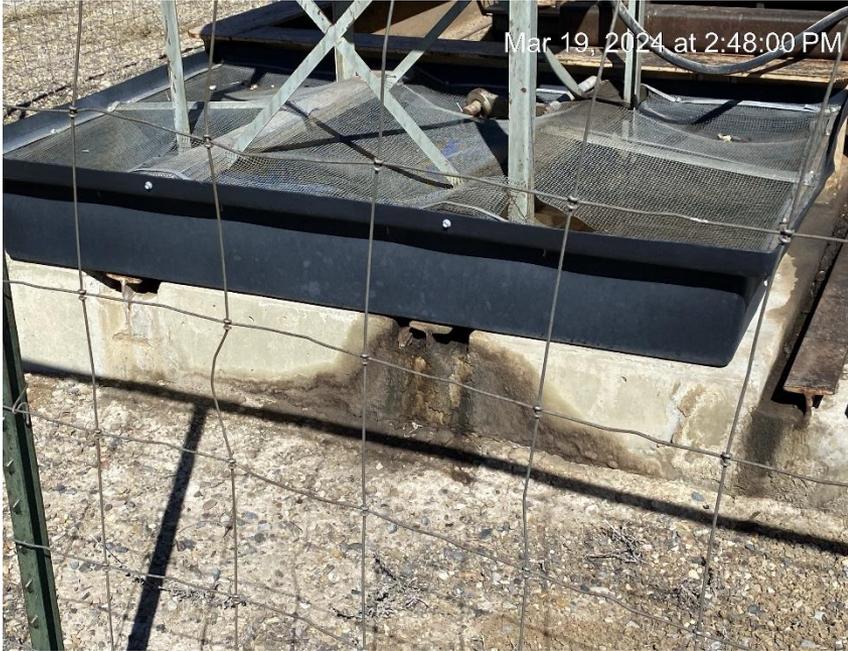
Oily waste and staining

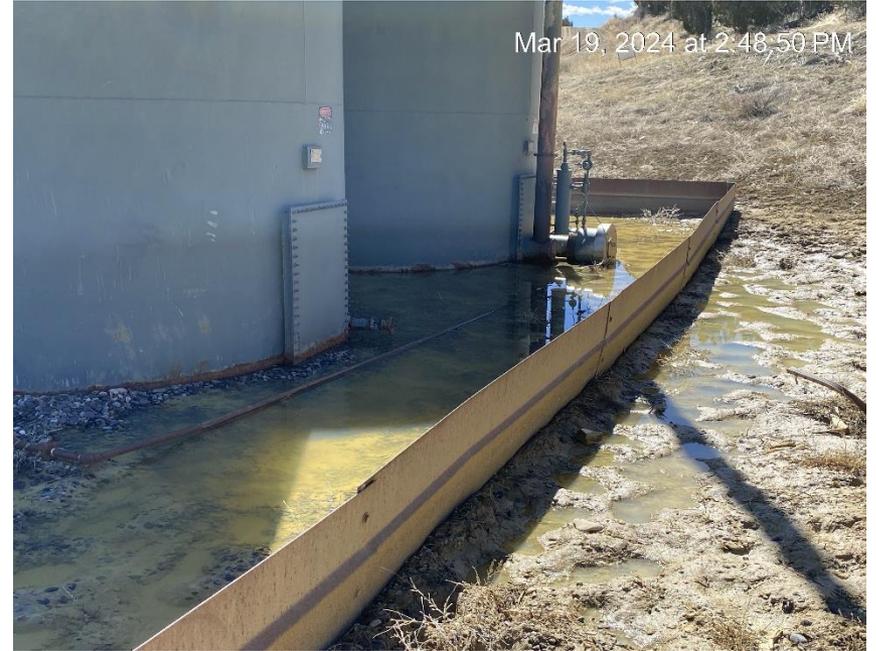
Impervious berm?

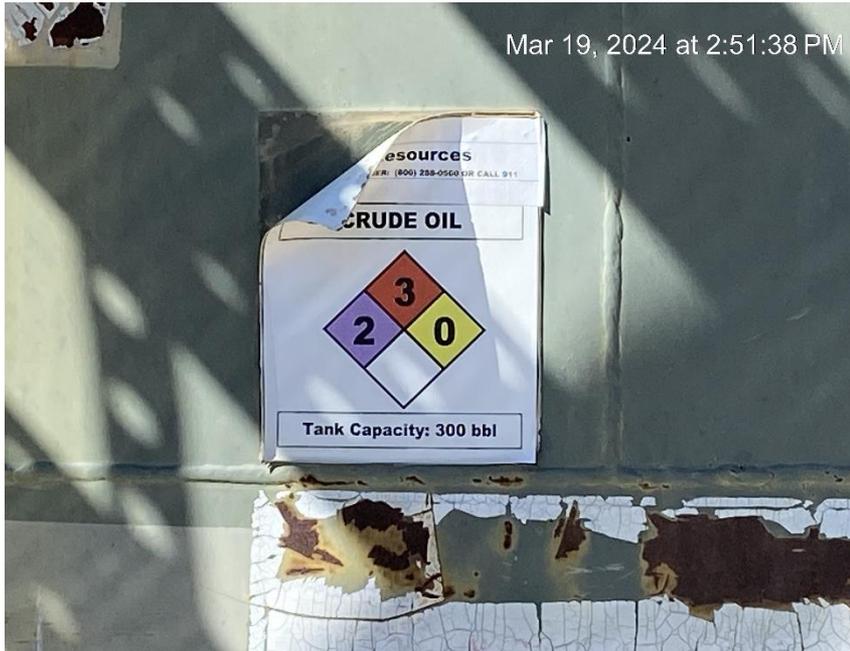
Replace labels as needed

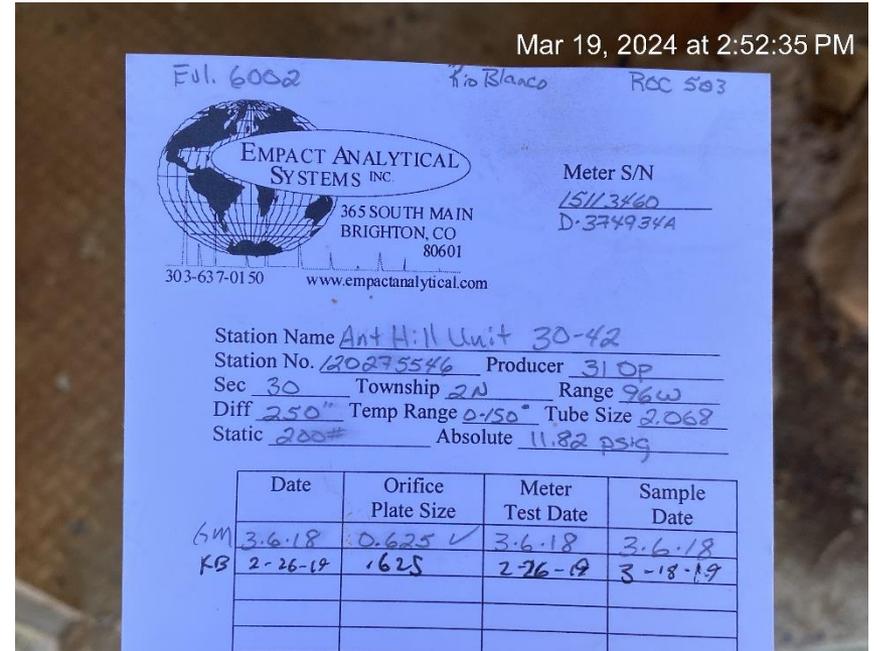
Out of date calibration

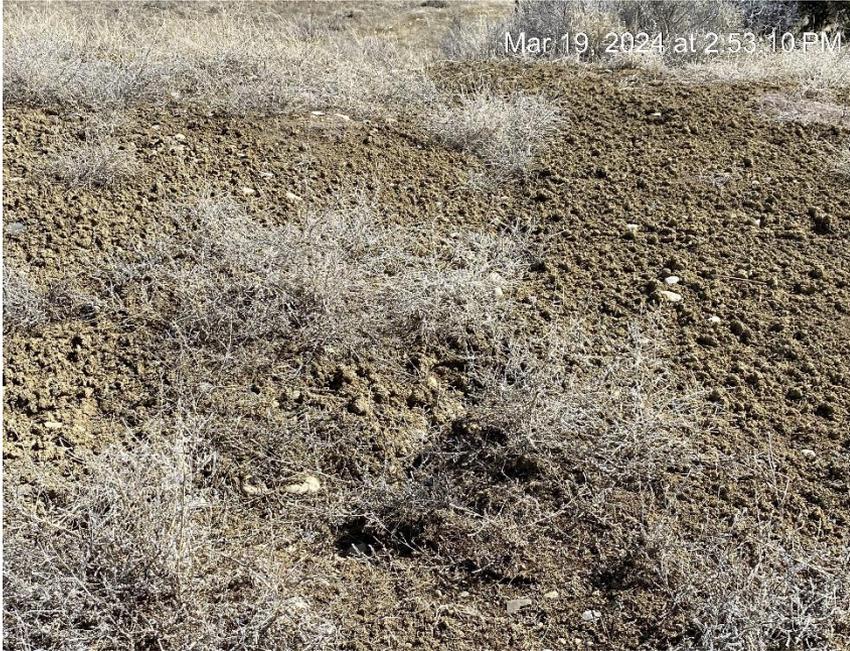
Erosion and sediment migration

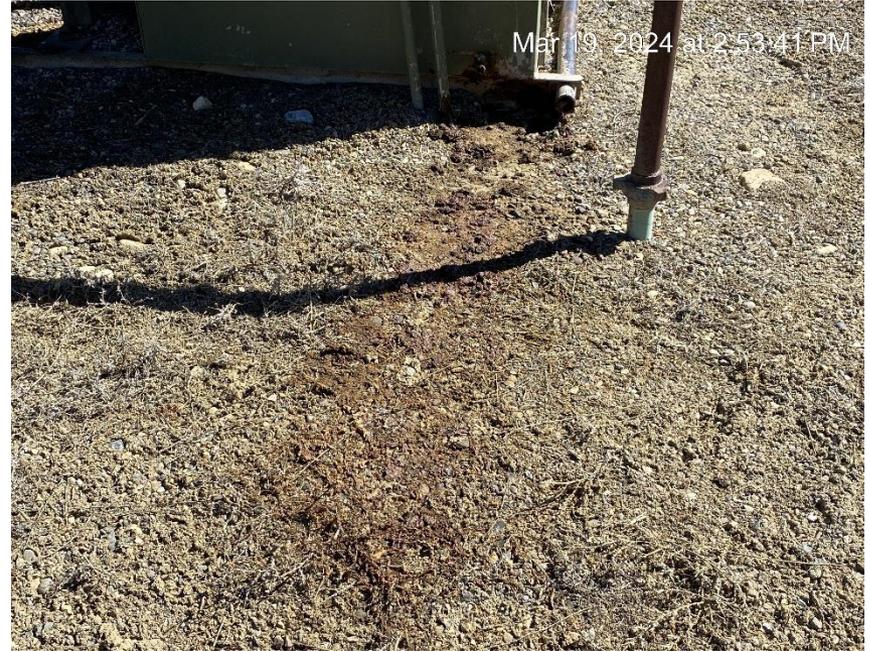
Oily waste blown out of separator

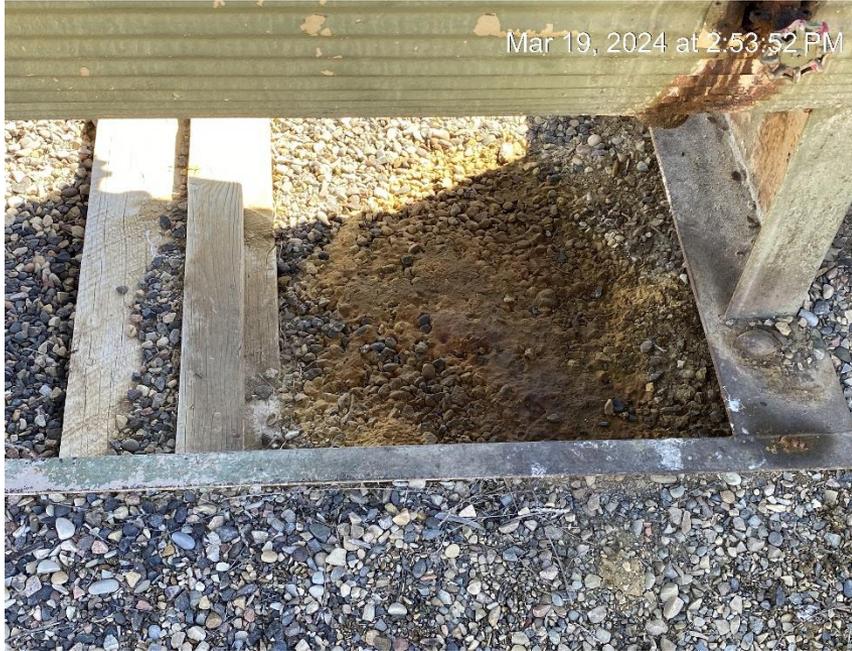
Oily waste and stained soil

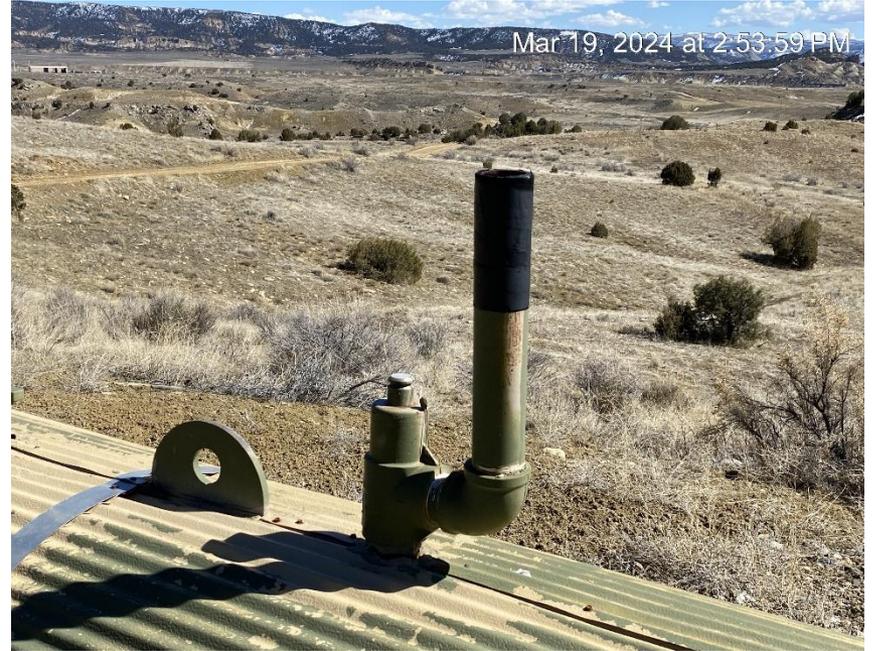
Rain protection missing on relief riser
