**KT Resources LLC
Federal A 5
Location ID: 314930**

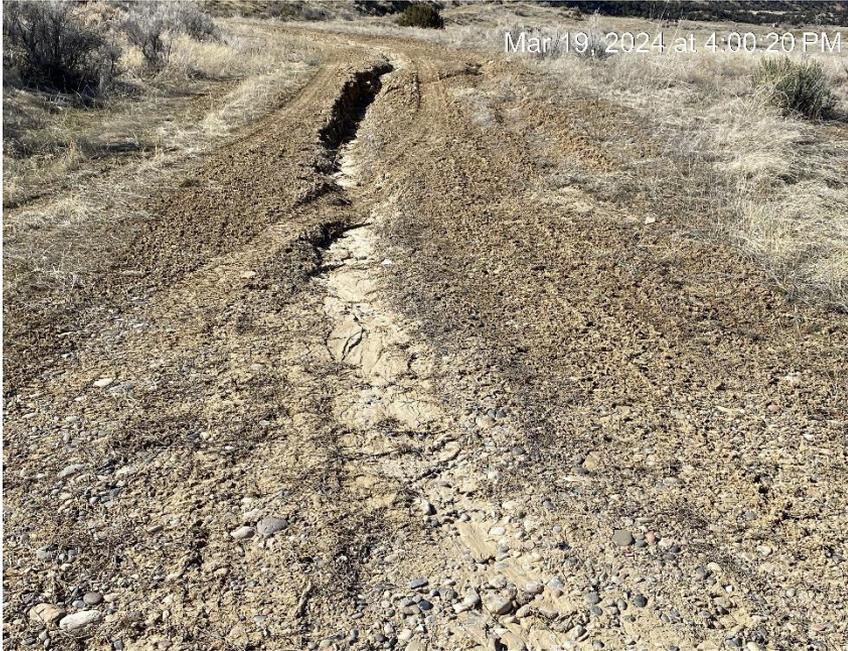
Erosion and sediment migration

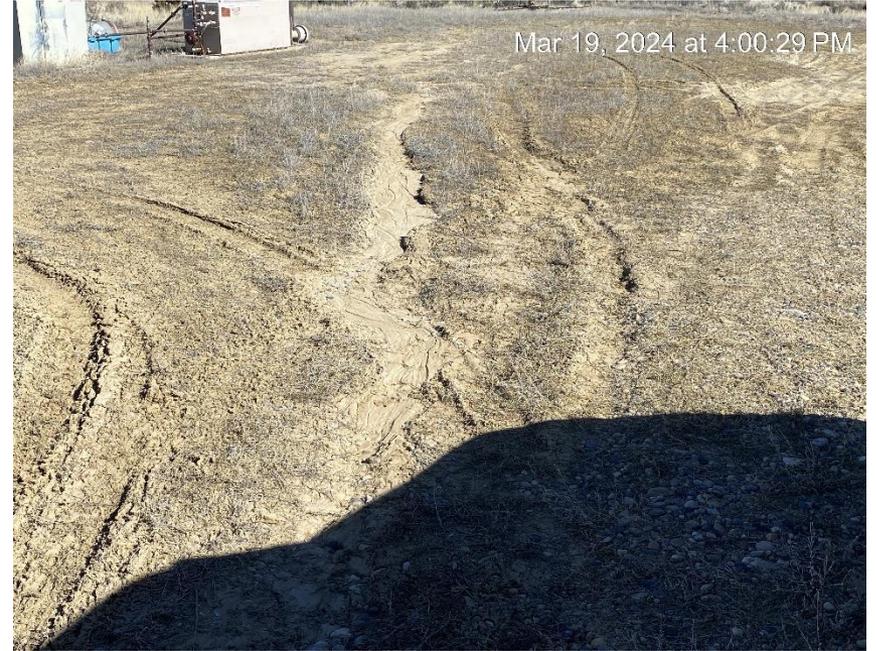
Erosion and sediment migration

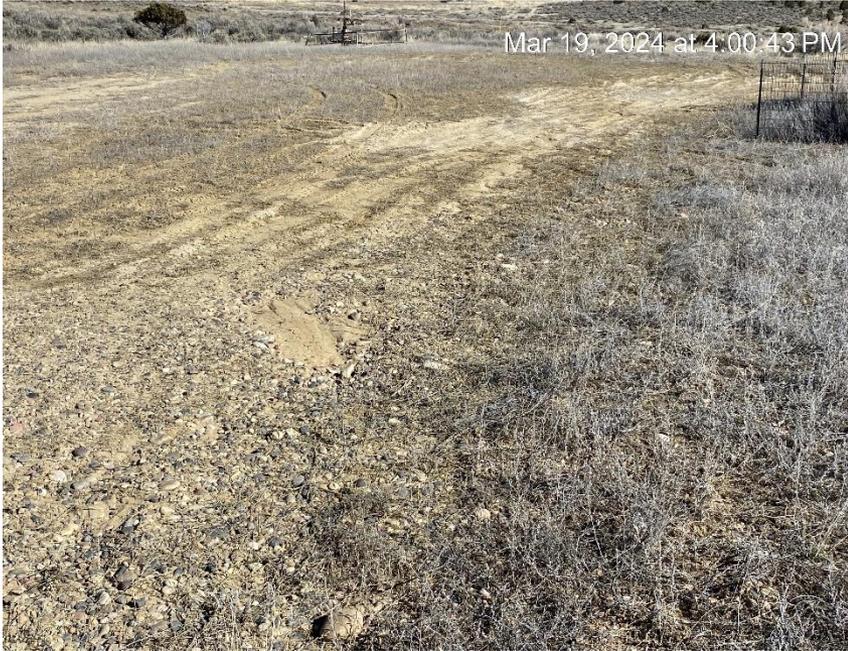
Sediment migration

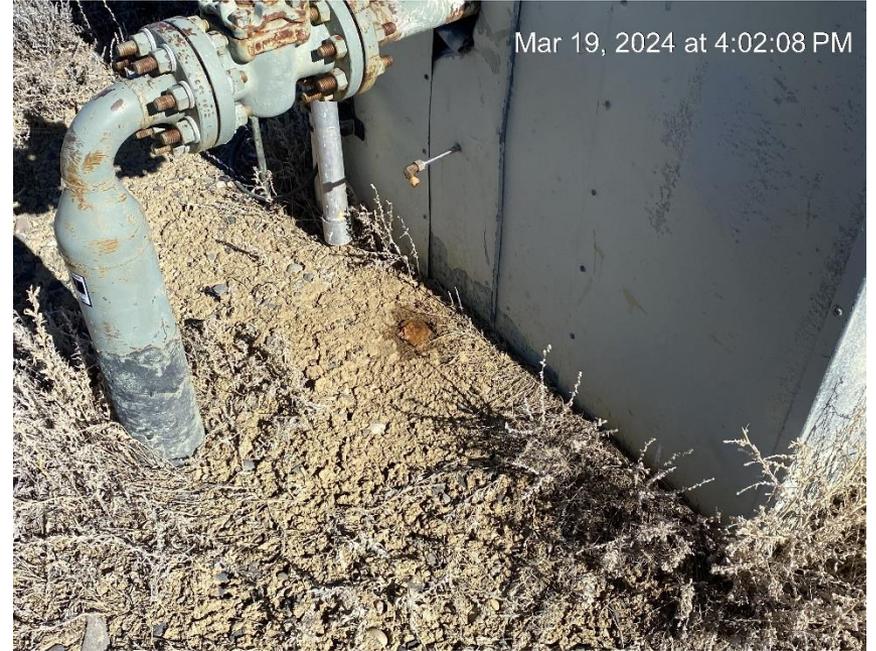
Oily waste and stained soil

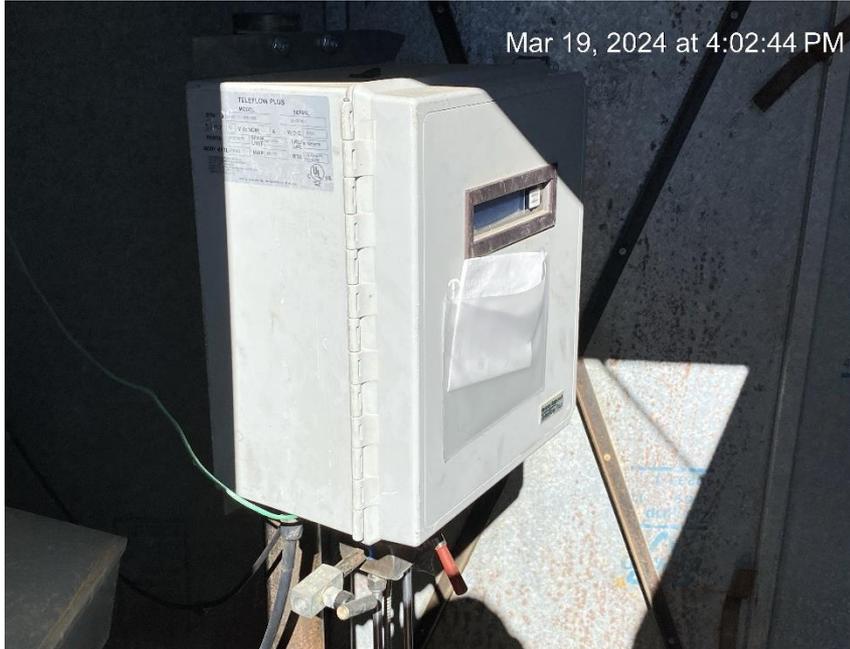
Display. No gas calibration card

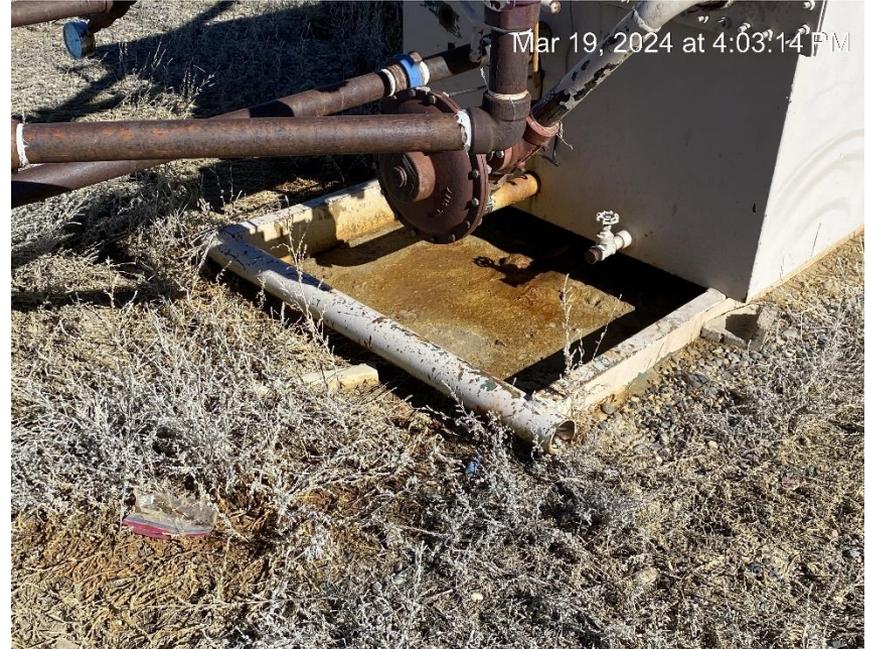
Oily waste and stained soil

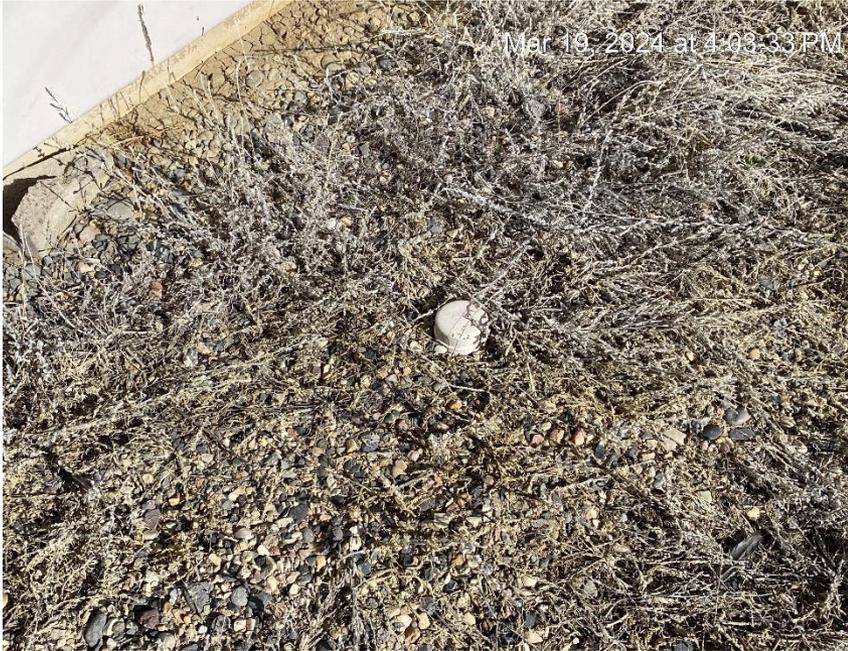
Debris. Cap for separator reservoir

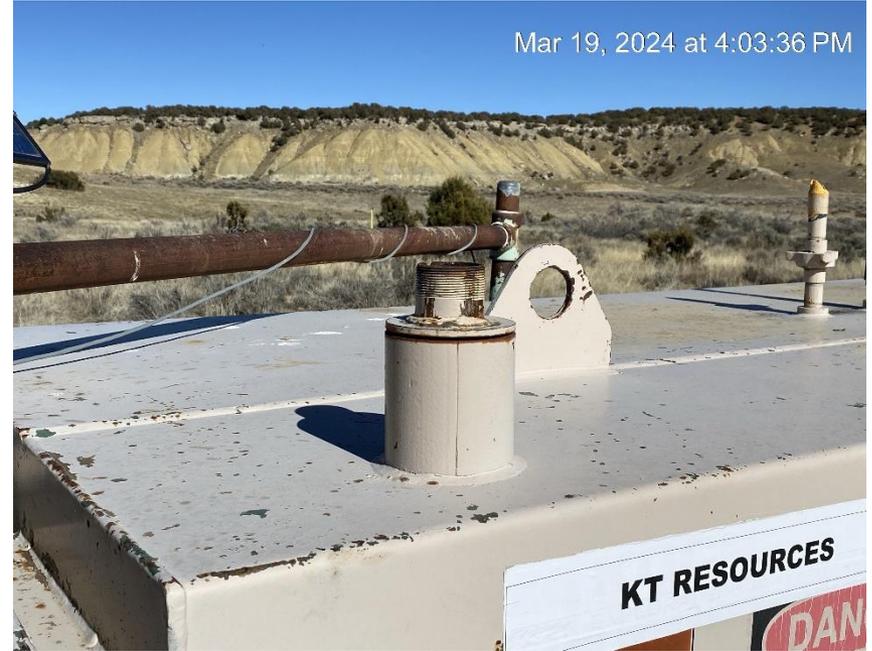
Open to wildlife. Cap on the ground.

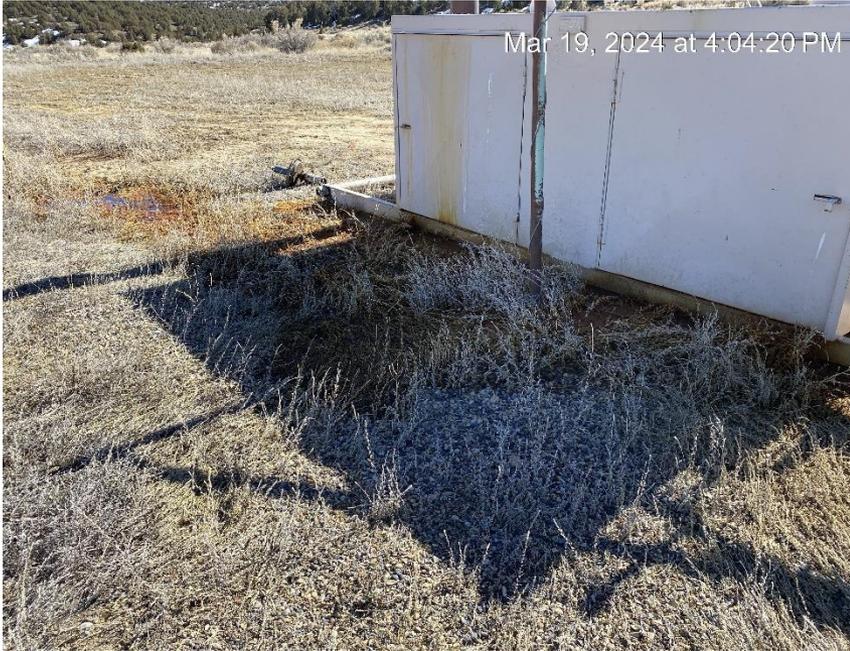
Oily waste and stained soil

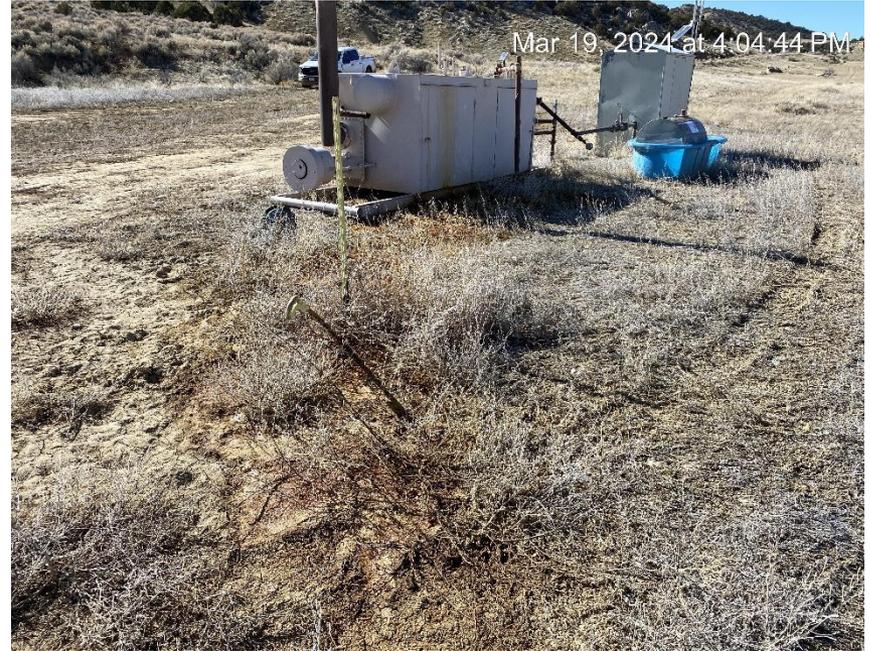
Oily waste and stained soil

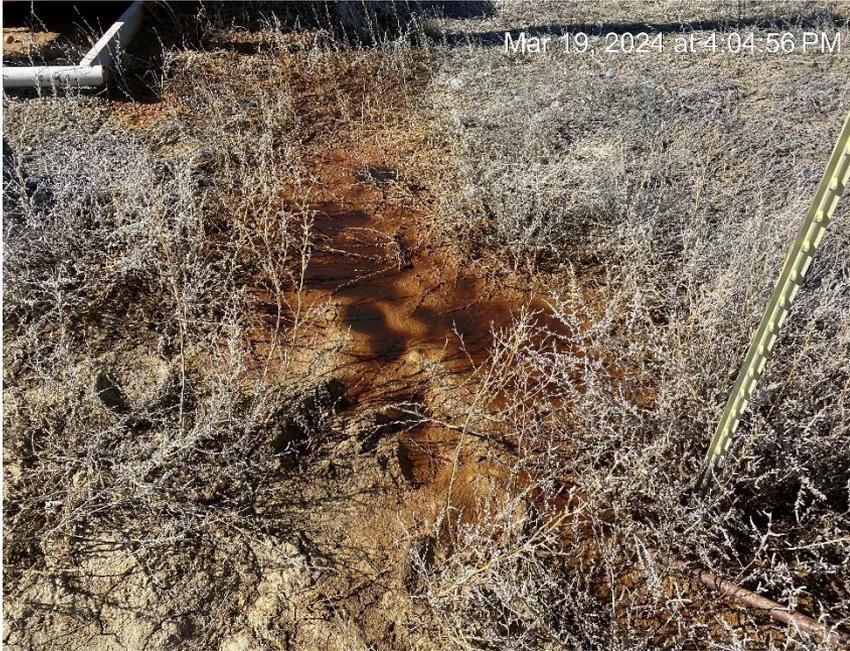
Oily waste and stained soil

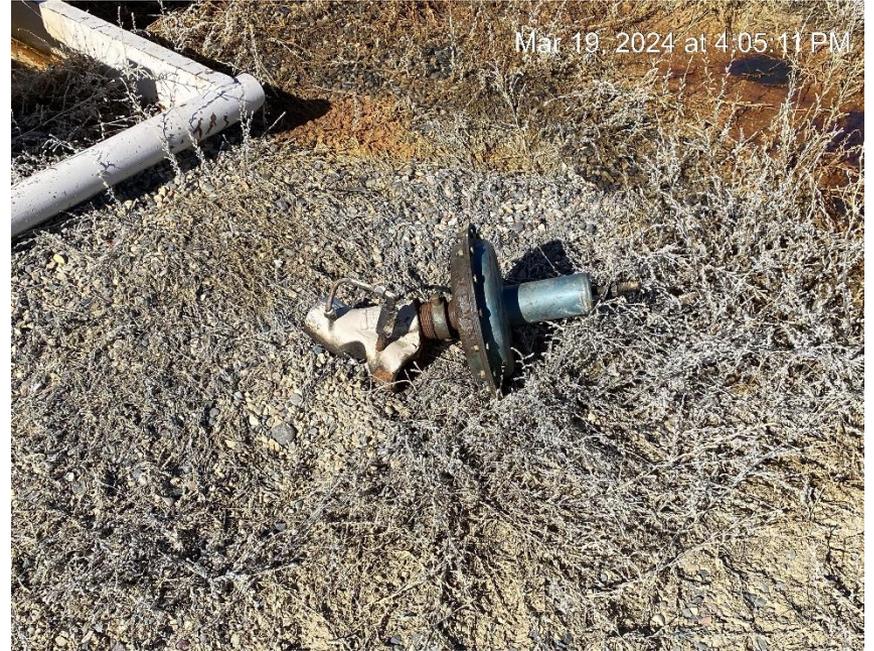
Debris

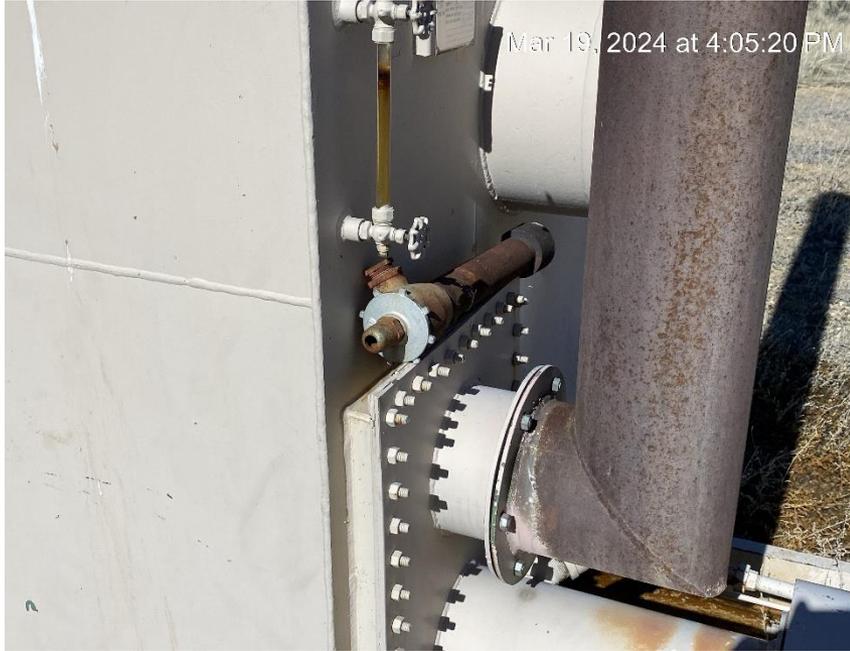
Debris

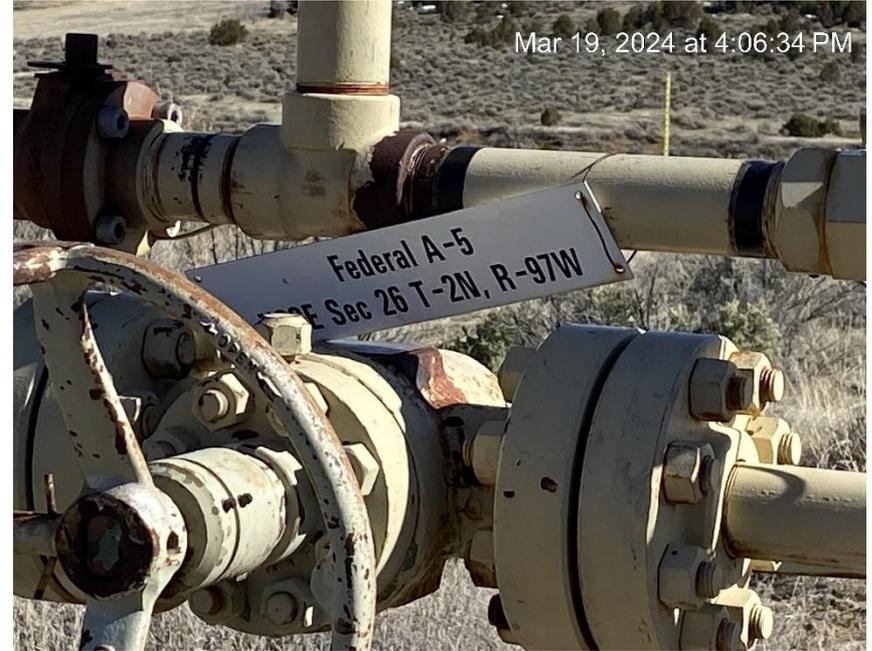
As signs are replaced additional information is required

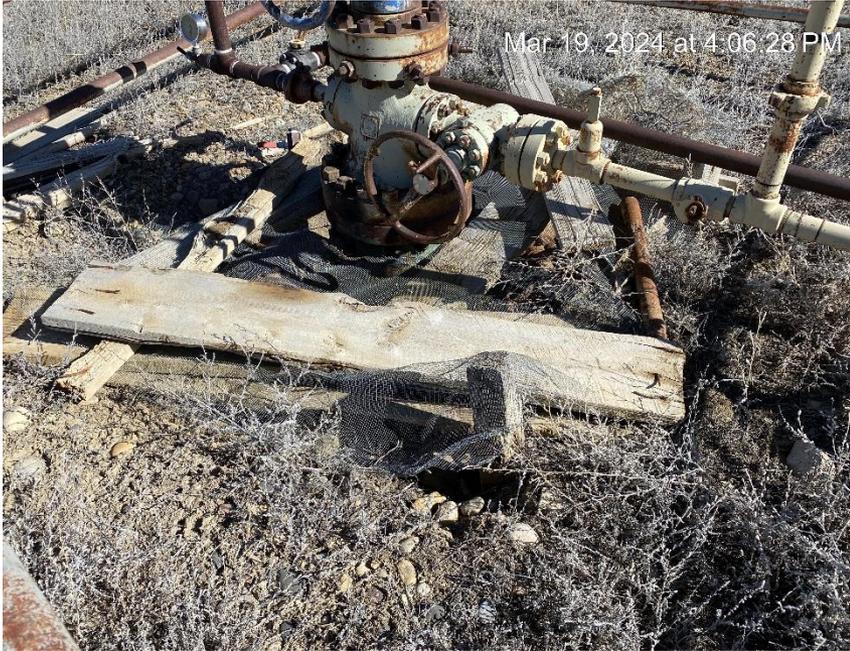
Unsafe cellar covering

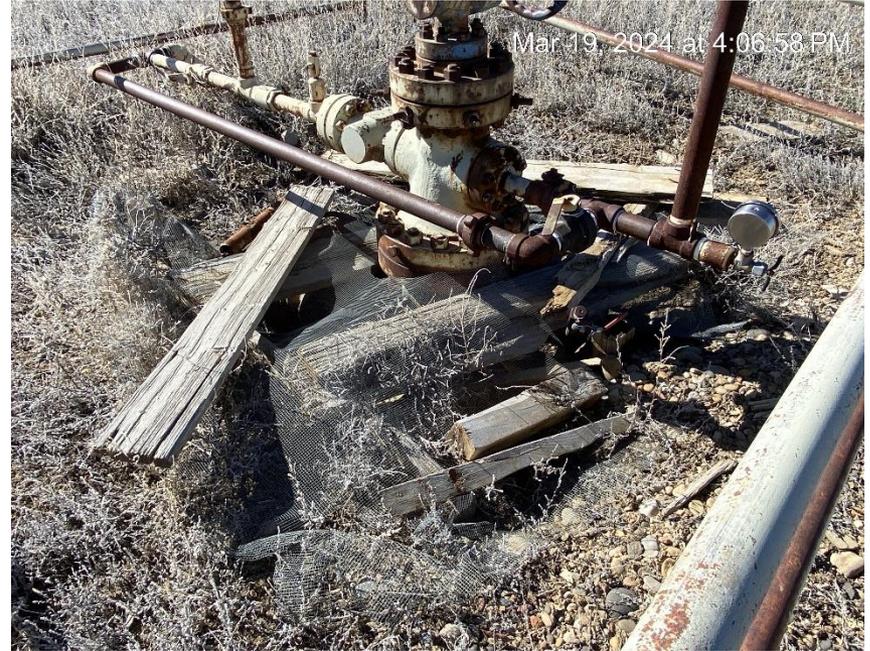
Unsafe cellar covering

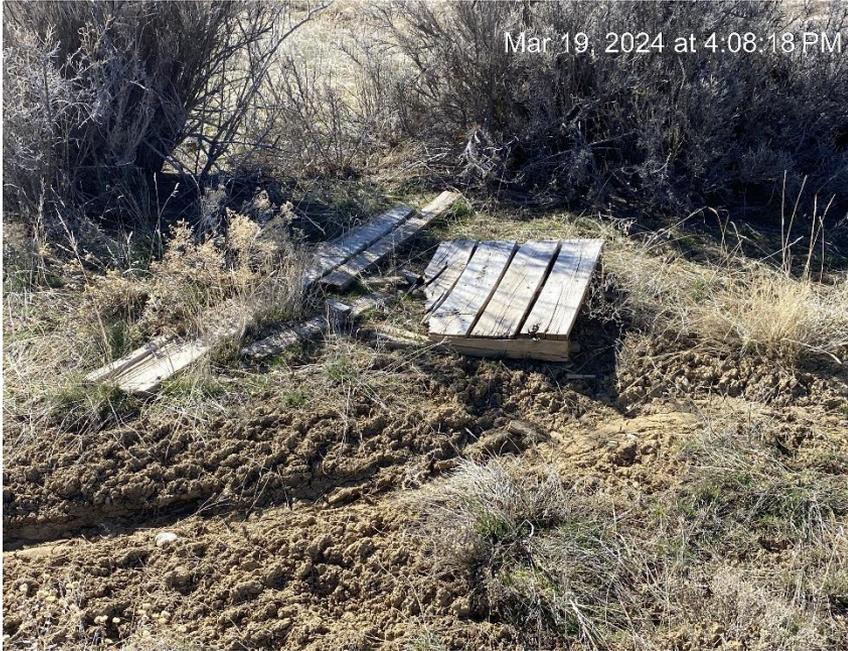
Debris

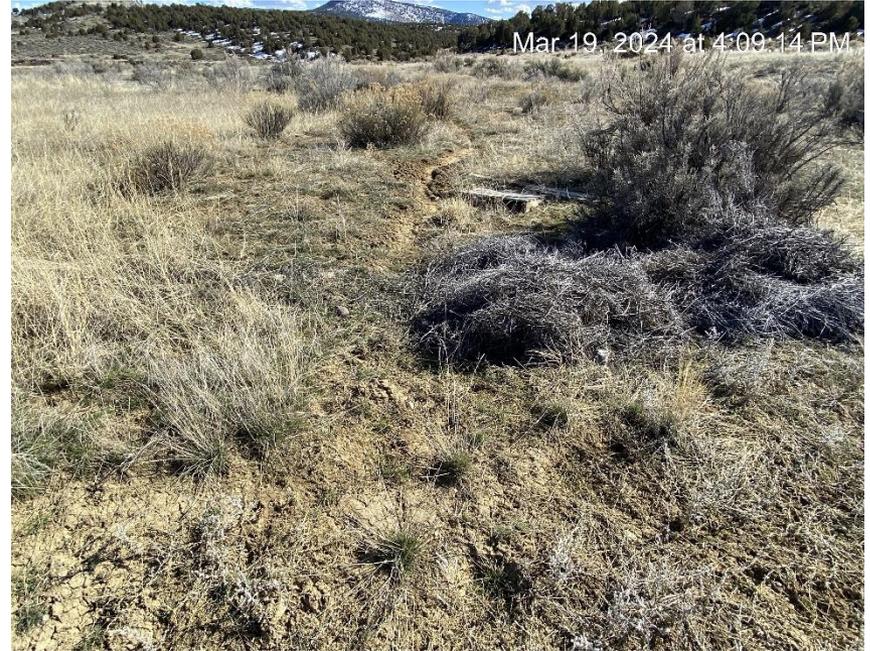
Erosion and sediment migration

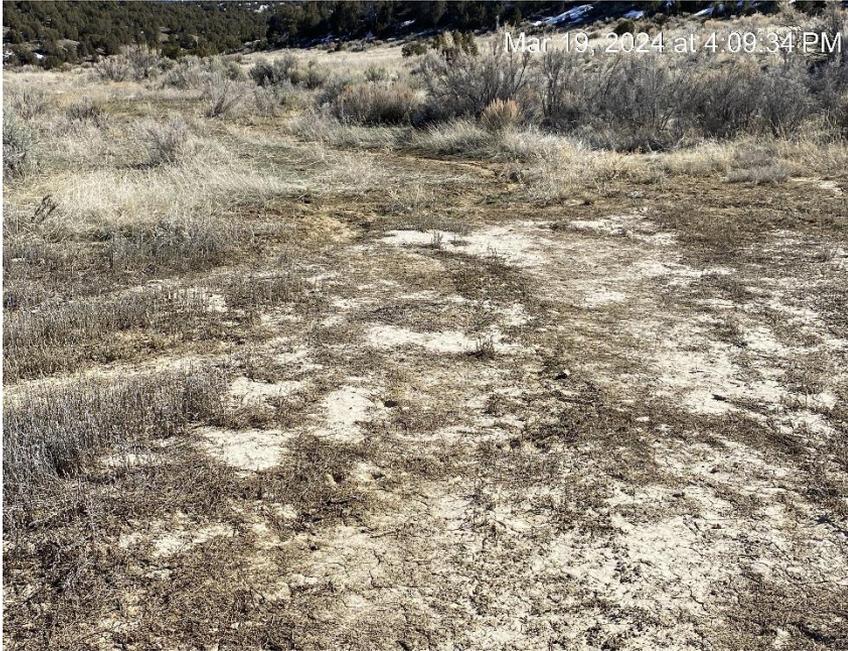
Sediment migration

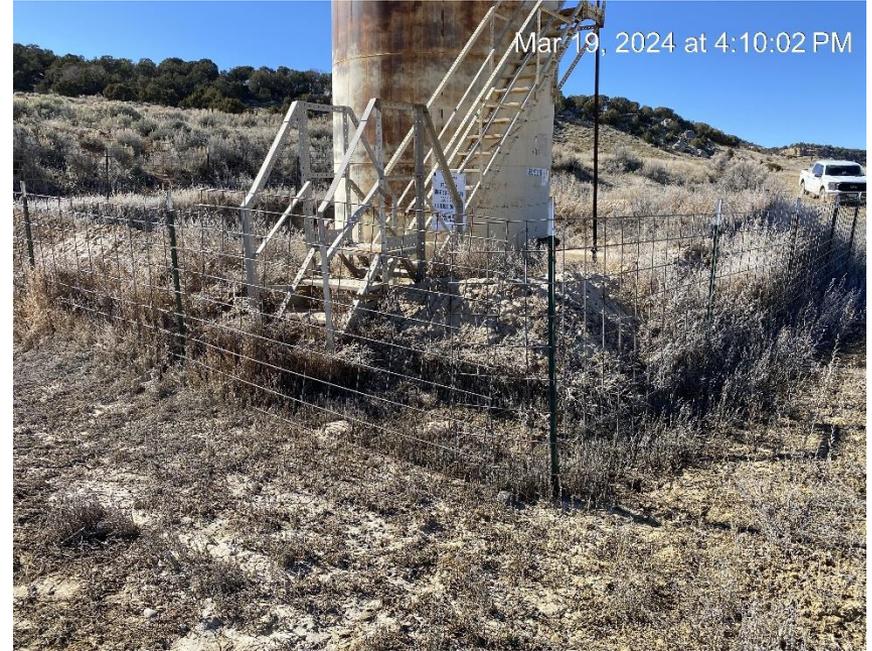
Last year's weeds
