Inspection Photos
Location Name: Grant 4
Location ID: 311319

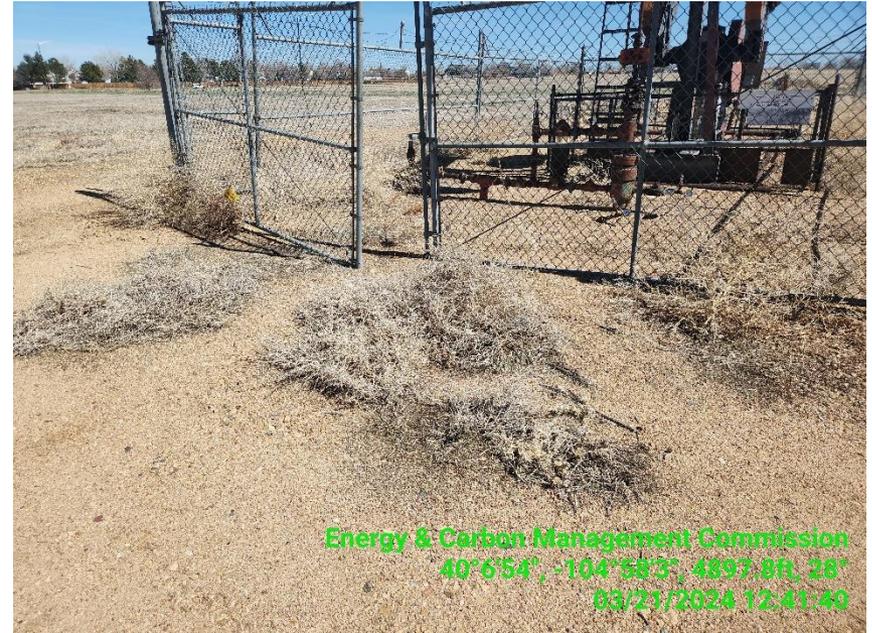
Photo 2 Dead vegetation(debris) just outside of wellsite fencing.

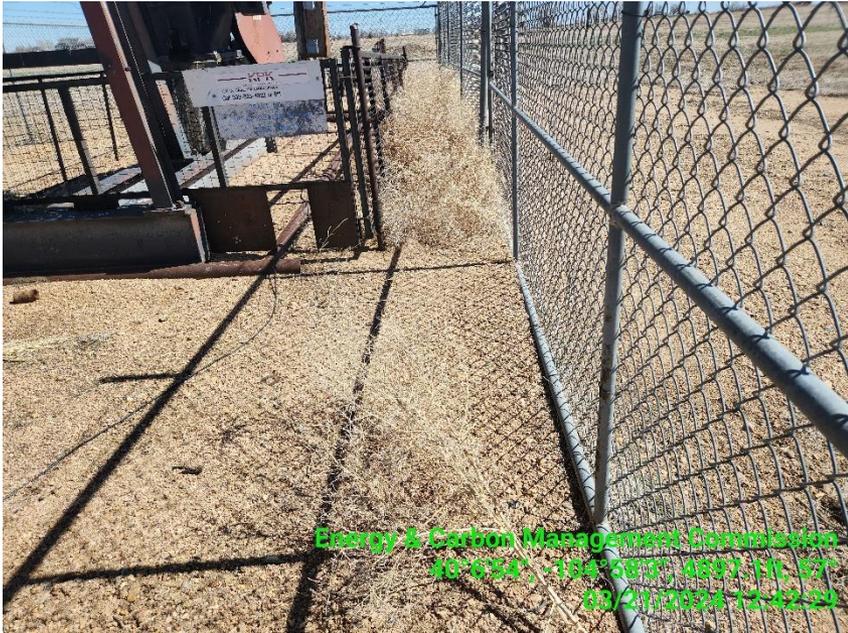
Photo 5 Dead vegetation(debris) between the wellsite fencing & pump jack fencing.

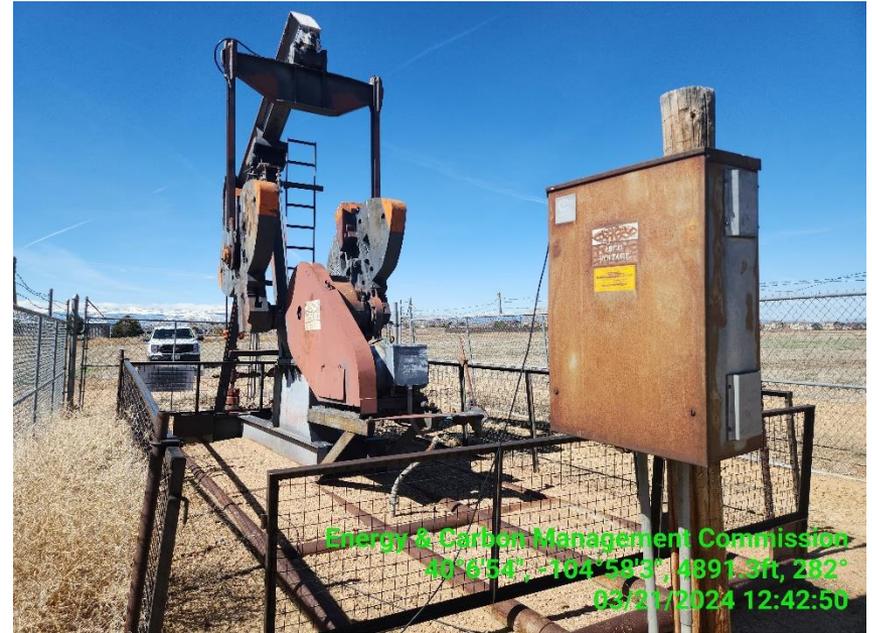
Photo 6 Electric panel, pump jack.

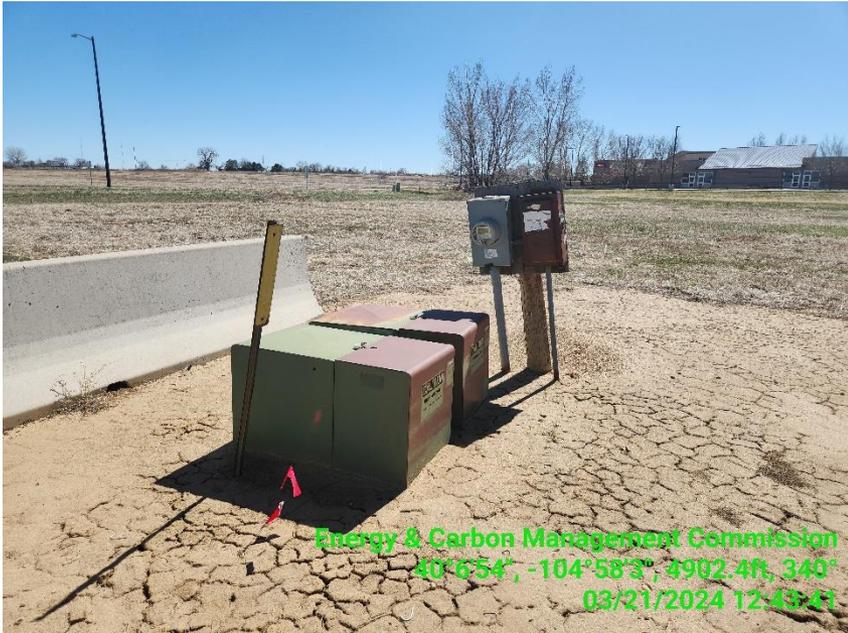
Photo 7 Ancillary equip.
