## Inspection Photos

Location Name: CAERUS PICEANCE LLC FEDERAL SAVAGE 11-4A (RD11) Pad

Location # 335004

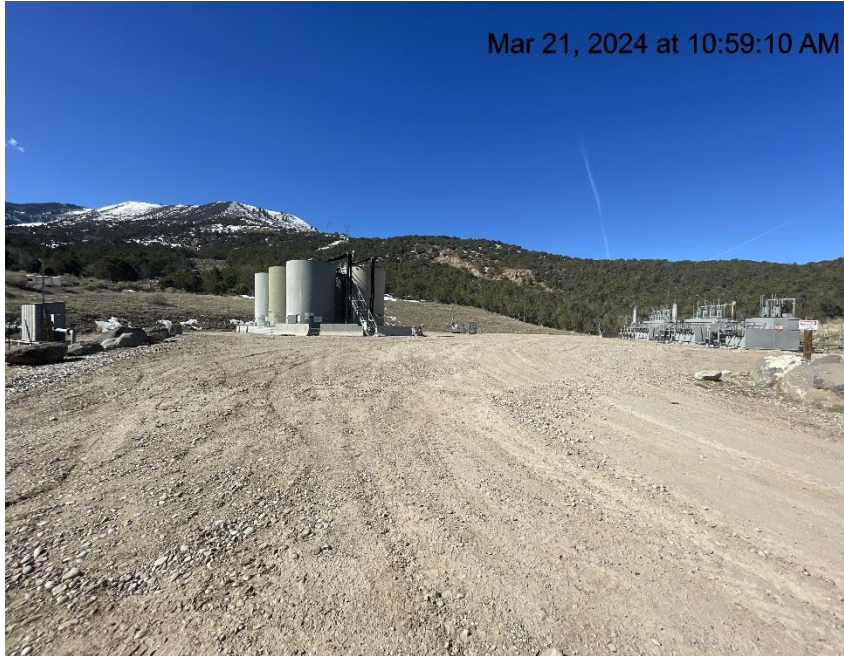
Photo # 854 From entrance to location

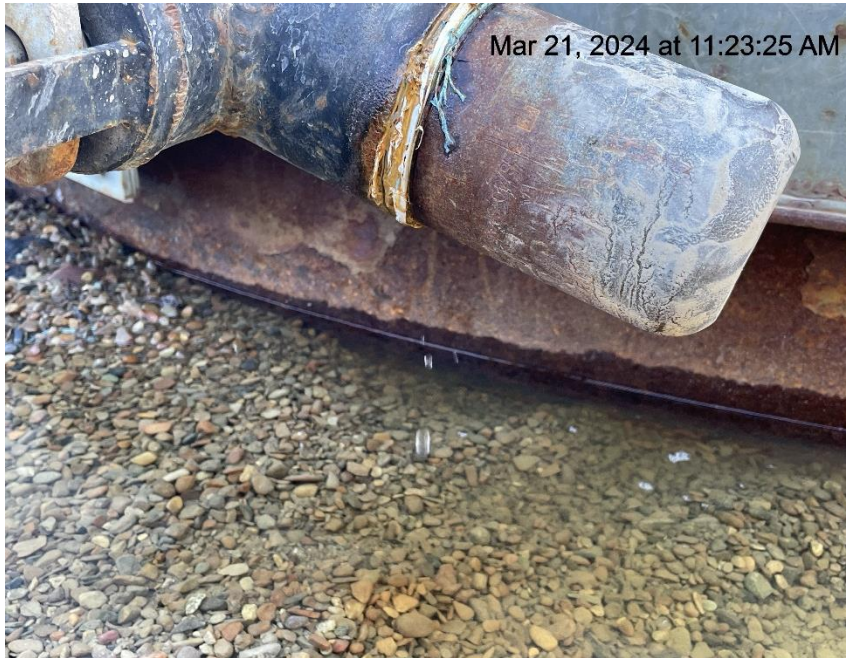
**Photo # 864 Mechanical condition – fluid leaking from tank valve**

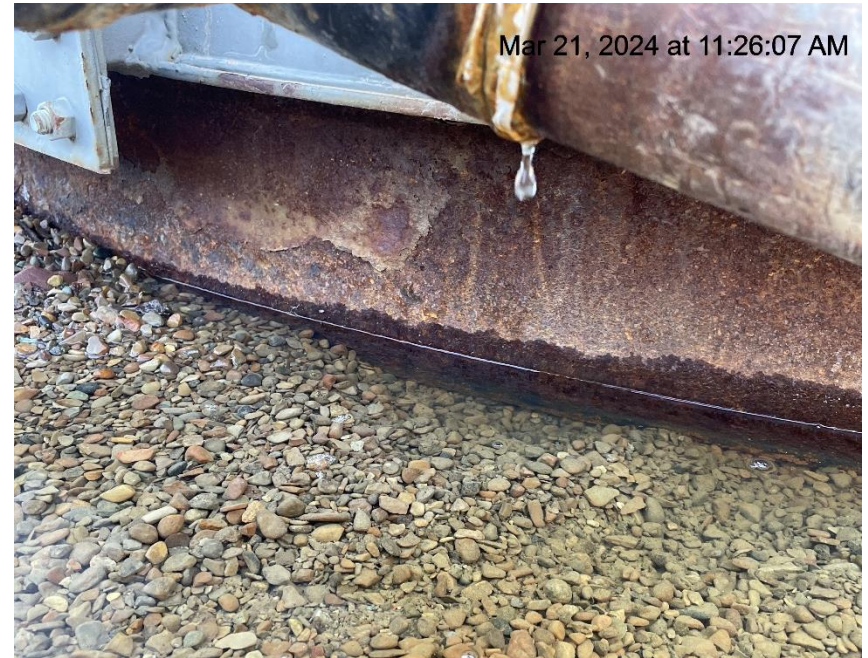
**Photo # 865 Mechanical condition – fluid leaking from tank valve**

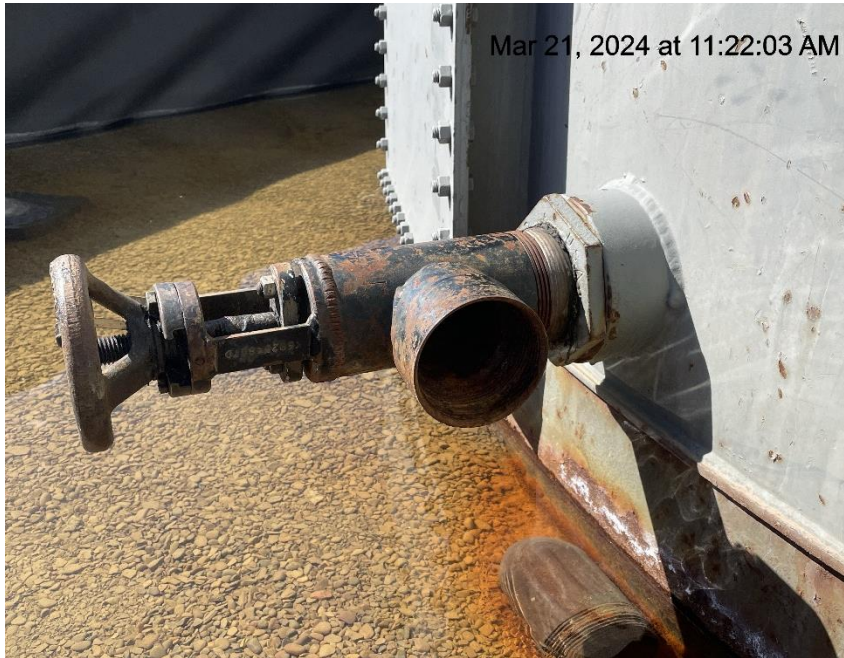
Photo # 866 Open ended load line
