**Inspection Photos**  
**Location Name: Hahn 1-4H**  
**Location ID: 424891**

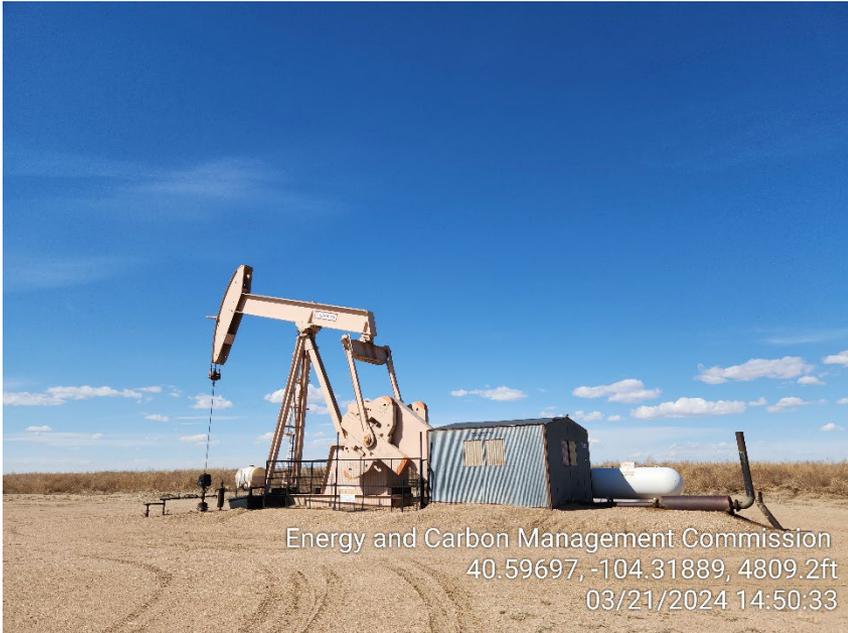
**Photo 1 – Pumping Unit**

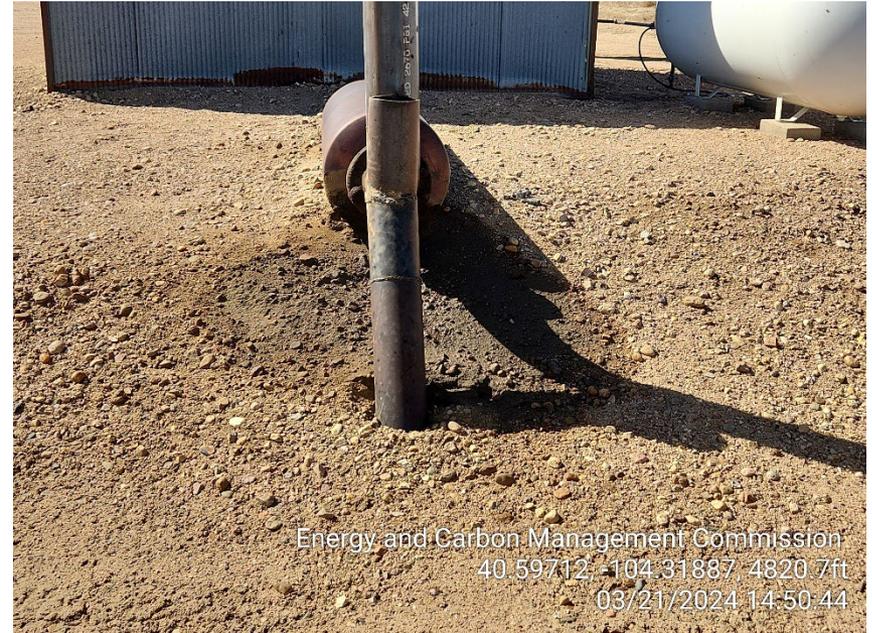
**Photo 2 – Stained Soil at Exhaust**

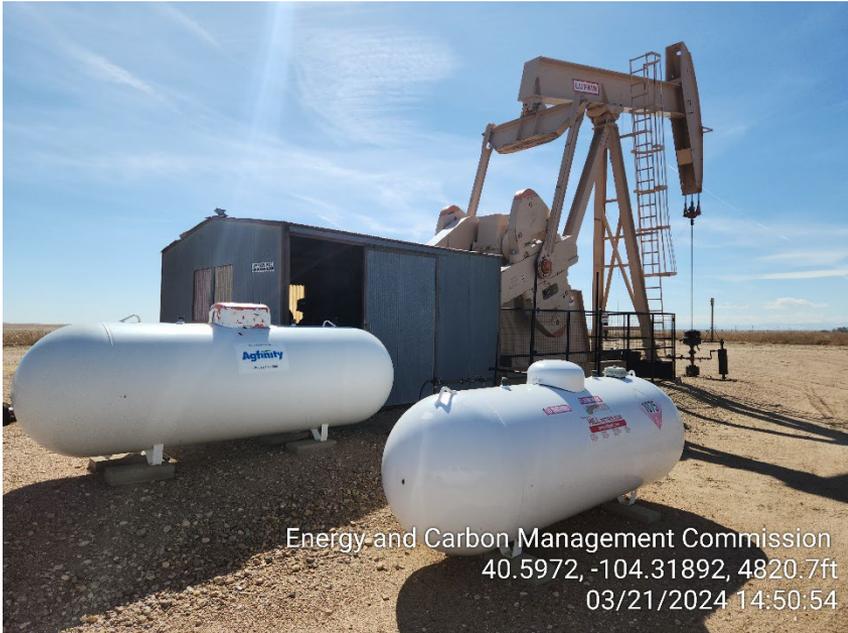
**Photo 3 – Propane Tanks**

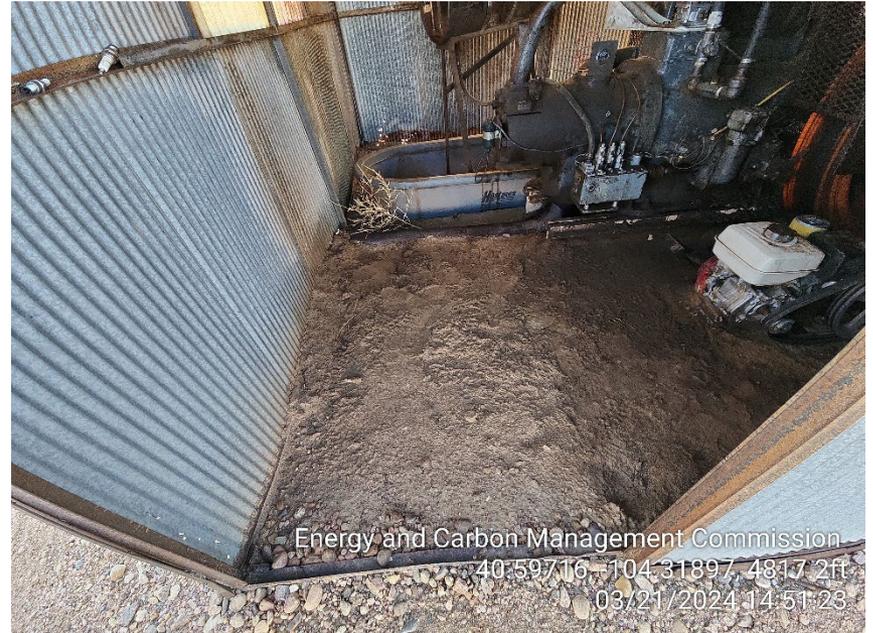
**Photo 4 – Gas Engine – Stained Soil**

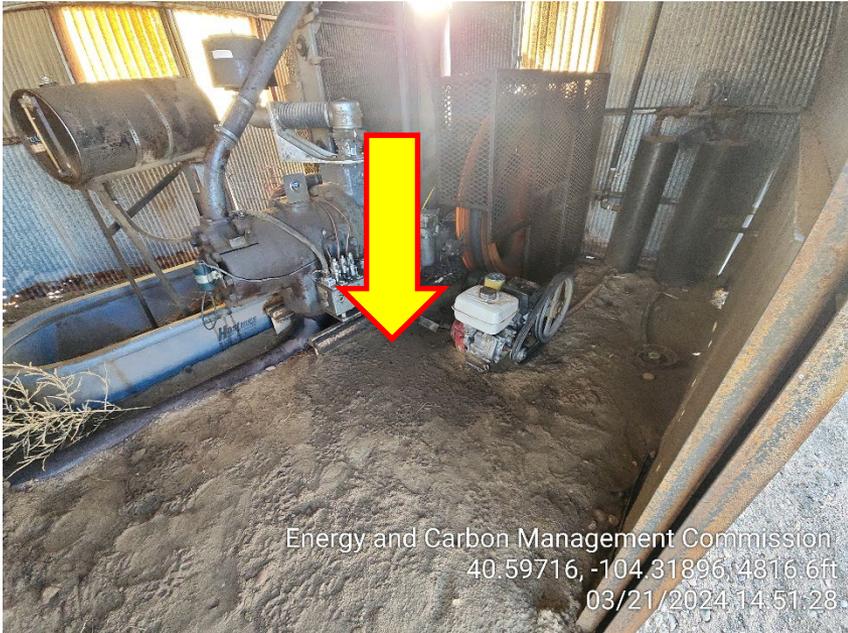
**Photo 5 – Stained Soil**

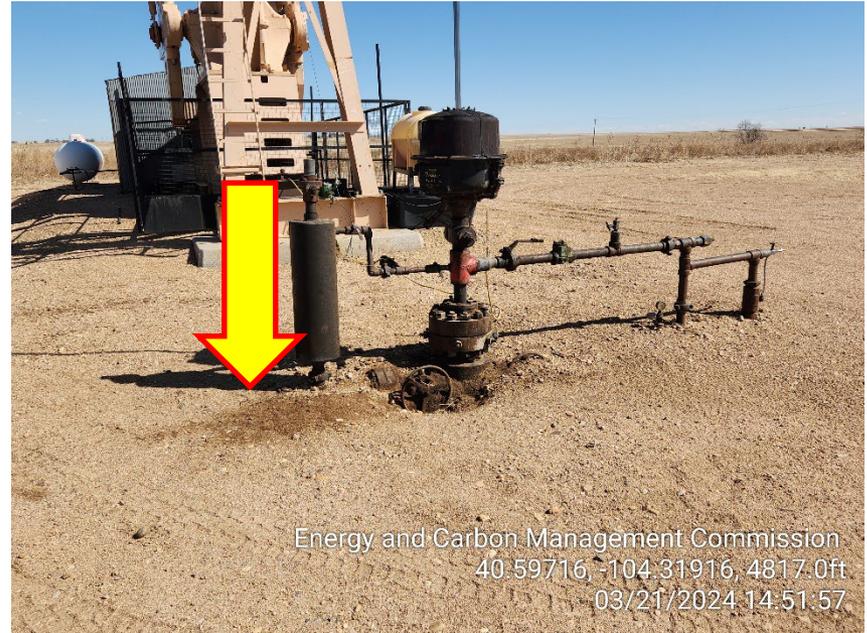
**Photo 6 – Wellhead – Stained Soil**

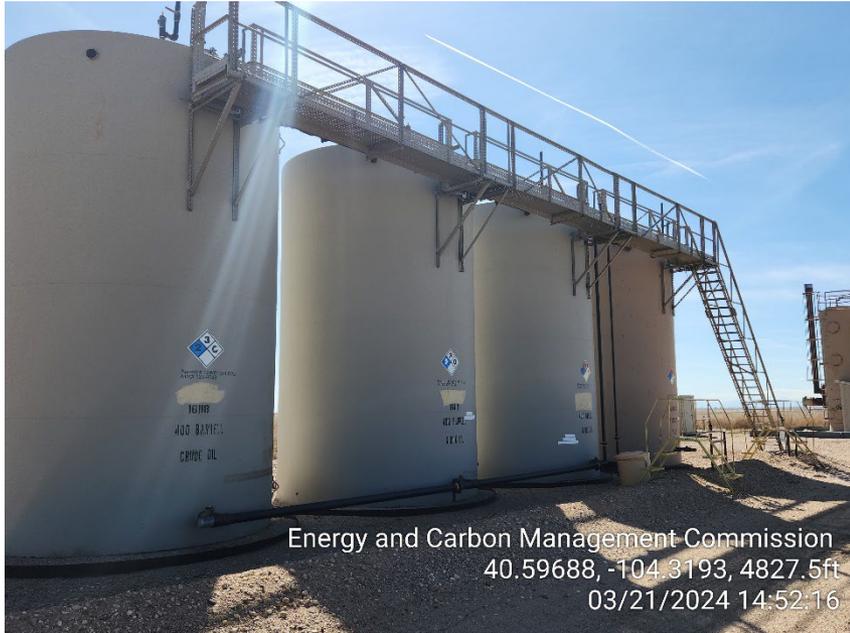
**Photo 7 – Tank Battery**

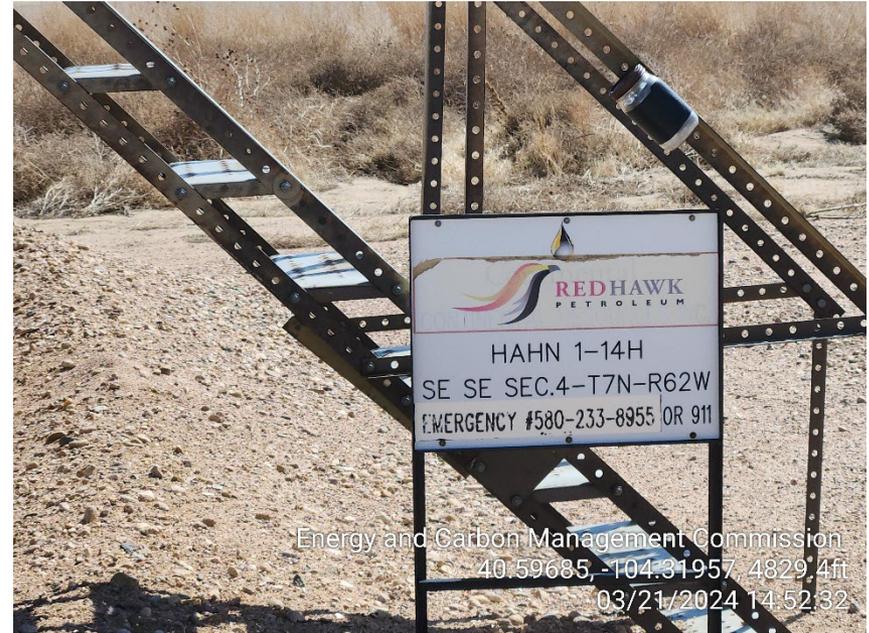
**Photo 8 – Tank Battery Sign**

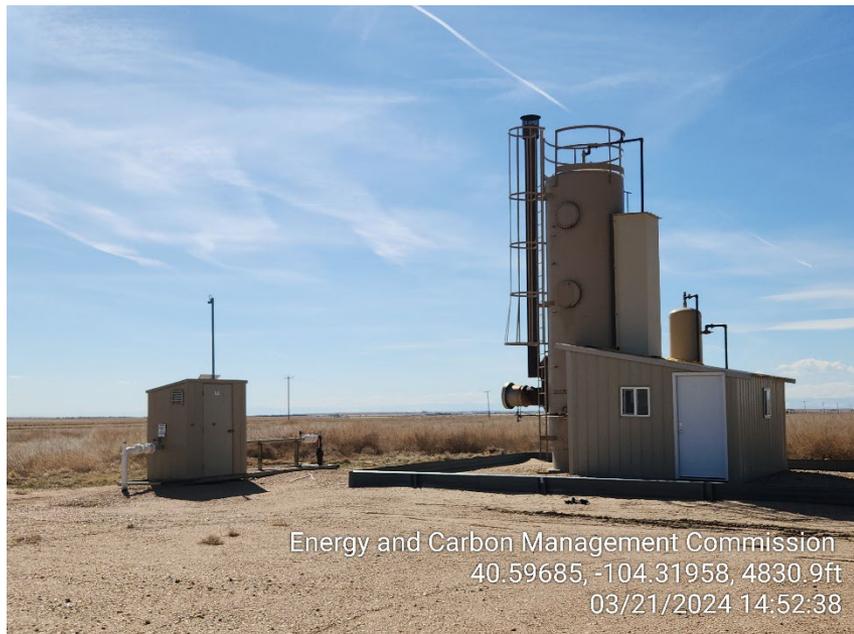
**Photo 9 – Heater Treater and Gas Meter**

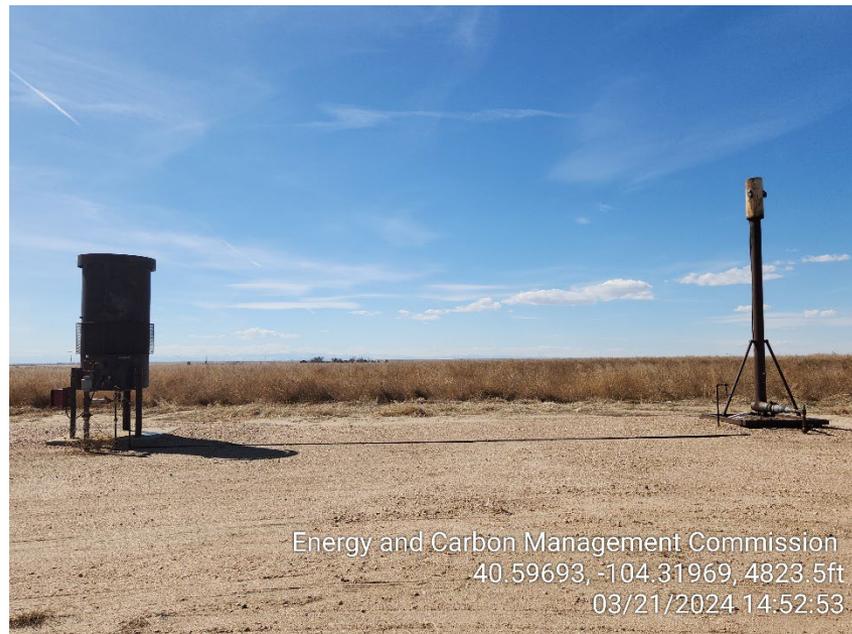
**Photo 10 – ECD and Flare**
