Inspection Photos

Operator: ANSCHUTZ EXPLORATION CORP
#3104

Location ID: 315979

Inspection Doc: 696205703

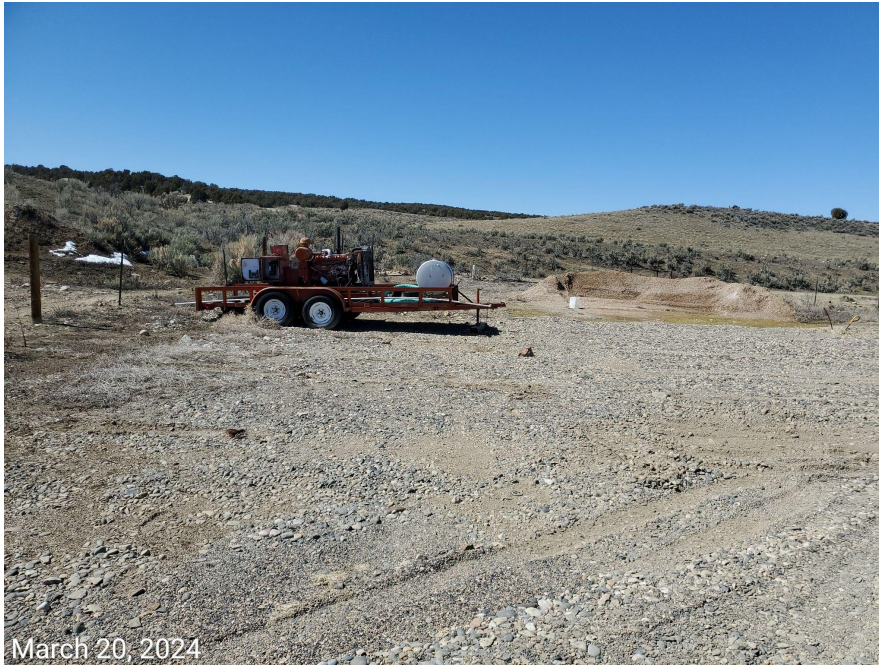
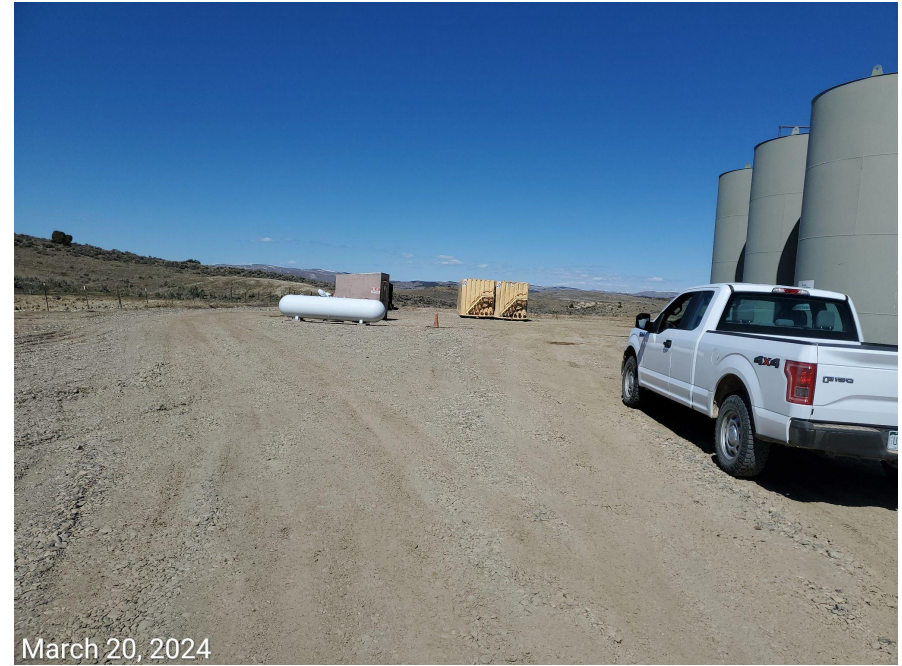
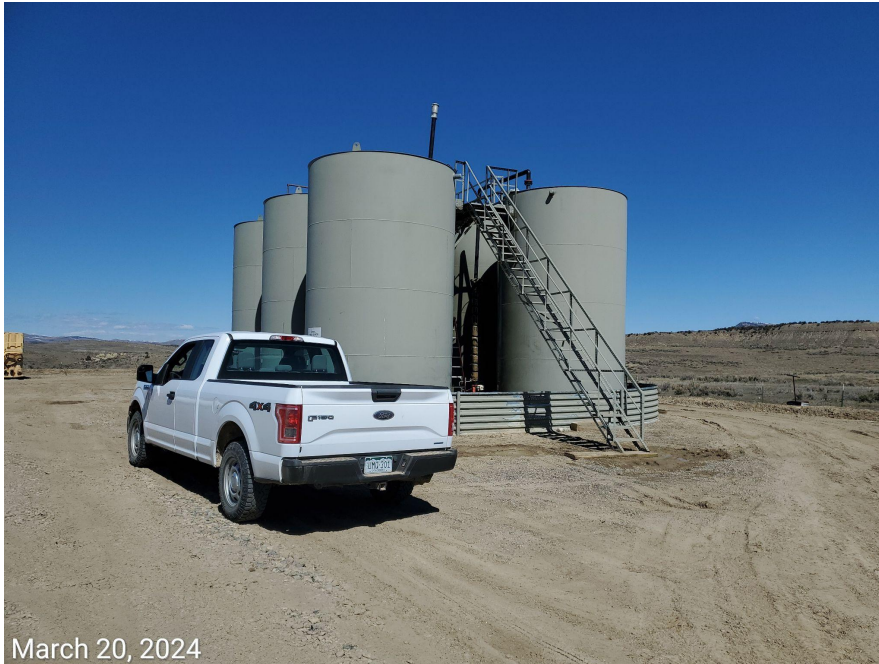
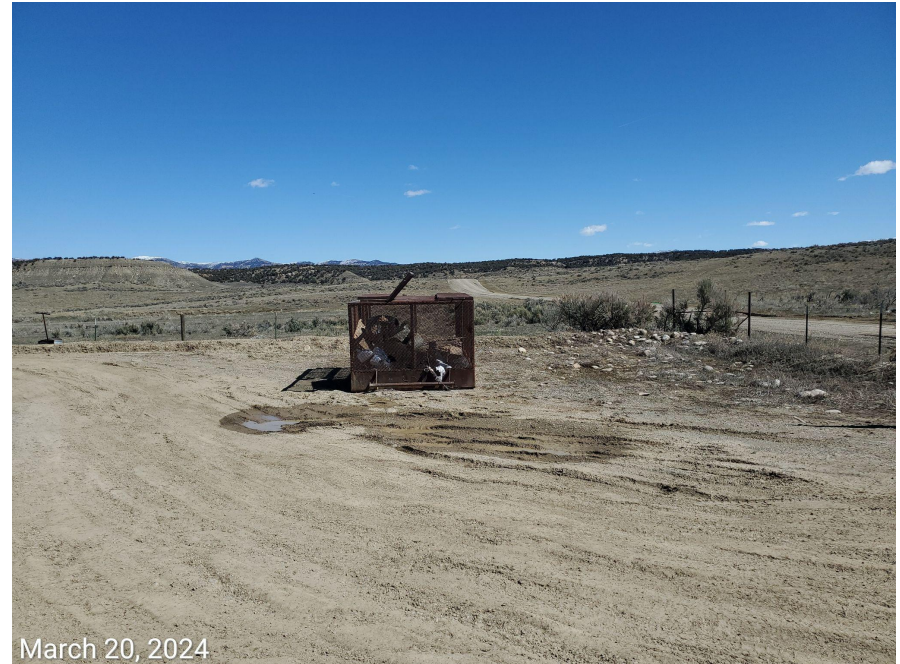
Photo 1: Photos 1-2 taken from Location entrance on the south end of the Location. Photos provide an overview of the Location from west, northwest, northeast to east.

Photo 2: See comments under photo 1.

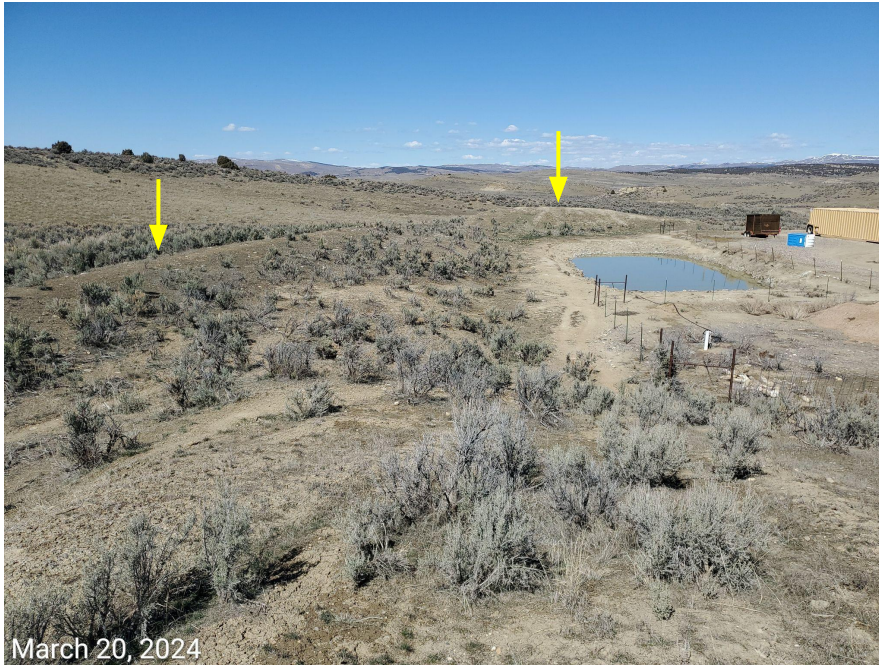
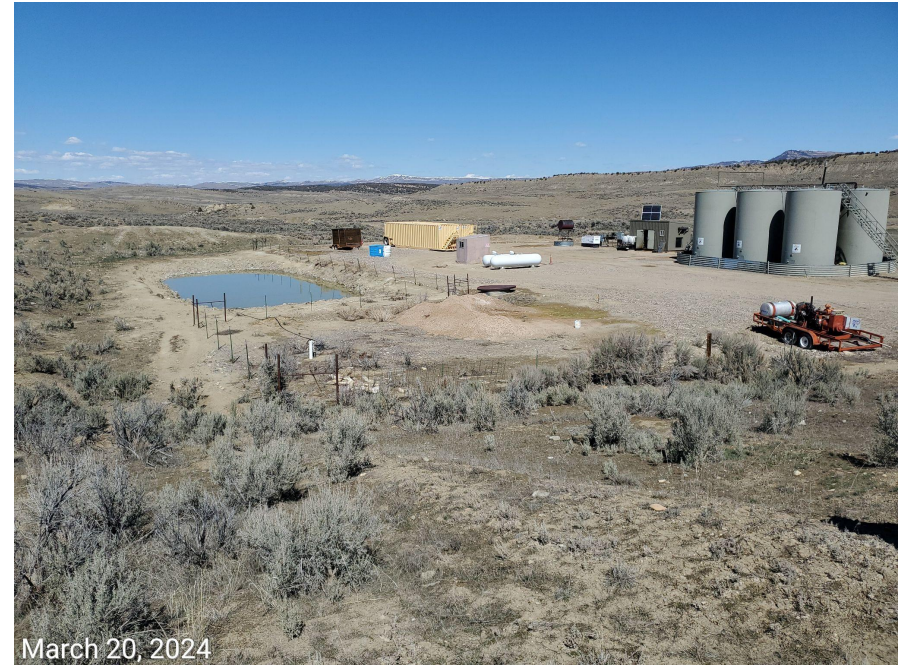
Photo 3: Photos taken from the soil stockpile on the southwest end of the Location. Photos provide an overview of the Location from north and northeast. Photo left shows locations of other stockpiles stored on the Location.

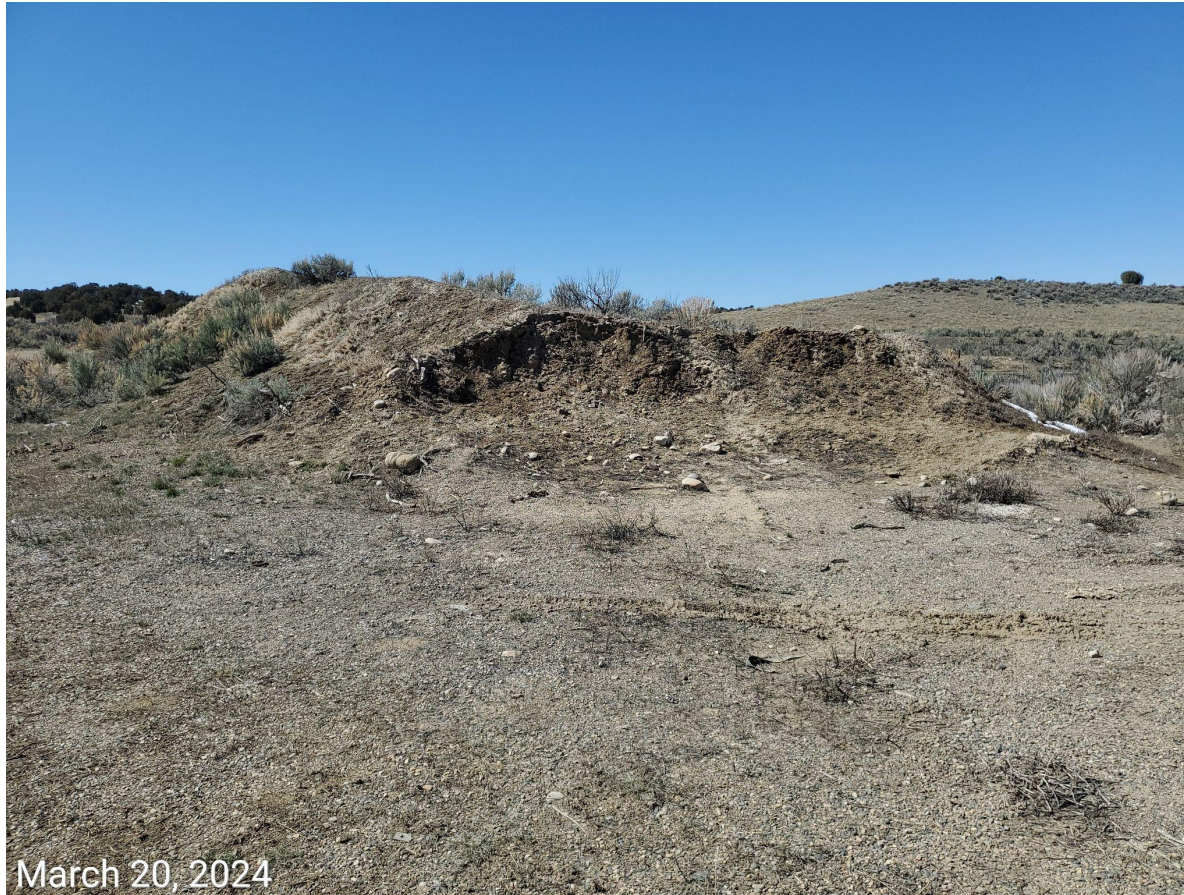
Photo 4: Photo taken from the soil stockpile on the southwest end of the Location, facing west. Photo shows Operator appears to be using the stockpile on the southern end of the Location as a borrow area. This has resulted in unstabilized soils, and sediment transport. BMPs to protect stockpiles on Location from contamination, compaction, wind and water erosion, as well as to prevent weed establishment are missing or insufficient.

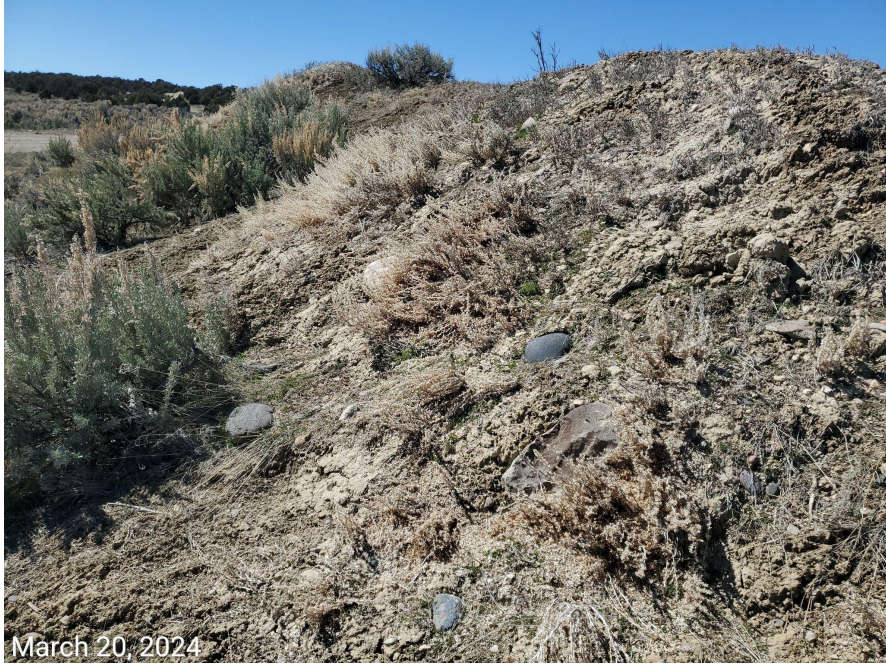
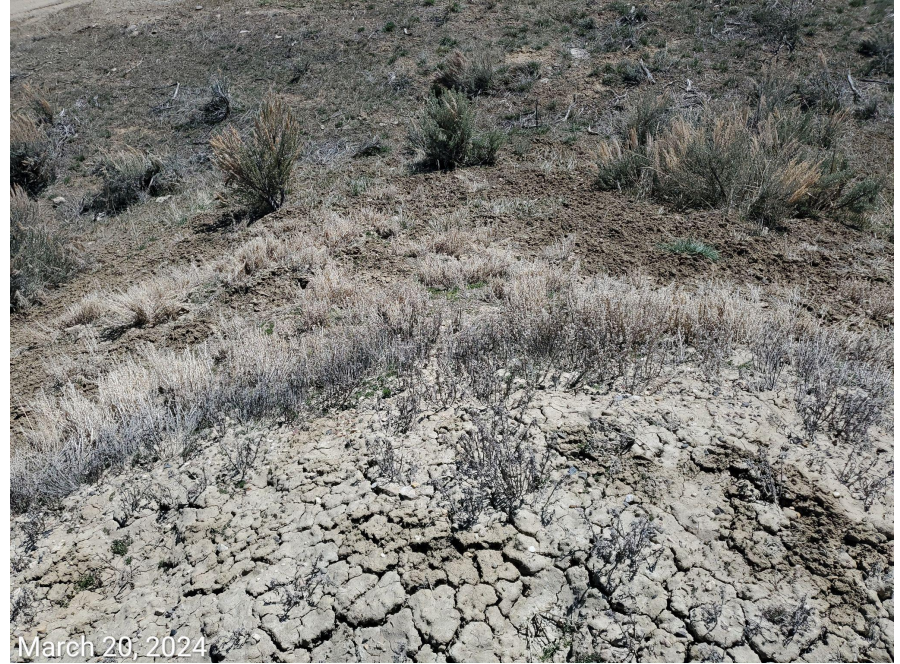
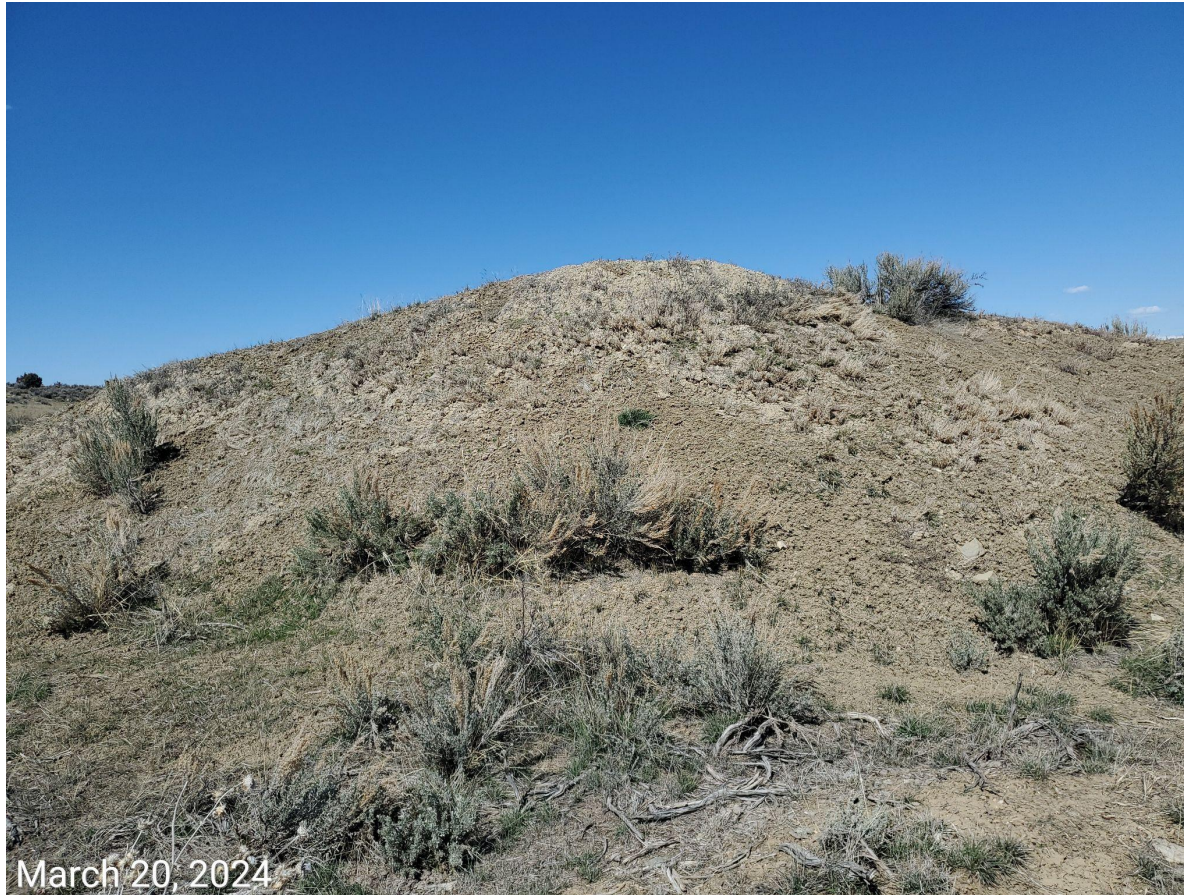
Photo 5: Continued from photo 4. Photos 5-6 also show Noxious weeds (Halogeton) observed established on the stockpiles of the Location. BMPs to protect stockpiles on Location from contamination, compaction, wind and water erosion, as well as to prevent weed establishment are missing or insufficient.

Photo 6: See comments under photo 4 and 5.

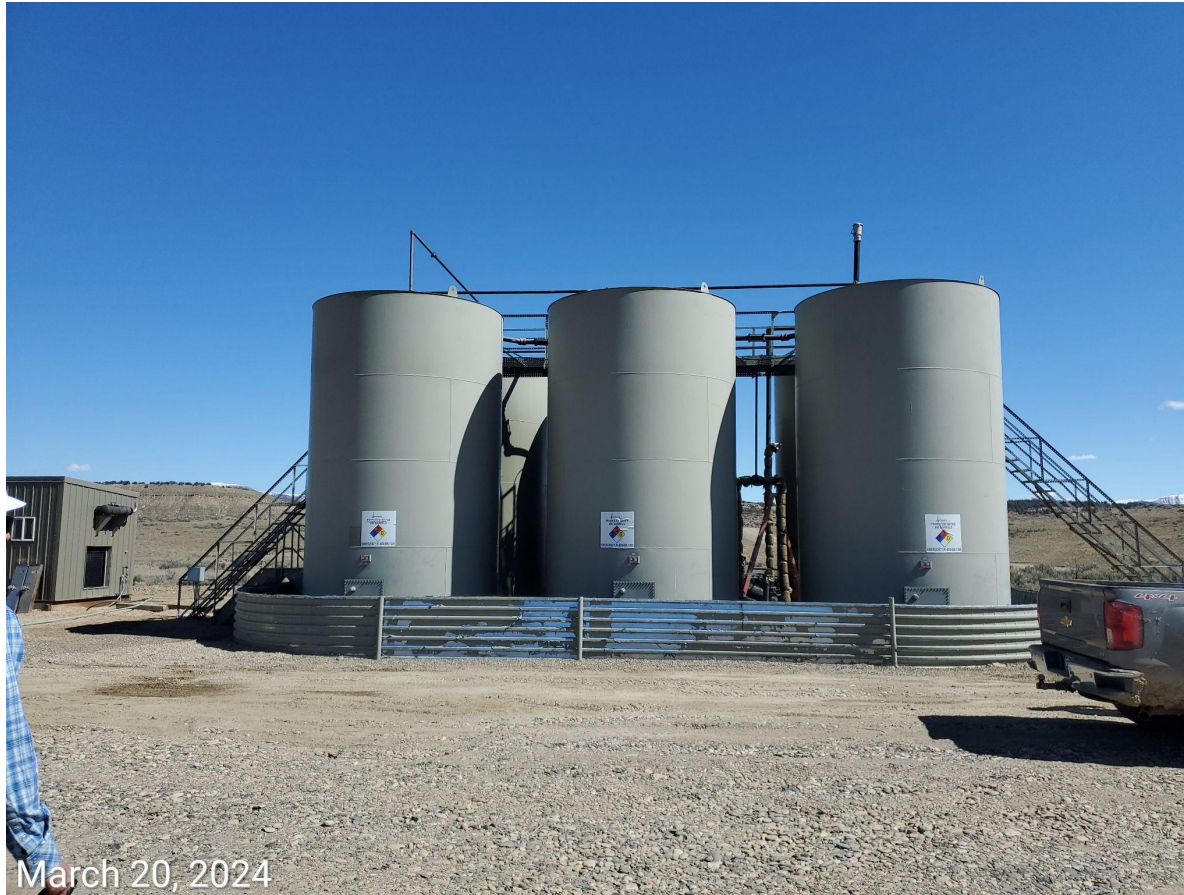
Photo 7: Photo of tank battery facility on the southeast end of the Location, facing east. Signage pursuant to Rule 605.e not posted.

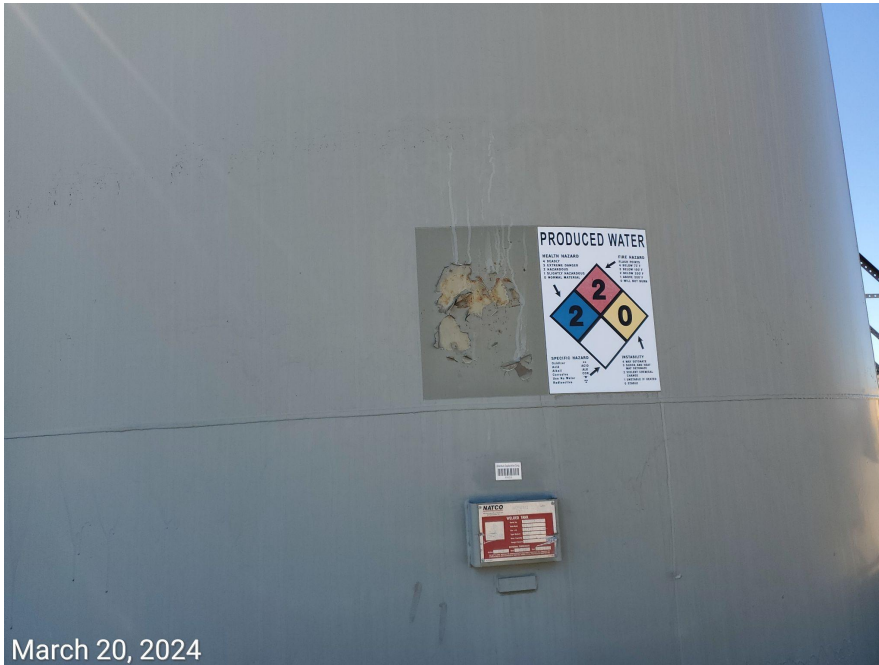
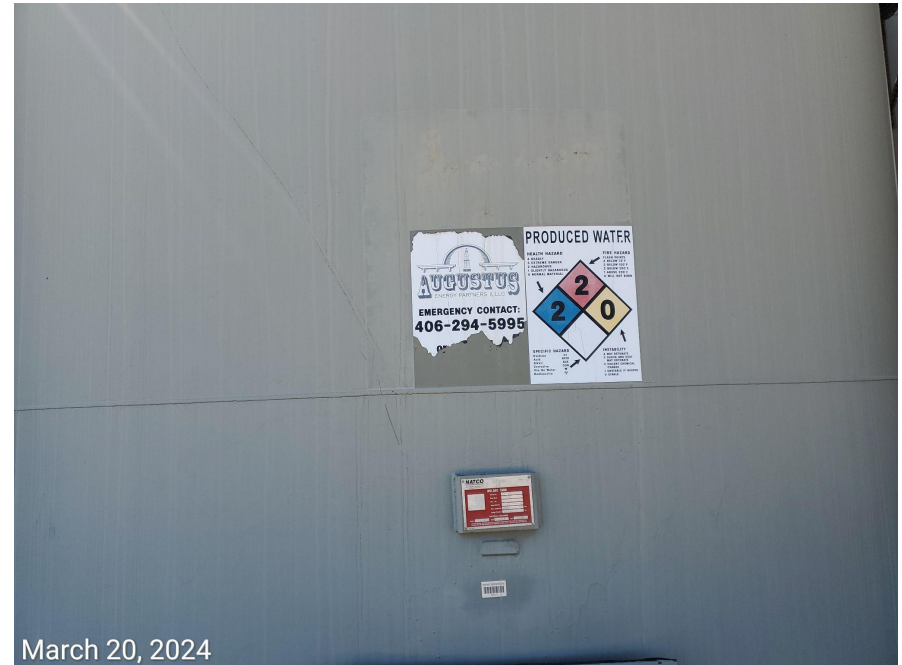
Photo 8: Photos taken from tanks at the battery facility. Photos examples showing signage at tanks are missing required information, or information is inaccurate pursuant to Rule 605.h.

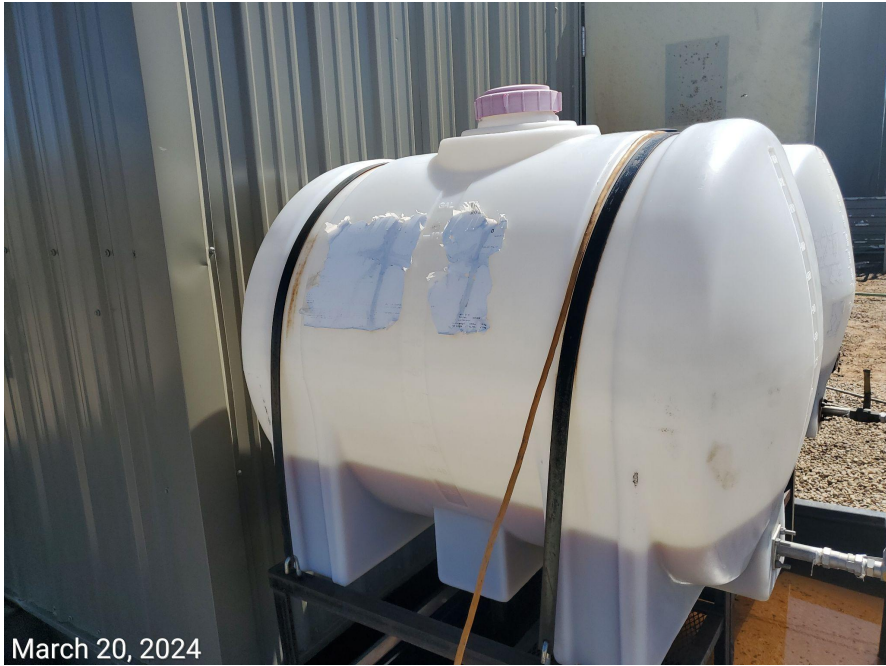
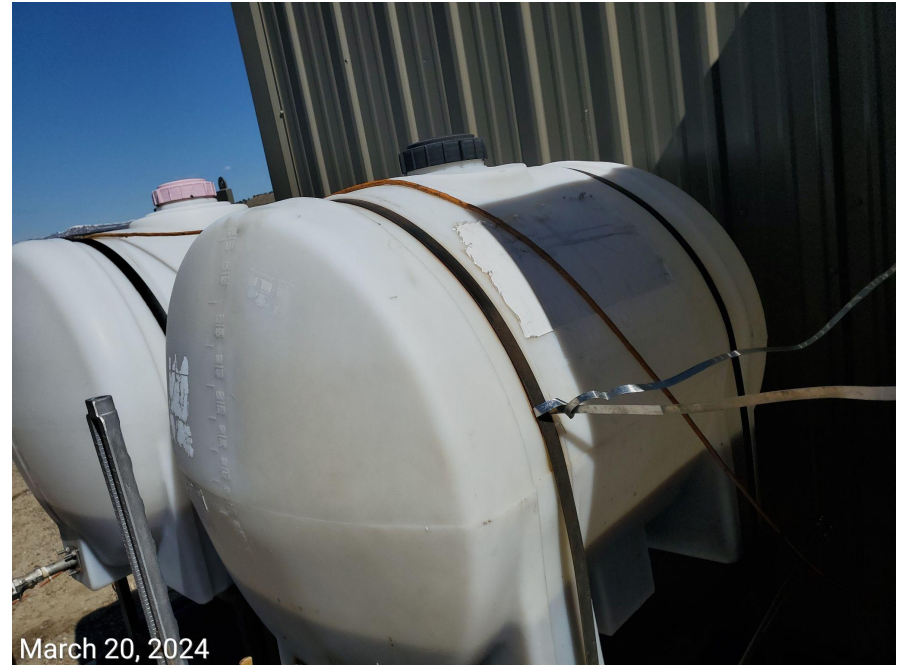
Photo 9: Photos taken from, what appears to be, two methanol containers on the northeast end of the Location. Signage/labels on containers no longer legible.

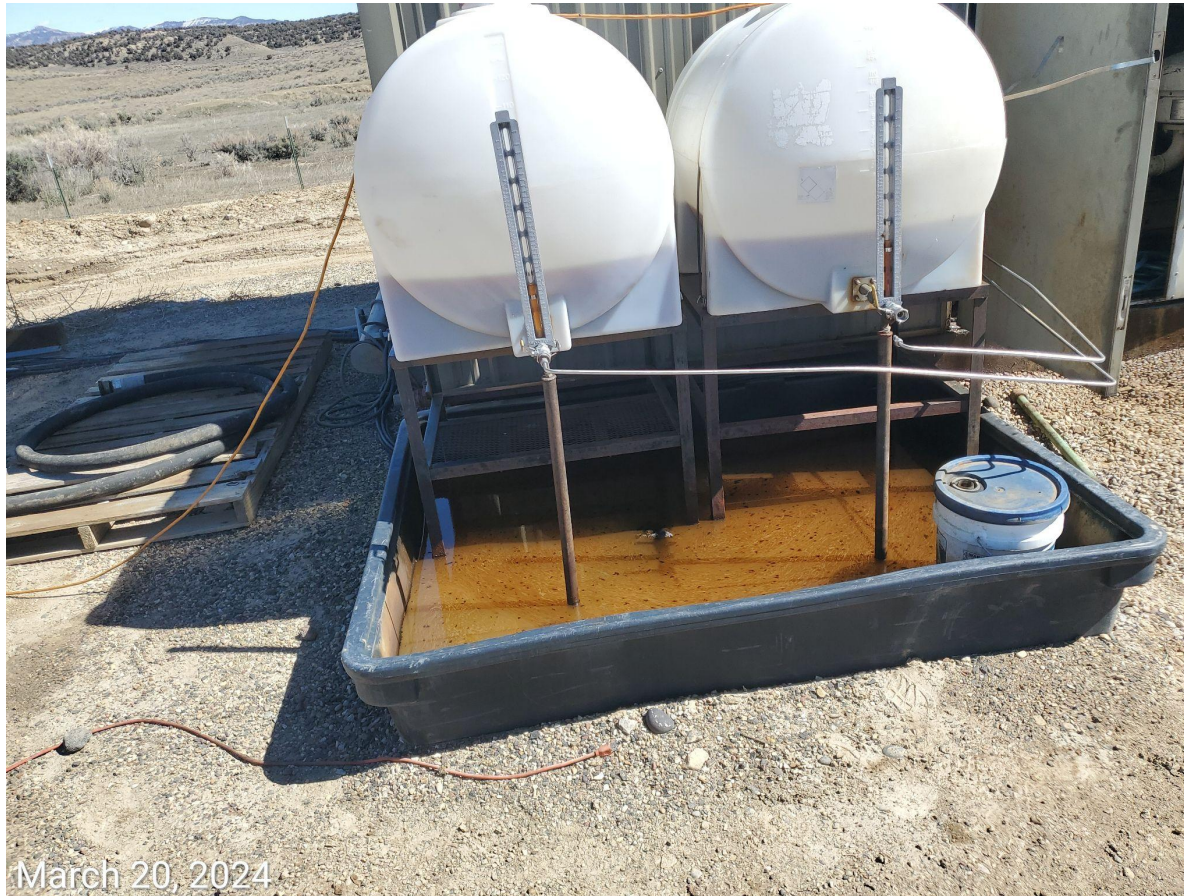
Photo 10: Continued from photo 9. Photo shows fluids within secondary containment. Photo also shows wildlife protection BMPs are missing or insufficient at the containment measure.

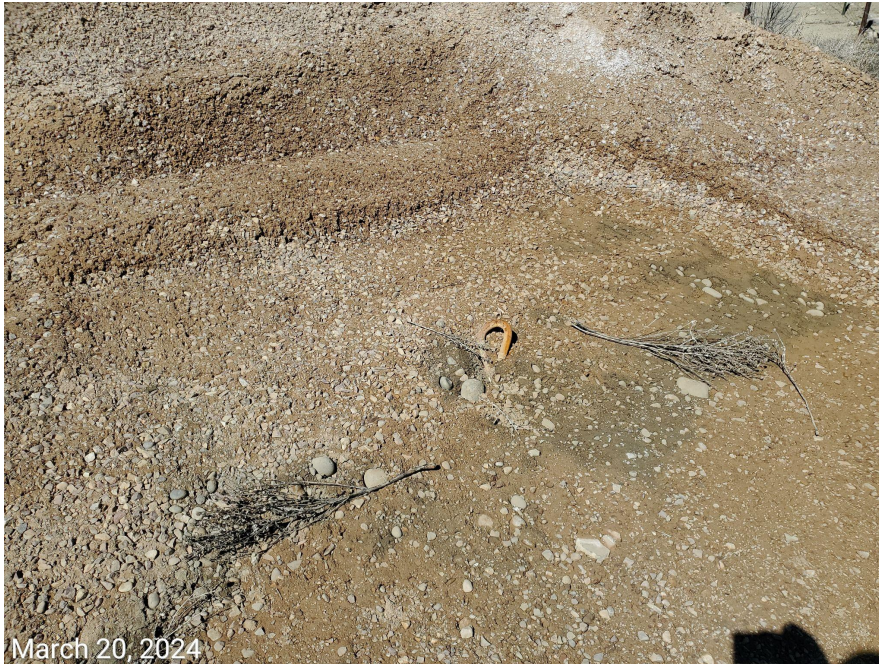
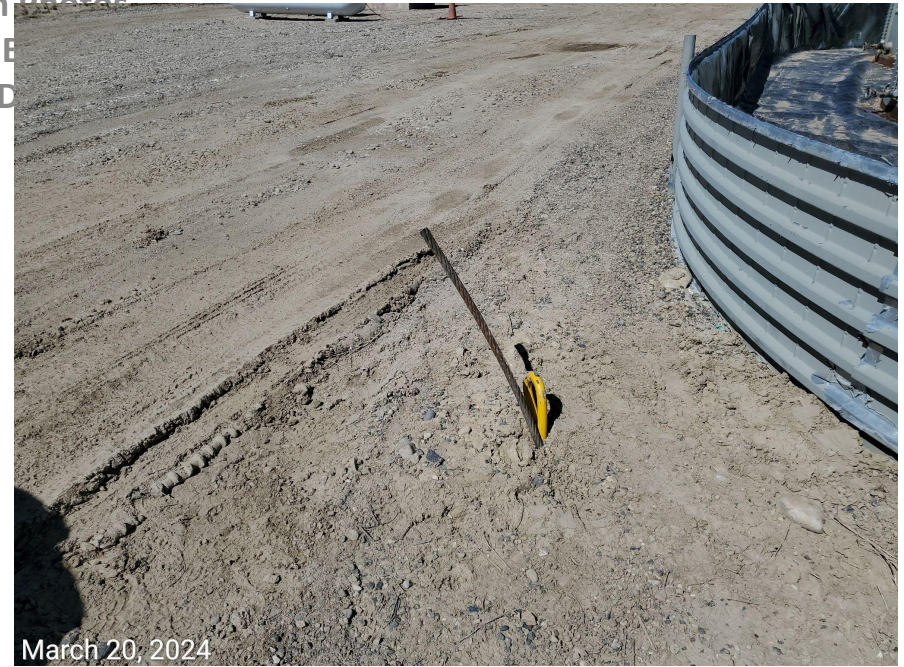
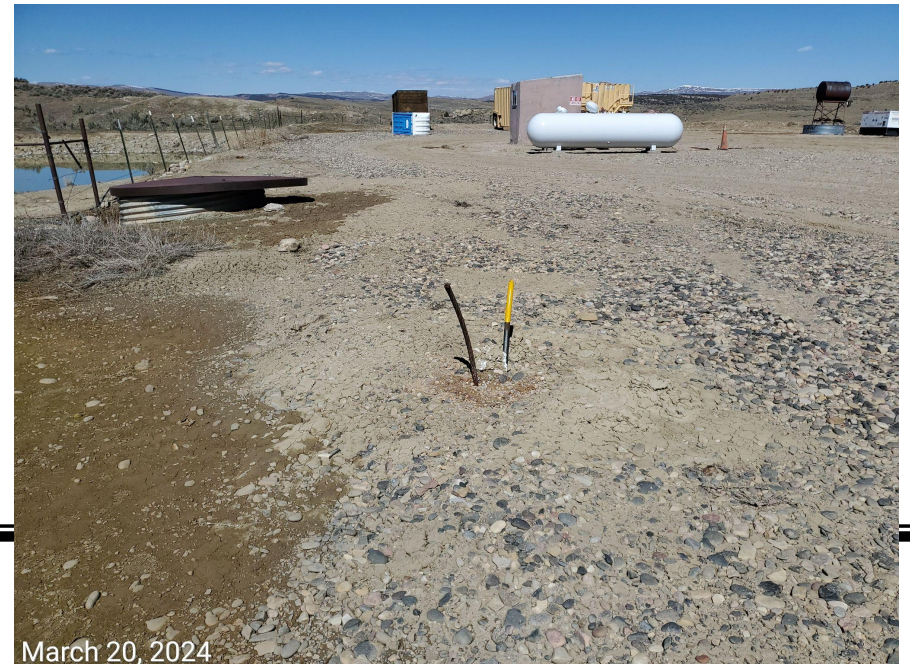
Photo 11: Photos examples showing anchors on the Location have either not been marked, or haven't been marked in accordance with Rule 1003.a and 603.j requirements.

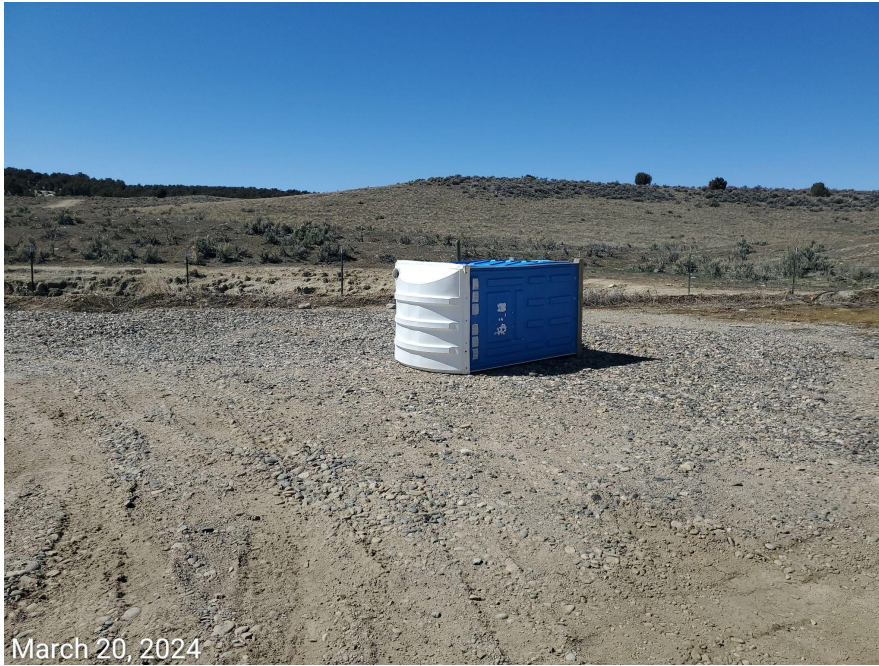
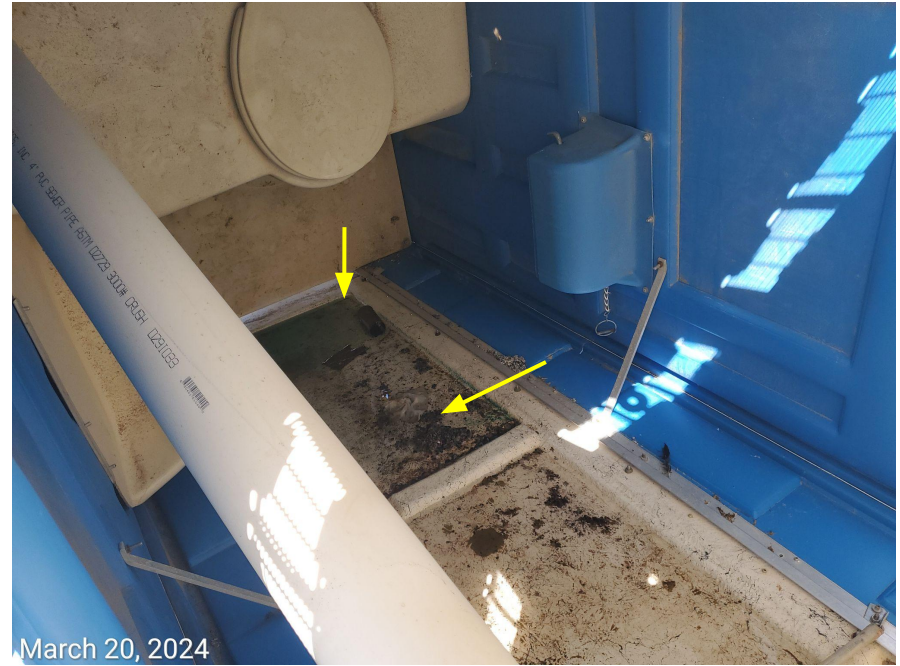
Photo 12: Photos taken from the northwest end of the working pad surface. Photos show a Sanitary Facility (Porta-John) on Location has not been properly secured and is currently laying on its side. Waste and fluids observed spilled within the facility.

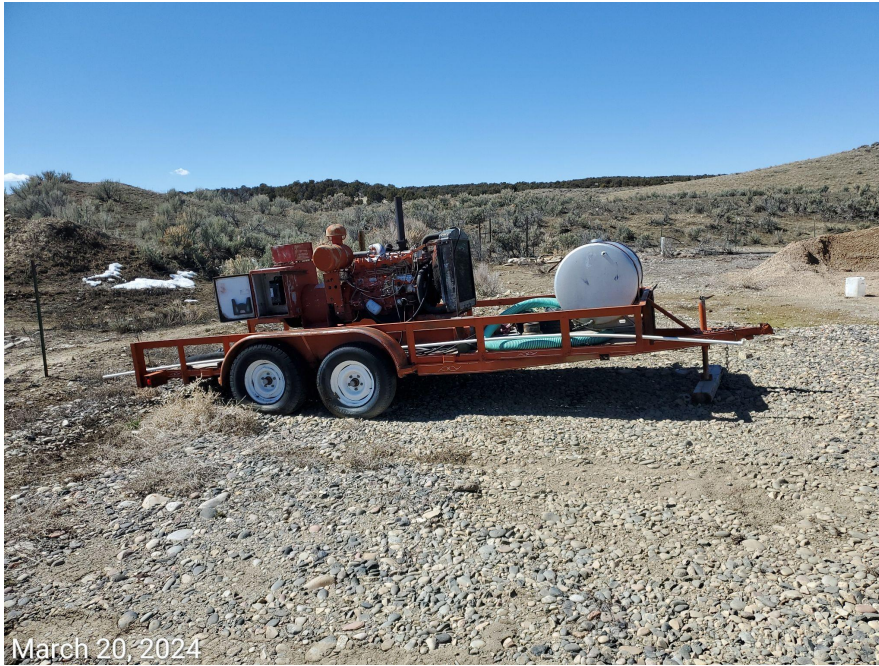
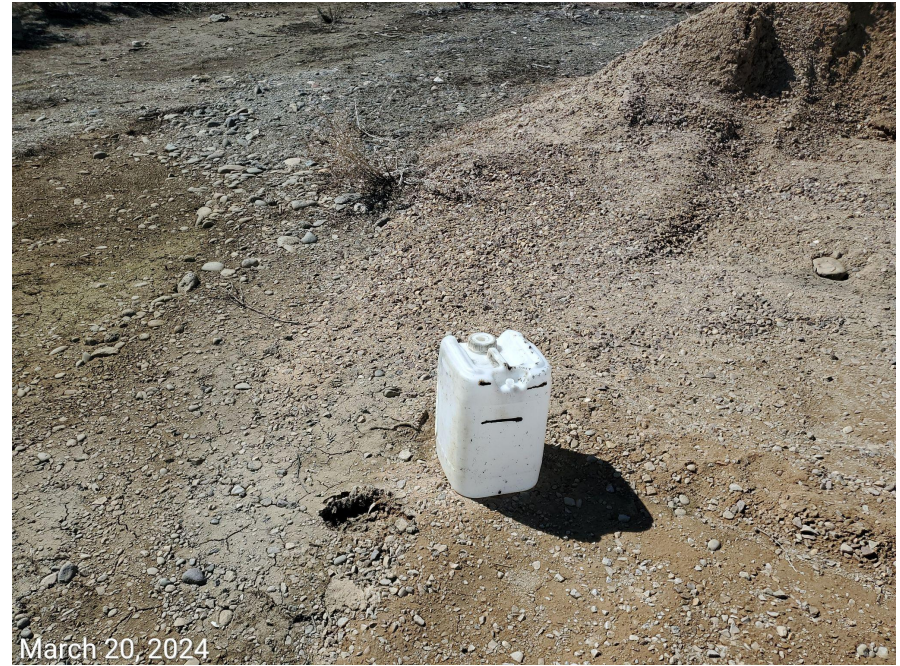
Photo 13: Photos 13-19 taken throughout the Location, including the tank battery facility. Photos are examples showing various trash, debris and/or unused equipment observed improperly stored on the Location; the storage, placement, or maintenance of equipment, vehicles, trailers, commercial products, Chemicals, drums, totes, Containers, materials, and all other supplies not necessary for use on an Oil and Gas Locations is prohibited.

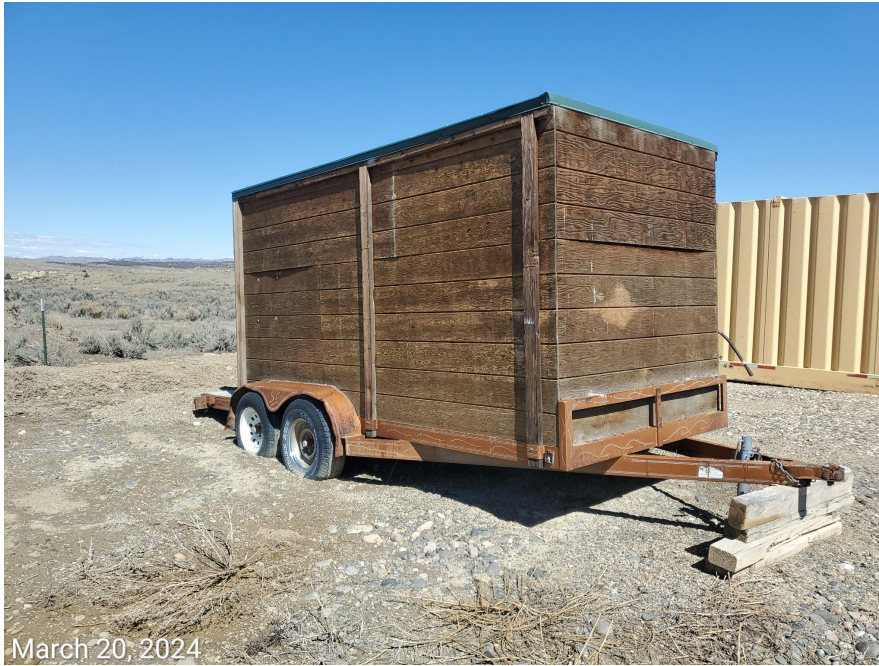
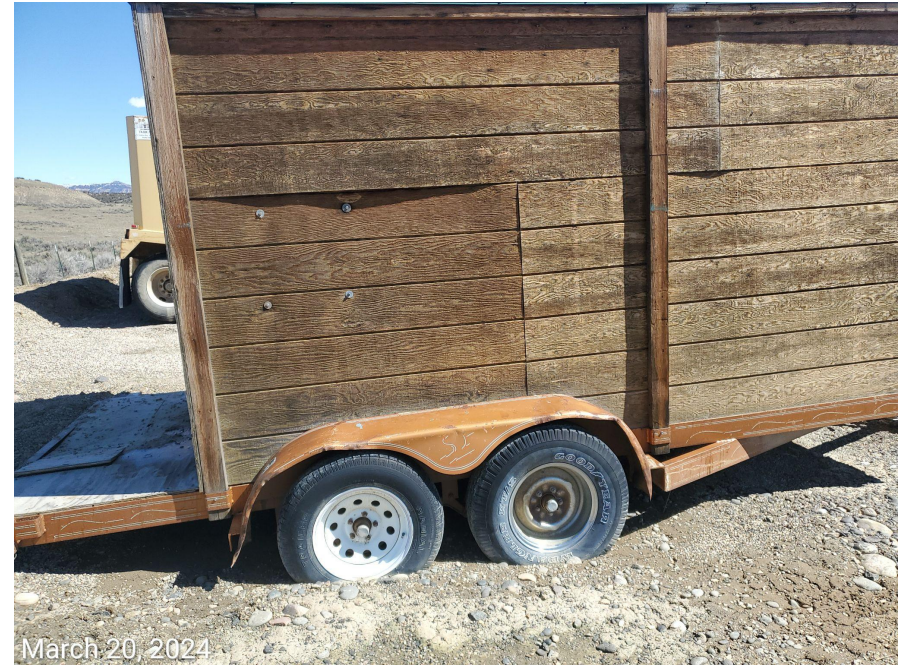
Photo 14: See comments under photo 13.

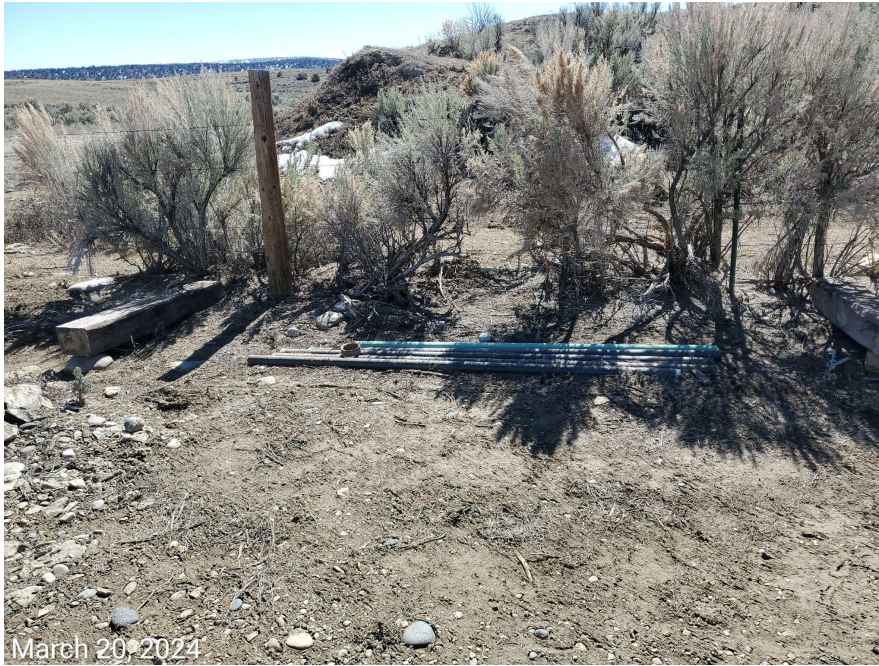
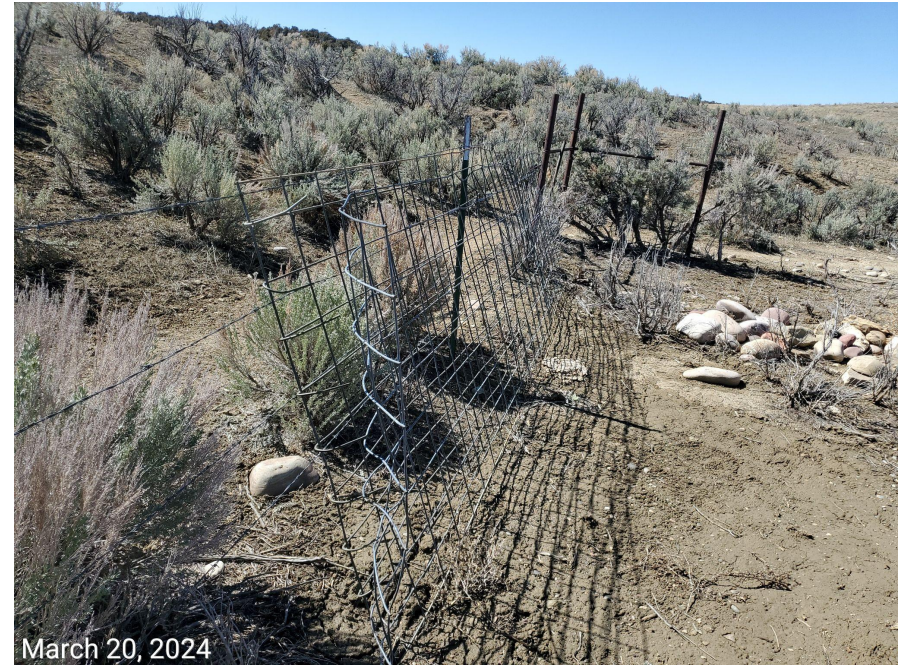
Photo 15: See comments under photo 13.

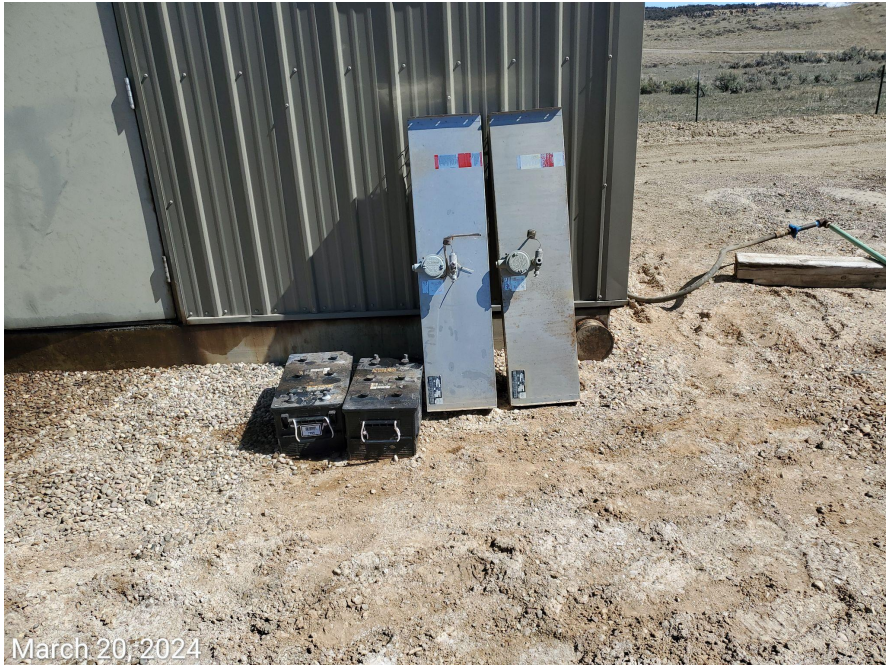
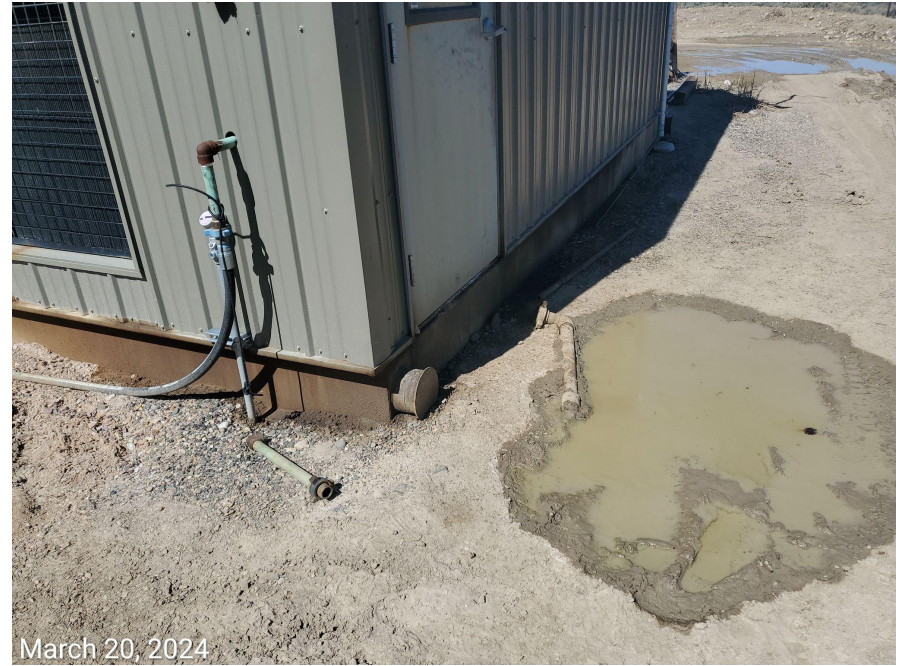
Photo 16: See comments under photo 13.

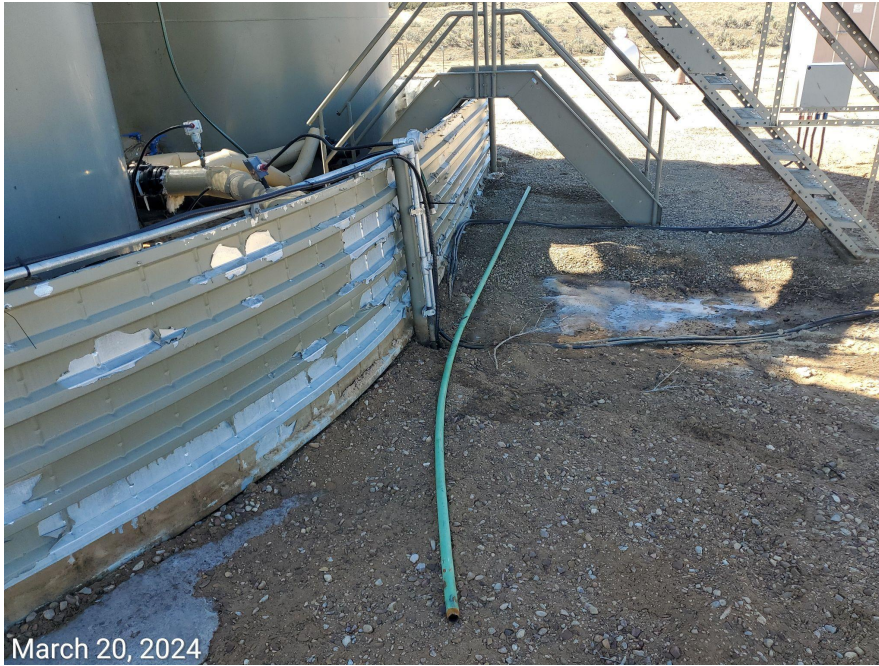
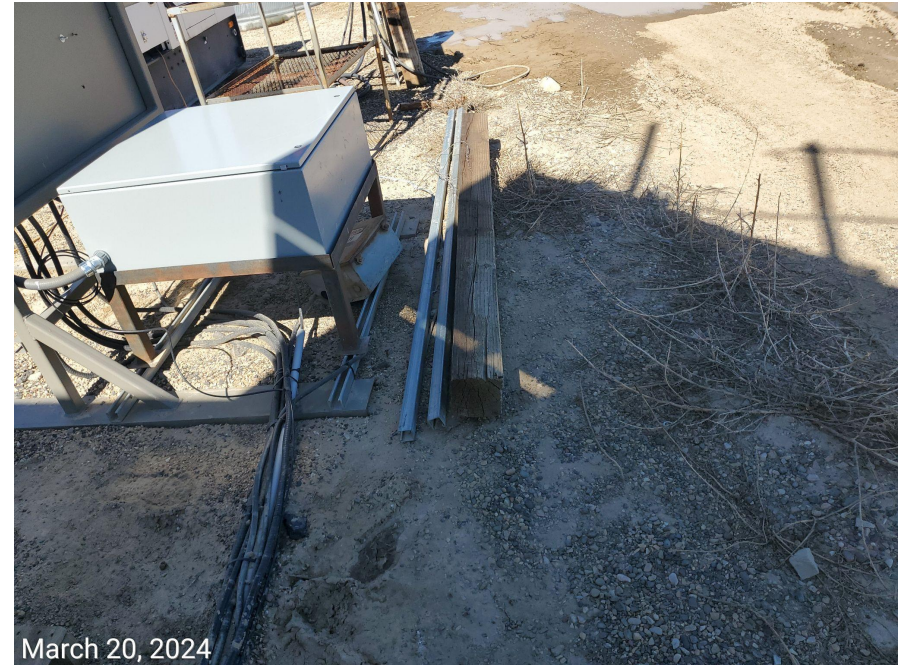
Photo 17: See comments under photo 13.

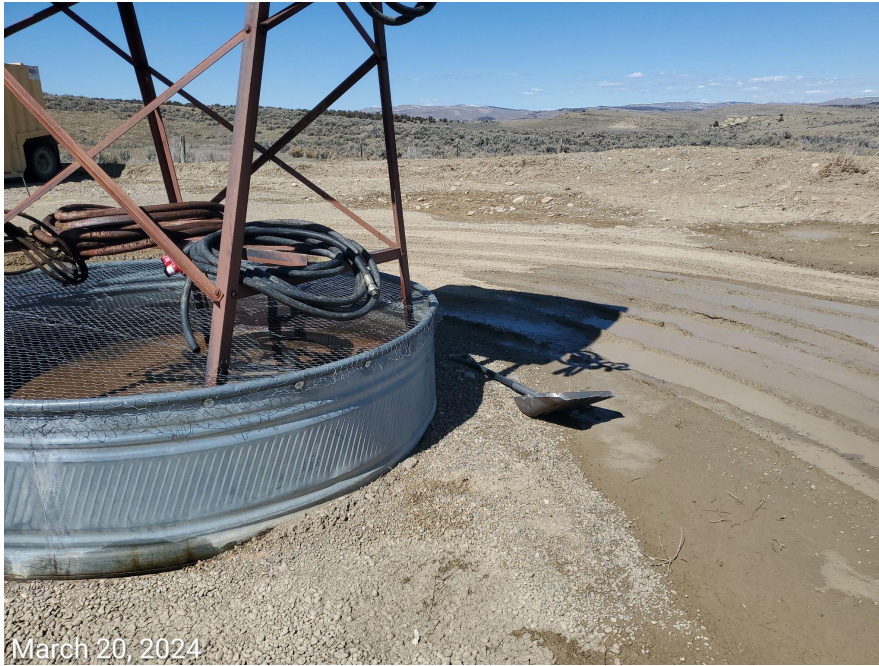
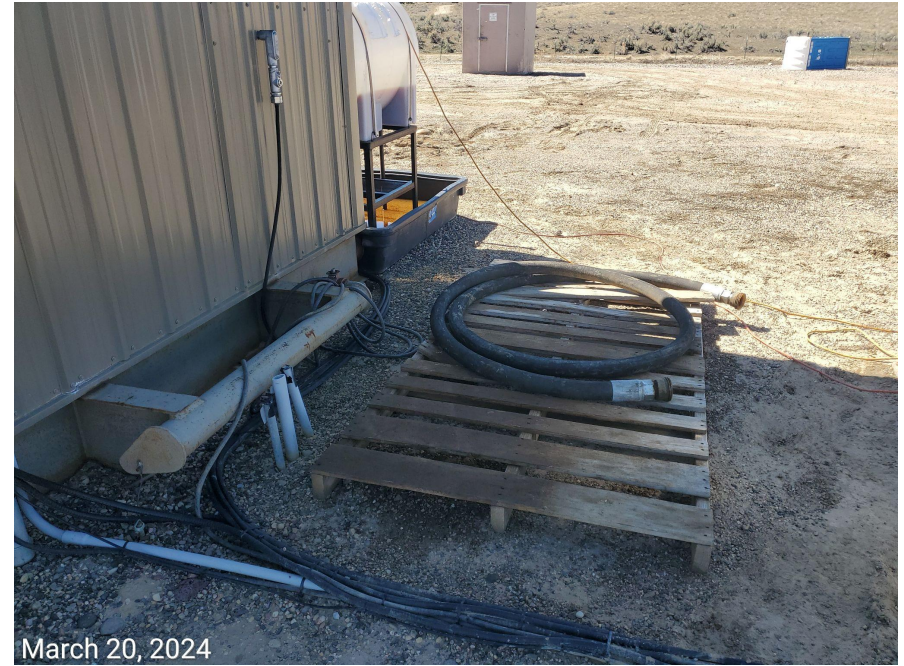
Photo 18: See comments under photo 13.
