Inspection Photos

Operator: ANSCHUTZ EXPLORATION CORP
#3104

Location ID: 315979

Inspection Doc: 696205703

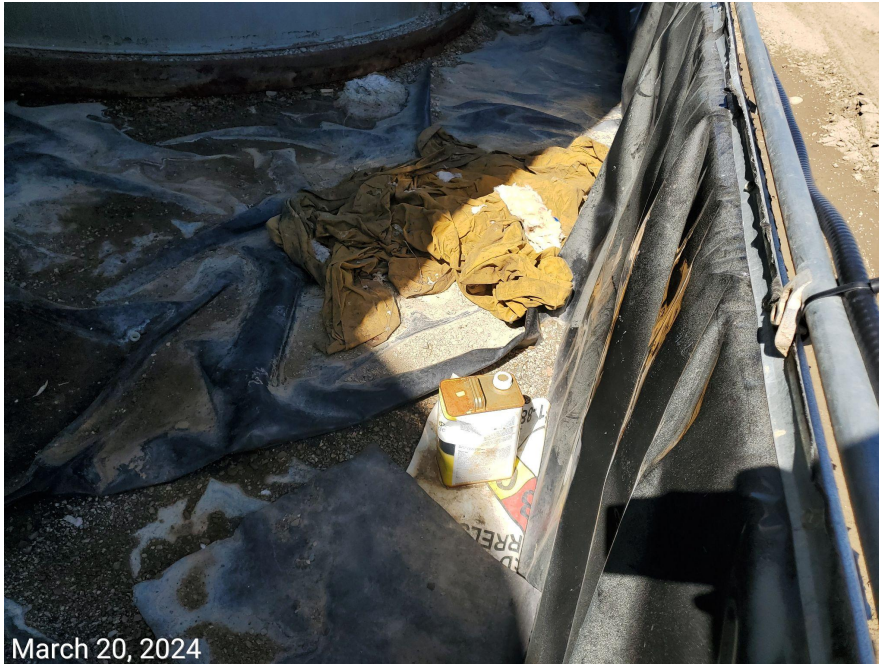
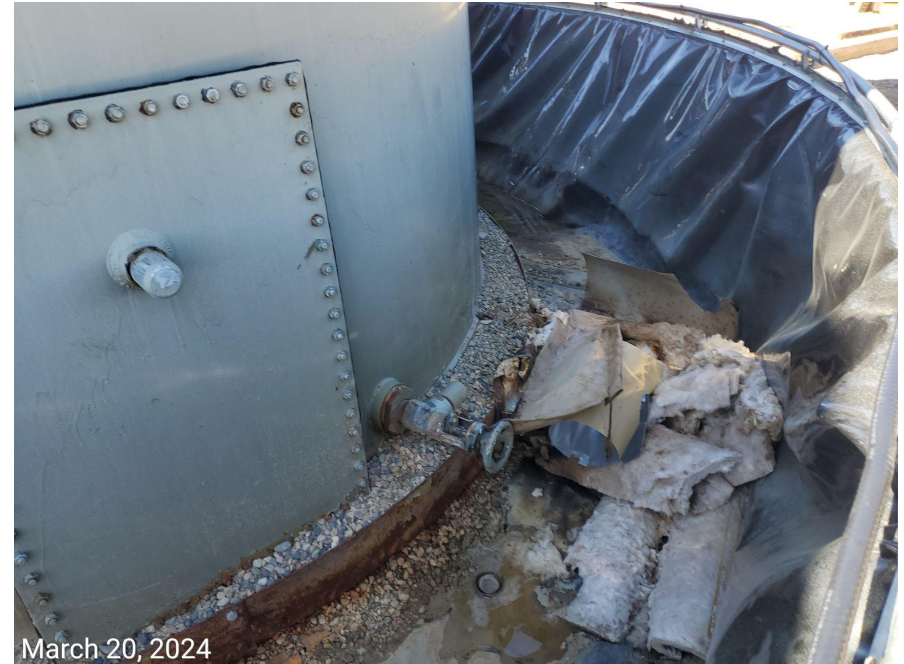
Photo 13: Photos 13-19 taken throughout the Location, including the tank battery facility. Photos are examples showing various trash, debris and/or unused equipment observed improperly stored on the Location; the storage, placement, or maintenance of equipment, vehicles, trailers, commercial products, Chemicals, drums, totes, Containers, materials, and all other supplies not necessary for use on an Oil and Gas Locations is prohibited.

Photo 19: See comments under photo 13.
