Inspection Photos

API: 017-06625

Operator: **WILLIFORD ENERGY COMPANY**

Inspection Date: 3/26/2024

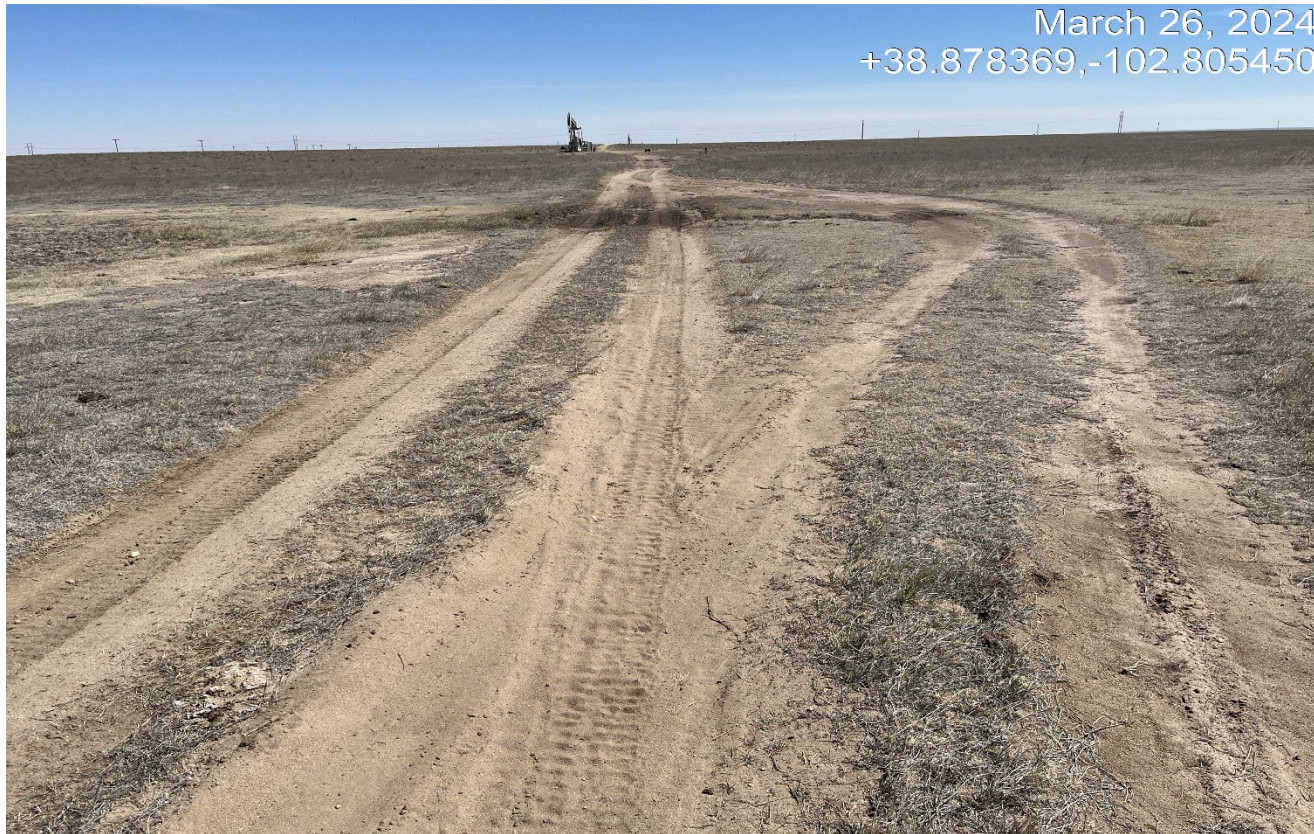
Photo 1. Facing east along the access road. Vehicles are causing unnecessary disturbance driving outside of the access road due to stormwater pooling on the road. The access road must be maintained and shall not drive outside of the access road boundary.

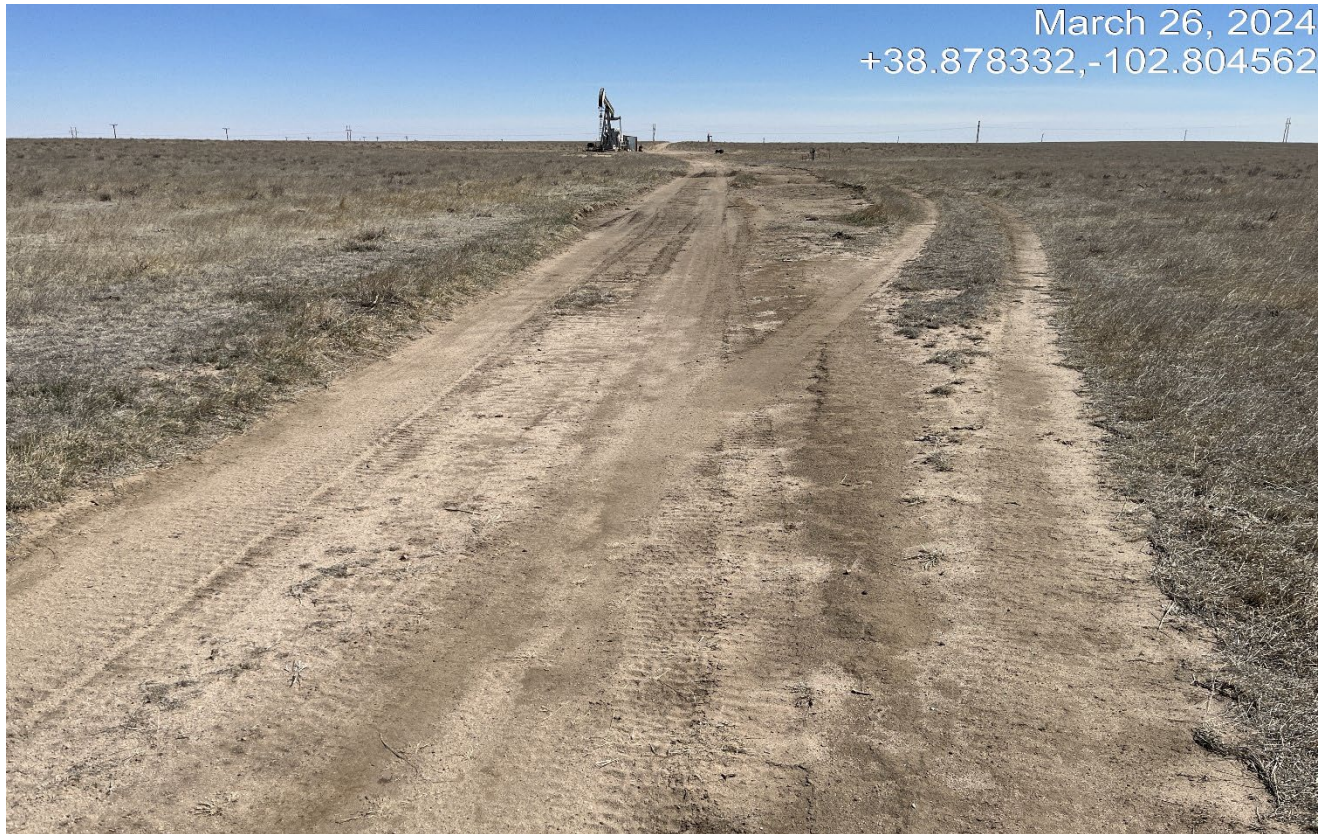
Photo 2. Facing east along the access road. Vehicles are causing unnecessary disturbance driving outside of the access road due to stormwater pooling on the road. The access road must be maintained and shall not drive outside of the access road boundary.

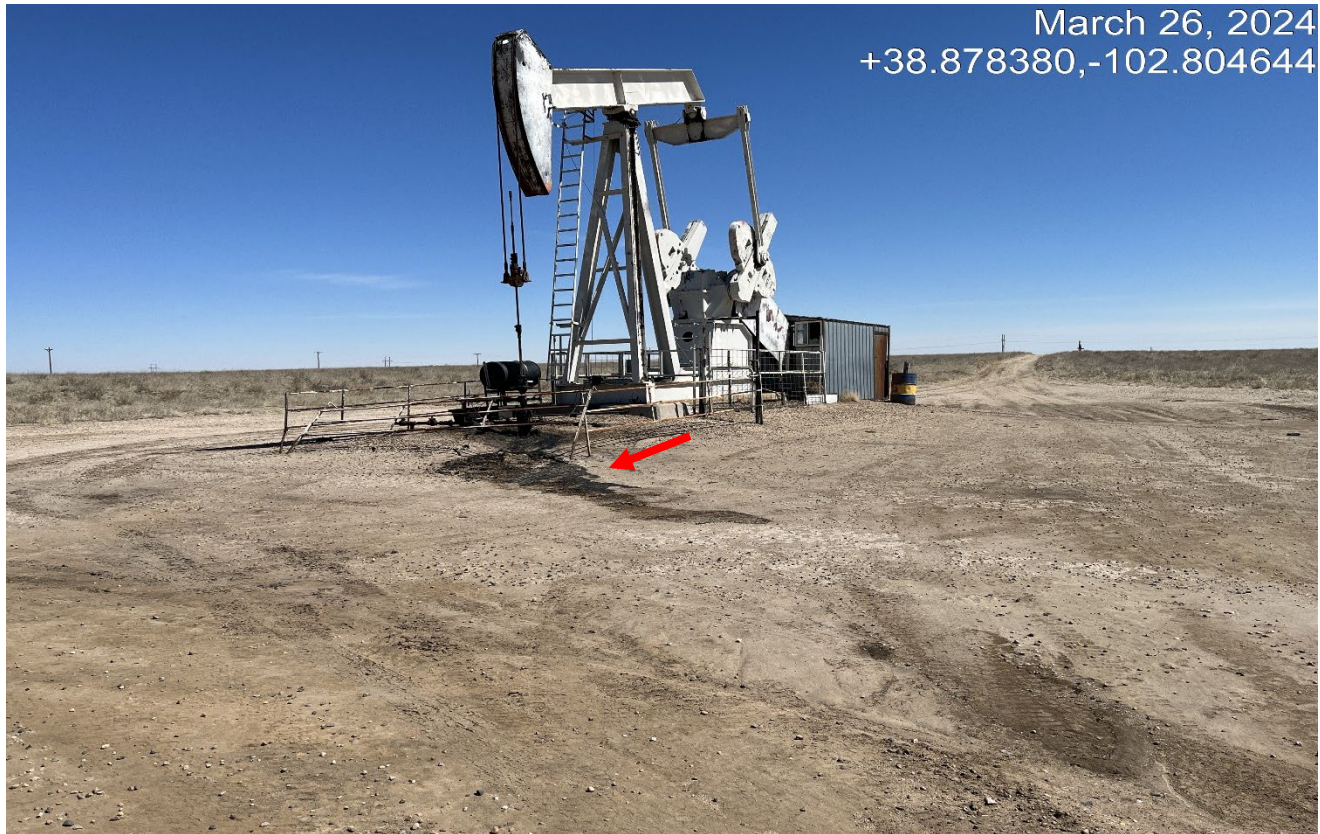
Photo 3. Facing northeast toward the wellsite. There is oil leaking out of the wellhead that must be controlled and cleaned up.

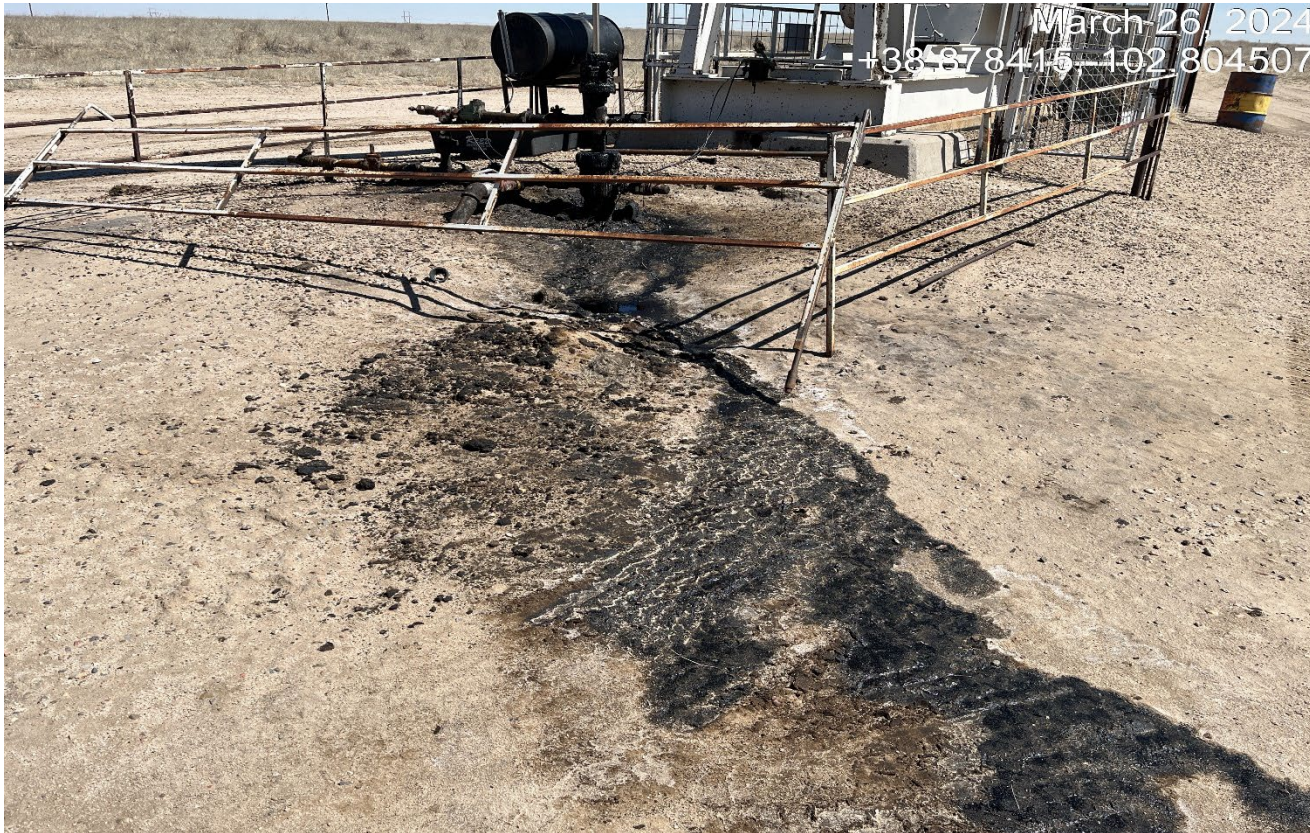
Photo 4. View of oil that has leaked out of the well.

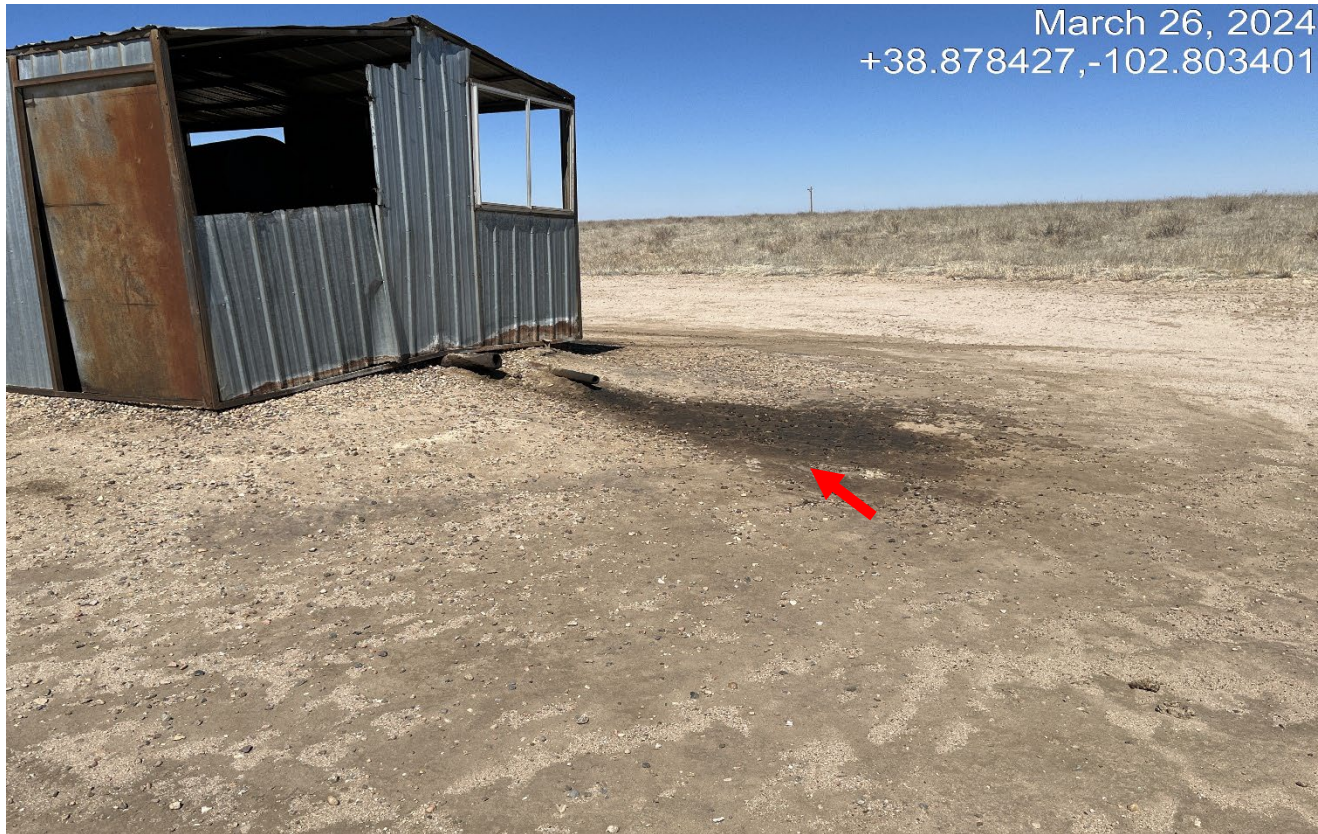
Photo 5. There is oil coming out of the exhaust pipe which is staining the soil and needs to be cleaned up.

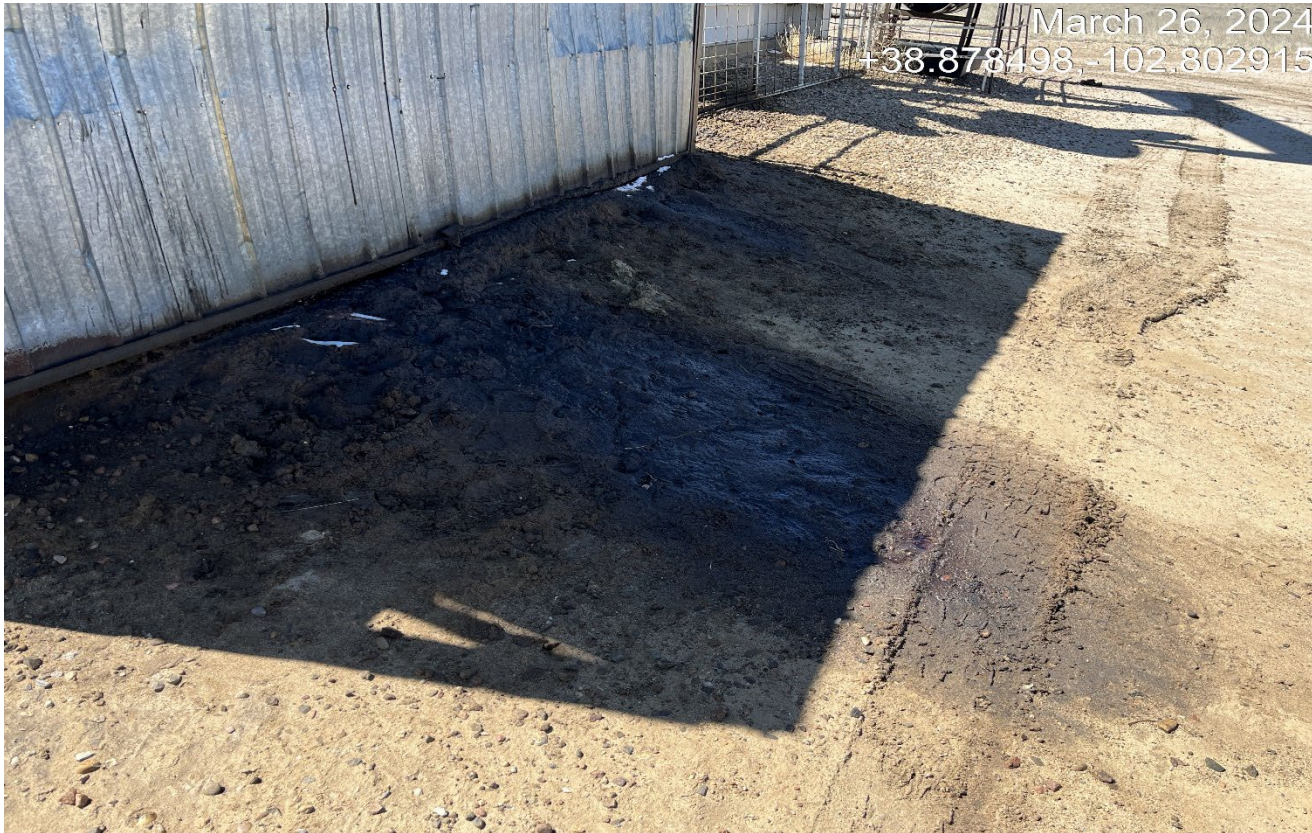
Photo 6. There is lube oil leaking out of the pumpjack engine that must be controlled and cleaned up.

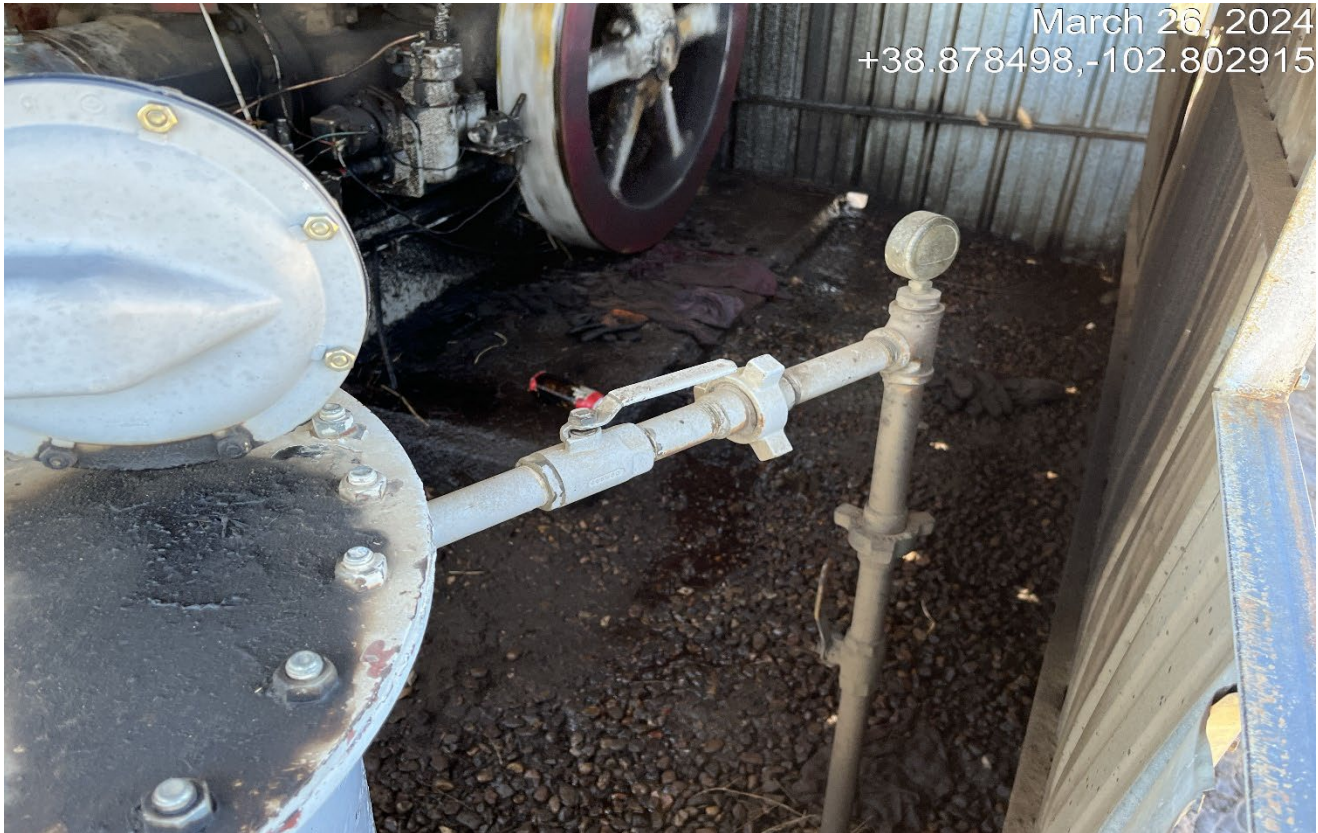
Photo 7. View of inside the shed where oil is leaking out of the pumpjack engine.

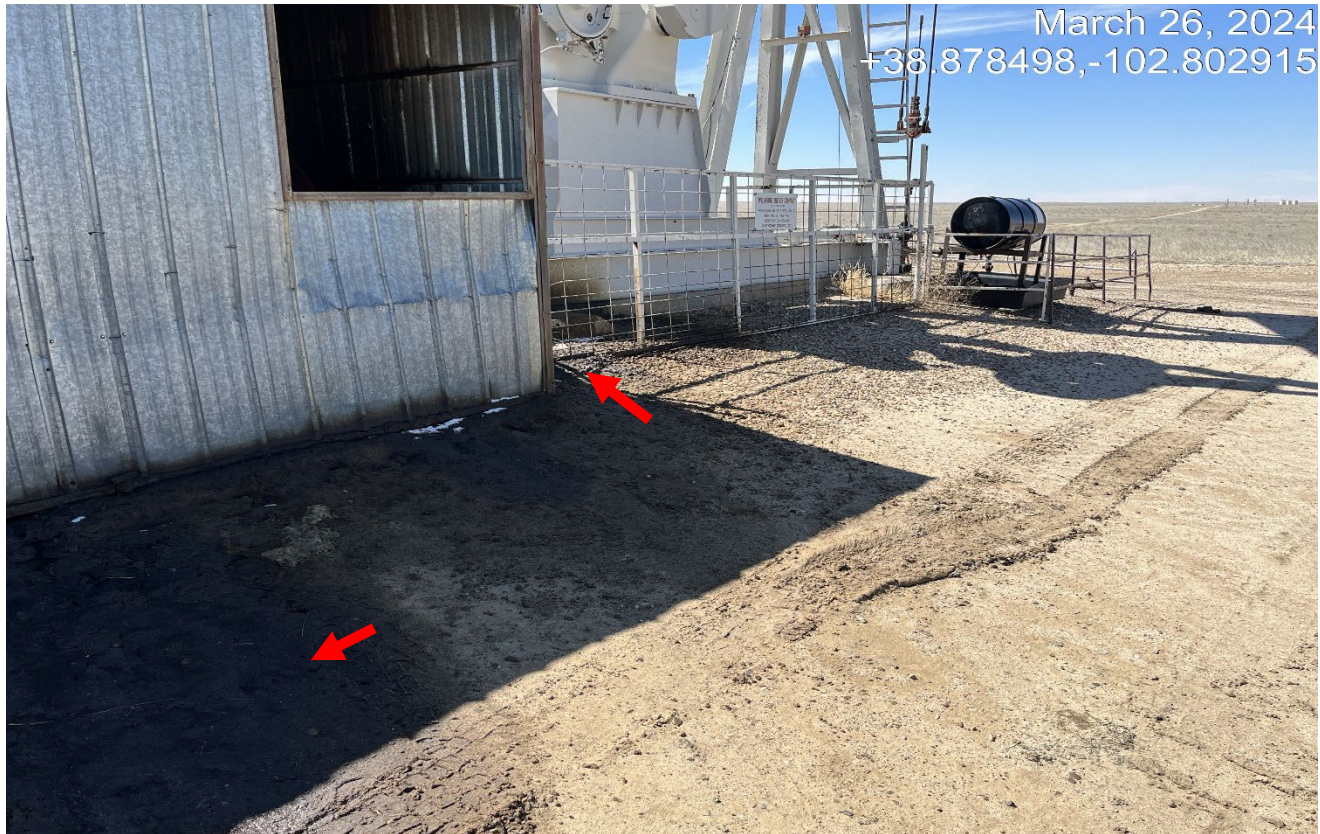
Photo 8. The red arrows point to oily impacted soils coming from the pumpjack.
