Interim Reclamation and Stormwater Inspection

Operator: PDC ENERGY INC - 69175

Location ID: 322843

Inspection Document #: 708201008

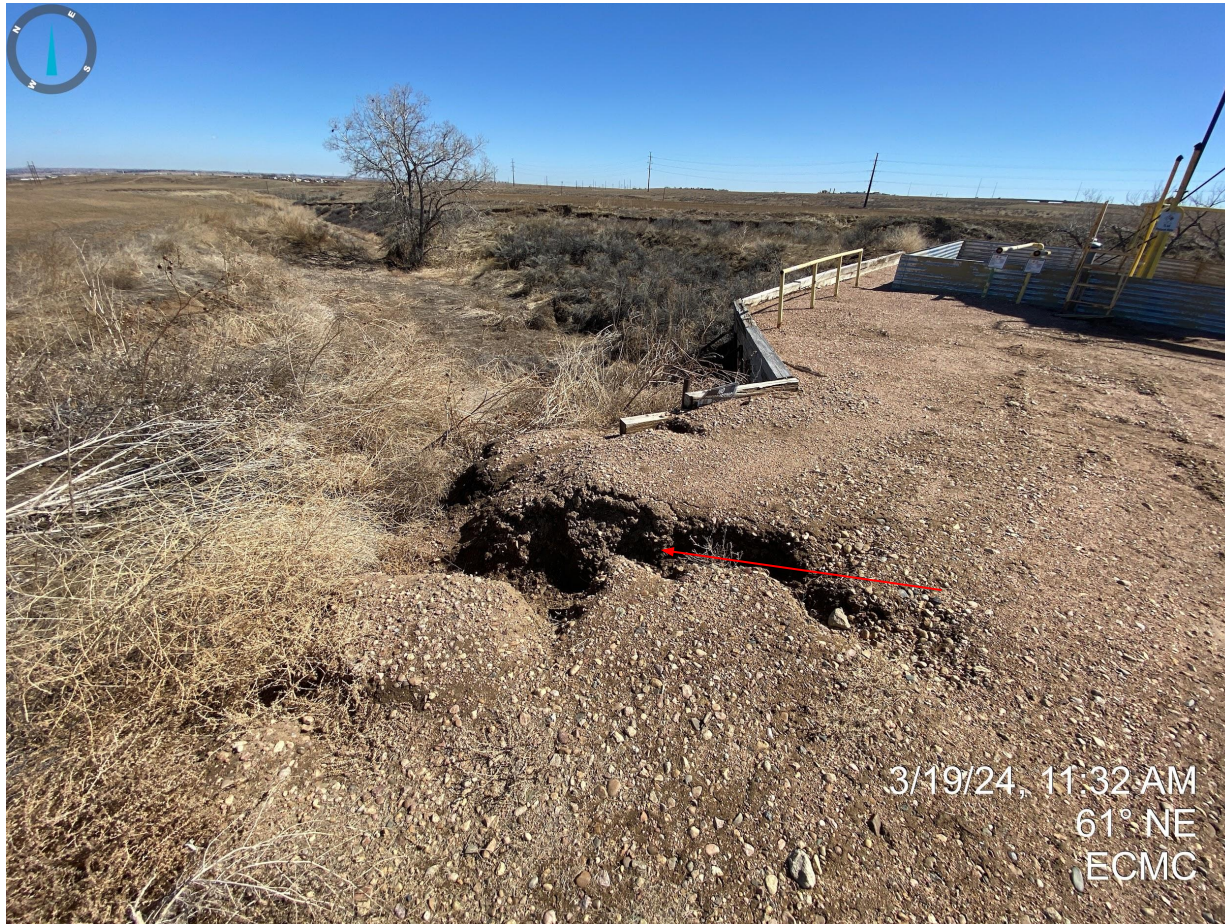
Photo 1. Taken from the northern end of the location. Erosion degradation evident and no stormwater controls measures observed during this inspection.

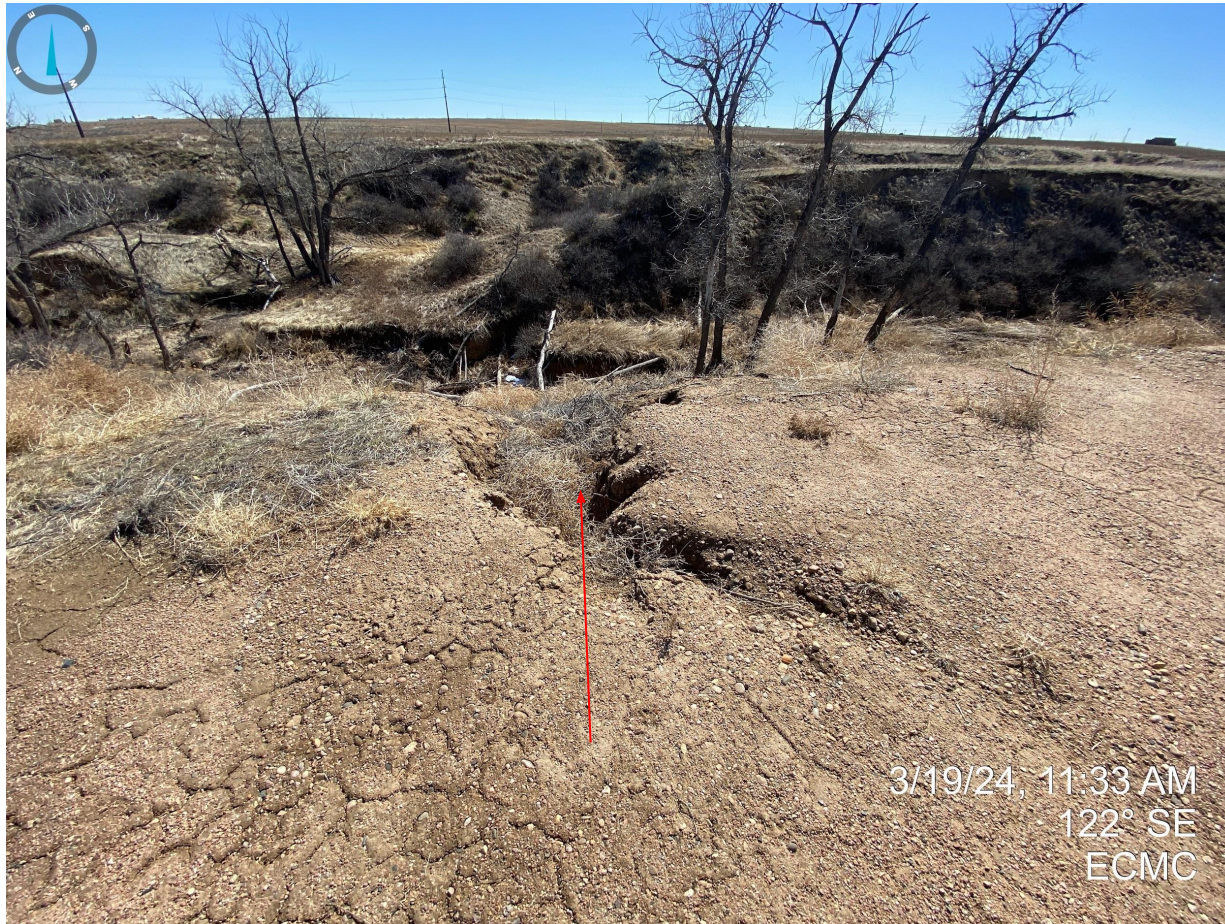
Photo 2. Taken from the eastern end of the location. Erosion degradation evident and no stormwater controls measures observed during this inspection.

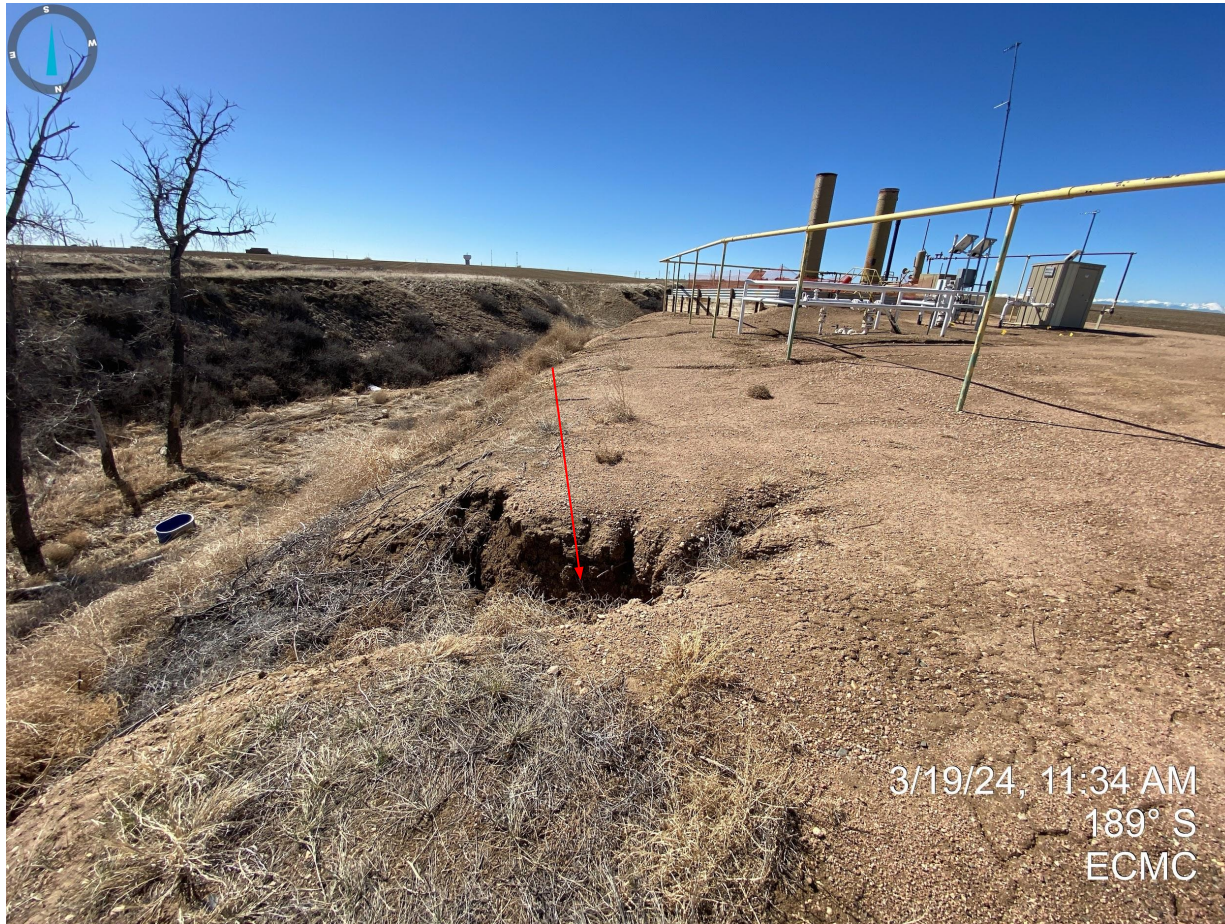
Photo 3. Continued from Photo 2, facing south.

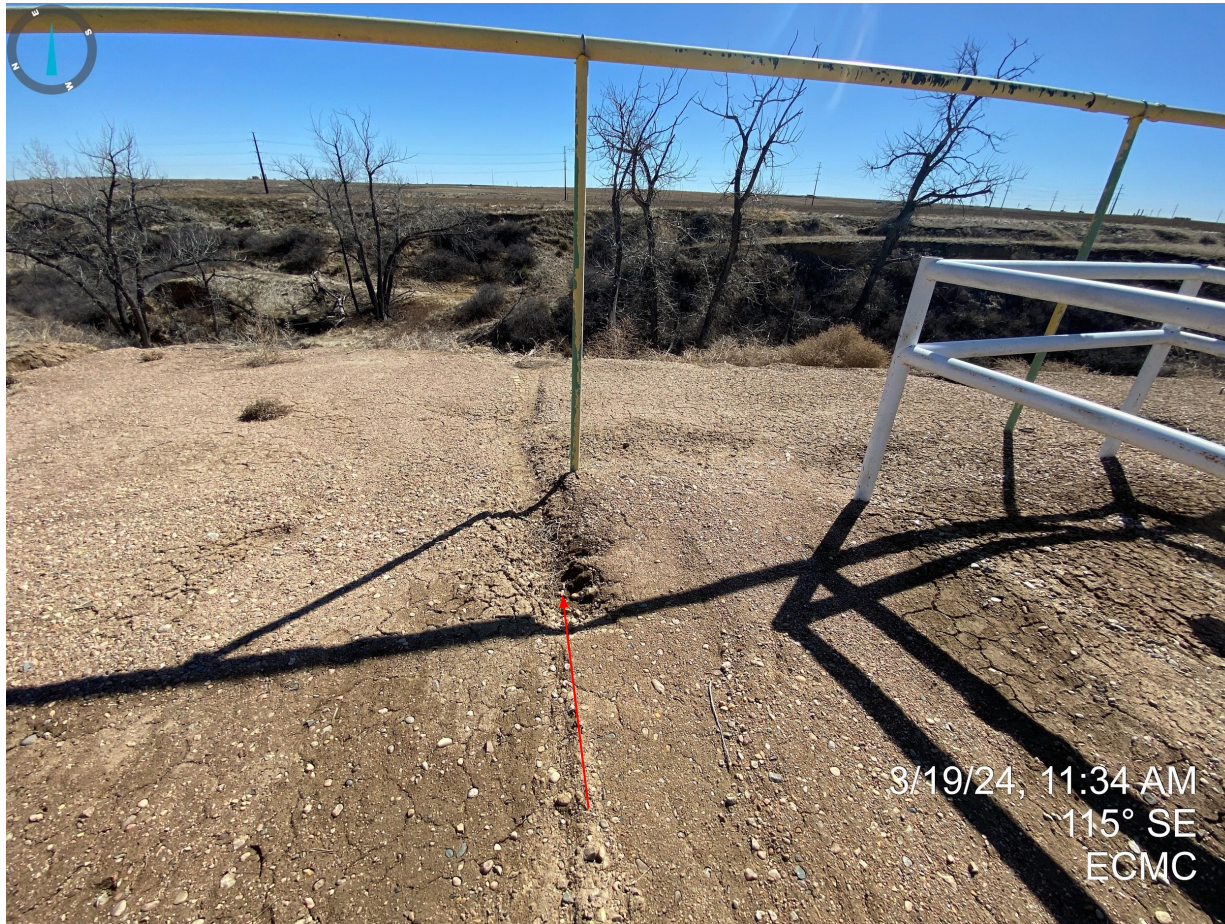
Photo 4. Taken from the eastern end of the location. Erosion degradation evident and no stormwater controls measures observed during this inspection.

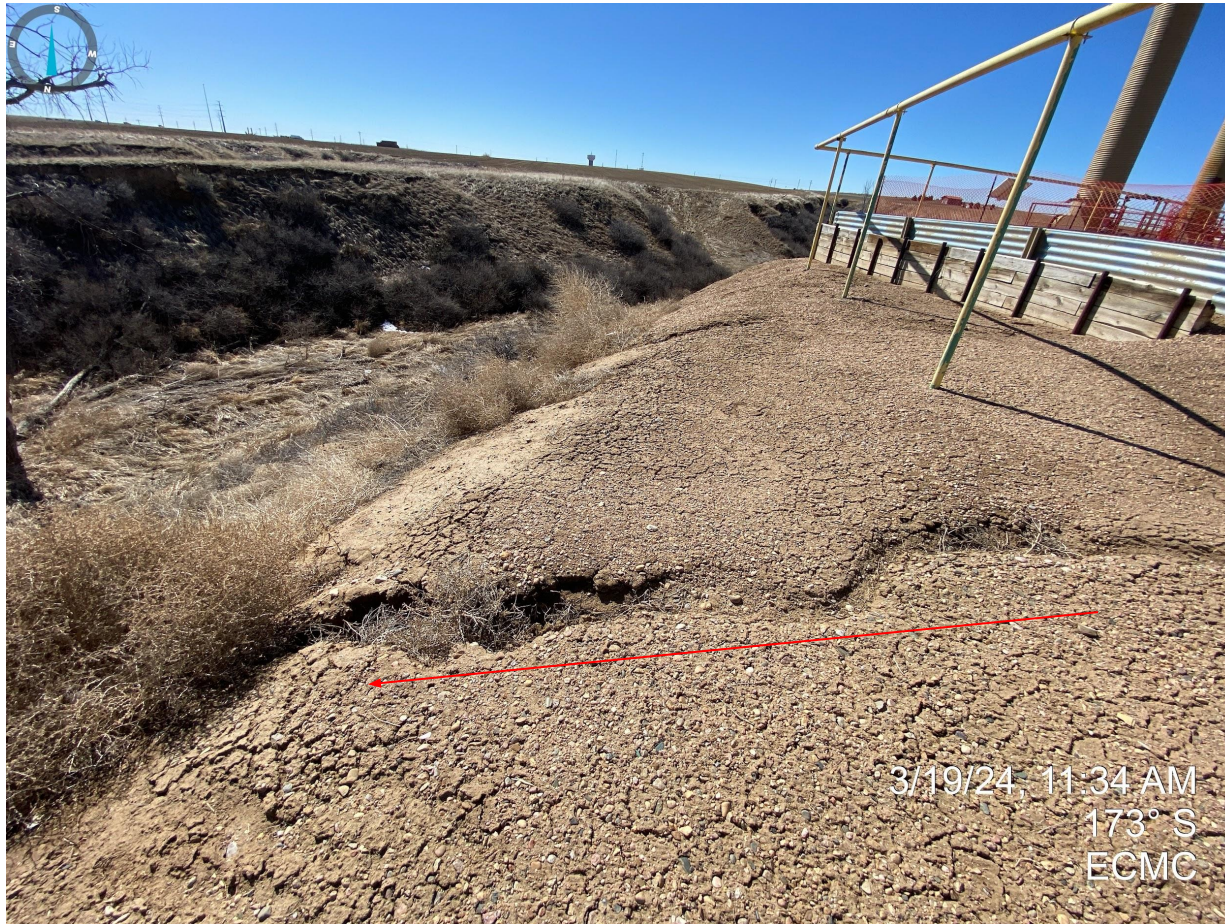
Photo 5. Continued from Photo 4, facing south.

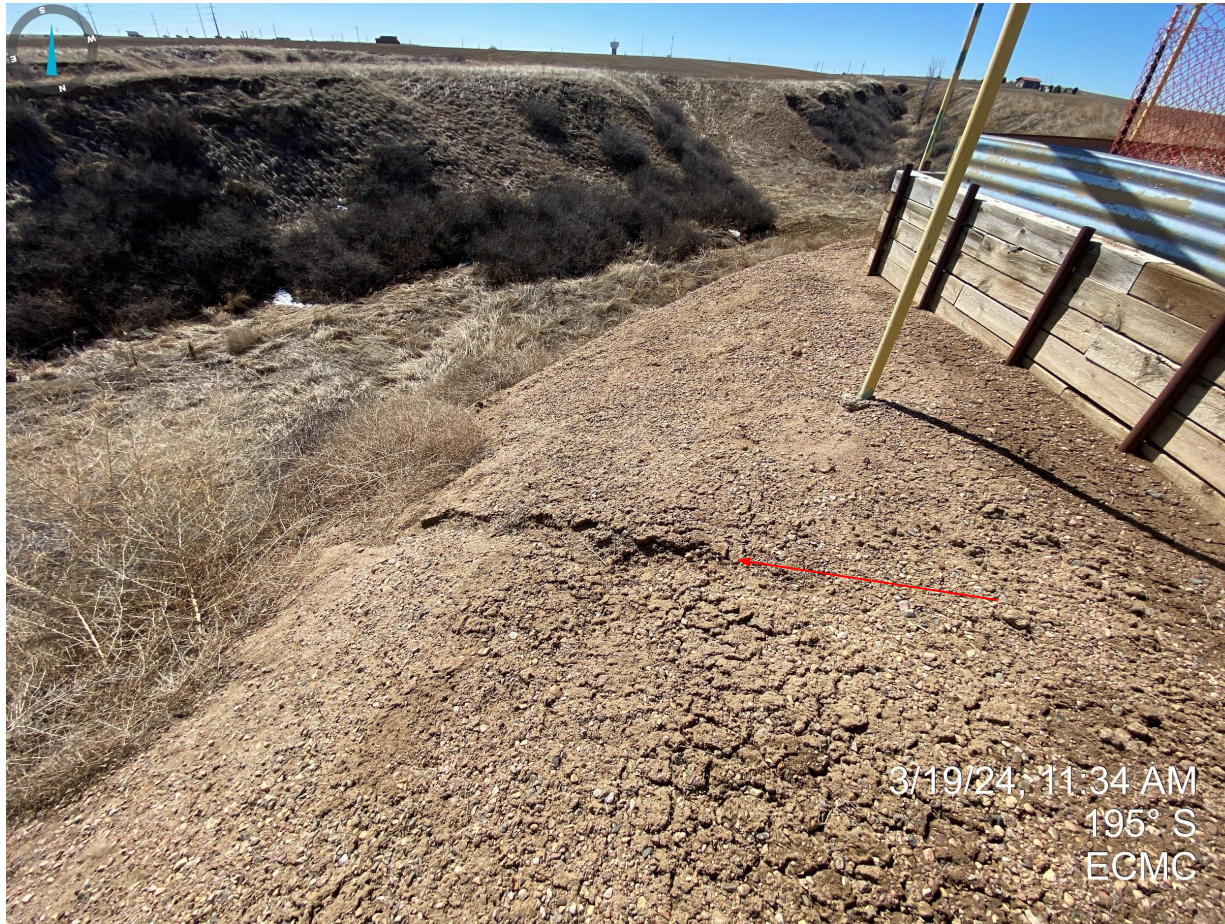
Photo 6. Taken near the southeast end of the location. Erosion degradation evident and no stormwater controls measures observed during this inspection.

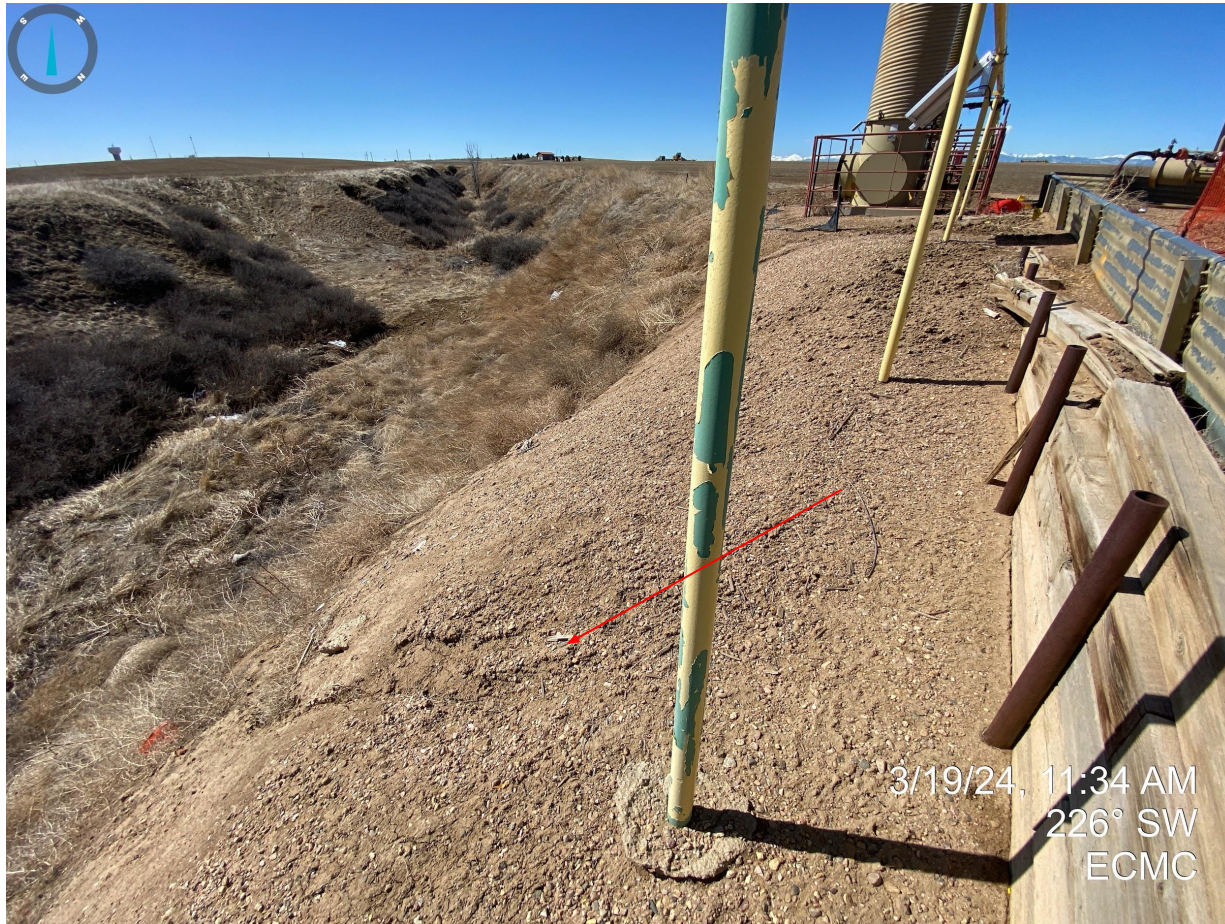
Photo 7. Taken near the southeastern corner of the location. Erosion degradation evident and no stormwater controls measures observed during this inspection.

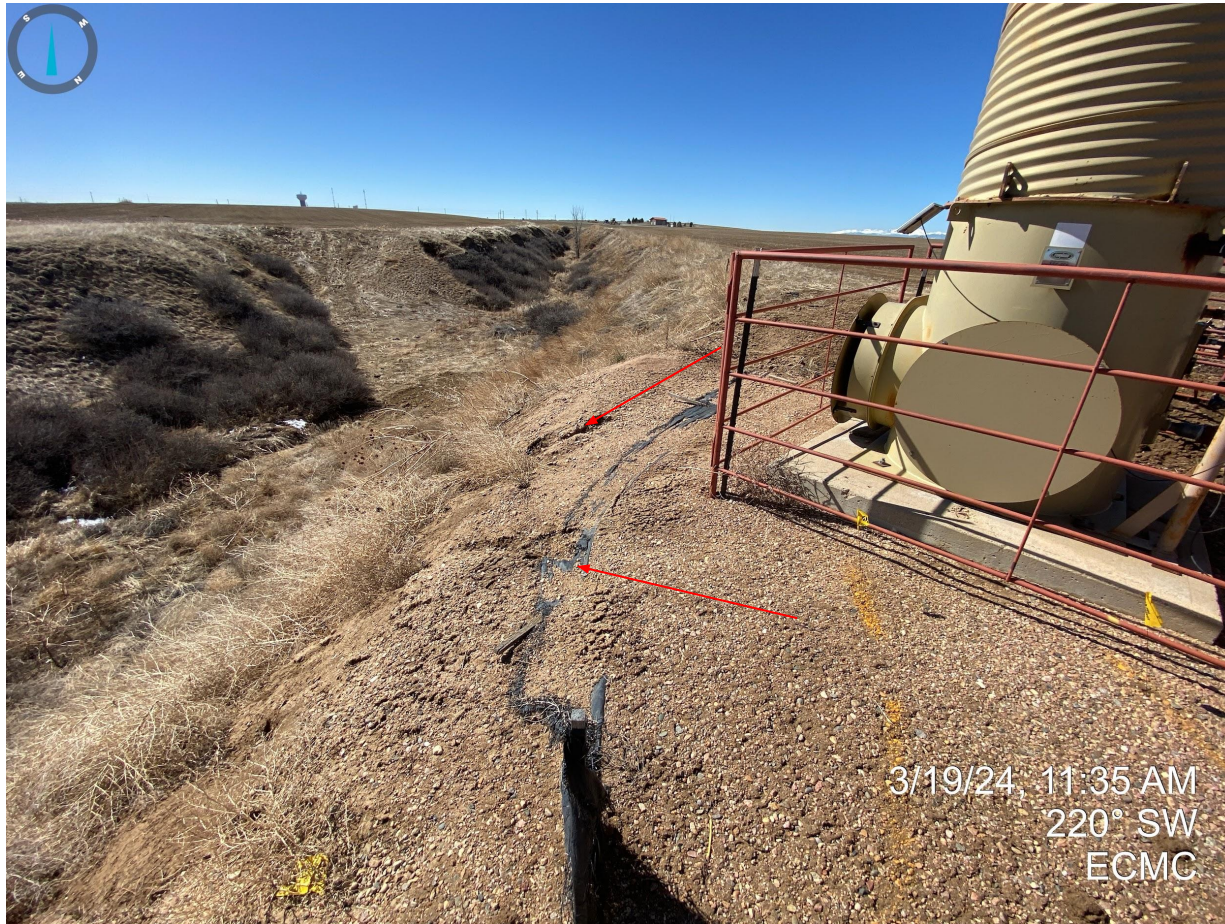
Photo 8. Taken from the vertical heater treater on the southern end of the location. Erosion degradation evident and no stormwater controls measures observed during this inspection.

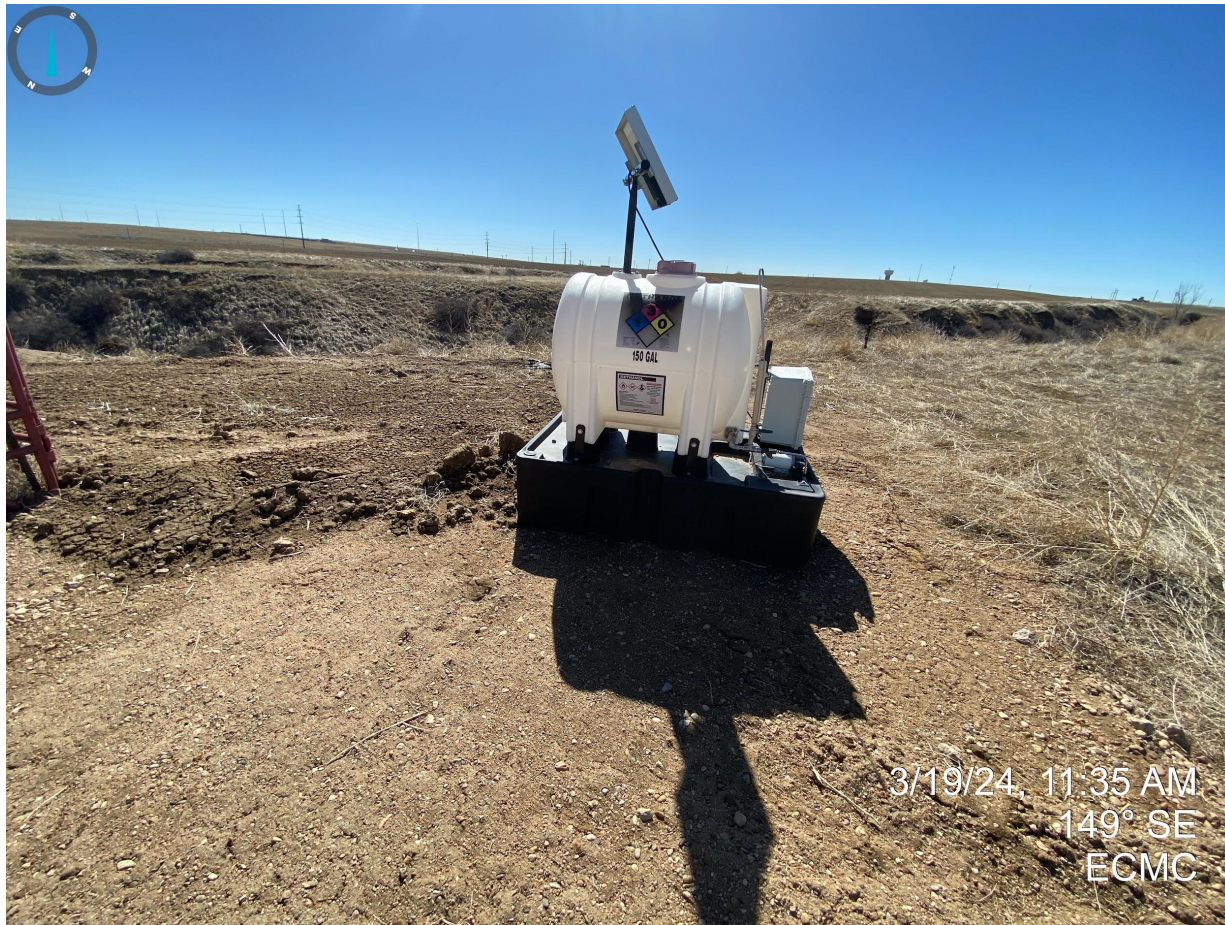
Photo 9. Unused equipment (day tank) observed on the southern end of the location. Day tank did not appear to be in use at the time of this inspection.

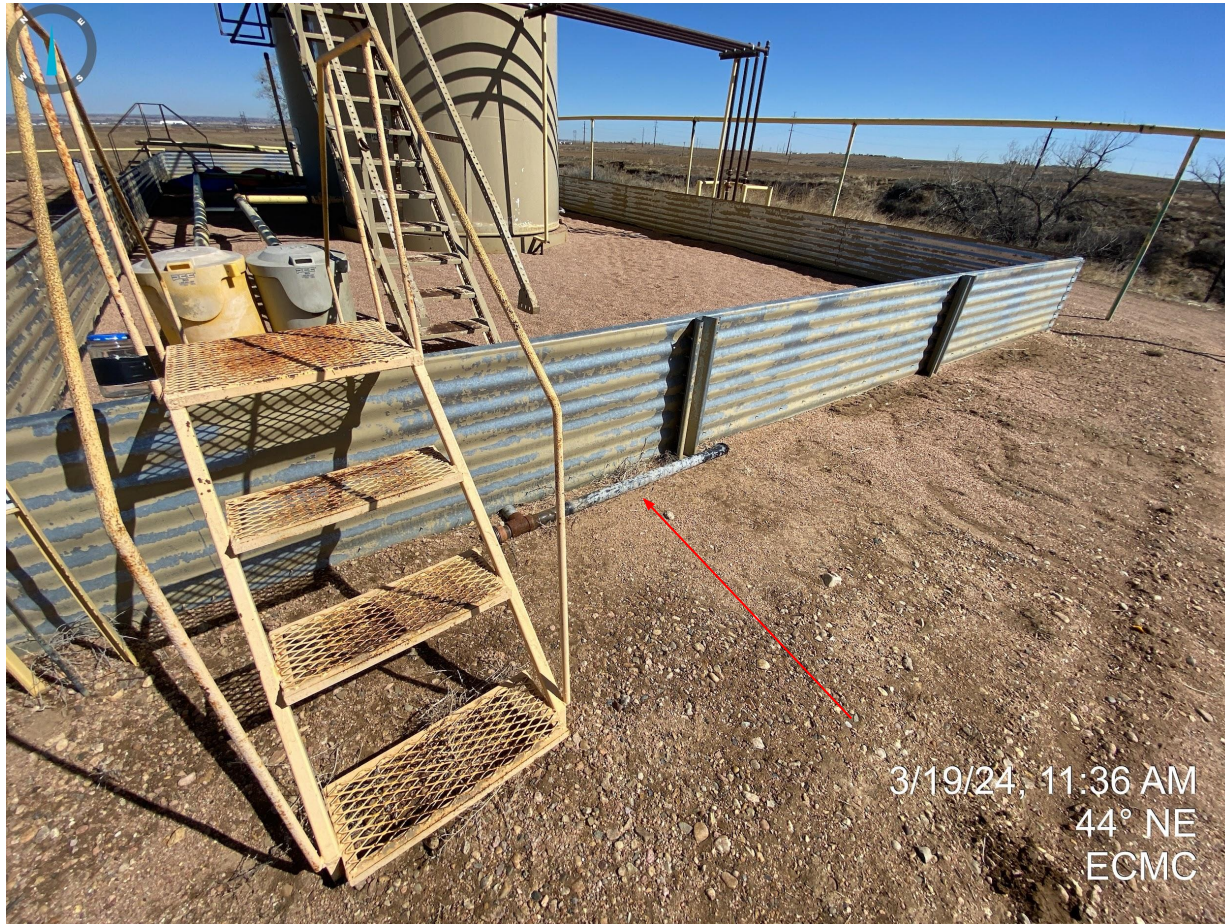
Photo 10. Unused equipment at tank battery secondary containment.

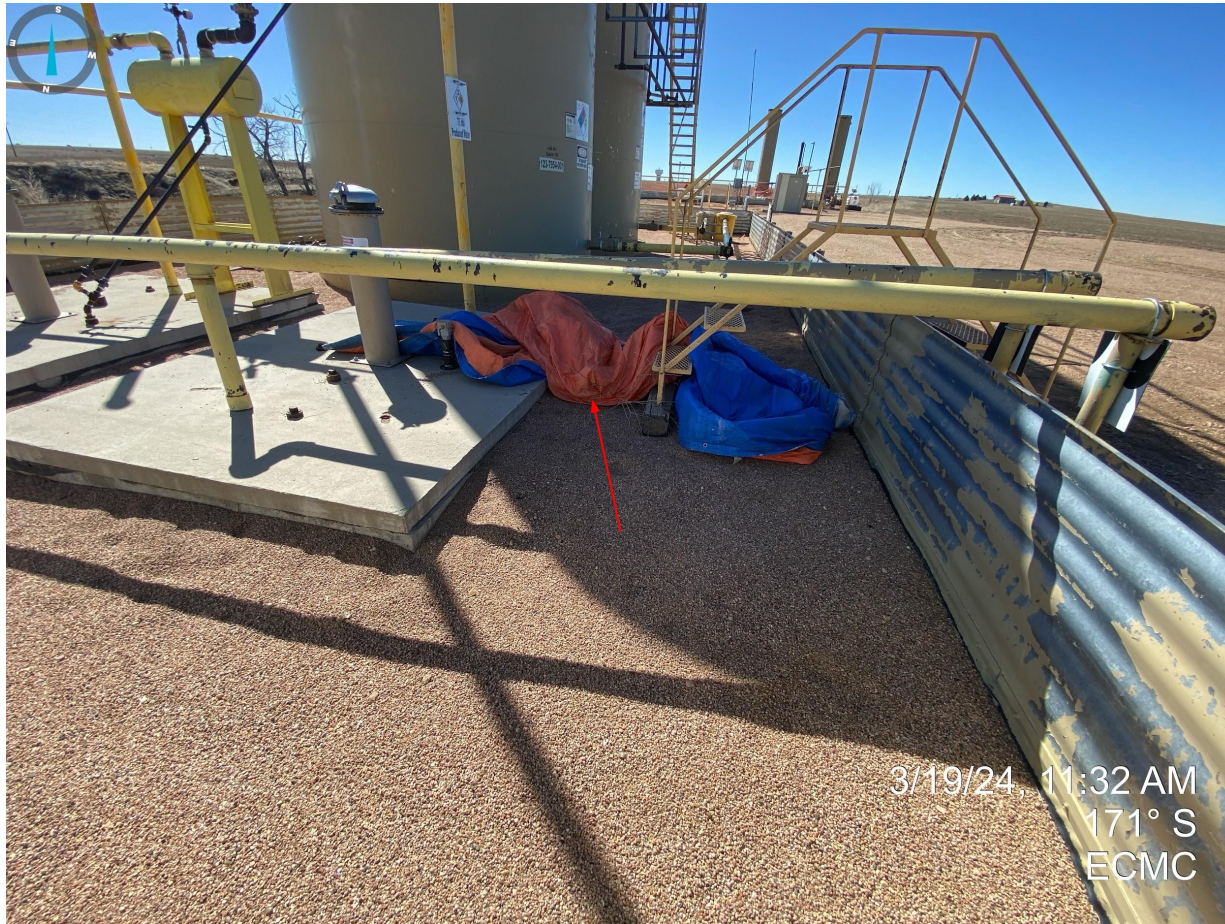
Photo 11. Unused equipment within tank battery secondary containment.

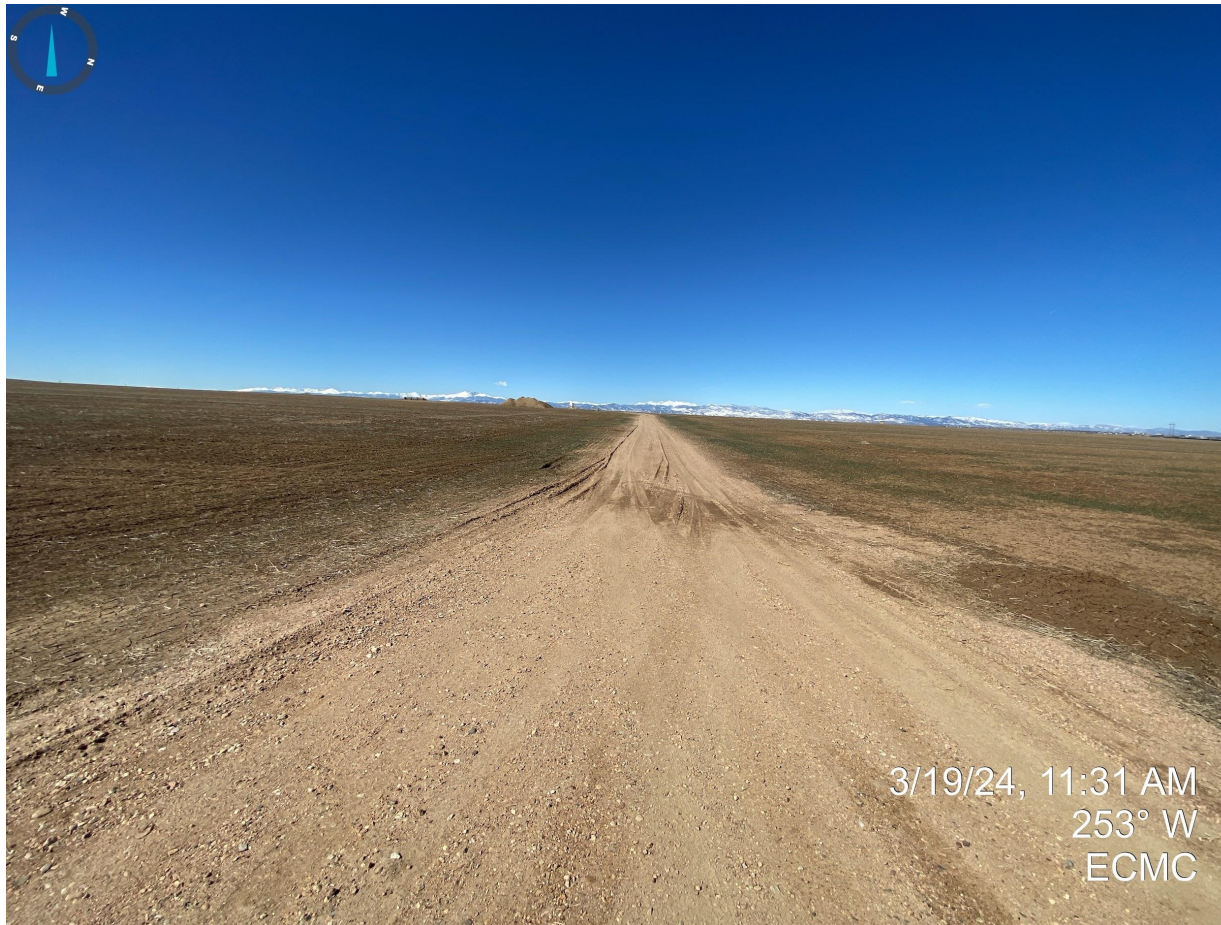
Photo 12. Taken from the access road/location, facing west. Interim reclamation activities appear to have been performed; a follow-up inspection will be conducted during the active growing season to verify vegetative compliance with Rule 1003.
