Storm Water Management and Erosion control
Location Name: TEP Rocky Mountain LLC SAVAGE RMV 48-35 Pad
Location # 334873

**Location Overview: Location is within High
Priority/Density/Black Bear Habitat areas.**
Section/Township/Range: 35 6S94W

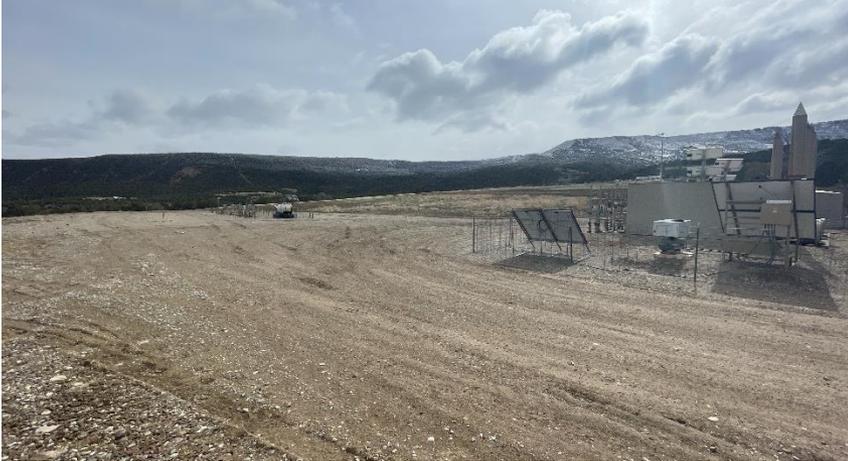
North West corner of location.

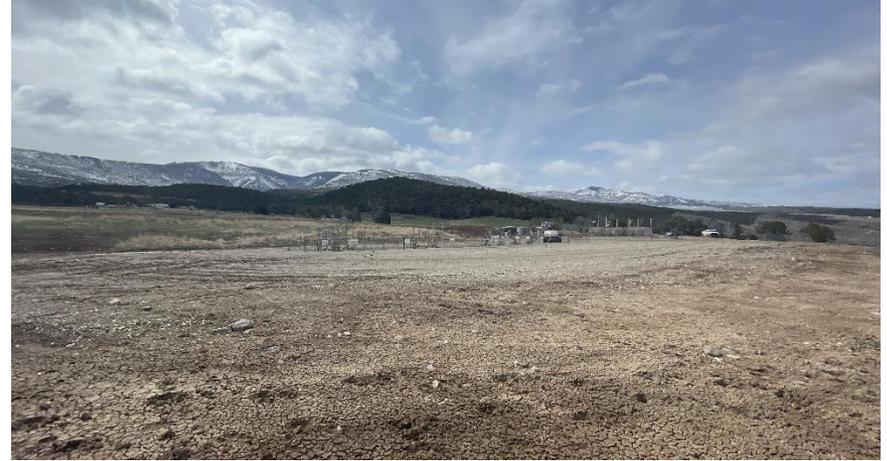
North East corner of location.

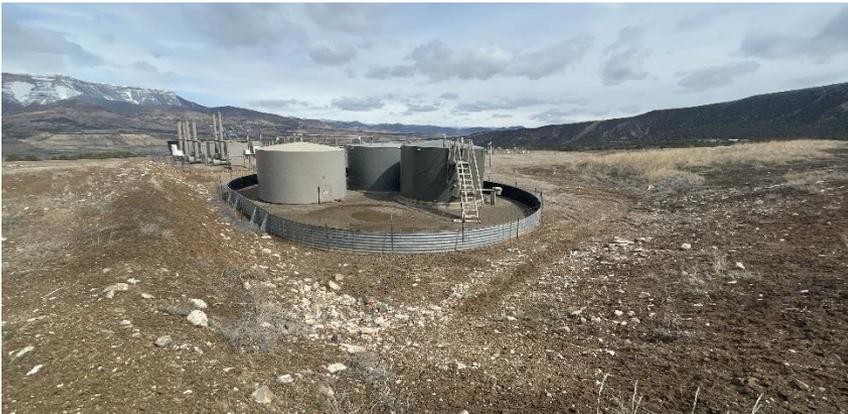
South West corner of location.

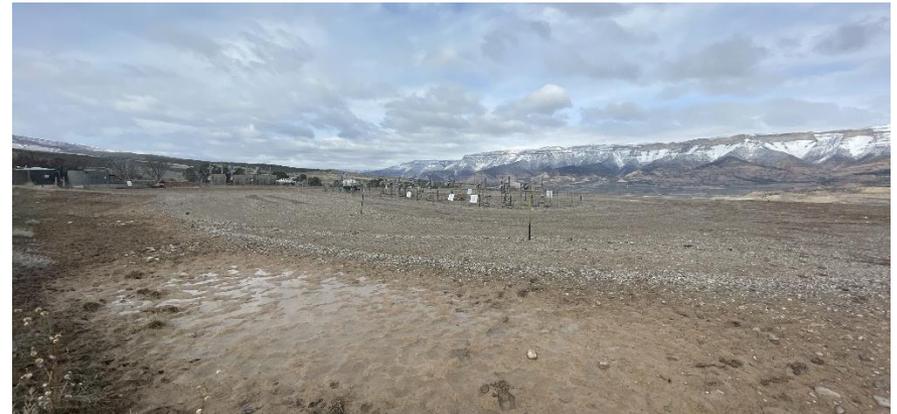
South East corner of location.

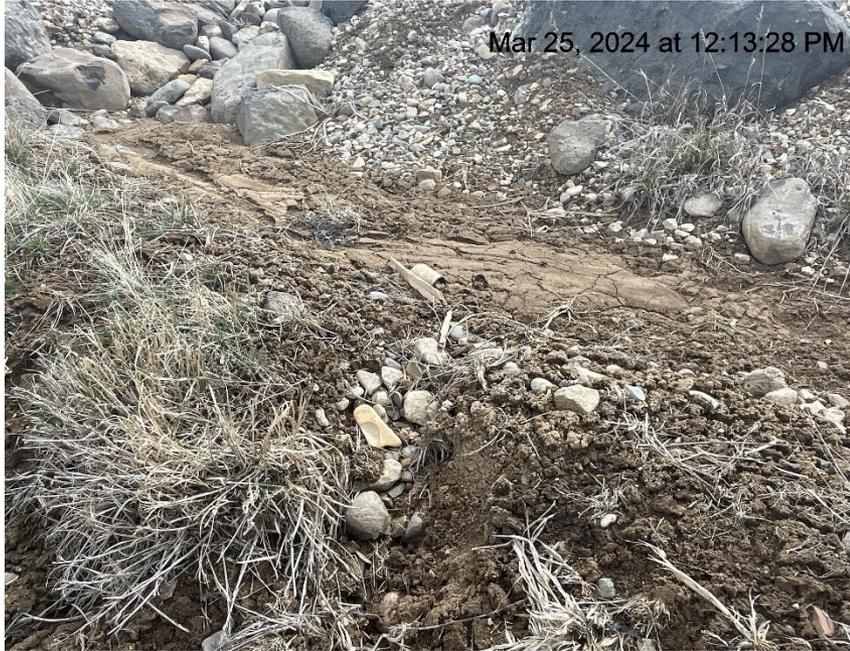
Photo # 1271 Ditch/BMP near entrance to location needs maintenance/sediment buildup & small breach in ditch allowing sediment transport from ditch into the interim area & causing more erosion & sediment transport in the interim area itself.

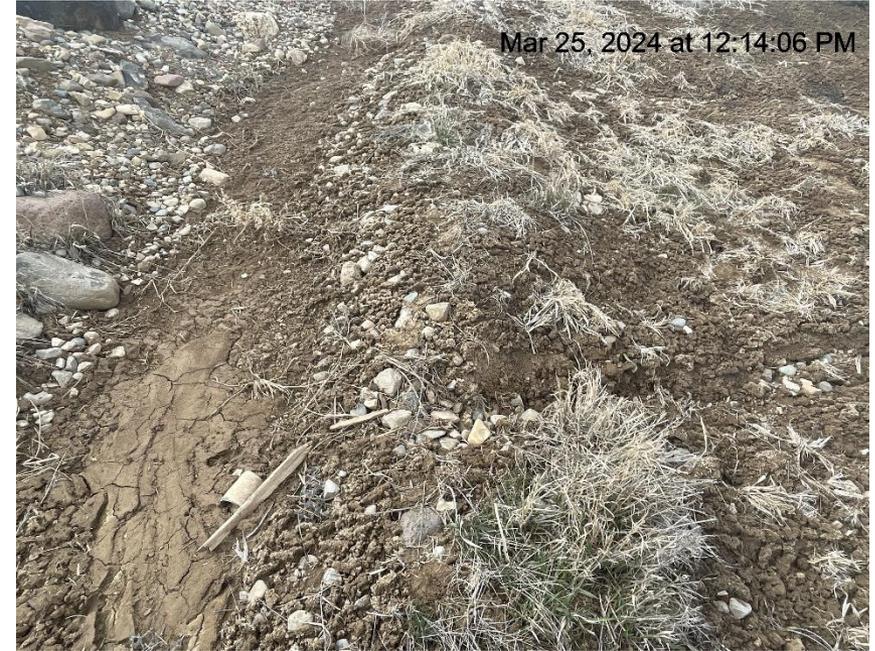
Photo # 1272 Ditch/BMP near entrance to location needs maintenance/sediment buildup & small breach in ditch allowing sediment transport from ditch into the interim area & causing more erosion & sediment transport in the interim area itself.

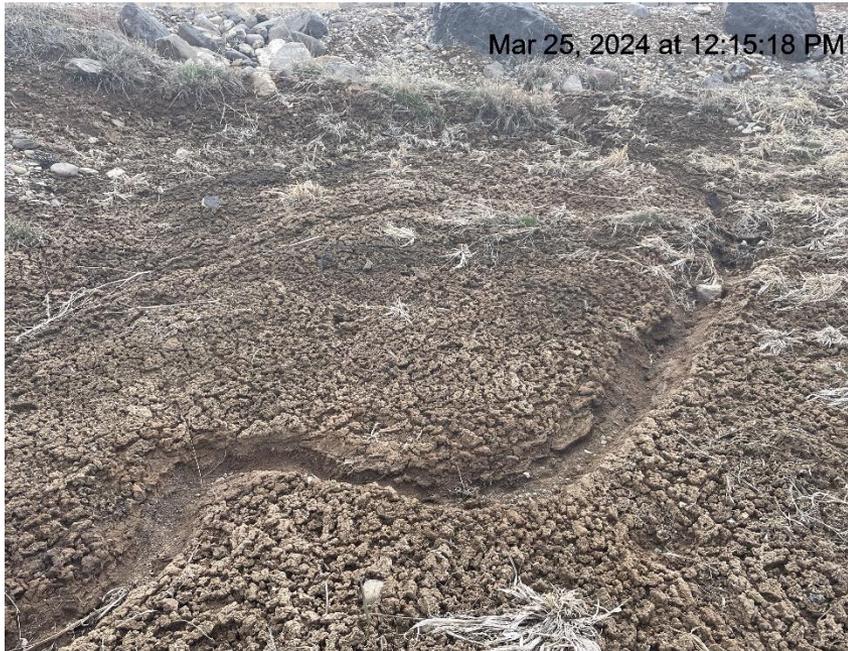
Photo # 1273 Ditch/BMP near entrance to location needs maintenance/small breach in ditch allowing sediment transport from ditch into the interim area & causing more erosion & sediment transport in the interim area itself.

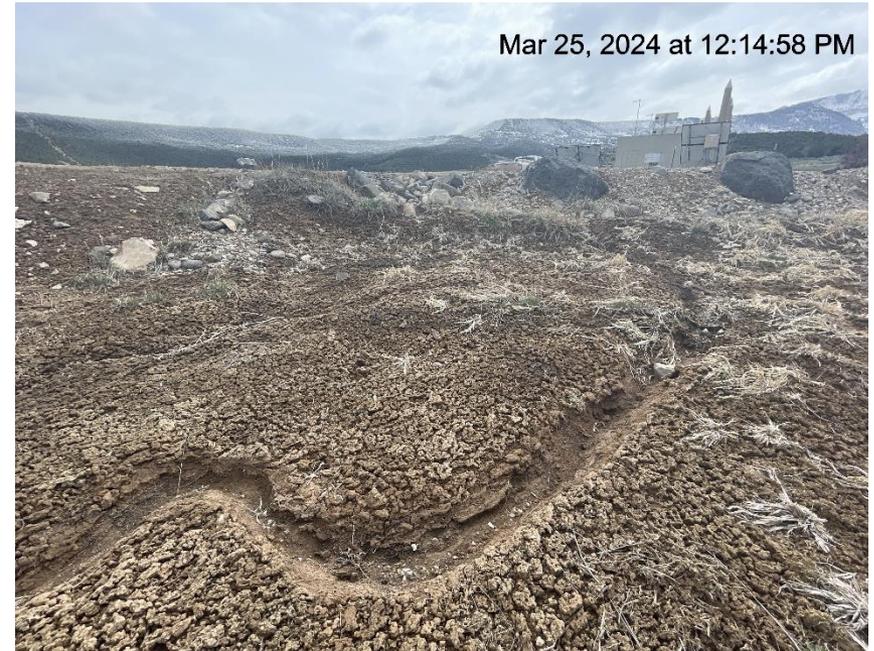
Photo # 1274 Ditch/BMP near entrance to location needs maintenance/small breach in ditch allowing sediment transport from ditch into the interim area & causing more erosion & sediment transport in the interim area itself.

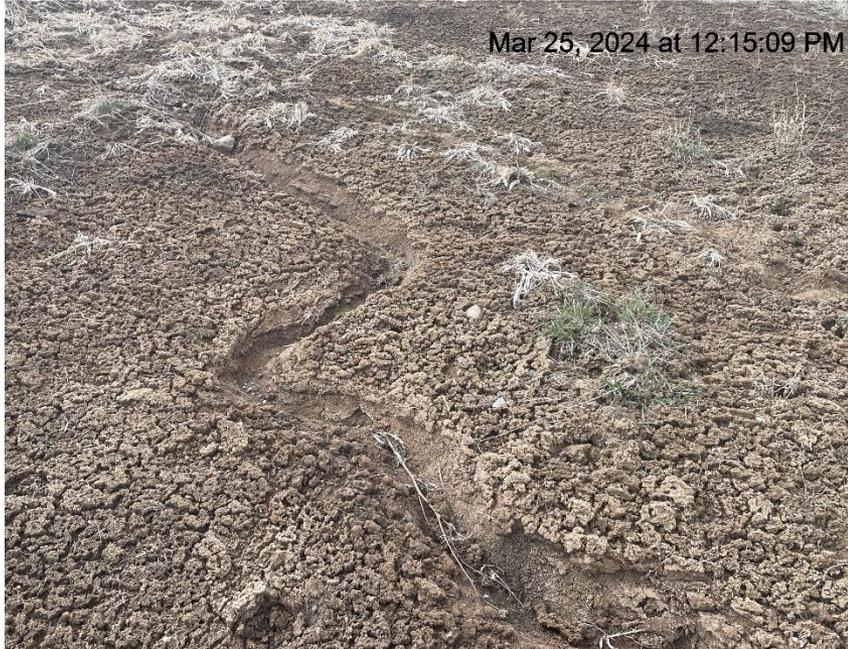
Photo # 1275 Ditch/BMP near entrance to location needs maintenance/small breach in ditch allowing sediment transport from ditch into the interim area & causing more erosion & sediment transport in the interim area itself.

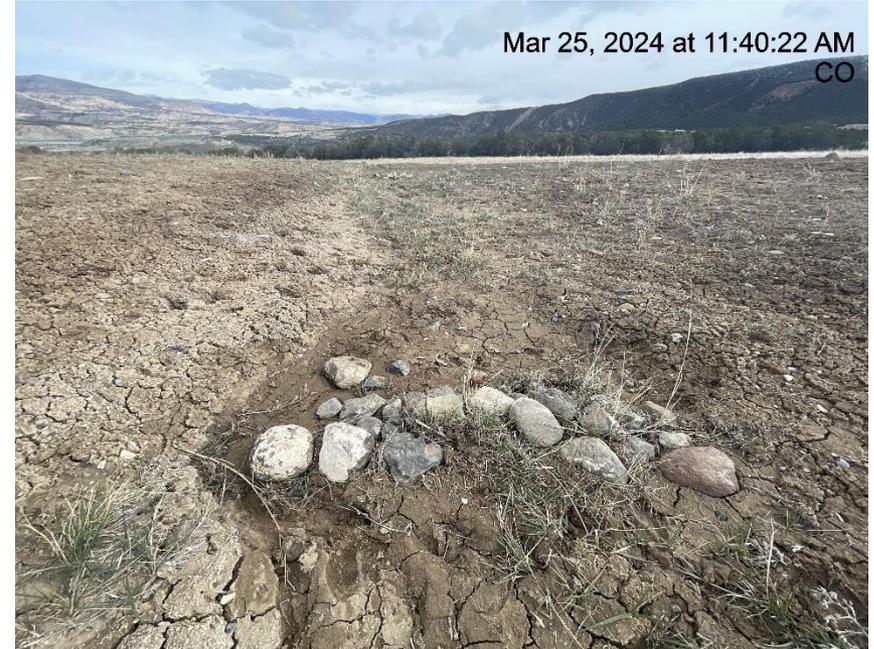
Photo # 1276 Check dam/BMP needs maintenance.

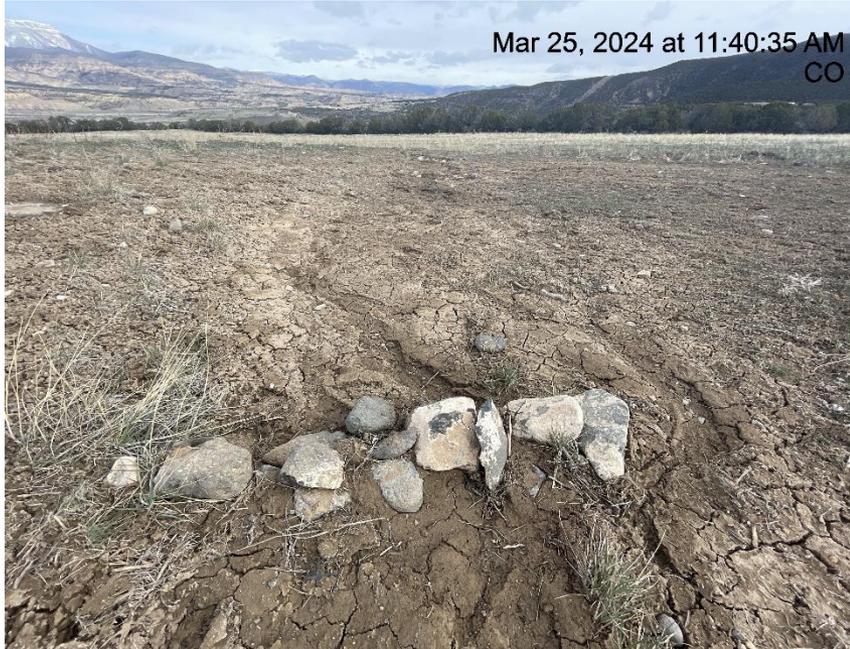
Photo # 1277 Check dam/BMP needs maintenance.

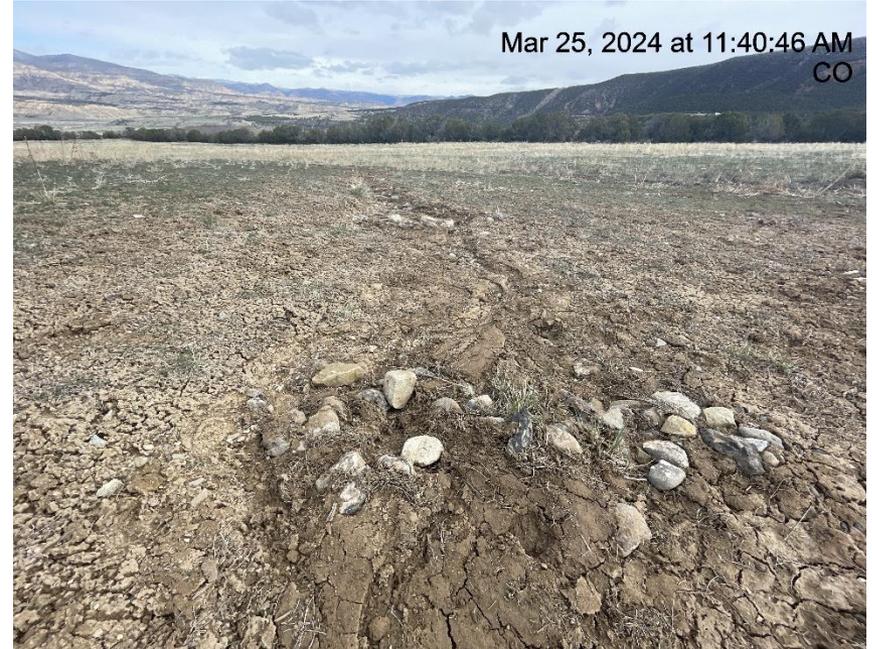
Photo # 1278 Check dam/BMP needs maintenance.

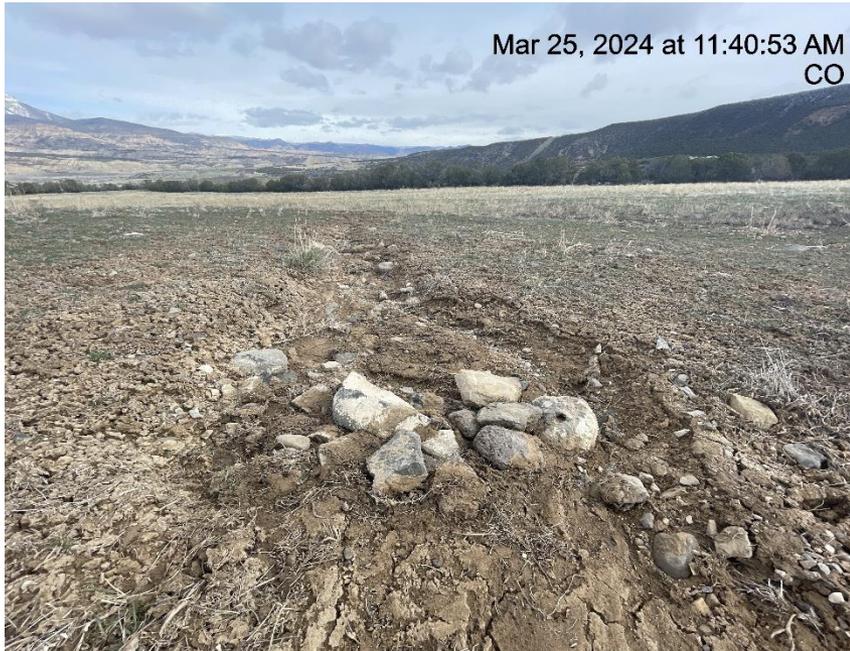
Photo # 1279 Check dam/BMP needs maintenance.

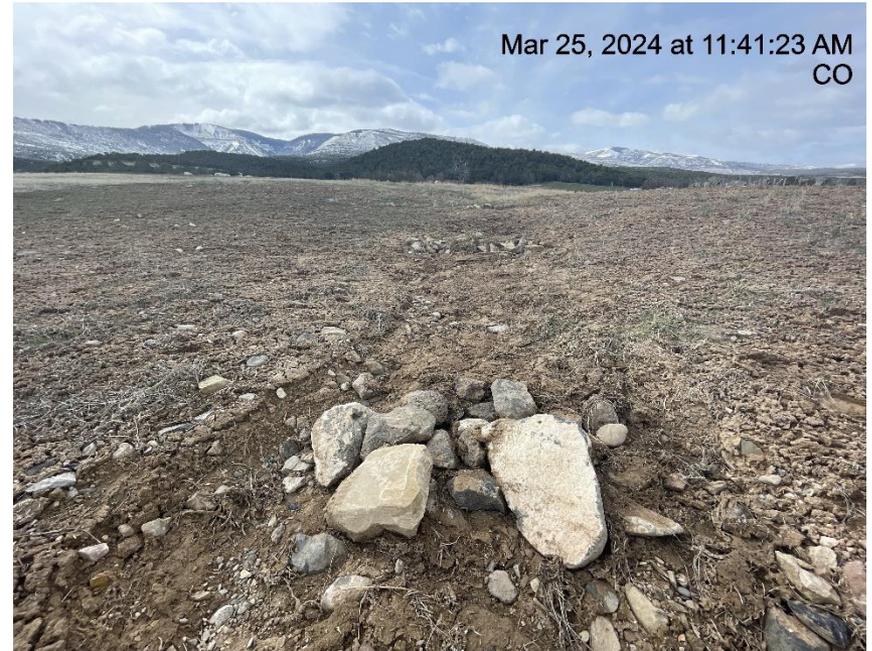
Photo # 1280 Check dam/BMP needs maintenance.

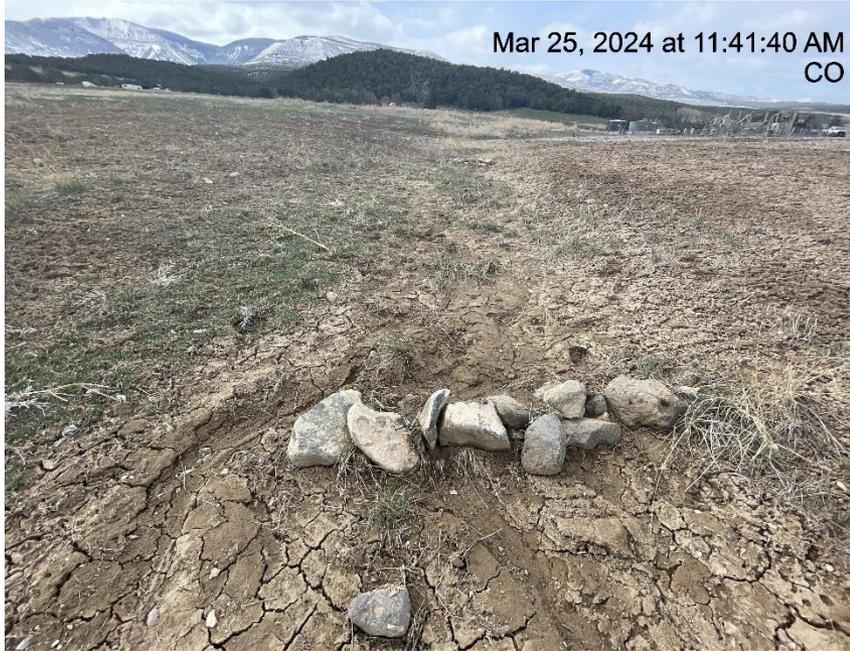
Photo # 1281 Check dam/BMP needs maintenance.

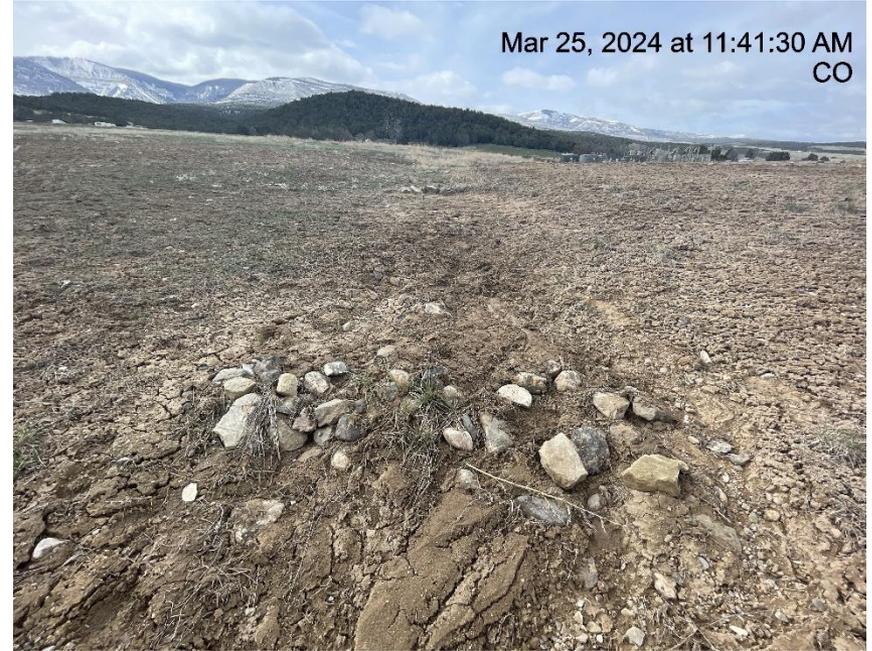
Photo # 1282 Check dam/BMP needs maintenance.

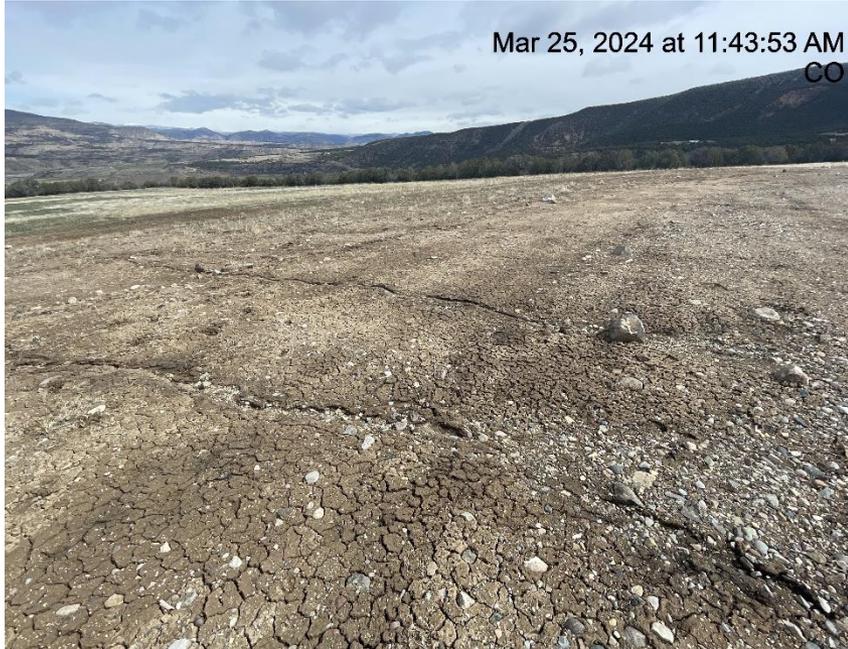
Photo # 1283 Rill erosion & transport of sediment off location/insufficient runoff controls/BMP's

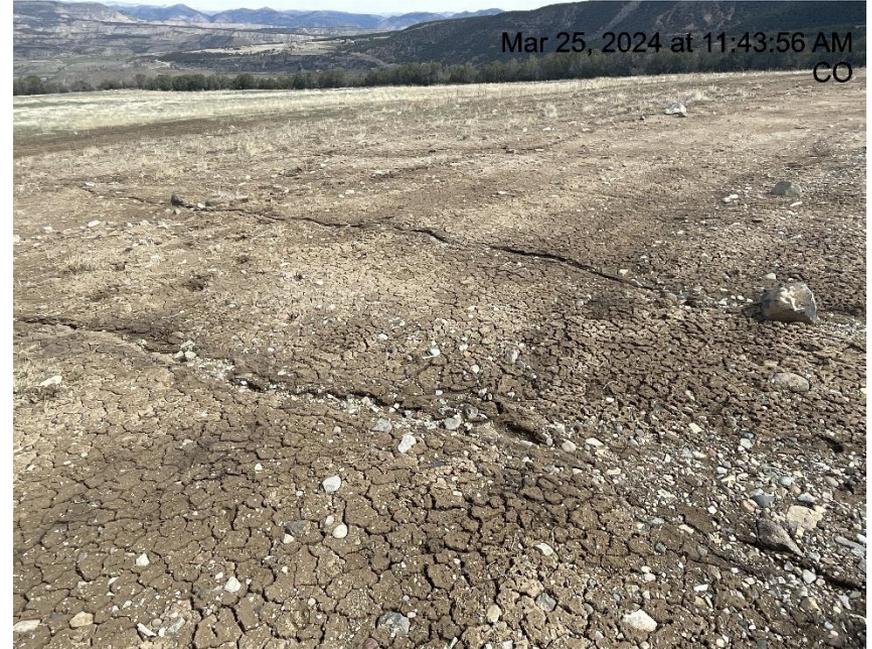
Photo # 1284 Rill erosion & transport of sediment off location/insufficient runoff controls/BMP's

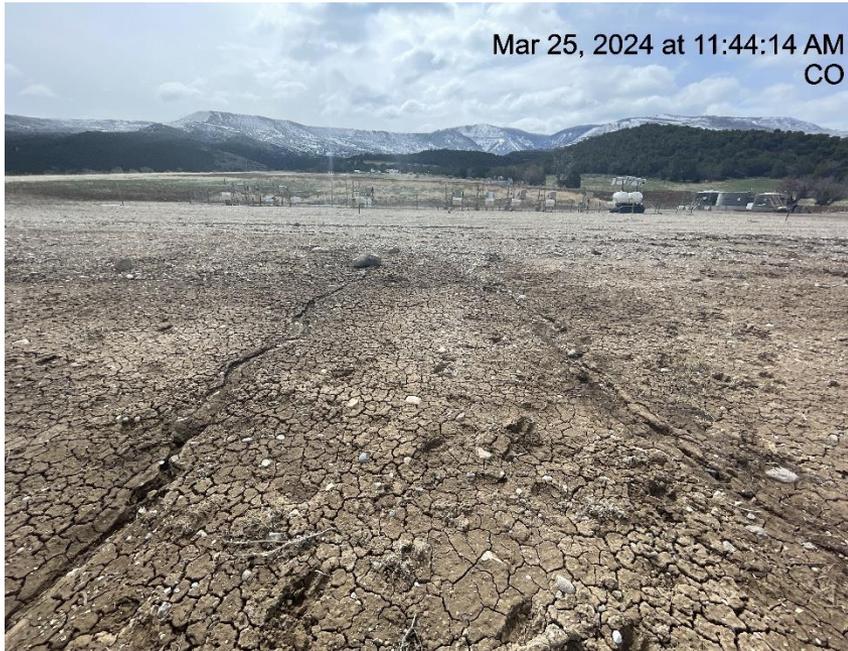
Photo # 1285 Rill erosion & transport of sediment off location/insufficient runoff controls/BMP's
