Interim Reclamation and Stormwater Inspection

Operator: LONGS PEAK RESOURCES LLC- #10611

Location ID: 439459

Inspection Photos
Location Name: Motu East /2821-8CH
Location ID: 439459

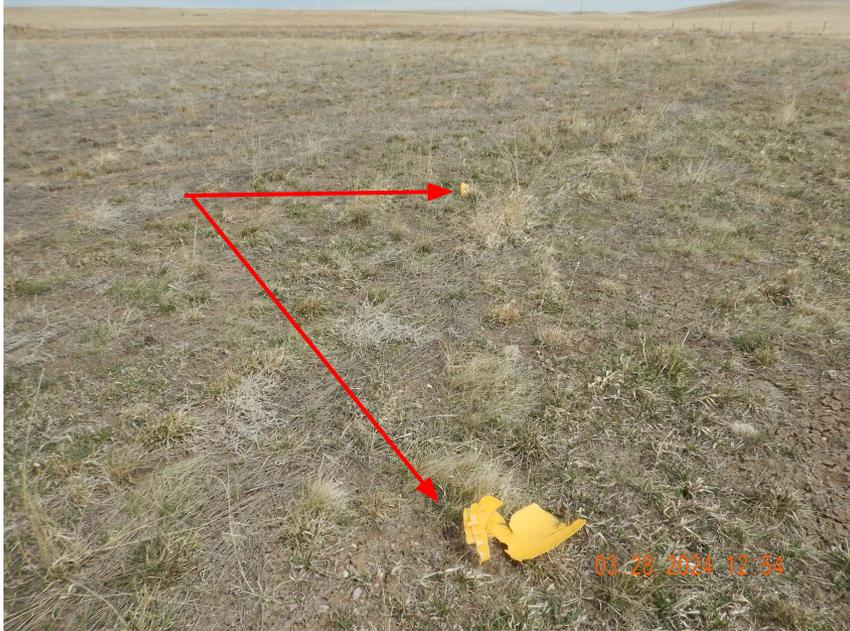
Photo 1. Photo taken from the southeastern location. Photo illustrates trash, possible lid for load line, that needs to be removed and properly disposed of. Trash was observed throughout the location and continues to be issue.

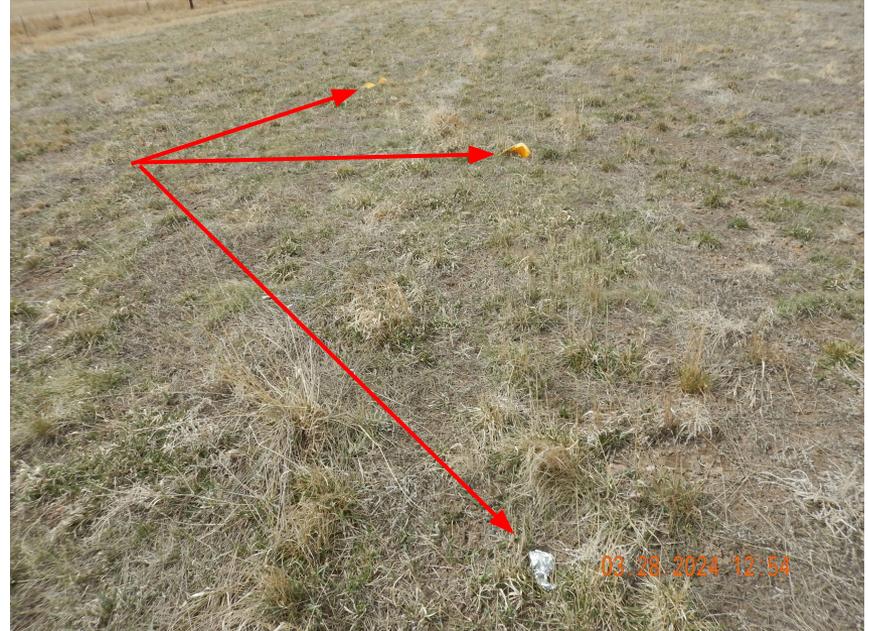
Photo 2. Photo taken from the southeastern location. See comments on Photo 1.

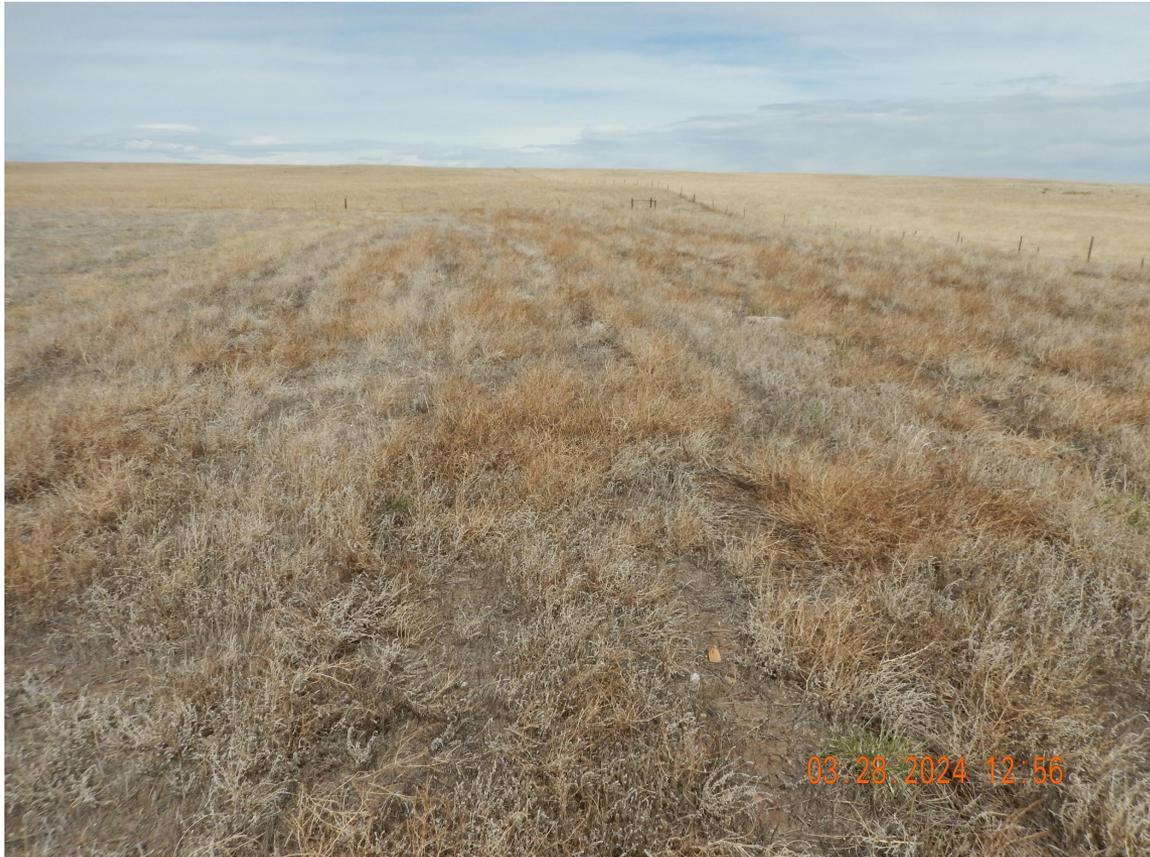
Photo 3. Photo taken from the eastern interim reclamation area along the topsoil stockpile, facing North. Photo illustrates the topsoil stockpile consists mostly of weedy, annual vegetation.

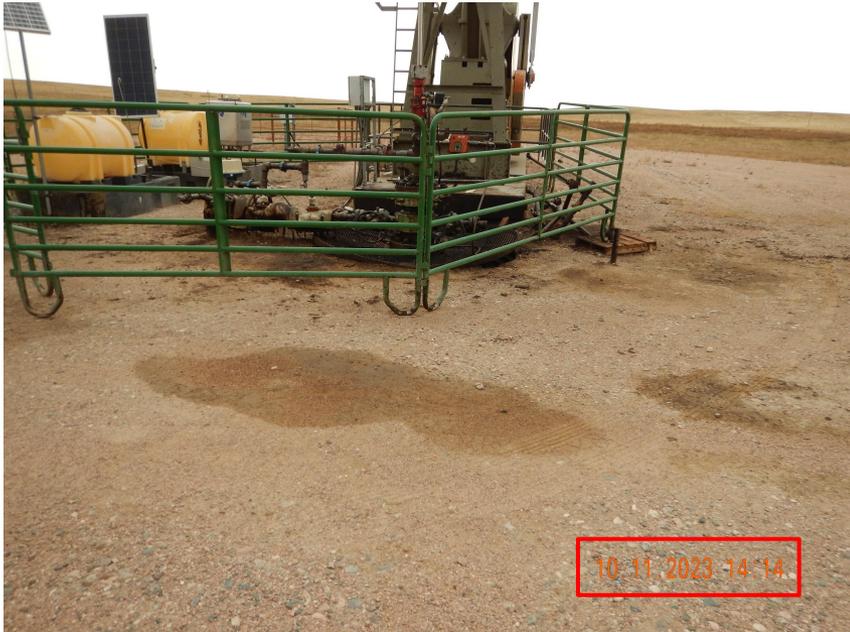
Photo 4. Photo taken from the wellhead on 10/11/2023. Photo illustrates stained soil around the wellhead and outside of the cattle guards.

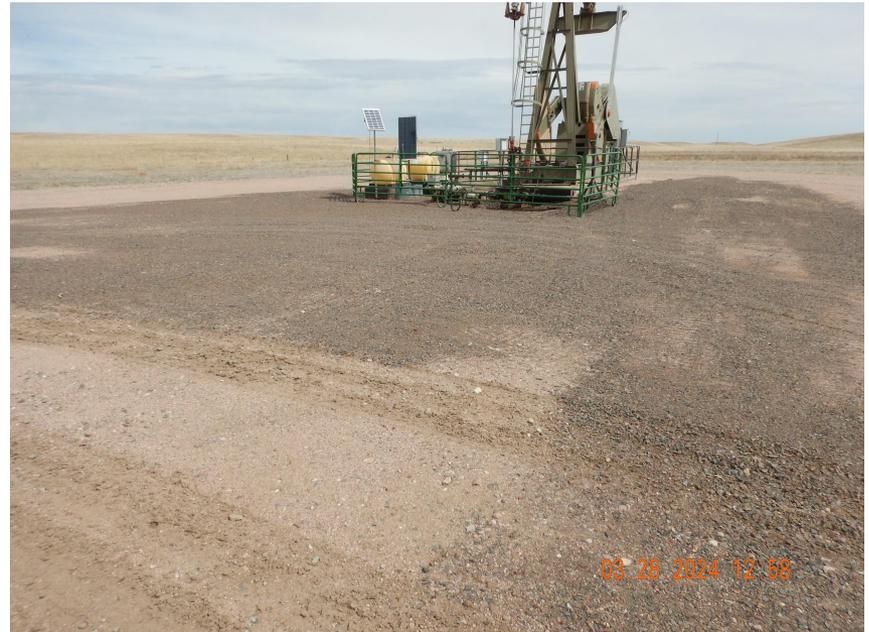
Photo 5. Photo taken from the wellhead area. ECMC staff could not confirm or deny the Operator properly disposed of stained soil outside of the green cattle guard due to importing roadbase on top of previous area.

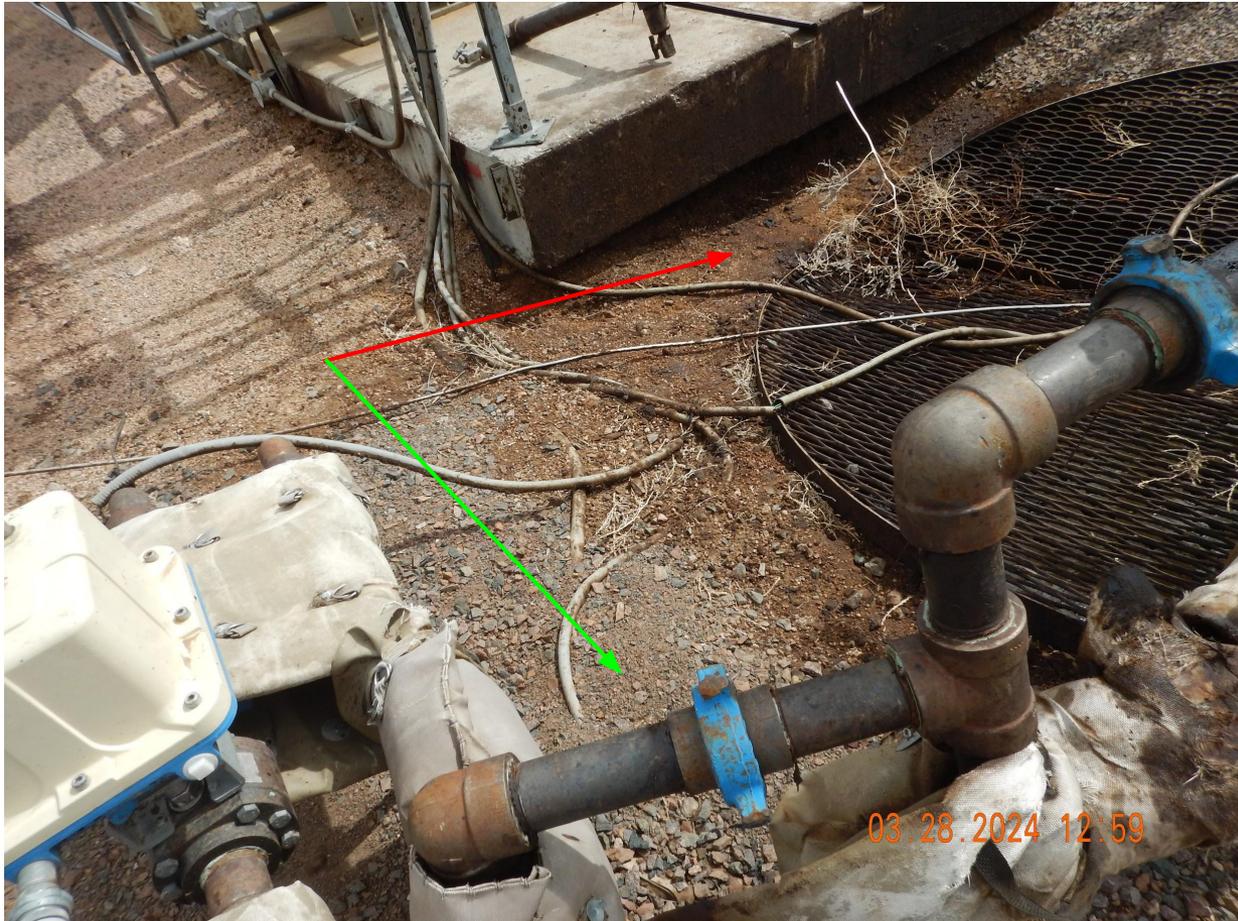
Photo 6. Photo taken from the wellhead. Photo illustrates stained soil around the wellhead (red arrow) has not been removed. Operator appears to have imported roadbase (green arrow) and placed on top of stained soil.

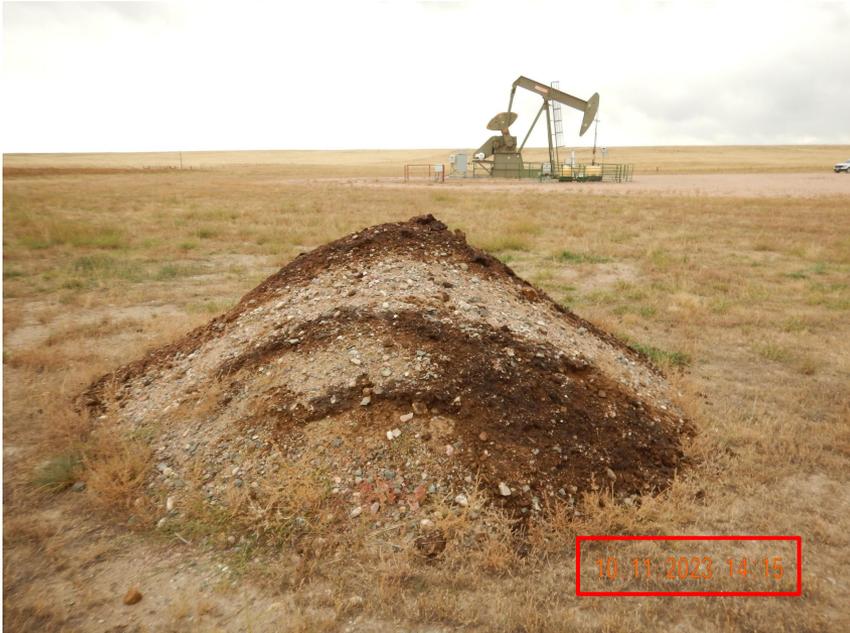
Photo 7. Photo taken from the interim reclamation area, facing South. Photo illustrates improper waste disposal and waste management.

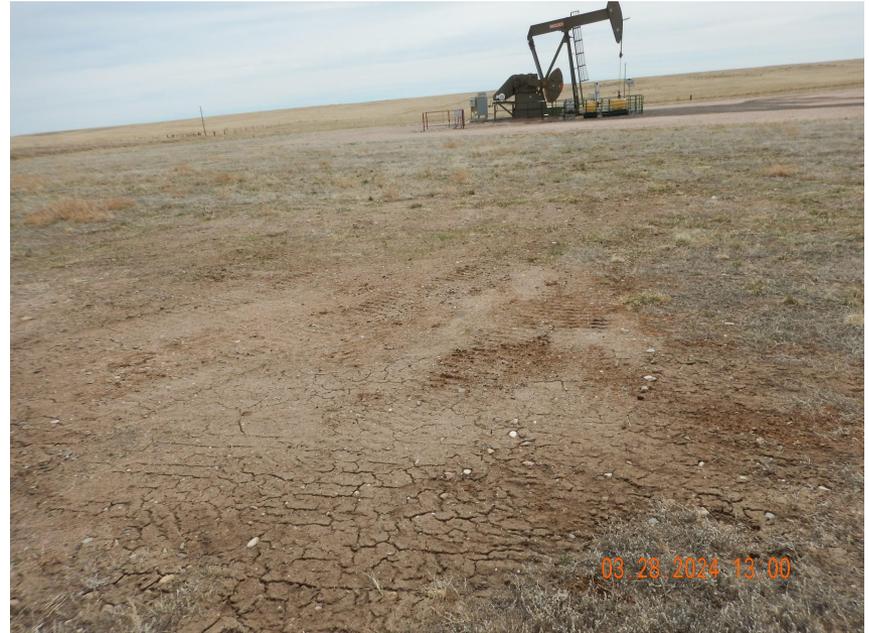
Photo 8. Photo taken from the interim reclamation area, facing South. Photo illustrates improper waste disposal and waste management appears to have been removed. Operator will be responsible for reseeding the disturbance area.

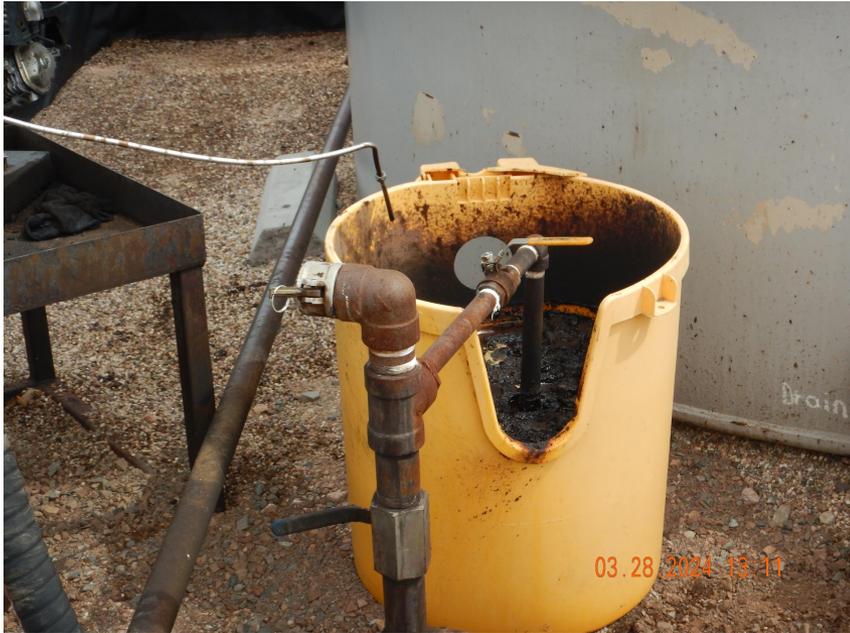
Photo 9. Photo taken from within the secondary containment. Stained soil/gravel appears to have been removed and cleaned out.

Note- the lid is missing and appears to be scattered throughout the interim reclamation areas.

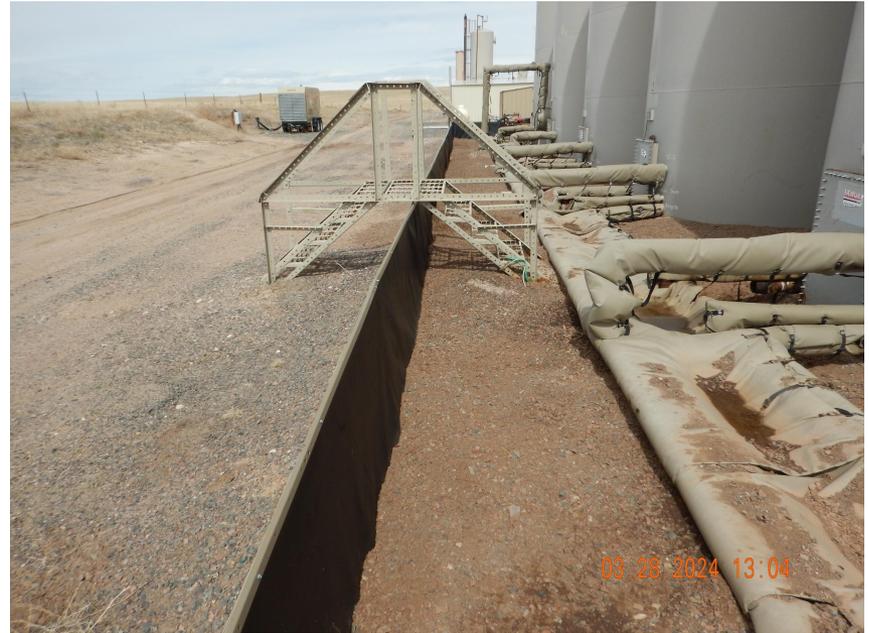
Photo 10. Photo taken from within the secondary containment. Stained soil/gravel appears to have been removed and cleaned out.

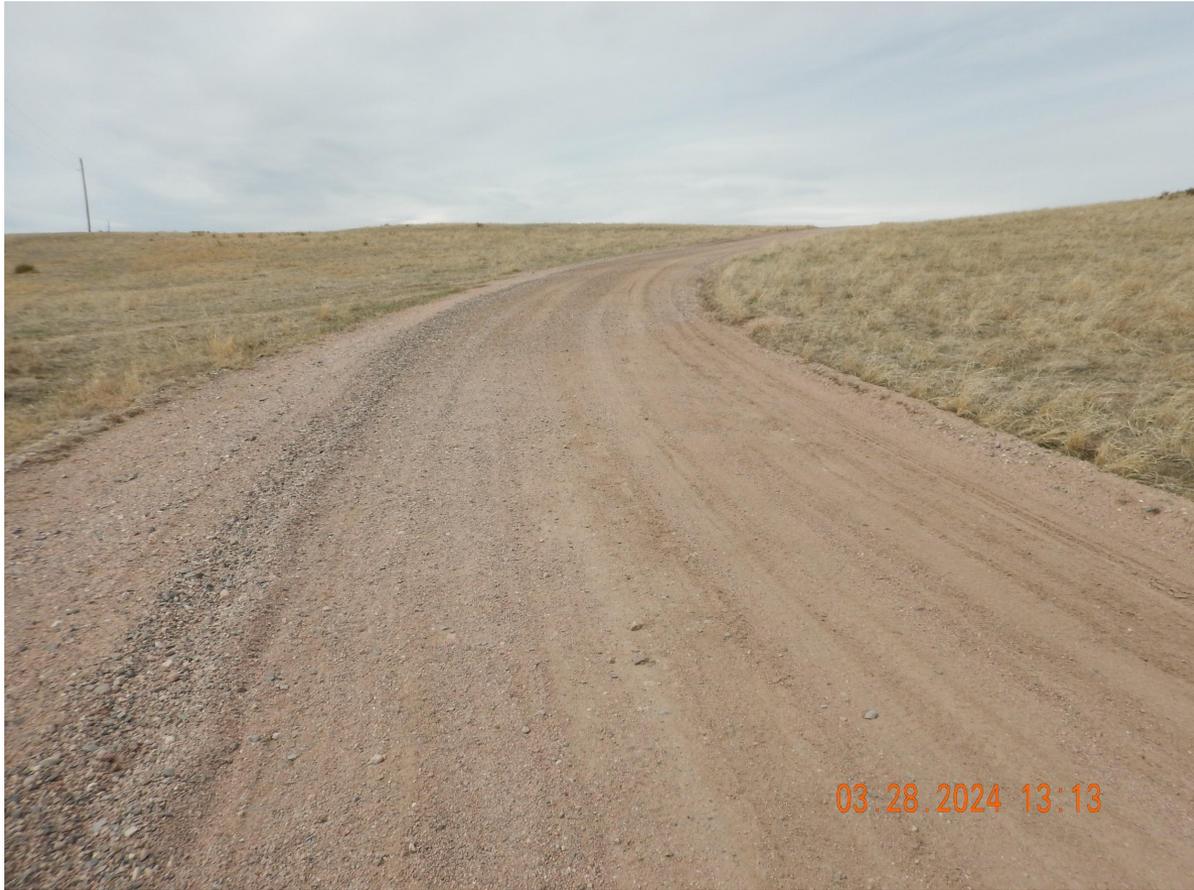
Photo 11. Photo taken along a portion of the access road, facing West. Photo illustrates rill erosion has been repaired.
