Caerus Piceance LLC  
Piceance Creek Unit-62S97W 7SENE  
Location ID: 335884

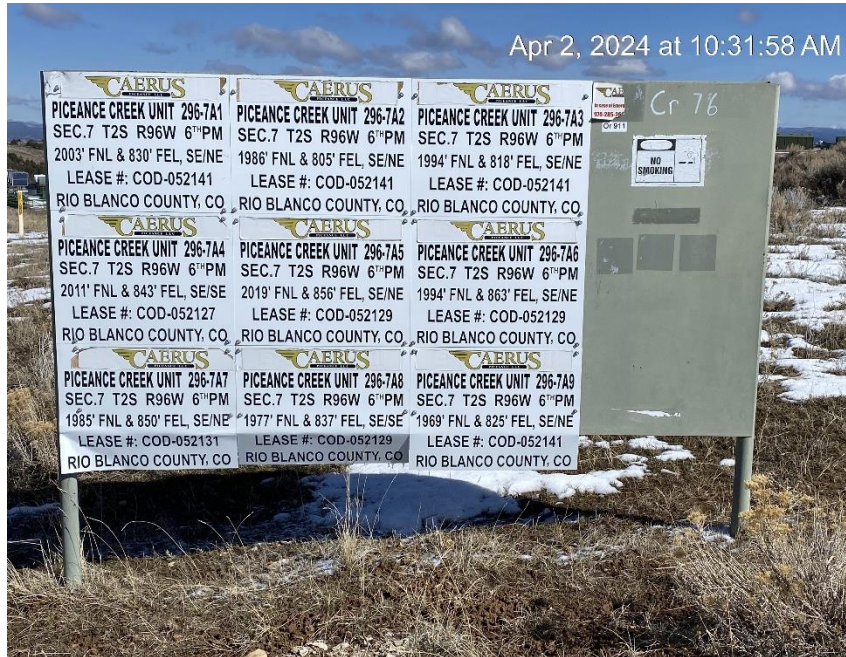
When replaced additional information is required. Operator contact information illegible.

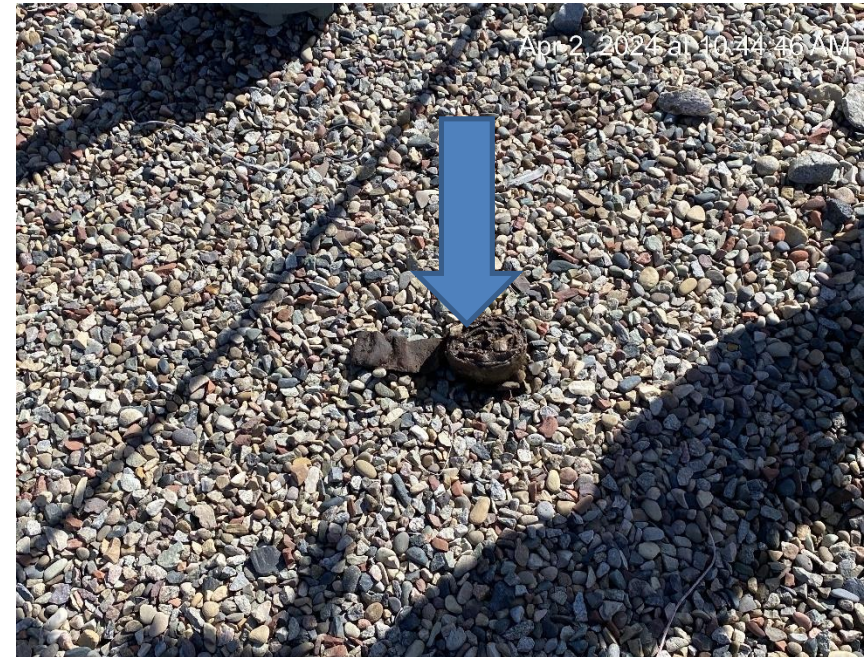
Debris

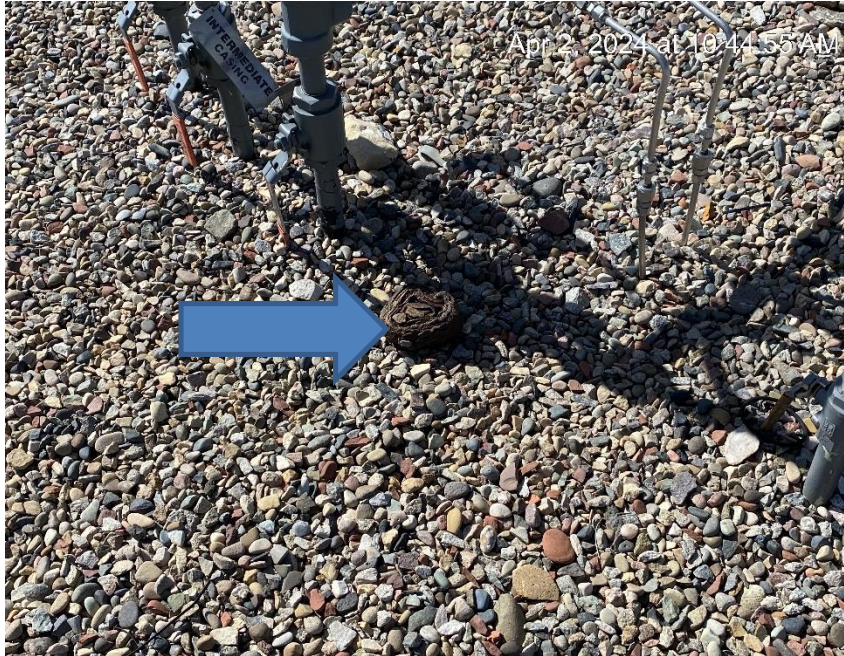
Debris

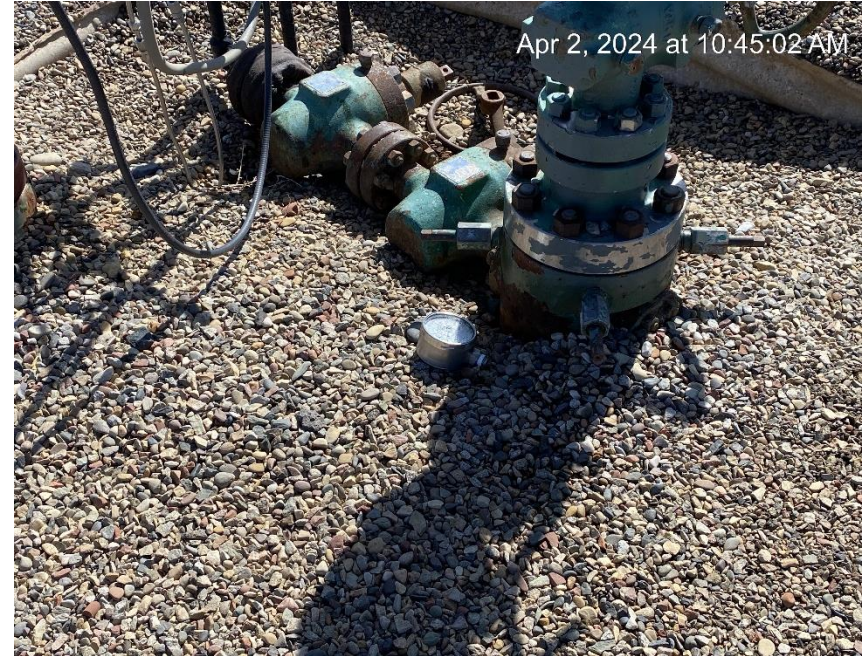
Debris

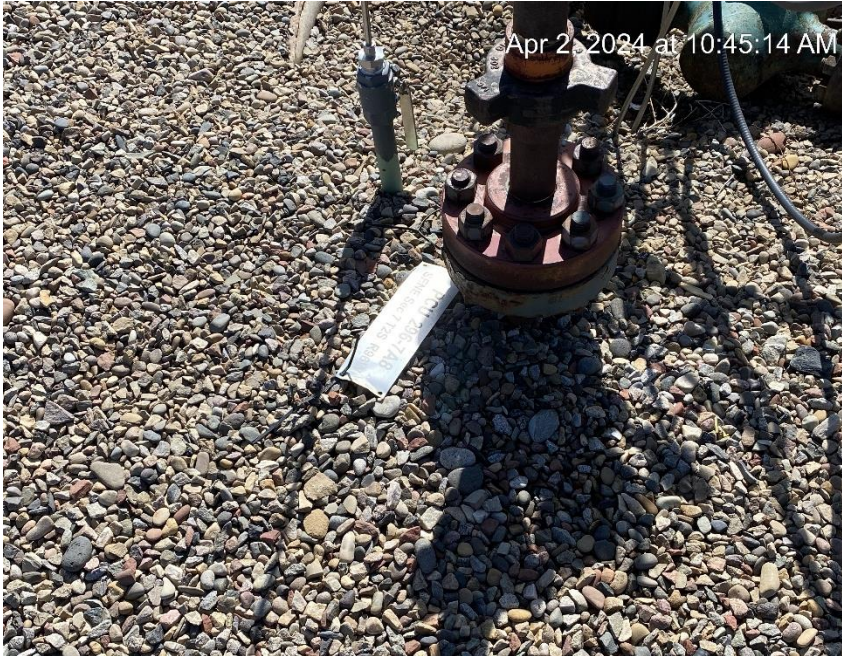
**Sign not visibly displayed**

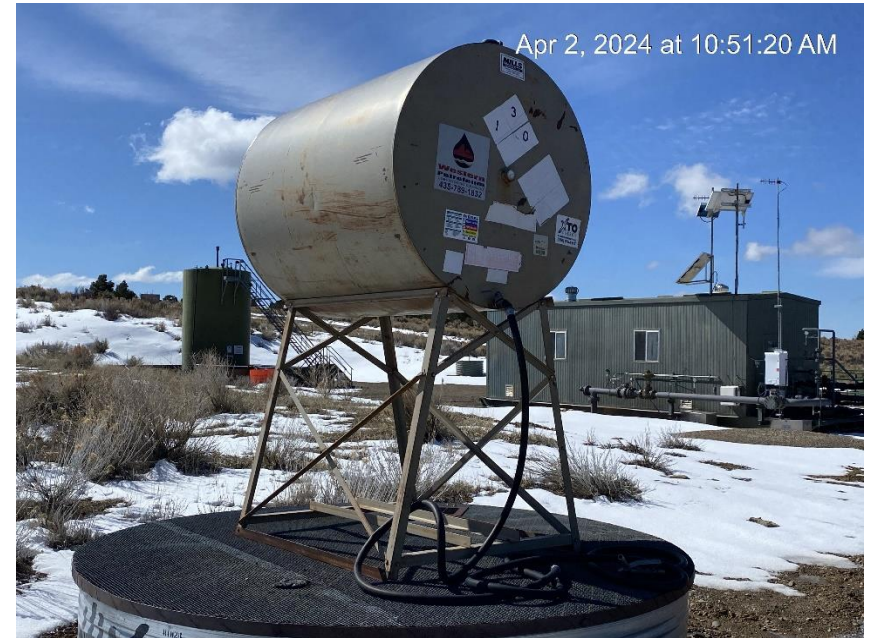
**Unused equipment.**

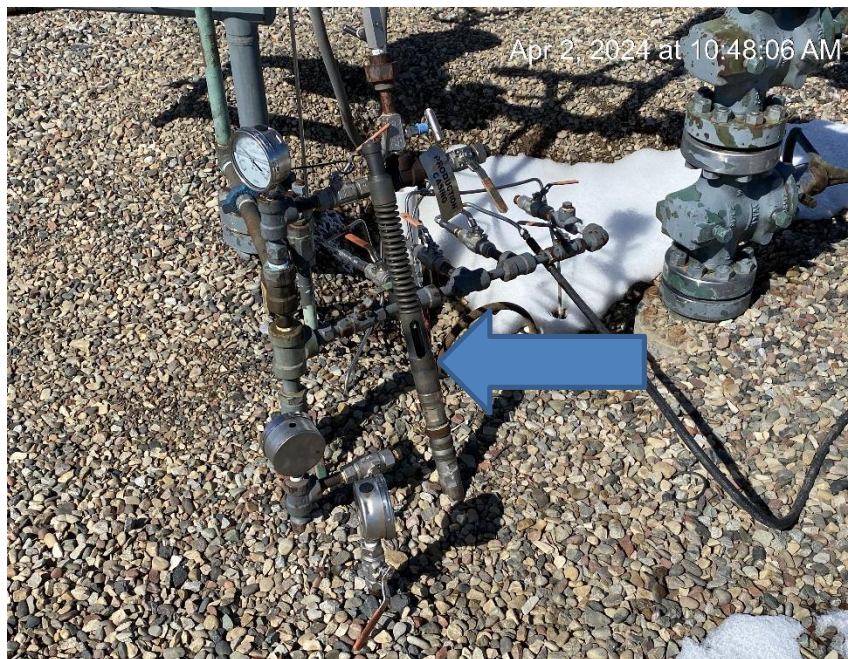
Debris

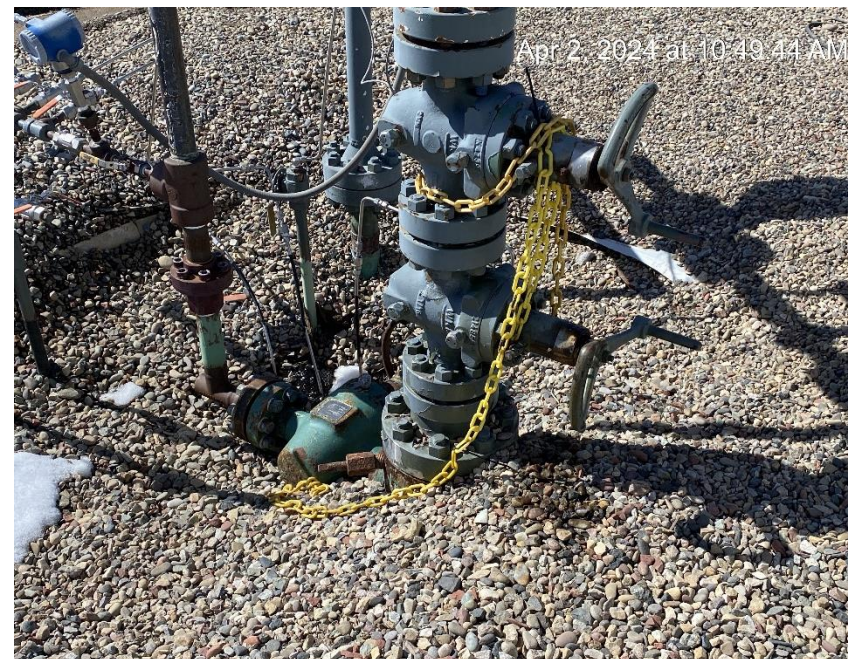
Debris

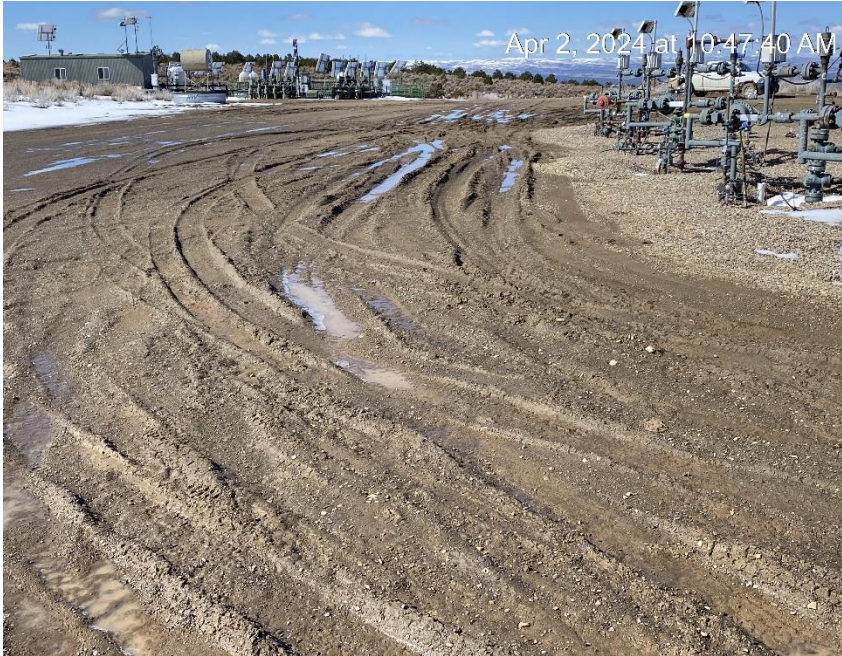
**Lack of stabilization. Vehicle tracking.**

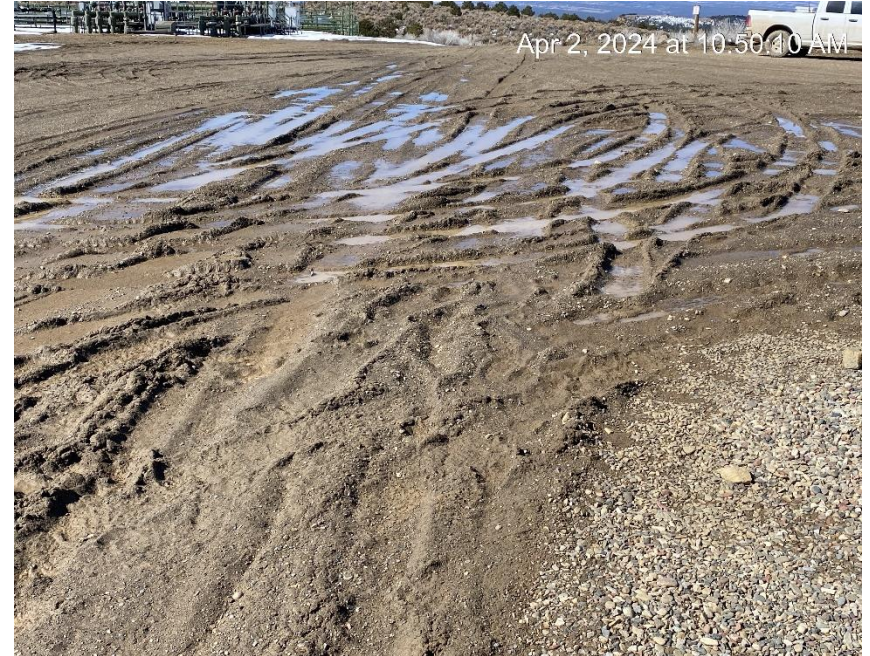
**Lack of stabilization. Vehicle tracking.**

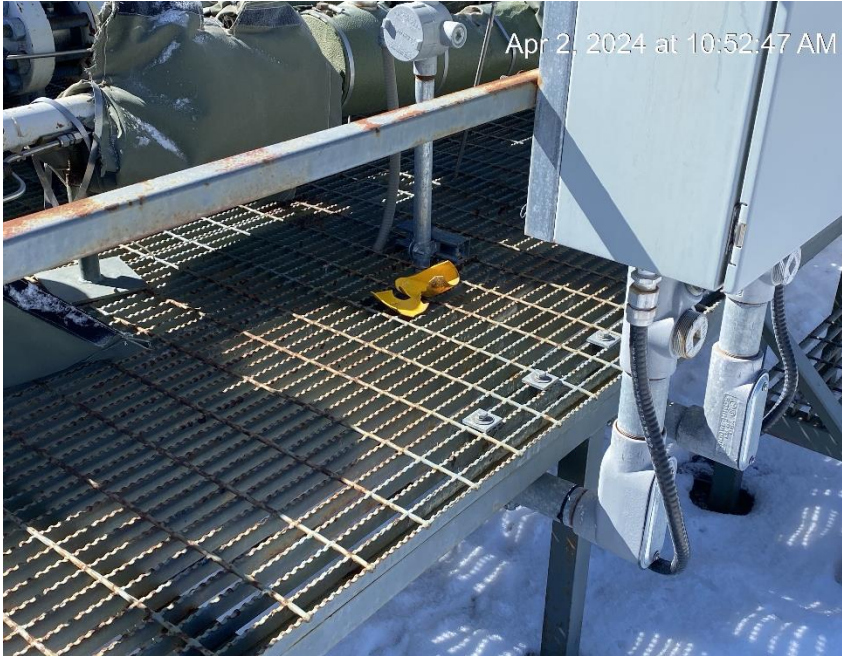
**Debris**

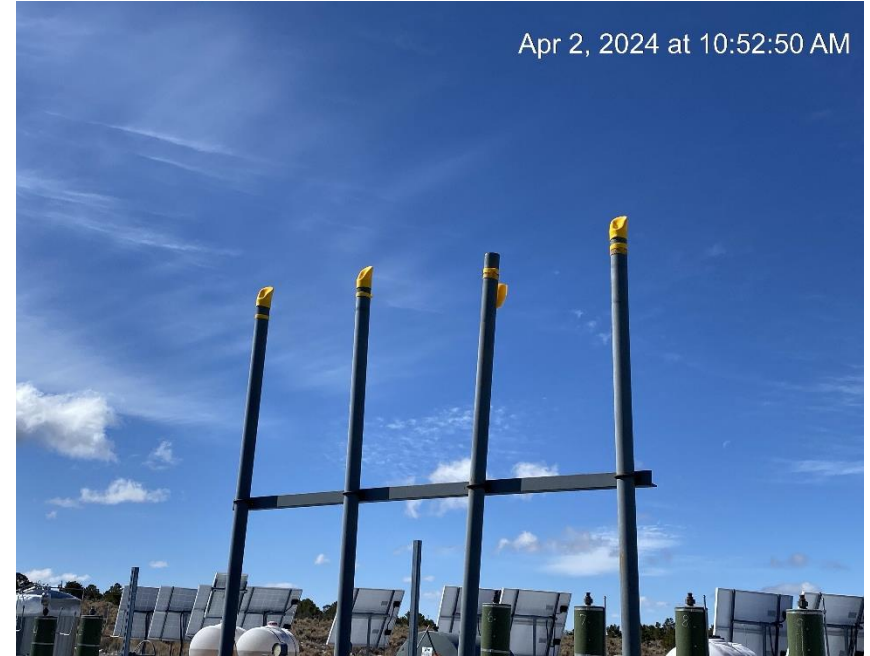
**Relief riser missing rain protection**

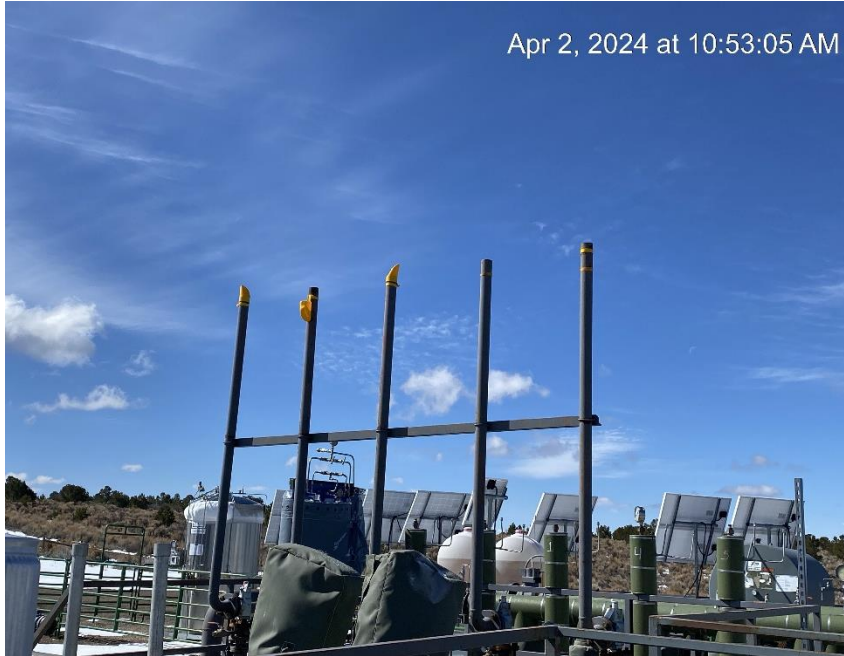
**Relief risers missing rain protection**

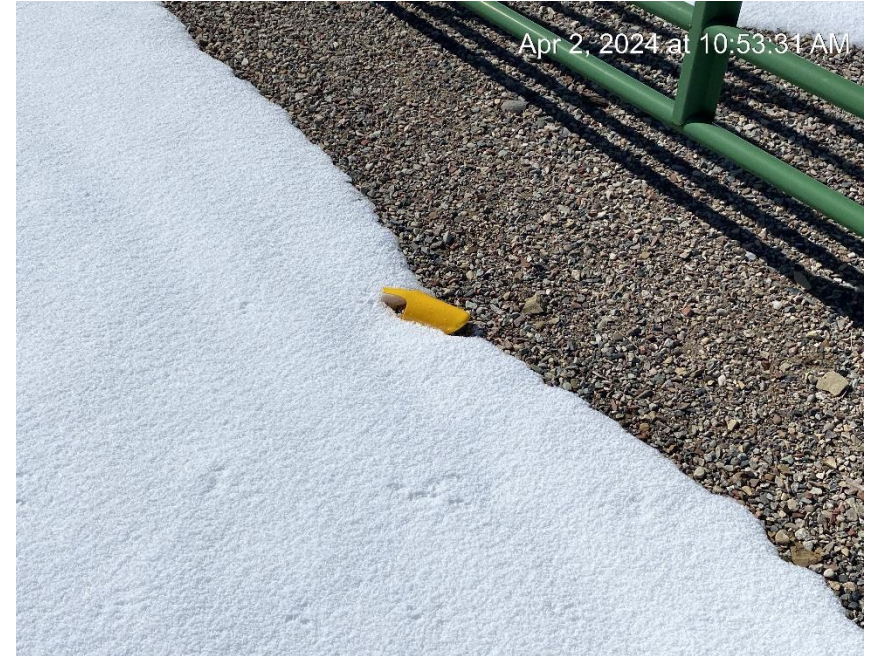
**Debris**

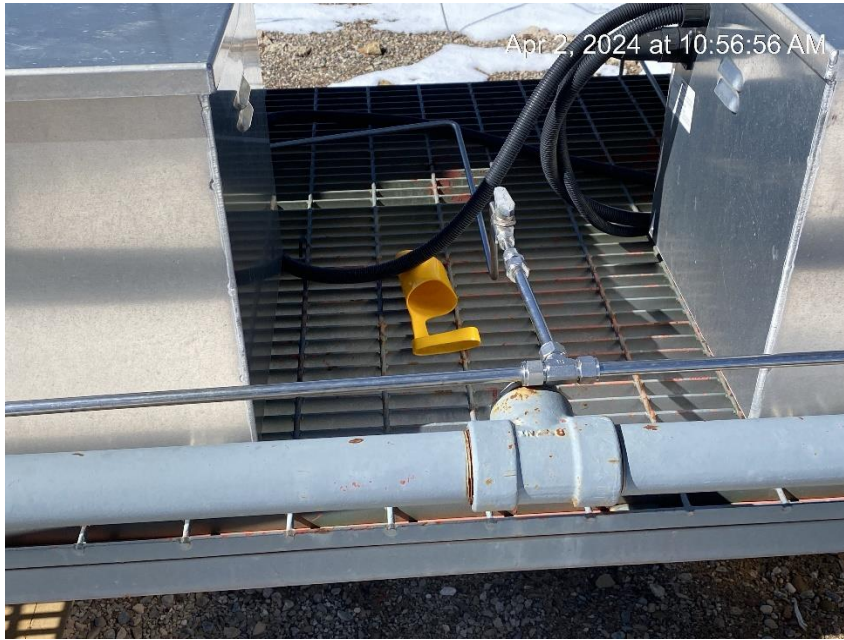
Debris

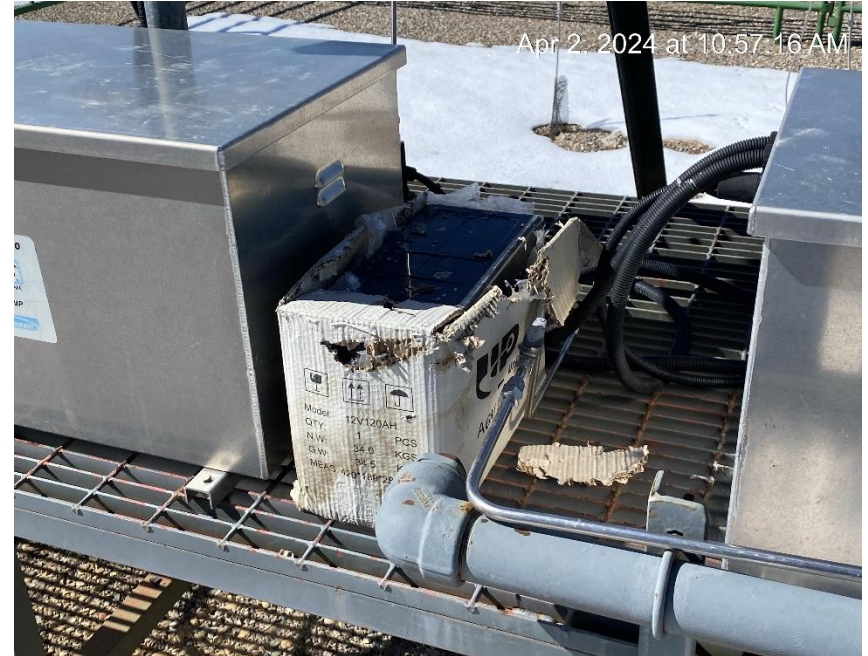
Debris. Unused equipment.

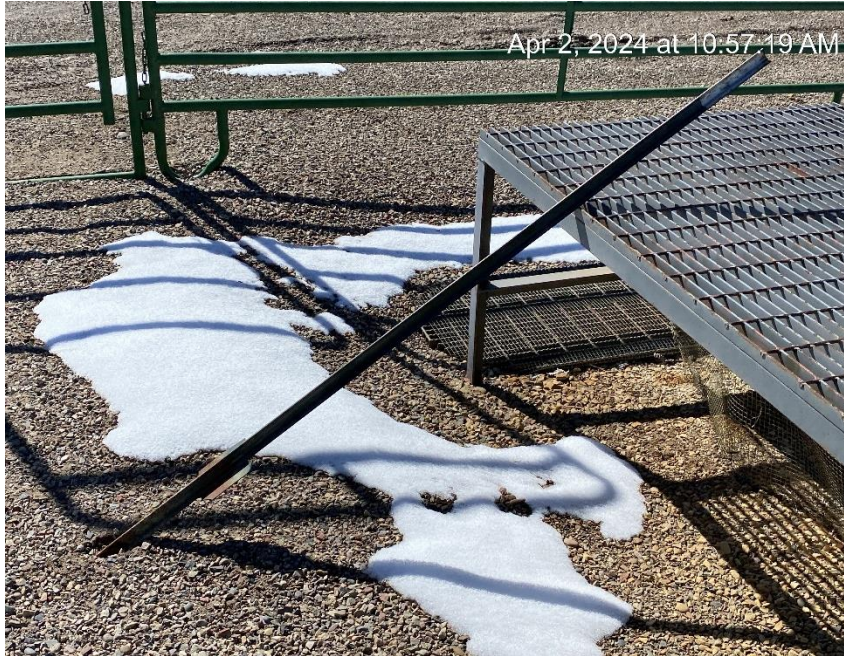
**Debris**

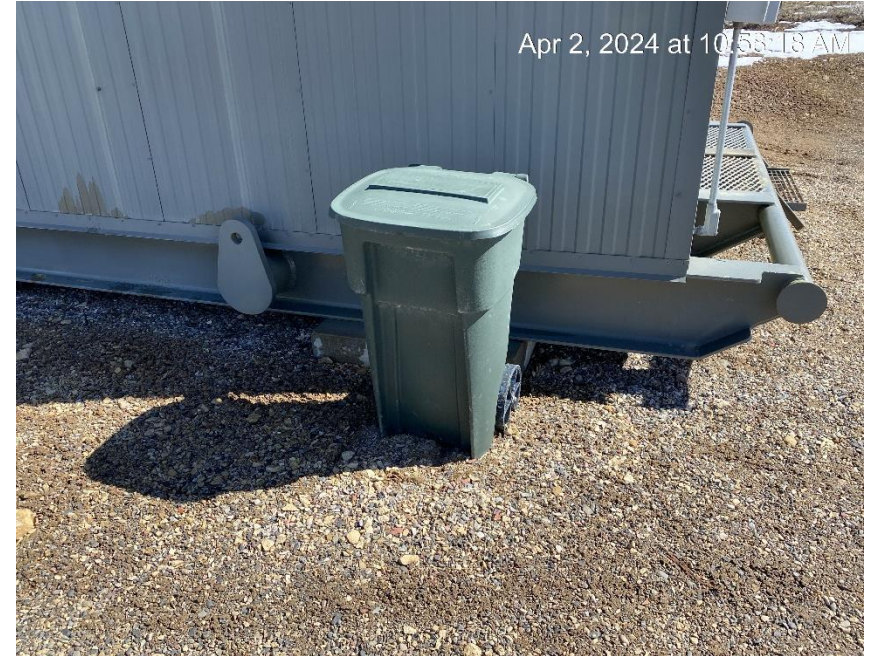
**Debris. Bear proof container required if food waste is present.**

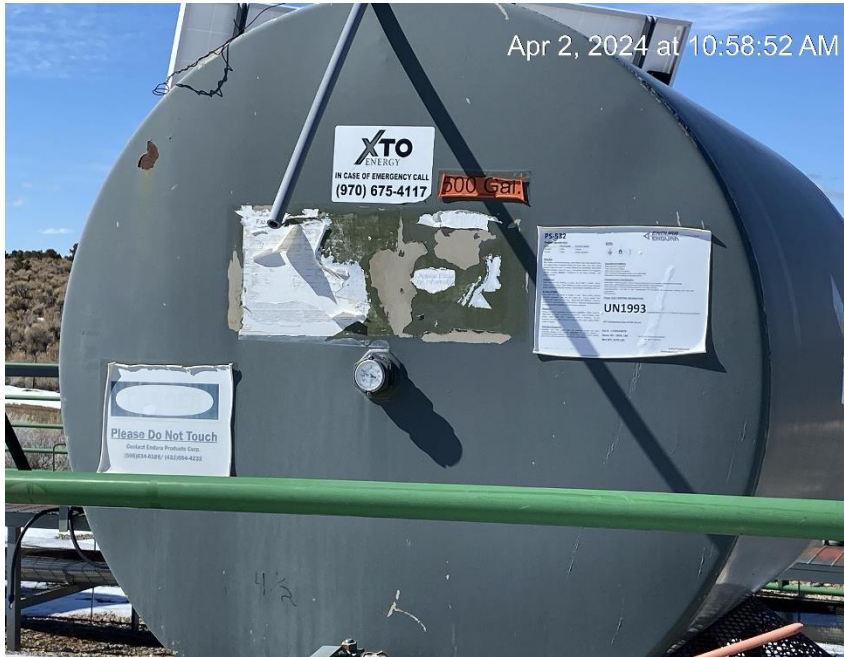
Faded and illegible labels

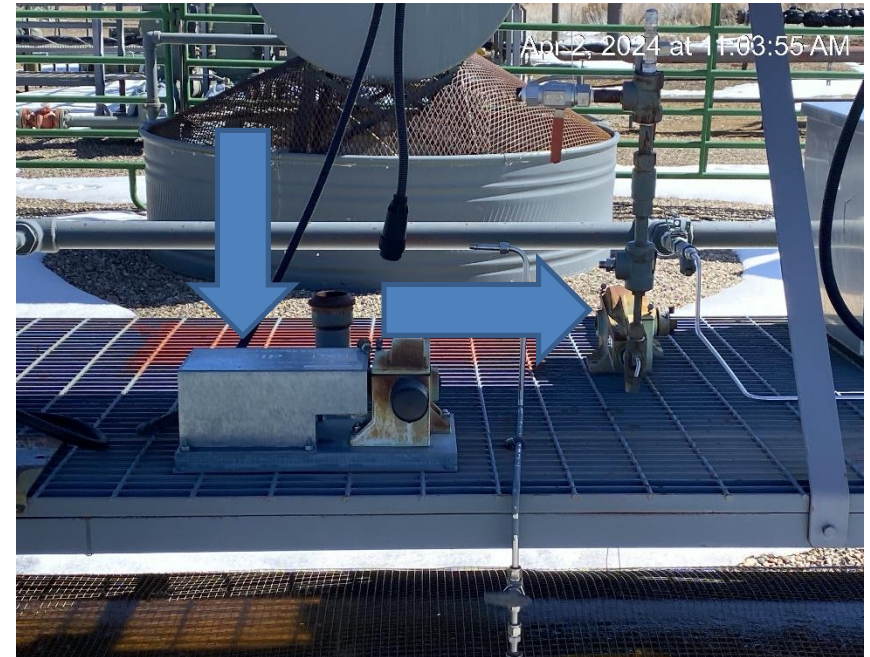
Debris. Unused equipment.

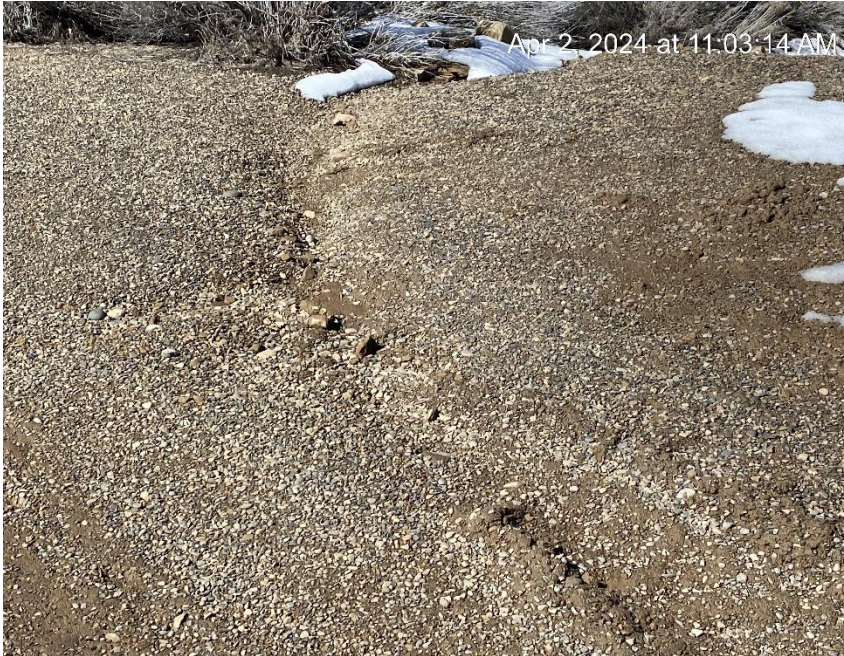
**Erosion and sediment migration**

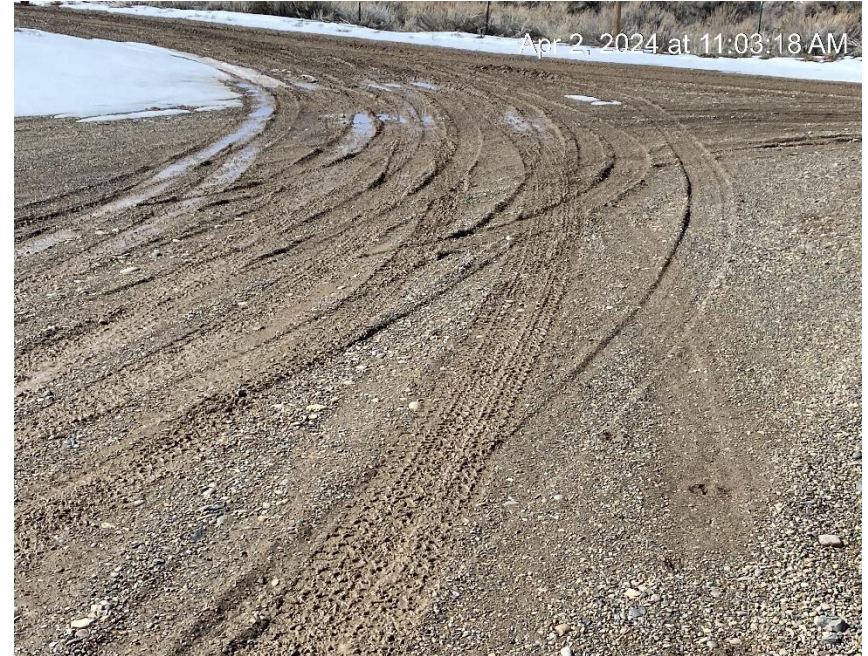
**Vehicle tracking from production facility**

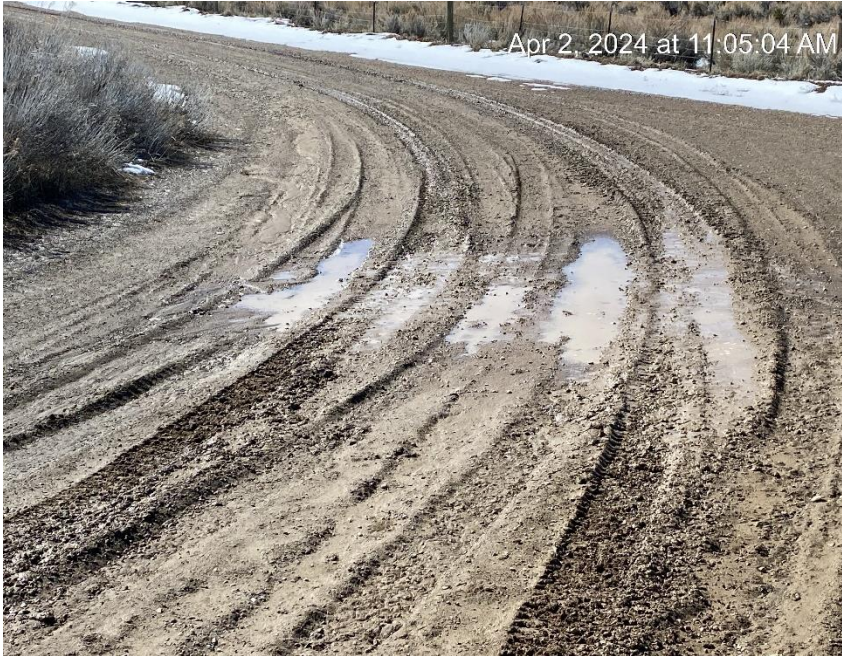
**Sediment migration. Vehicle tracking from well pad.**

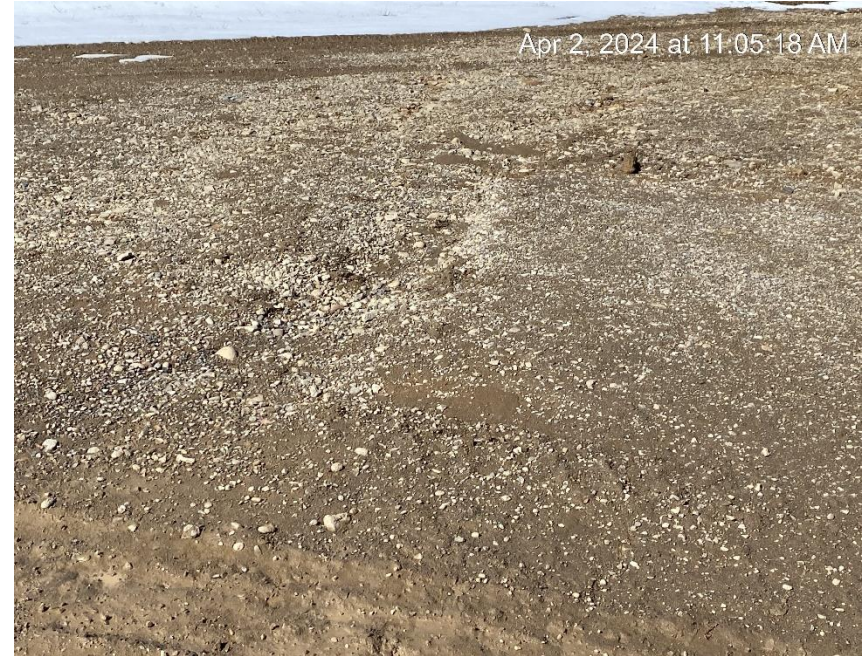
**Erosion and sediment migration**

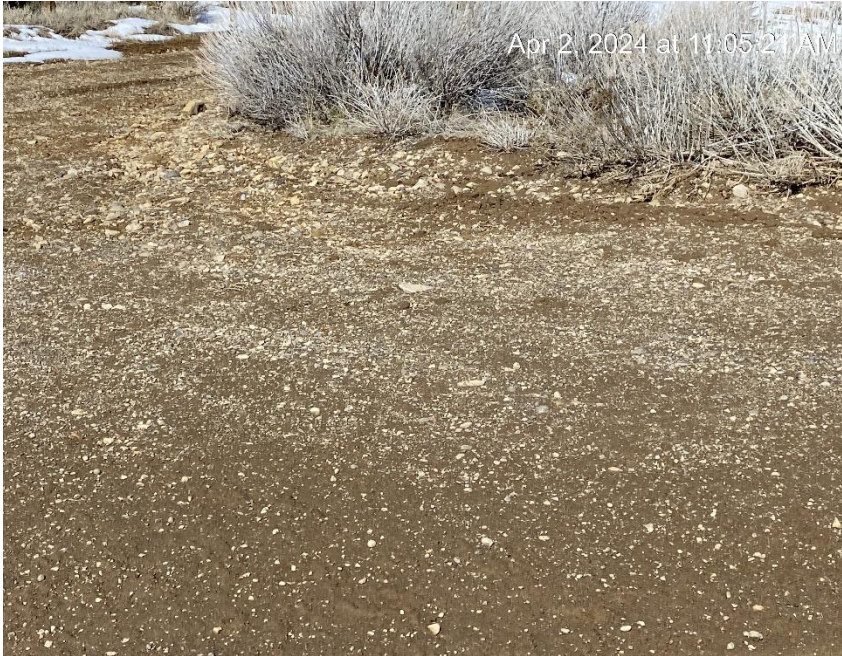
**Erosion and sediment migration**

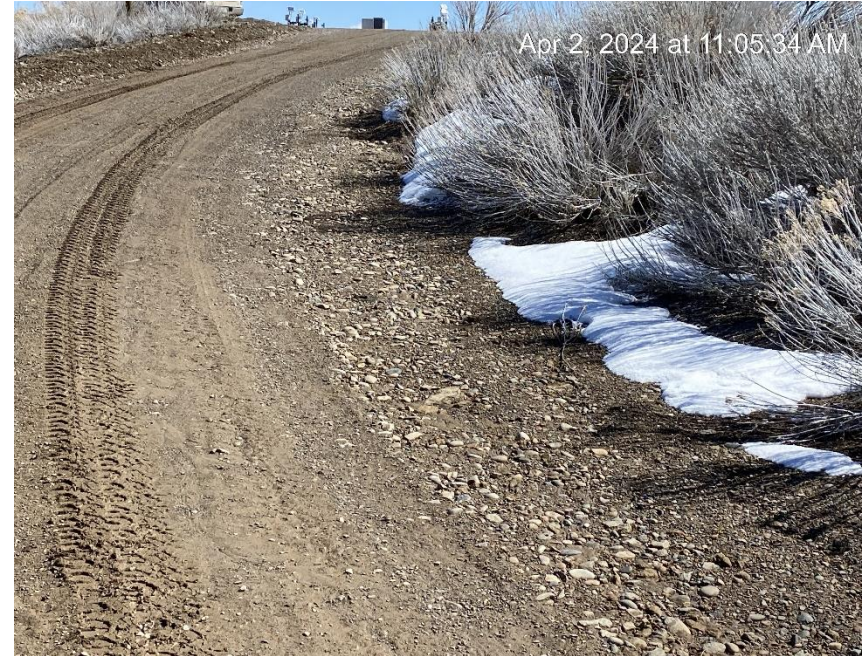
**Erosion and sediment migration**

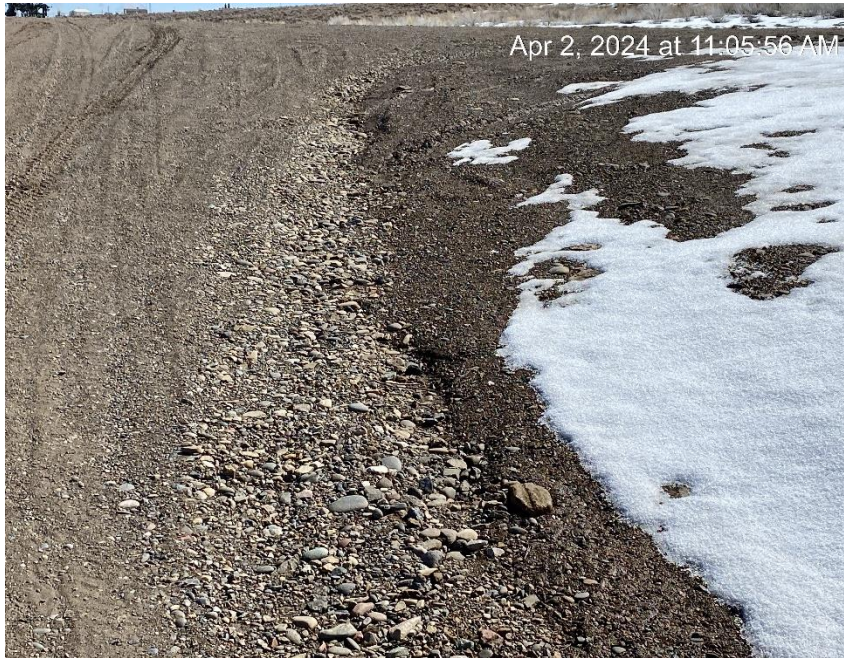
**Erosion and sediment migration**

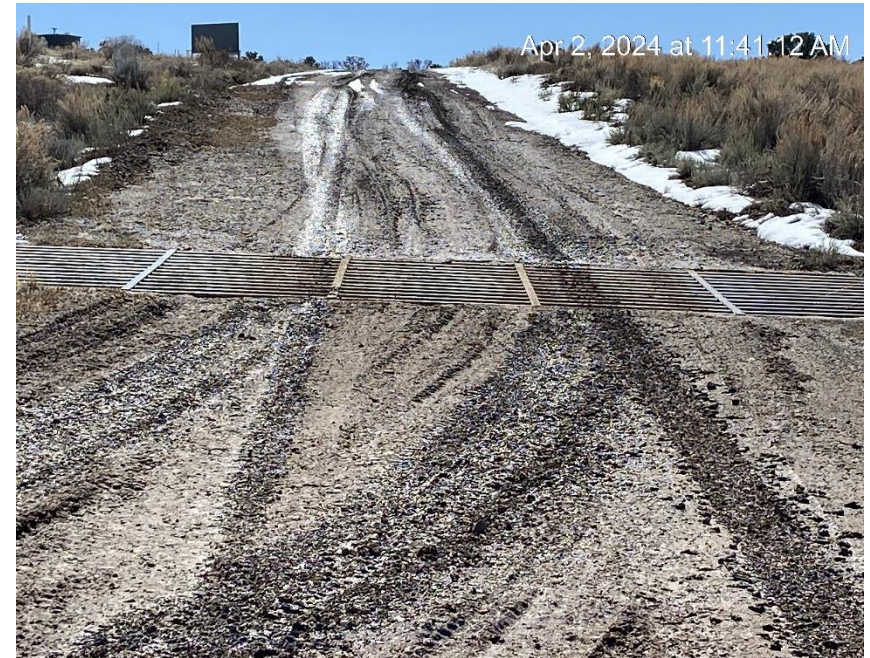
**Access road to location. Vehicle tracking.**
