Caerus Piceance LLC
Piceance Creek Unit-62S97W 3NESE
Location ID: 335695

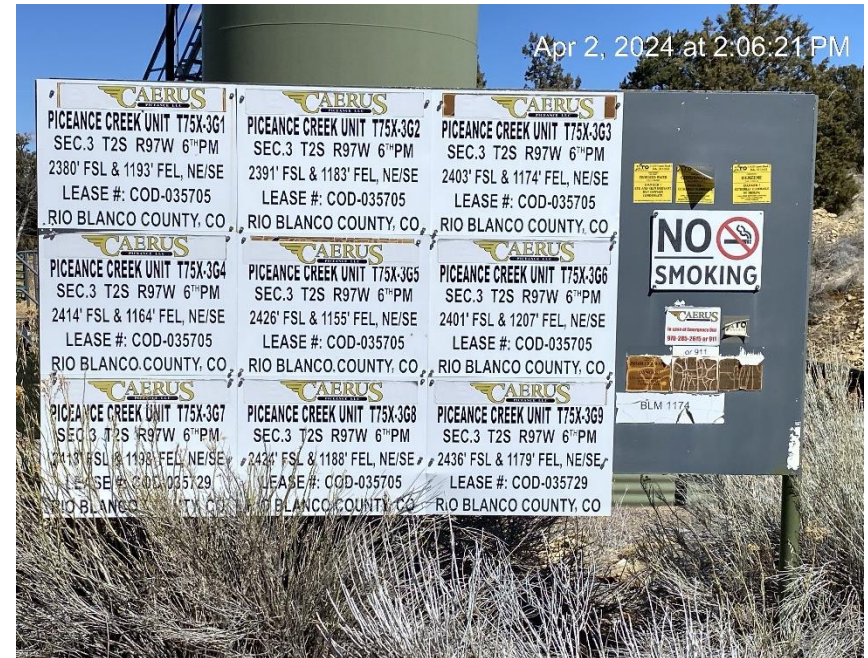
When replaced additional information is required

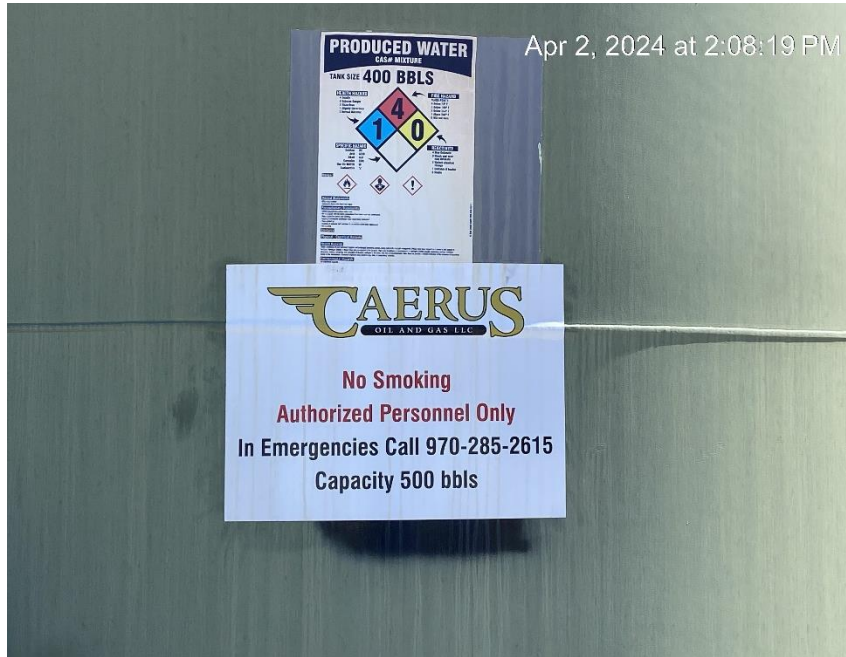
Conflicting labels

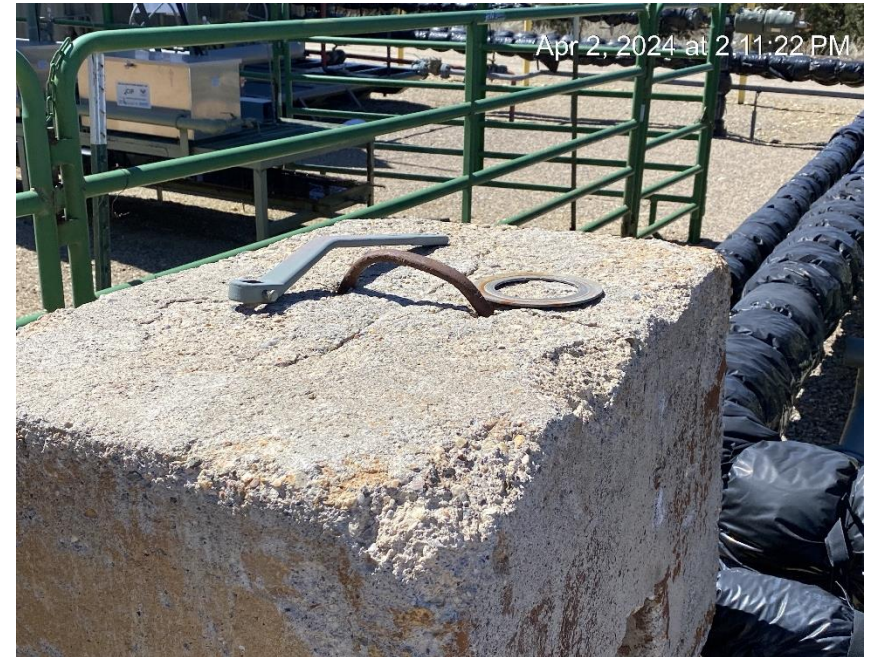
Debris

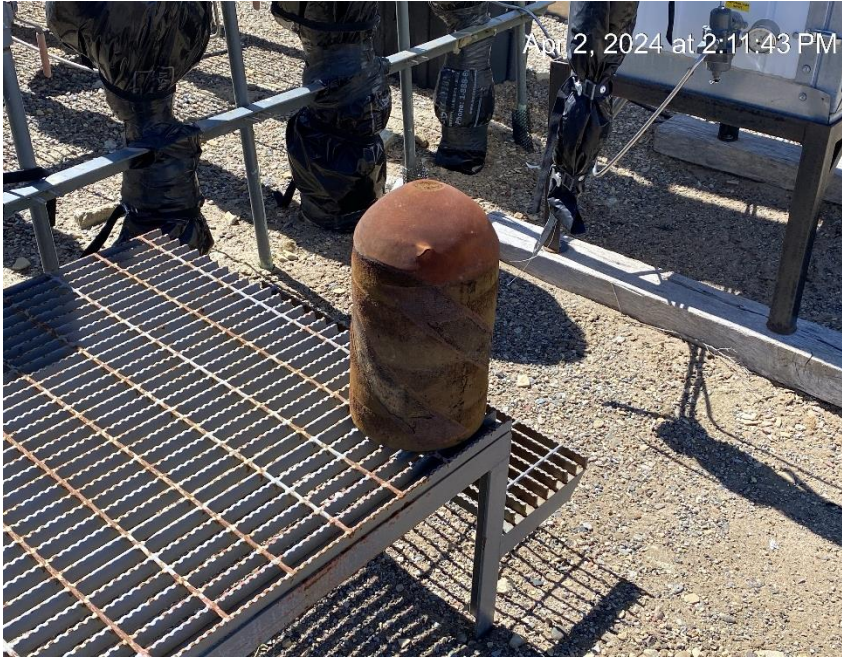
Debris

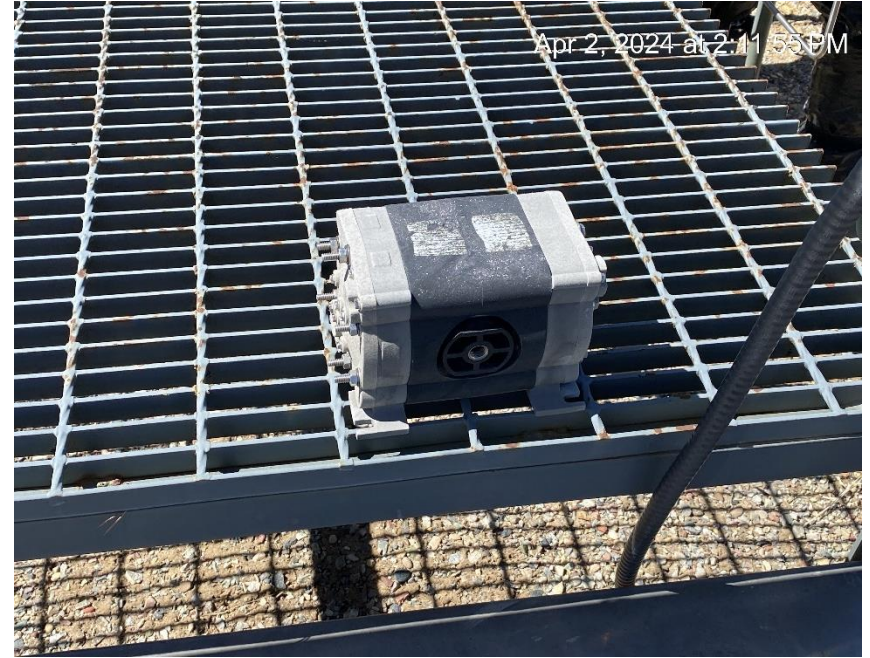
Debris

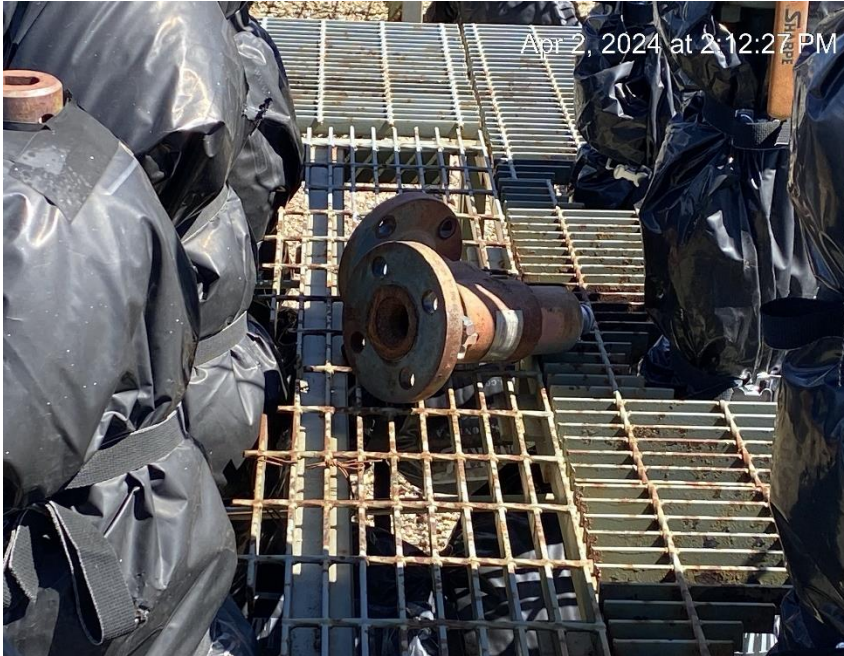
Debris

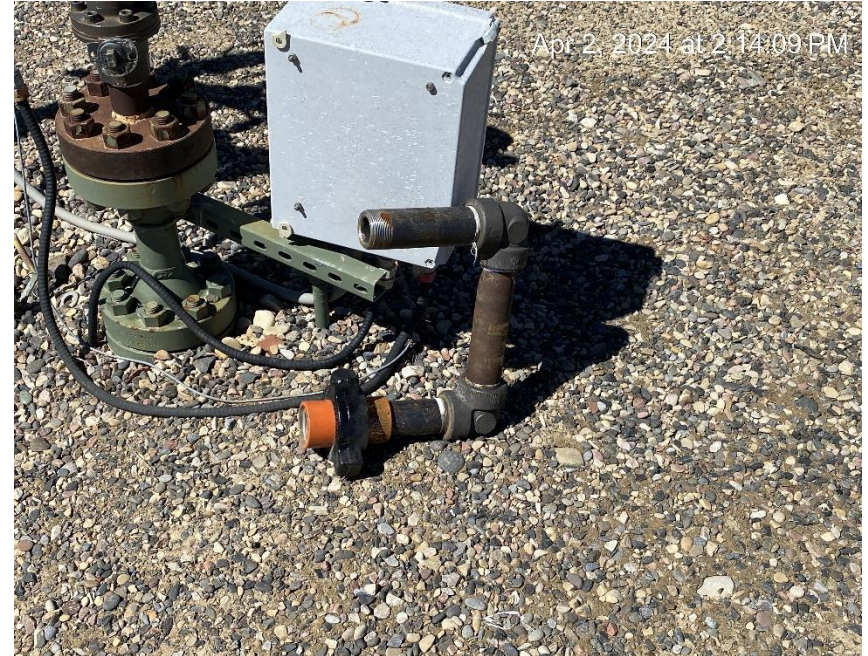
Debris

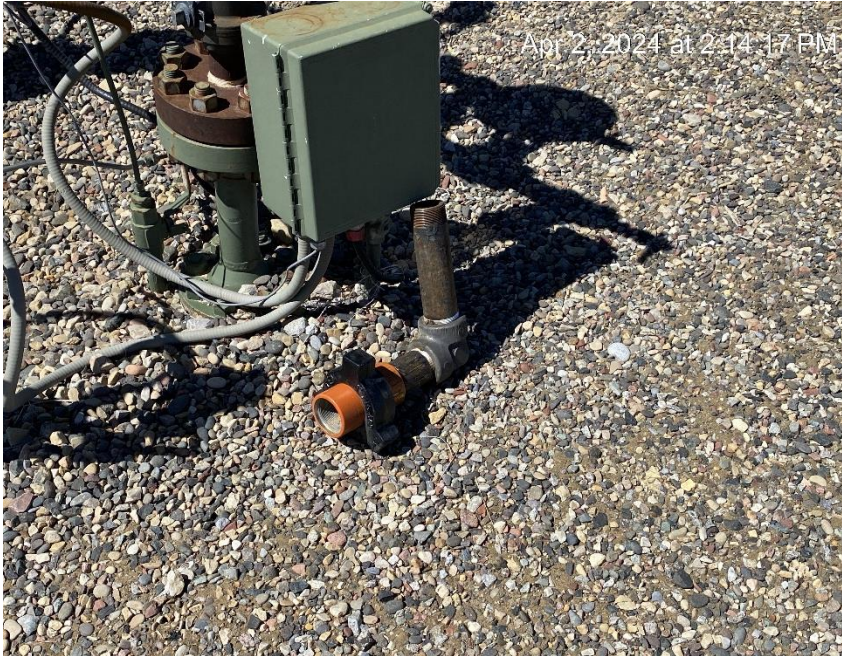
Debris

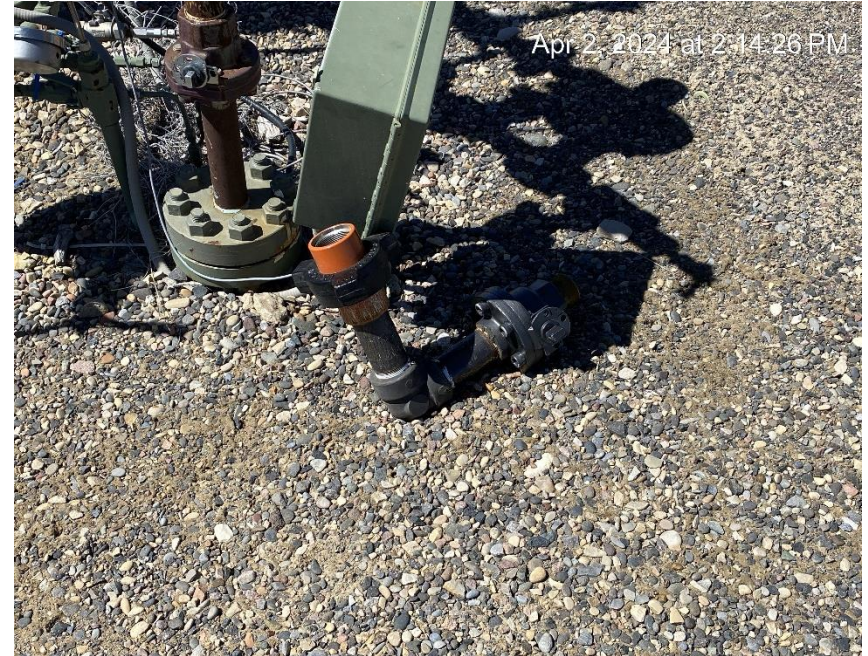
Debris

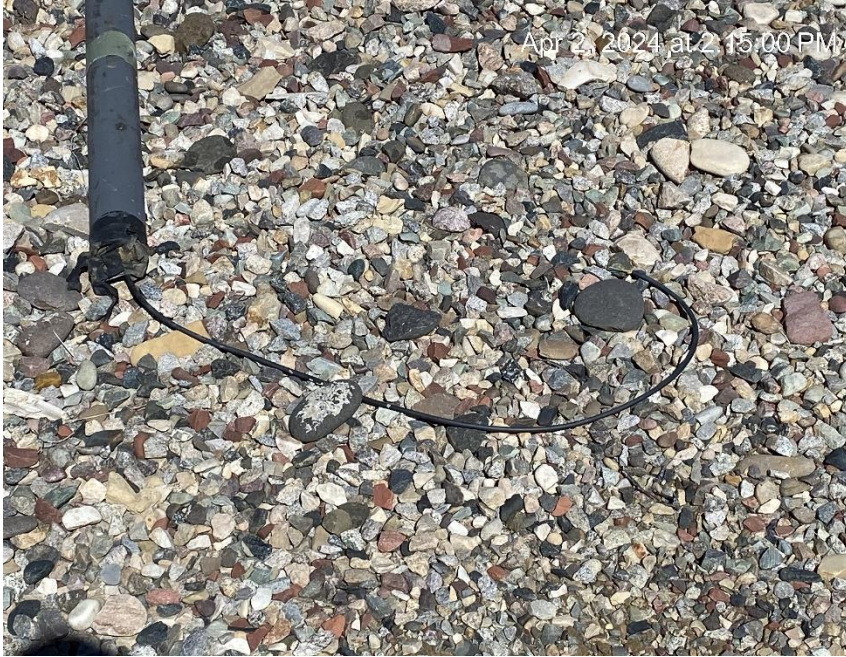
Equipment not hooked up

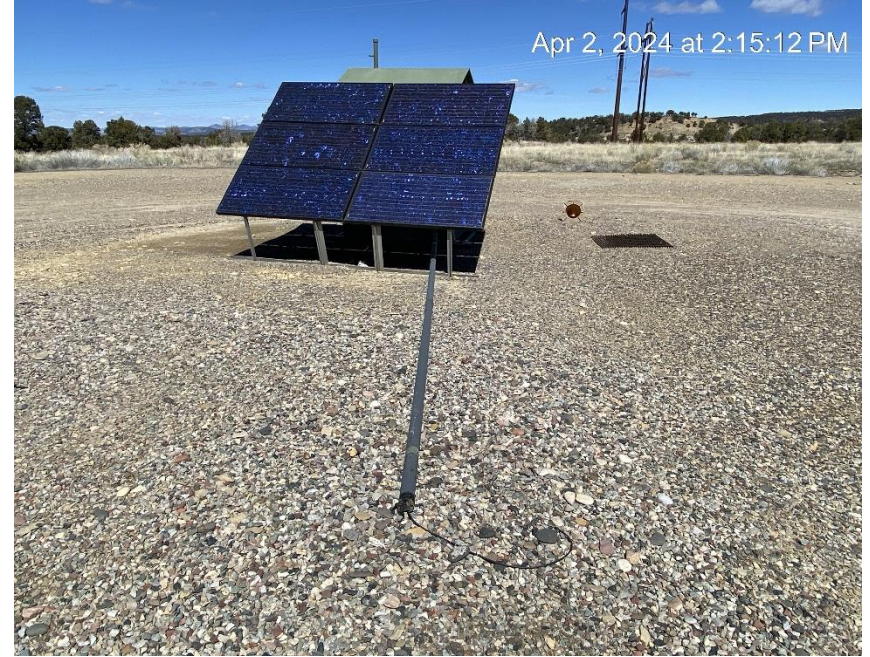
Unused equipment

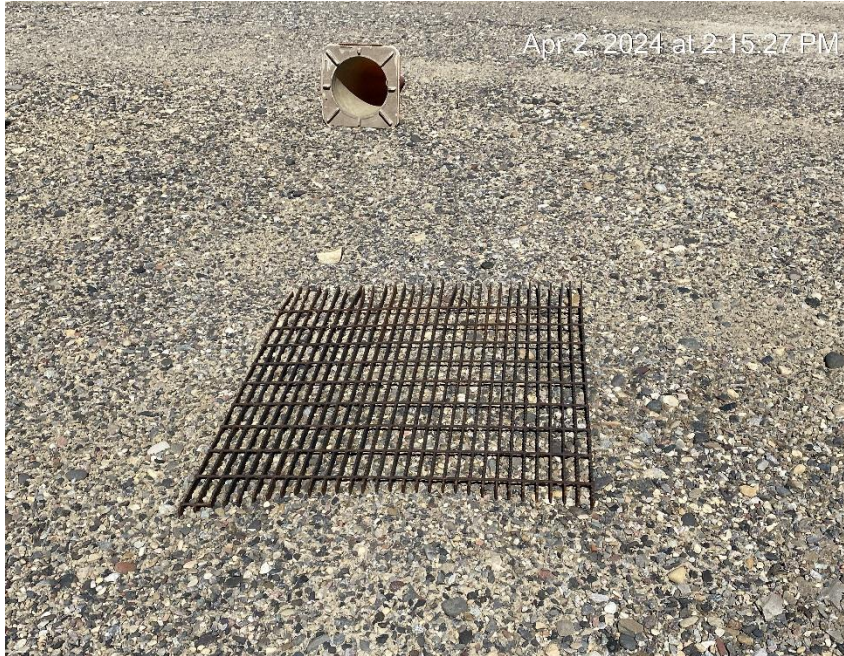
Debris

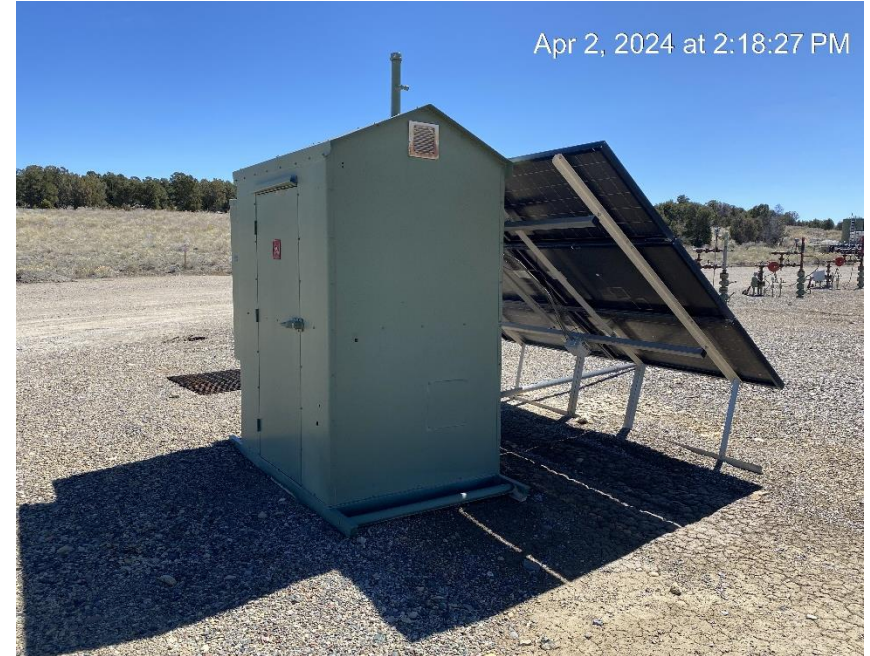
Unused equipment

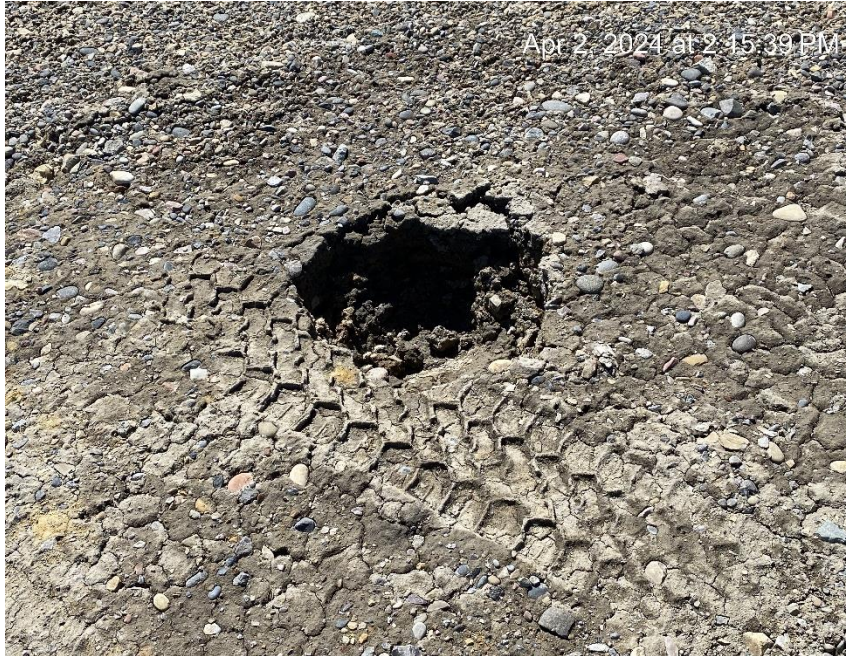
Sinkhole

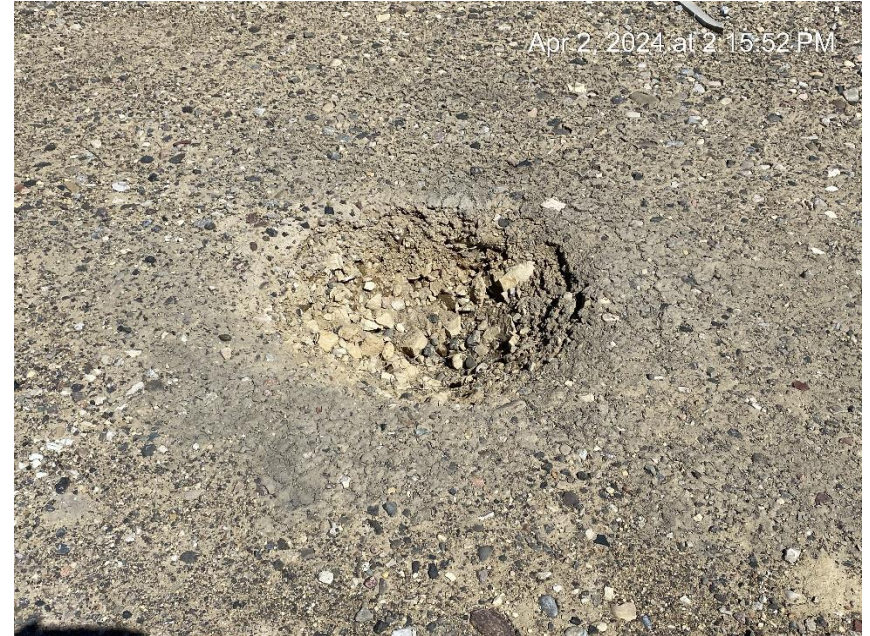
Sinkhole

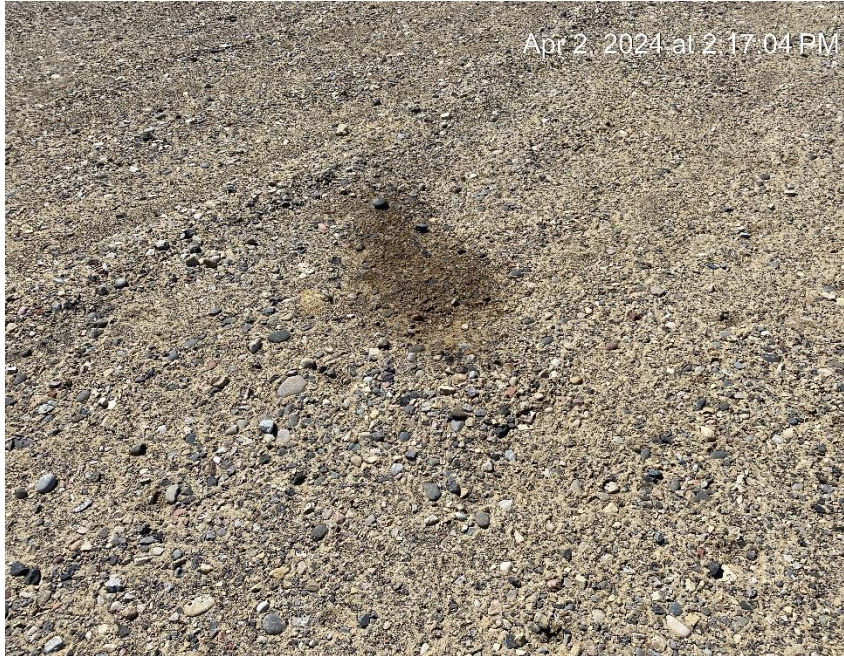
Stained soil

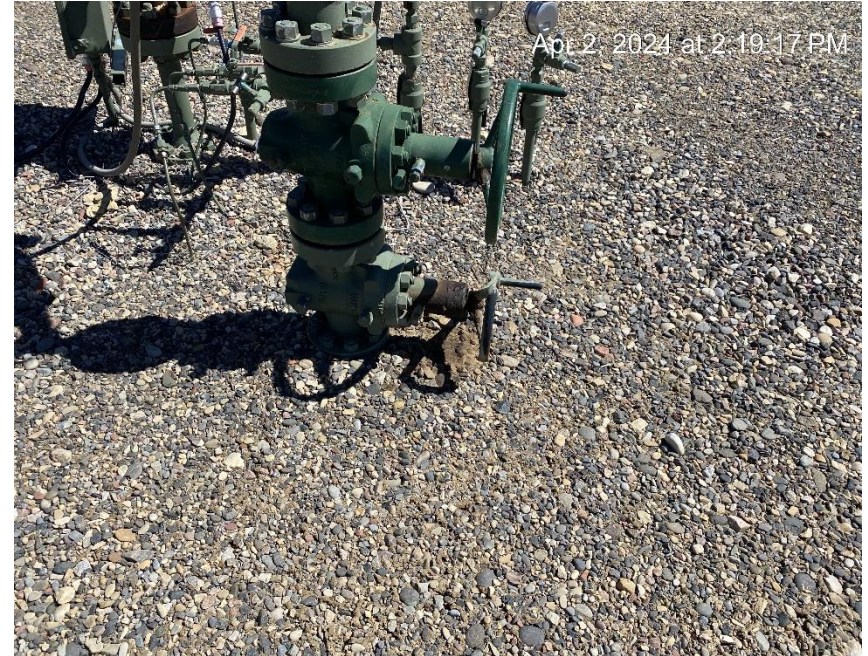
Stained soil
