Inspection Photos

Loc: 476137

Operator: **WILLIFORD ENERGY COMPANY**

Inspection Date: 3/26/2024

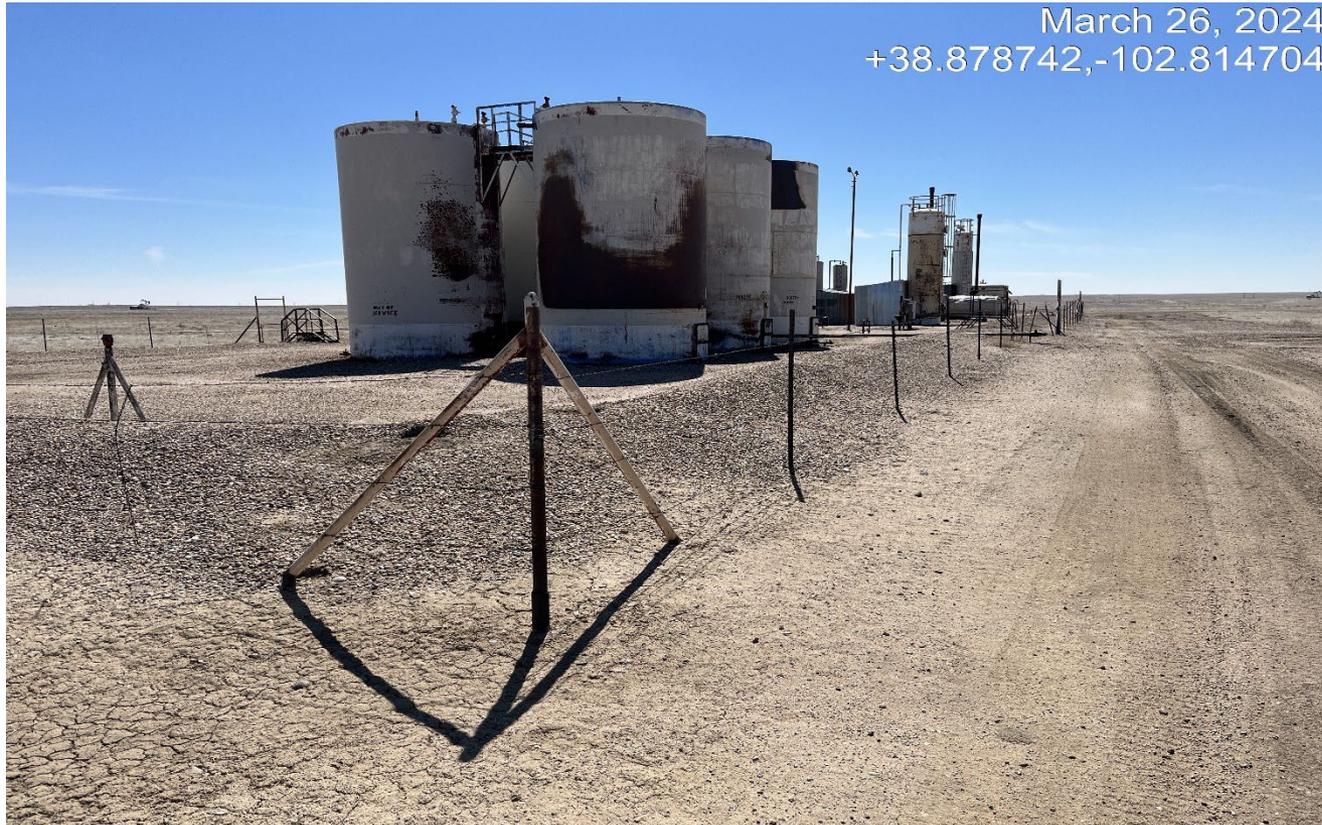
Photo 1. Facing southeast toward the tank battery,

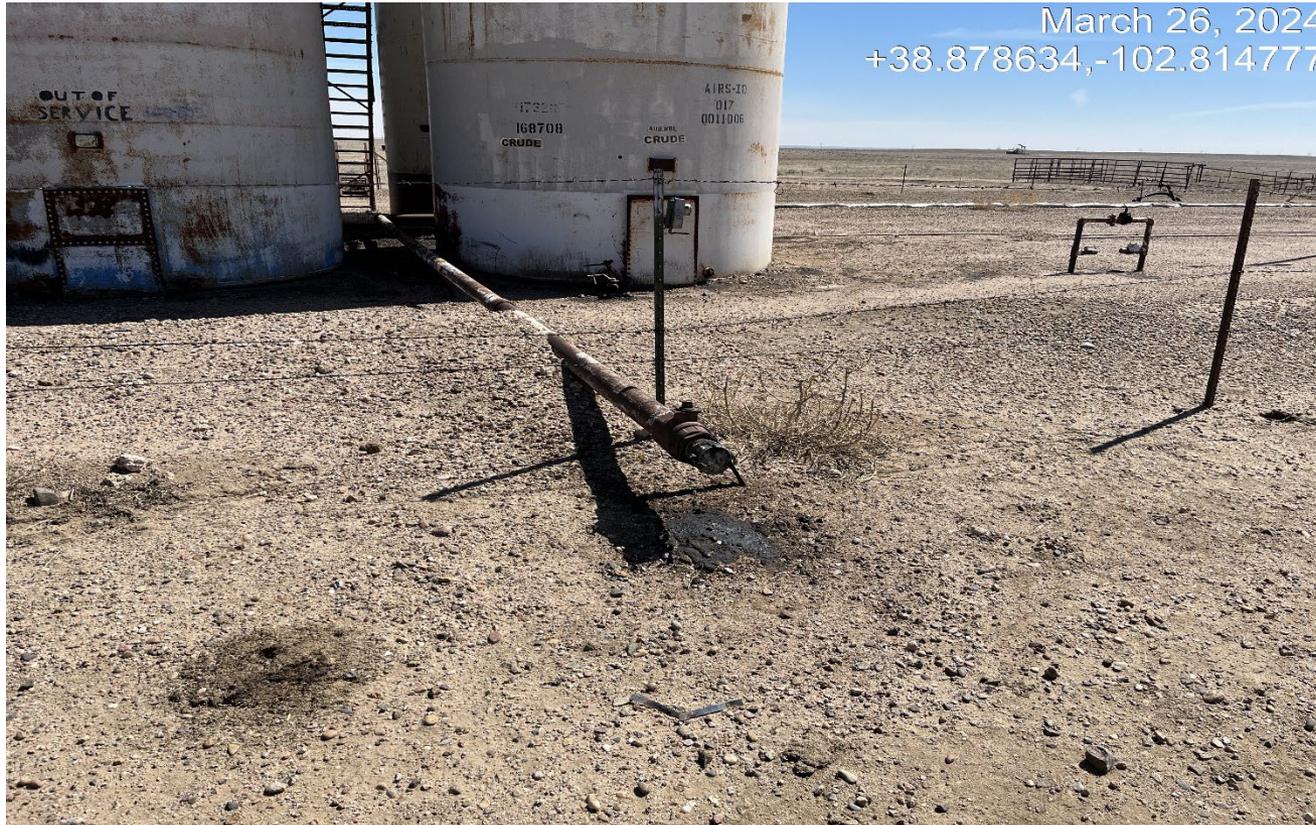
Photo 2. There is oily sludge that has leaked out of the tank load out pipe. Secondary containment needs to be installed and the stained material must be cleaned up.

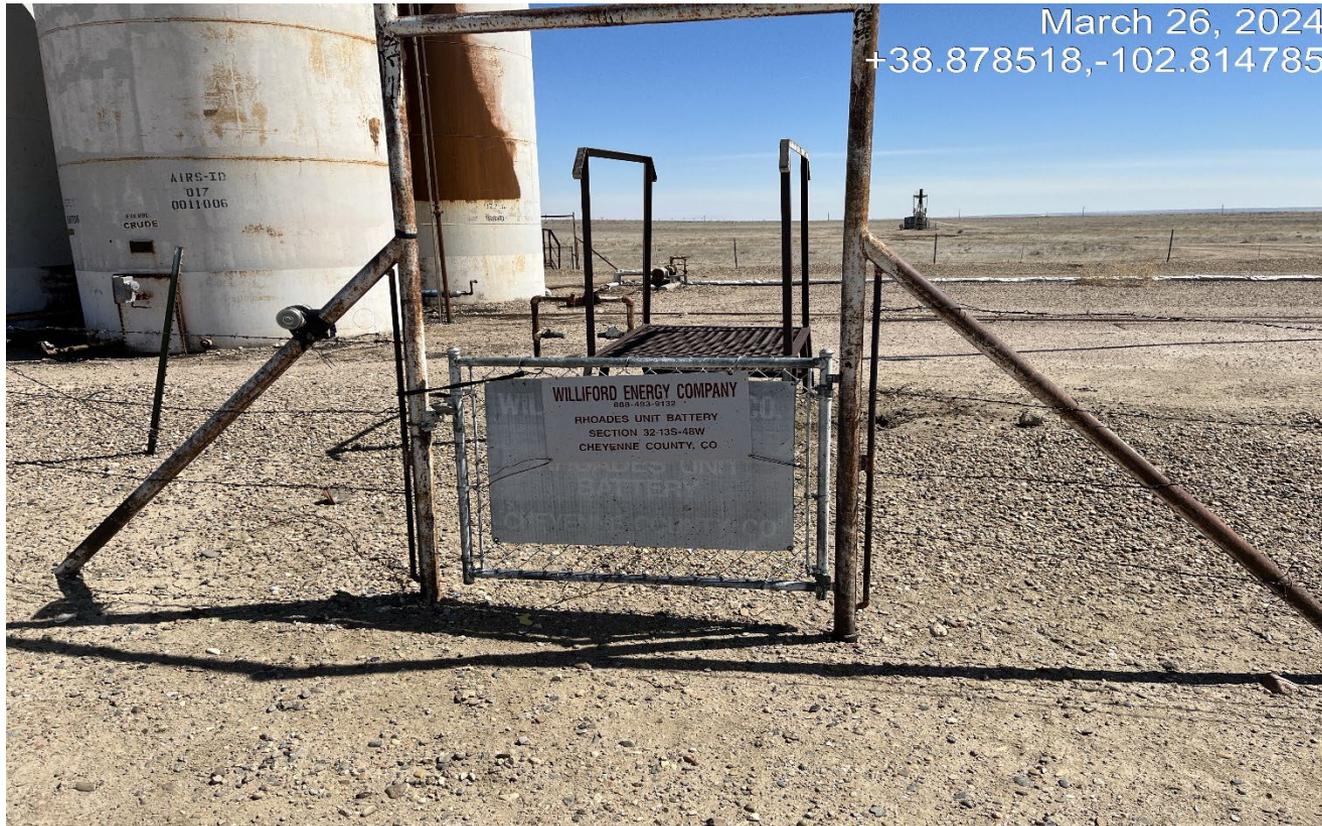
Photo 3. Tank battery sign is posted at west side gate.

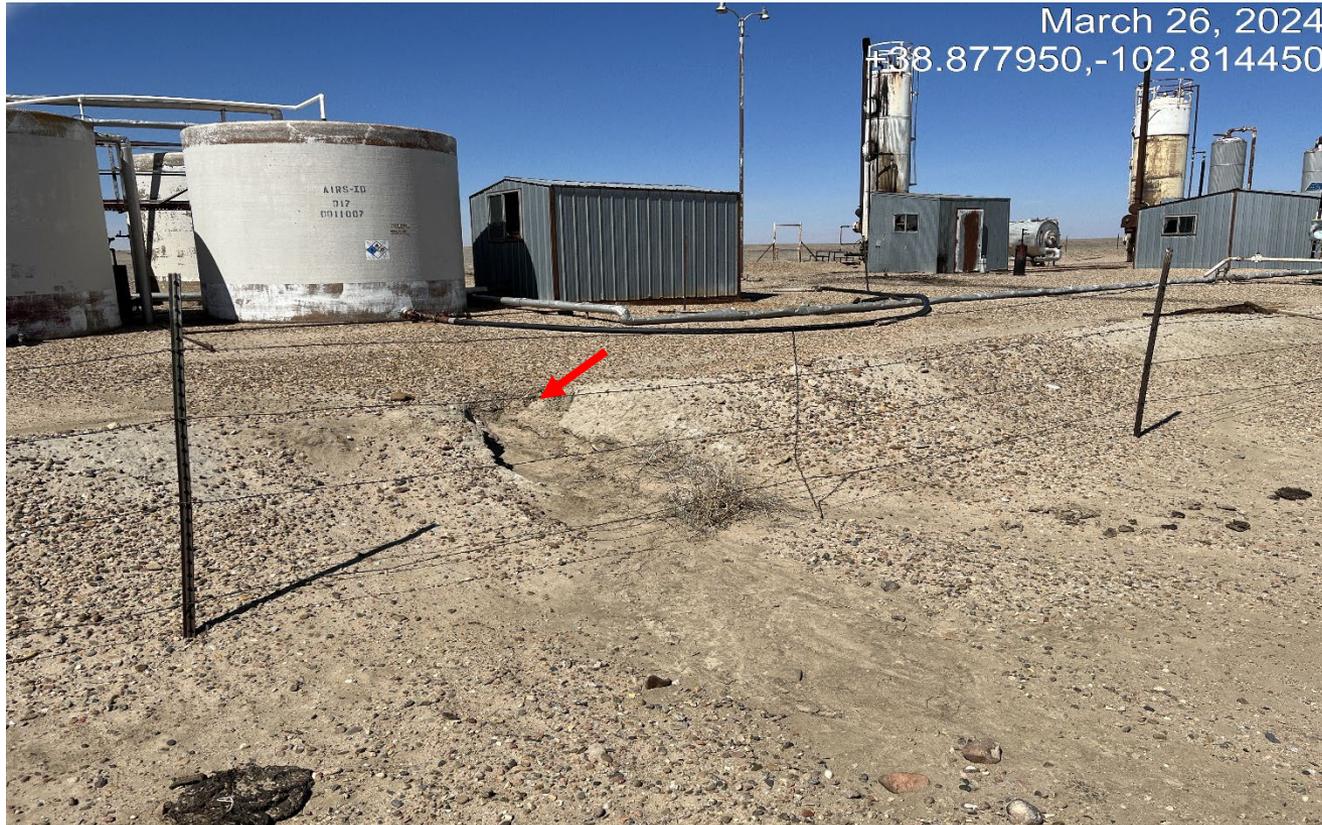
Photo 4. Southeast side of the location facing northwest, The secondary containment has been eroded and needs to be rebuilt in this area.

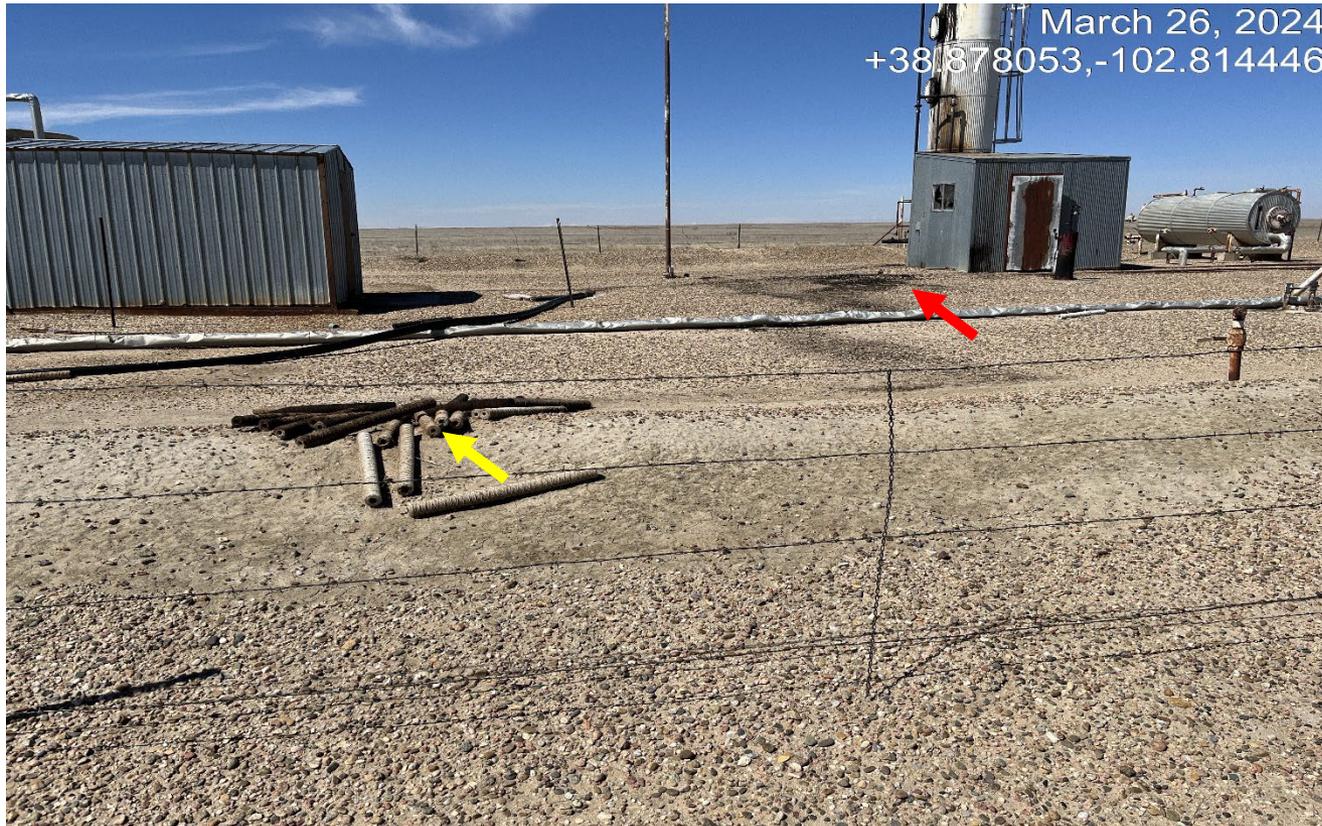
Photo 5. Facing west at the battery. There is stained soils shown at red arrow that need to be cleaned up. The yellow arrow points to insulation debris that needs to be removed.

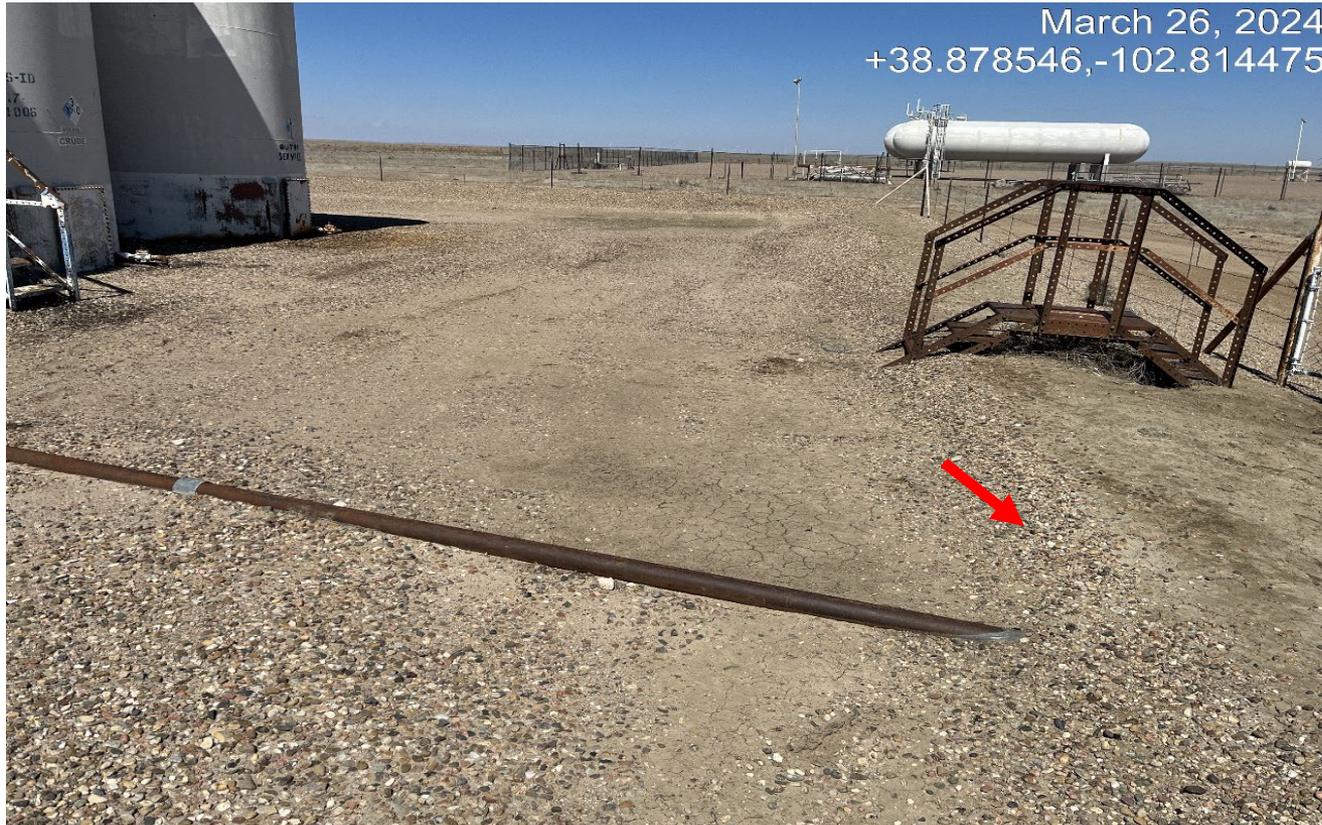
Photo 6. Facing toward the northeast side of the tank battery. The berm along the area is worn down and needs to be built up better for containmat.
