Final Reclamation and Stormwater Inspection

Operator: KERR MCGEE OIL & GAS ONSHORE LP

Location ID: 333265

Inspection Photos
Location Name: Trolco 65N67W
Location ID: 333265

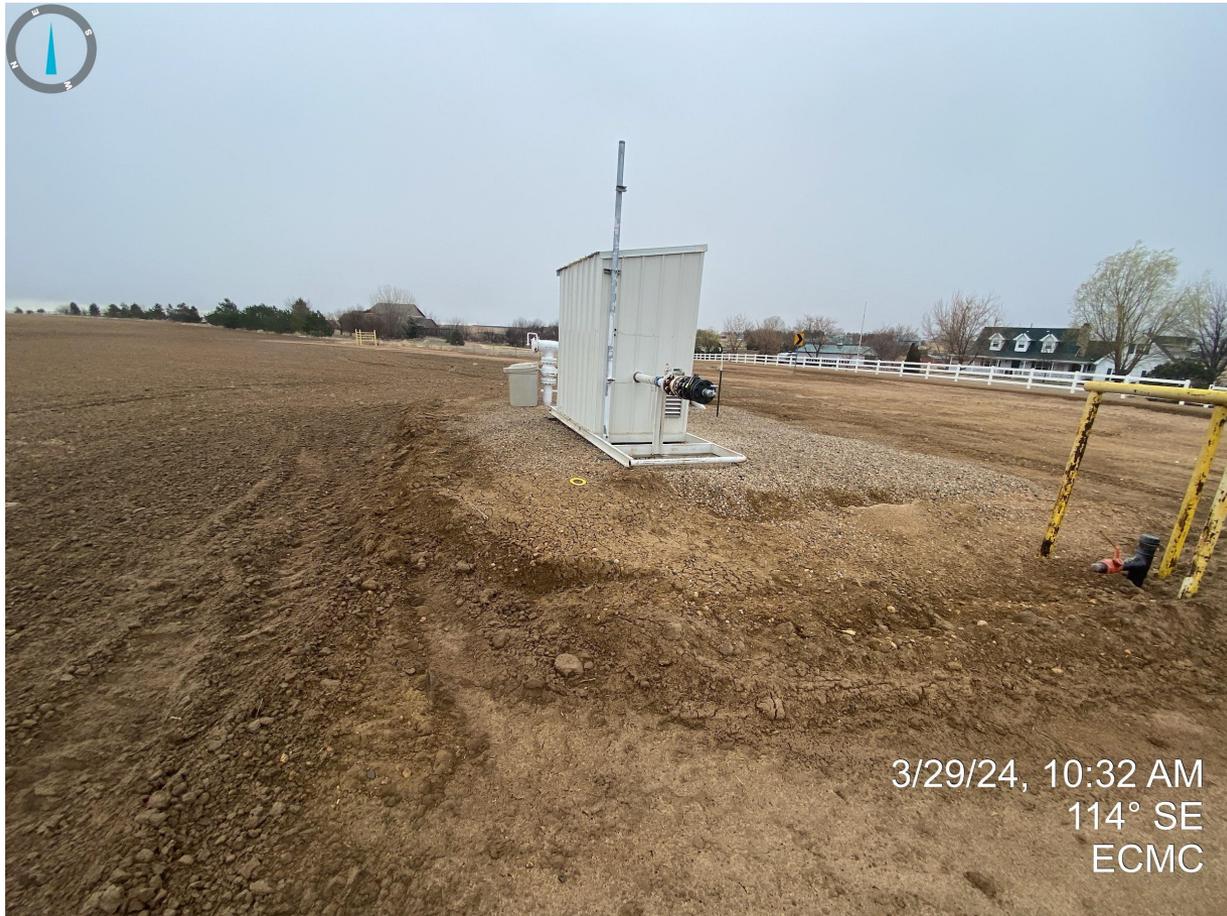
Photo 1. Midstream equipment remains on the former tank battery location. Operator shall continue to work with Midstream Operator to remove equipment as soon as possible.

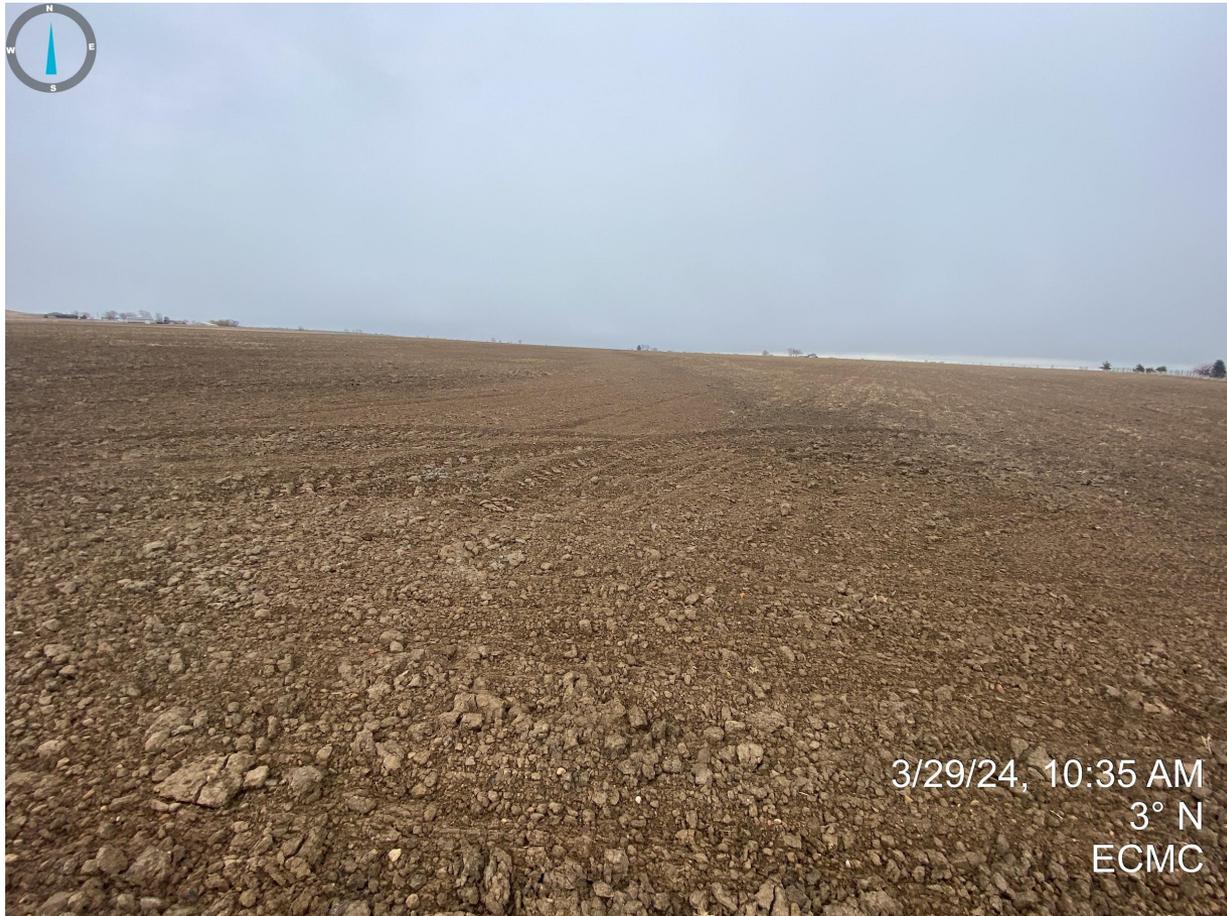
Photo 2. Taken from the southern portion of the former access road. Road base material has been removed and the former access road has been contoured/graded to match existing ag field.

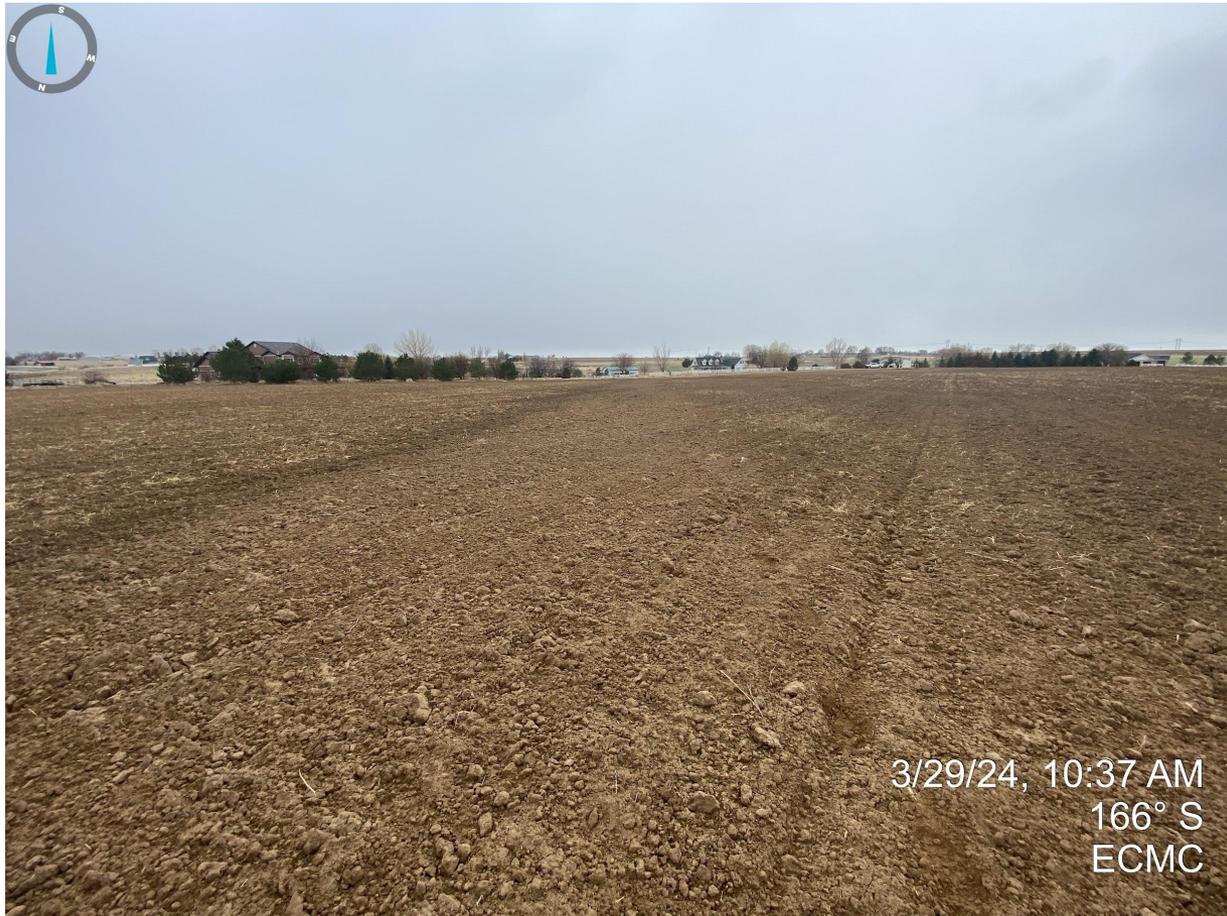
Photo 3. Taken from the access road/southern portion of the location, facing south. See comments in Photo 2.

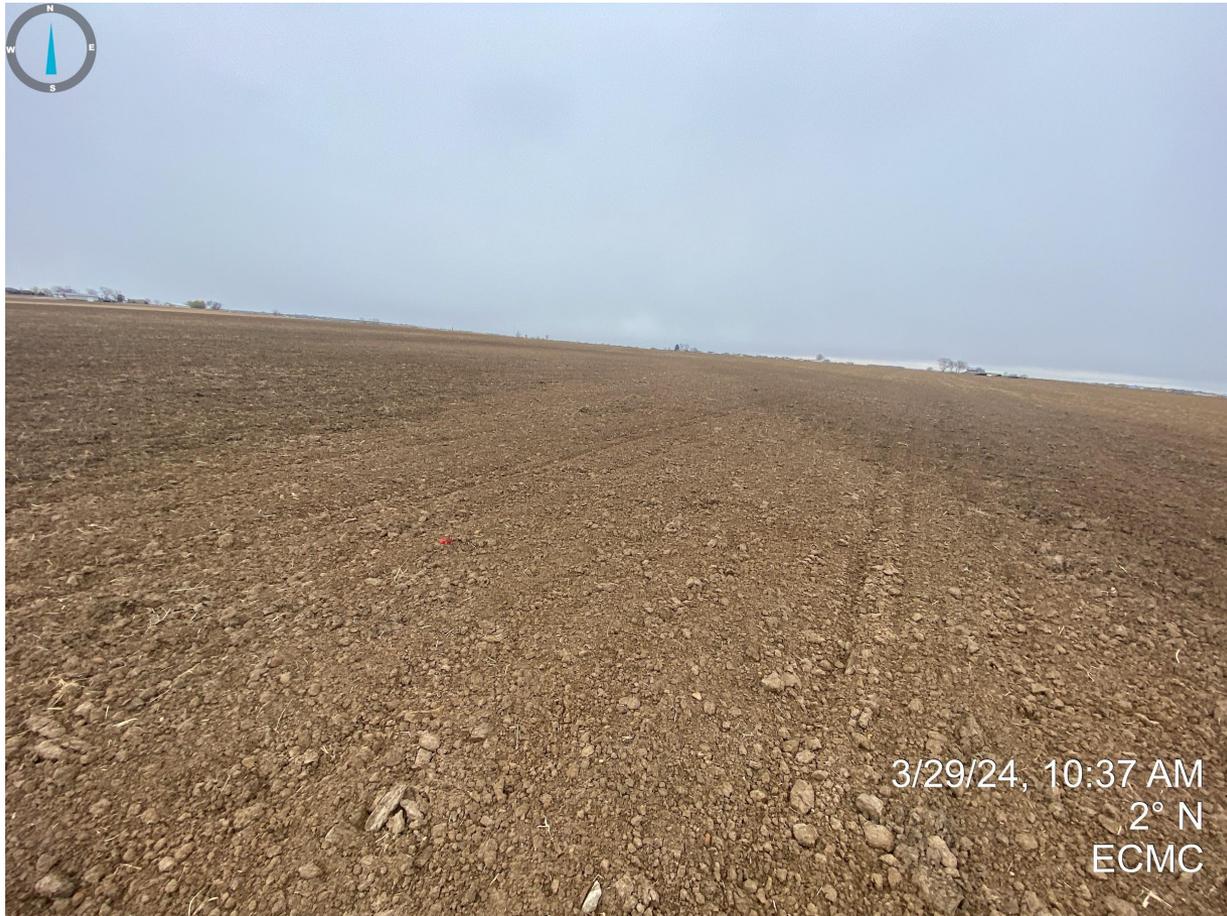
Photo 4. Taken from the access road/southern portion of the location, facing north. See comments in Photo 2

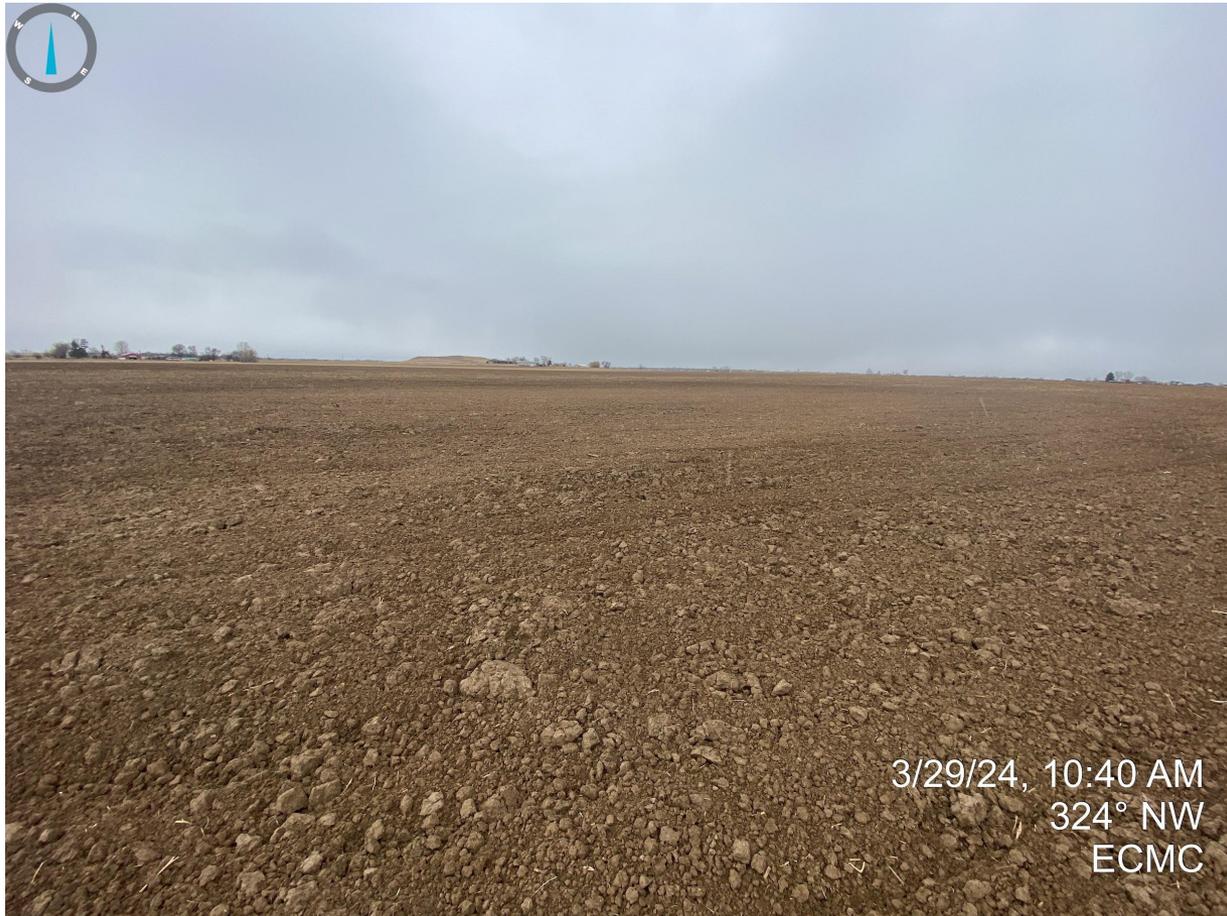
Photo 5. Taken from the eastern portion of the well location, facing northwest. The former well location has been contoured/graded to match existing ag field and all surface equipment has been removed. A follow-up inspection will be conducted at a later date to verify vegetative compliance with Rule 1004.

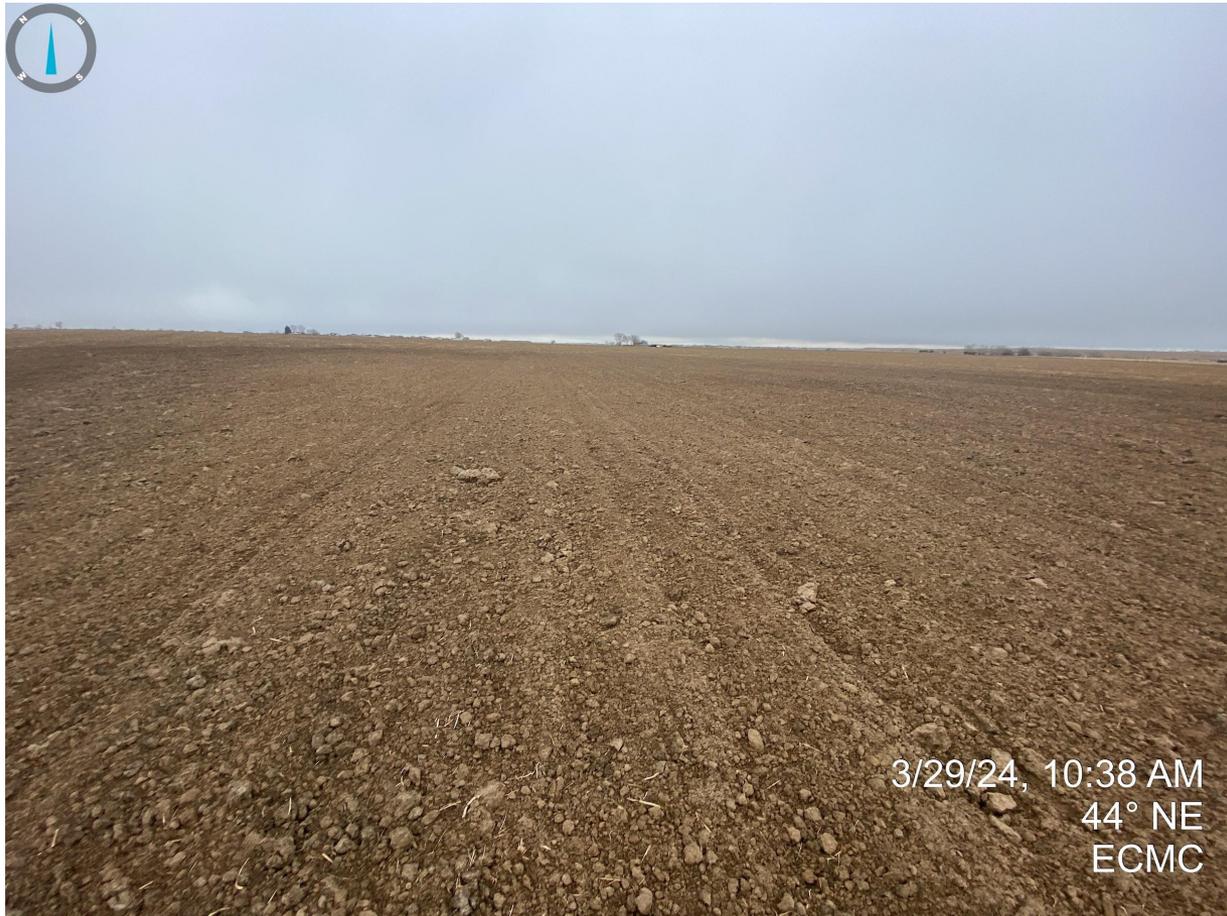
Photo 6. Taken from the southern portion of the well location, facing northeast. See comments in Photo 5.

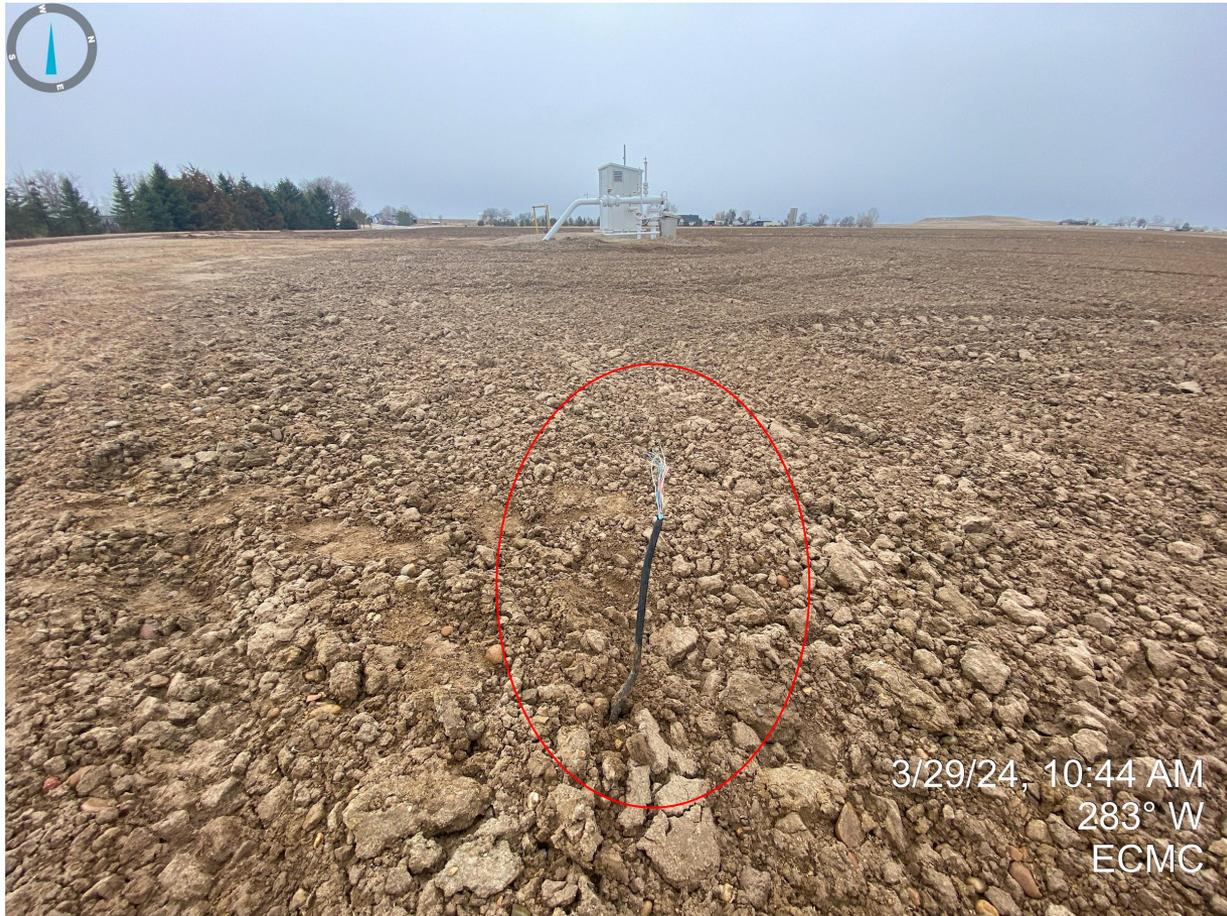
Photo 7. Debris (wire) observed along the former access road.
