KT Resources LLC
 Ant Hill Unit 19-44
 Location ID: 316310

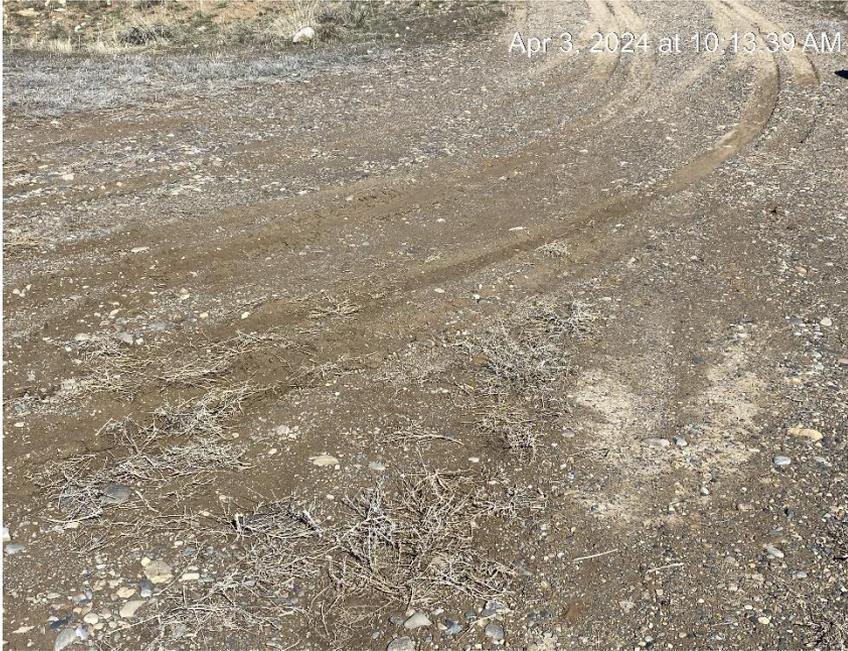
Entrance to location

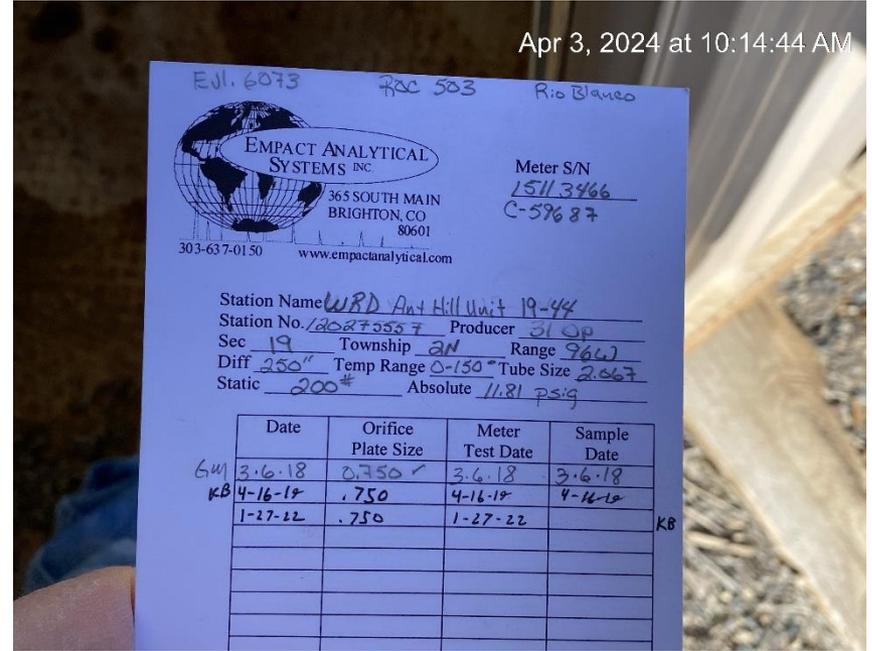
Gas meter calibration overdue

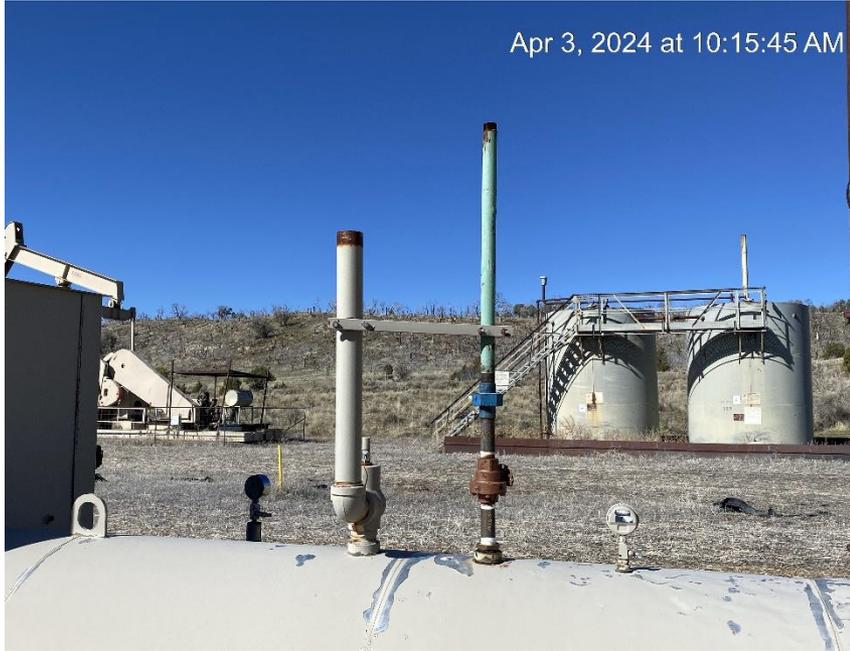
Relief risers missing rain protection

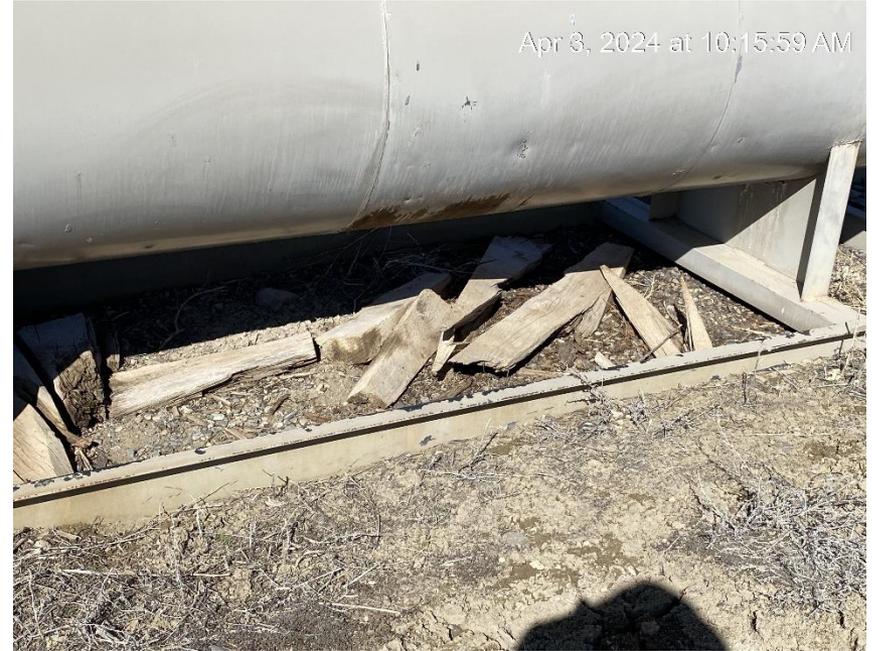
Debris

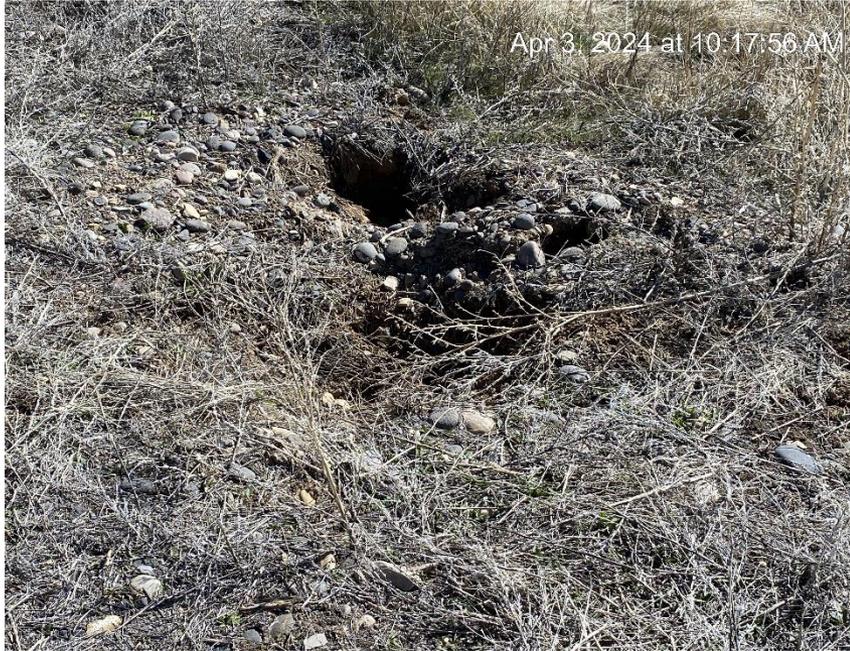
Erosion and sediment migration

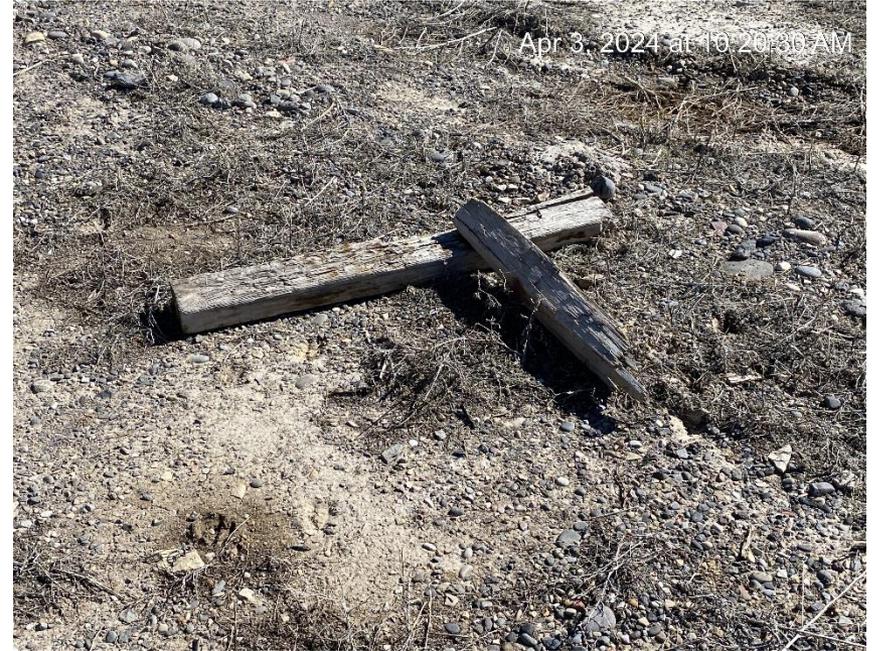
Debris

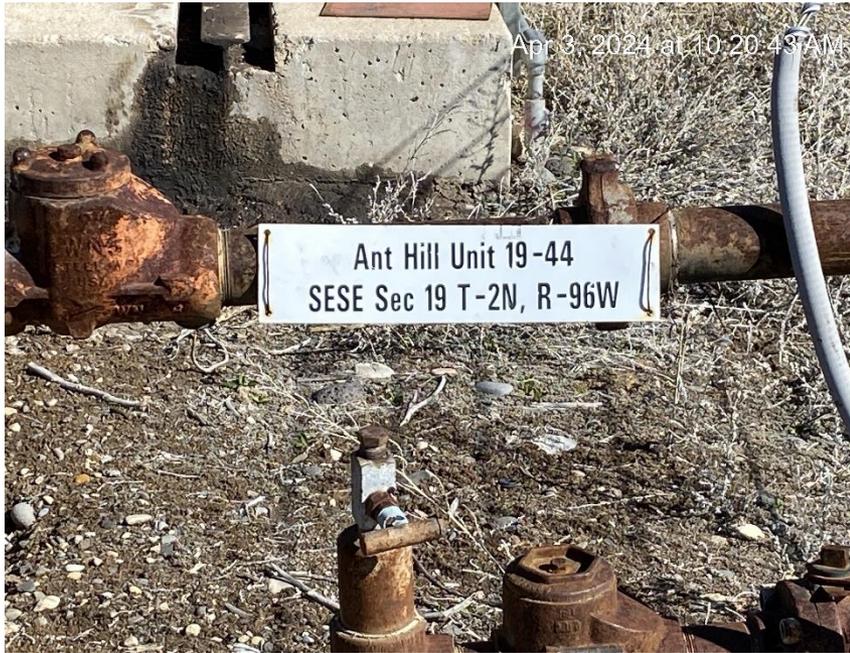
When replaced additional information is required

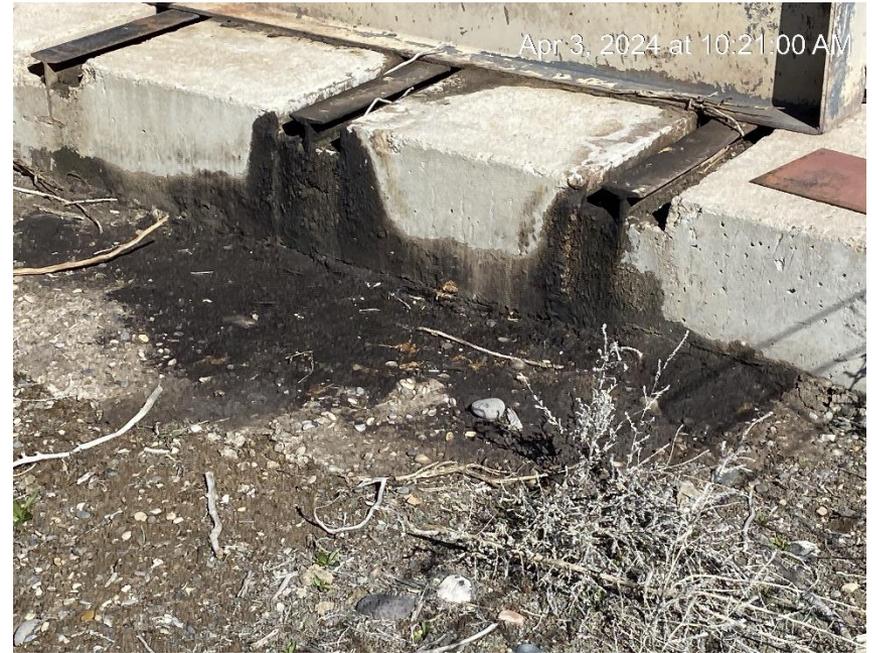
Soil staining

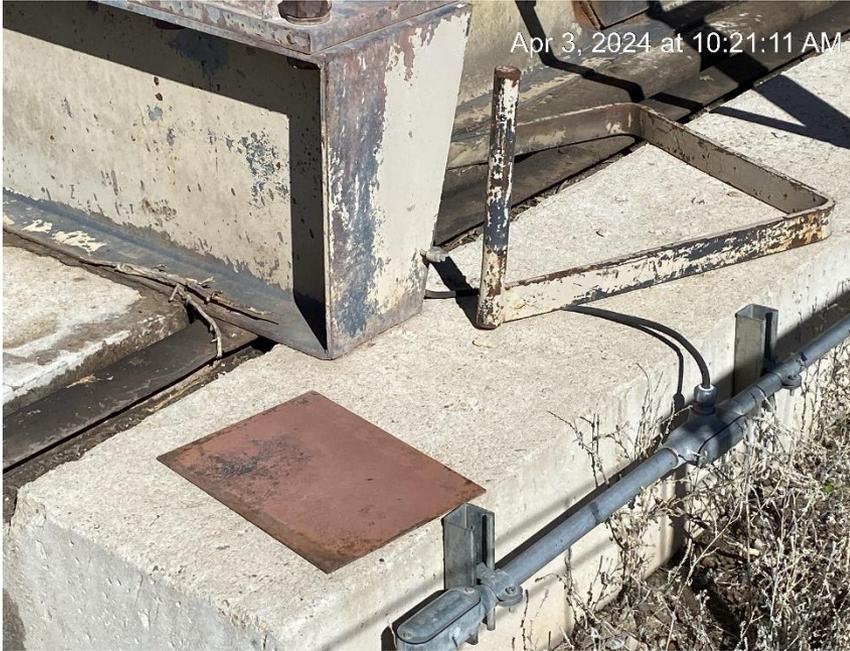
Debris

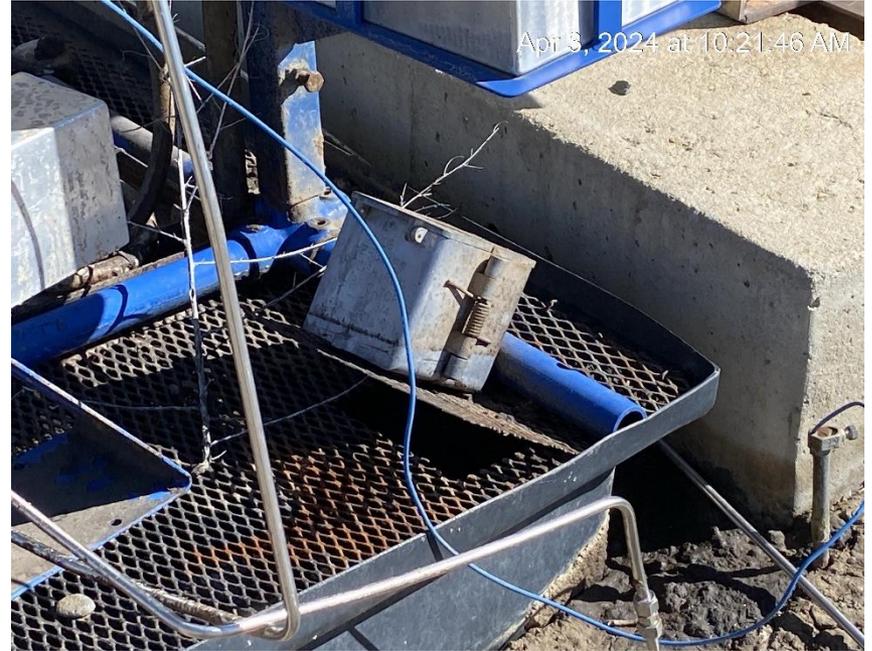
Debris

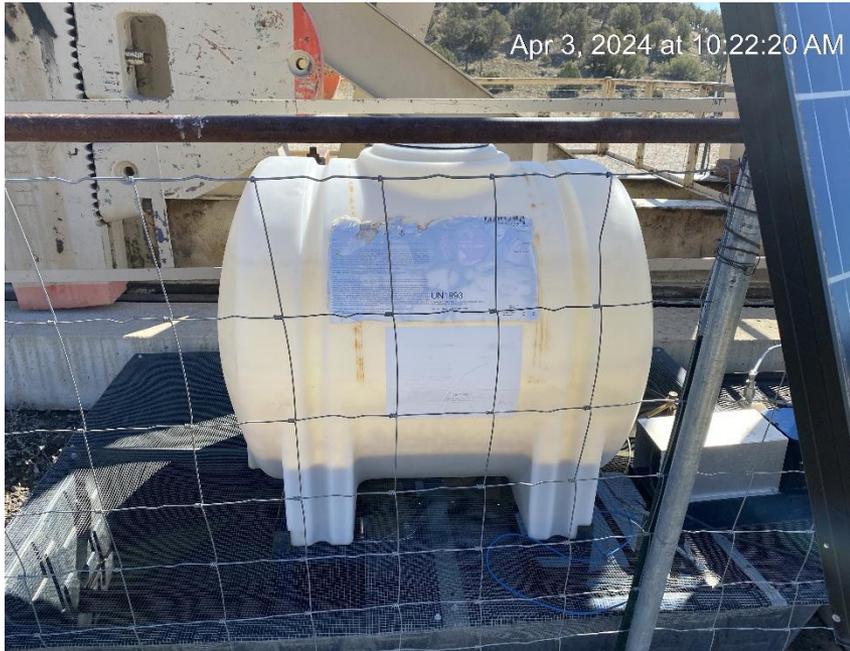
Illegible label

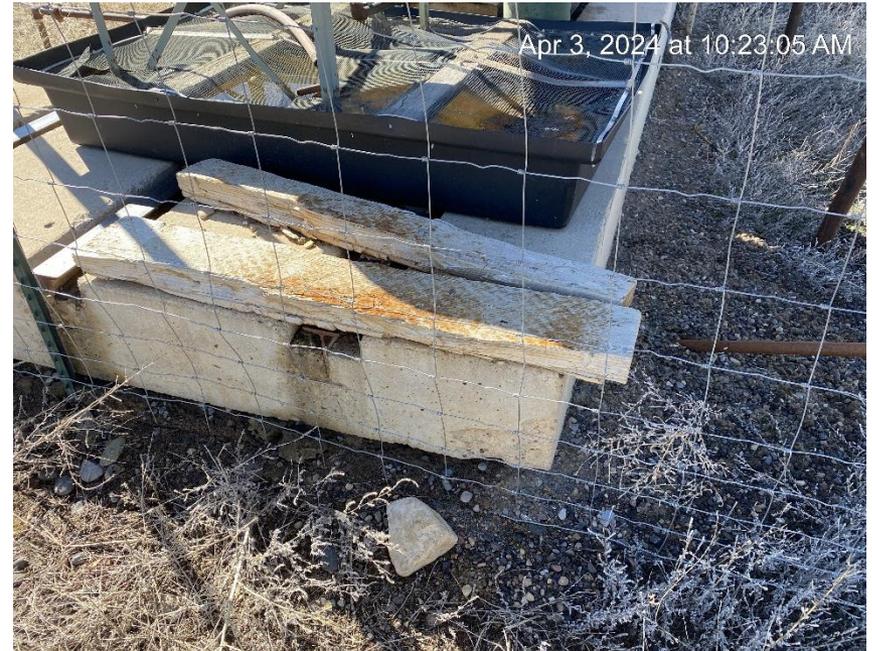
Debris

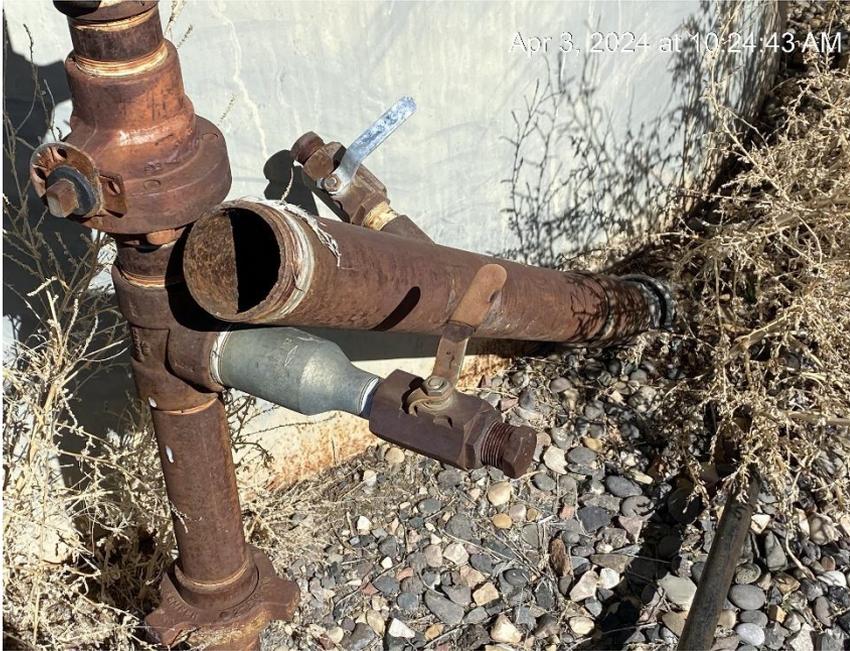
Debris

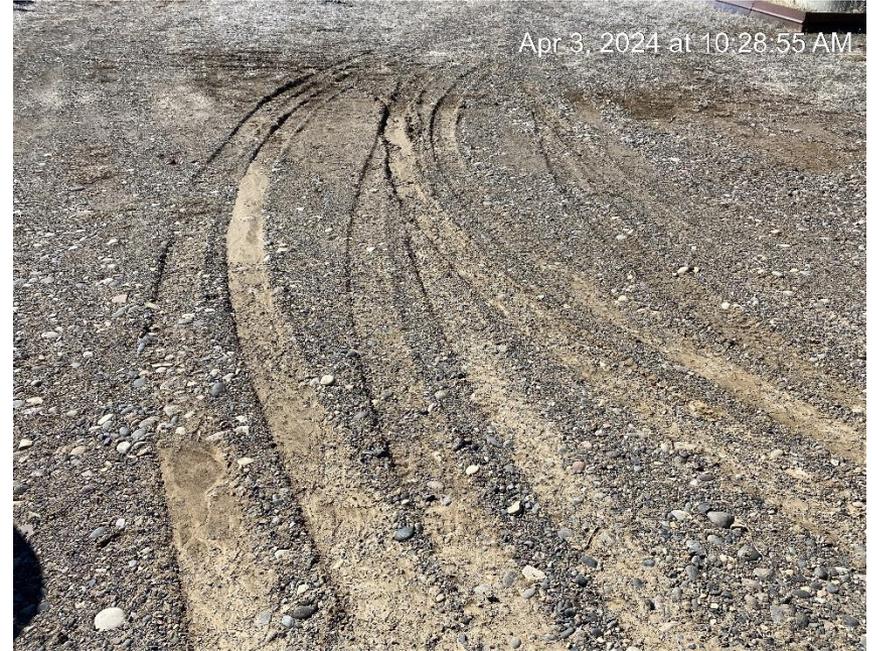
Sediment migration
