Inspection Photos

Loc: 483886

Operator: BNL (ENTERPRISE) INC

Inspection Date: 4/2/2024

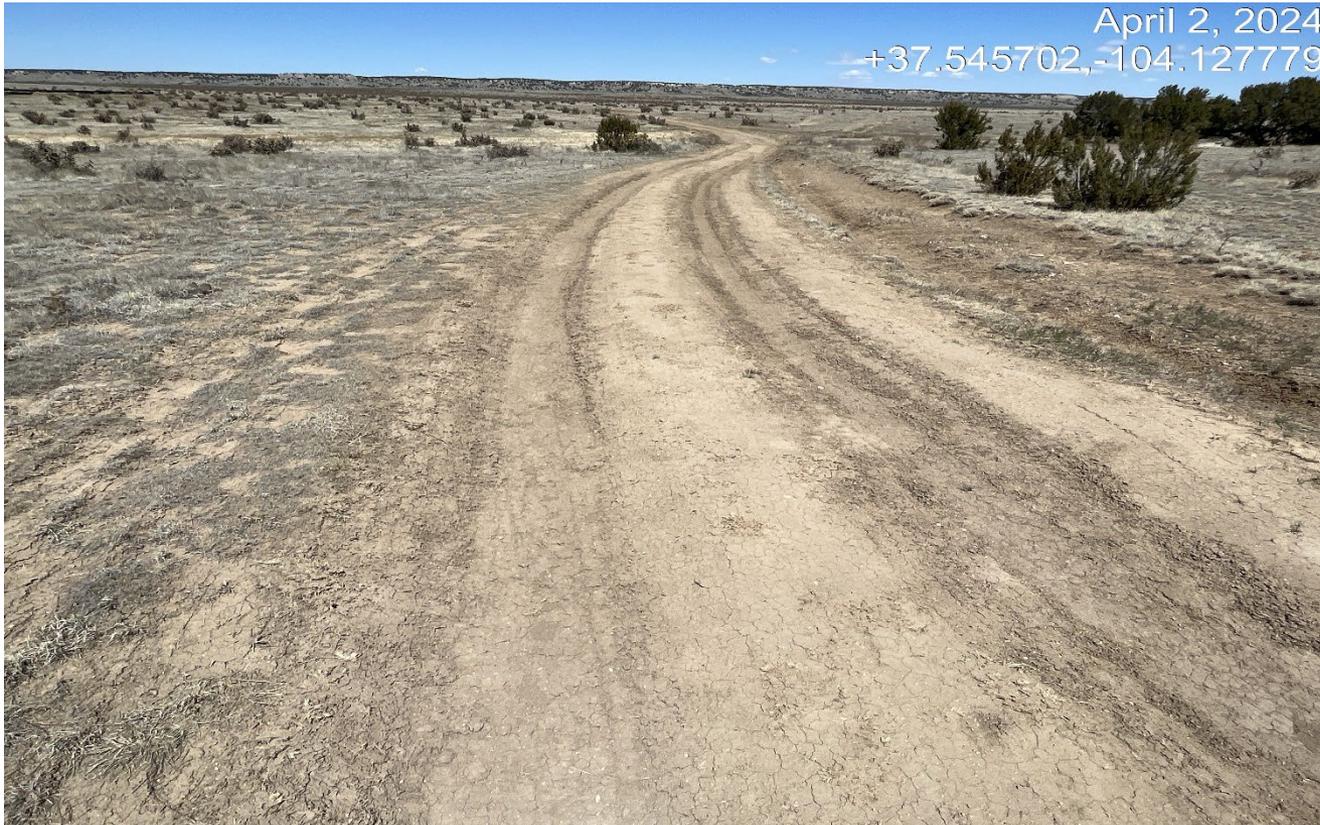
Photo 1. Facing north along the access road. The road needs to be built and stabilized with BMP's.

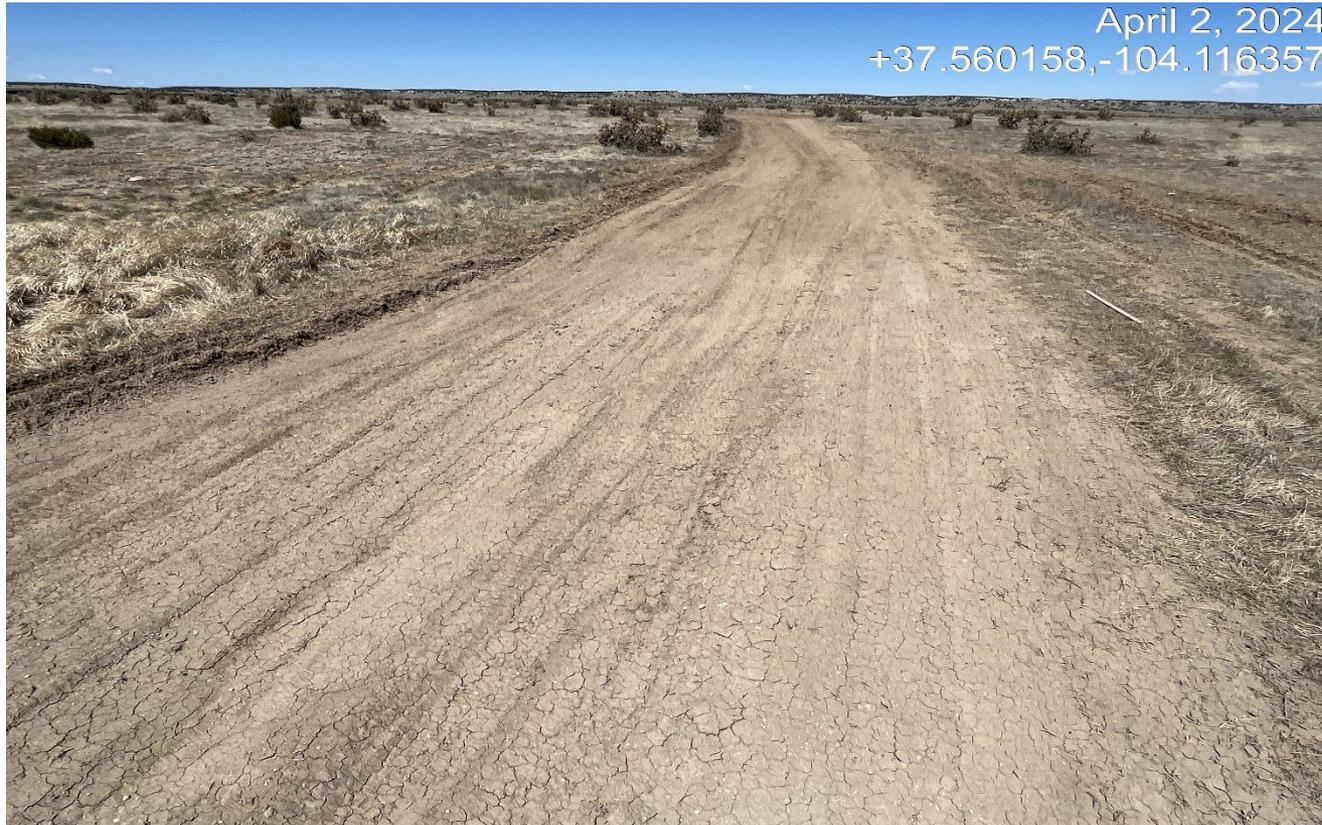
Photo 2. Facing north along the road. There is vehicle rutting that needs to be repaired and stabilized to prevent rutting and road damage. Previous corrective action was not completed.

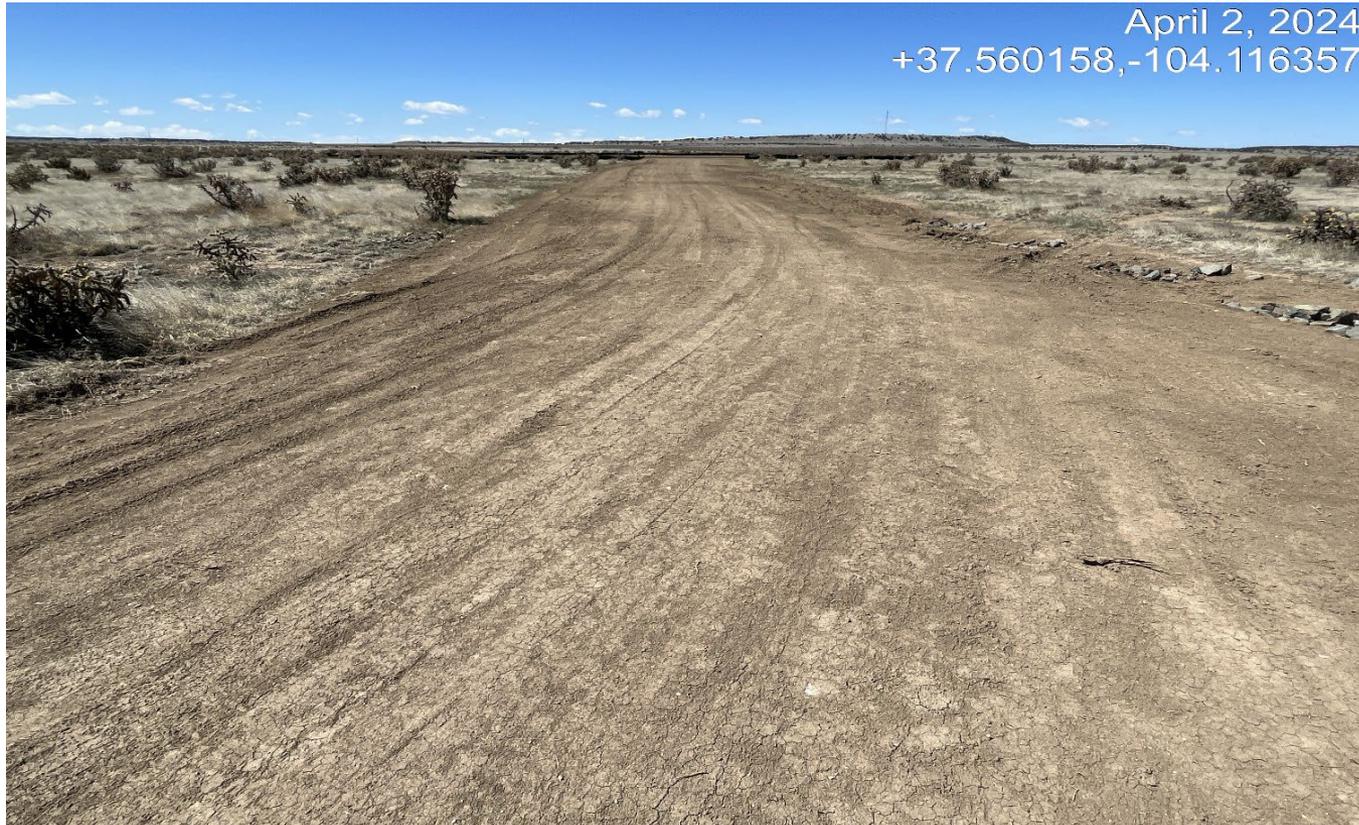
Photo 3. Facing northwest toward the access road. The side of the road needs to be seeded and stabilized and the road needs to be crowned and graveled if the well is developed. Previous corrective action was not completed.

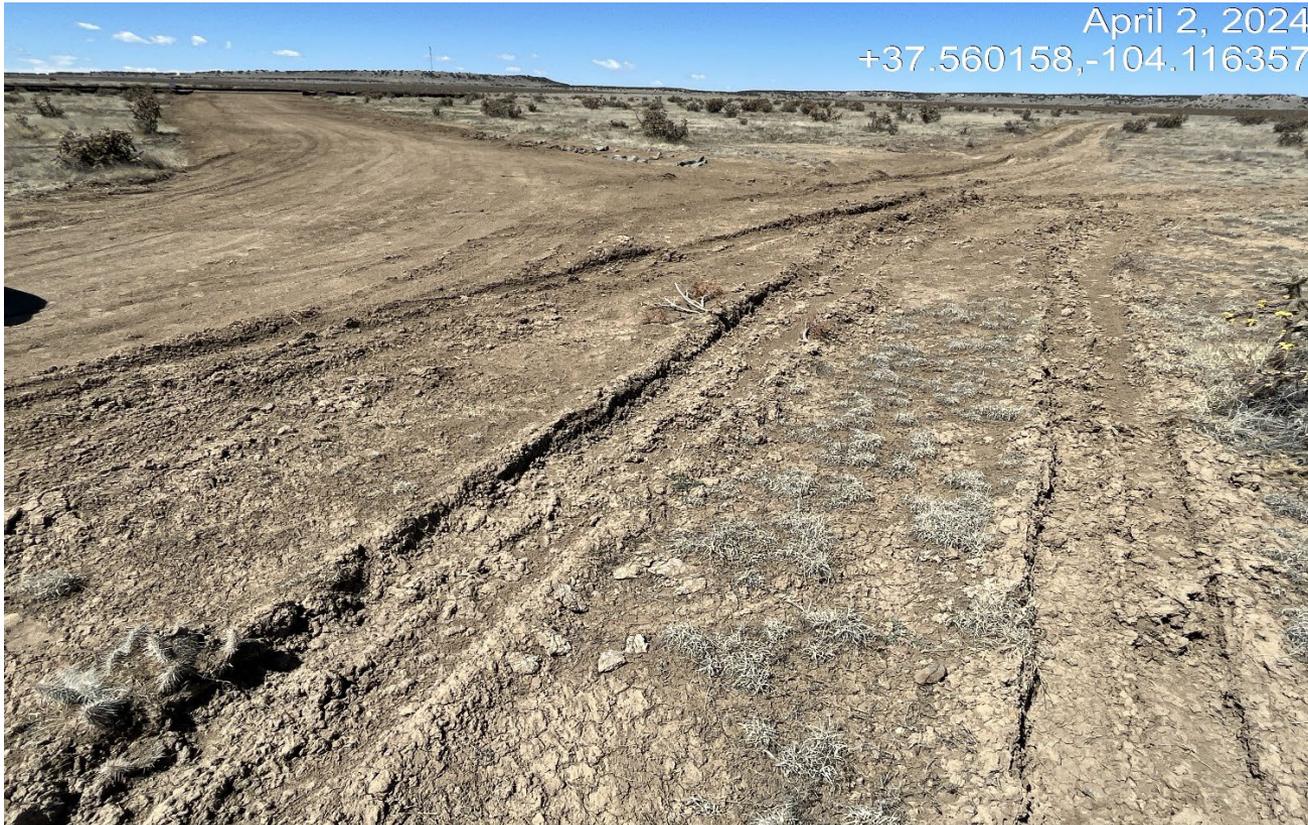
Photo 4. The vehicle ruts that went outside of the road will need to be raked and seeded. Previous corrective action was not completed.

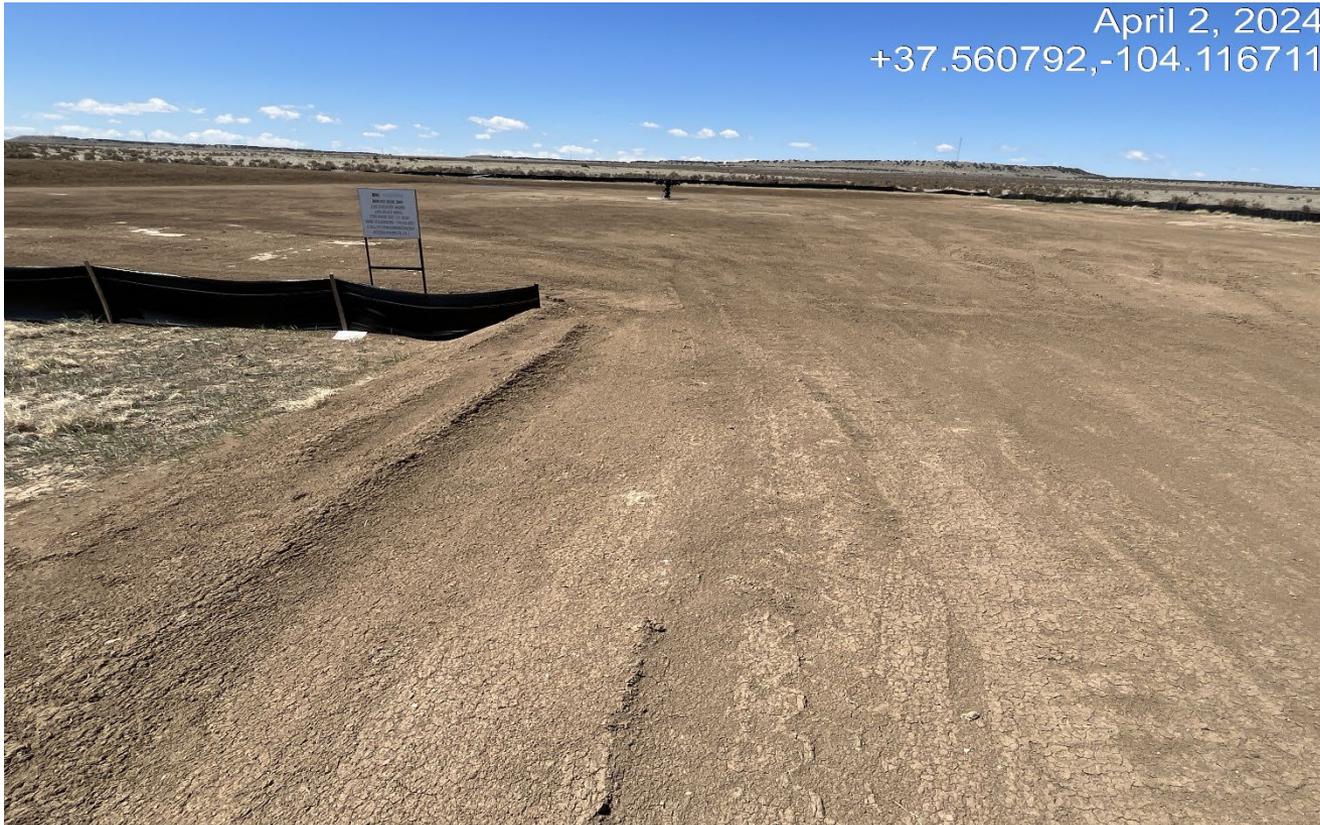
Photo 5. Facing northwest toward the location.

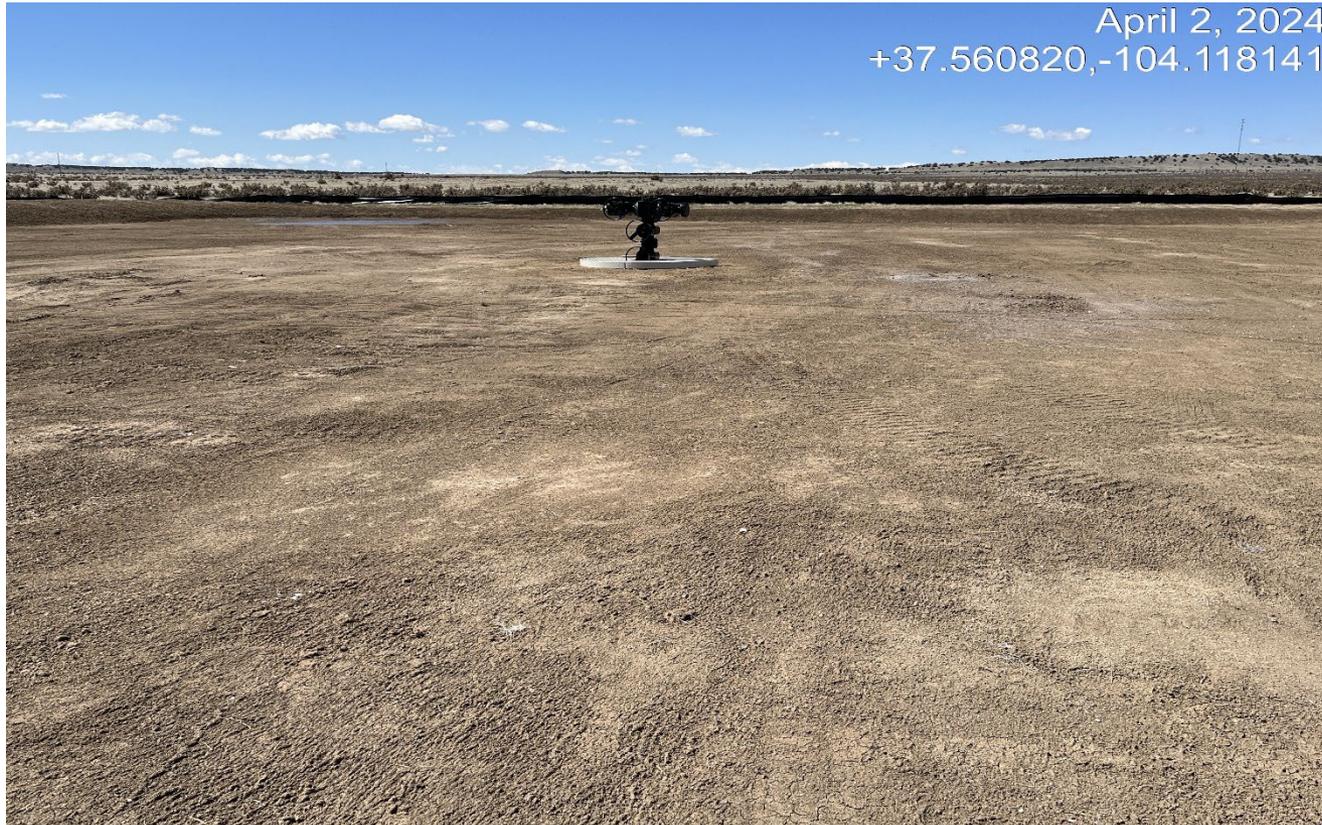
Photo 6. Facing toward the drilled well. The drill cuttings have been removed.

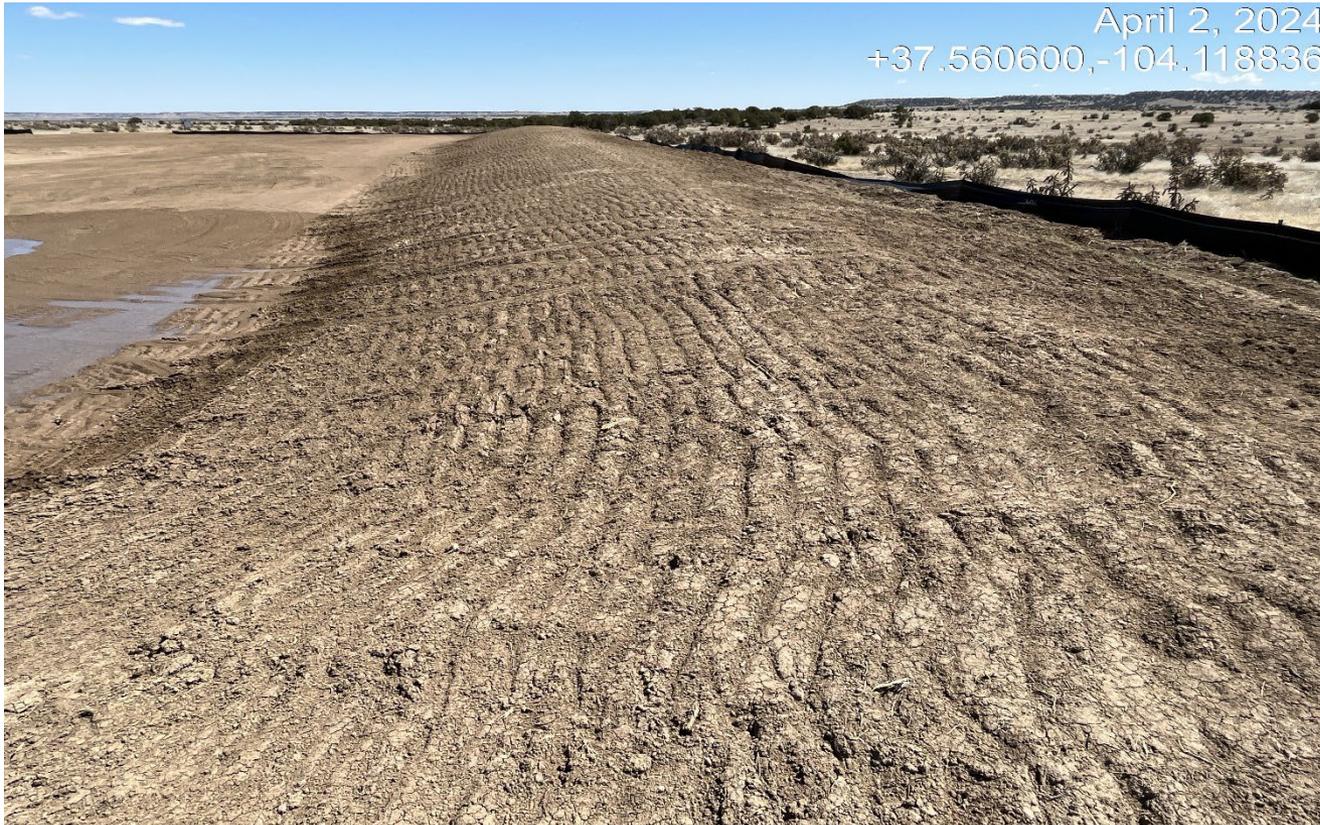
Photo 7. Facing toward the soil stock pile. The stock pile will need to be seeded before the growing season unless it will be re-spread for reclamation before that time.

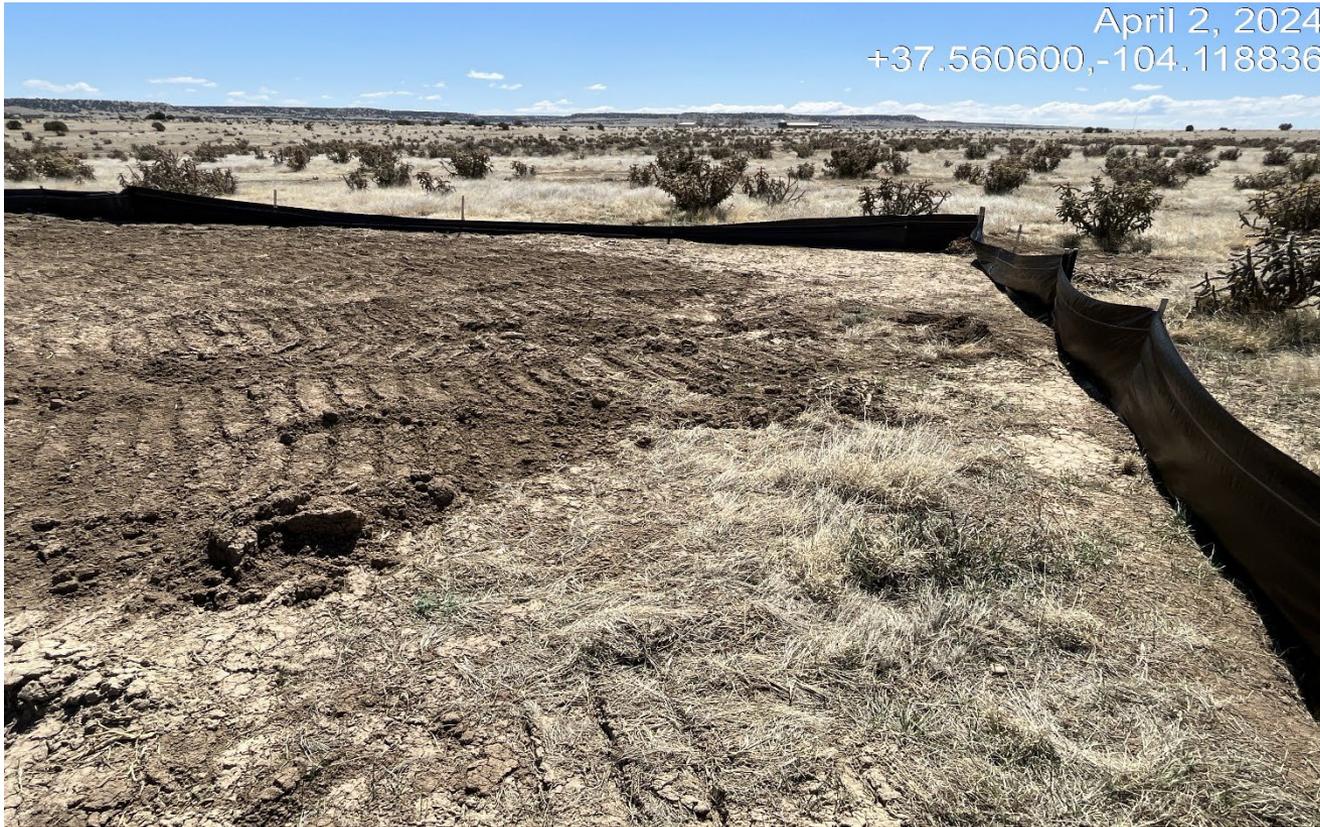
Photo 8. There are several areas where the silt fence is not maintained.

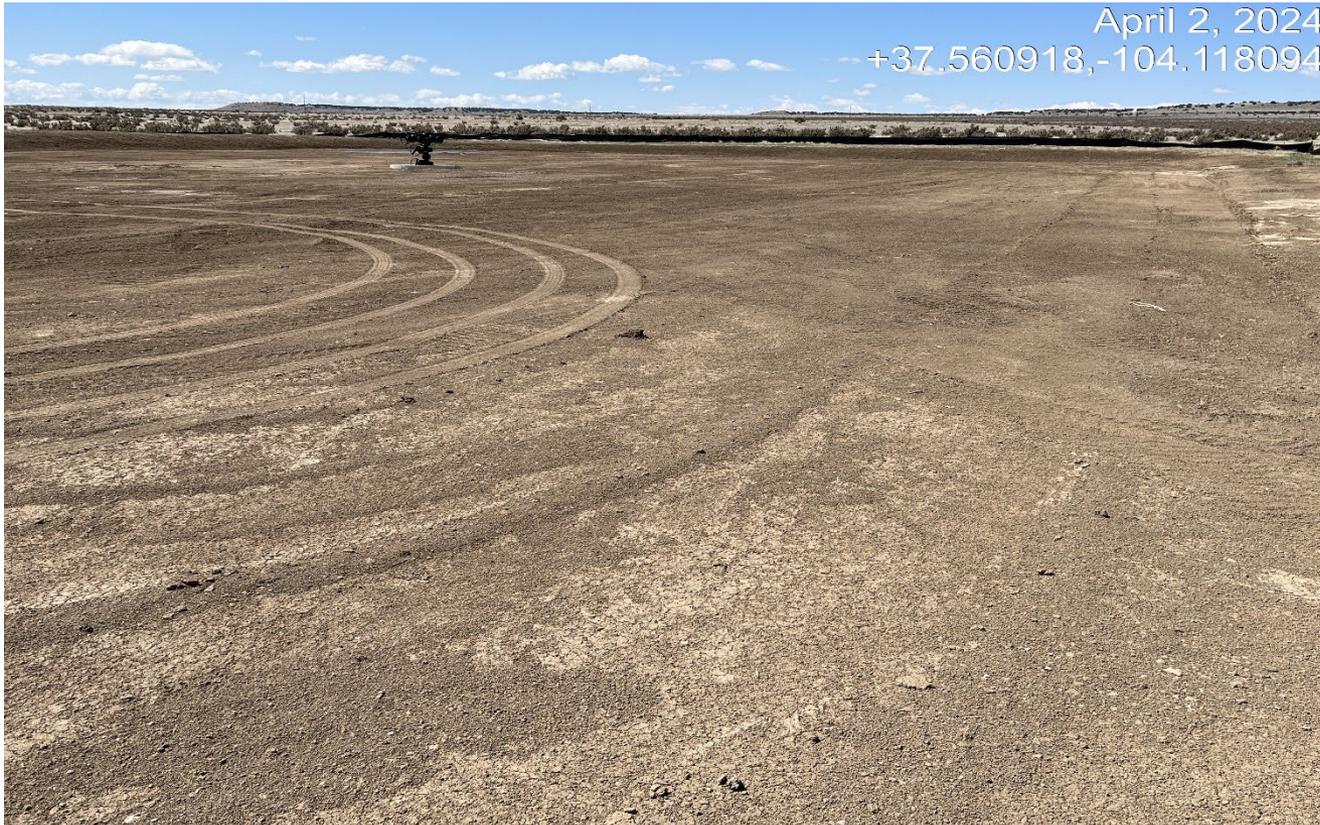
Photo 9. Facing northwest at the corner of the location. Unused areas of the location will need to be recontoured and reclaimed with 6 months of drilling.
