Inspection Photos

Location Name: TEP ROCKY MOUNTAIN LLC, GM/41-4

Location ID: 333109

Date: 4/4/2024

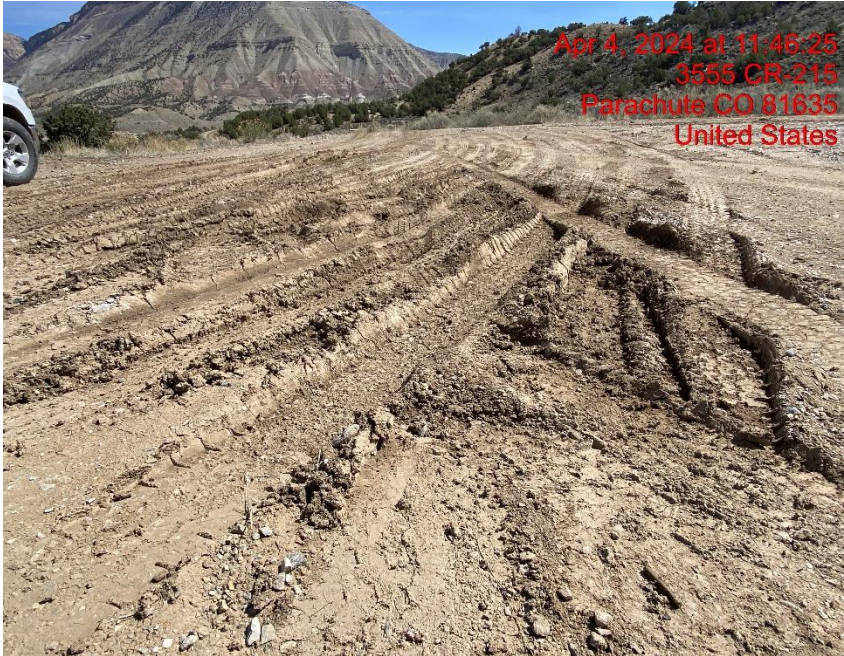
Lack of Stabilization – Photo #00415

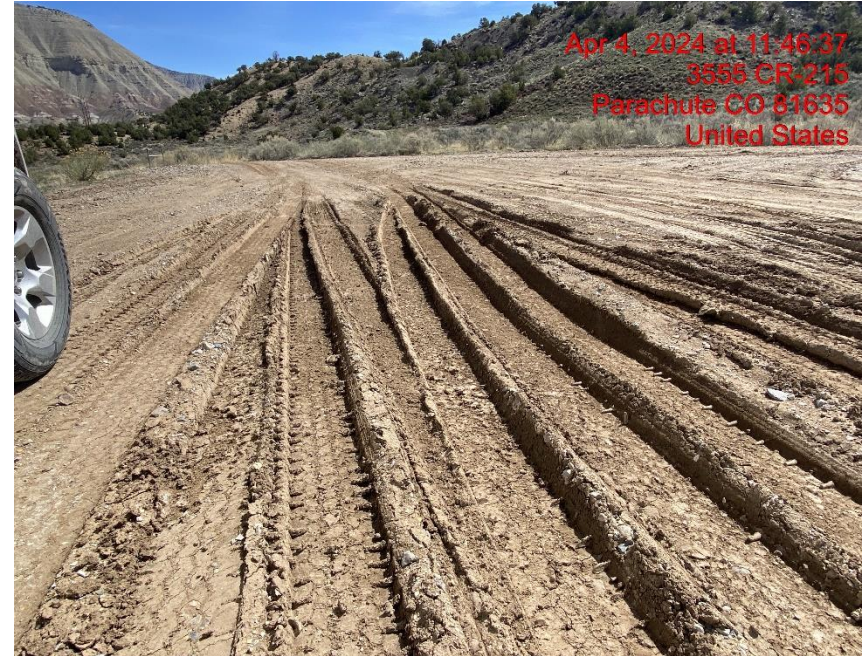
Lack of Stabilization/Insufficient Vehicle Tracking BMPs at
Location Entrance/Exit – Photo #00416
