# Interim Reclamation and Stormwater Inspection

Operator: Highpoint Operating Corporation - 10071

Location ID: 444717

Location Name: Anschutz Equus Farms

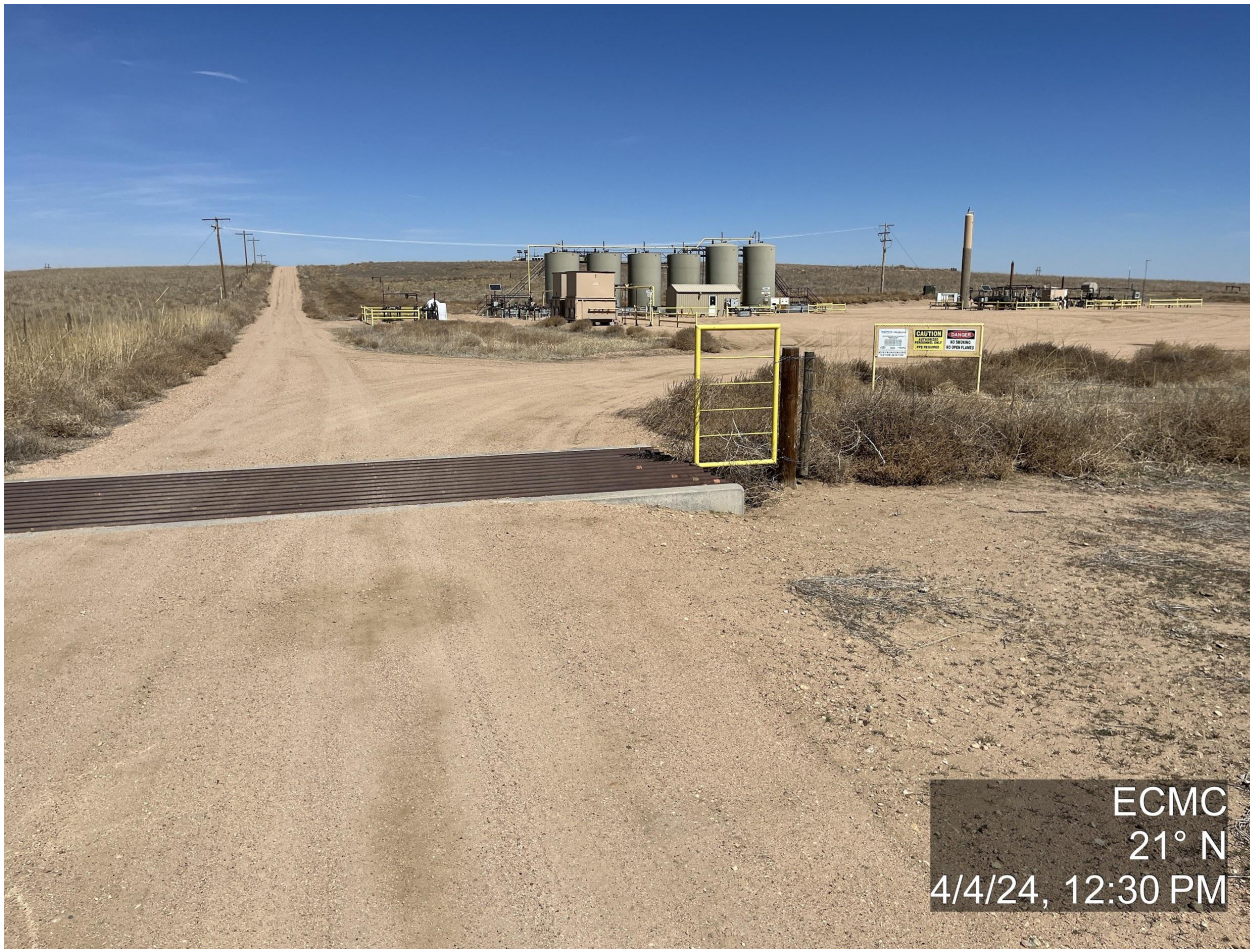
**Photo 1.** The photo was taken at the entrance to the tank battery location facing North. The photo illustrates the cattle guard at the entrance.

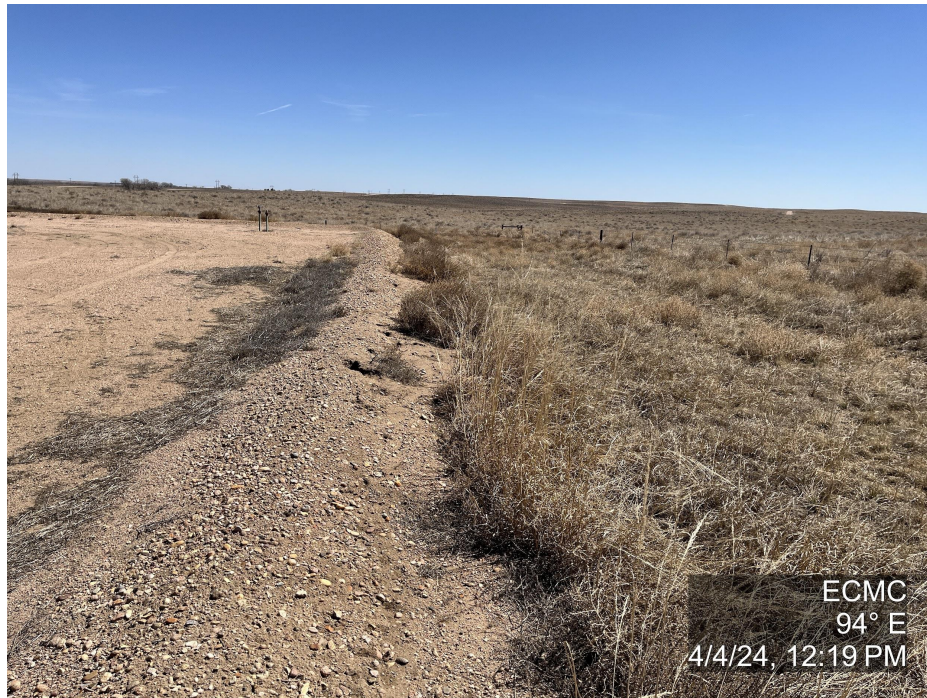
**Photo 2.** The photo was taken at the tank battery location facing East. The photo illustrates the production pad boundary and perimeter berm.

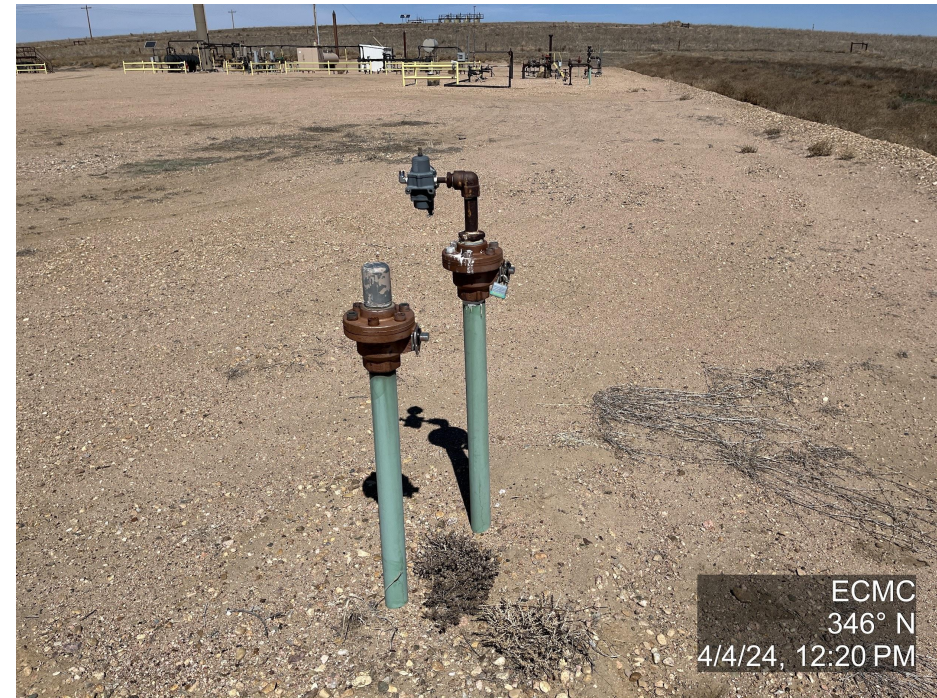
**Photo 3.** The photo was taken from the tank battery location facing North. The photo illustrates unmarked well risers on the Southeast corner of the production pad.

Note - Interim areas shown on the right are dominated by Russian thistle.

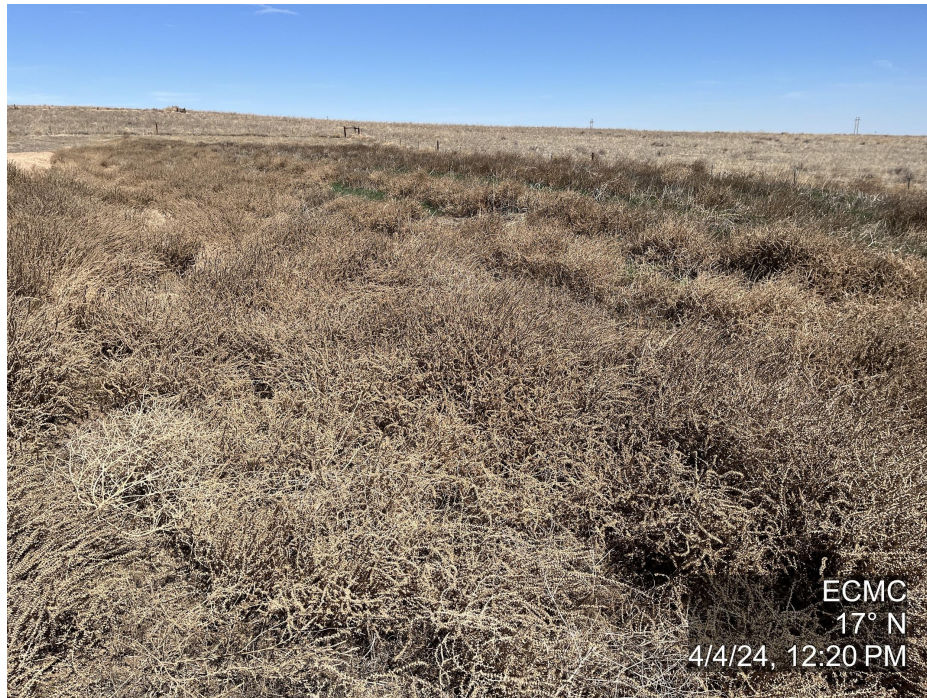
**Photo 4.** The photo was taken at the tank battery location facing North. The photo illustrates topsoil stockpile and interim areas dominated by Russian thistle.

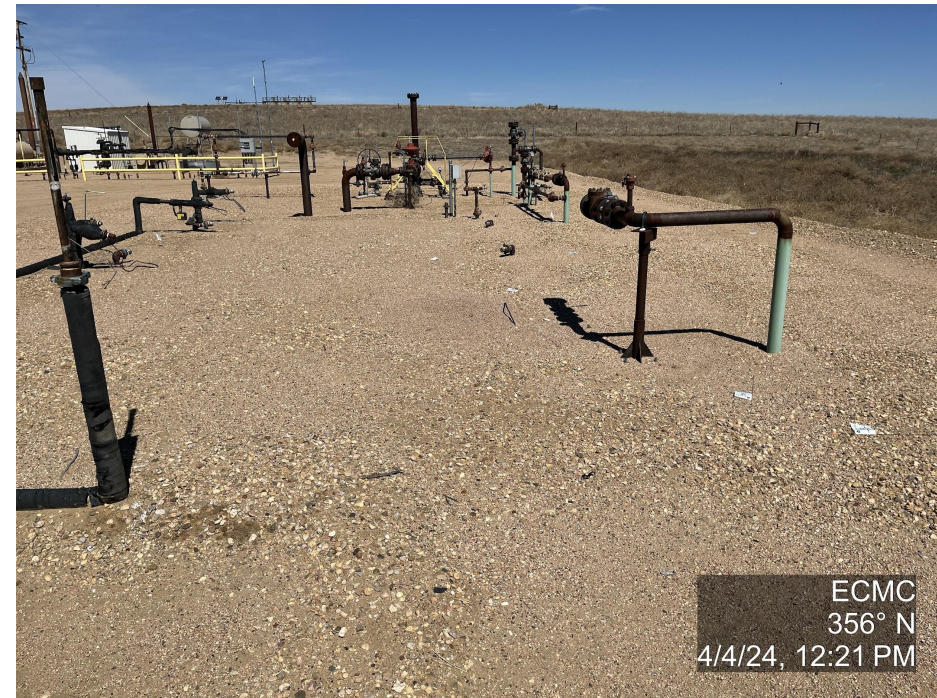
**Photo 5.** The photo was taken at the tank battery location facing North. The photo illustrates unmarked risers on the East side of the production pad.

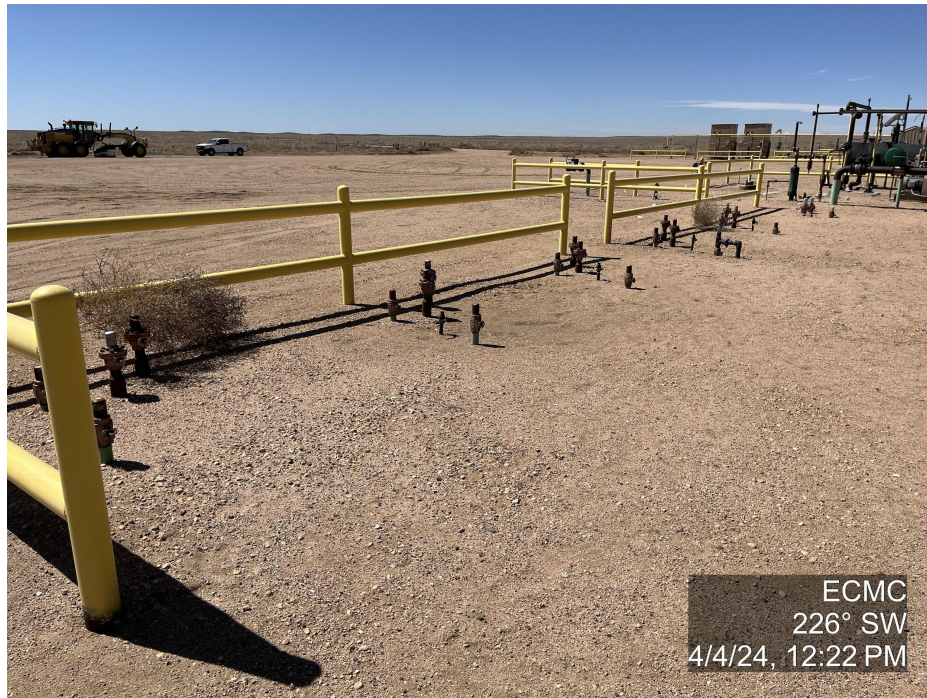
**Photo 6.** The photo was taken at the tank battery location facing Southwest. The photo illustrates unmarked risers along the North of the production pad.

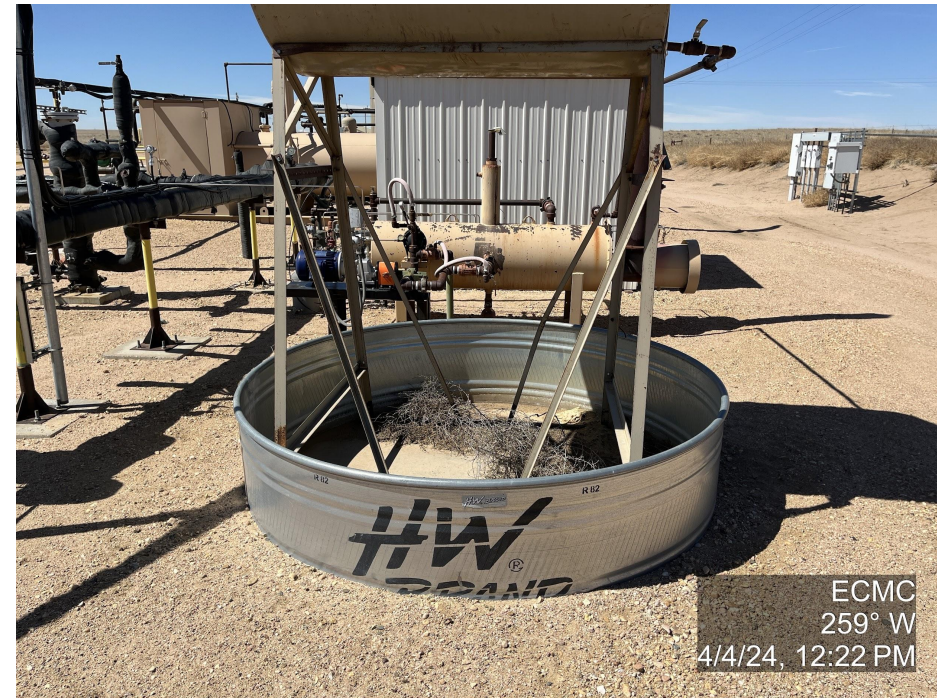
**Photo 7.** The photo was taken at the tank battery location facing West. The photo illustrates secondary containment without any wildlife protection such as netting.

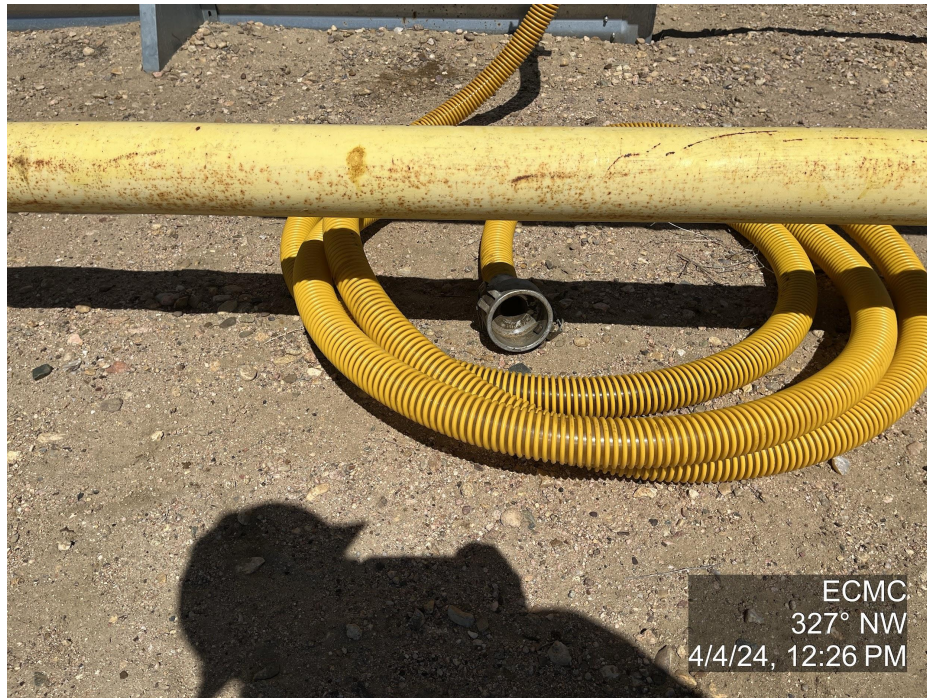
**Photo 8.** The photo was taken at the tank battery location facing Northwest. The photo illustrates a hose attached to production equipment without any type of plug.

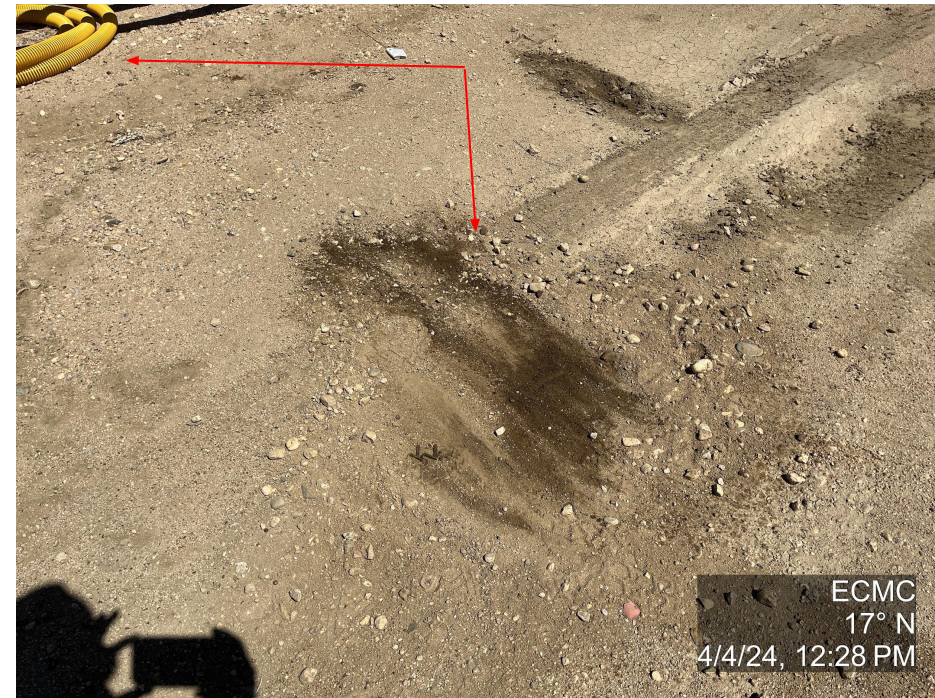
**Photo 9.** The photo was taken at the tank battery location facing North. The photo illustrates stained soil that has been covered with gravel near the hose in the previous photo.
