WELL NAME: LORENCITO 13-2, API #: 071-08516, INSP. # 695109417

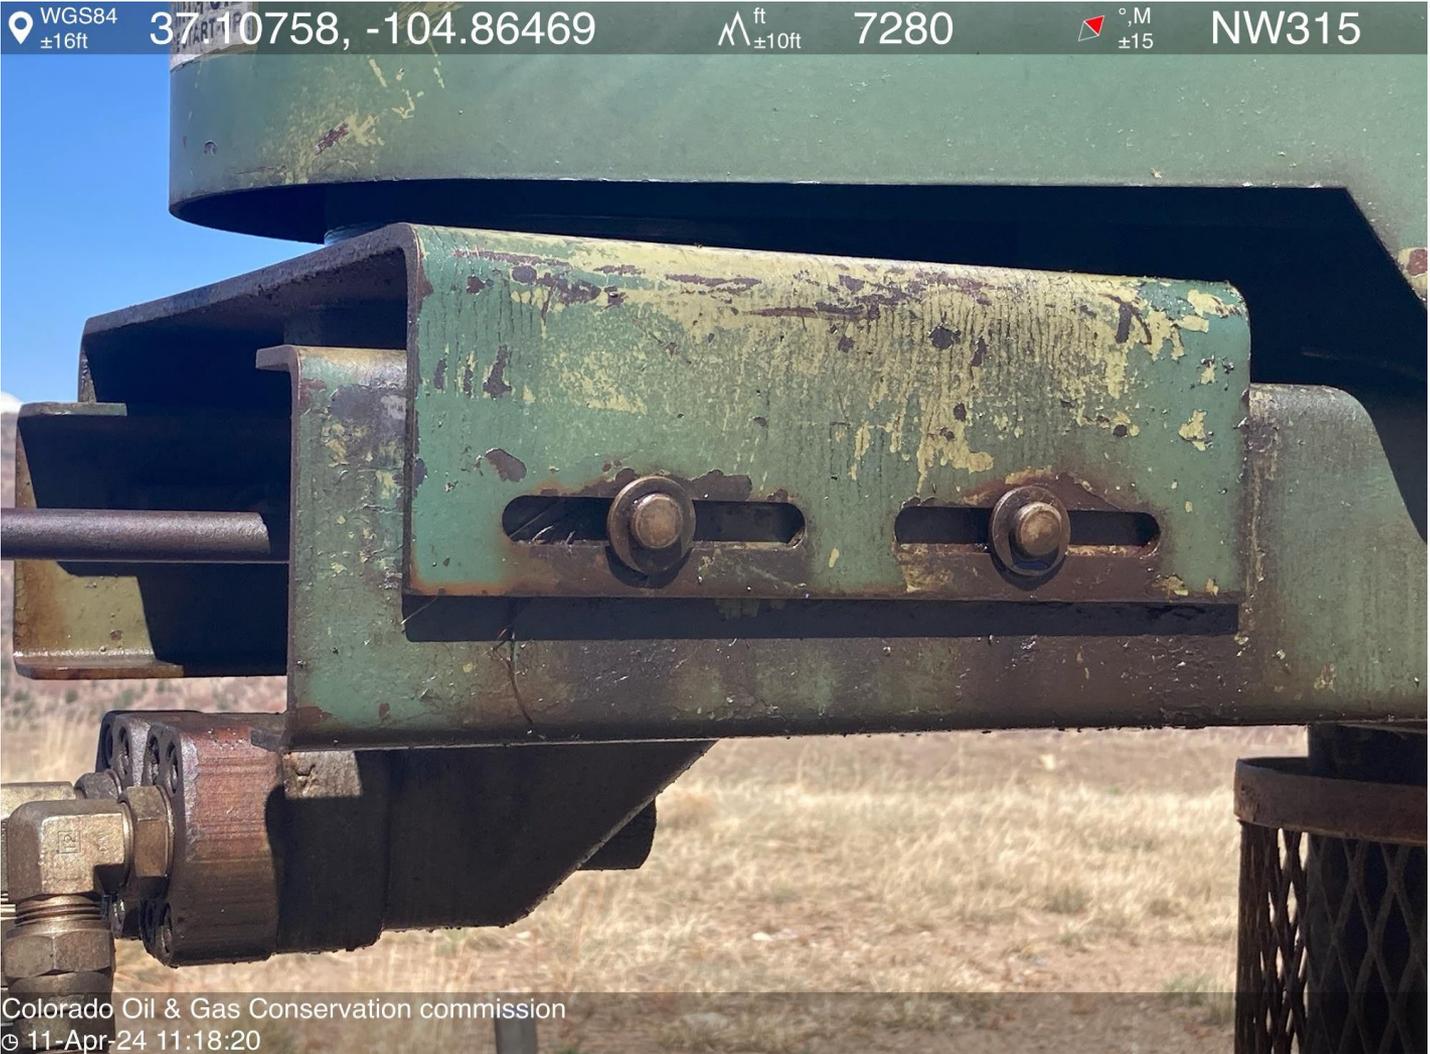
**PHOTO 4: APPEARS TO BE A HYDRAULIC LEAK ON THE DRIVE HEAD. Securely fasten all valves, pipes, fittings, and Production Facilities to ensure good mechanical condition, inspect at regular intervals and maintain in good mechanical condition per Rule 608.e. CA DATE 4-18-2024.**

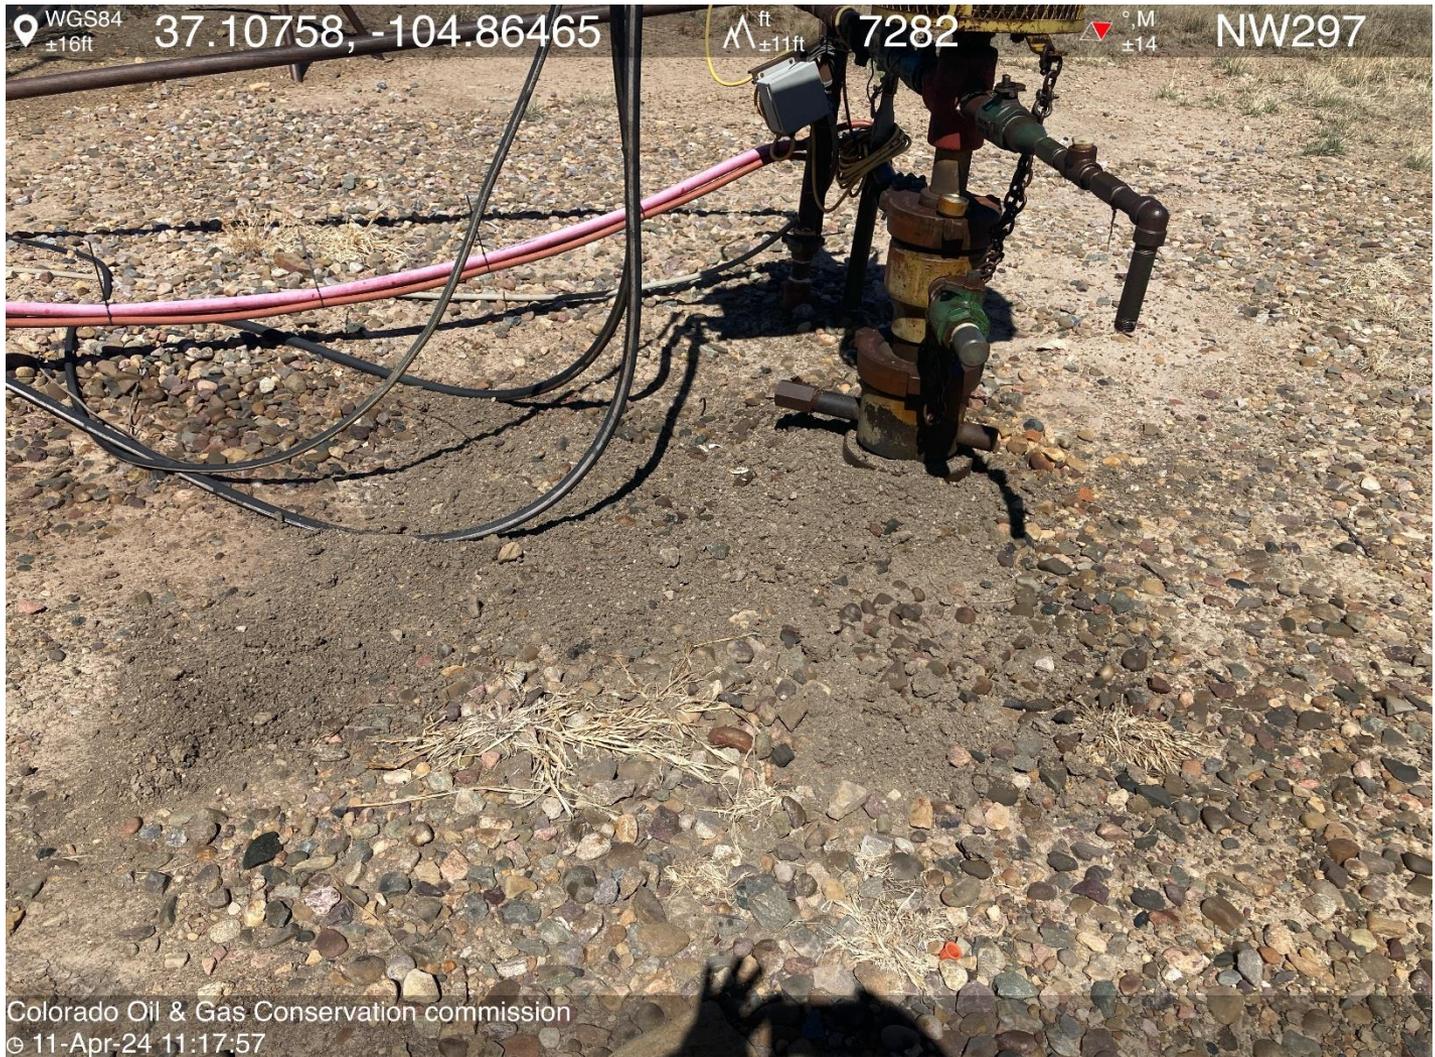
**PHOTO 5: AREA OF IMPACTED SOIL NEAR WELLHEAD APPEARS TO BE HYDRAULIC OIL FROM LEAKING DRIVEHEAD (IT APPEARS THAT OPERATOR ATTEMPTED TO COVER IMPACTED SOIL WITH SOIL FROM PIT BERM). Conduct maintenance on equipment, cleanup stained material and review self inspection processes. COMPLY WITH RULE 1002, (2).D. CA DATE 4-18-2024.**

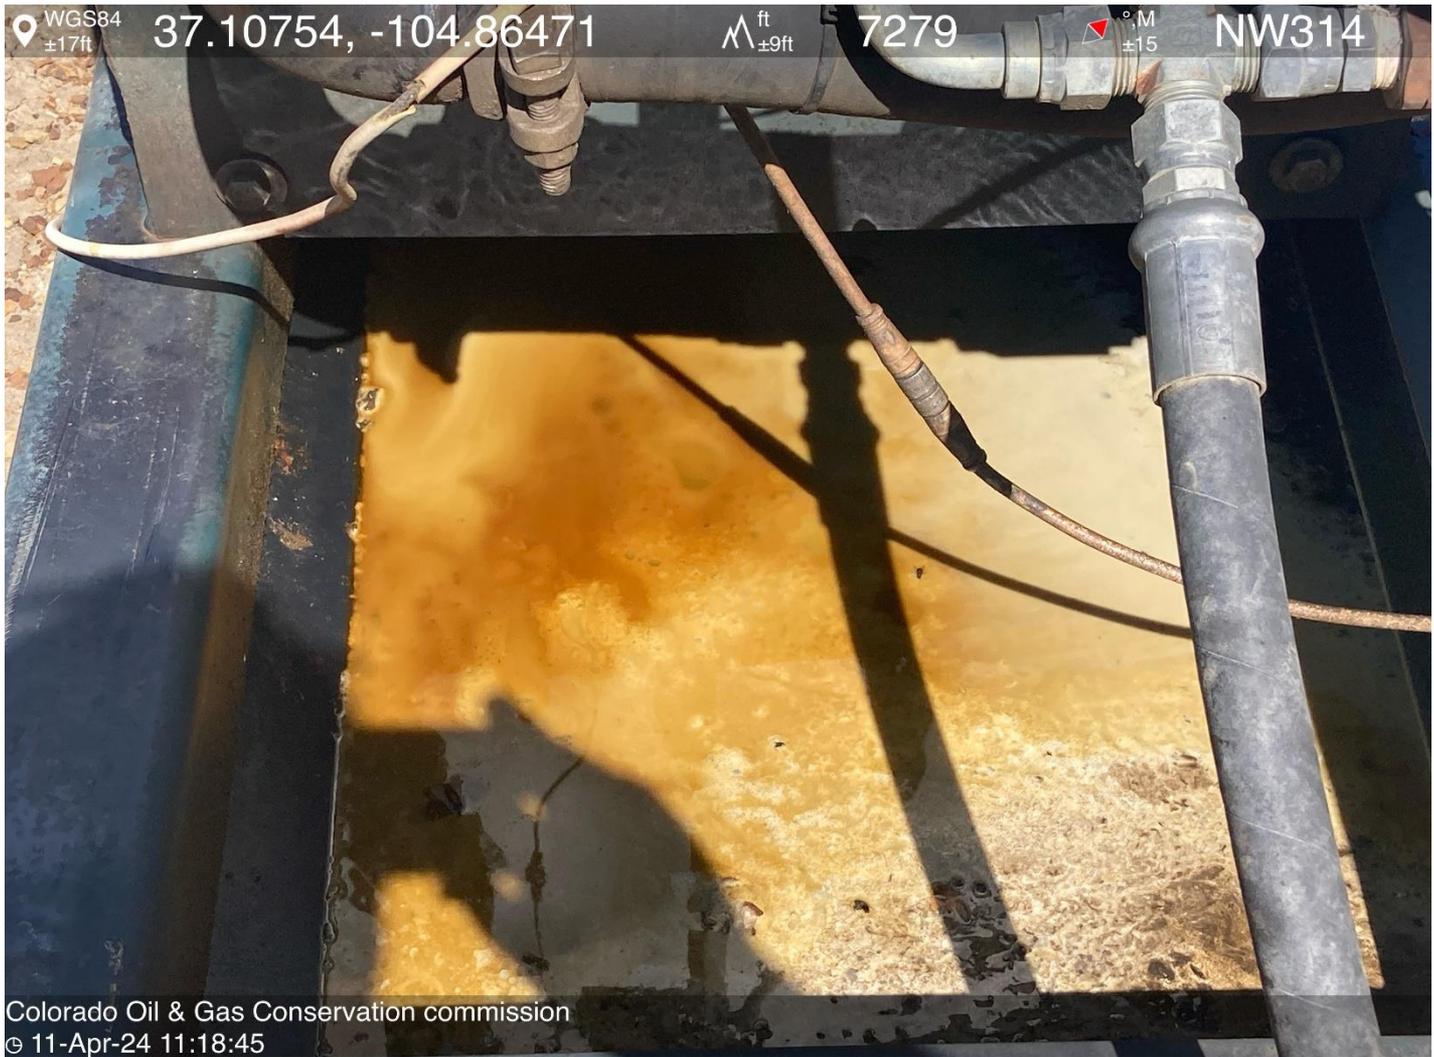
**PHOTO 6: OILY WASTE IN ENGINE SKID. COMPLY WITH RULE 1002.f.(2)B, Comply with general provisions of the oil and gas act for wildlife protection AND SB-181. CA DATE 4-12-2024.**
