WELL NAME: LORENCITO 8-2, API #: 071-09023, INSP. # 695109425

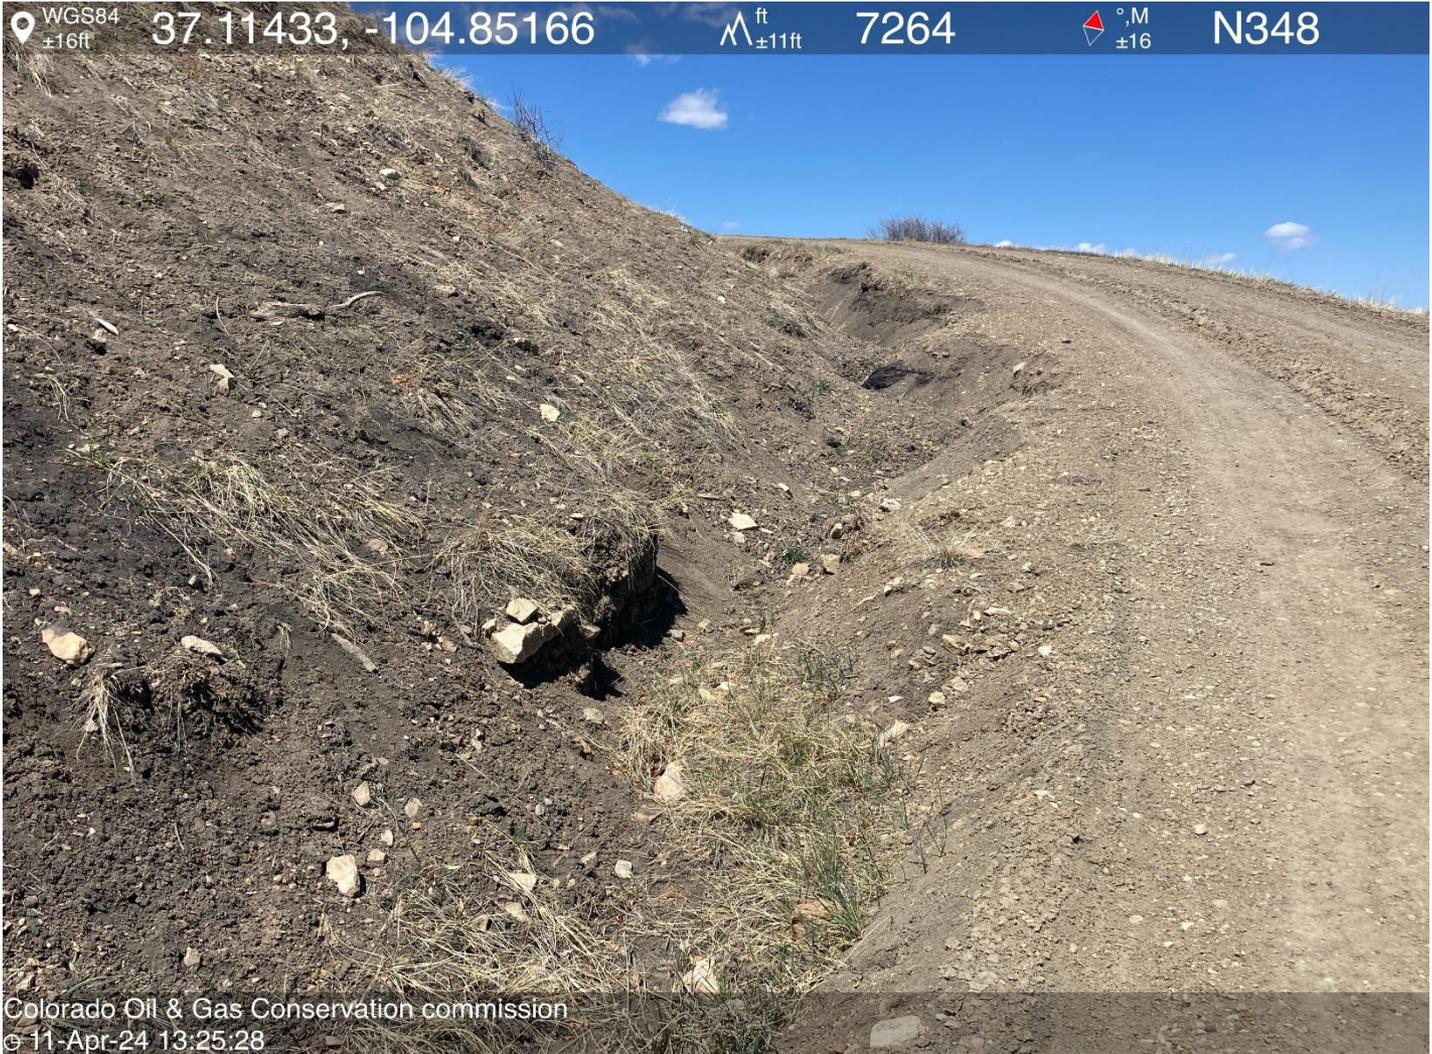
**PHOTO 4: LACK OF BMP'S OR BMP FAILURE HAS RESULTED IN SEDIMENT WASHING DOWN THE ROW BMP DITCH. **INSTALL OR REPAIR BMP'S AND INSPECT AT REGULAR INTERVALS TO PREVENT SEDIMENT MIGRATION PER RULE 1002. CA DATE 5-11-2024.****

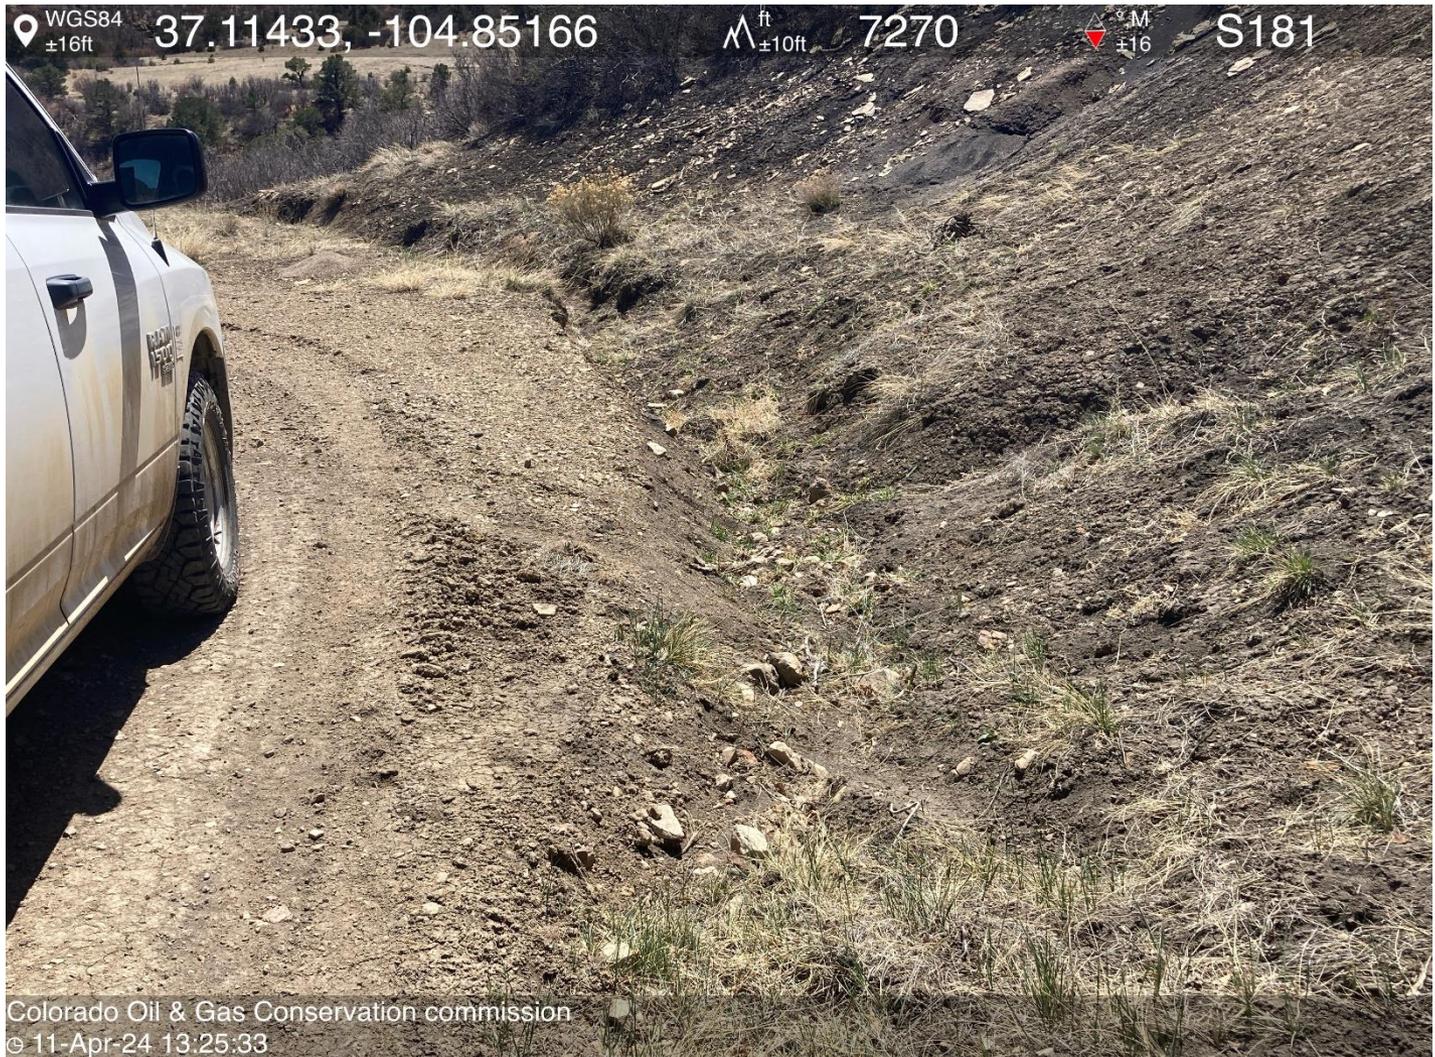
**PHOTO 5: ANOTHER IMAGE OF BMP FAILURE NOTED IN PREVIOUS PHOTO.**

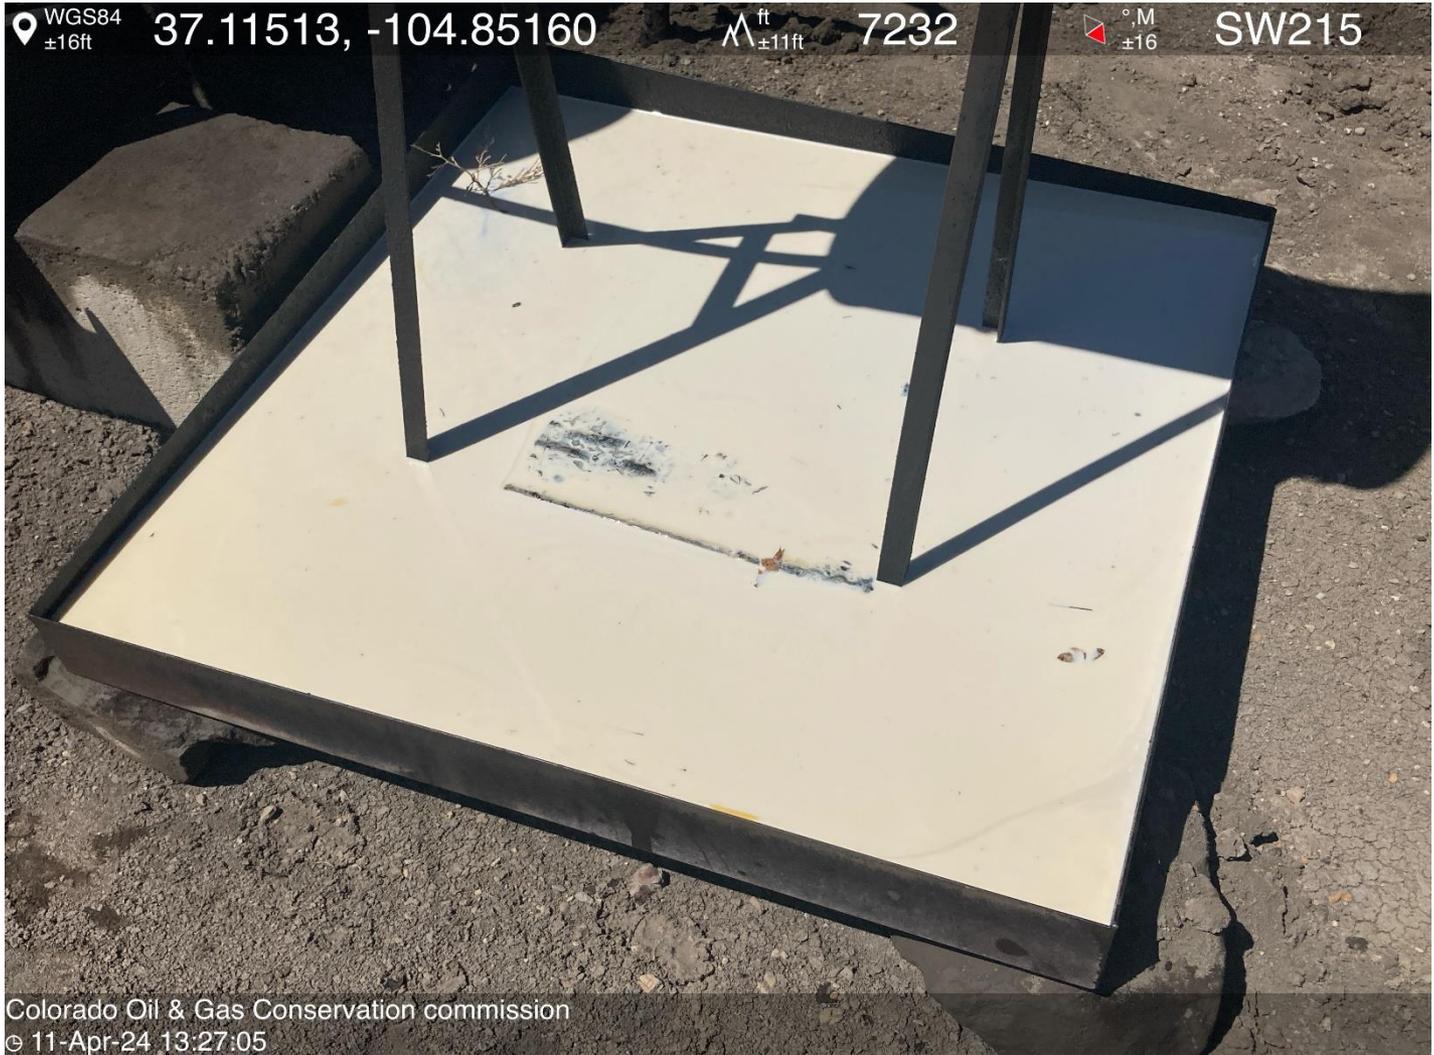
**PHOTO 6: OILY WASTE IN OILER SECONDARY CONTAINMENT IS CLOSE TO RUNNING OVER. COMPLY WITH RULE 1002.f.(2)B, Comply with general provisions of the oil and gas act for wildlife protection AND SB-181. IMMEDIATE ACTION IS REQUIRED. CA DATE 4-12-2024.**
