**COLORADO**  
Energy & Carbon Management  
Commission  
Department of Natural Resources

REM 28246, Facility 116587 Date 4/9/24, all photos taken by ECMC Staff Kris Neidel

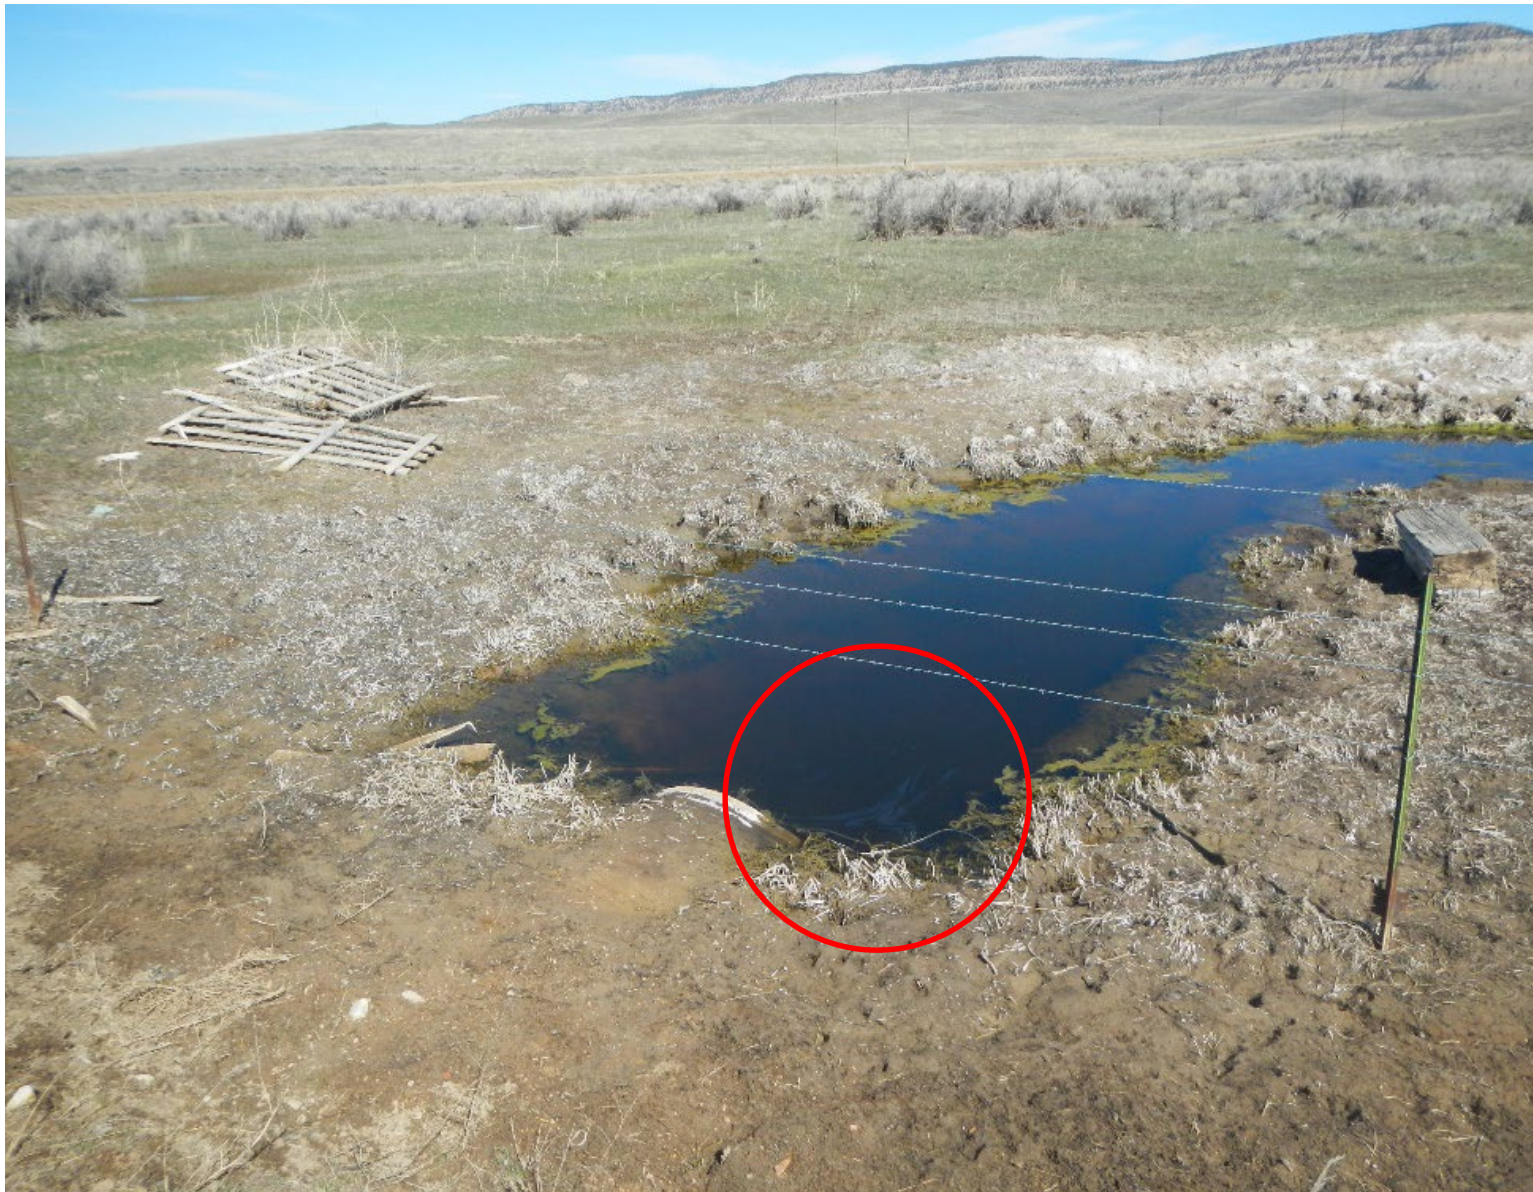
Photo #1 Below culvert, sheen observed near culvert at right. Note: sheen inside red circle.

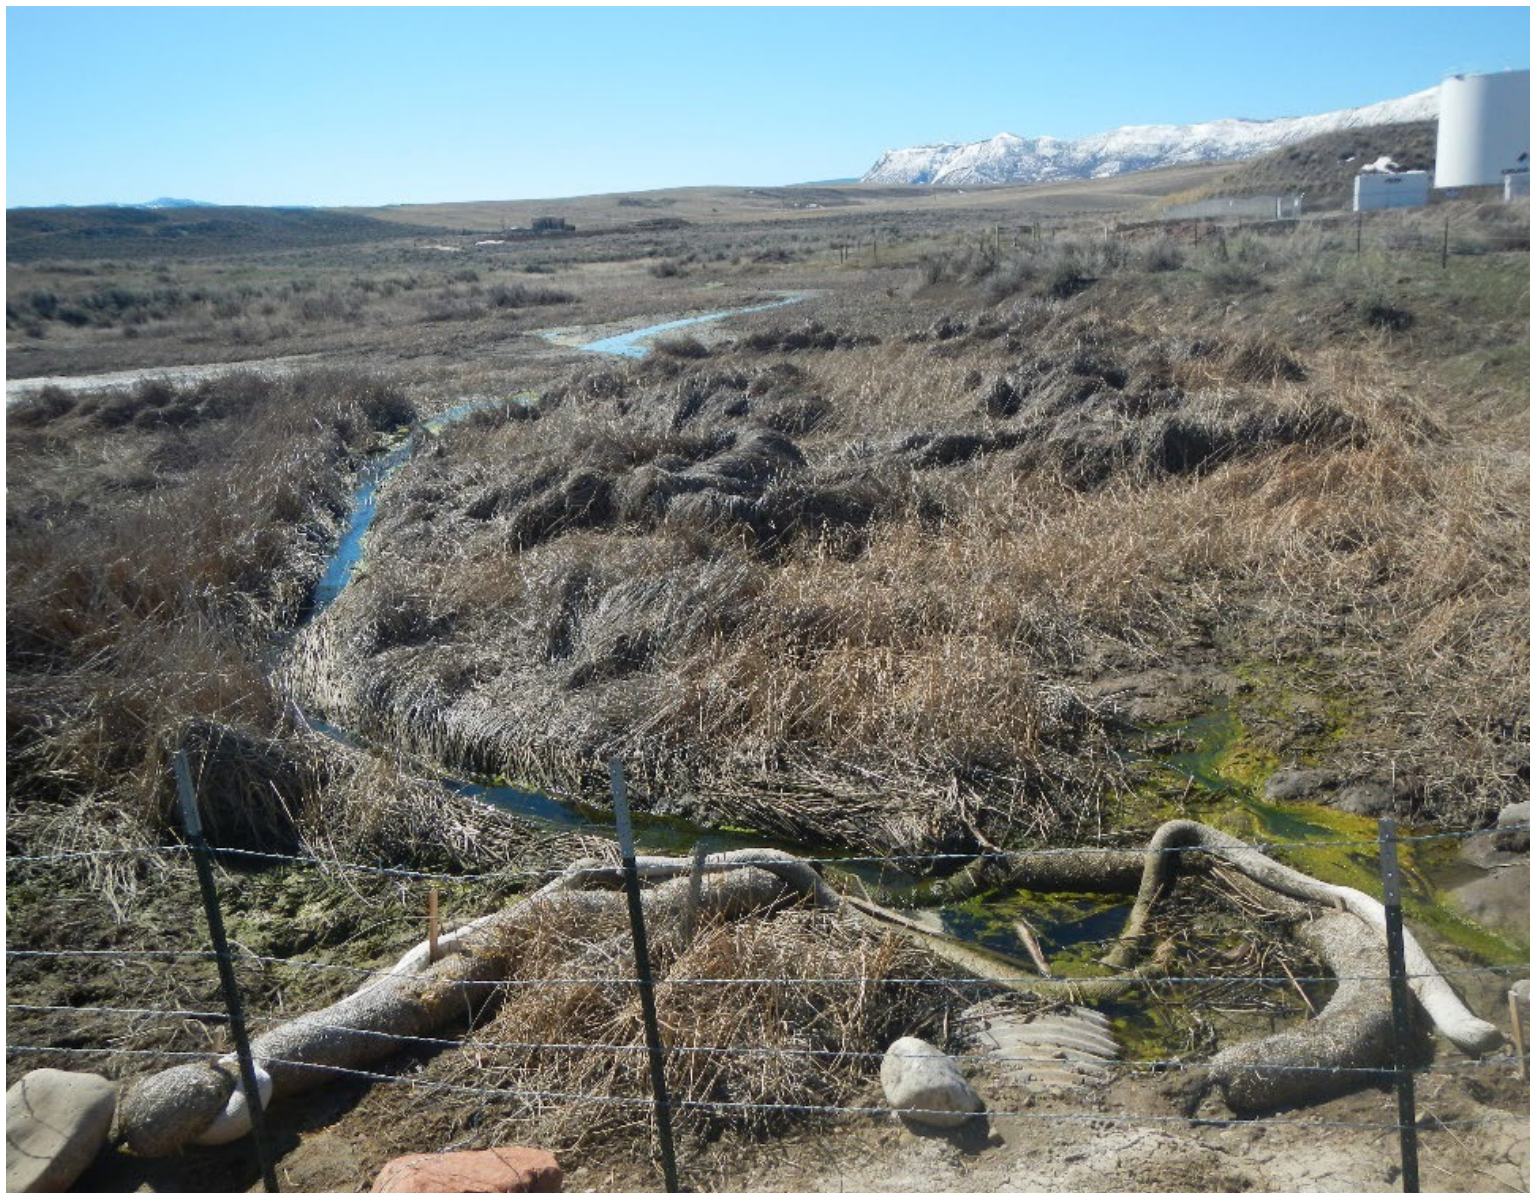
**REM 28246, Facility 116587 Date 4/9/24, all photos taken by ECMC Staff Kris Neidel**  
**Photo #2 upstream from county road, upstream side of culvert.**

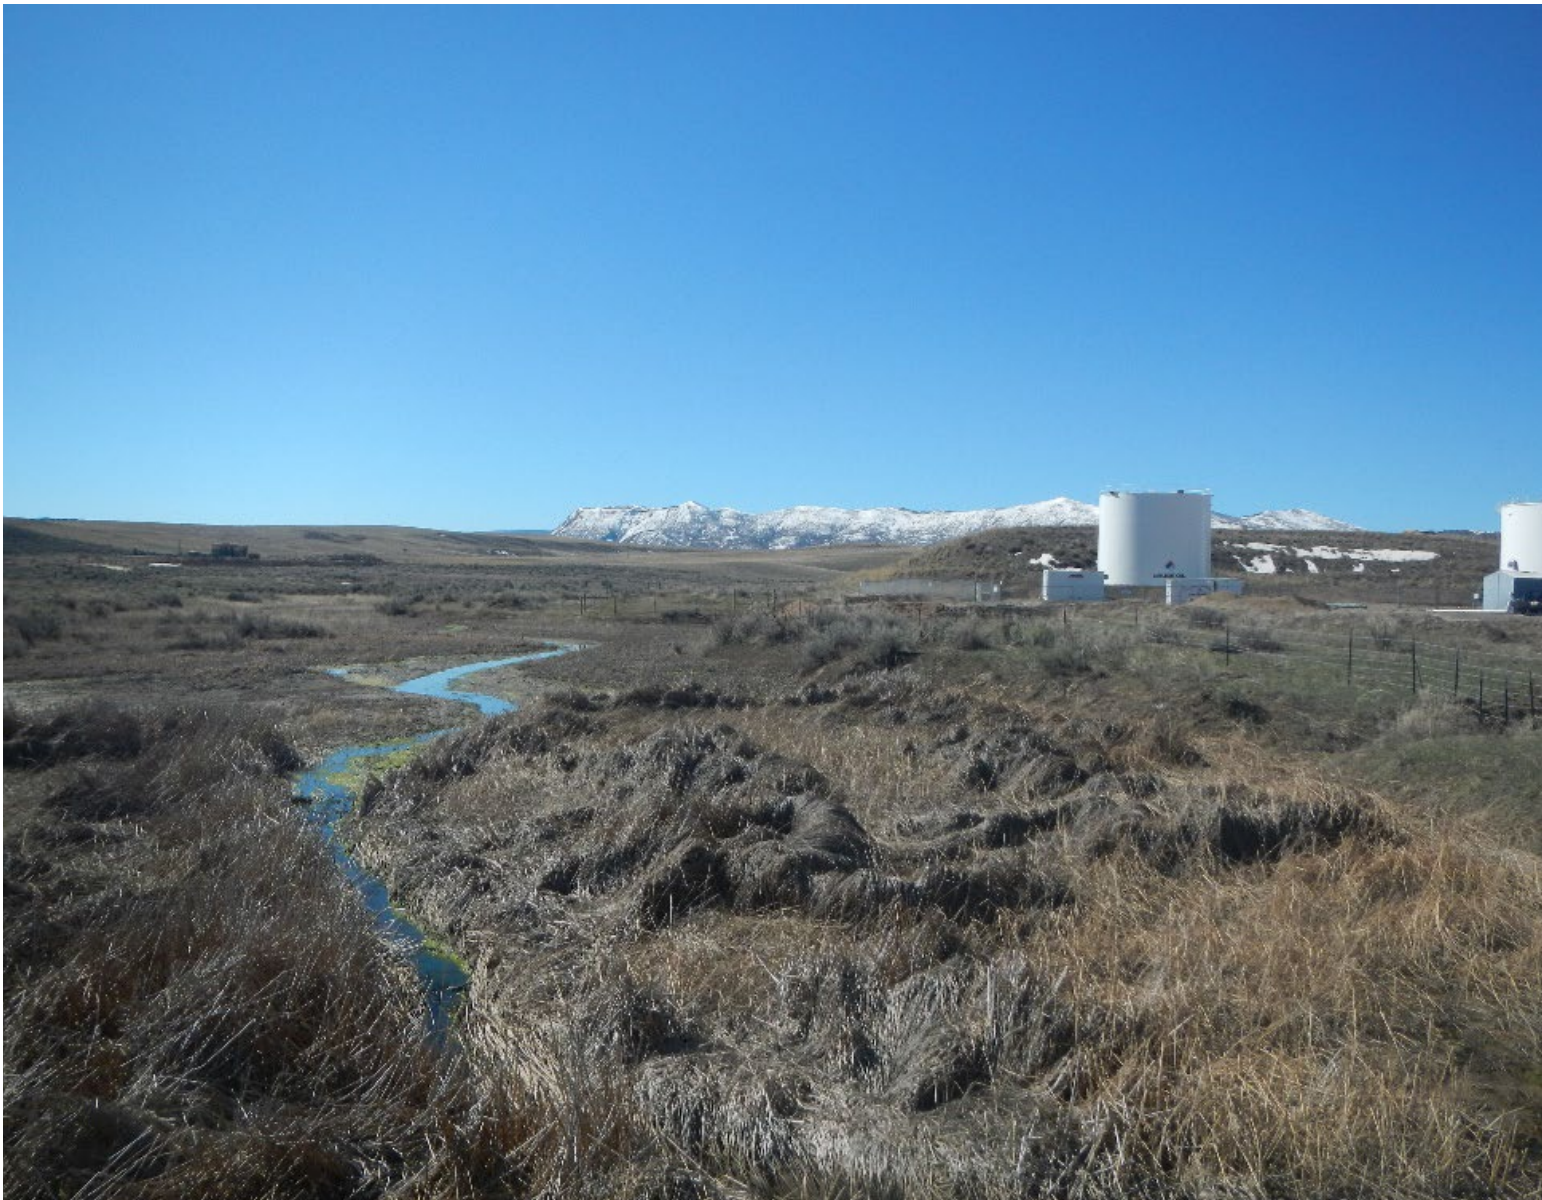
REM 28246, Facility 116587 Date 4/9/24, all photos taken by ECMC Staff Kris Neidel  
Photo #3 Seeping Spring Gulch

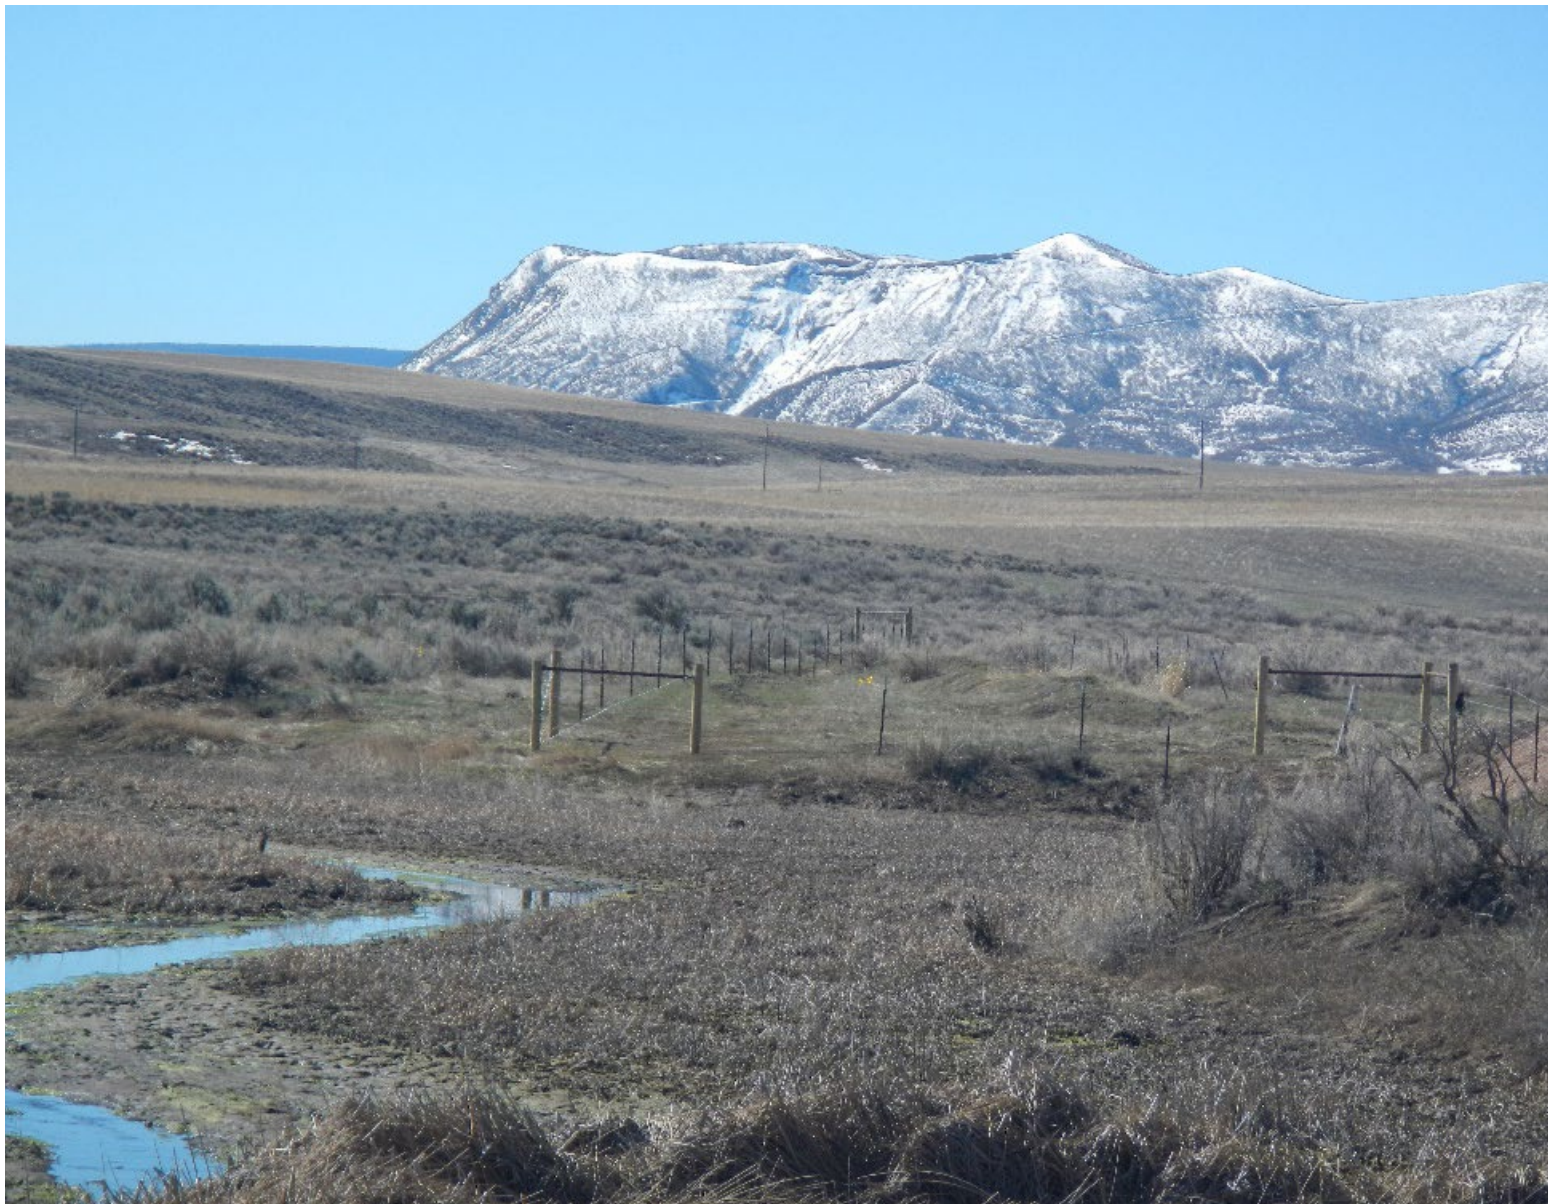
**REM 28246, Facility 116587 Date 4/9/24, all photos taken by ECMC Staff Kris Neidel**  
**Photo #4 zoomed in from same perspective as #3. Fence was installed by POC in 2023.**

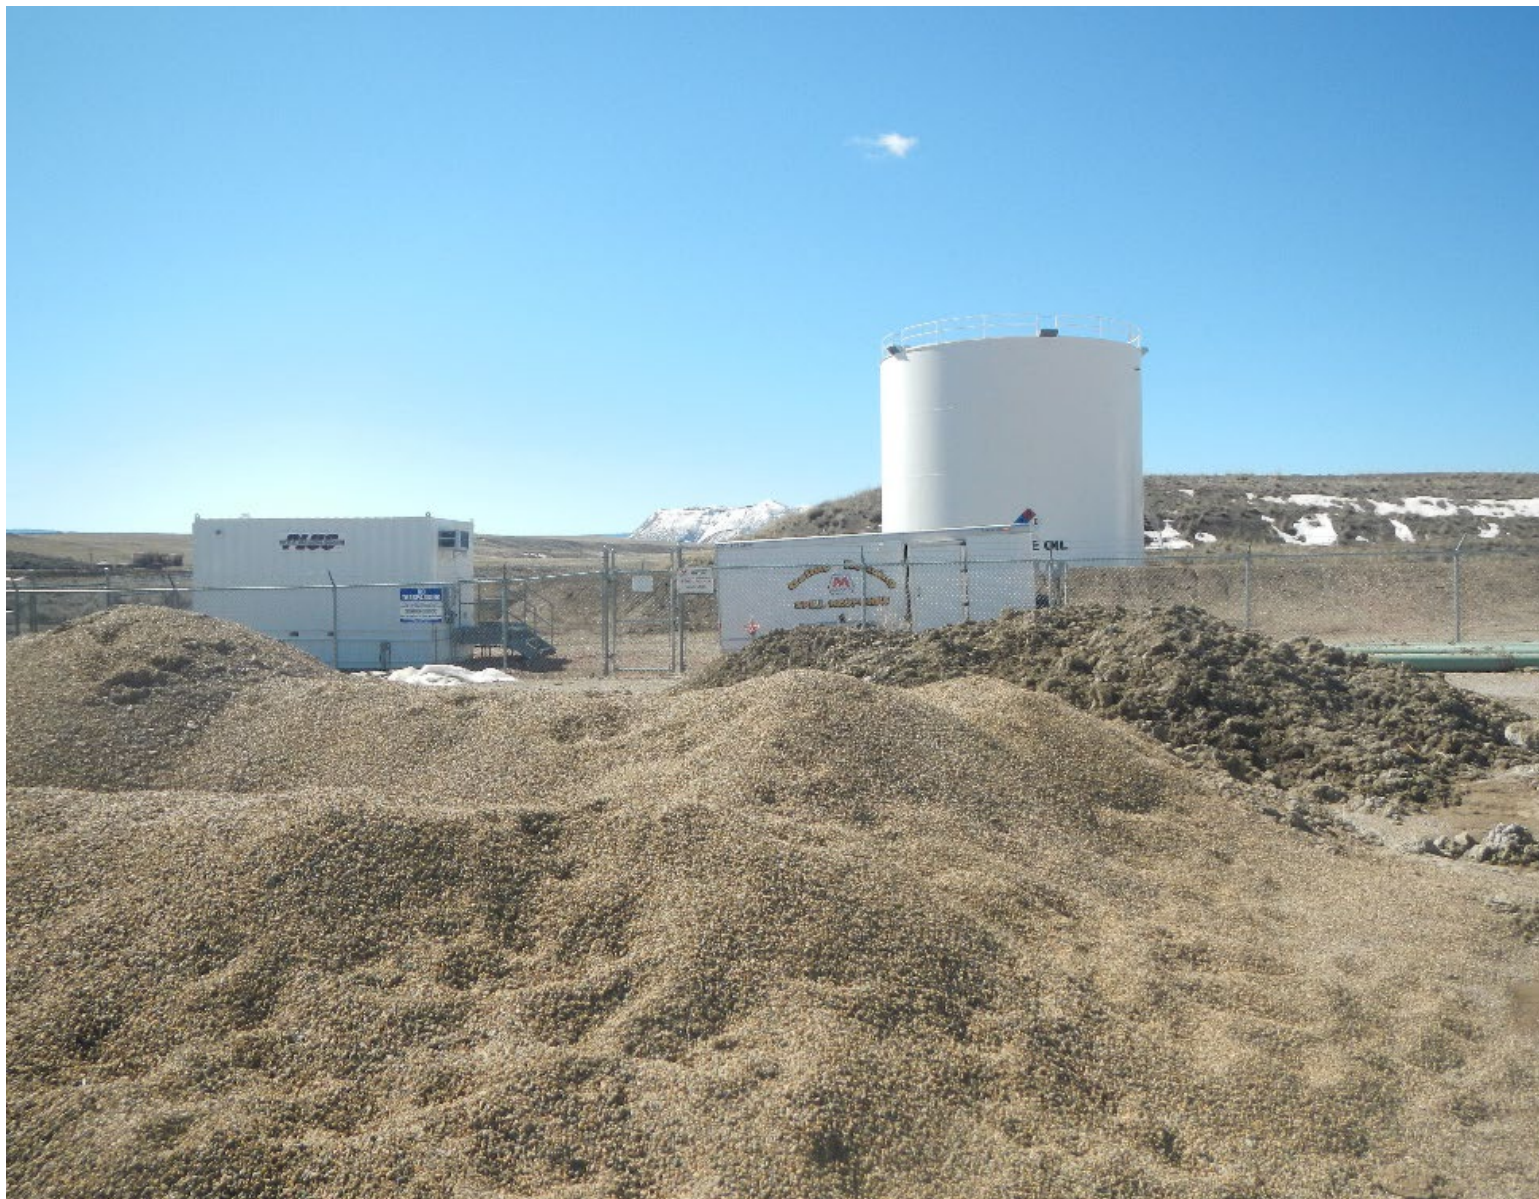
Photo #5 Photo taken on Marathon Iles Facility property. In photo is fresh gravel and a soil pile. No hydrocarbon or other debris observed as a results of the 4/3/2024 Marathon tank overflow.

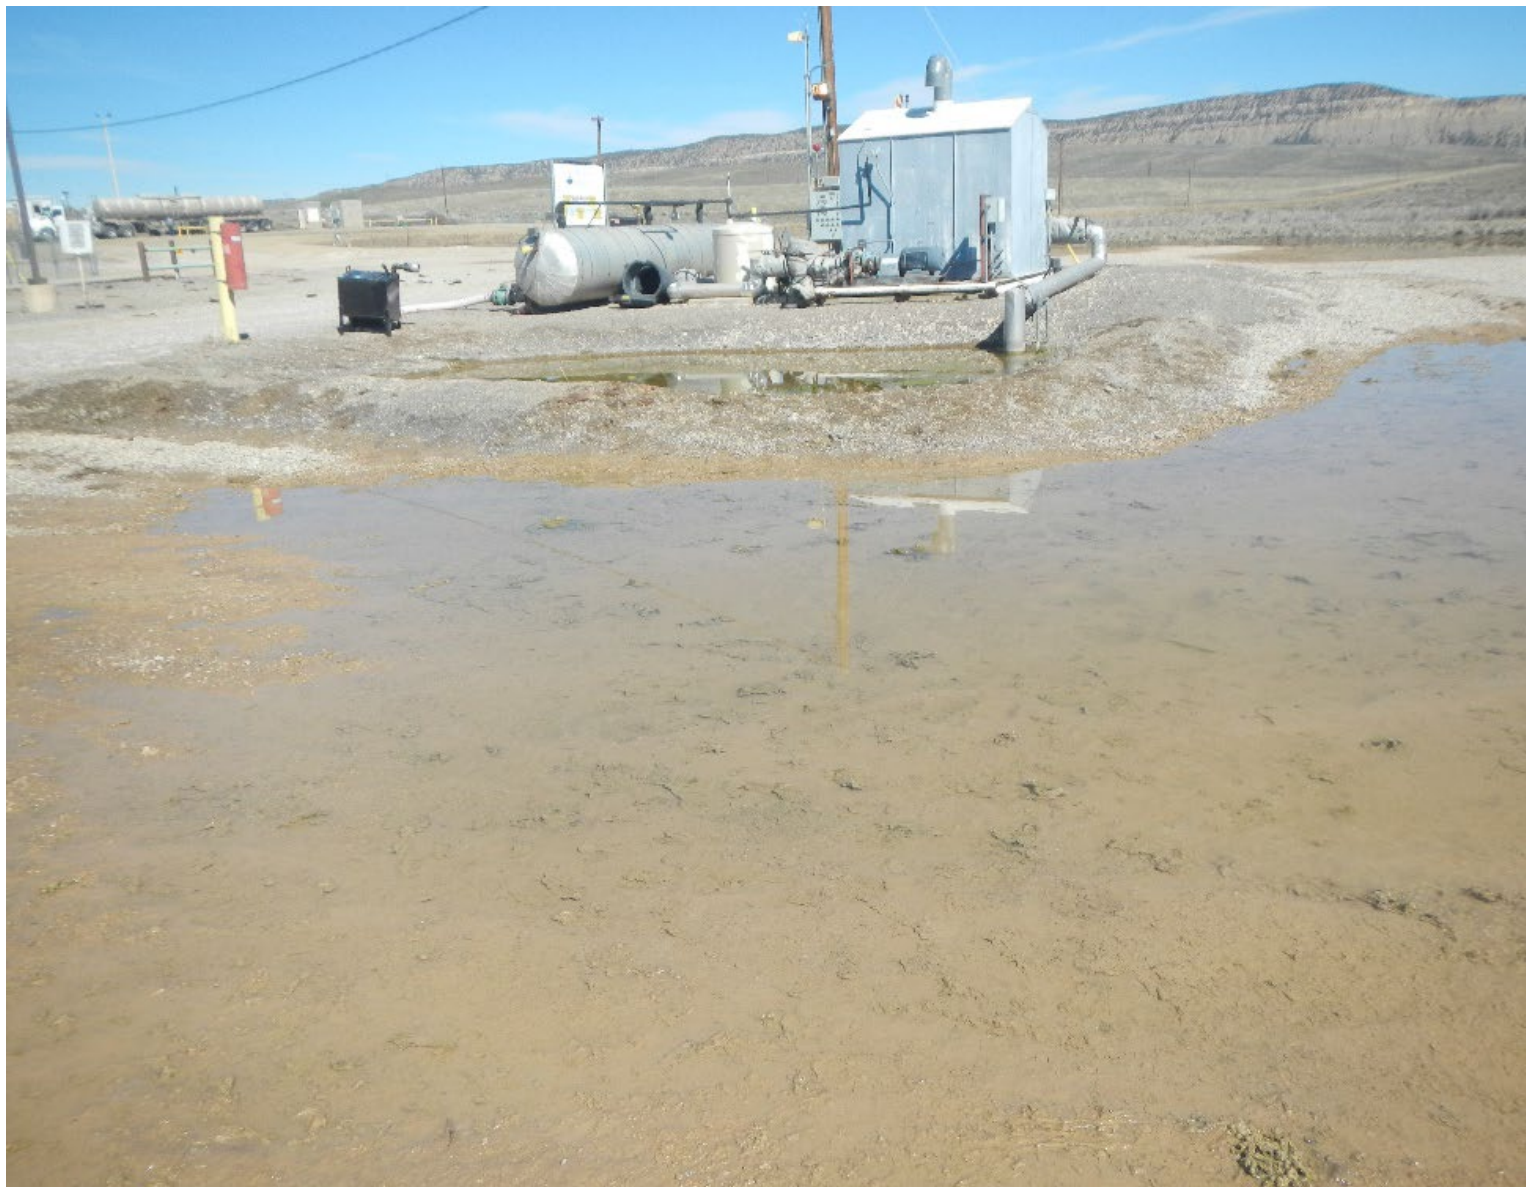
Photo #6 Photo taken on Marathon Iles Facility property. Surface water pooled, No hydrocarbon or other debris observed as a results of the 4/3/2024 Marathon tank overflow.

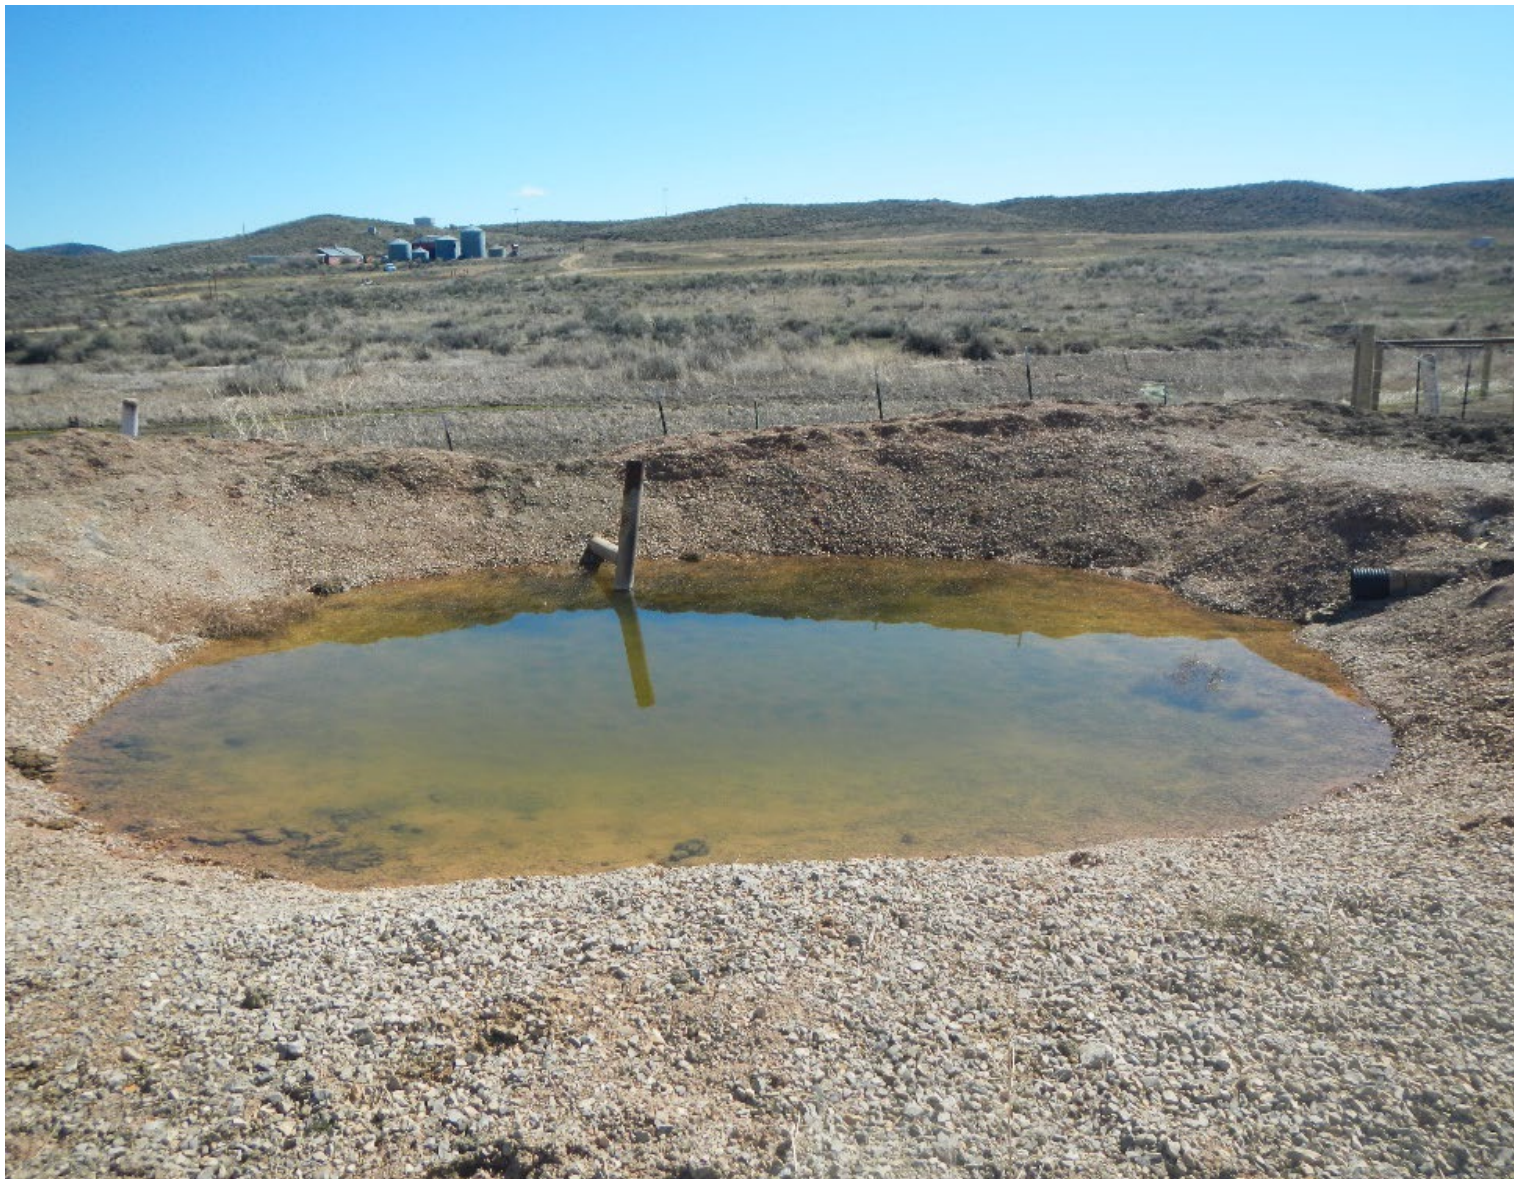
**Photo #8** Photo taken on Marathon Iles Facility property. Surface water discharge feature. Note: inlet pipe on right of photo, the facility drains (or partially drains) through this pipe. No hydrocarbon or other debris observed as a results of the 4/3/2024 Marathon tank overflow.

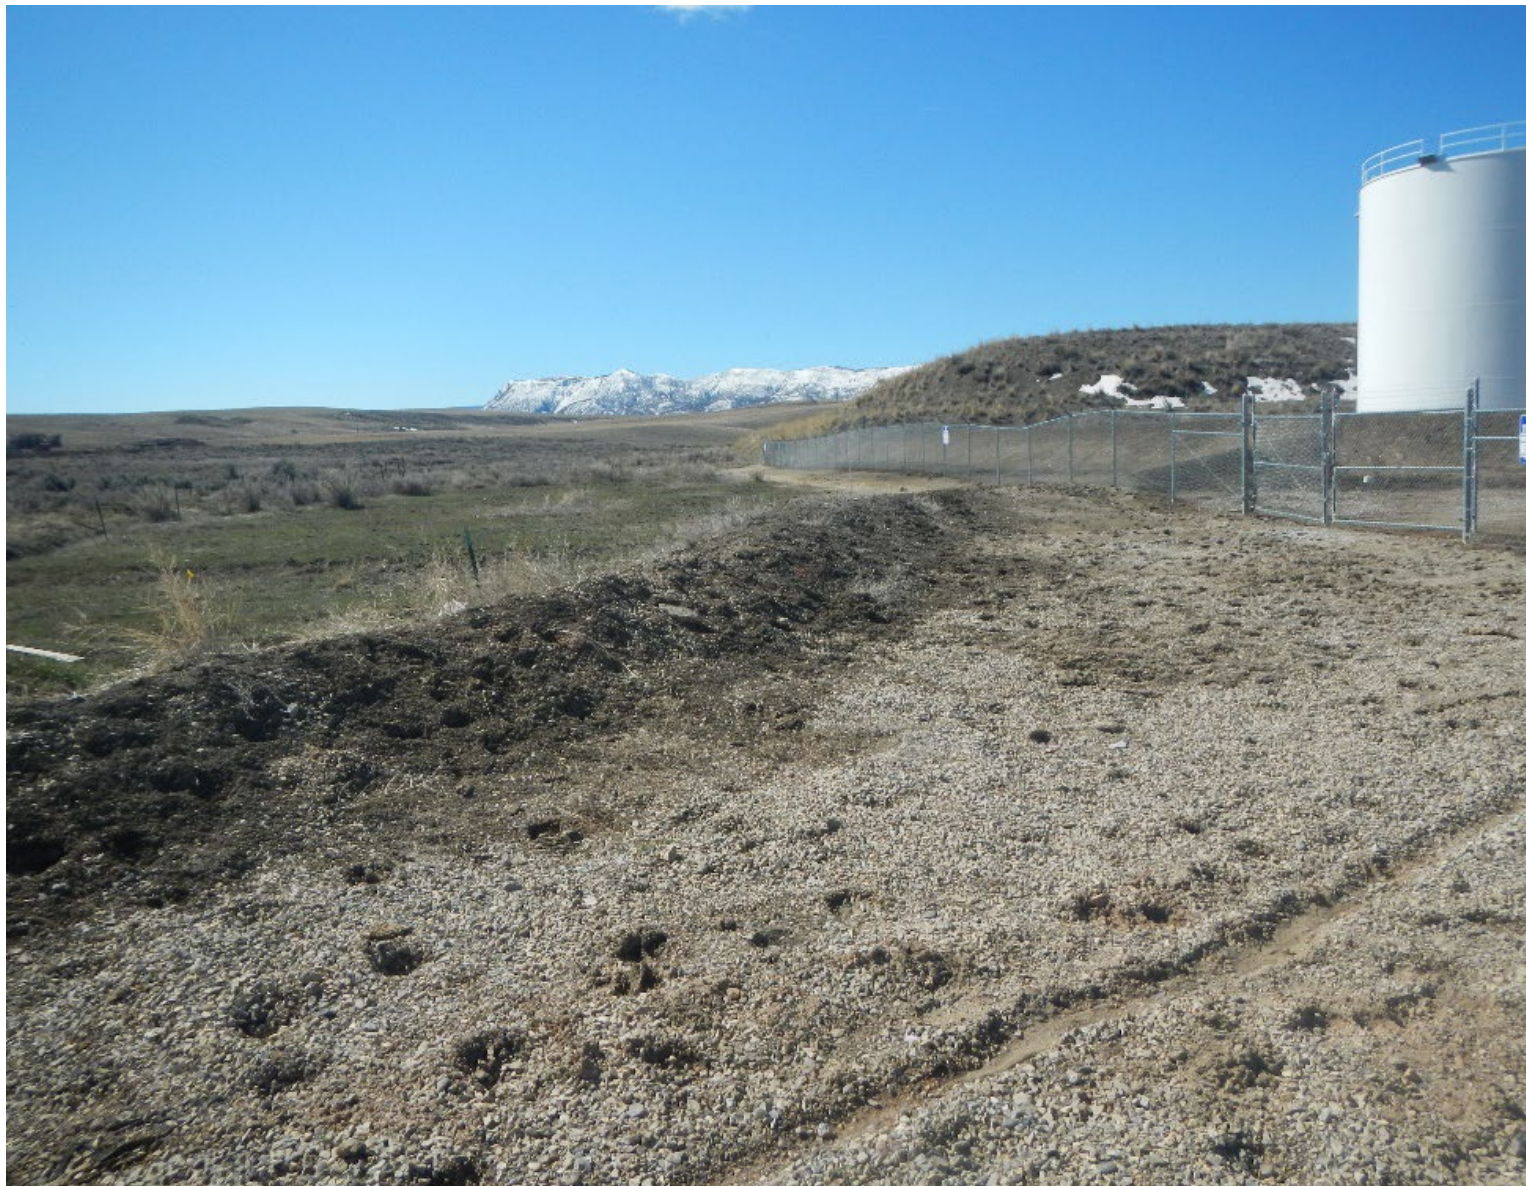
Photo #9 Photo taken on Marathon Iles Facility property. perimeter fencing of the east side of Marathon Facility. Ground was soft and muddy. No hydrocarbon or other debris observed as a results of the 4/3/2024 Marathon tank overflow.

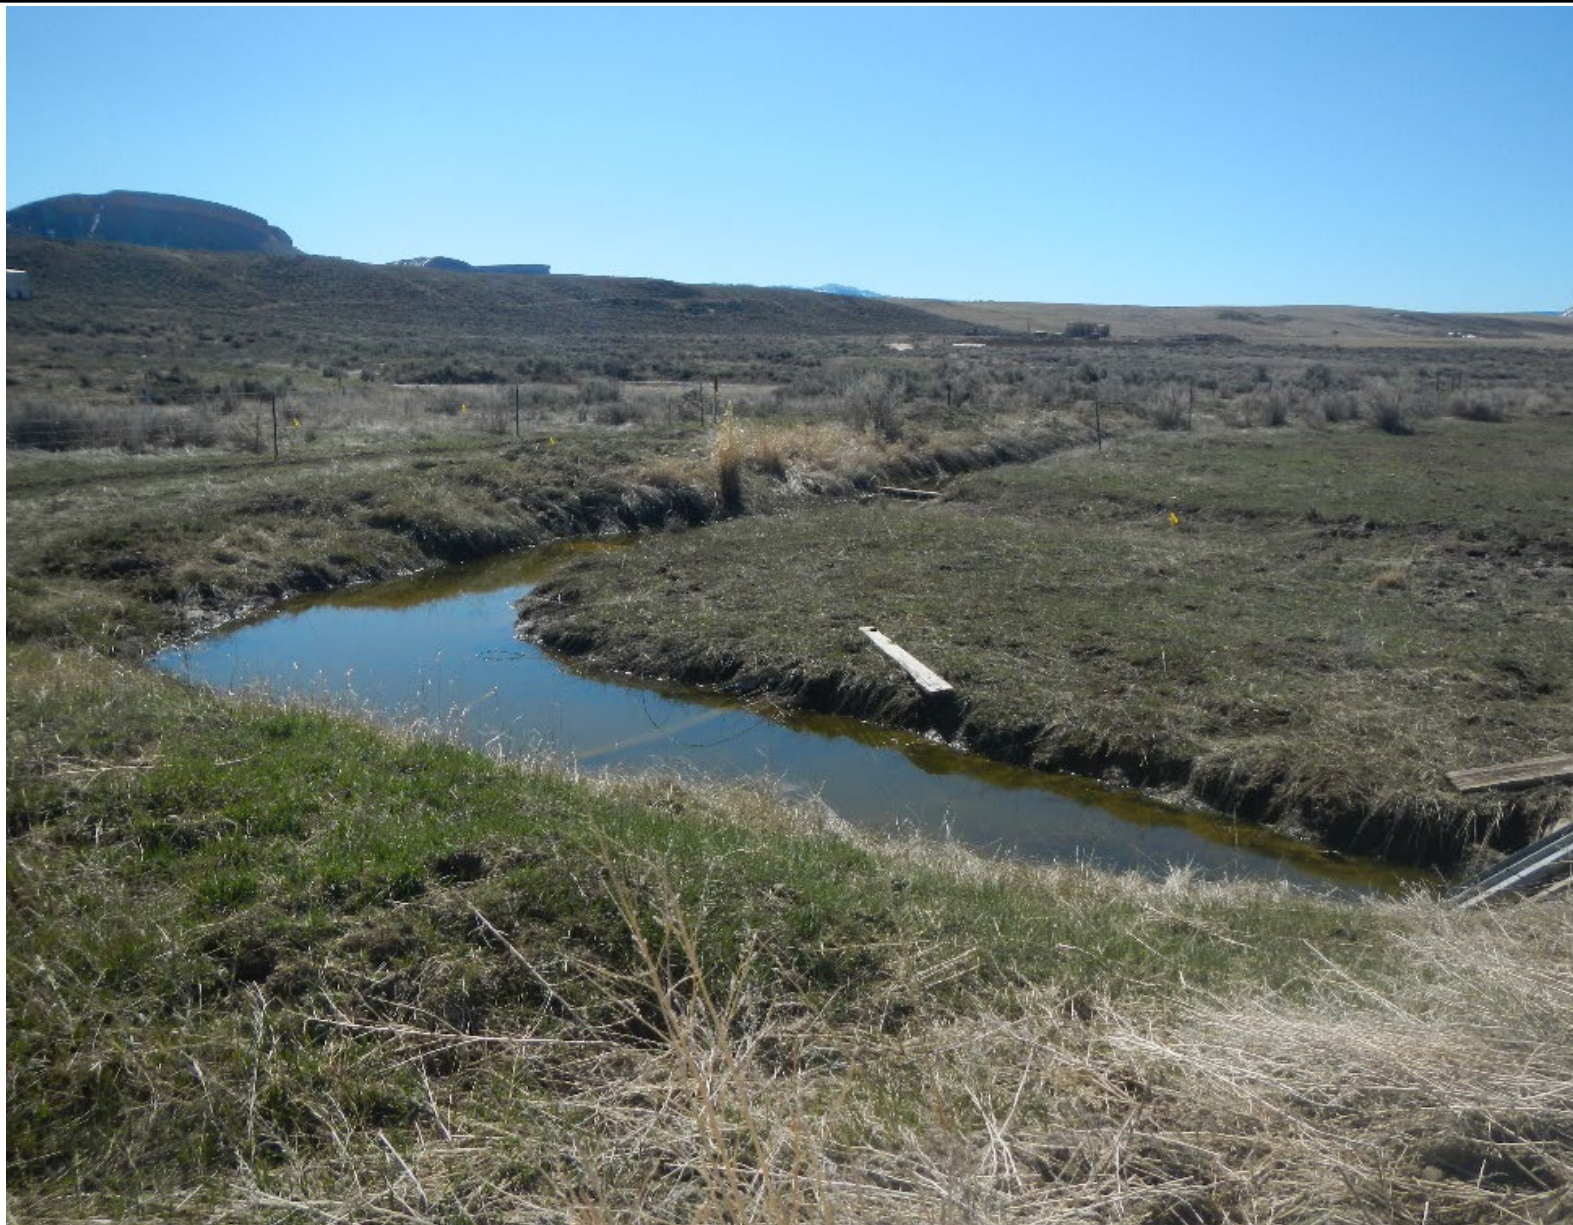
Photo #10 Seeping Spring Gulch near the discharge of surface water from the Marathon Facility. No Hydrocarbon staining or sheen was observed at this point.

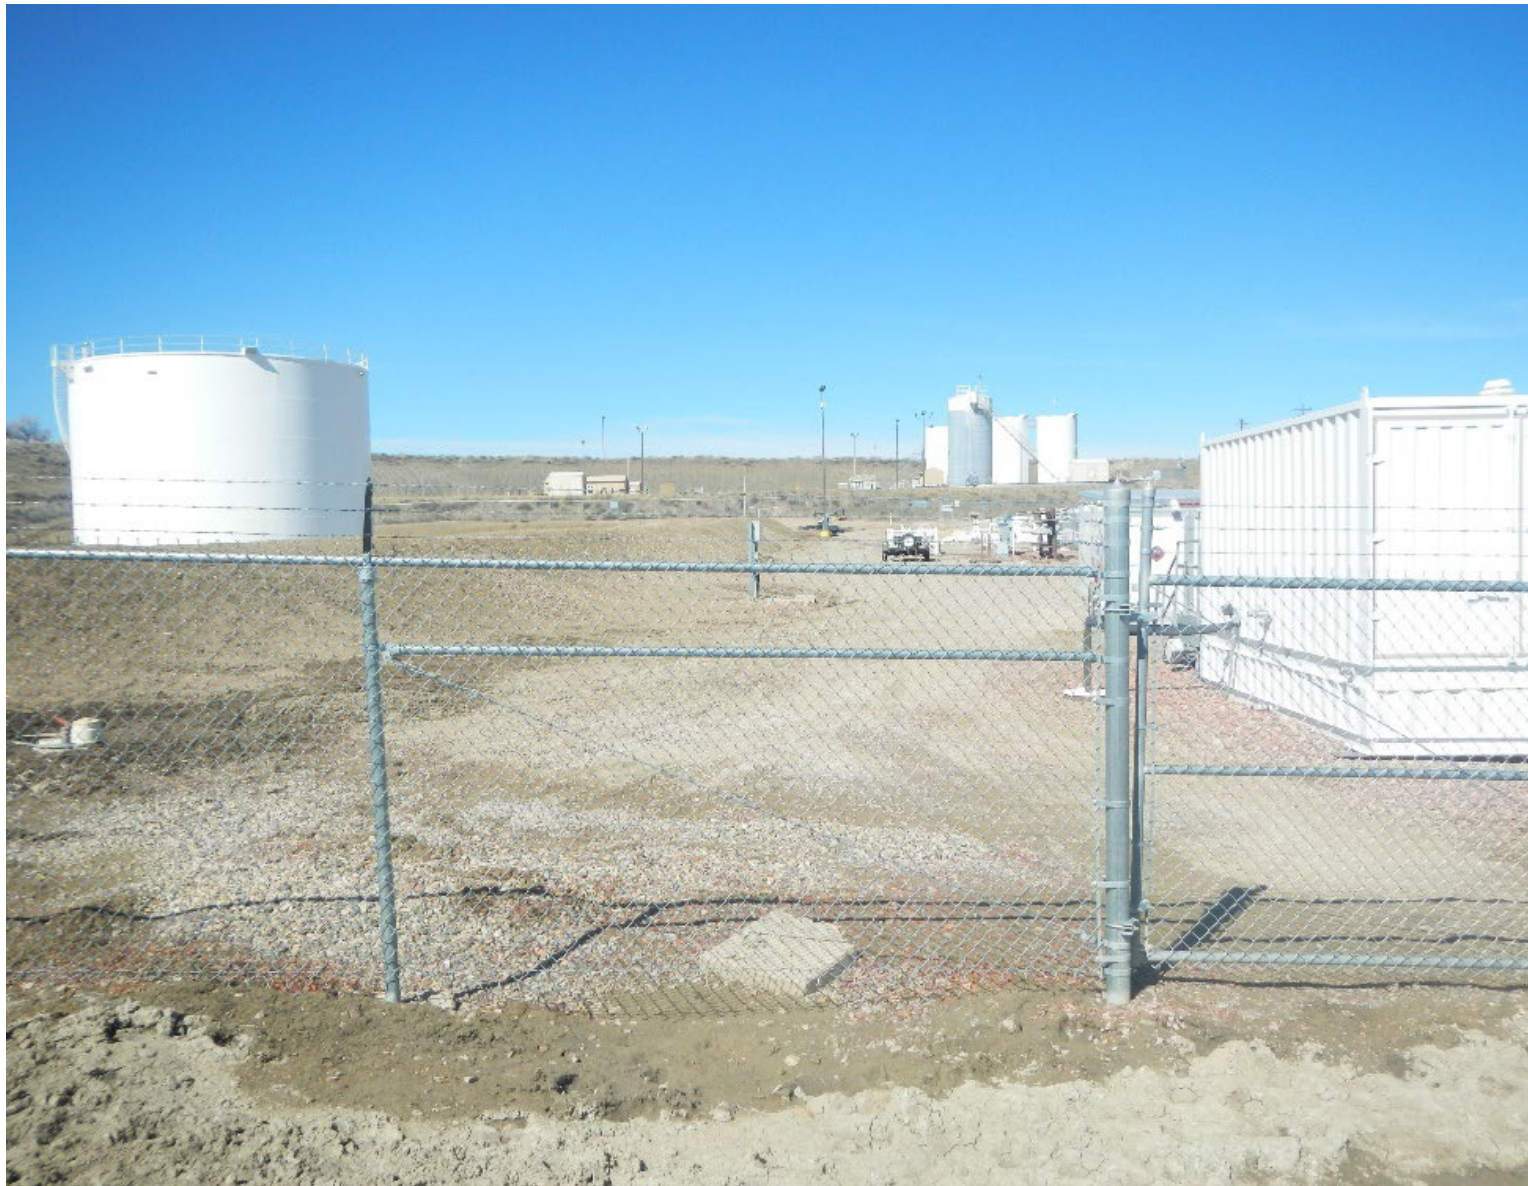
Photo #11 Photo taken on Marathon Iles Facility property. perimeter fencing of Marathon Facility.  
Looking west from the eastern side of facility.

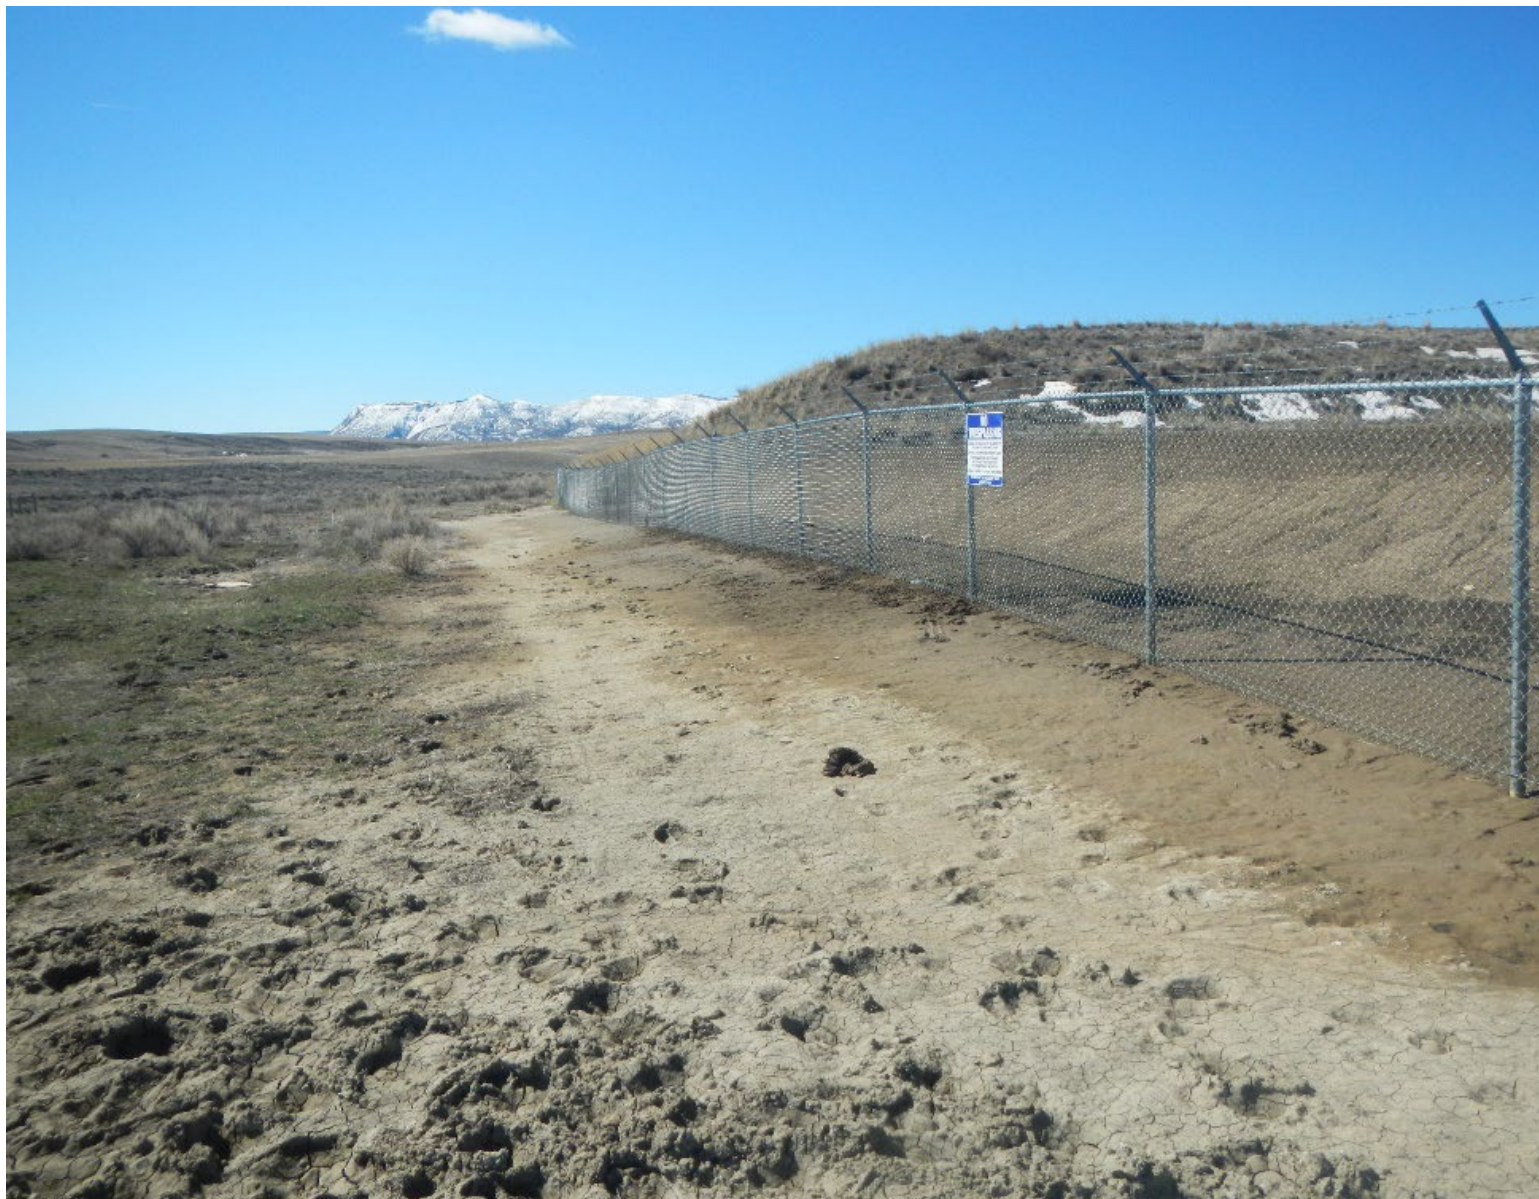
Photo #12 Photo taken on Marathon Iles Facility property. perimeter fencing of Marathon Facility. Ground was soft and muddy. Looking mostly south.

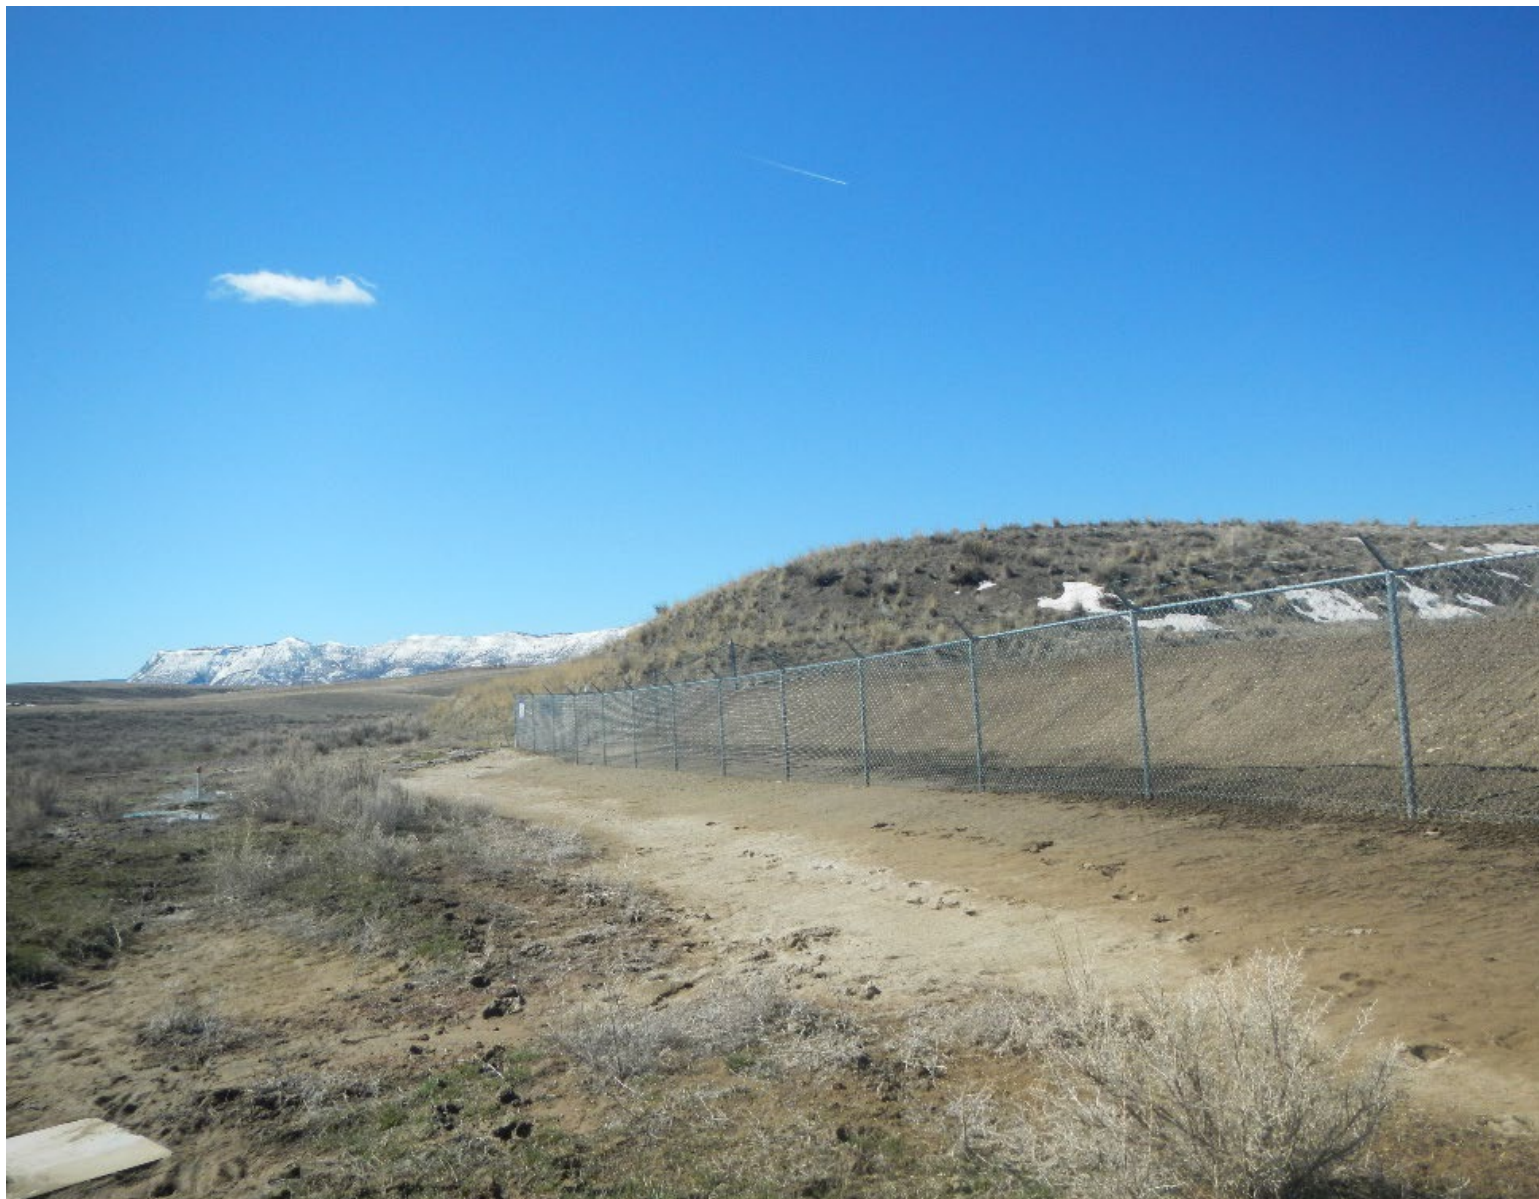
**Photo #13** Photo taken on Marathon Iles Facility property. perimeter fencing of Marathon Facility. Ground was soft and muddy. No hydrocarbon staining or sheen was observed along the perimeter.
