**COLORADO**  
Energy & Carbon Management  
Commission  
Department of Natural Resources

REM 28246, Facility 116587 Date 4/9/24, all photos taken by ECMC Staff Kris Neidel

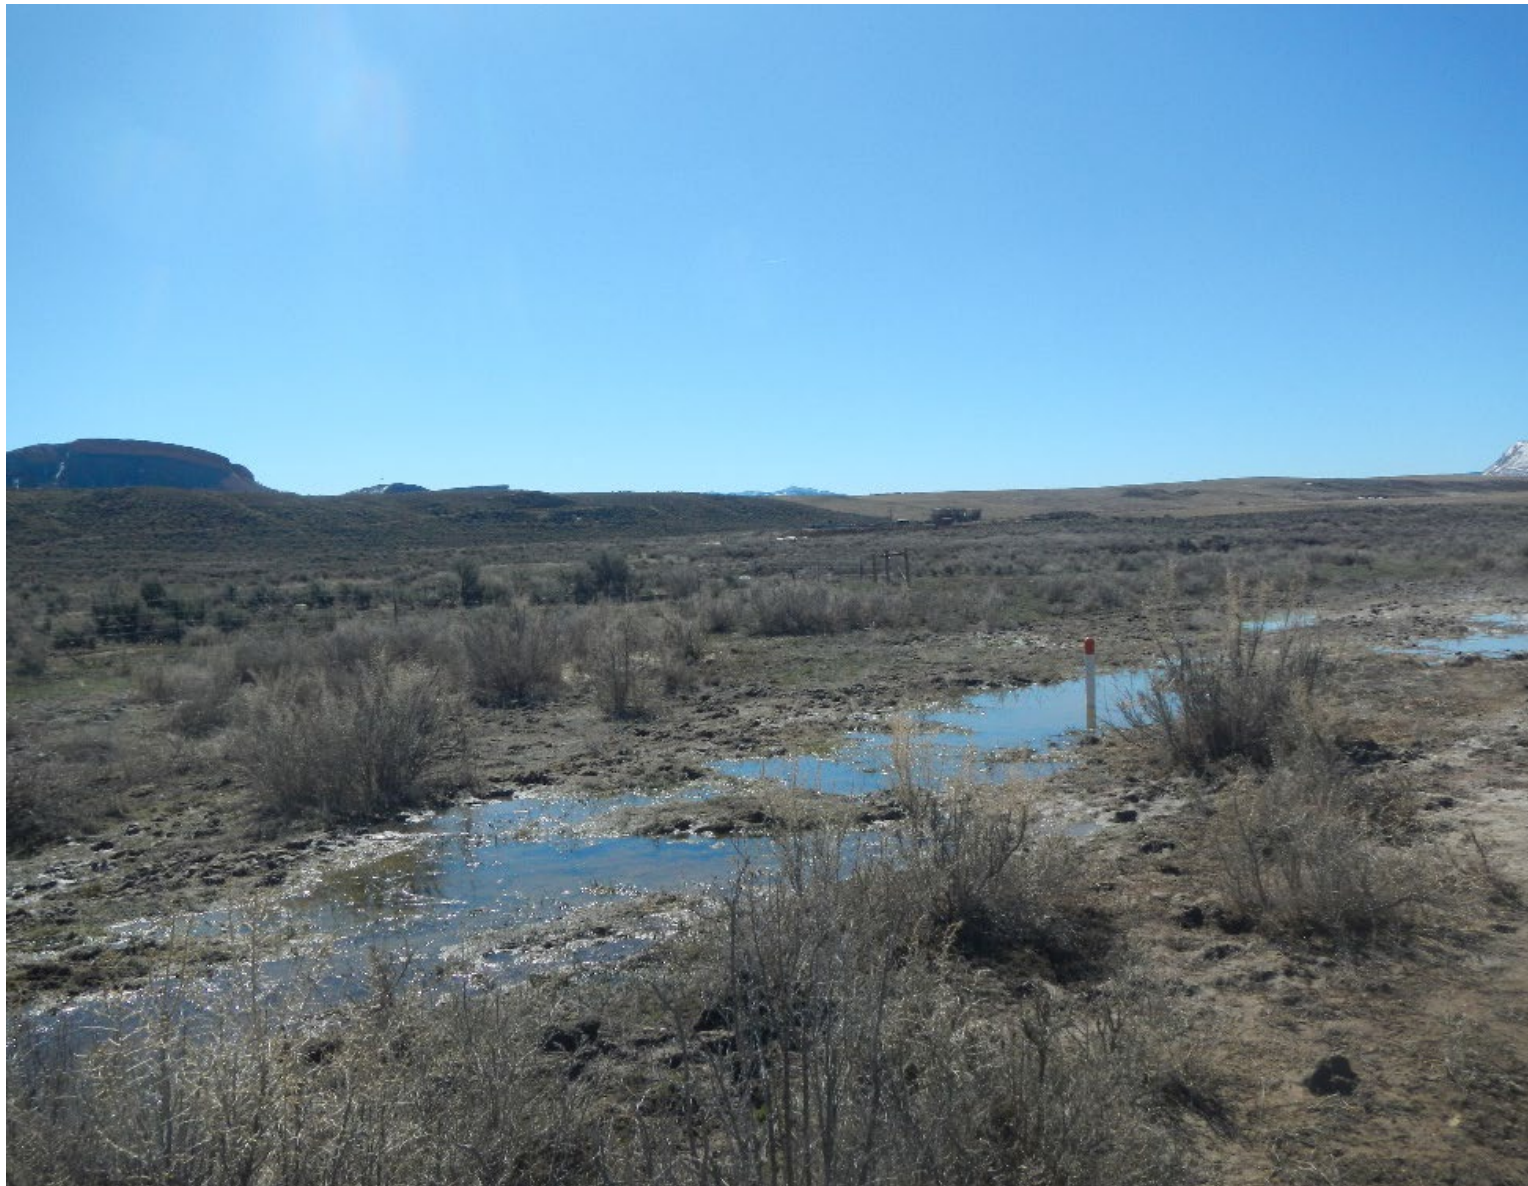
REM 28246, Facility 116587 Date 4/9/24, all photos taken by ECMC Staff Kris Neidel  
Photo #14 Seeping spring gulch from near the Marathon facility.

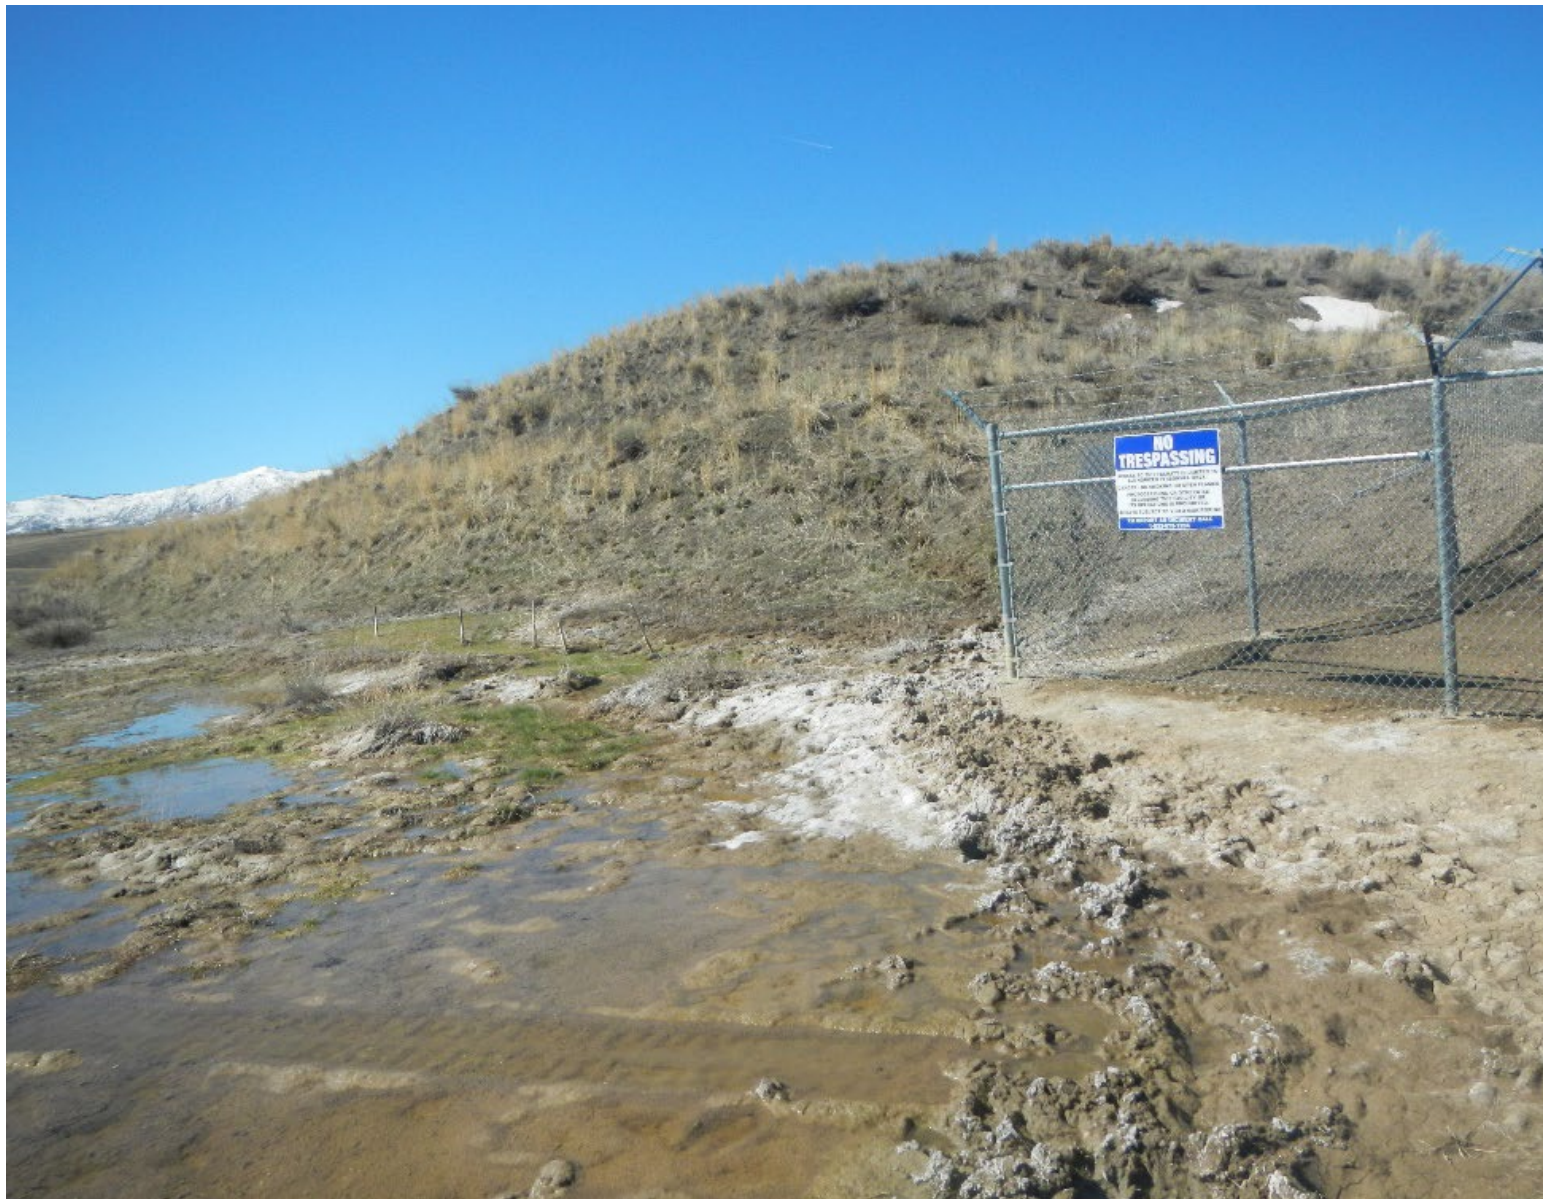
REM 28246, Facility 116587 Date 4/9/24, all photos taken by ECMC Staff Kris Neidel  
Photo #15 Photo taken on Marathon Iles Facility property. fence corner is the southeast corner of facility.

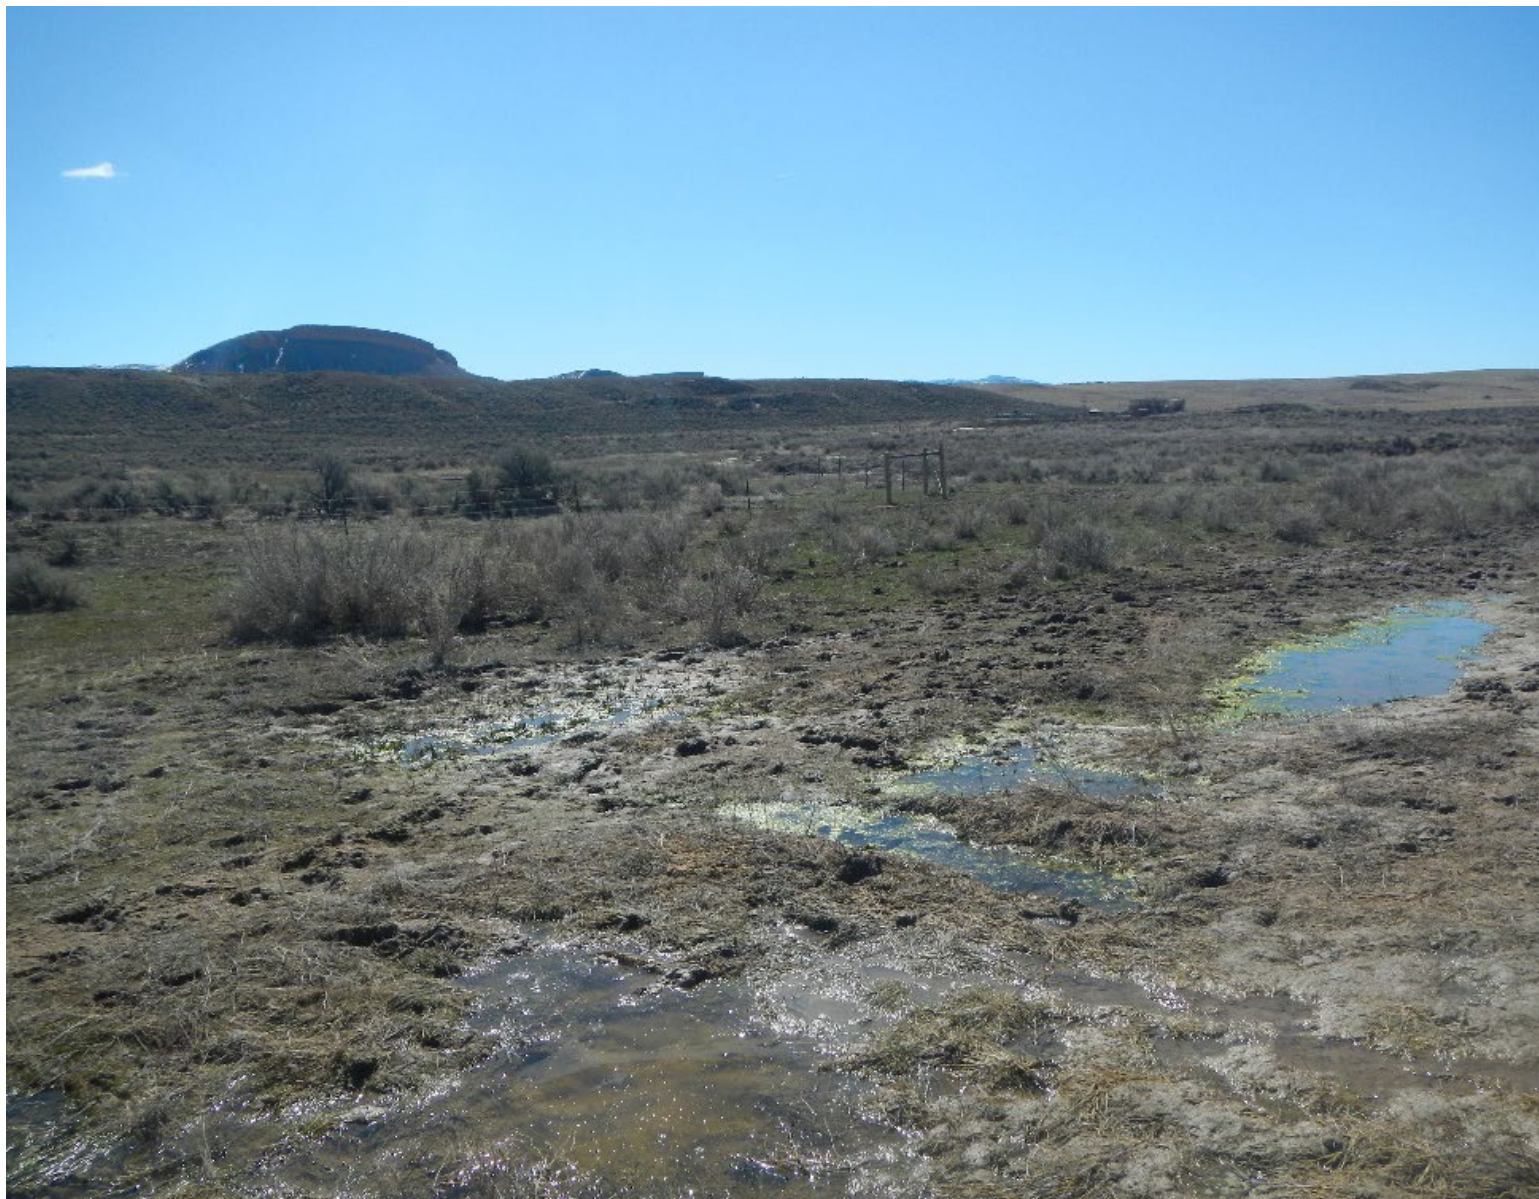
REM 28246, Facility 116587 Date 4/9/24, all photos taken by ECMC Staff Kris Neidel  
Photo #16 photo taken near the northeast corner of Marathon facility.

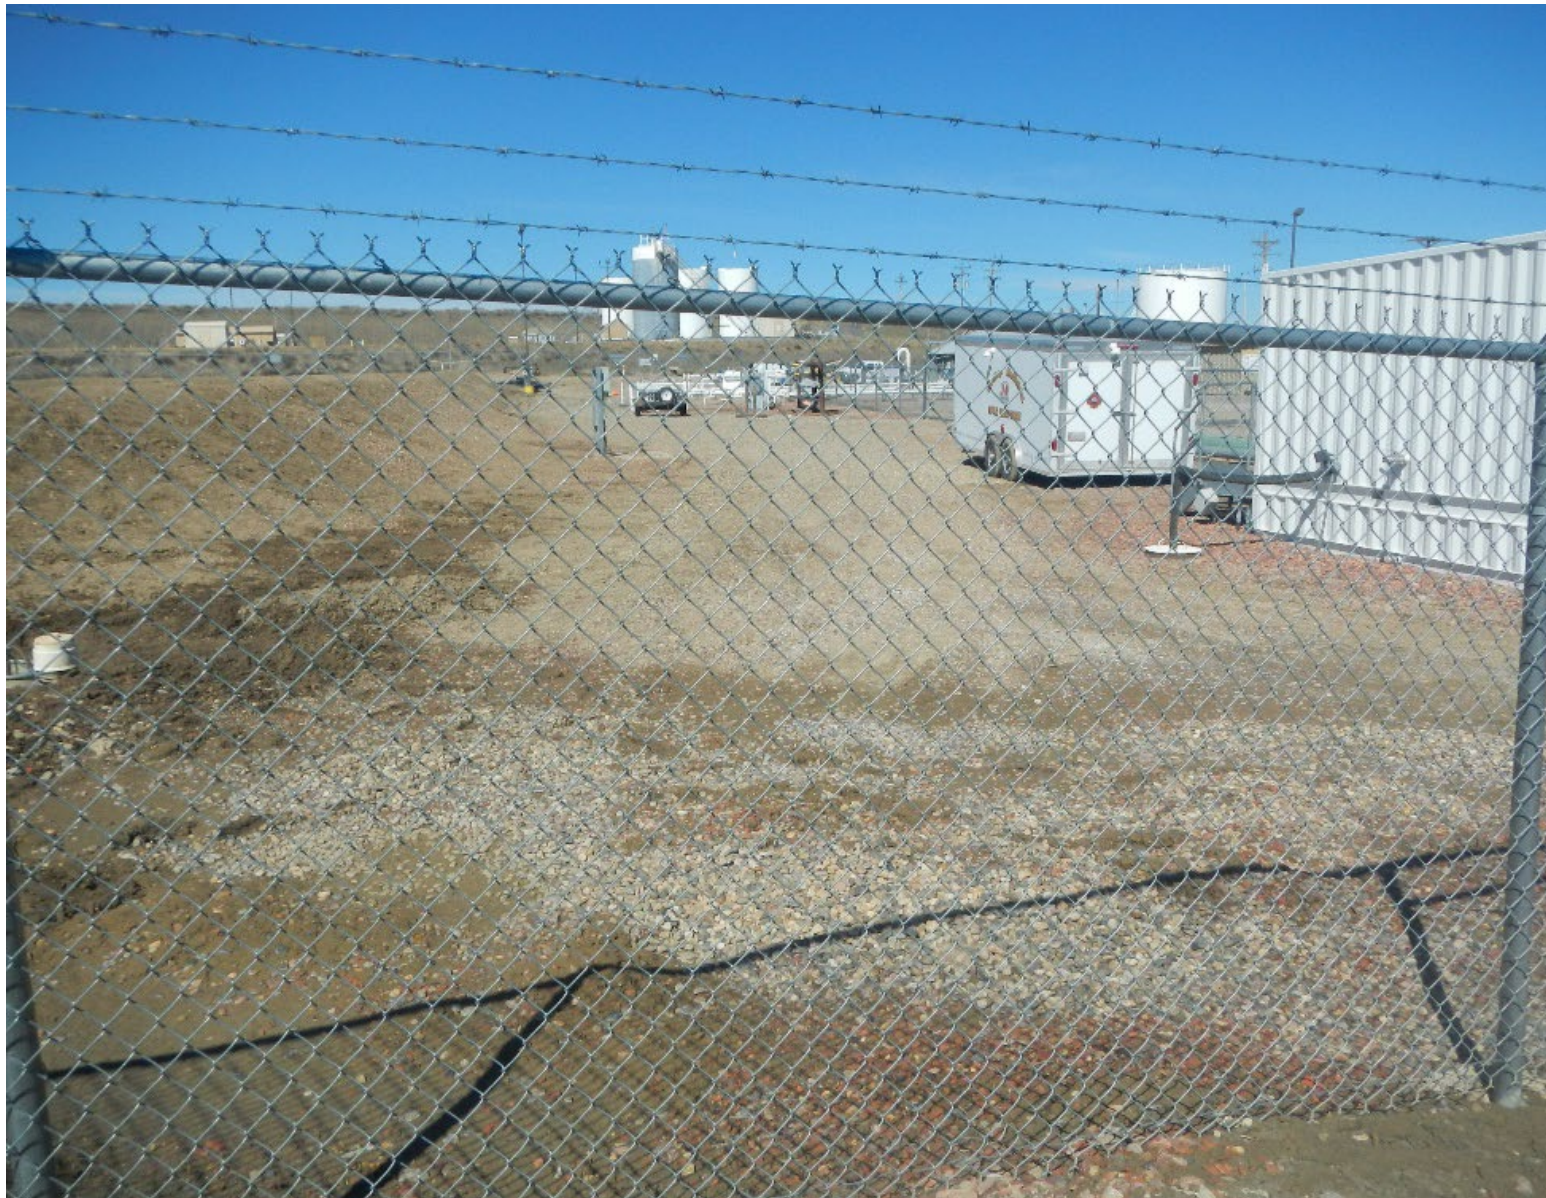
Photo #17 Photo taken on Marathon Iles Facility property. Looking in from eastern perimeter fence.

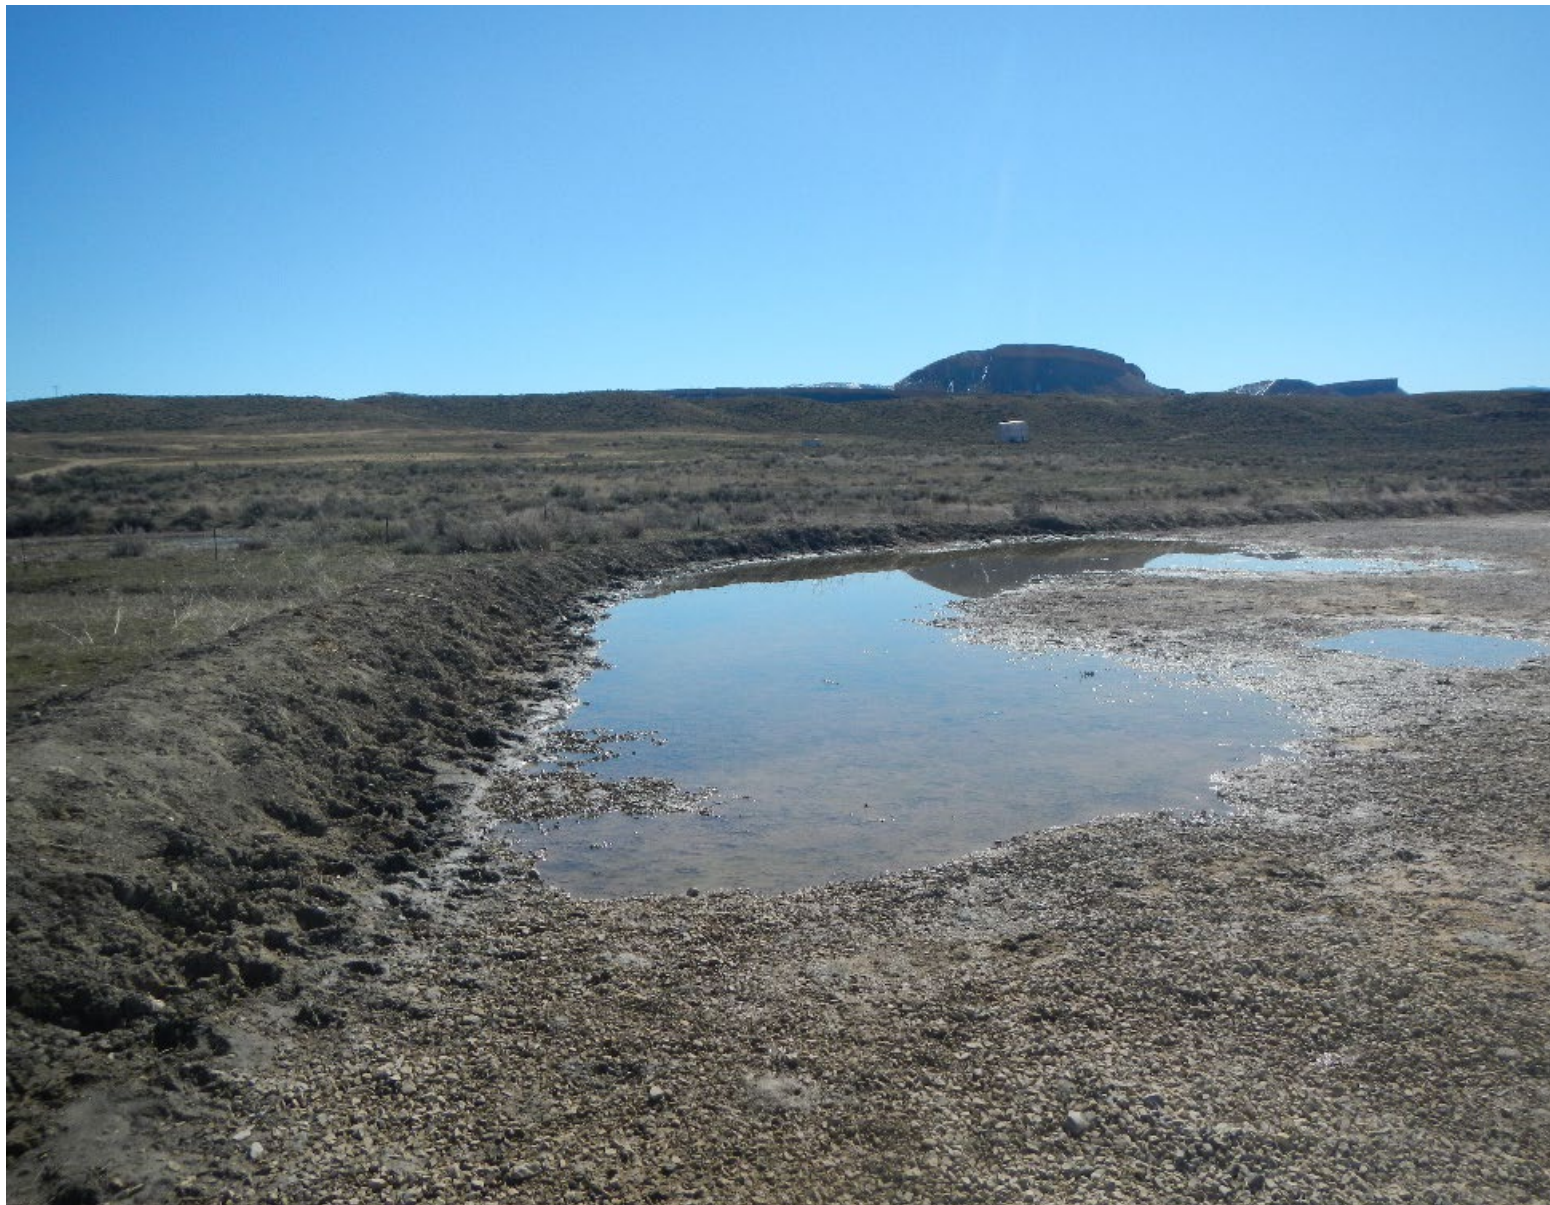
Photo #18 Photo taken on Marathon Iles Facility property. Puddle in the north east portion of facility pad. No observed staining or sheen.

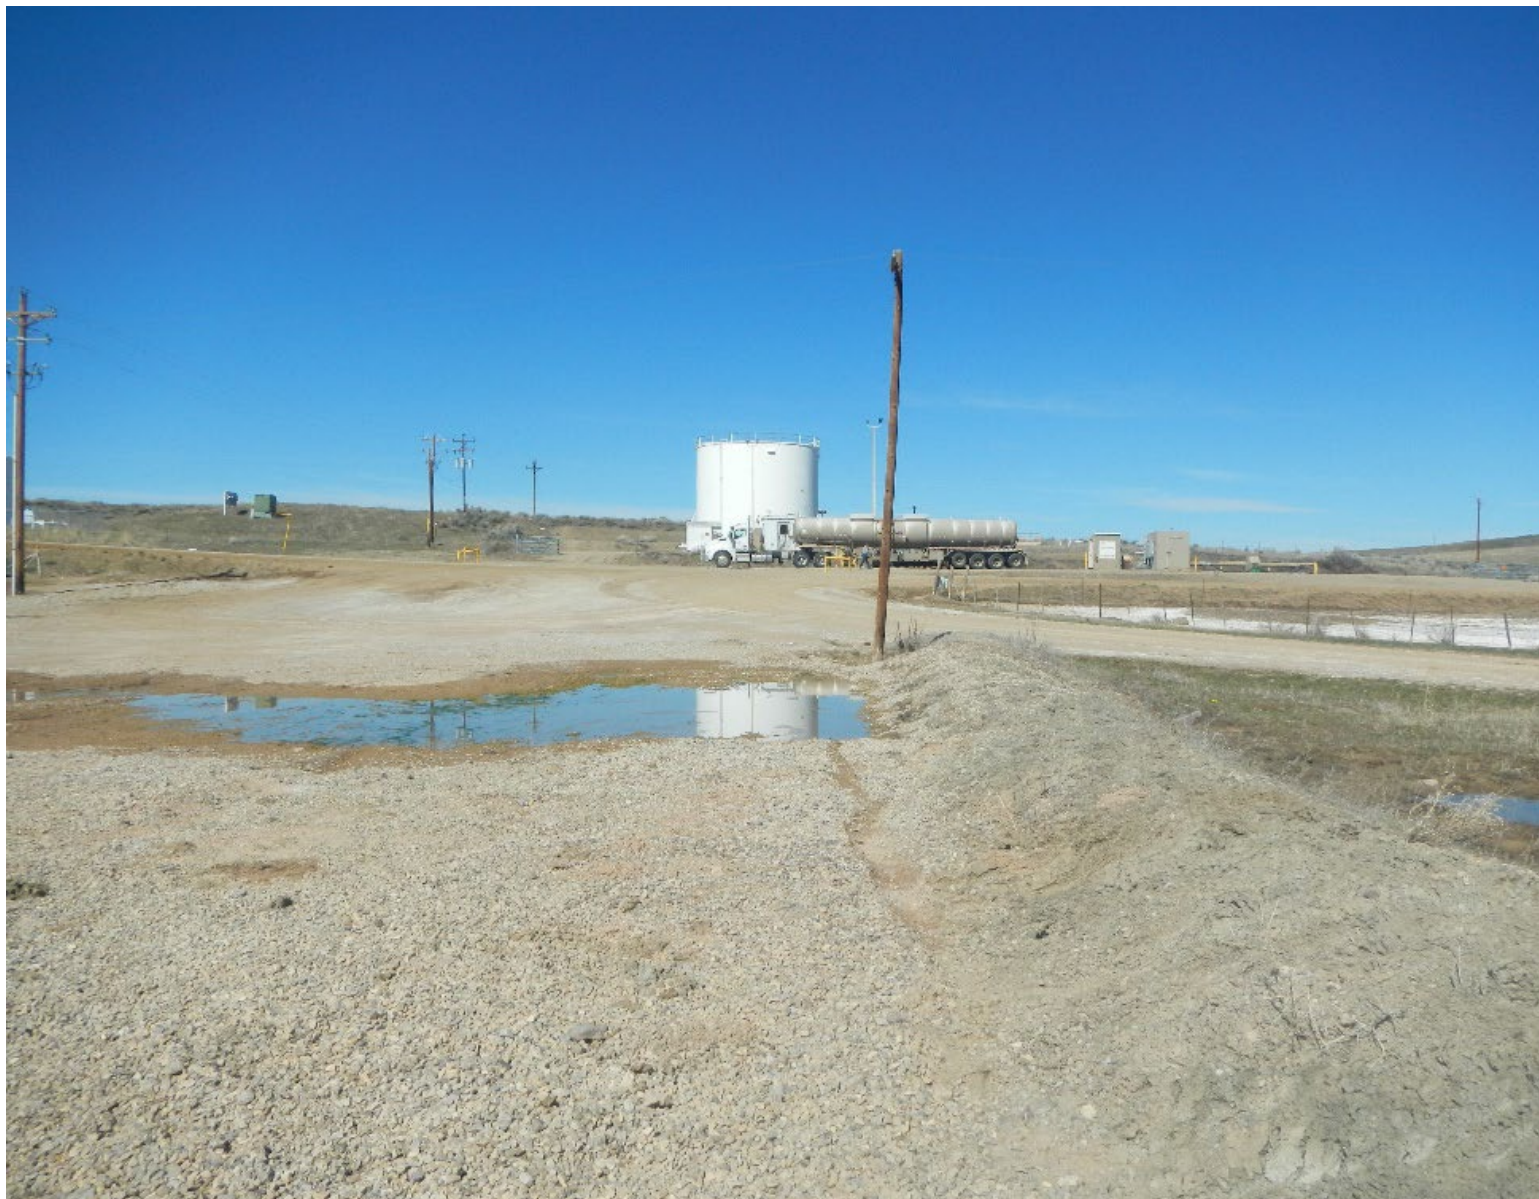
Photo #19 Photo taken on Marathon Iles Facility property. Looking west. Note: truck load unloading in center of photo.

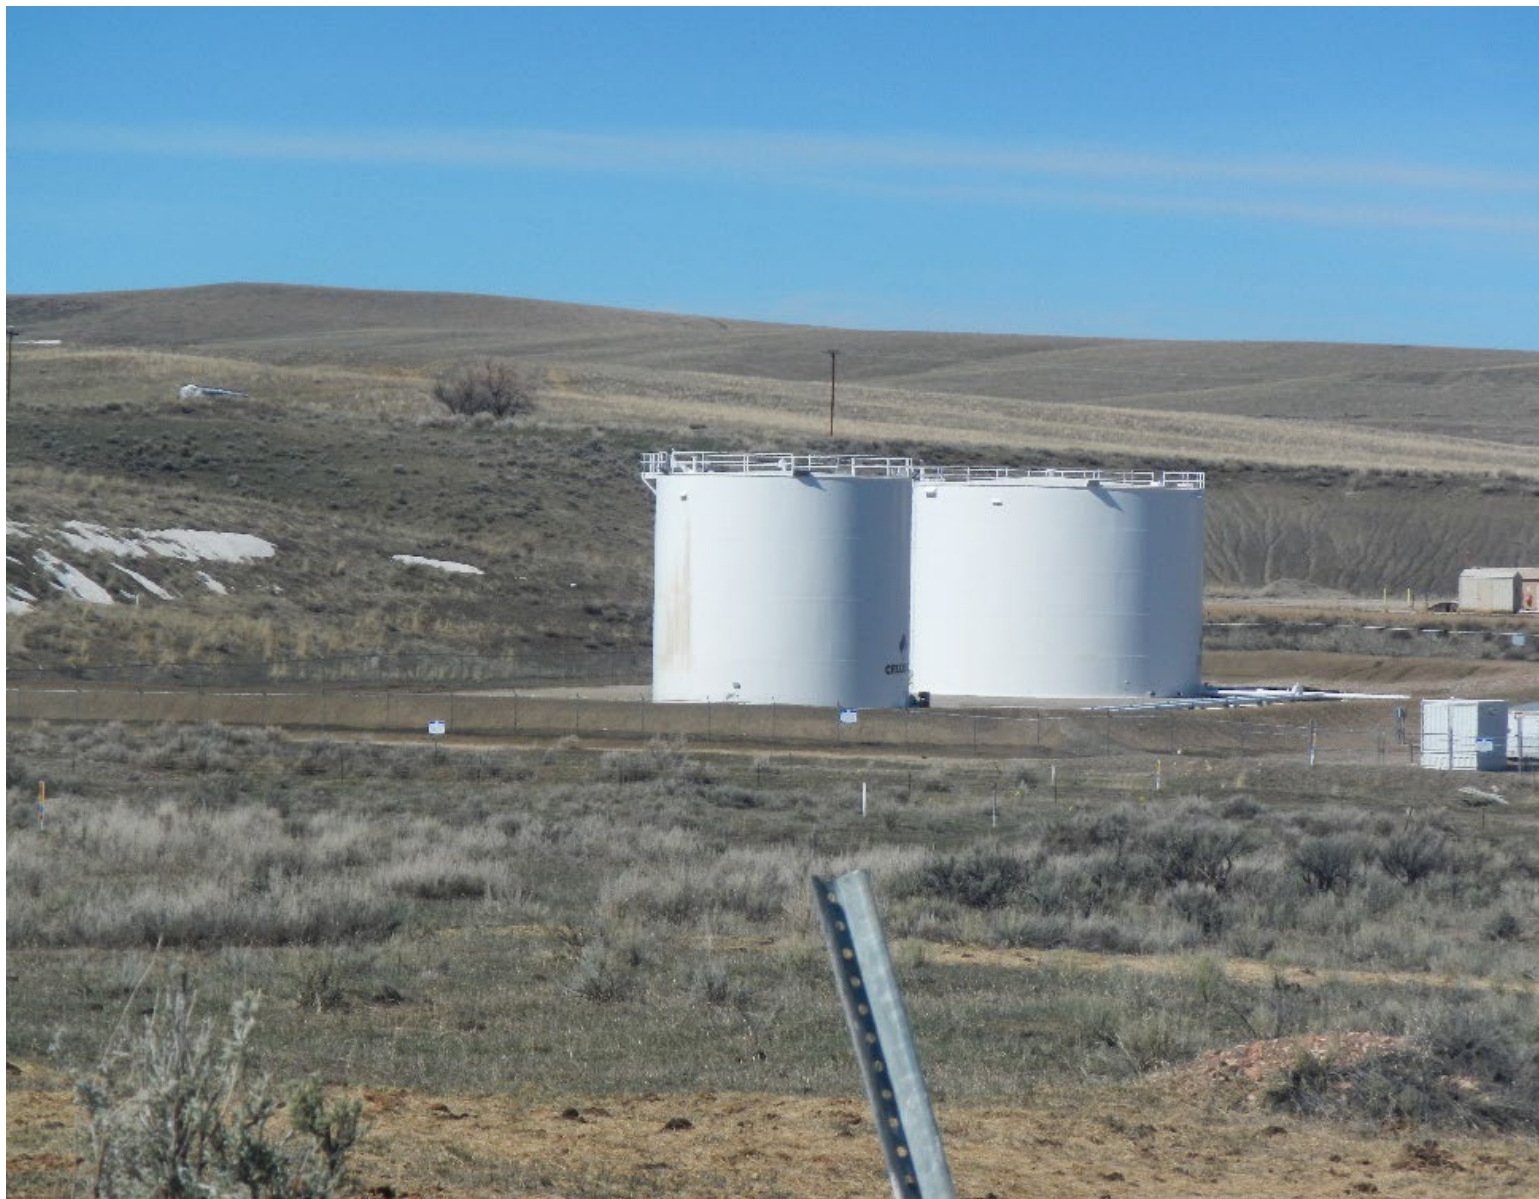
Photo #20 photo taken of Marathon Iles Facility from near culvert. Note: fence line in photo was the perimeter that was documented in Photos 11-17.

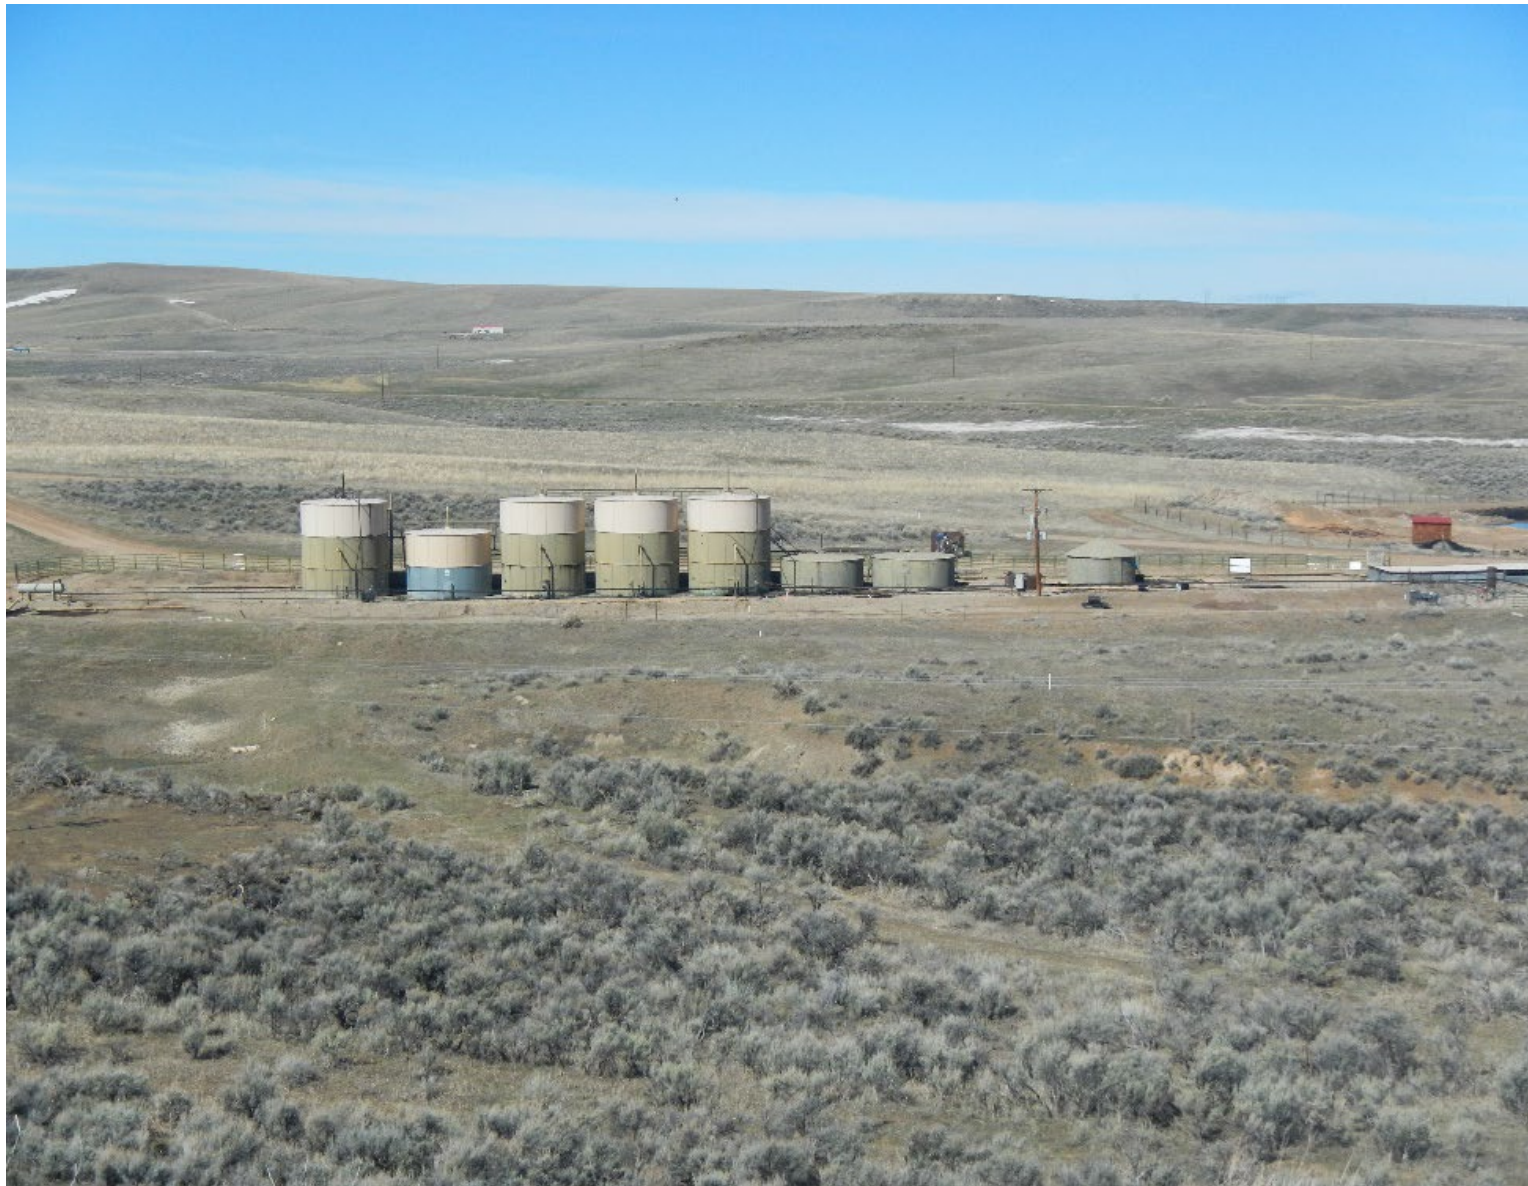
**REM 28246, Tank Battery Facility ID 480890 Date 4/9/24, all photos taken by ECMC Staff Kris Neidel  
Photo #21. POC Iles dome tank battery, facility 312756. Photo taken from the east side of facility**

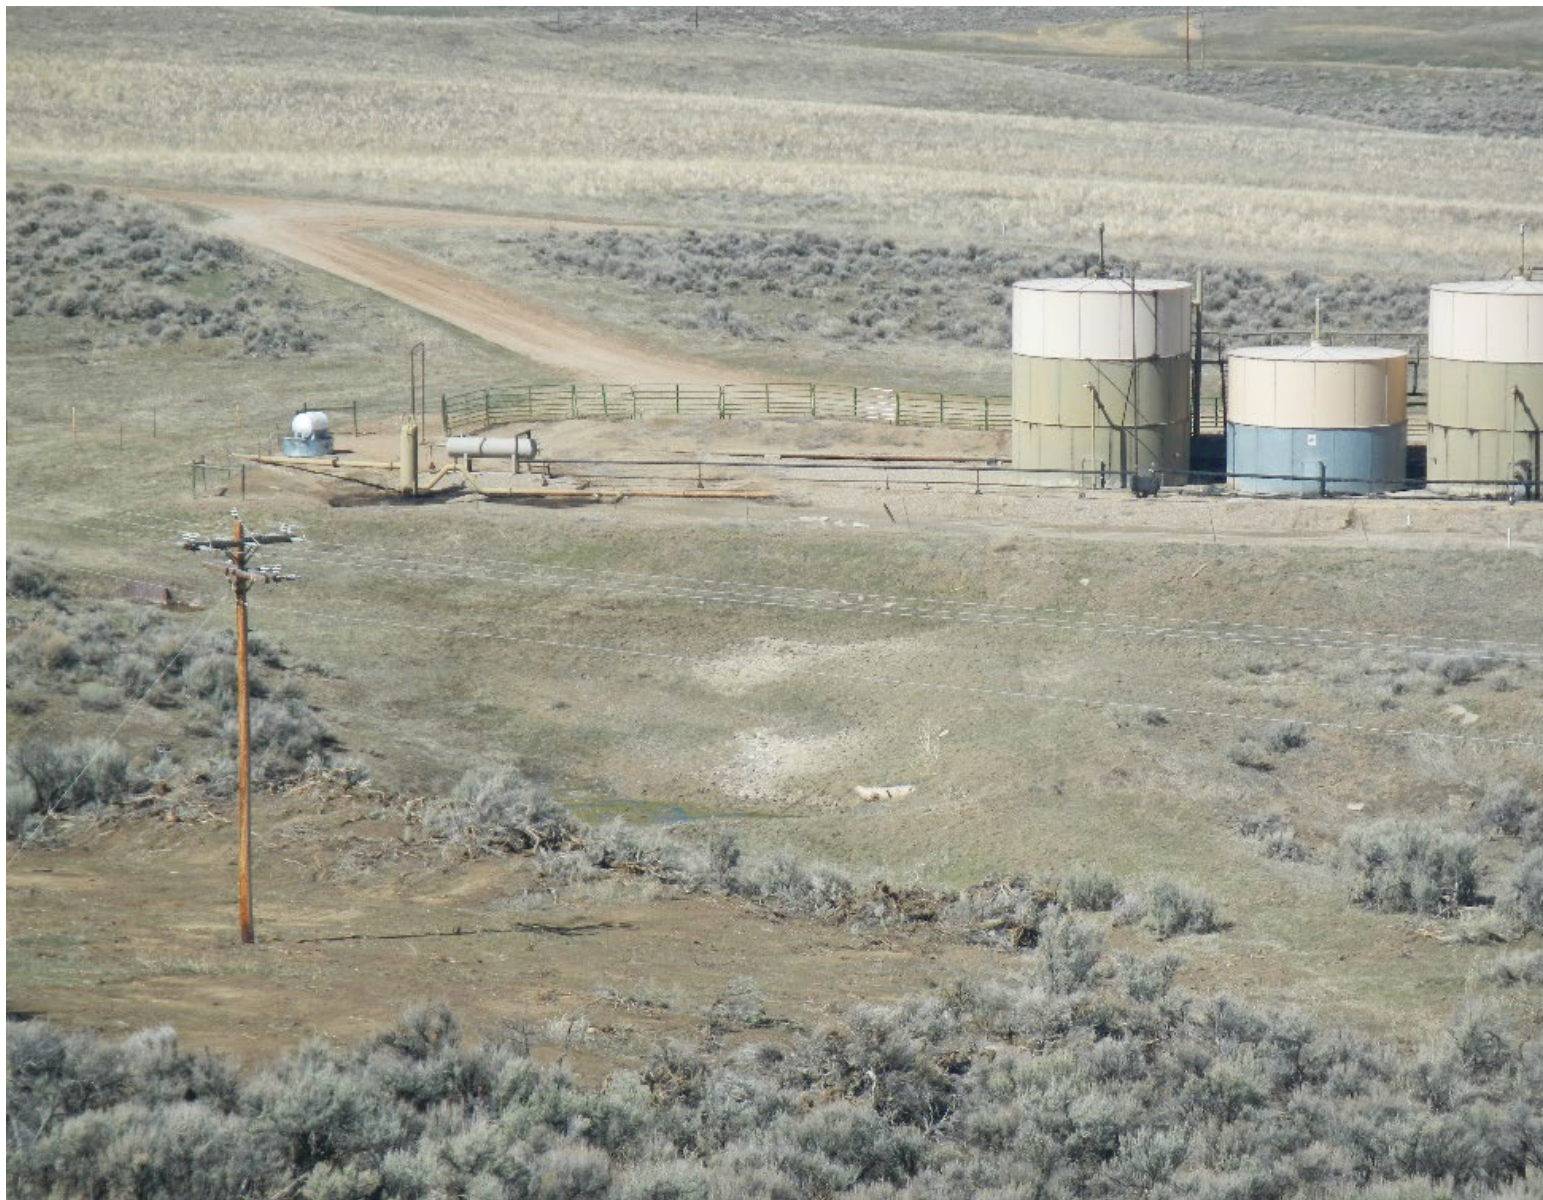
**REM 28246, Tank Battery Facility ID 480890 Date 4/9/24, all photos taken by ECMC Staff Kris Neidel**  
**Photo #22 POC Iles dome tank battery, facility 312756. Photo taken from the east side of facility**

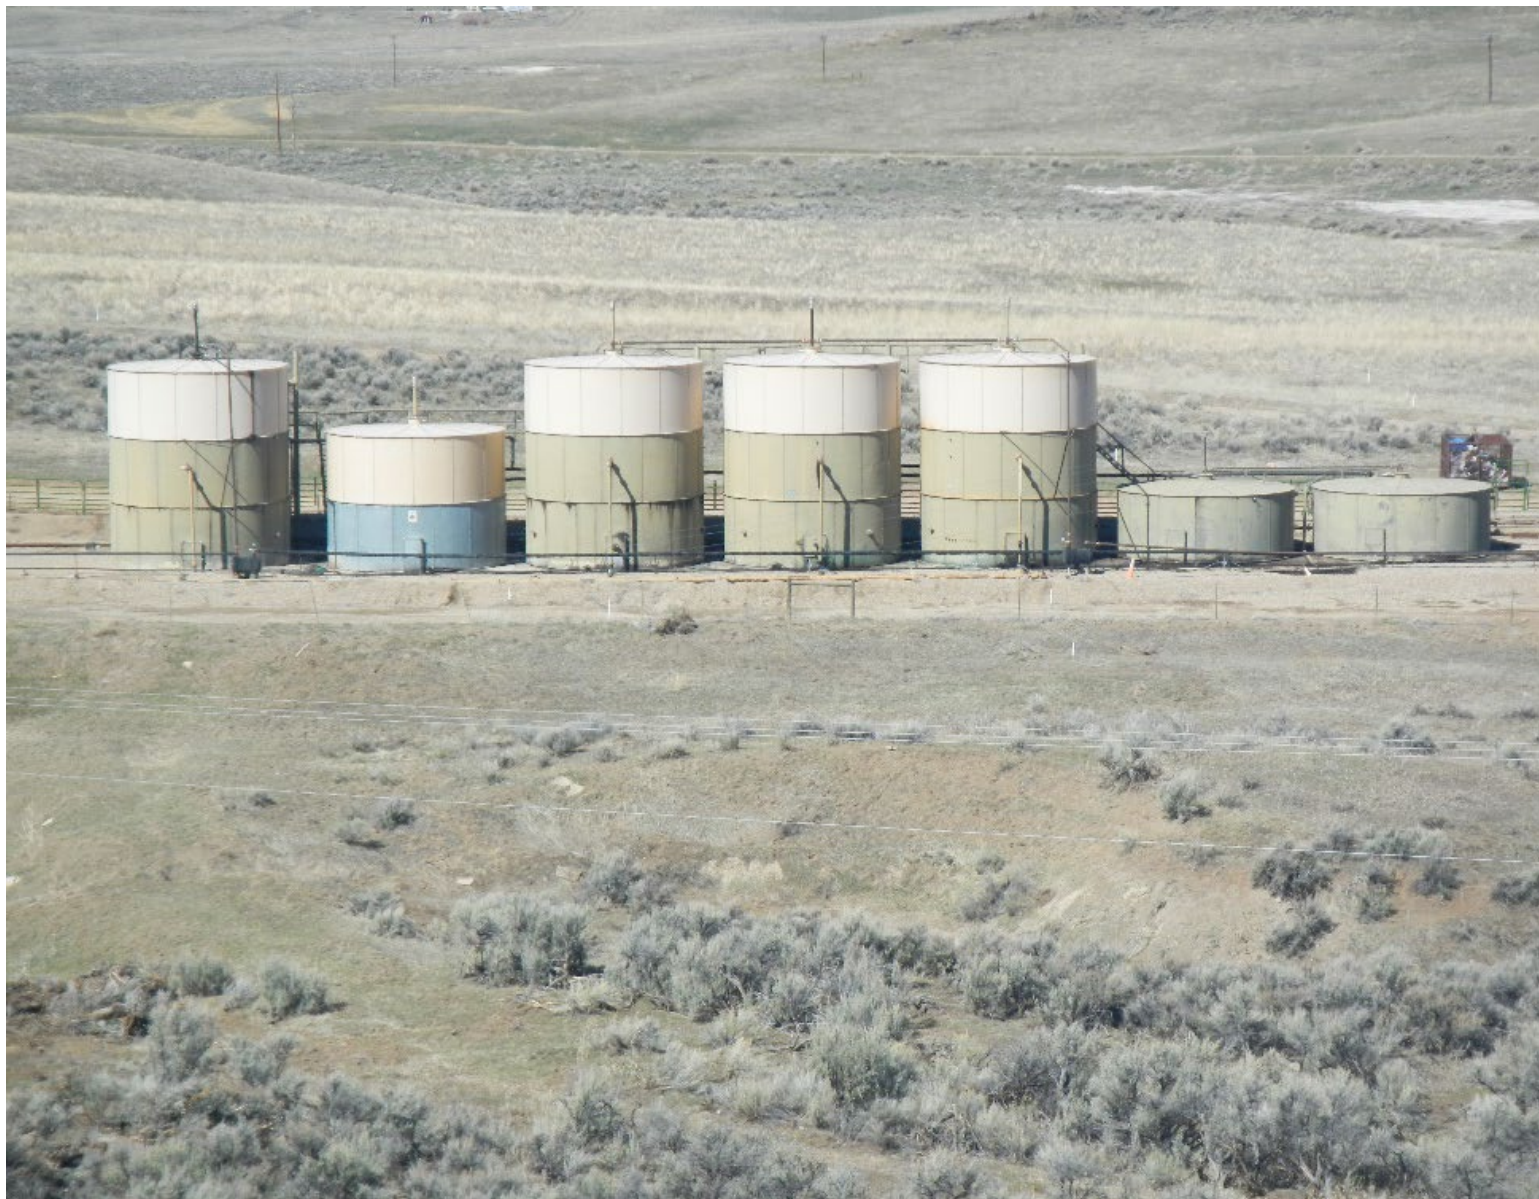
**REM 28246, Tank Battery Facility ID 480890 Date 4/9/24, all photos taken by ECMC Staff Kris Neidel**  
**Photo #23 POC Iles dome tank battery, facility 312756. Photo taken from the east side of facility**

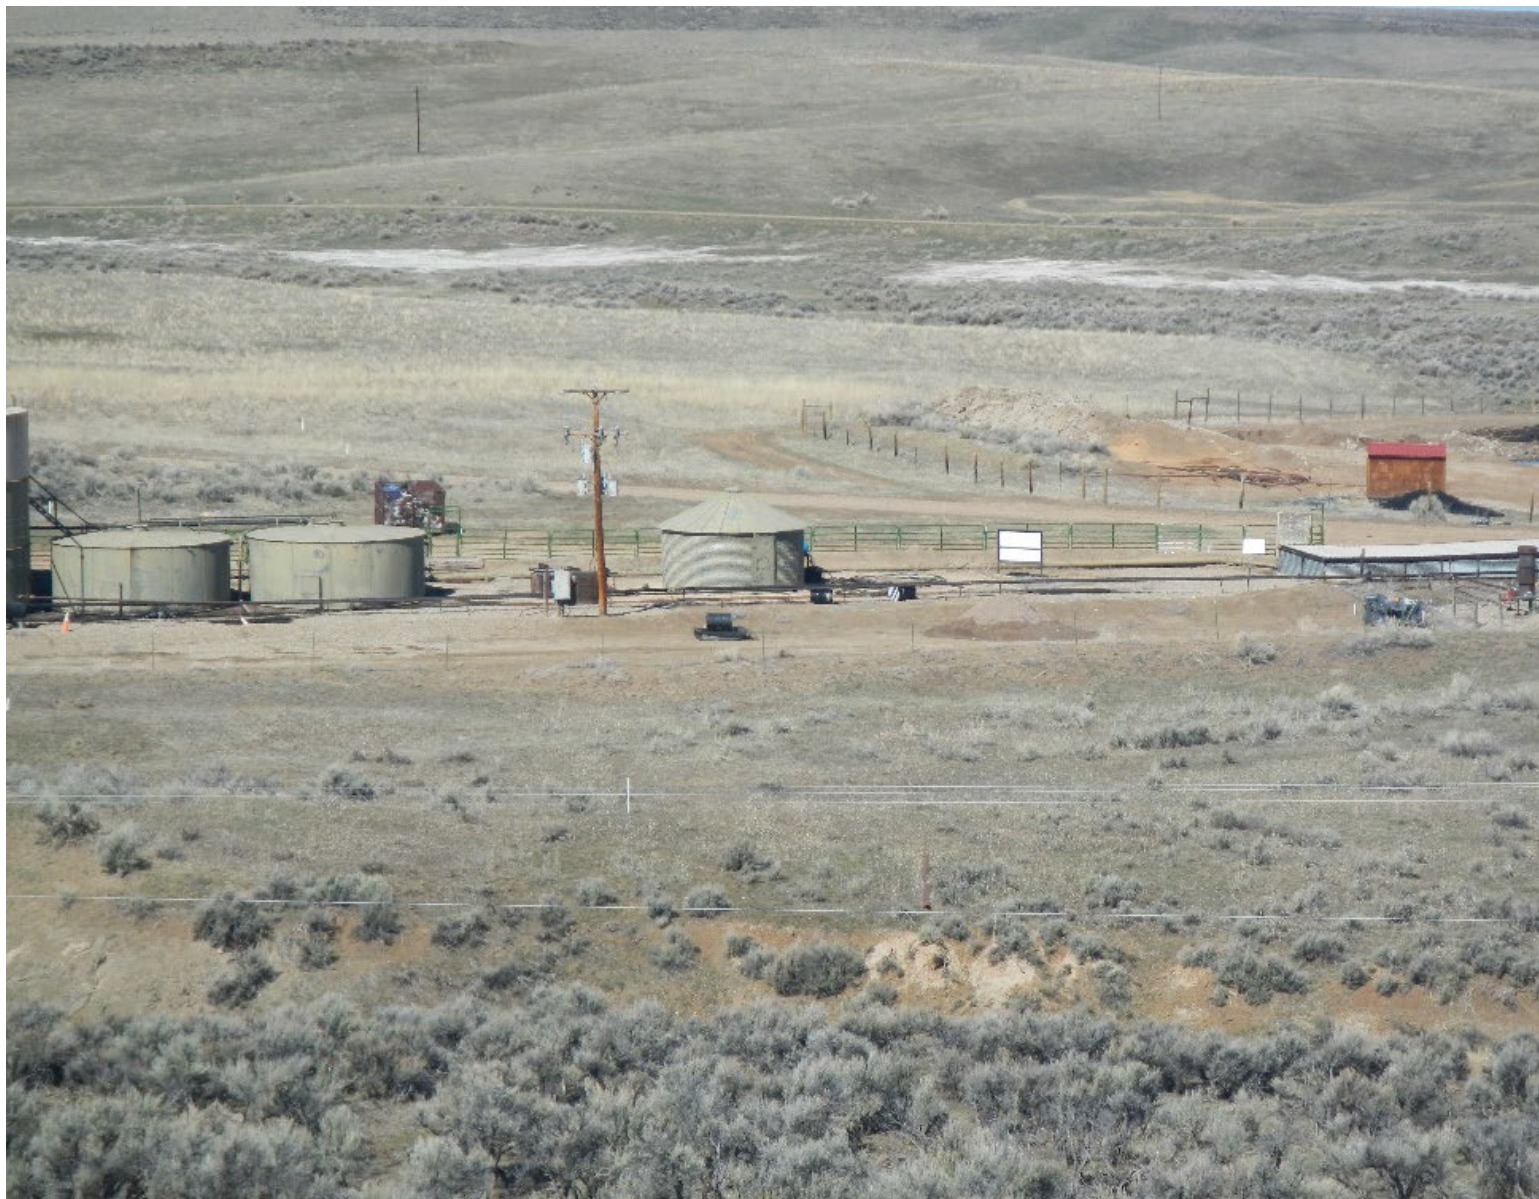
**REM 28246, Tank Battery Facility ID 480890 Date 4/9/24, all photos taken by ECMC Staff Kris Neidel**  
**Photo #24 POC Iles dome tank battery, facility 312756. Photo taken from the east side of facility**

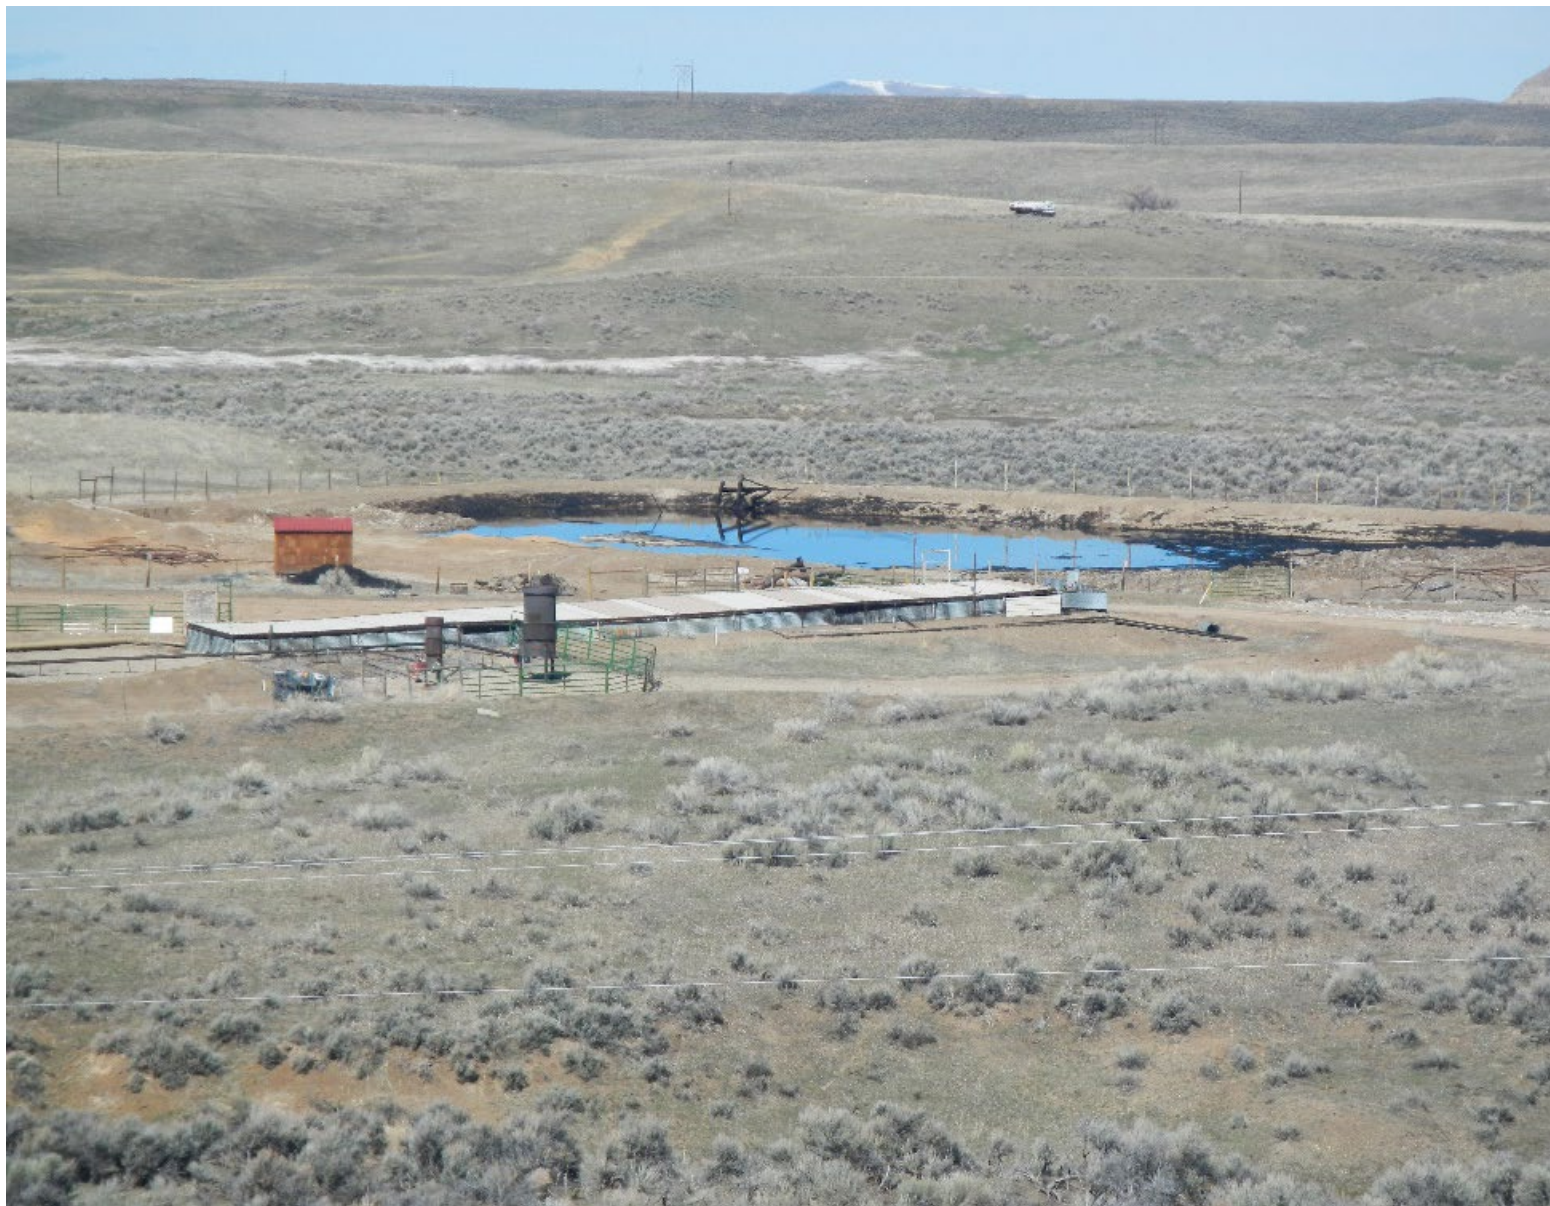
**REM 28244, Pit Facility 116587 Date 4/9/24, all photos taken by ECMC Staff Kris Neidel**  
**Photo #25 POC Iles dome Pit, facility 116587. Photo taken from the east side of facility**
