**COLORADO**  
Energy & Carbon Management  
Commission  
Department of Natural Resources

REM 28246, Facility 116587 Date 4/9/24, all photos taken by ECMC Staff Kris Neidel

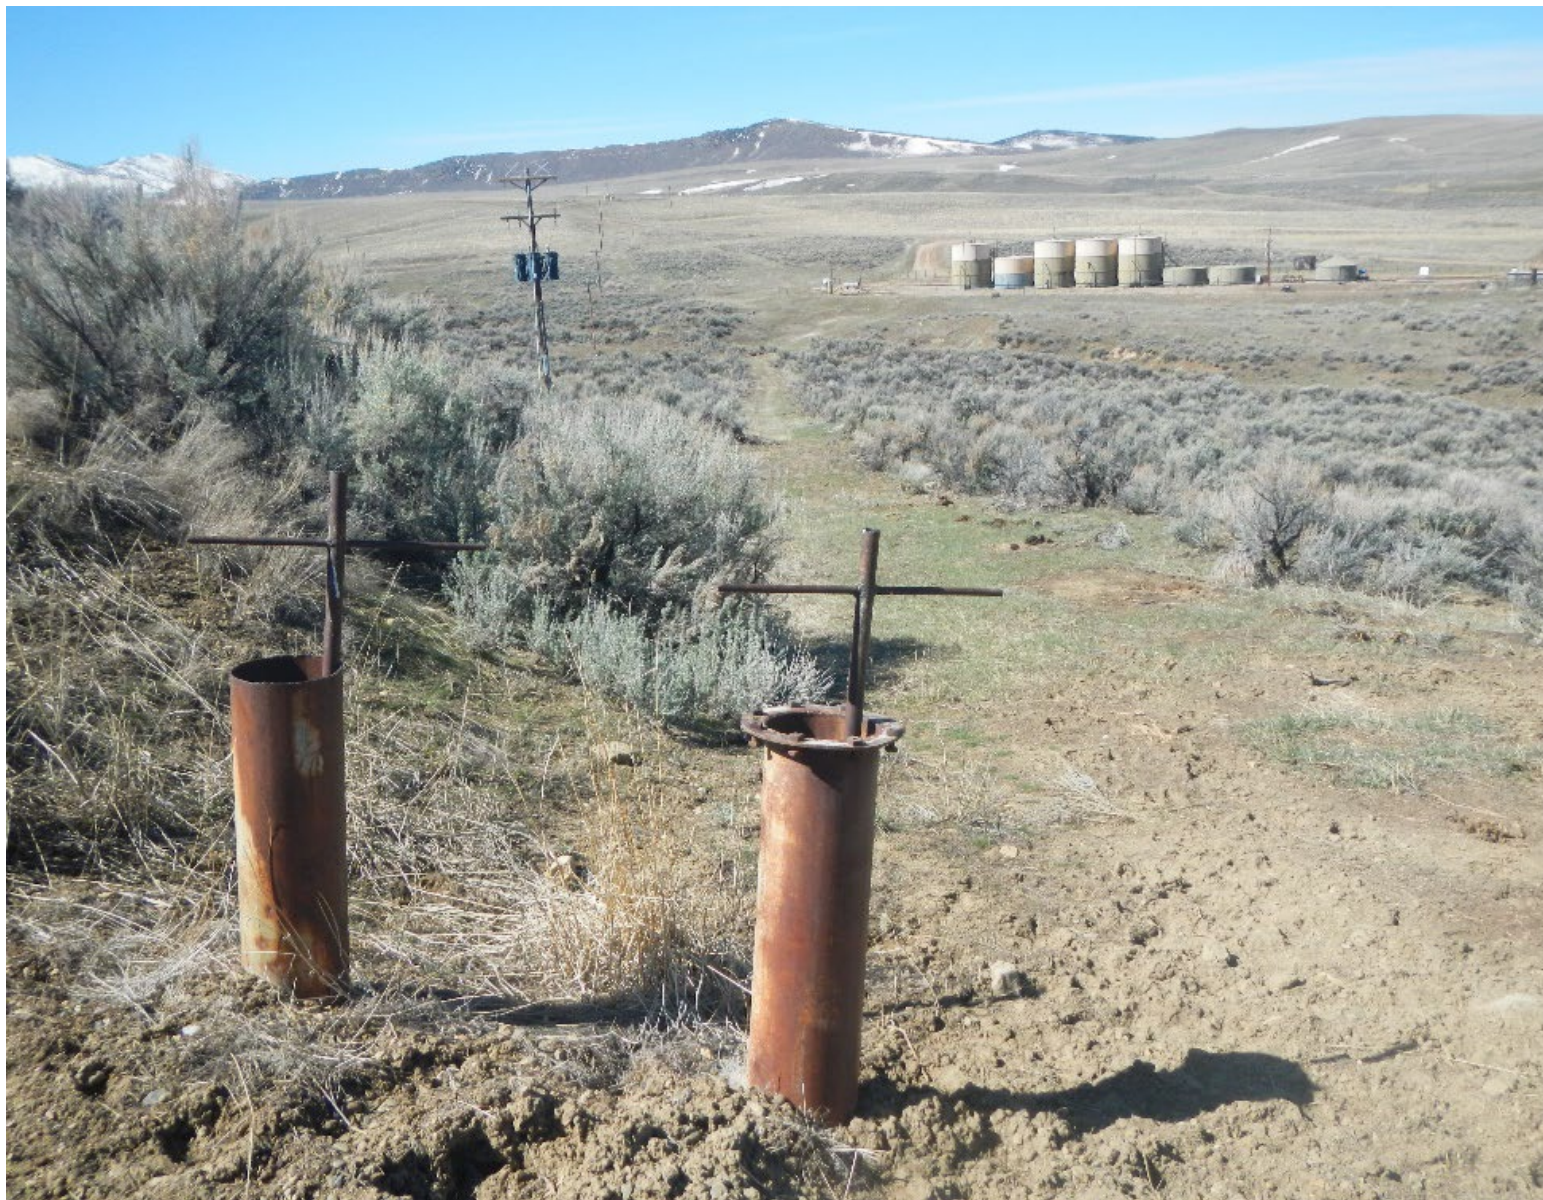
**Tank Battery Facility ID 480890 Date 4/9/24, all photos taken by ECMC Staff Kris Neidel  
Photo #26 Valves, on access road below the #8 pad (081-05119).**

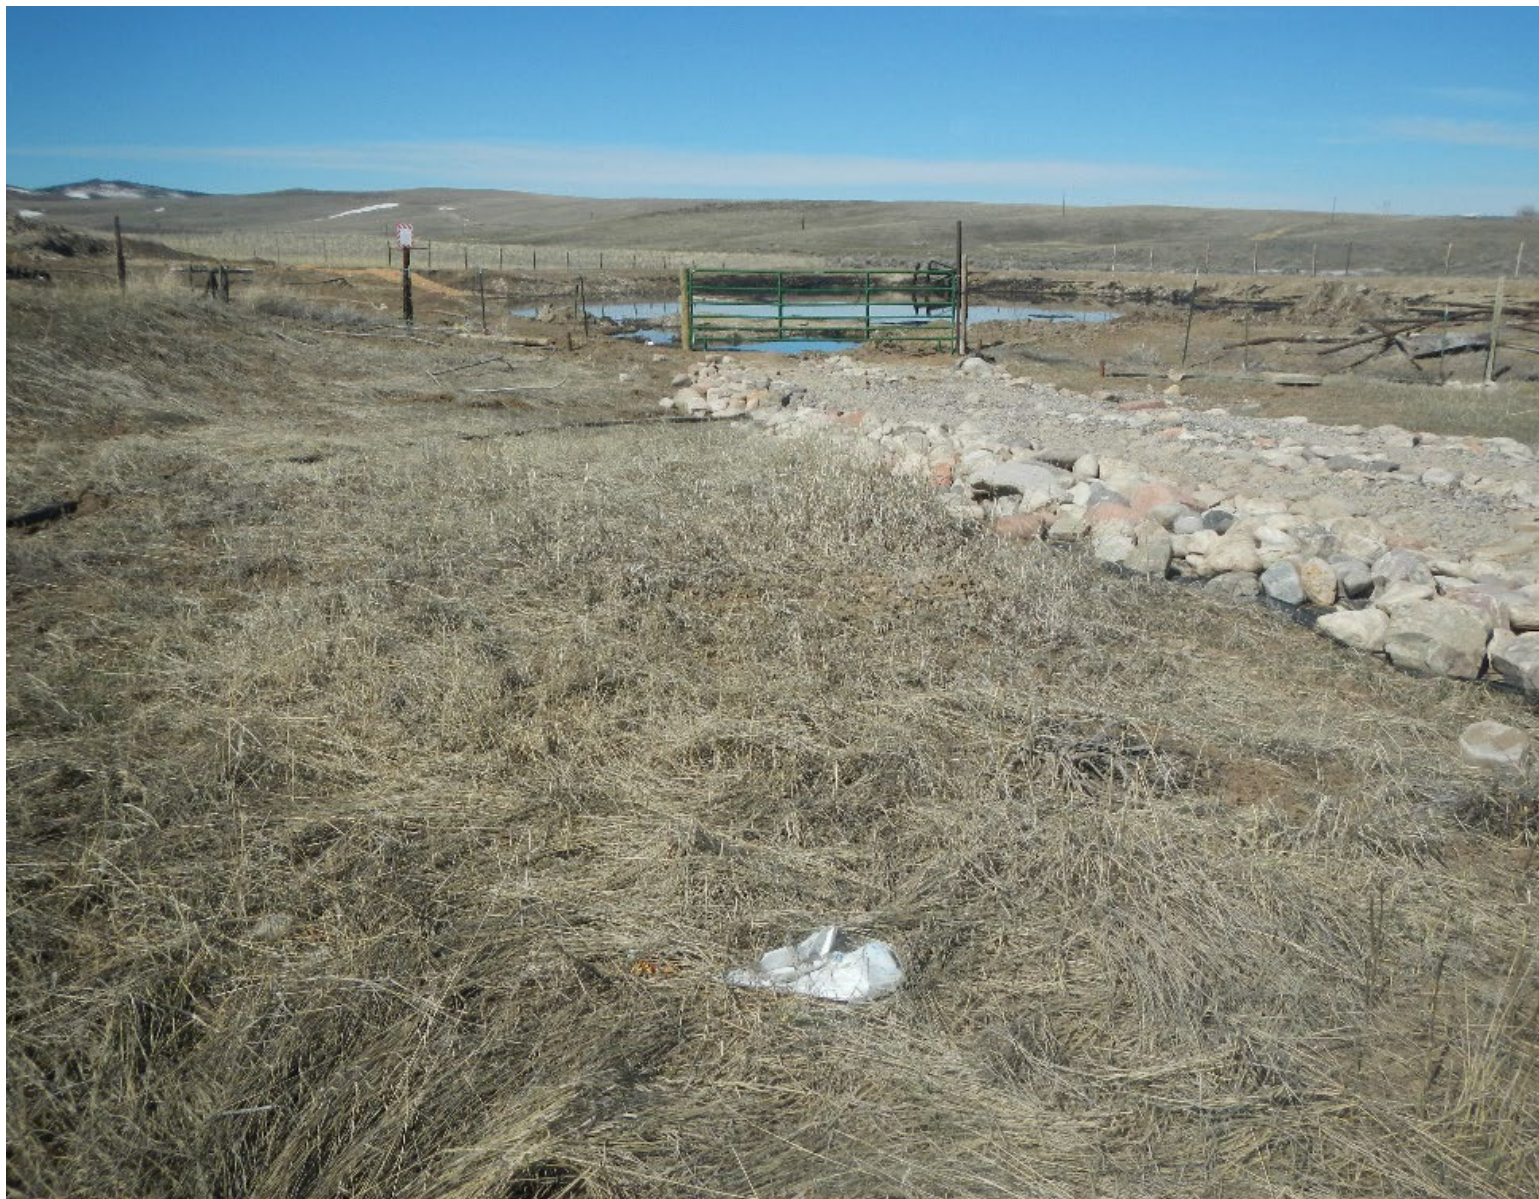
REM 28244, Facility 116587 Date 4/9/24, all photos taken by ECMC Staff Kris Neidel  
Photo #27 access for pit 116587. Note debris, trash.

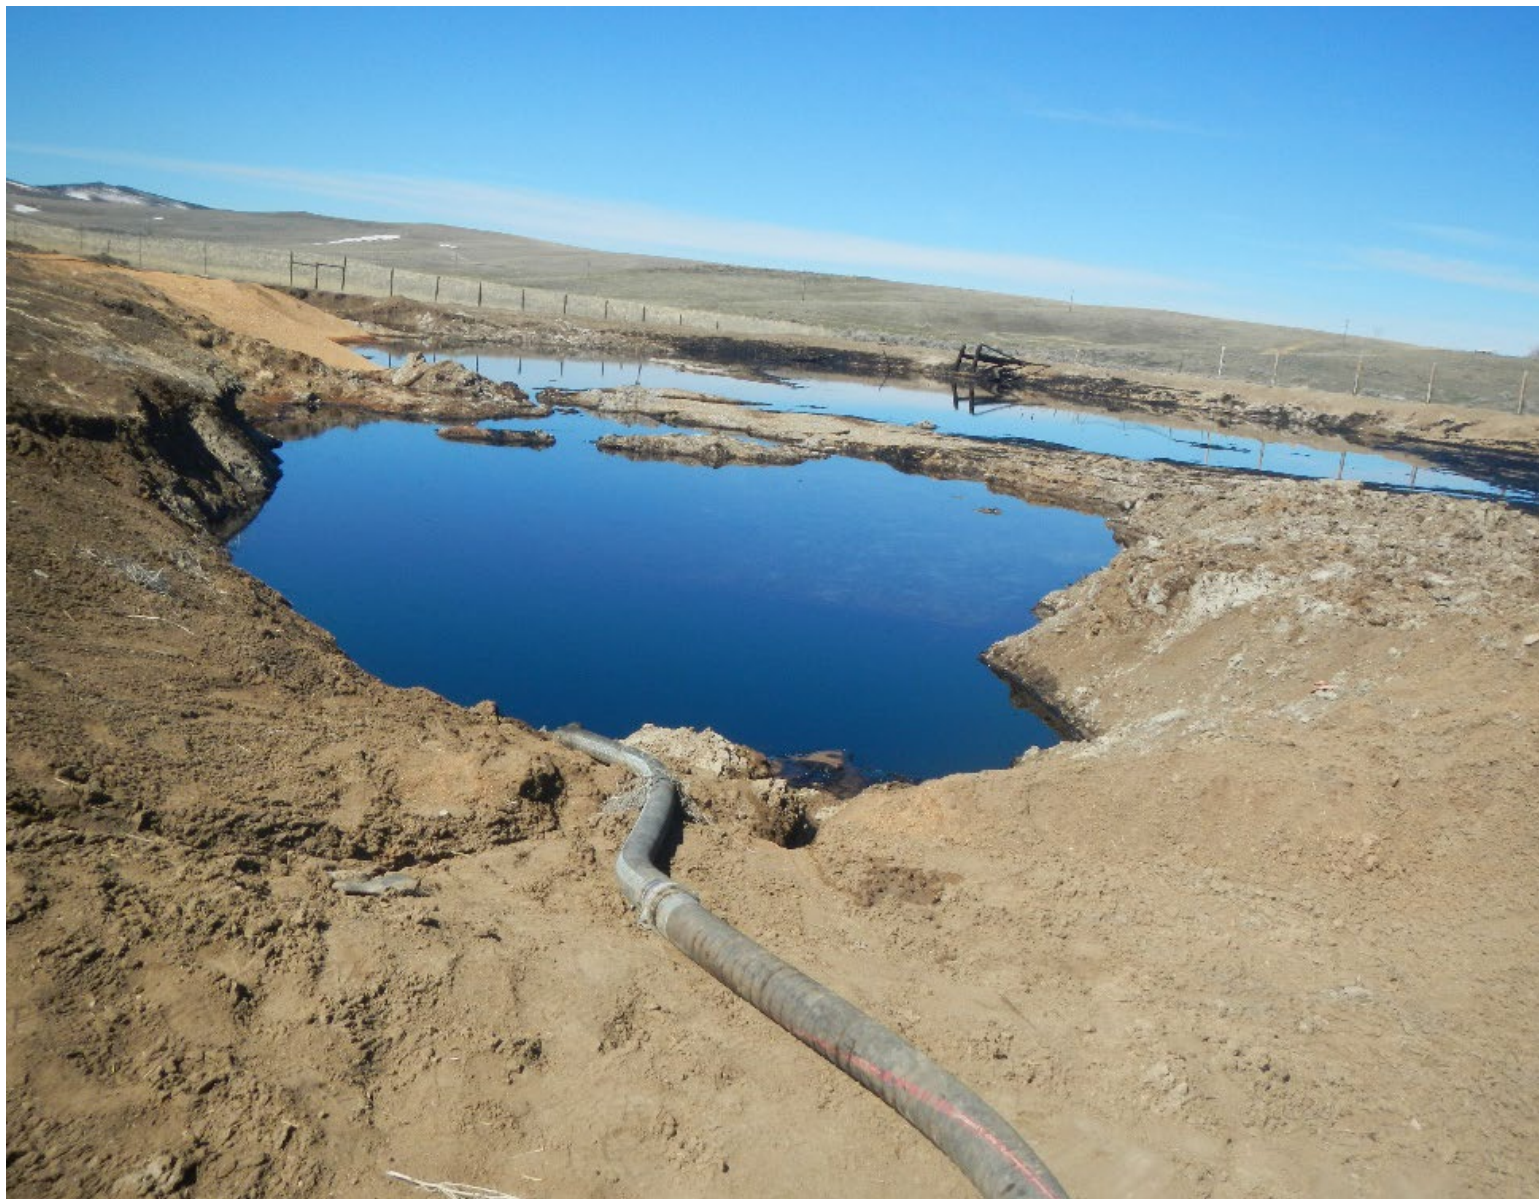
REM 28244, Facility 116587 Date 4/9/24, all photos taken by ECMC Staff Kris Neidel  
Photo #28 Inside Pit 116587 facility. Oil observed on all water and in soil.

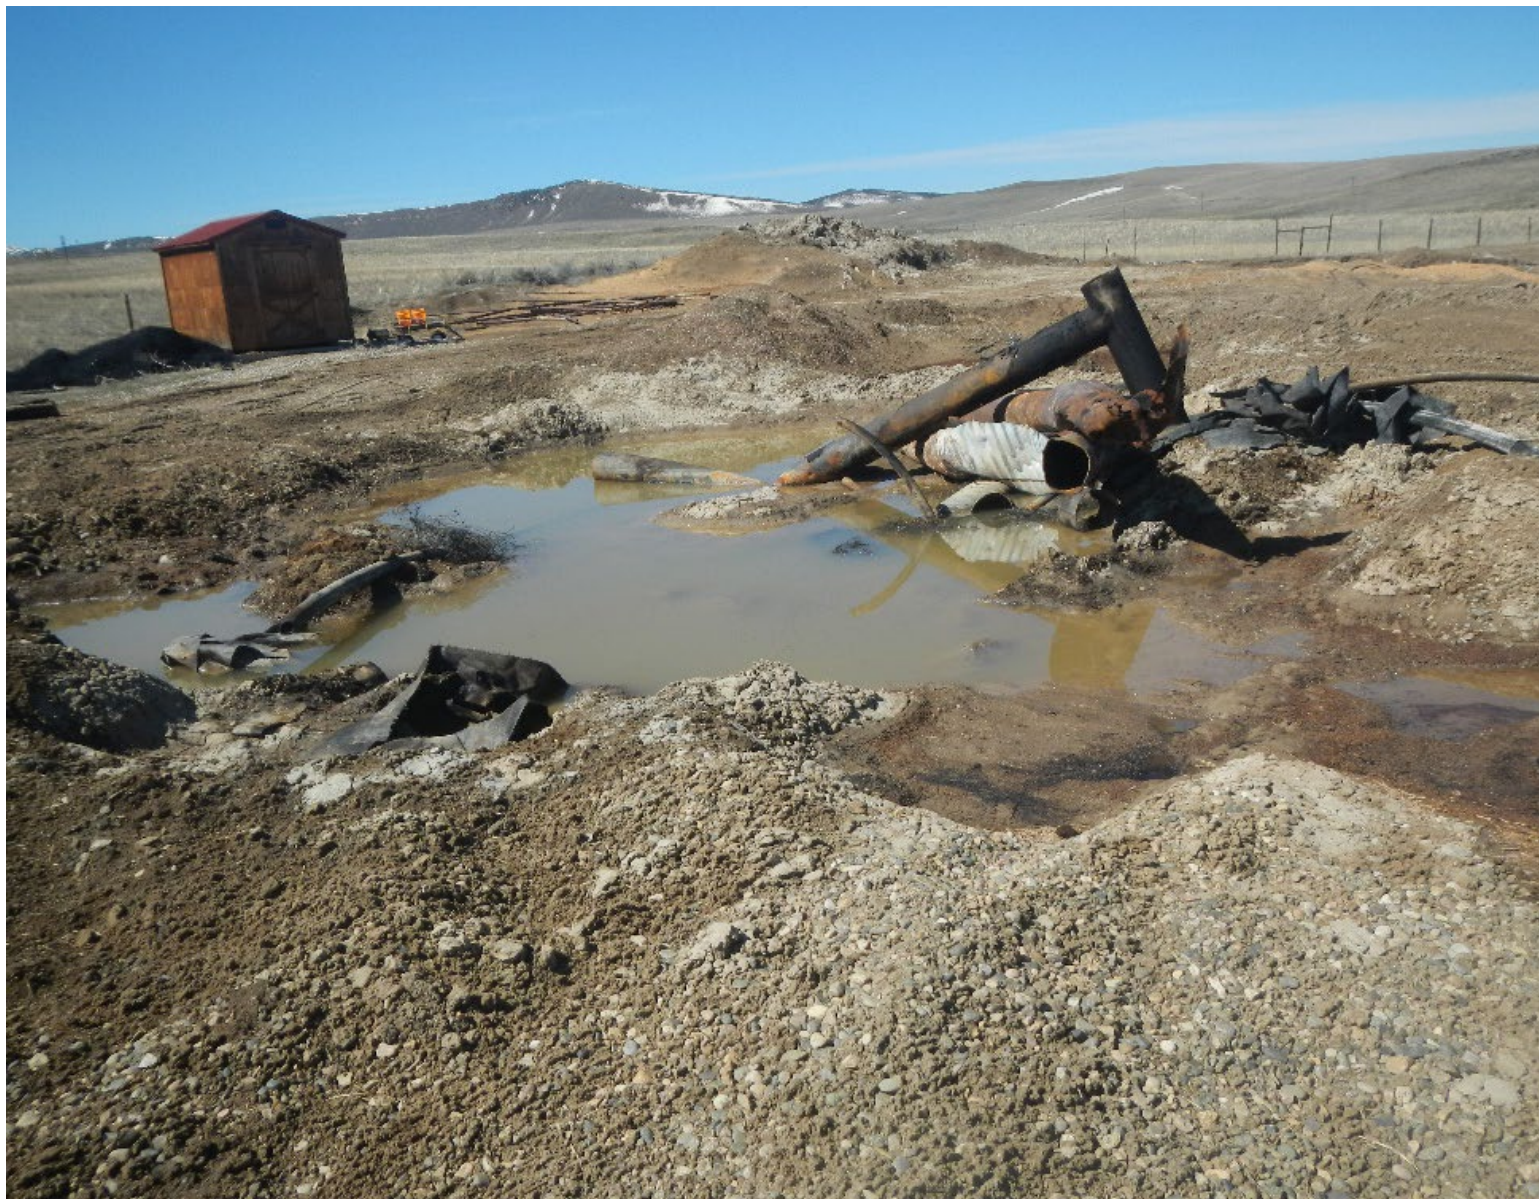
Photo #29 inside pit 116587 facility. Note; debris, oily water and soil in vicinity of pit facility ID's 119213 and 116589.

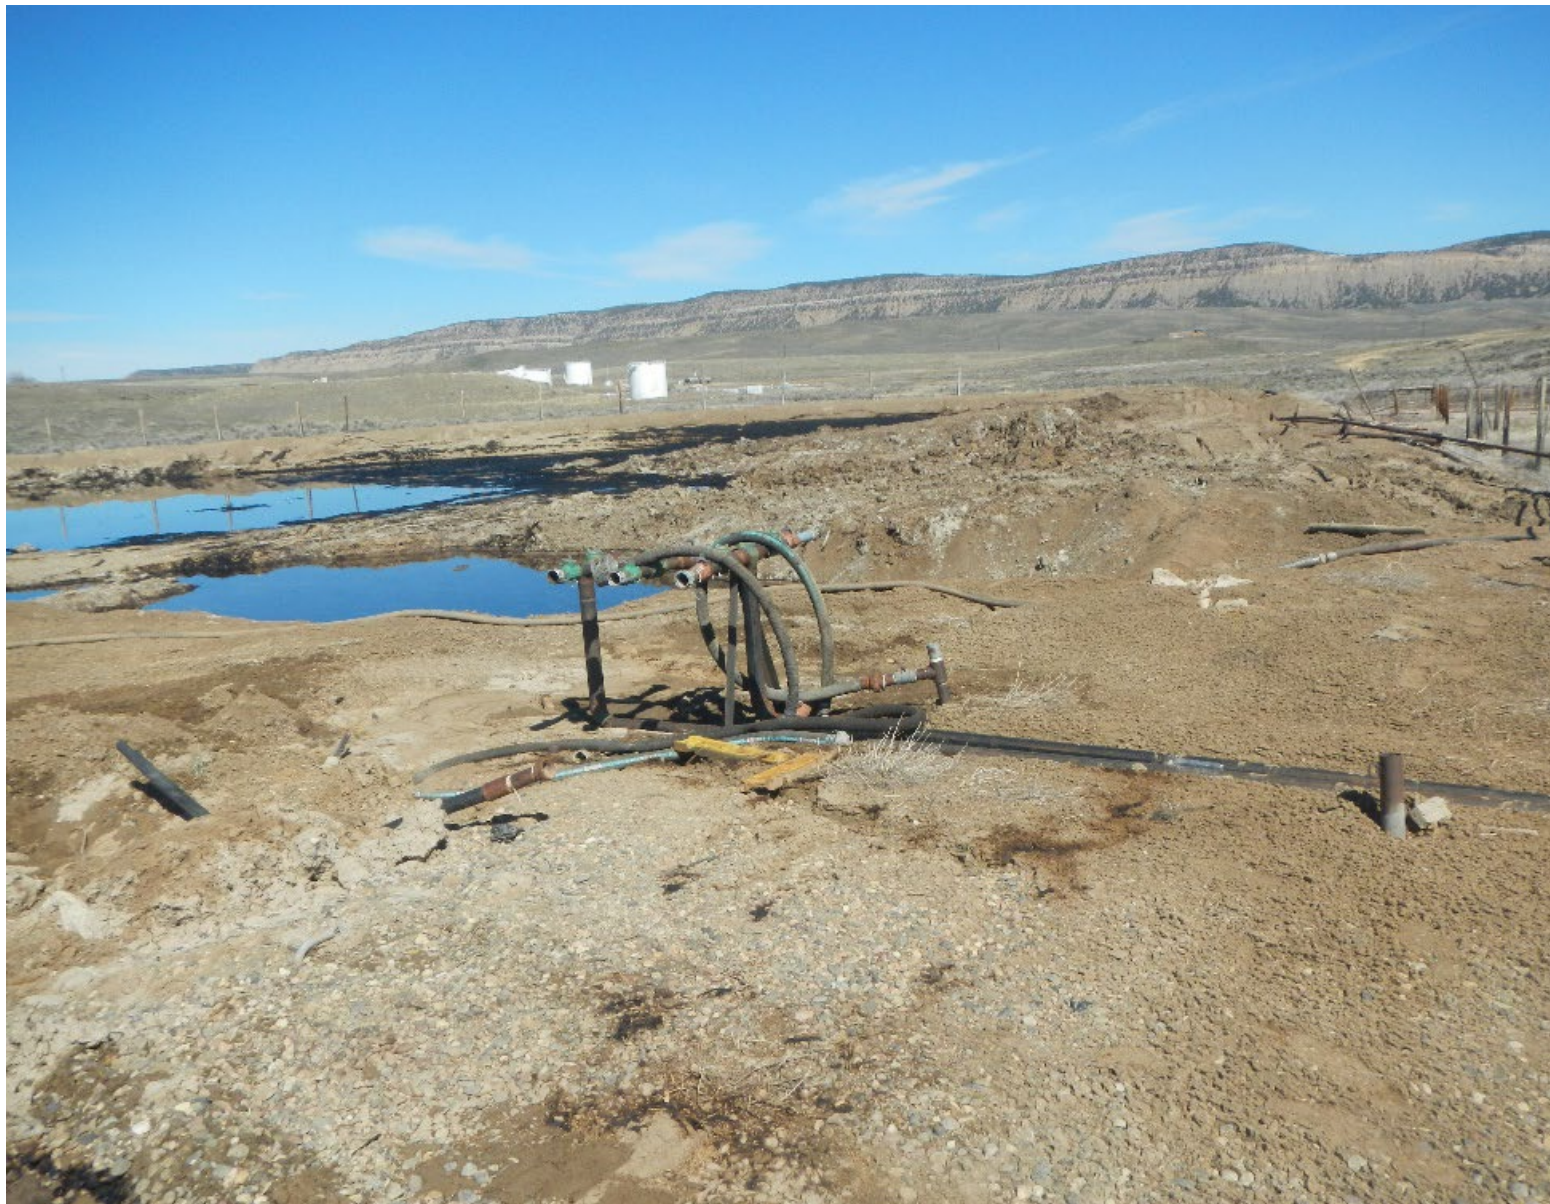
REM 28244, Facility 116587 Date 4/9/24, all photos taken by ECMC Staff Kris Neidel  
Photo #30 inside pit 116587 facility. Note; debris, oily water and soil.

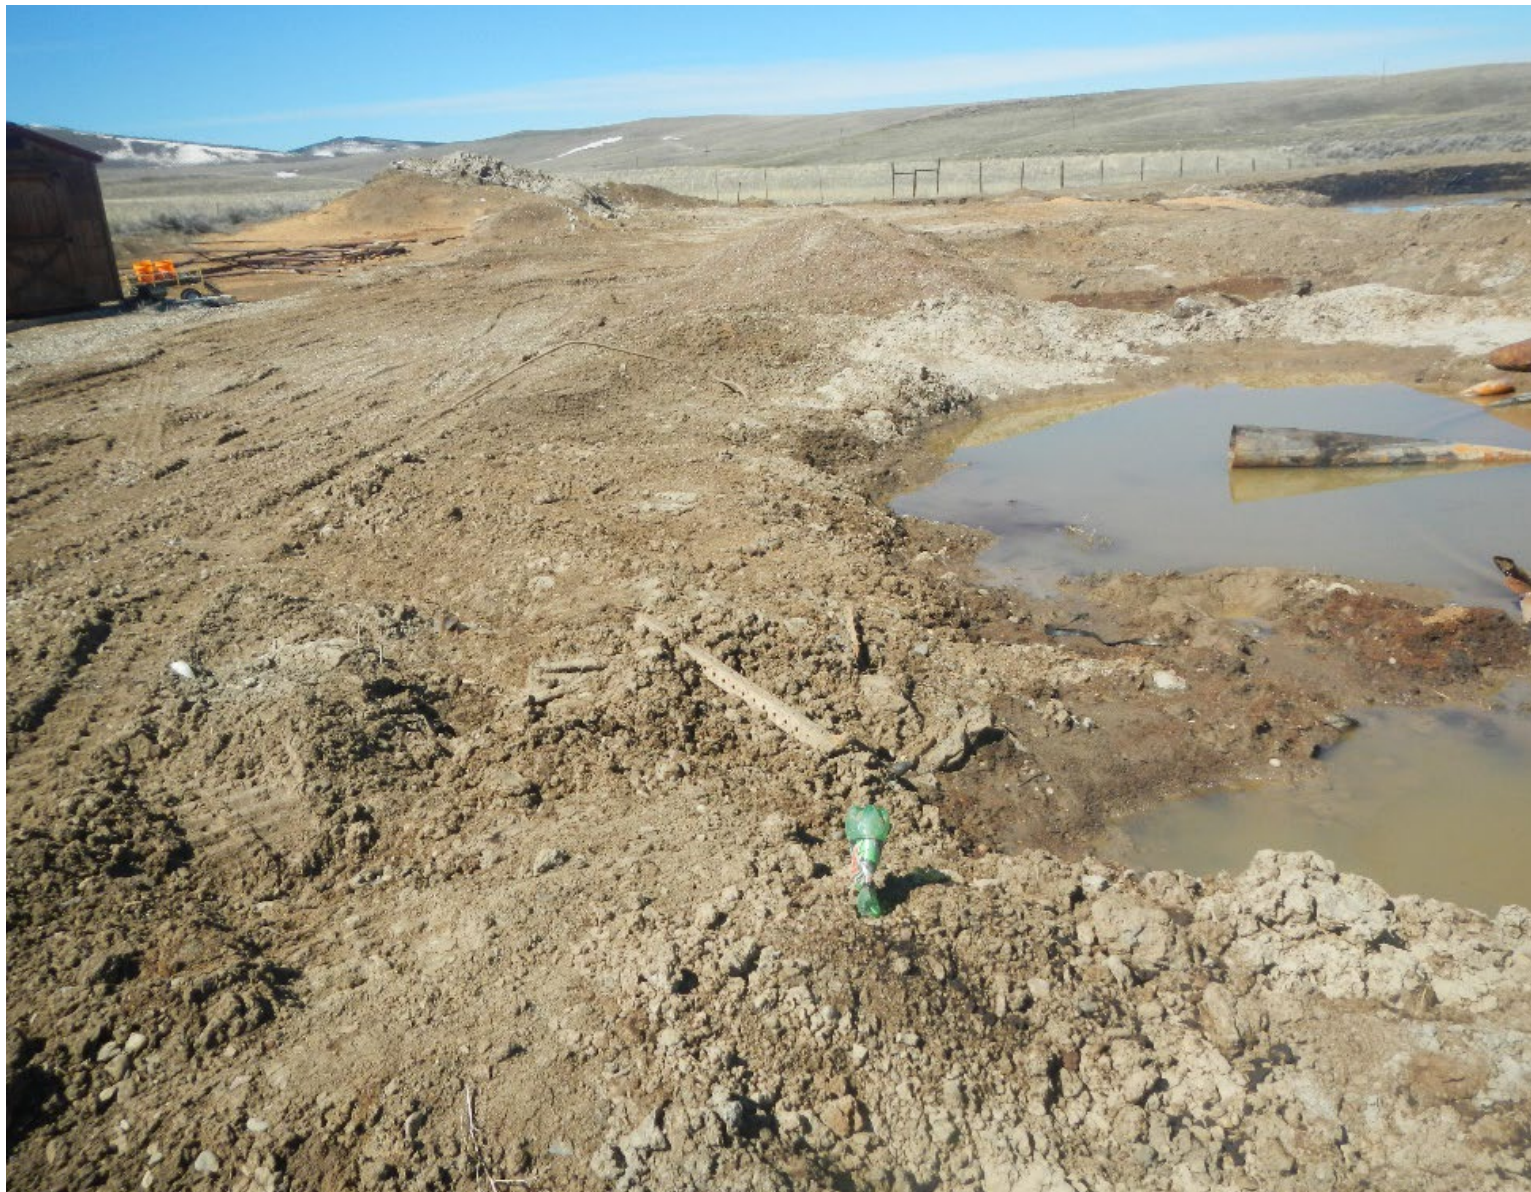
REM 28244, Facility 116587 Date 4/9/24, all photos taken by ECMC Staff Kris Neidel  
Photo #31 inside pit 116587 facility. Note; debris, trash, oily water and soil.

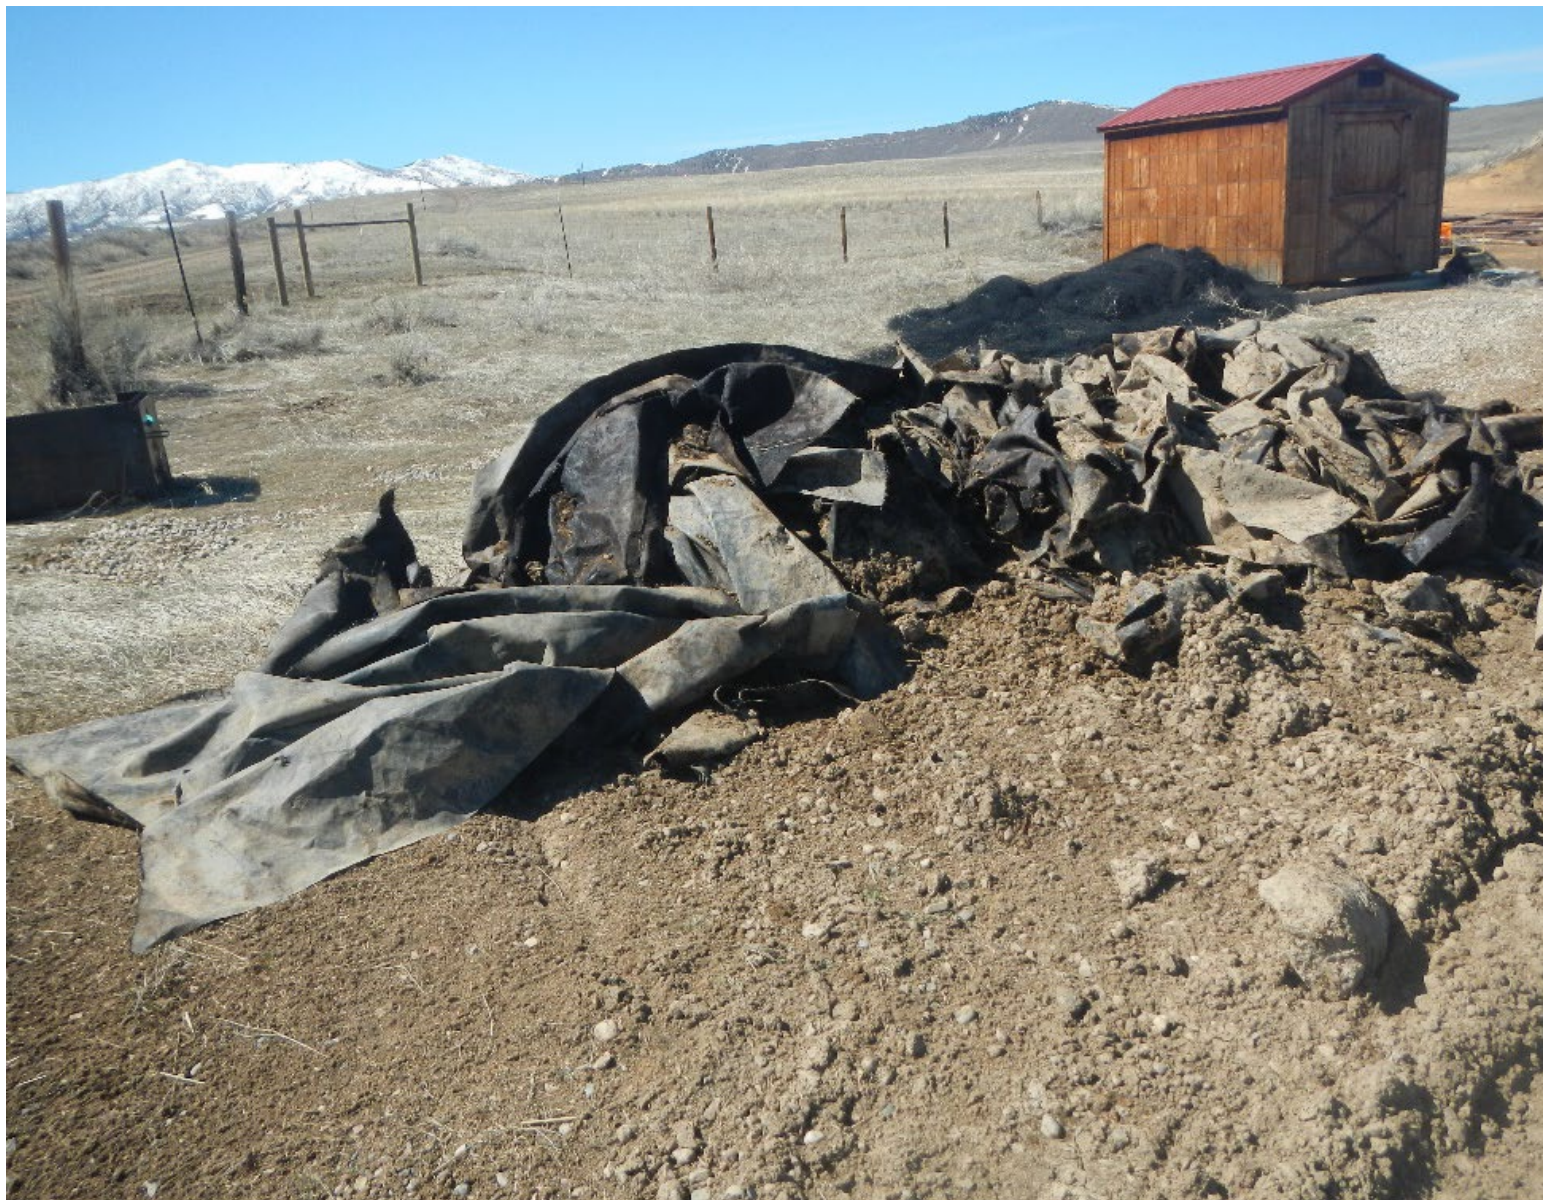
REM 28244, Facility 116587 Date 4/9/24, all photos taken by ECMC Staff Kris Neidel  
Photo #32 inside pit 116587 facility. Note; debris, pit liner and oily soil.

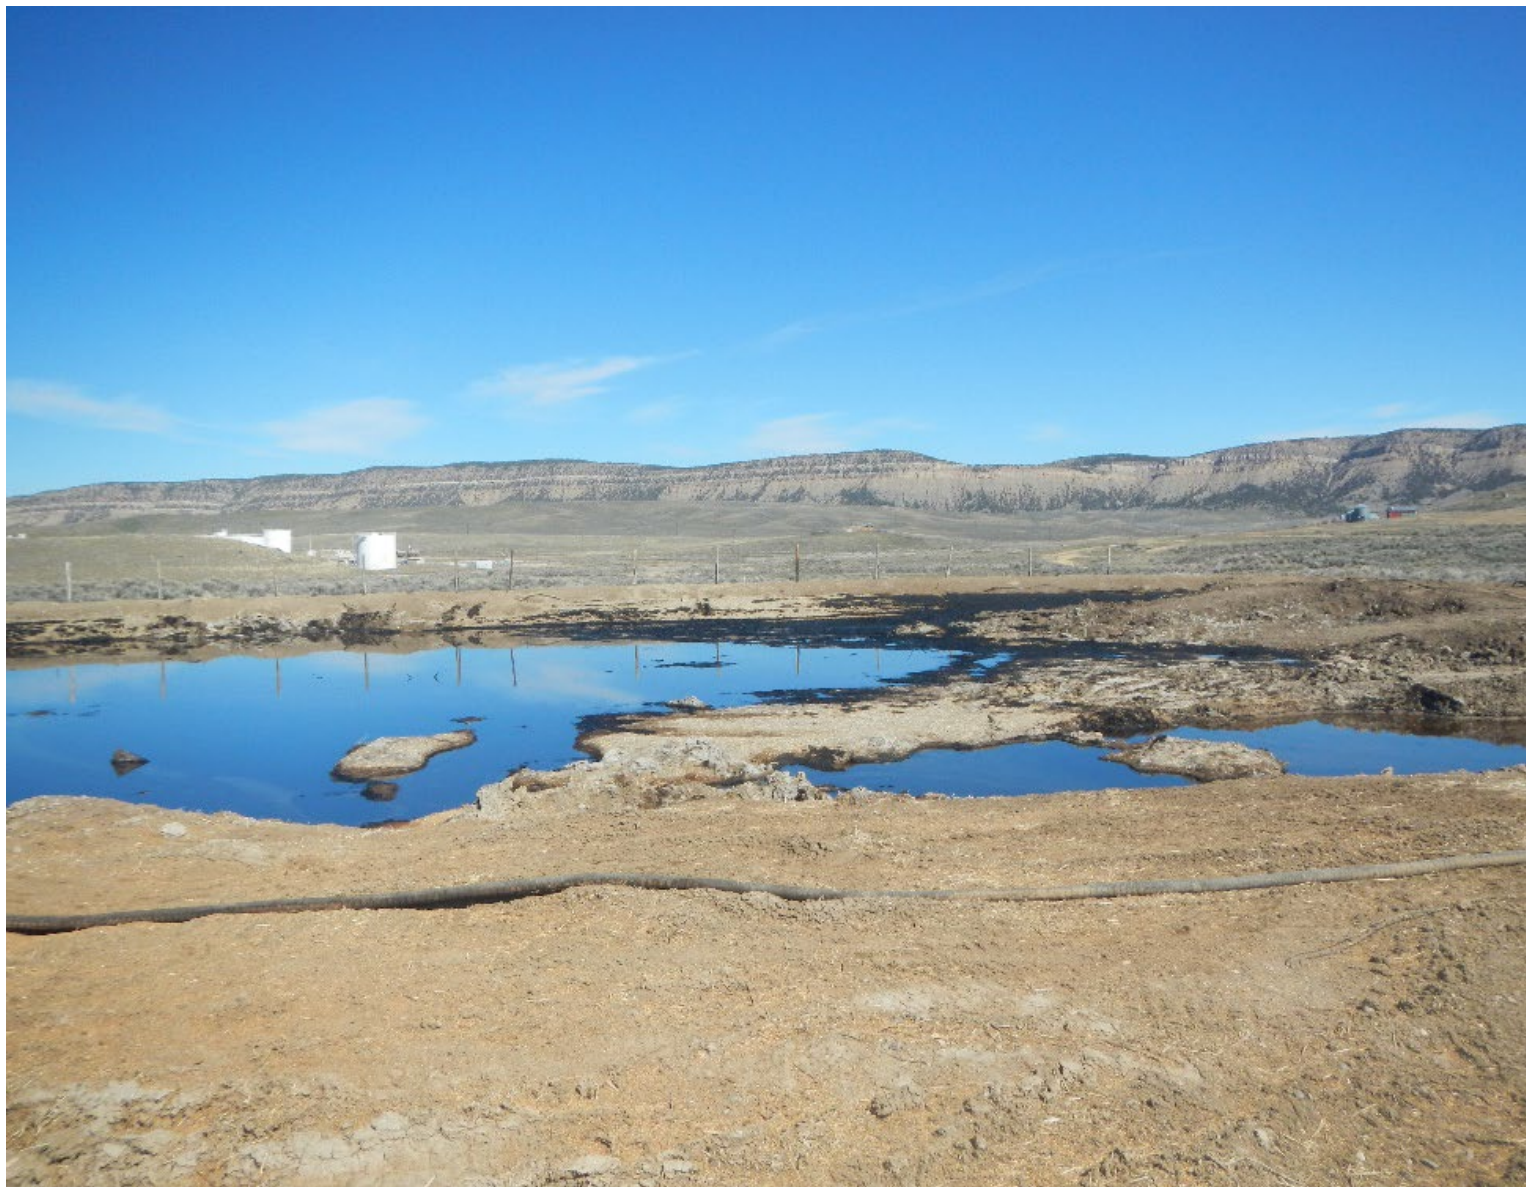
REM 28244, Facility 116587 Date 4/9/24, all photos taken by ECMC Staff Kris Neidel  
Photo #33 inside pit 116587 facility. Note; oily water and soil.

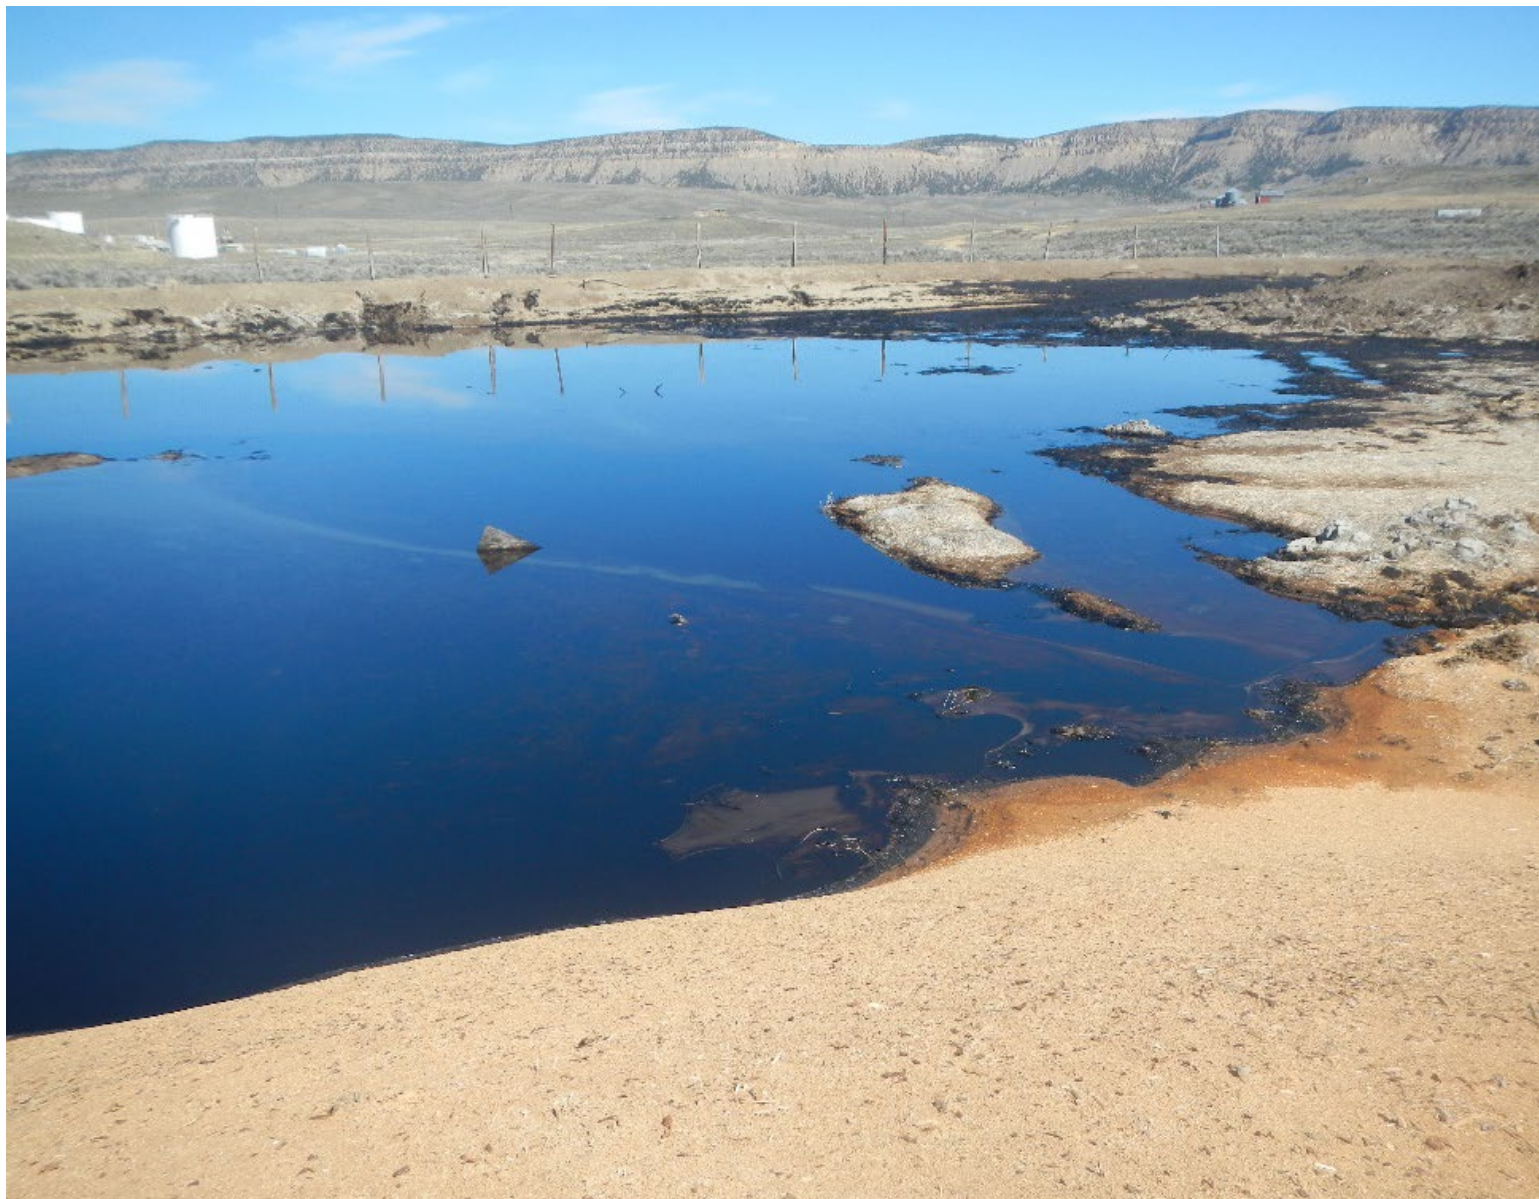
REM 28244, Facility 116587 Date 4/9/24, all photos taken by ECMC Staff Kris Neidel  
Photo #34 inside pit 116587 facility. Note; oily water and soil.

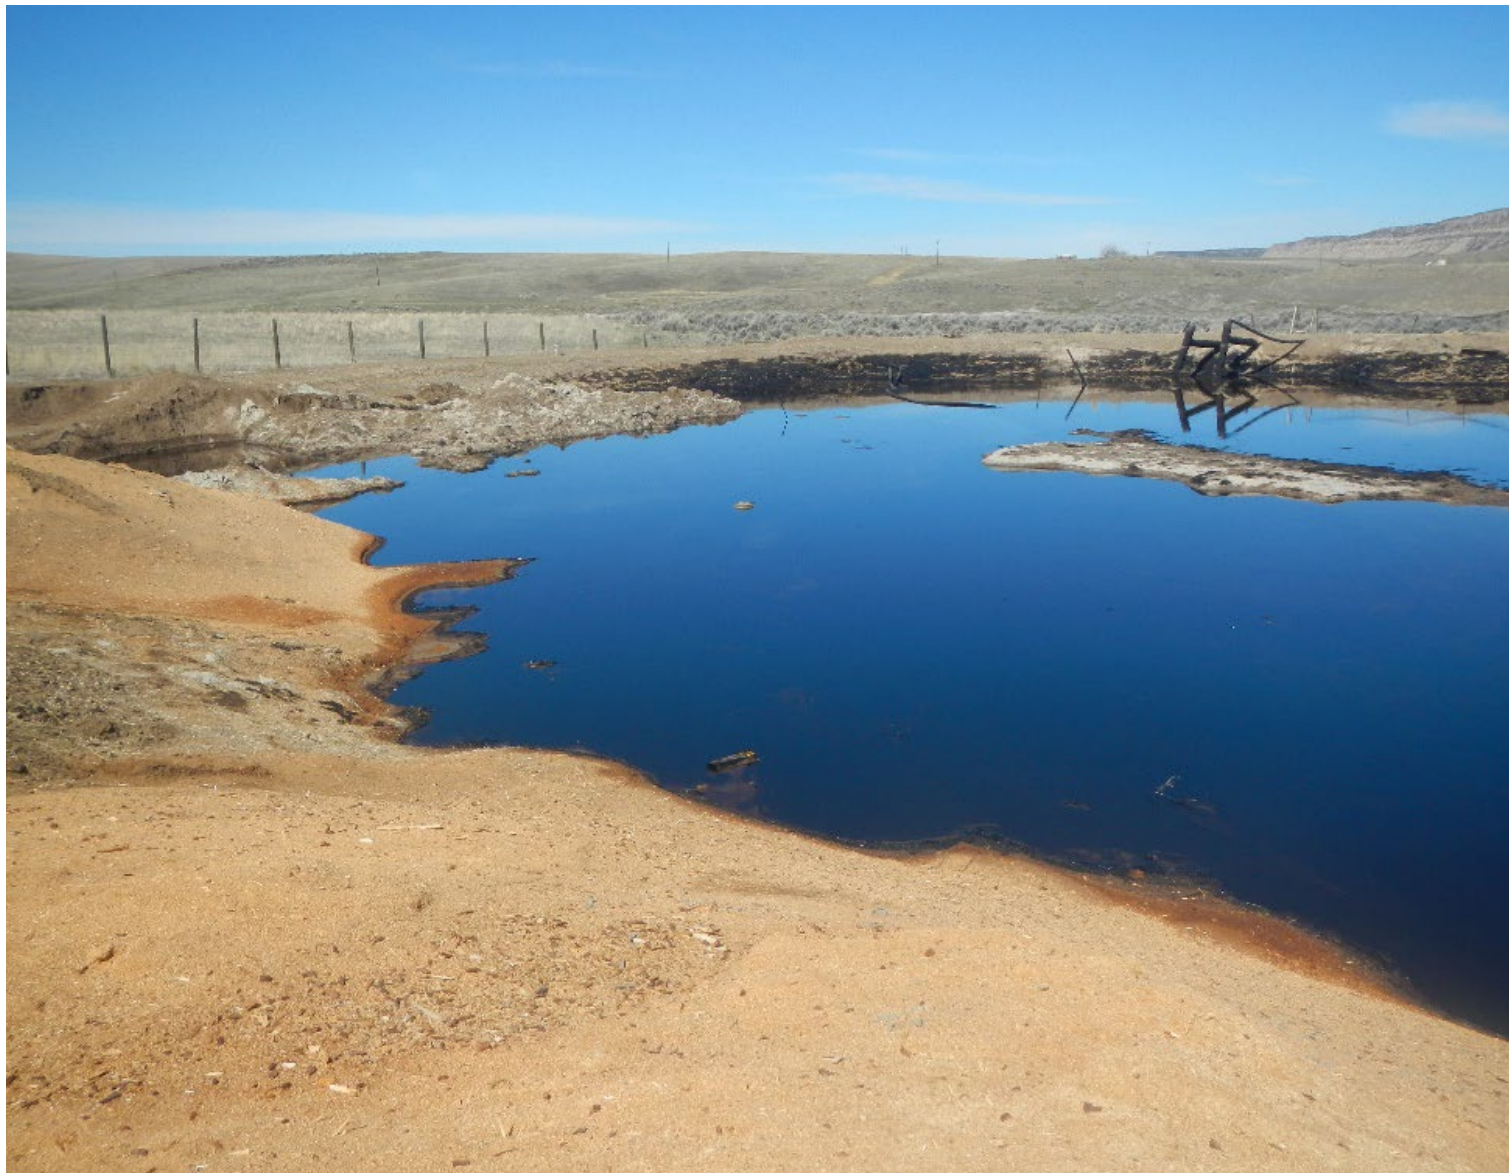
REM 28244, Facility 116587 Date 4/9/24, all photos taken by ECMC Staff Kris Neidel  
Photo #35 inside pit 116587 facility. Note; oily water and soil.

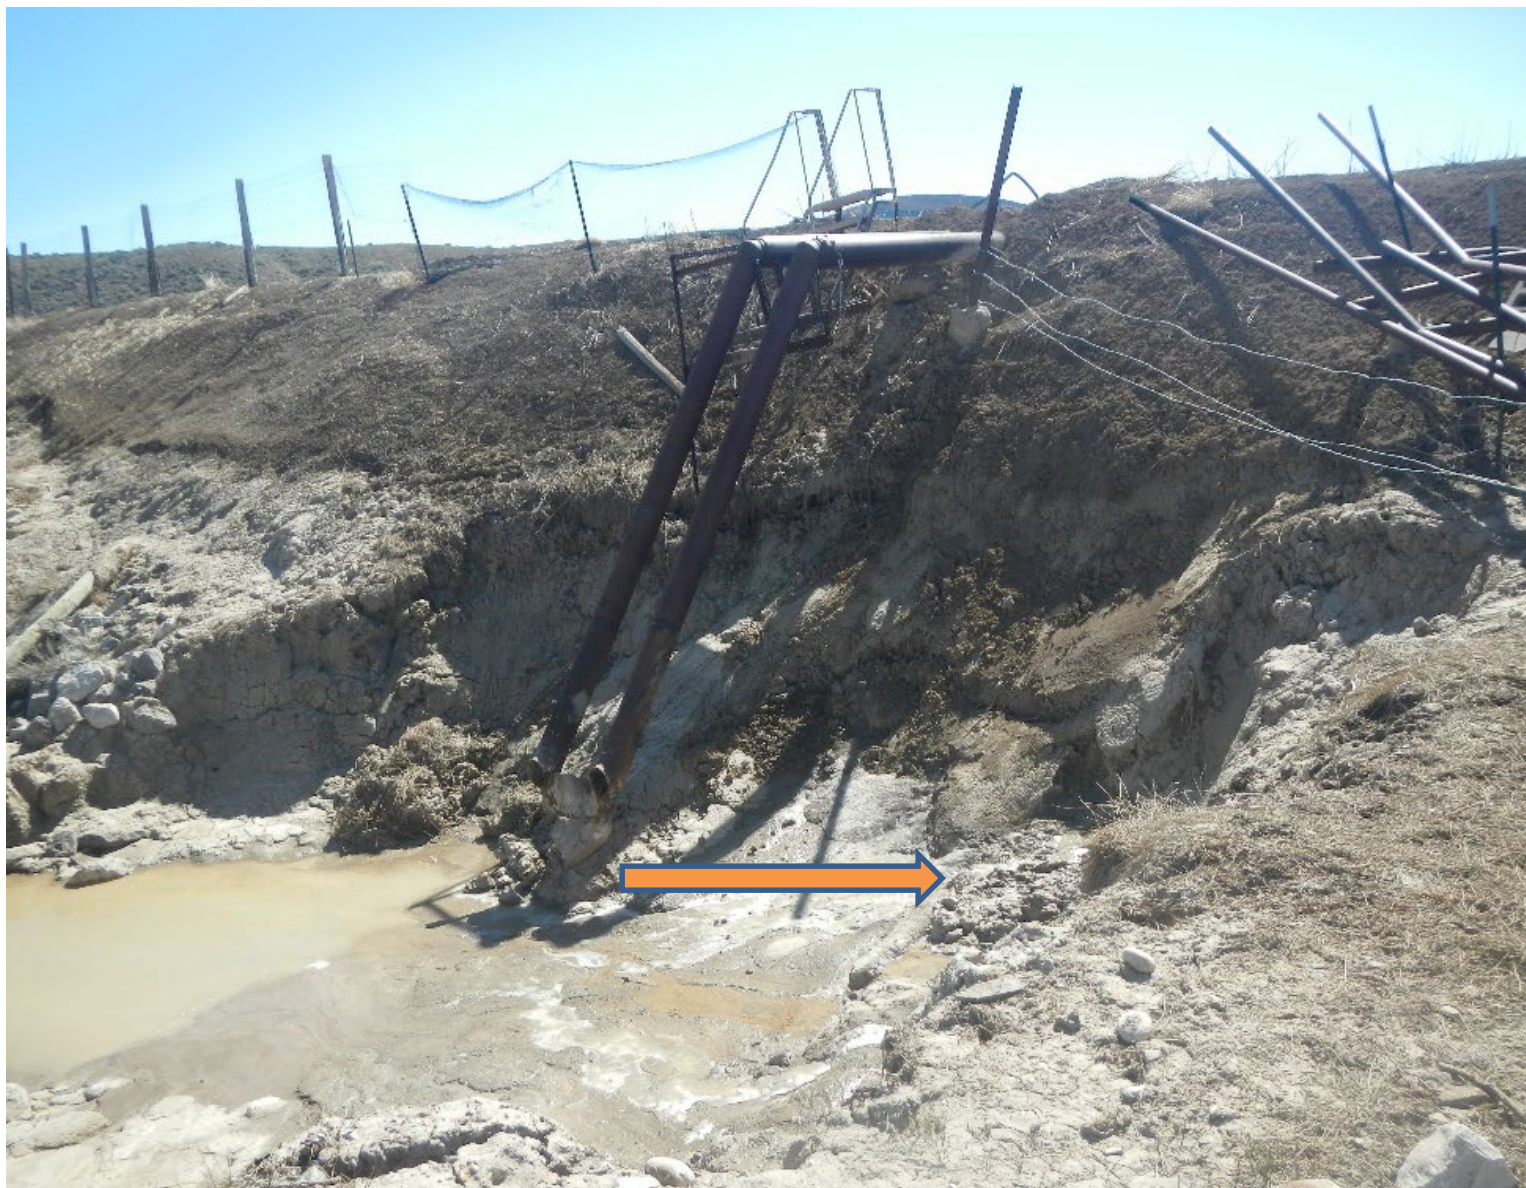
Photo #36 piping seen was formally used to discharge pit water, no water was observed coming out of the pipe. No hydrocarbon staining was obvious on the surface in this area. Water was observed seeping out of the toe of the Pit (near arrow).

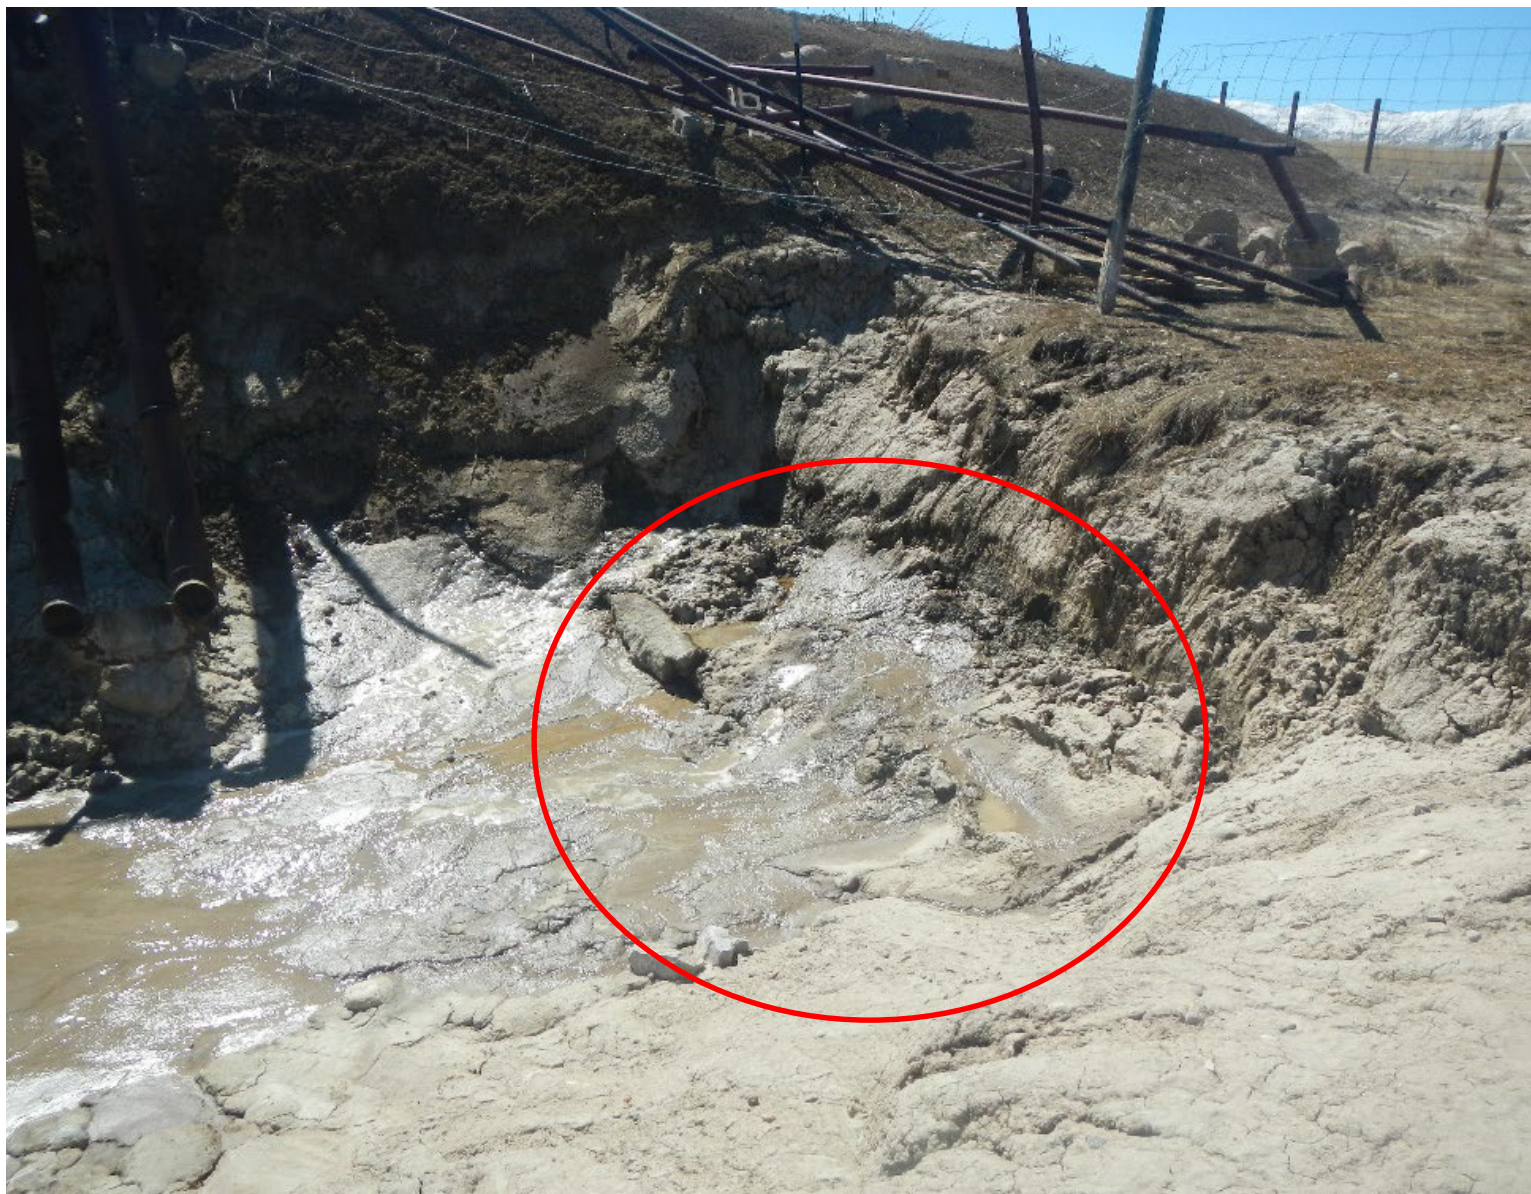
Photo #37 Area of former discharge. No obvious staining of hydrocarbon was observed in this area.

Note: fluids seeping out of the toe of the Pit.
