**COLORADO**  
Energy & Carbon Management  
Commission  
Department of Natural Resources

REM 28246, Facility 116587 Date 4/9/24, all photos taken by ECMC Staff Kris Neidel

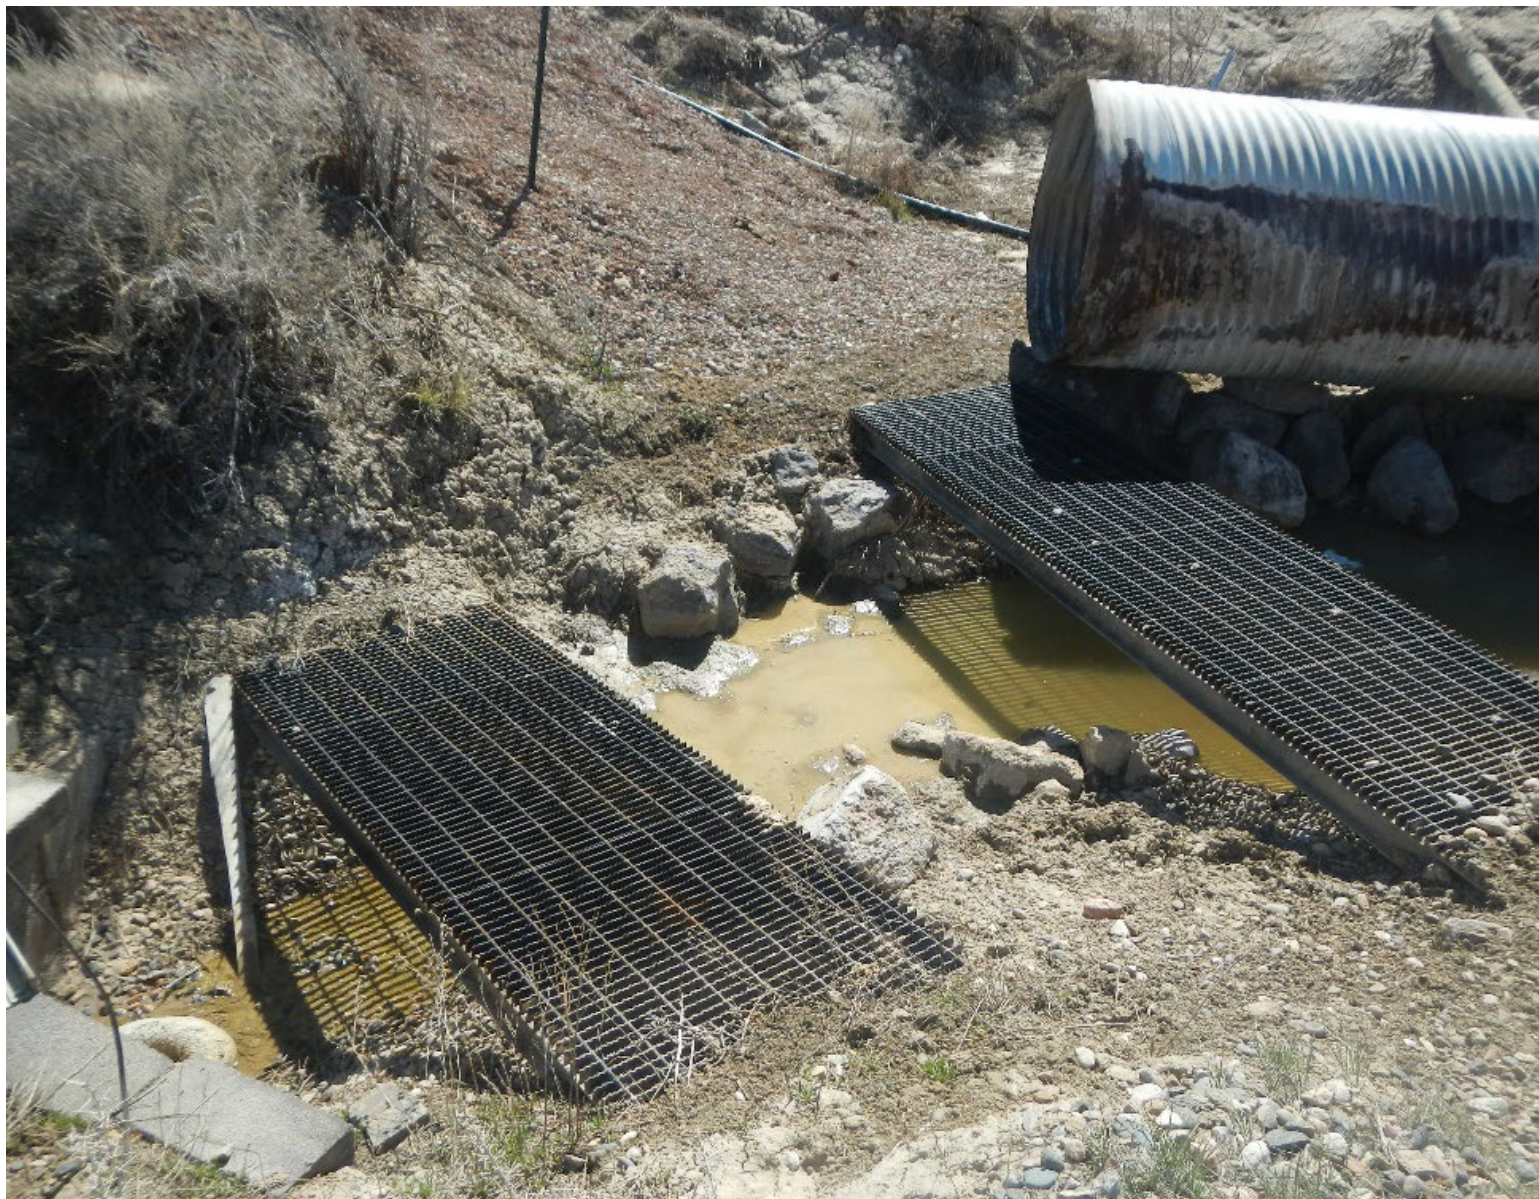
REM 28246, Facility 116587 Date 4/9/24, all photos taken by ECMC Staff Kris Neidel  
Photo #38 Area of former discharge.

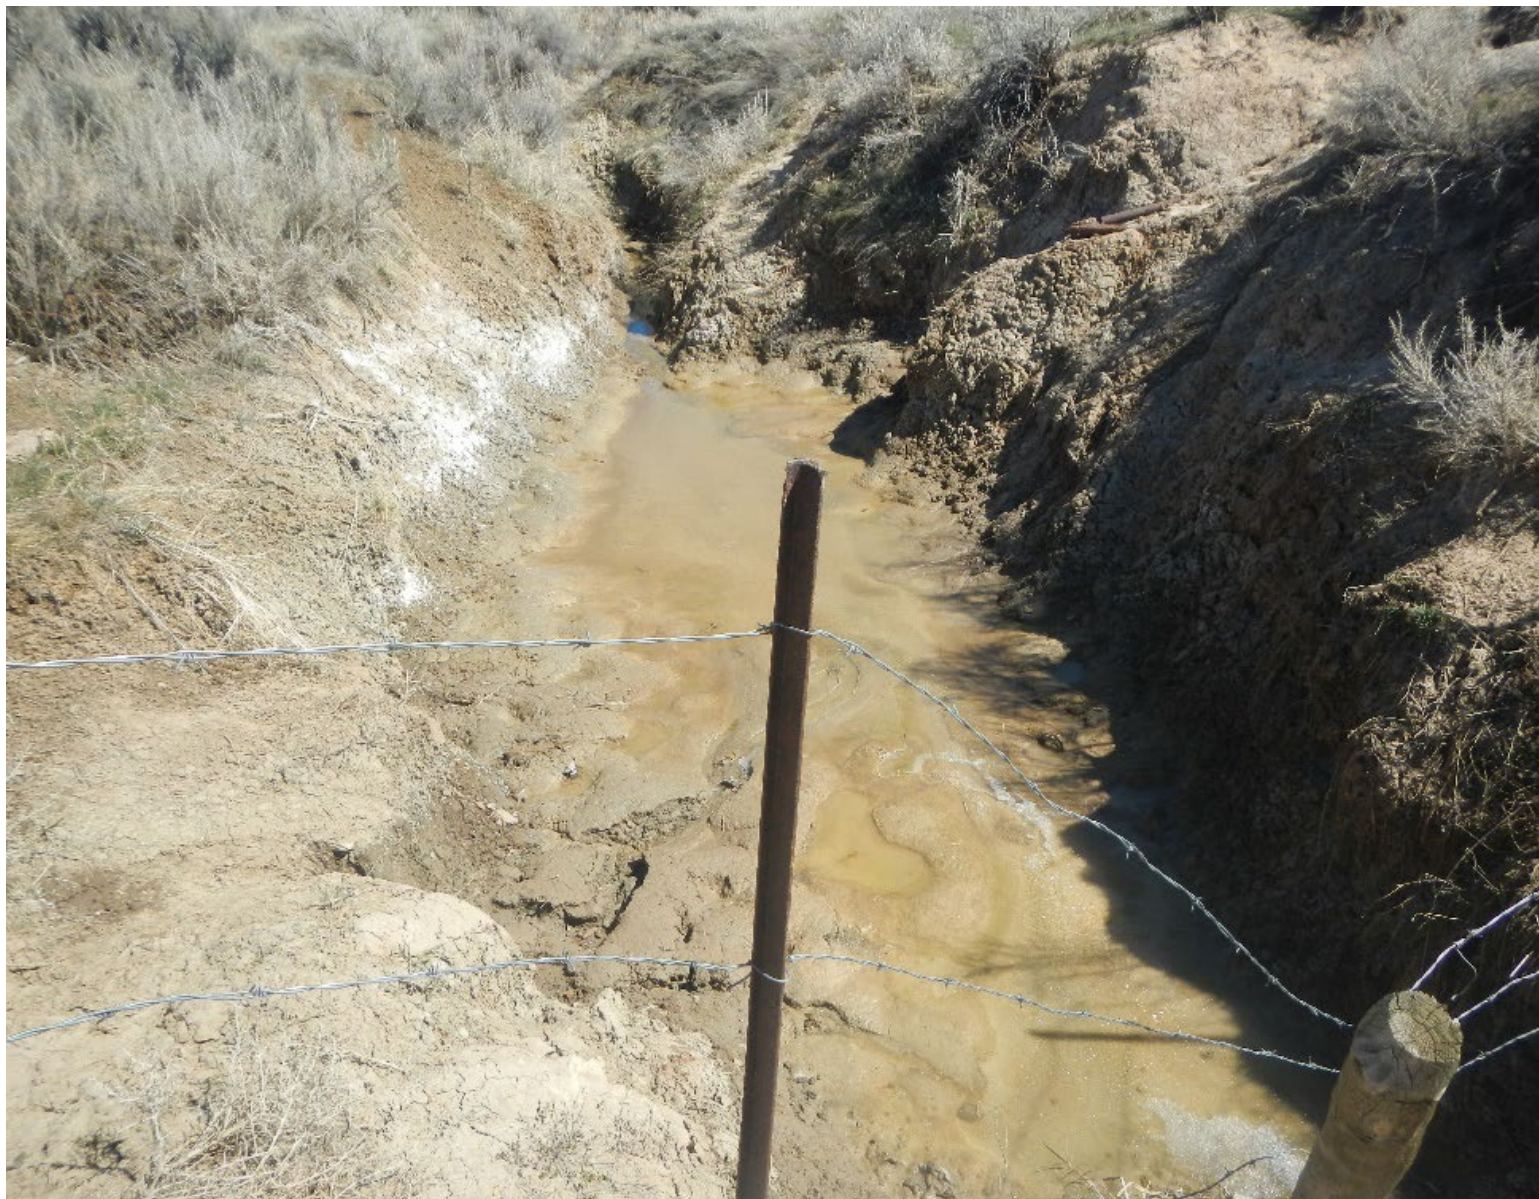
REM 28246, Facility 116587 Date 4/9/24, all photos taken by ECMC Staff Kris Neidel  
Photo #39 fenced area near discharge, weir still in the stream at this location.

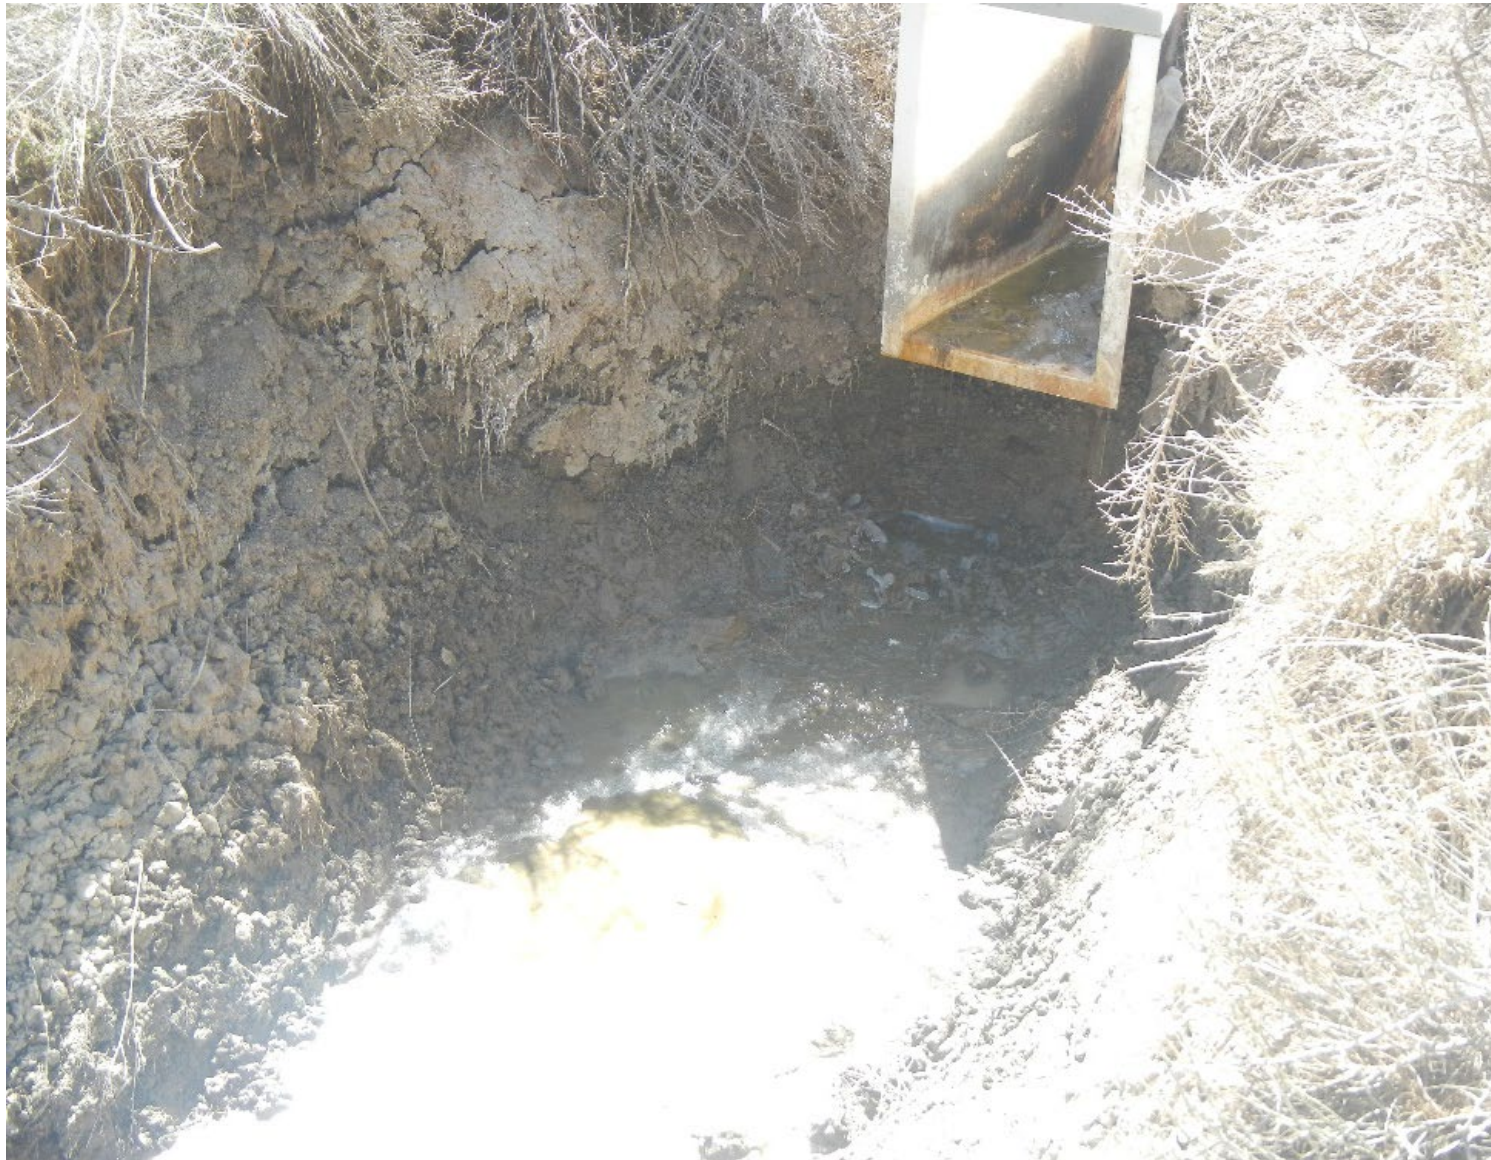
REM 28246, Facility 116587 Date 4/9/24, all photos taken by ECMC Staff Kris Neidel  
Photo #40 weir from former discharge.

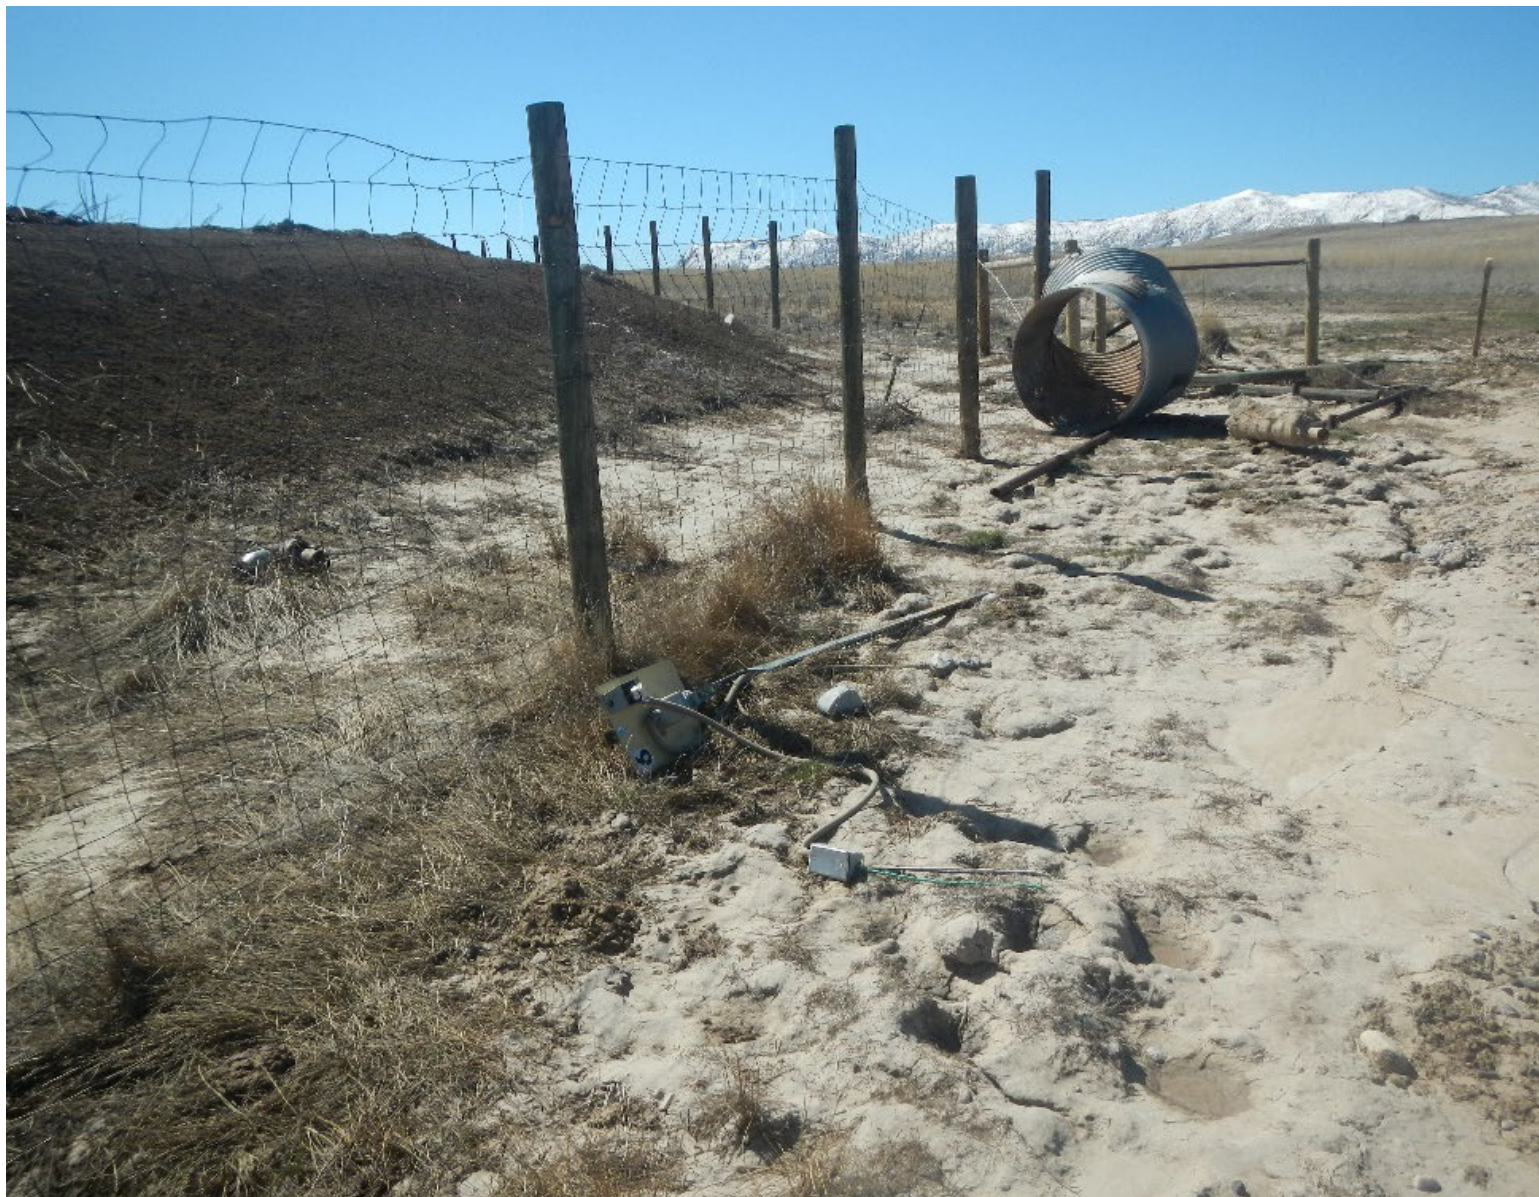
REM 28244, Facility 116587 Date 4/9/24, all photos taken by ECMC Staff Kris Neidel  
Photo #41 perimeter fence of pit facility 116587. Note: debris and trash.
