## Inspection Photos

Location Name: MUSTANG RESOURCES LLC SAVAGE 11-35-6-94 W Pad

Location ID: 324139

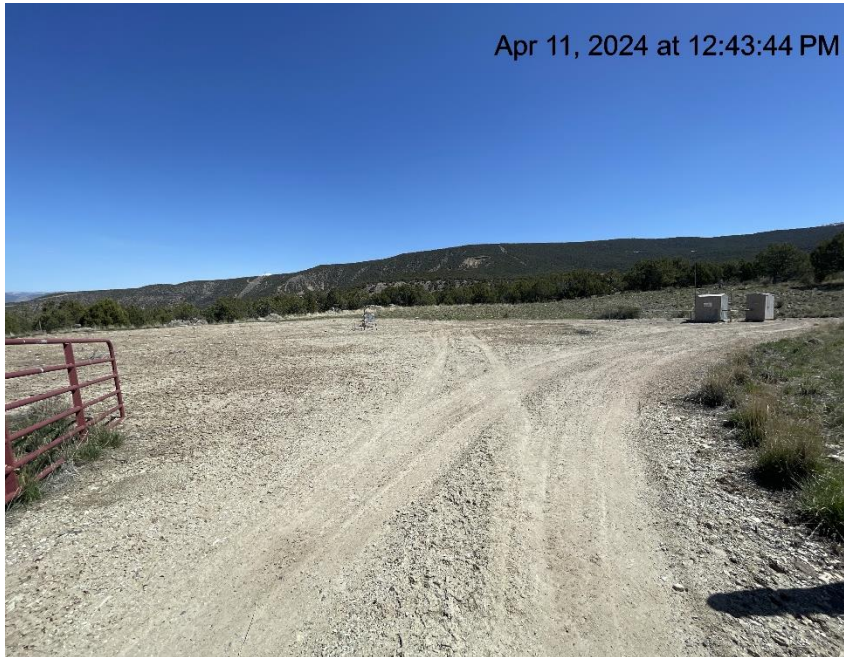
Photo # 3686 From entrance to location

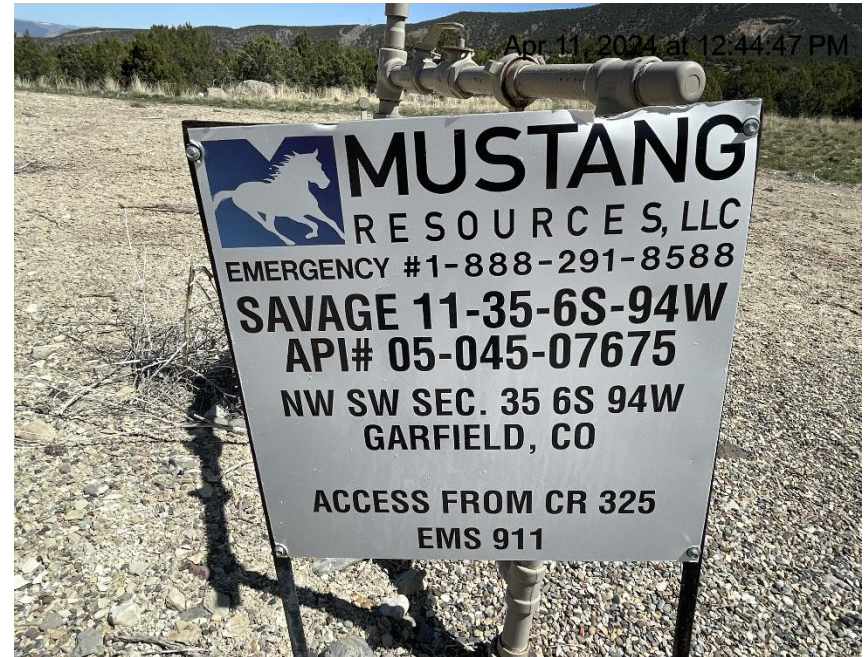
Photo # 3687 Location

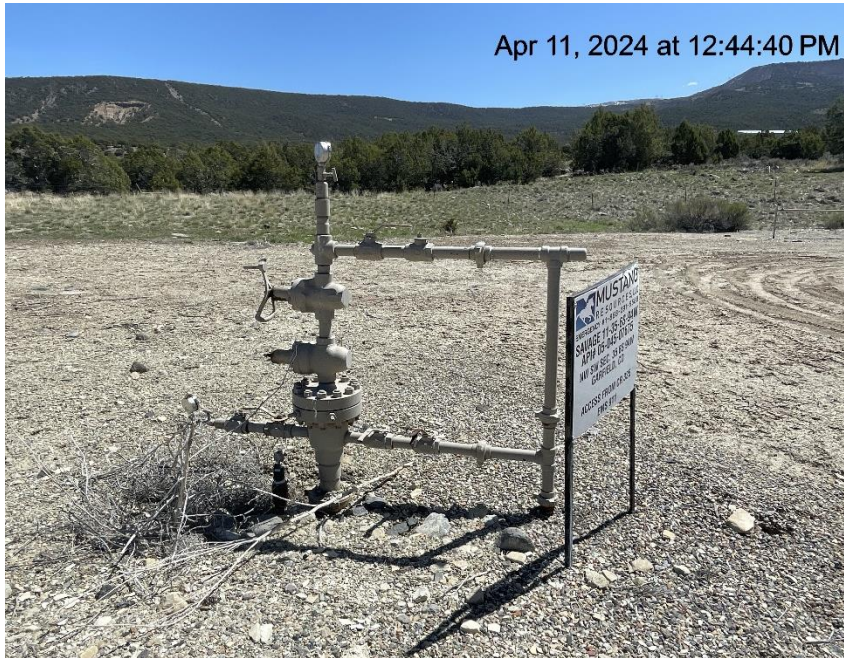
Photo # 3688 Location

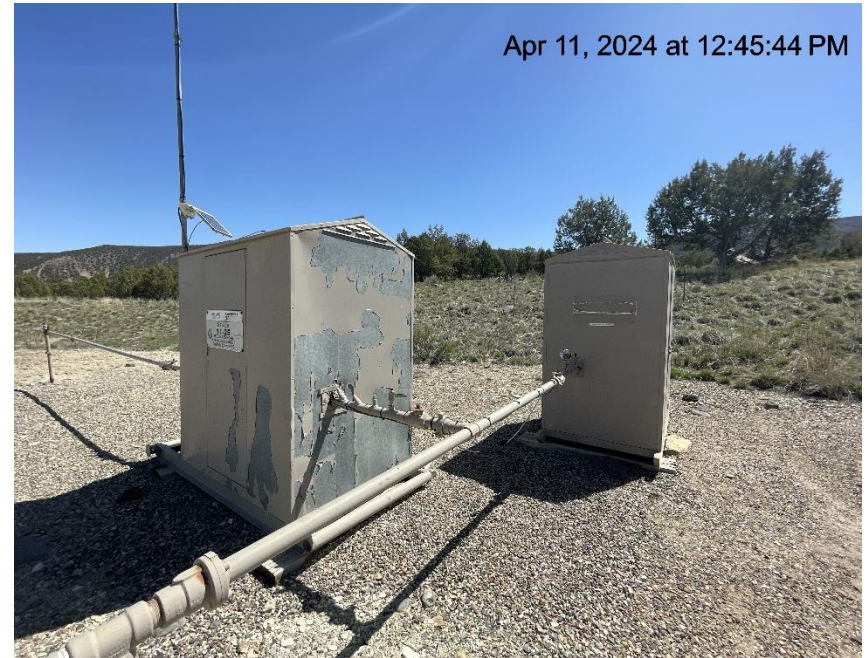
Photo # 3689 Location

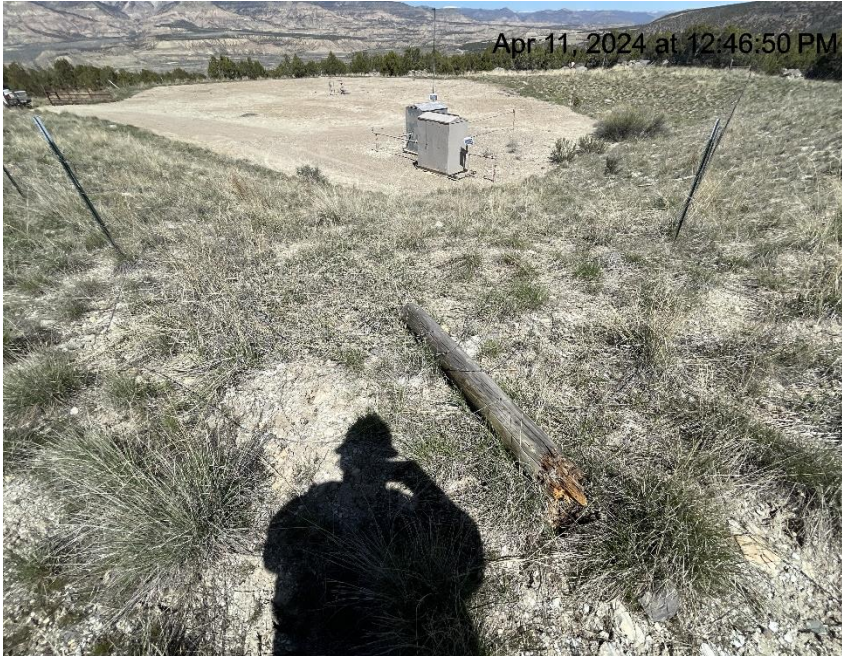
**Photo # 3690 Fencing needs maintenance - post & barbed wire laying on the ground/wildlife hazard**

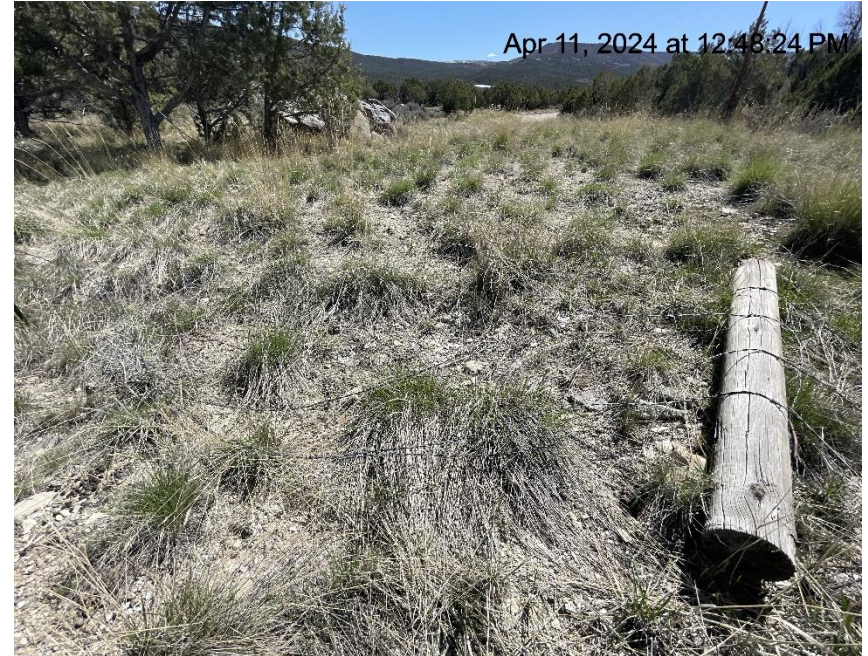
**Photo # 3691 Fencing needs maintenance - post & barbed wire laying on the ground/wildlife hazard**

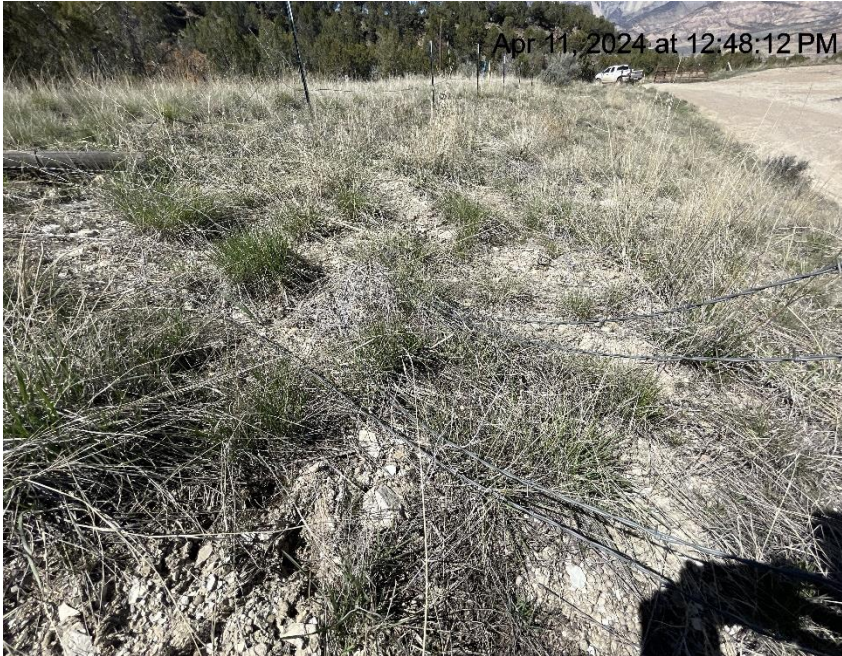
**Photo # 3692 Fencing needs maintenance - post & barbed wire laying on the ground/wildlife hazard**

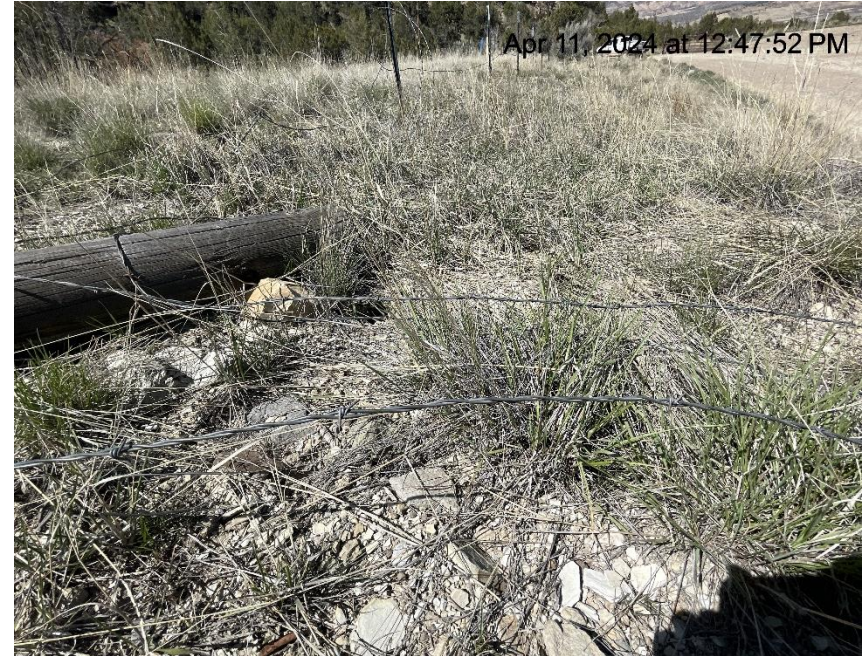
**Photo # 3693 Fencing needs maintenance - post & barbed wire laying on the ground/wildlife hazard**

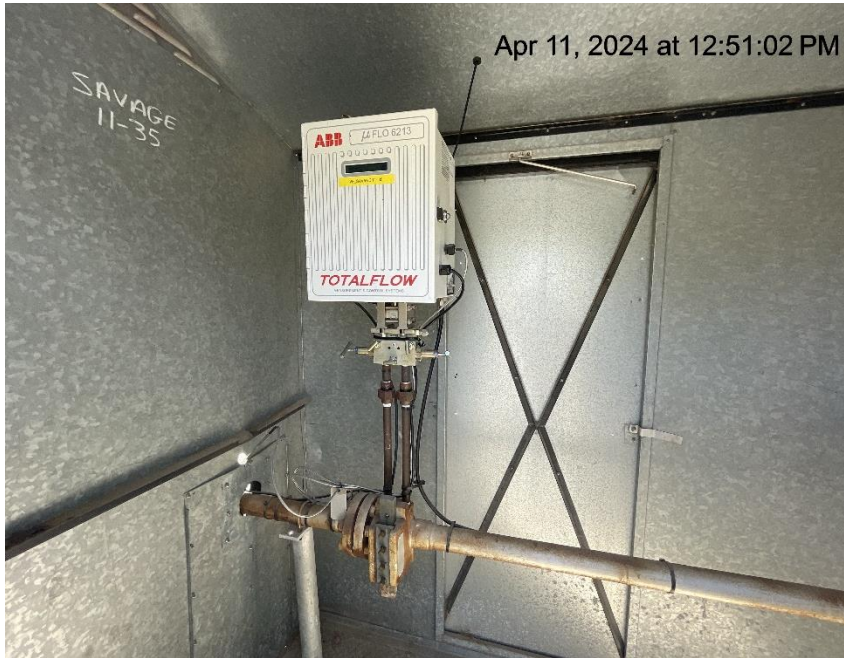
Photo # 3694 Gas meter calibration record for SAVAGE 11-35-6-94 W well not conspicuously displayed at meter

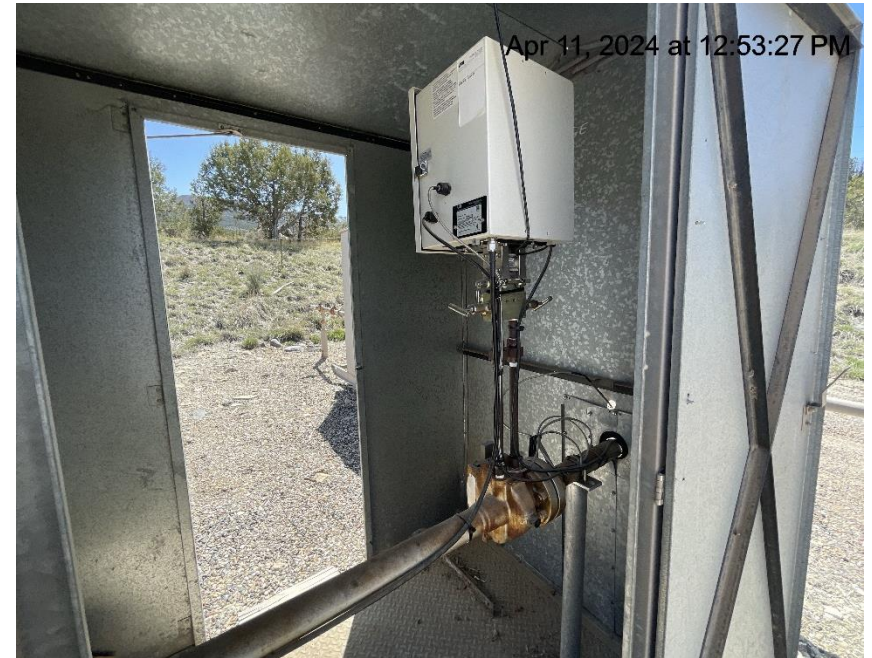
Photo # 3695 Gas meter calibration record for SAVAGE 11-35-6-94 W well not conspicuously displayed at meter

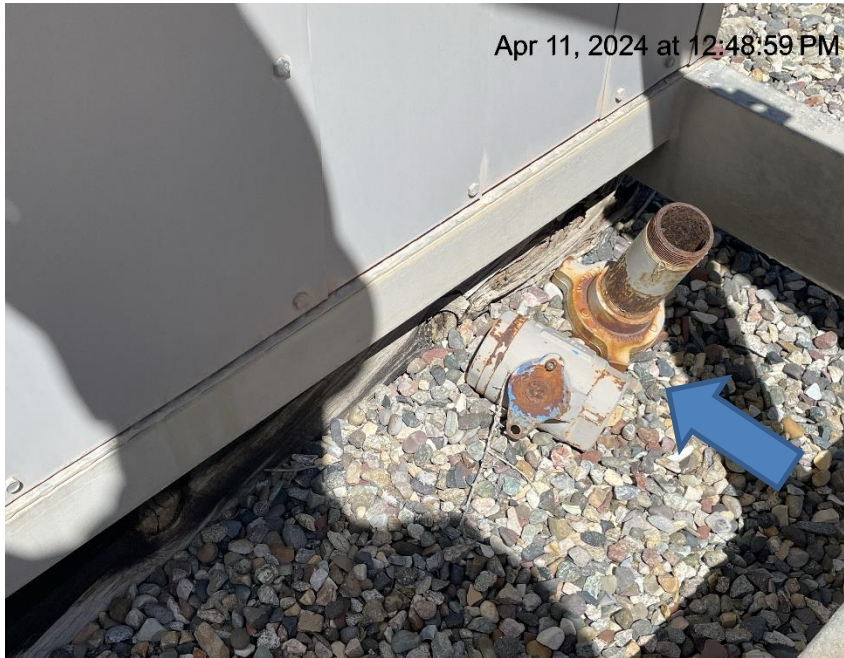
Photo # 3696 Debris

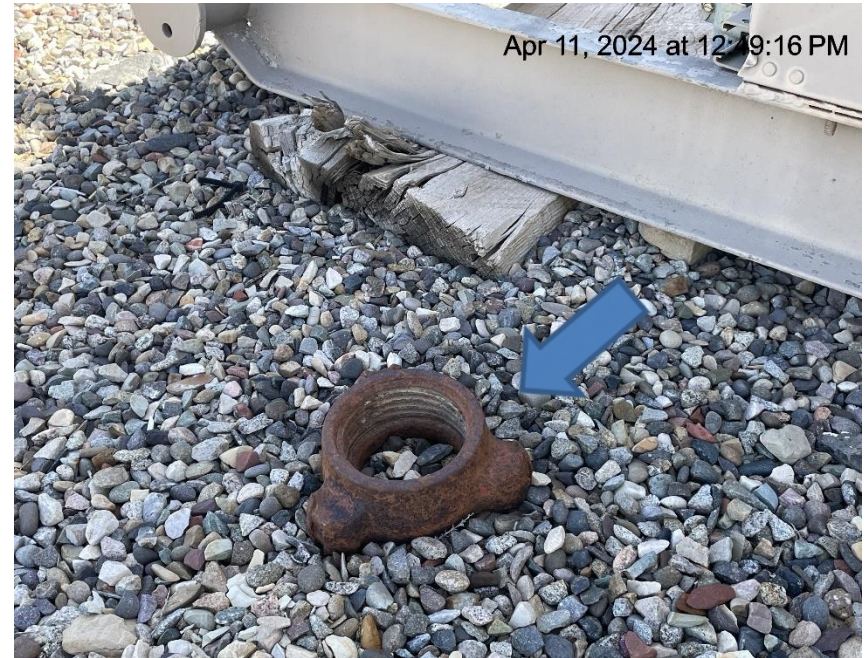
Photo # 3697 Debris
