# Inspection Photos

API: 061-05028

Operator: RENEGADE OIL & GAS COMPANY LLC

Inspection Date: 4/10/2024

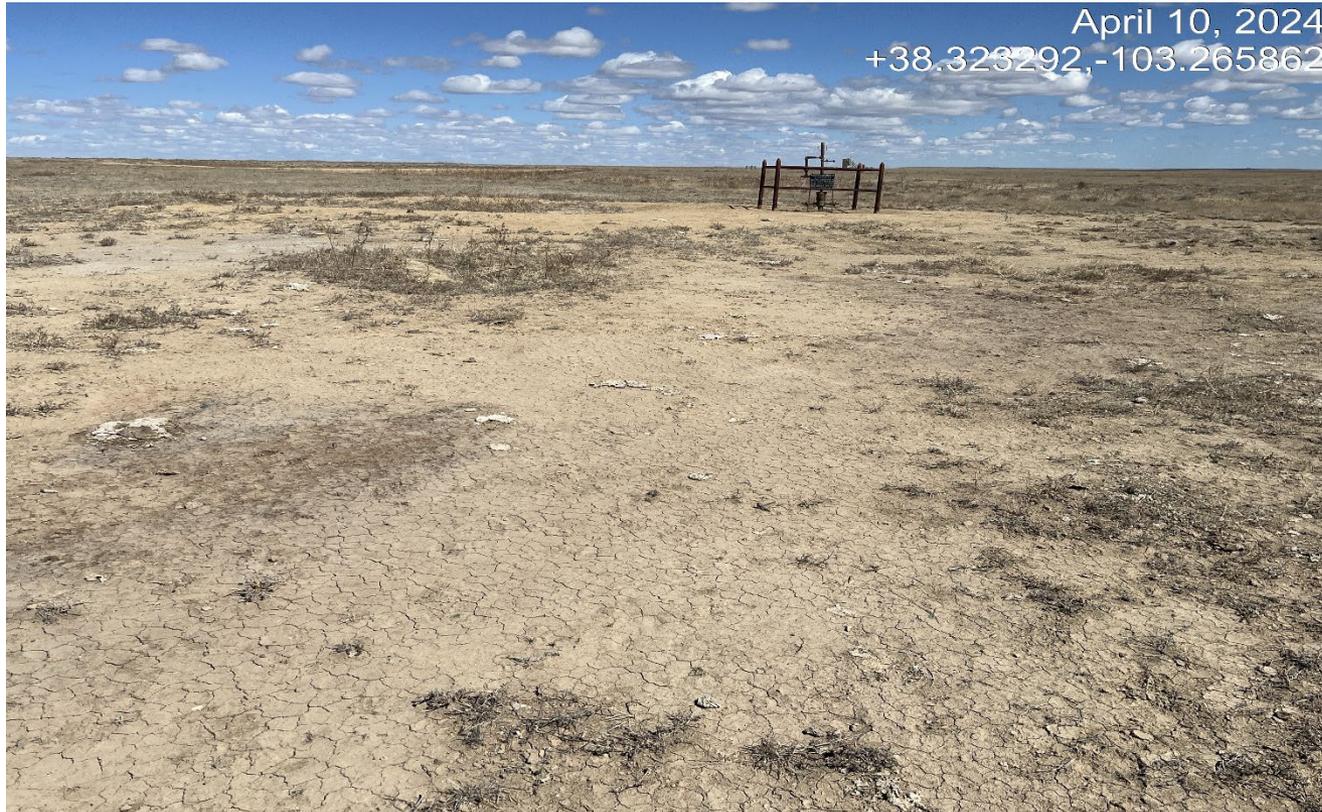
**Photo 1.** Facing north toward the wellsite. The area around the well has not revegetated. There is bare soils extending approximately 100 ft. out from the well that needs to be reclaimed.

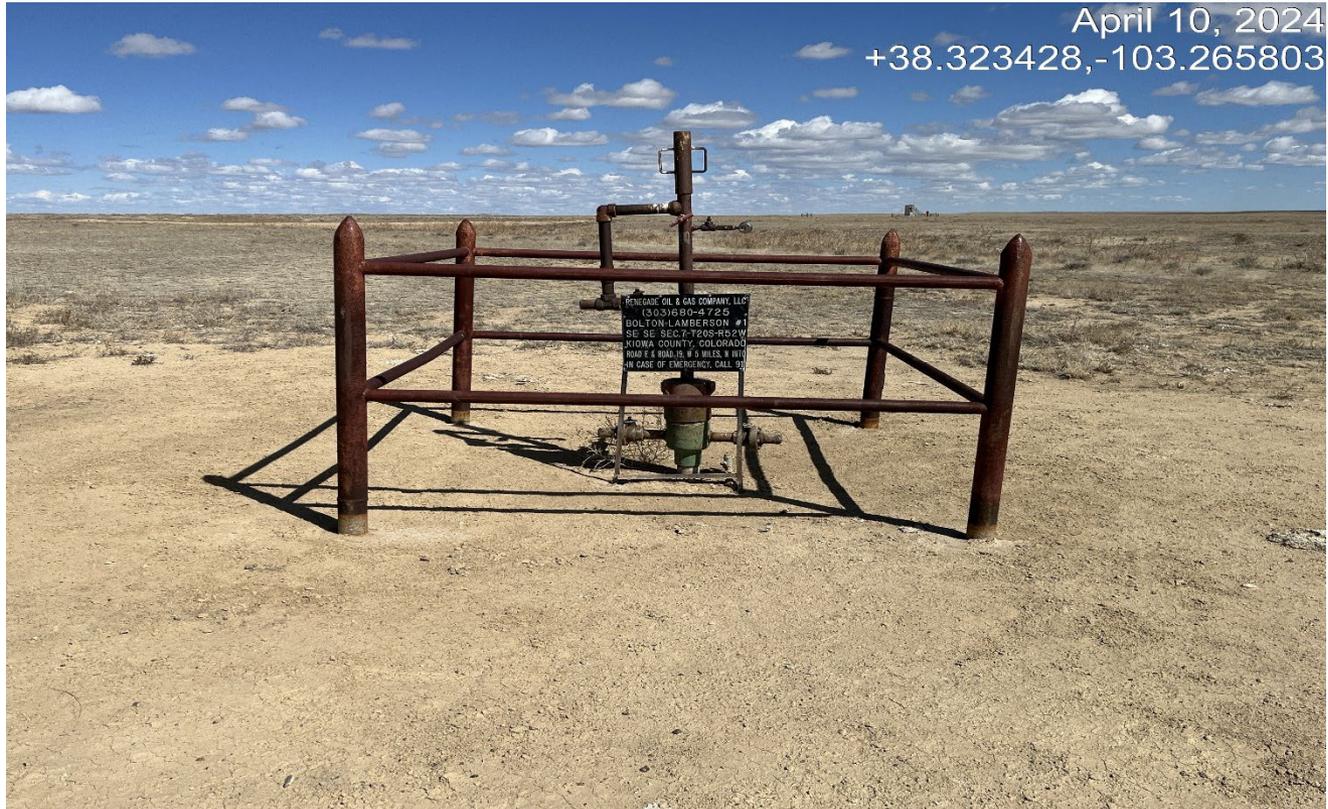
**Photo 2.** Facing toward the TA''d well.

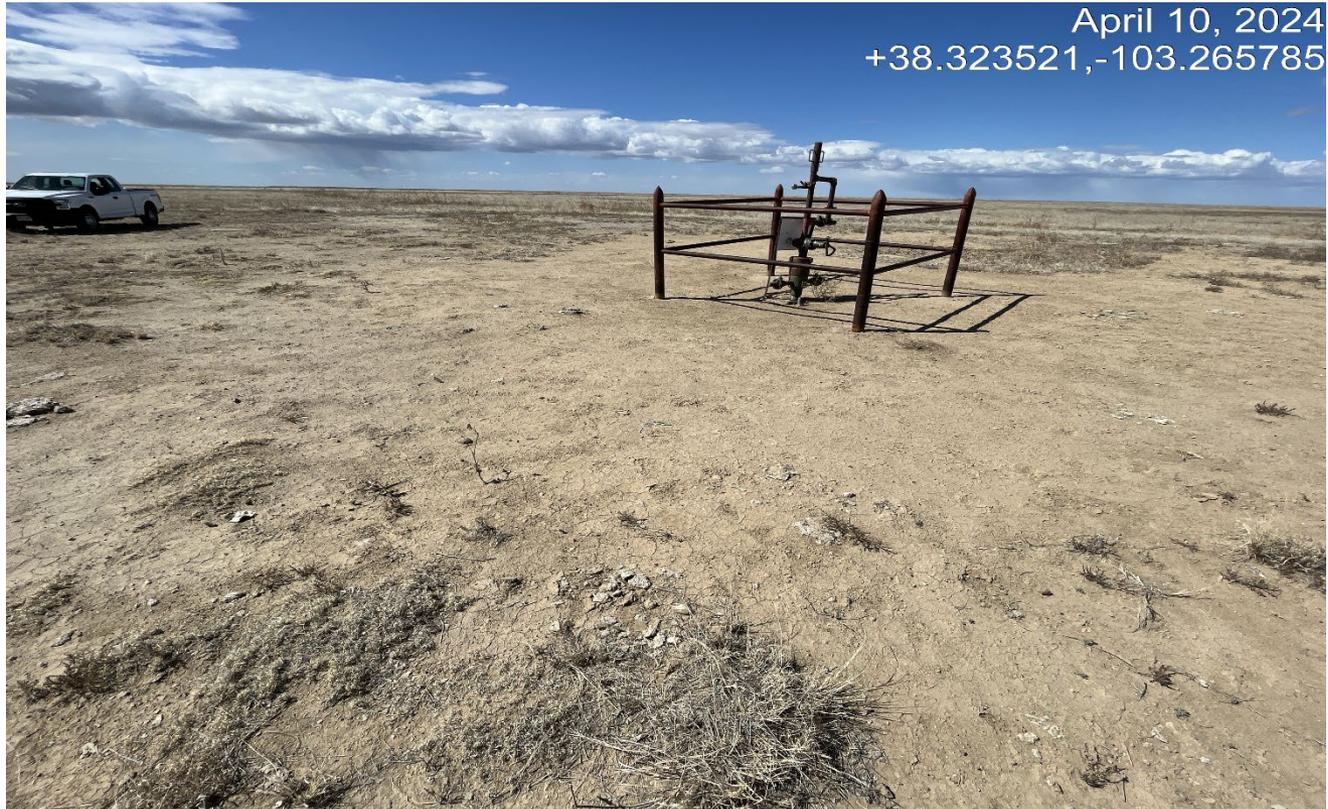
**Photo 3.** Facing southwest at the wellsite. There is bare soils extending approximately 100 ft. out from the well that needs to be reclaimed.
