Inspection Photos

API: 011-05055

Operator: RENEGADE OIL & GAS COMPANY LLC

Inspection Date: 4/10/2024

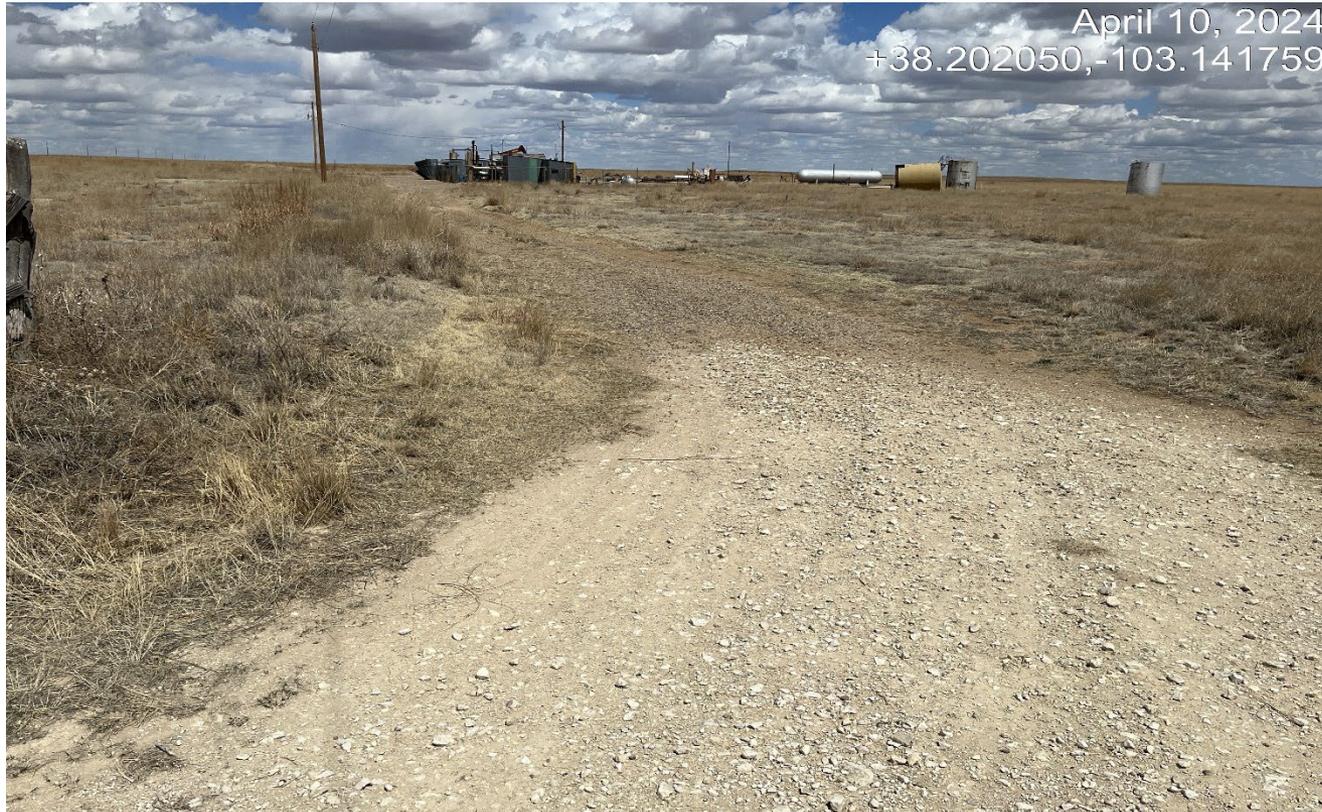
Photo 1. Facing northeast toward the GAS PROCESSING PLANT and Wellsite.

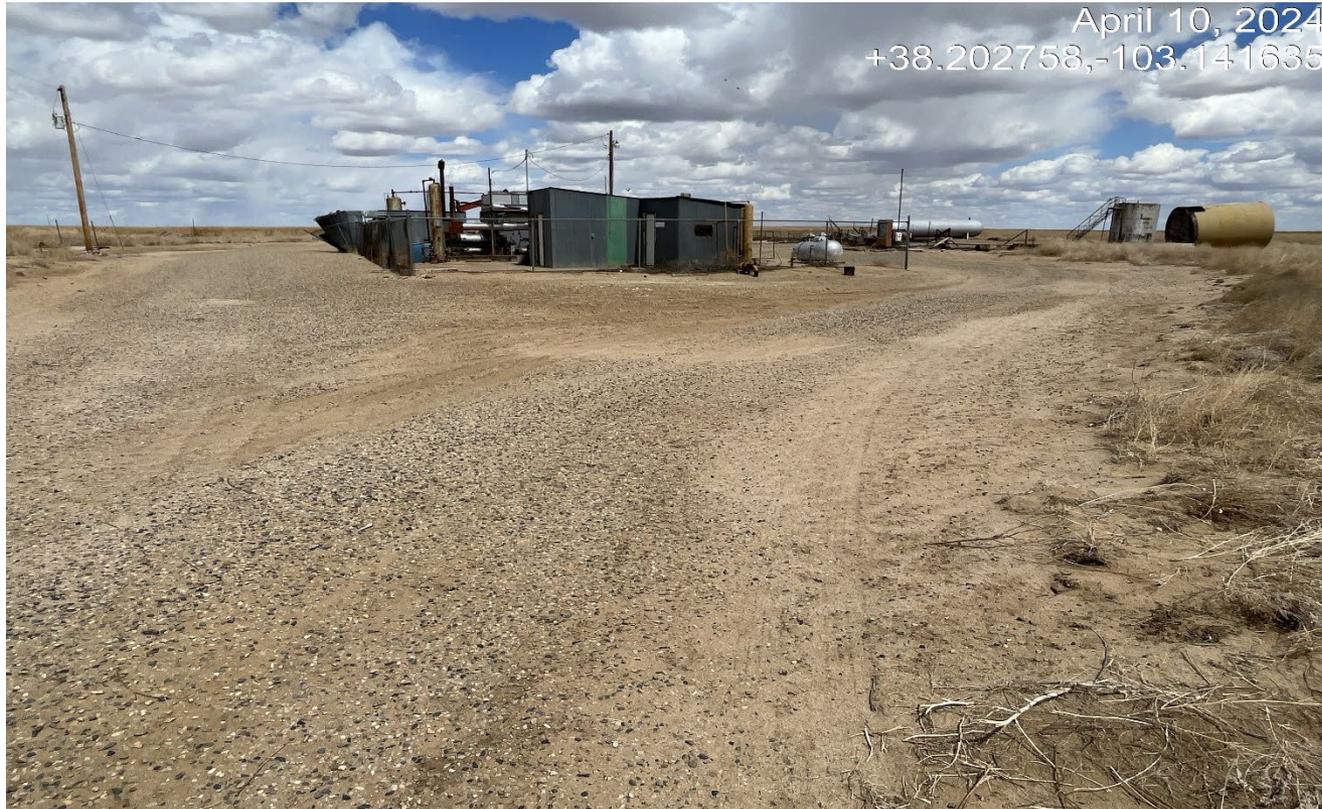
Photo 2. Facing northeast toward the GAS PROCESSING PLANT and Wellsite.

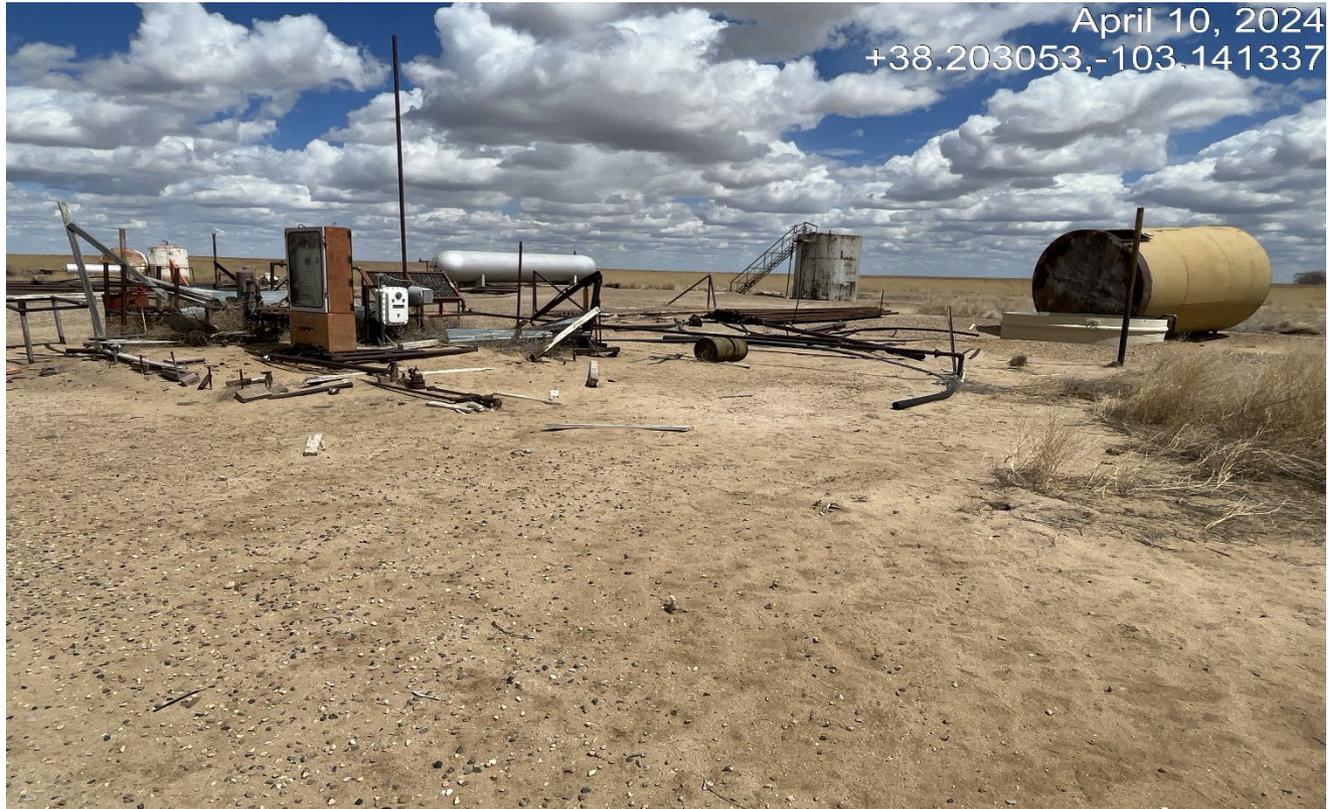
Photo 3. Facing northeast at the location. There is various unused equipment, supplies and tanks stored at the location that will need to be removed.

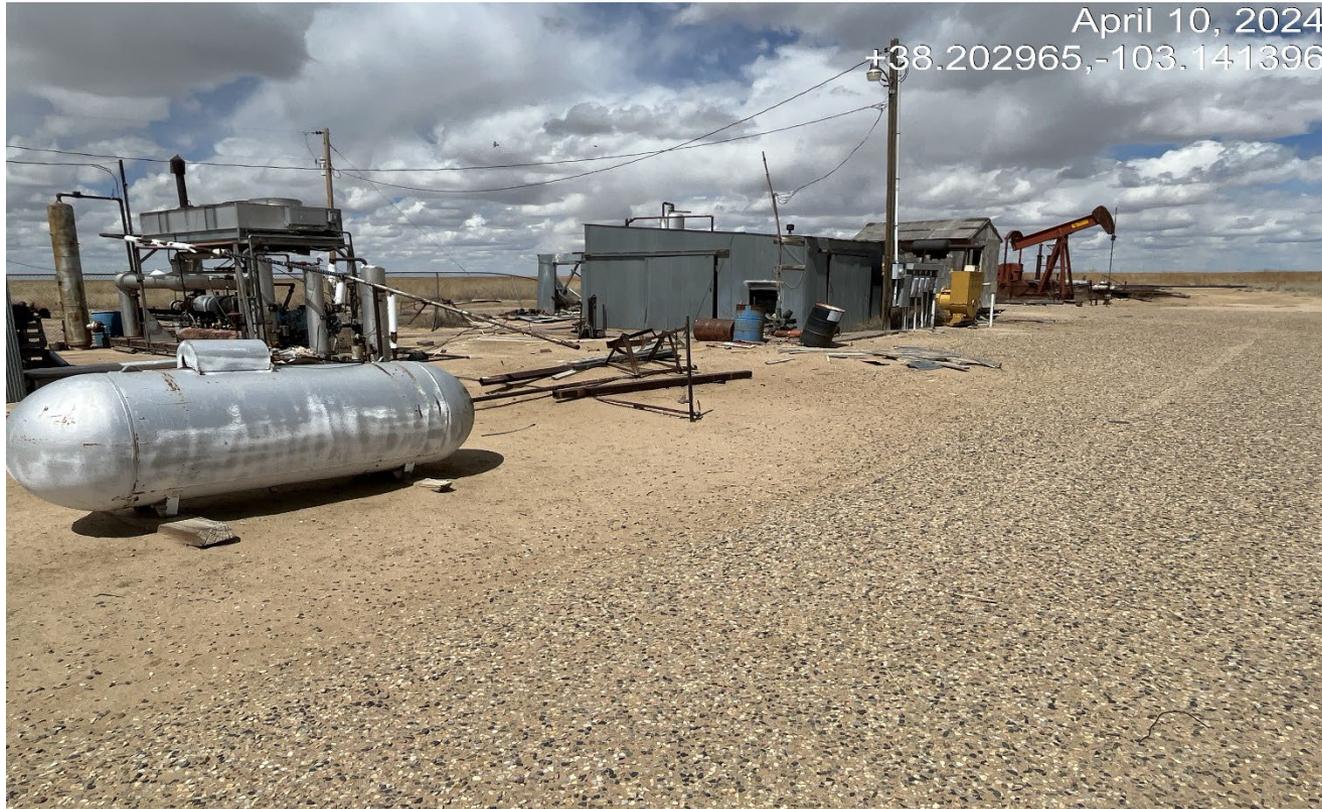
Photo 4. Facing northwest toward the GAS PROCESSING PLANT and Wellsite.

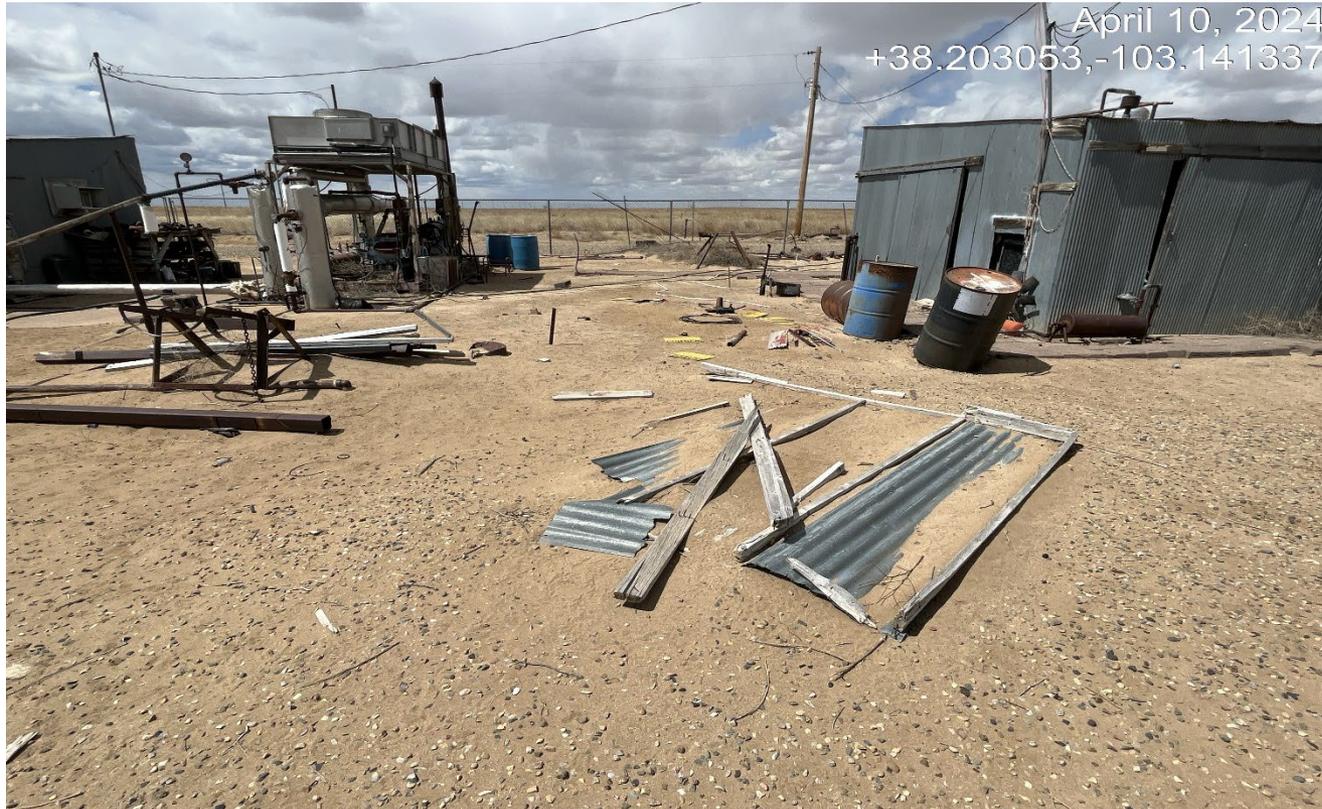
Photo 5. Facing west at the sheds and various equipment which are in disrepair. There is chemical barrels with no containment and various debris laying on the ground.

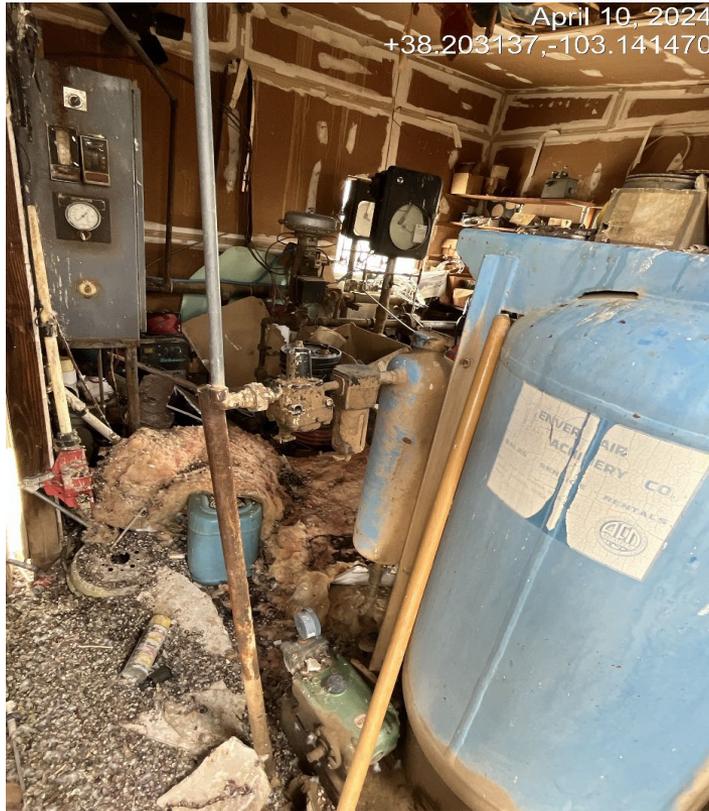
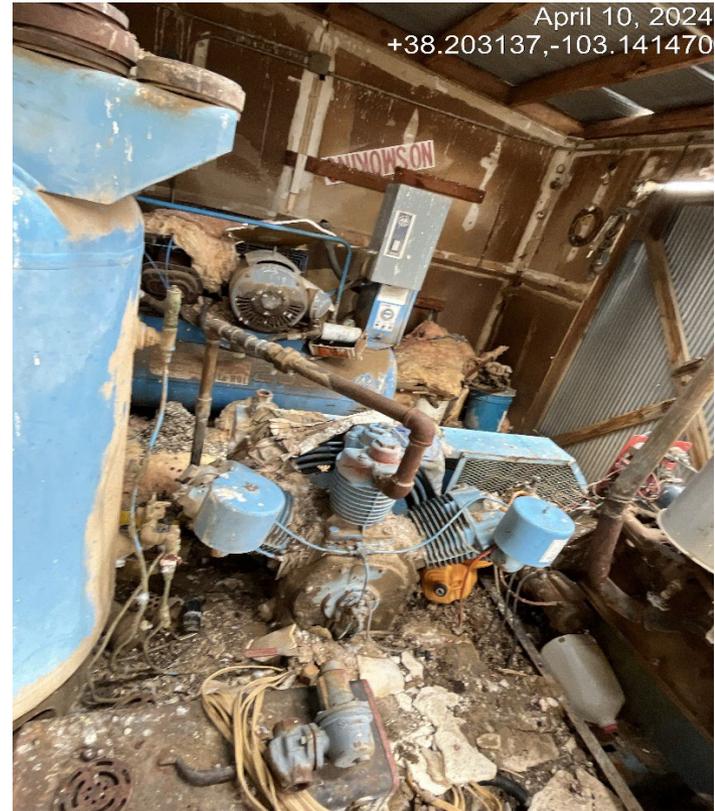
Photo 6&7. View of inside the shed shows debris and unmaintained equipment and supplies which is a fire hazard.

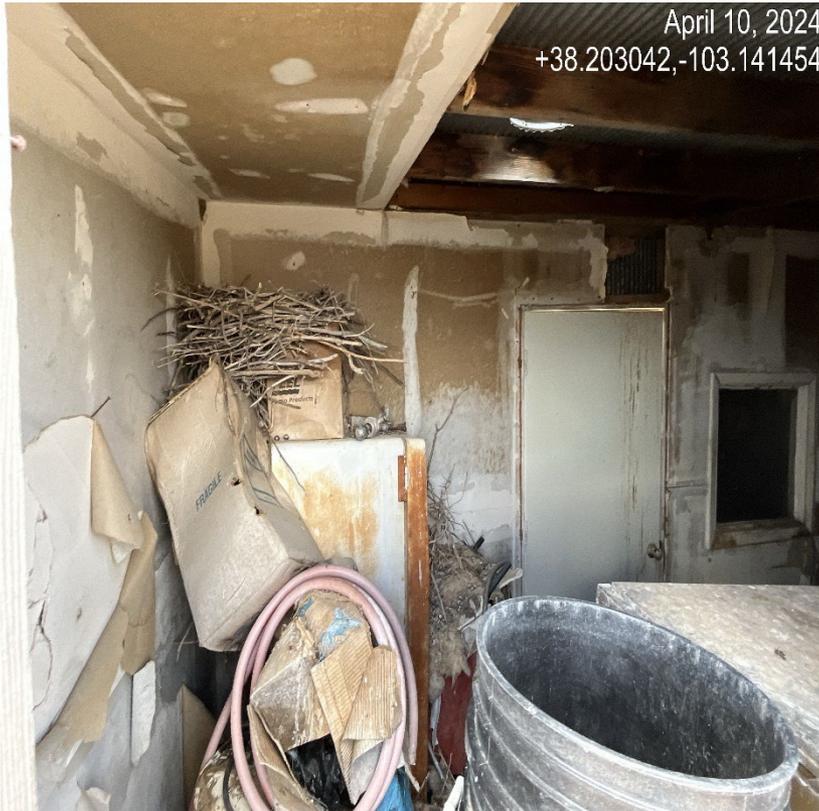
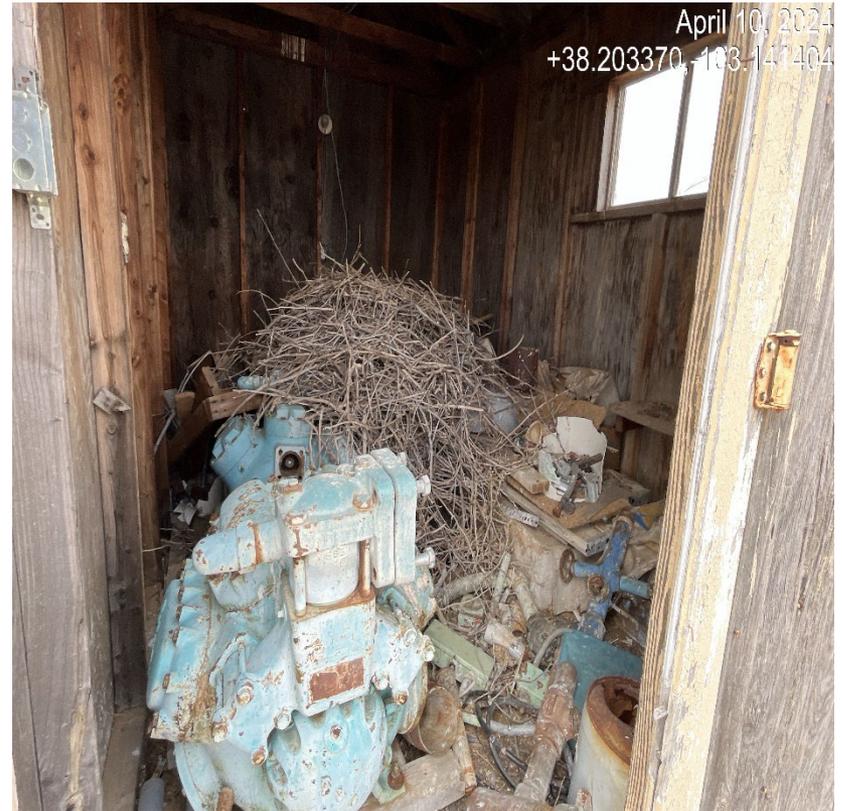
Photo 8&9. There are other sheds with large bird nests. Operator will need to consult with USFS and CPW regarding time restrictions and relocation.

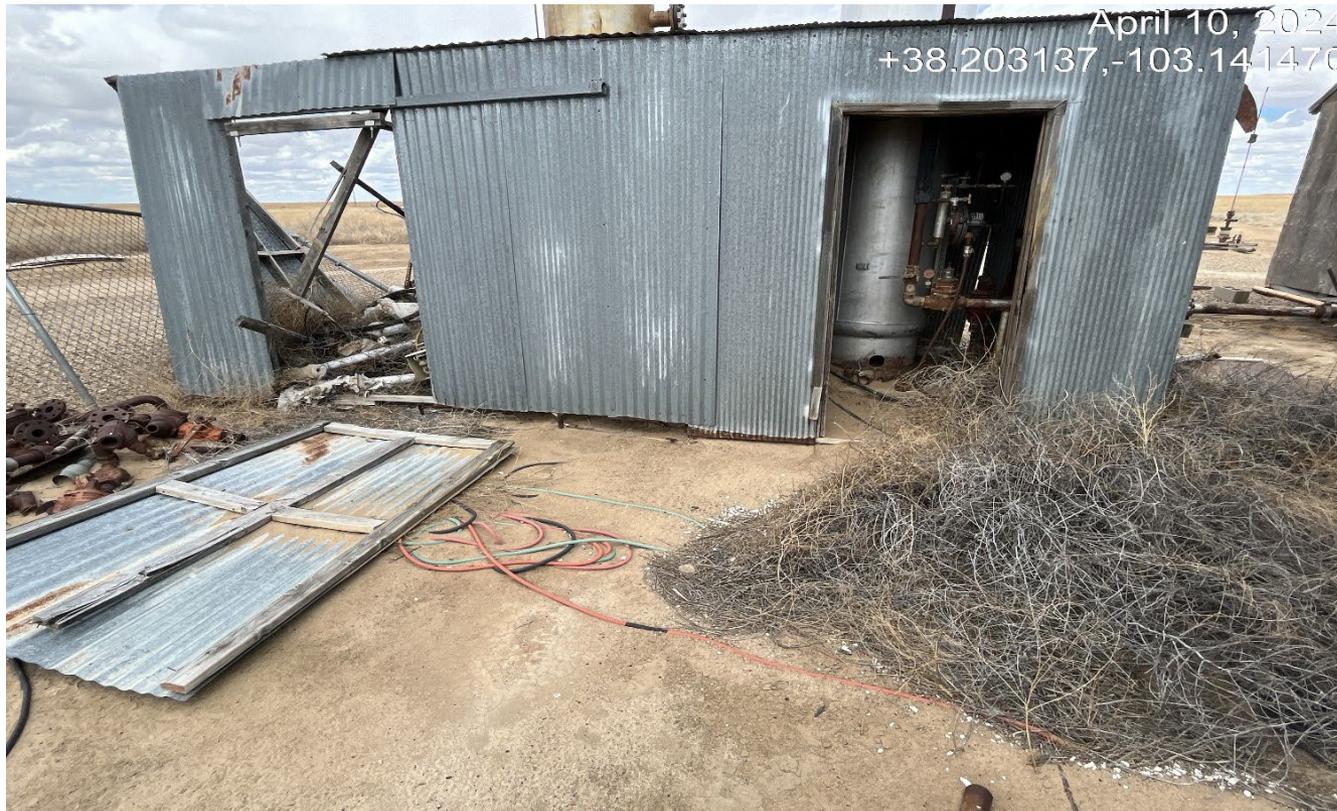
Photo 10. Facing northwest at the sheds and equipment which are in disrepair..

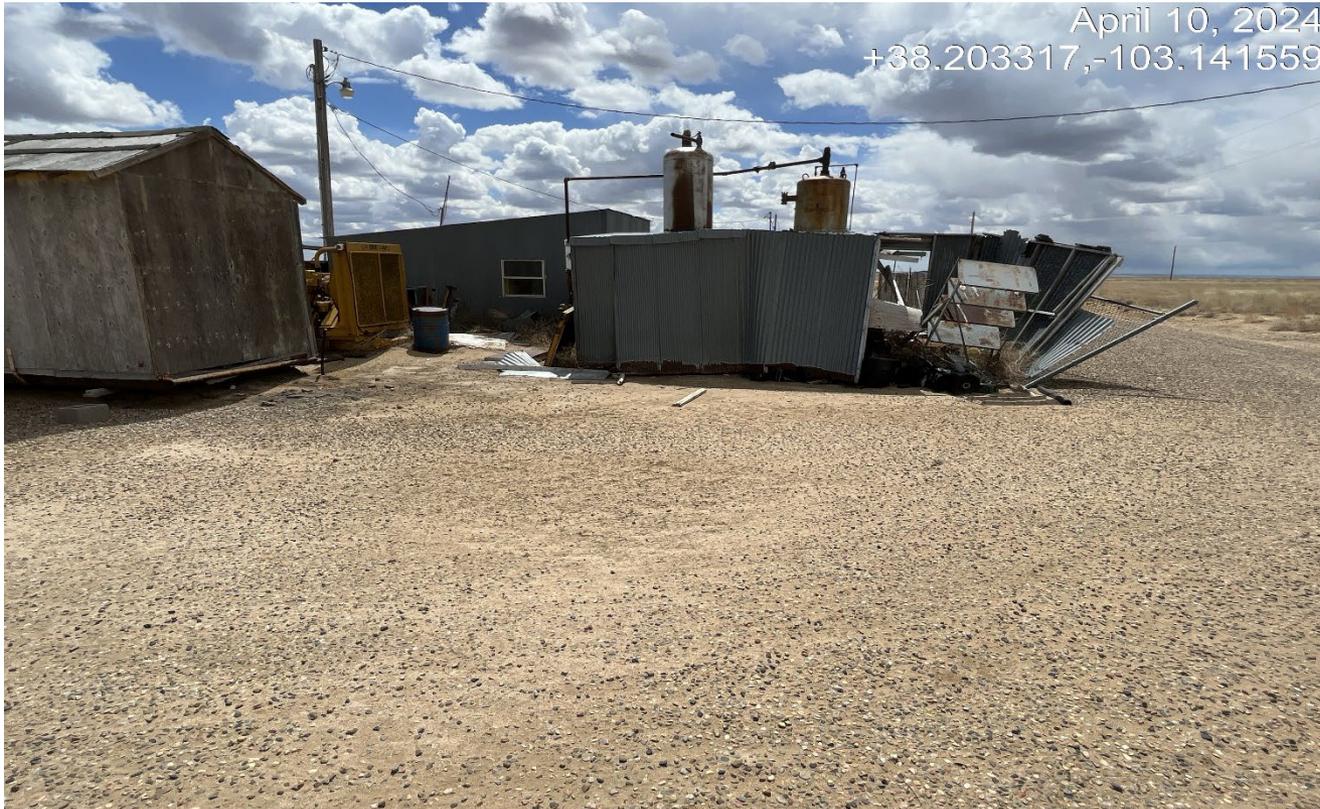
Photo 11. Facing southeast at the west side of the location. This shed and fence are in disrepair with various unused unneeded supplies.

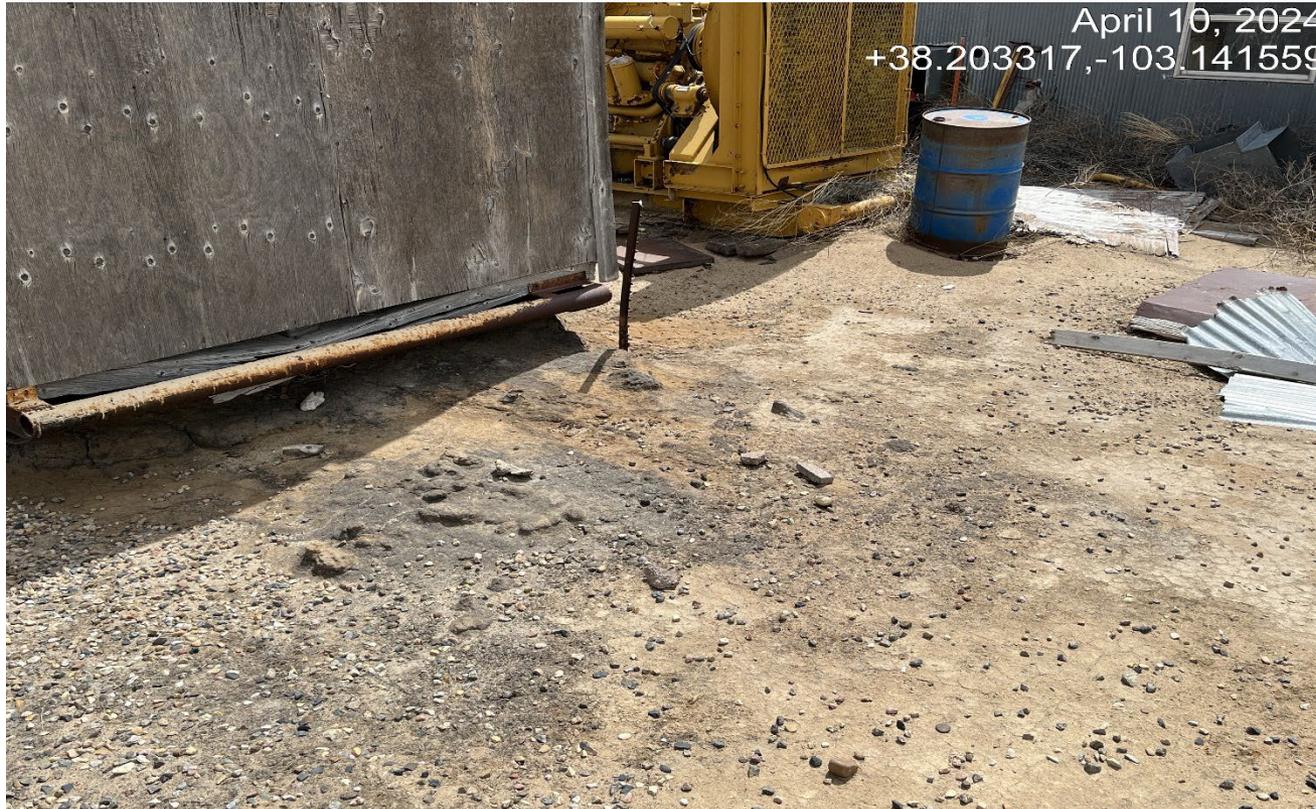
Photo 12. There are stained soils near this shed and engine compressor. There is chemical barrels with no containment and various debris laying on the ground.

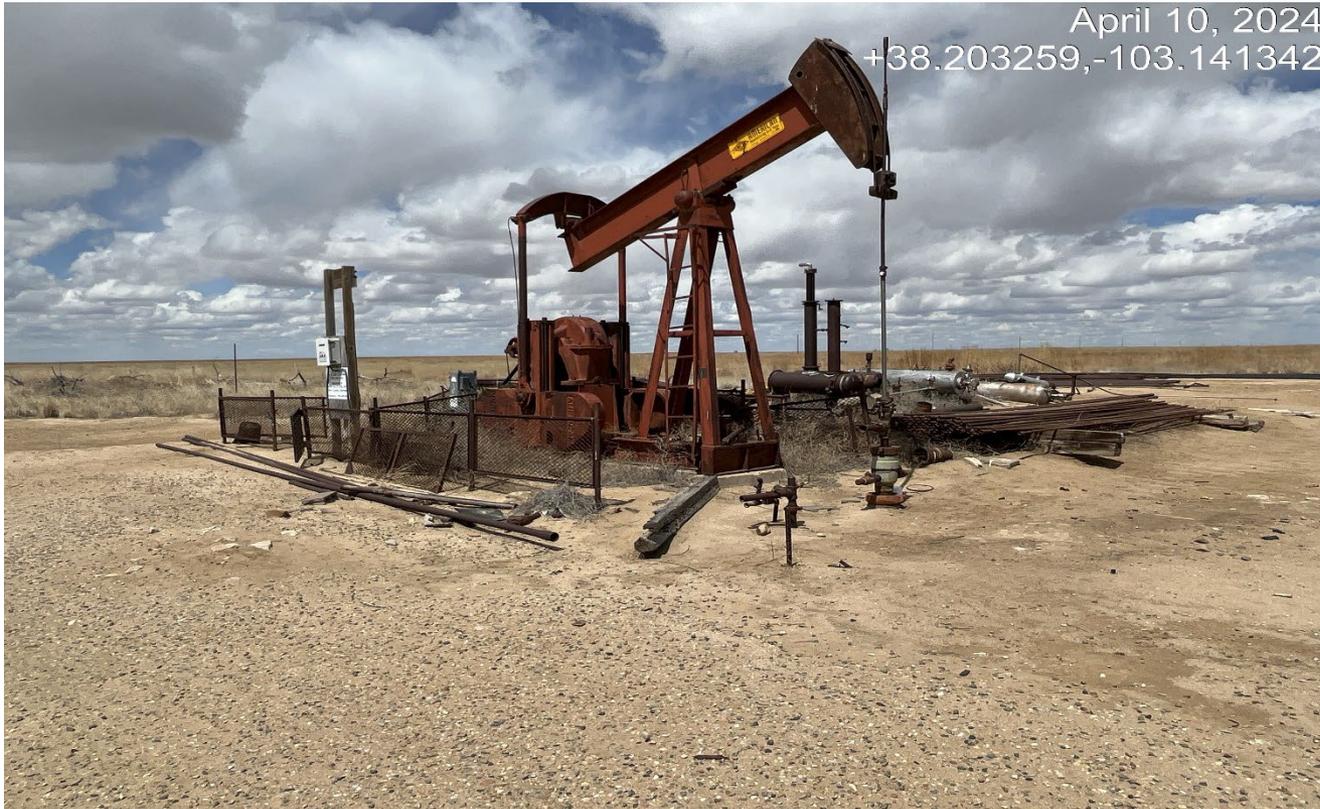
Photo 13. Facing northeast toward the well. The fence around the pumpjack is in disrepair and there is unused equipment stored near the well.

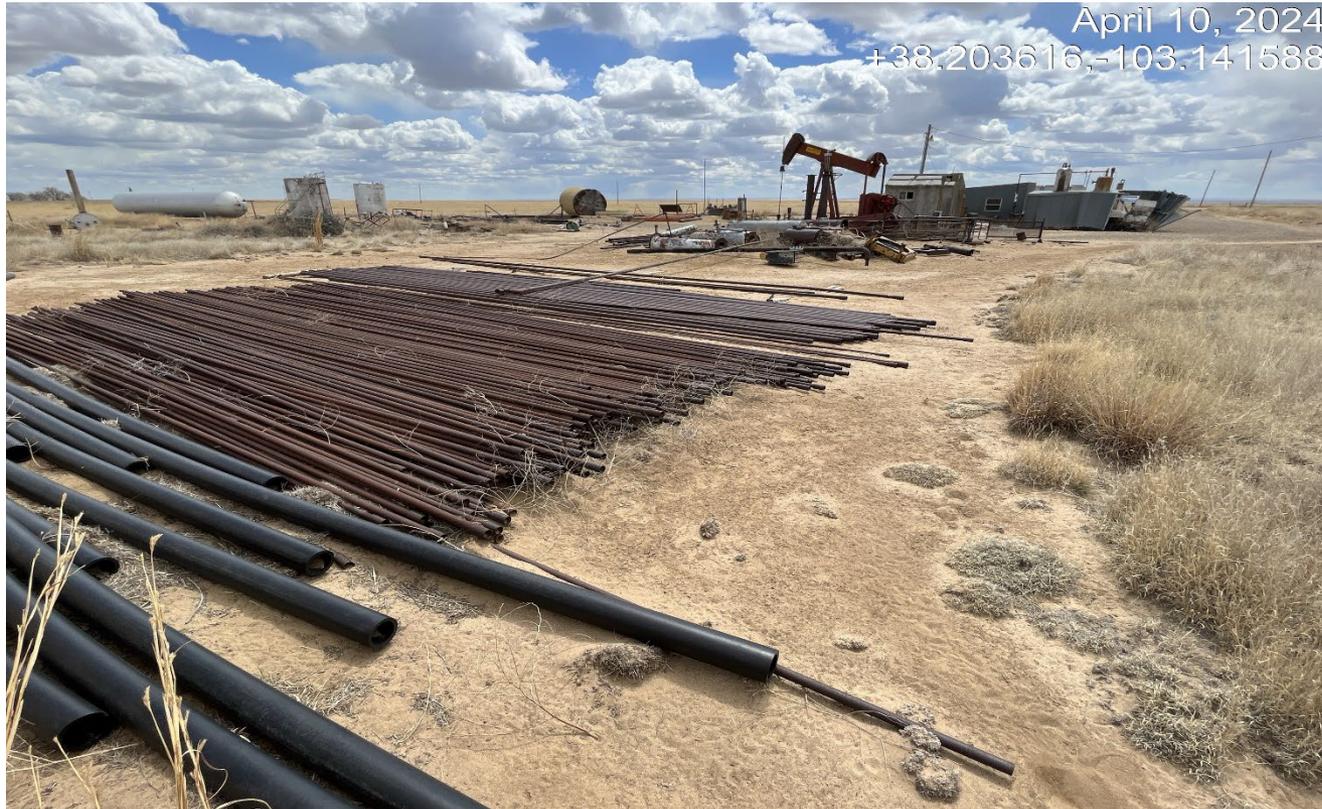
Photo 14. North side of the location facing southeast. There is unused pipe stored on location that needs to be removed.

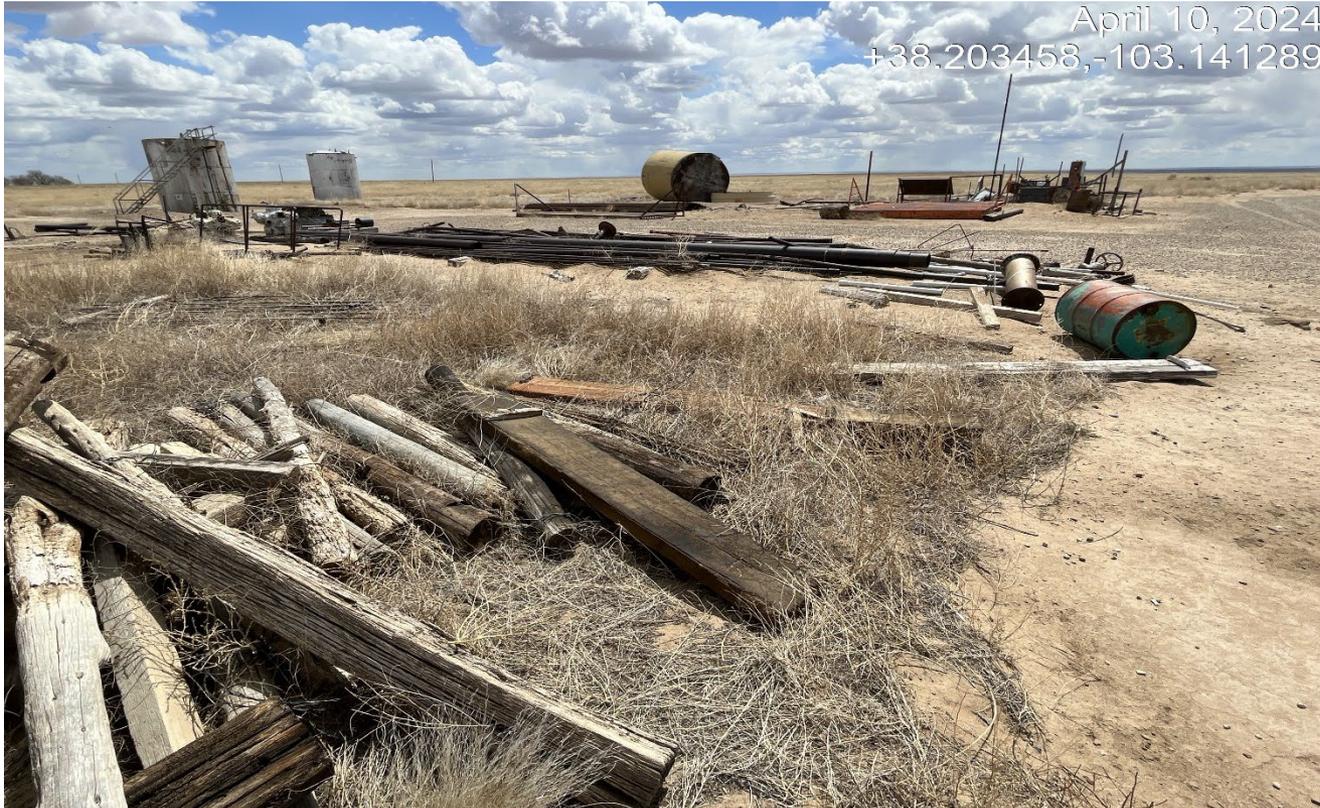
Photo 15. North side of the location facing southeast. There is unused equipment and supplies stored on location that needs to be removed.

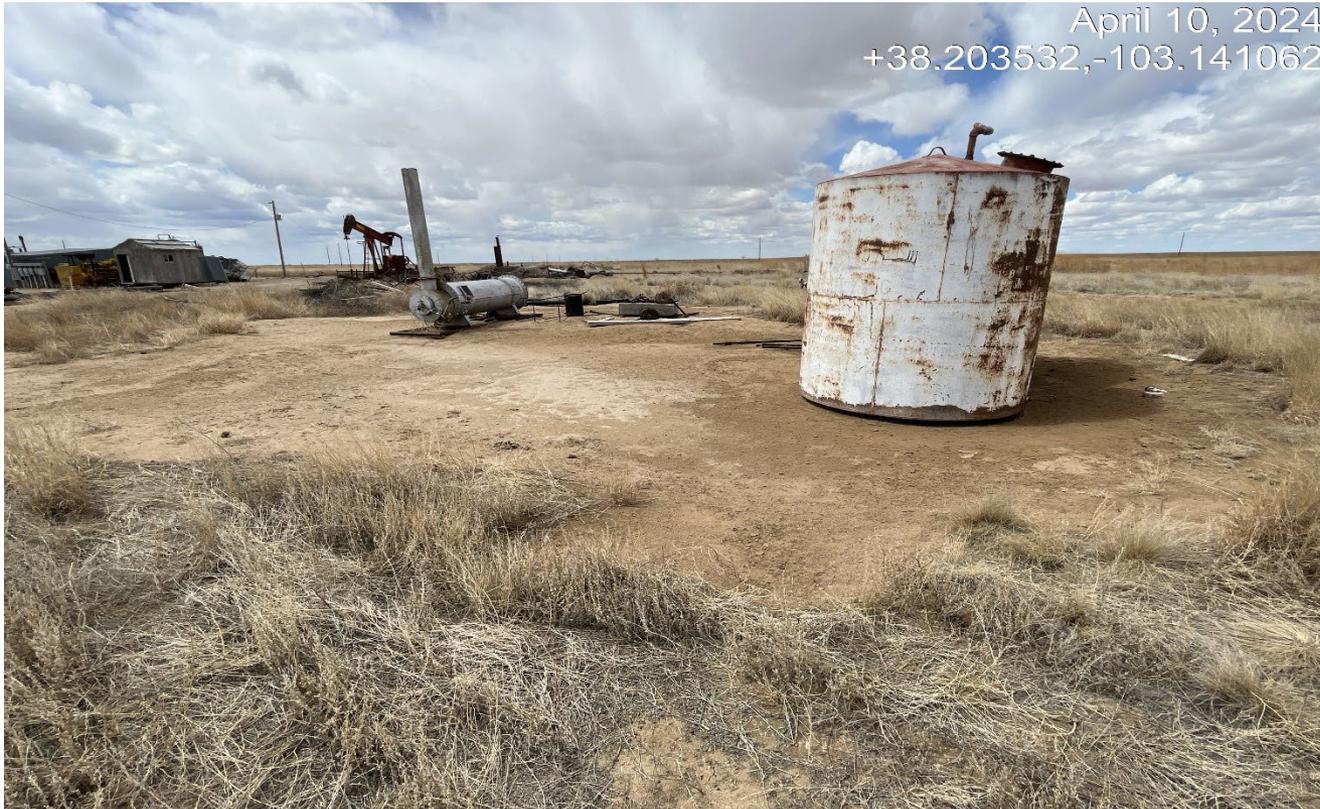
Photo 16. Northeast side of the location facing west. There is an unused tank stored on location which is impacting vegetation 9in this area.

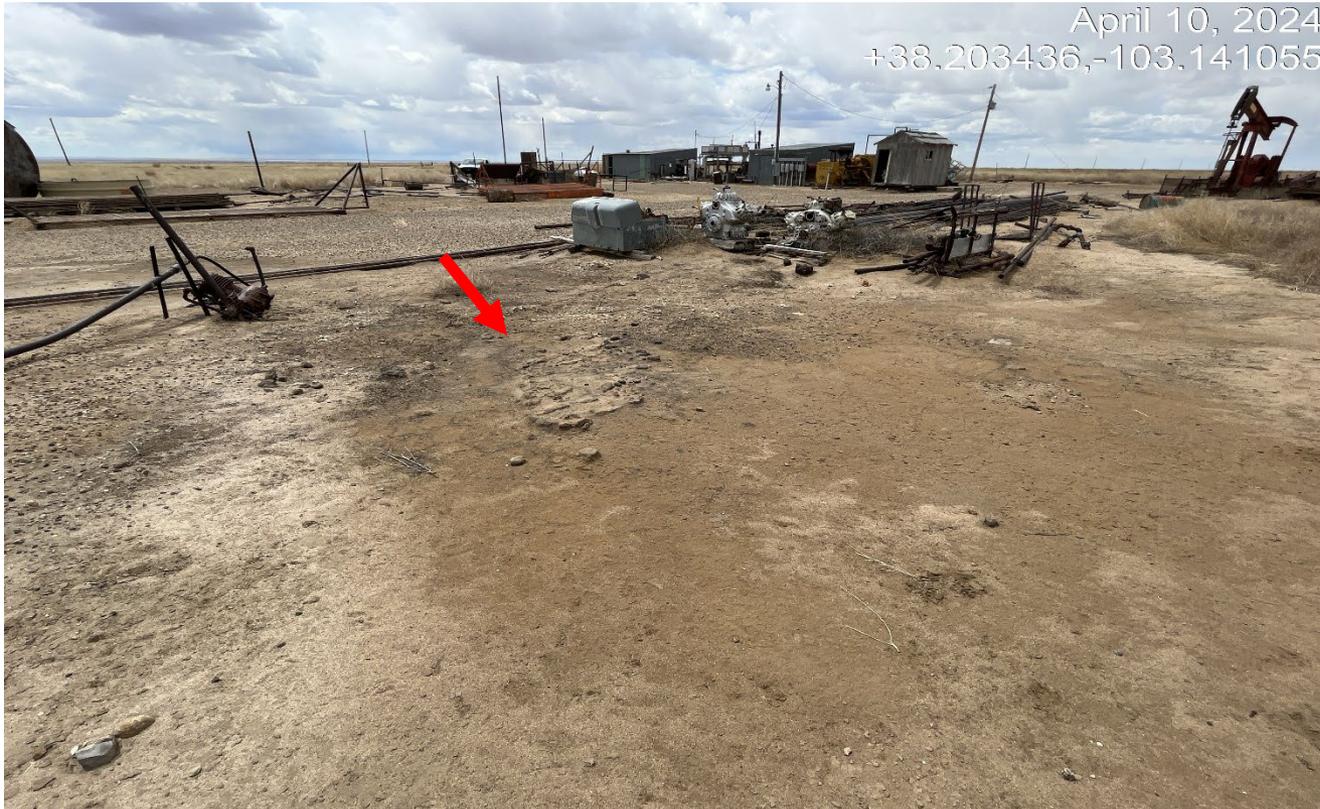
Photo 17. Facing southwest at the location. There appears to be impacted stained soil shown at red arrow.

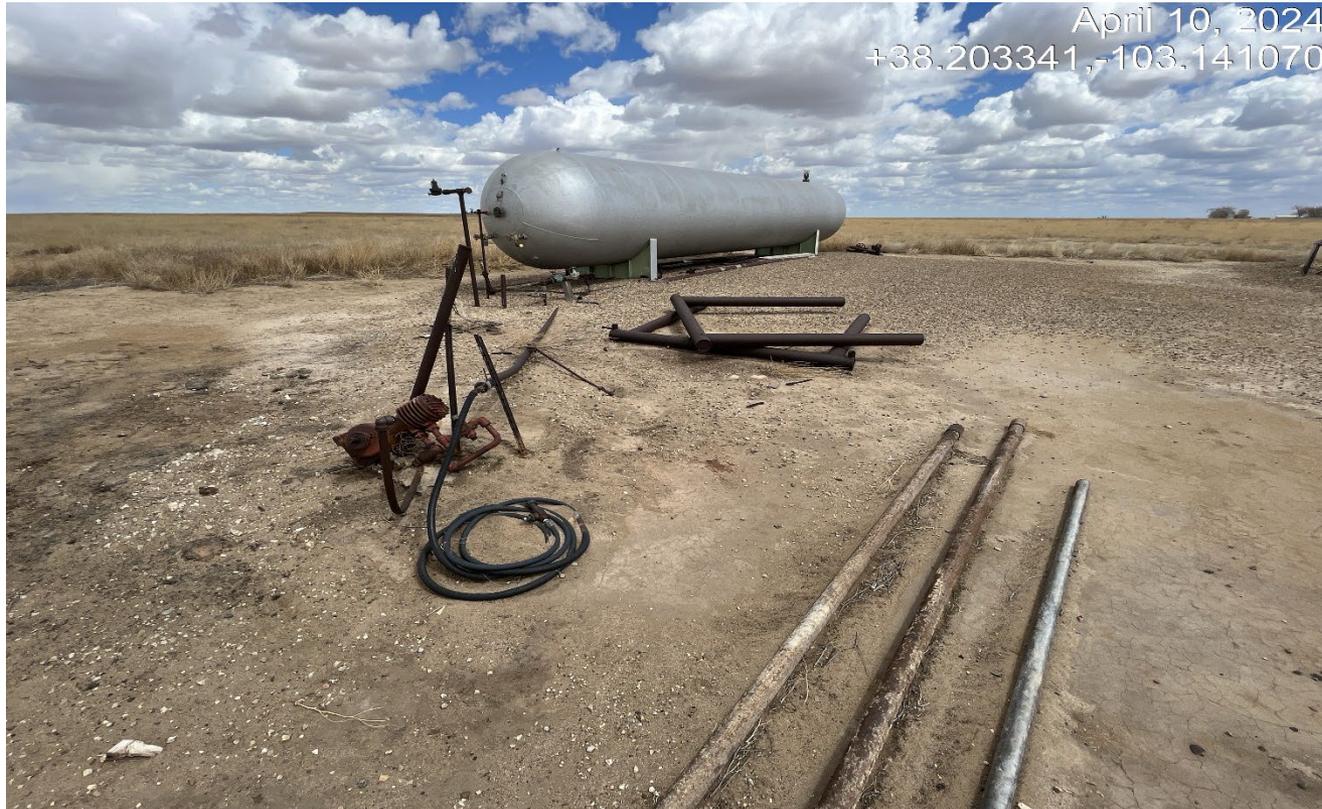
Photo 18. Facing toward the west side of the location There is a large volume tank with no labeling and appear to be unused.

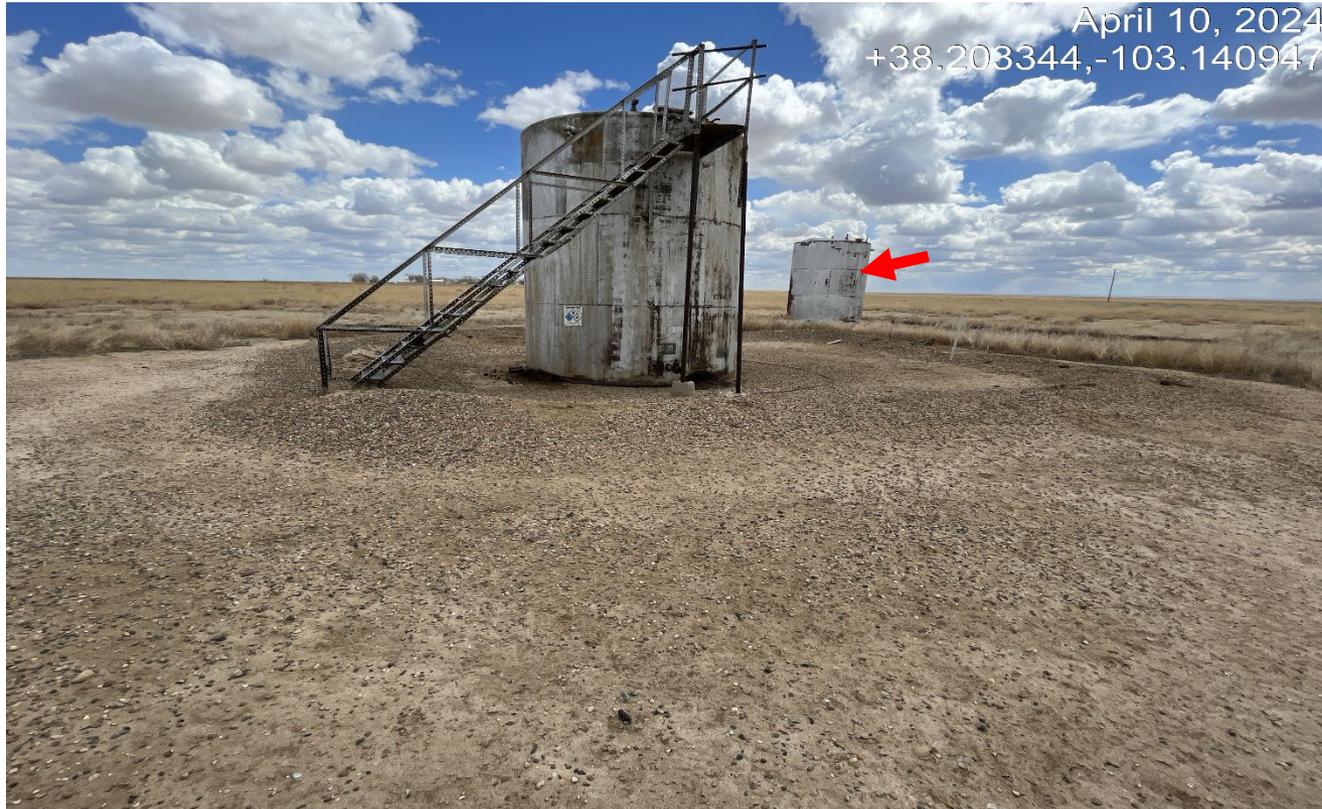
Photo 19. Facing toward the east side of the location. There is an tank with berm installed around the tank. The tank at red arrow is unused equipment.

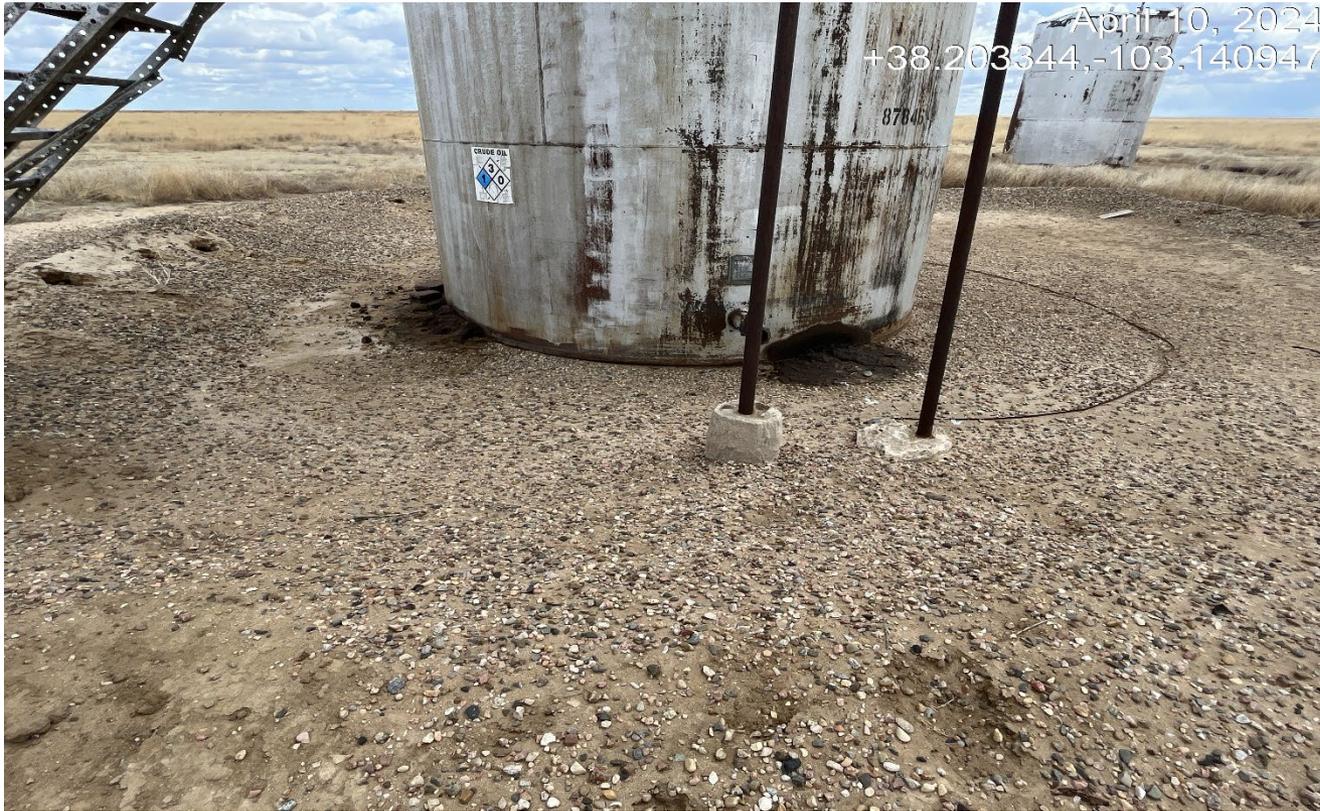
Photo 20. There is oily sludge at the base of the tank that needs to be cleaned up and properly disposed.

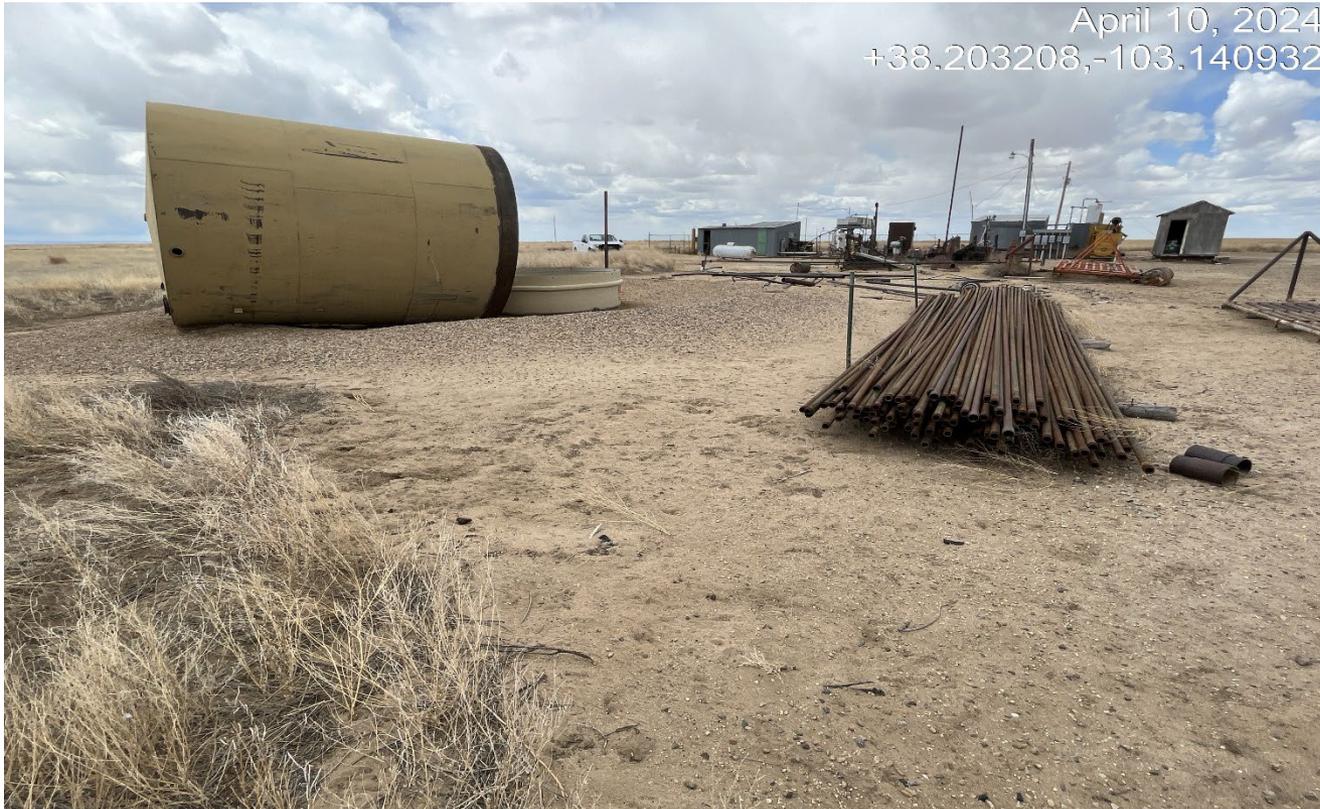
Photo 21. East side of the location facing southwest. There is unused pipe stored on location and a tank that is tipped over.
